NATIONAL AERONAUTICS AND SPACE ADMINISTRATION

APOLLO 13 MISSION REPORT

SEPTEMBER 1970

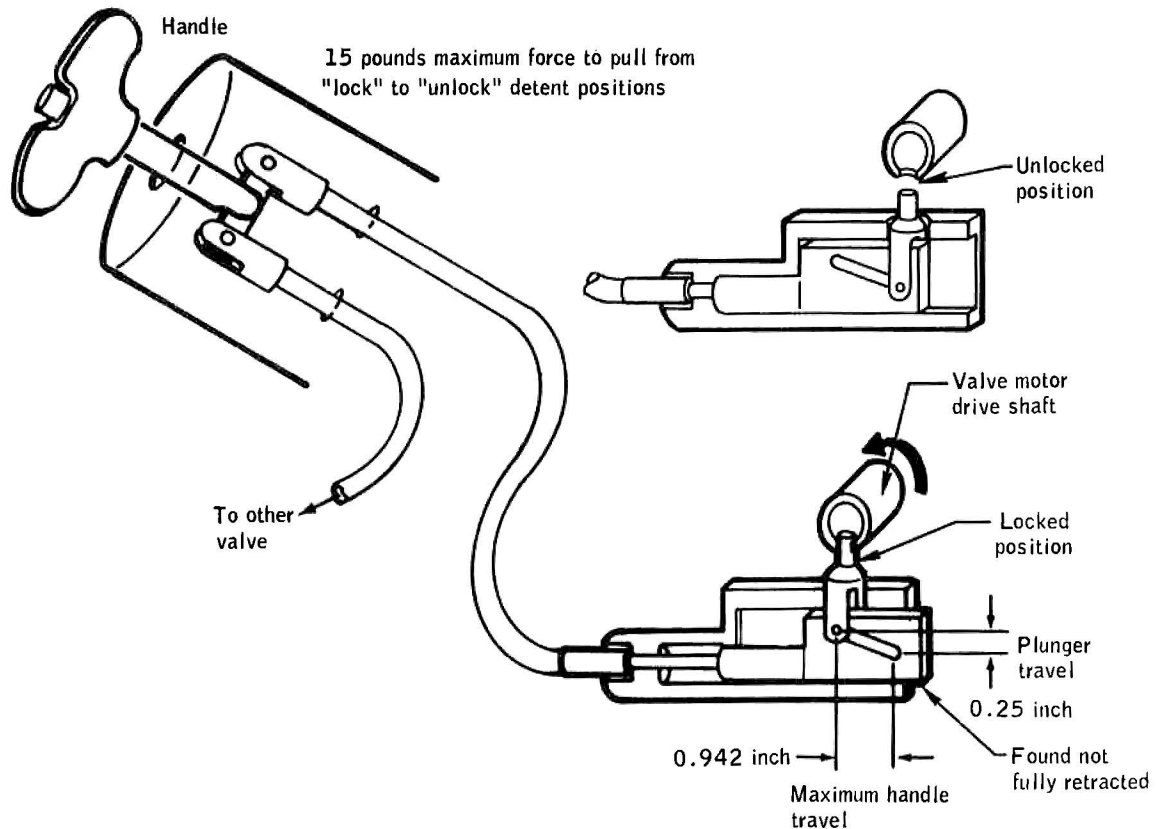
Figure 14-1.- Post-landing vent valve lock.

The valve-lock mechanism rigging tolerances were found to be within specifications. When reassembled in the spacecraft, the malfunction was duplicated with only partial travel of the handle.

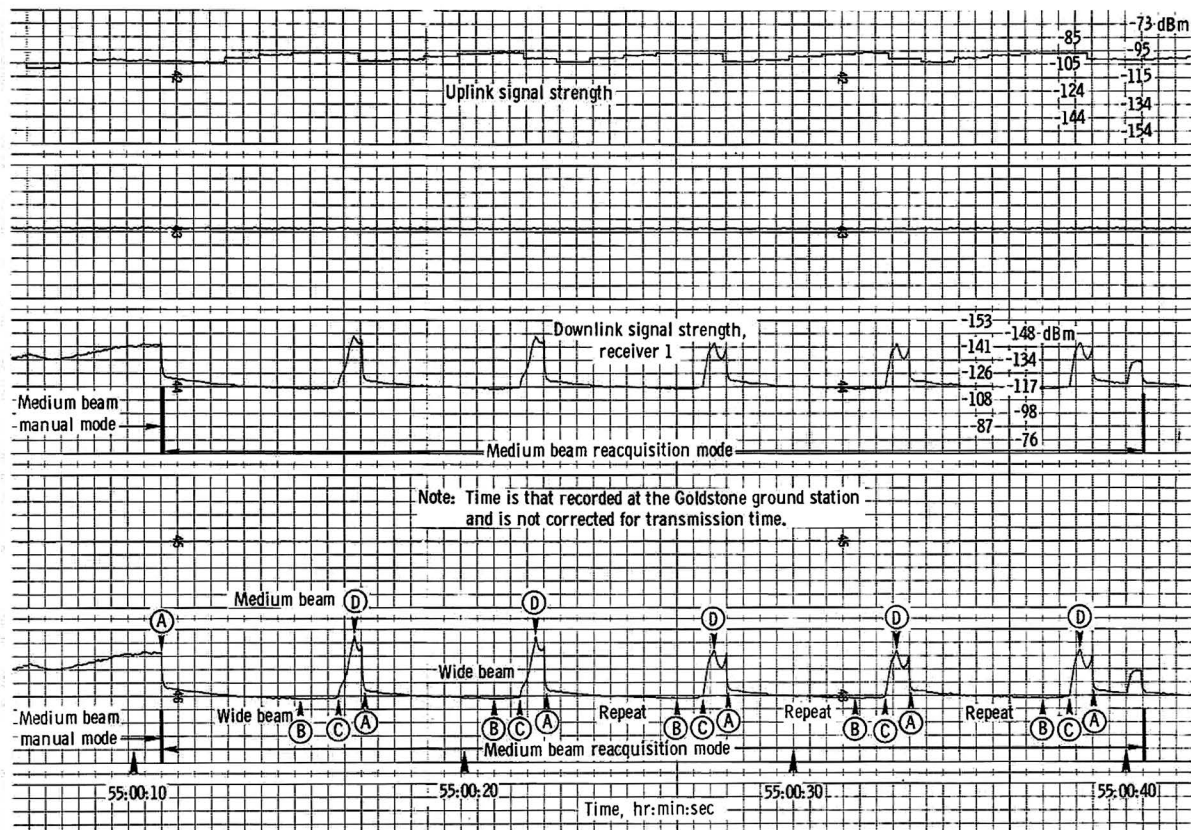
Figure 14-6.- Recorded signal strengths during high-gain antenna operation.

results of this test shifted the scan-limit functions but did not produce the necessary change in the scan-limit slope. Consequently, a failure in the electronic box is ruled out.

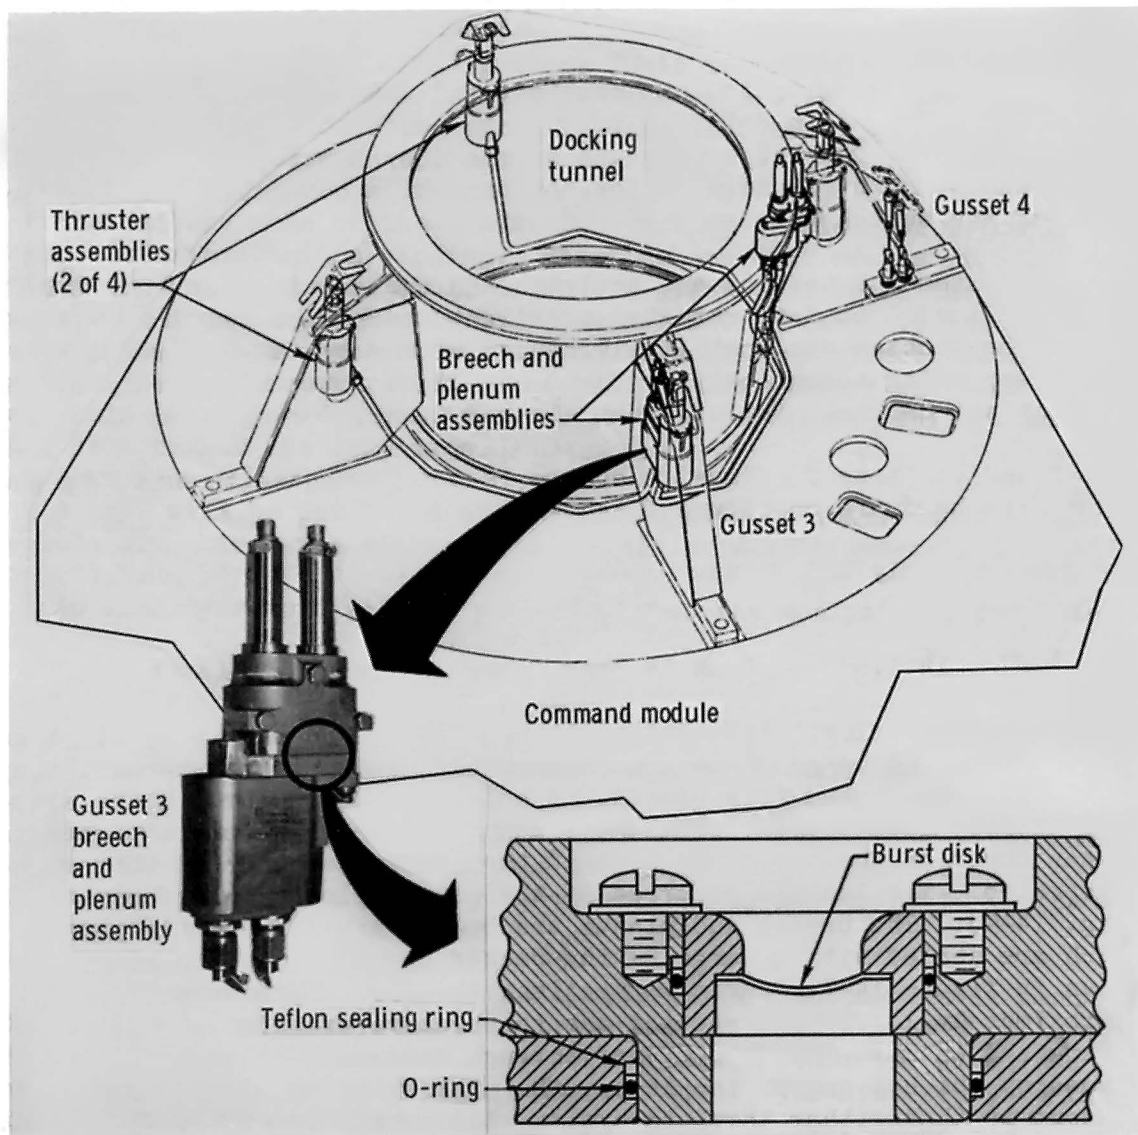
Figure 14-7.- Apex cover jettison system.

- a. Out of tolerance parts - Measurement of the failed parts indicate acceptable dimensions of the metal parts.
- b. Damaged O-rings - The 21 000-psi static proof-pressure test was successful.
- c. Gap in backup ring - The installation procedure specifies the backup ring may be trimmed on assembly to meet installation requirements,

but does not specify any dimensional control over the scarf joint. Since the gap portion was burned away, a gap in the backup ring could have caused the problem.

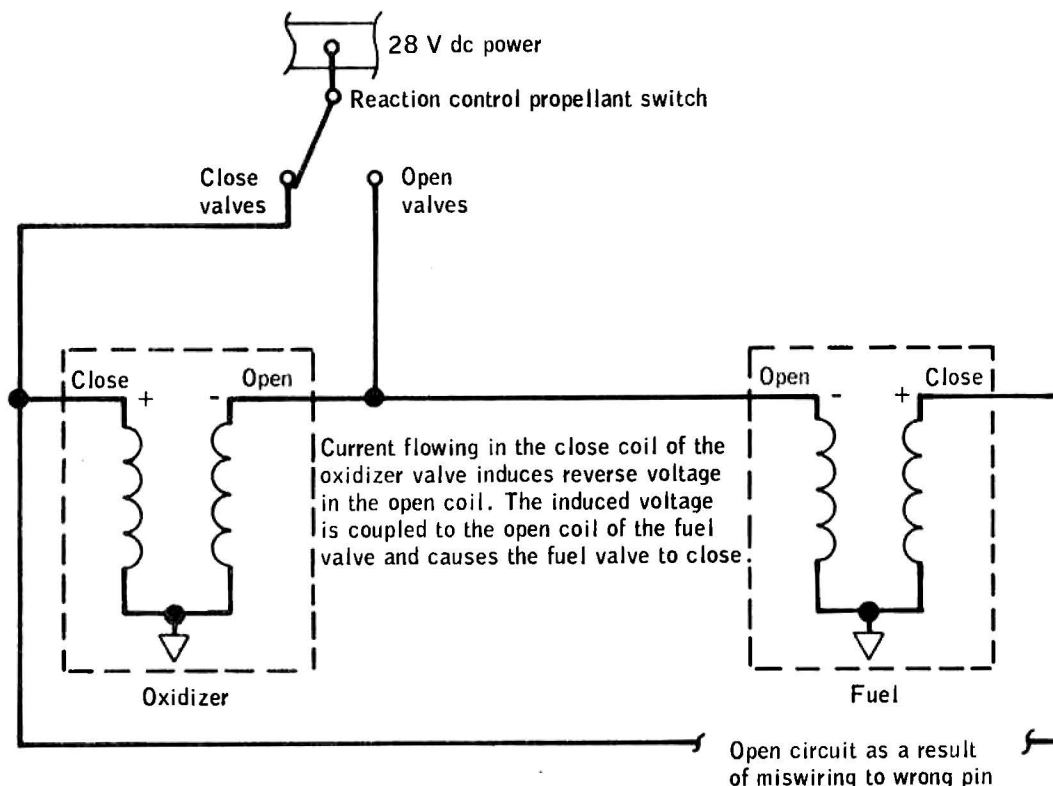
Figure 14-11.- Isolation valve circuit.

action. This voltage is applied to the fuel valve opening coil where it induces a magnetic field flux that closes the fuel valve. With 28 volts or more on the spacecraft bus, this phenomenon was consistently repeatable. With 24 to 28 volts on the bus, the valve would occasionally close, and with less than 24 volts, the valve would not close. Since preflight testing is accomplished at 28 volts, the functional tests did not disclose the miswiring. During the mission, the voltage was such that the valve did not close when commanded and therefore was found open after the flight.

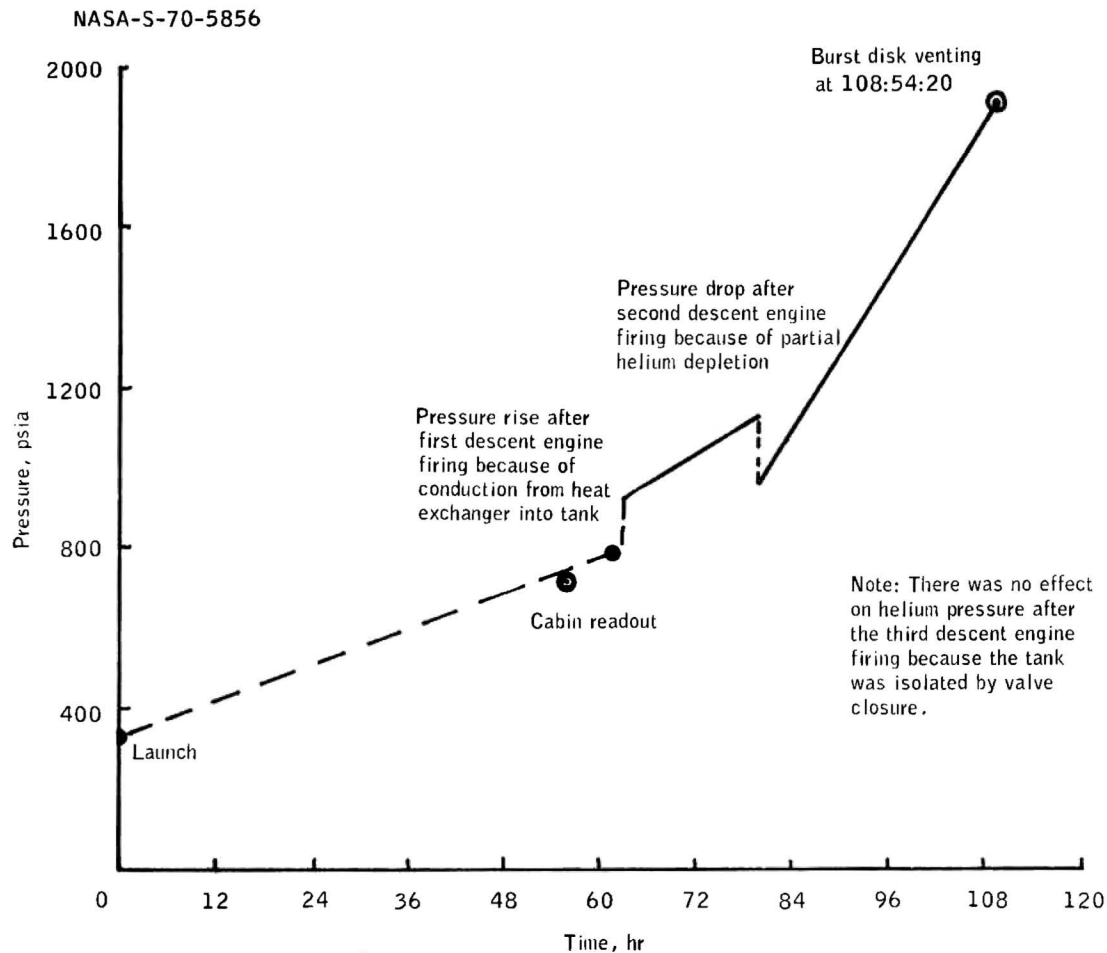
Figure 14-14.- Inflight profile of supercritical helium tank pressure.

The most likely cause of the anomaly is a tank-insulation degradation which would result in increased heat conduction to the helium. The insulating characteristics of the annular vacuum in tank was most likely degraded by the introduction of a contaminant (probably hydrogen) in extremely small concentrations (approximately  $10^{-6}$  pounds). These contaminants when vaporized can exponentially increase the thermal conductivity in proportion to their vapor pressure, as indicated by special tests. While loading helium into the tank, the contaminants would freeze upon the inner shell. In the frozen state, the pressure of the contaminant is too low to significantly affect the thermal conductivity. However, the flow check which preceded the cold-soak operation would vaporize the contaminants in the vicinity of the heat exchanger lines which pass through the annulus. The subsequent increase in thermal conductivity could cause the abnormally high pressure-rise rate observed during the cold soak. These vapors would slowly condense on the cold ( $10^{\circ}$  R) inner wall, resulting in the pressure rise rate dropping to the nominal level, as was observed. The rise rate would remain normal until the helium temperature increased above the vaporization temperature of the contaminant.

A screening test was devised for all future flight tanks to supplement normal helium tank testing. The purpose of this test is to determine the pressure rise rate for a wide range of helium temperatures from approximately 9° to 123° R. For a perfect tank, the steady-state rise rate should remain at approximately 8 psi/hour over the entire range of temperatures. The Apollo 14, 15, and 16 tanks have been subjected to the screening test, and each exhibit the same phenomena observed during Apollo 13, but to a lesser degree. For new tanks, the manufacturer will periodically analyze the gases removed from the vacuum jacket during pump down for possible contaminants. The pressure in the jacket will be measured 2 or 3 weeks after pumpdown to verify vacuum integrity.

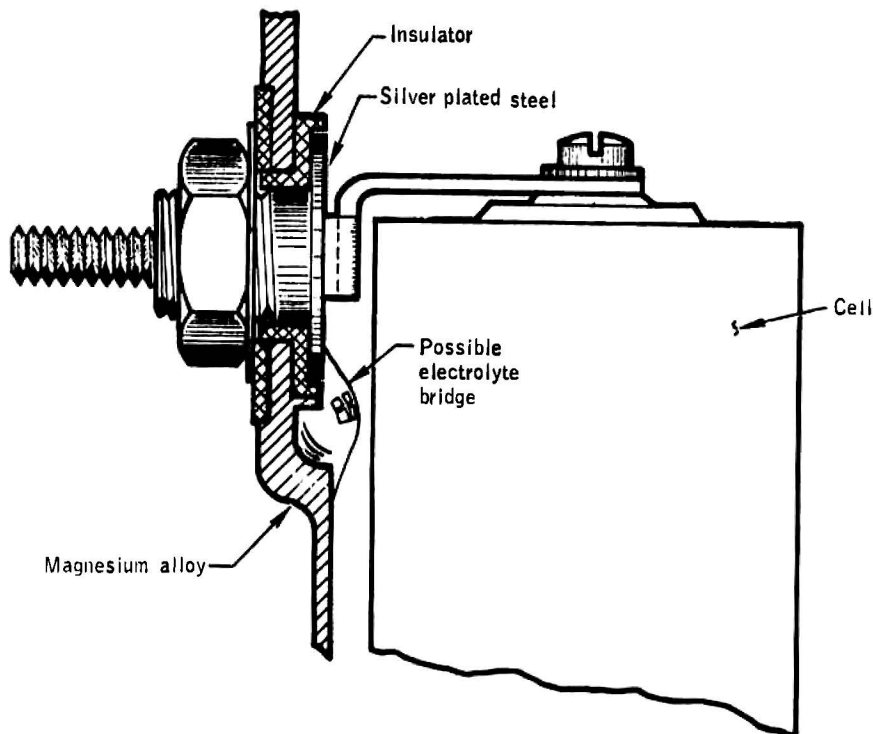
Figure 14-17.- Descent battery terminal configuration.

The thumping noise occurred at about the same time as the current spikes. The current spikes show that a momentary short circuit existed in the Lunar-Module-Pilot side of the dc electrical system, which includes descent batteries 1 and 2 (fig. 14-16). The current surge was not of sufficient duration either to open the balance-load cross-tie circuit breakers, to display a reverse current indication, or to trip a battery-off relay as a result of an overcurrent condition.

The battery potting will be improved to prevent electrolyte bridging between the battery terminals and case. These improvements include coating the inside of the battery case with epoxy paint before the battery is assembled and changing the potting material used at the ends of the case to a material which has better adhesion characteristics. Also, the cell chimneys will be manifolded together and to the case vent-valve with plastic tubing.

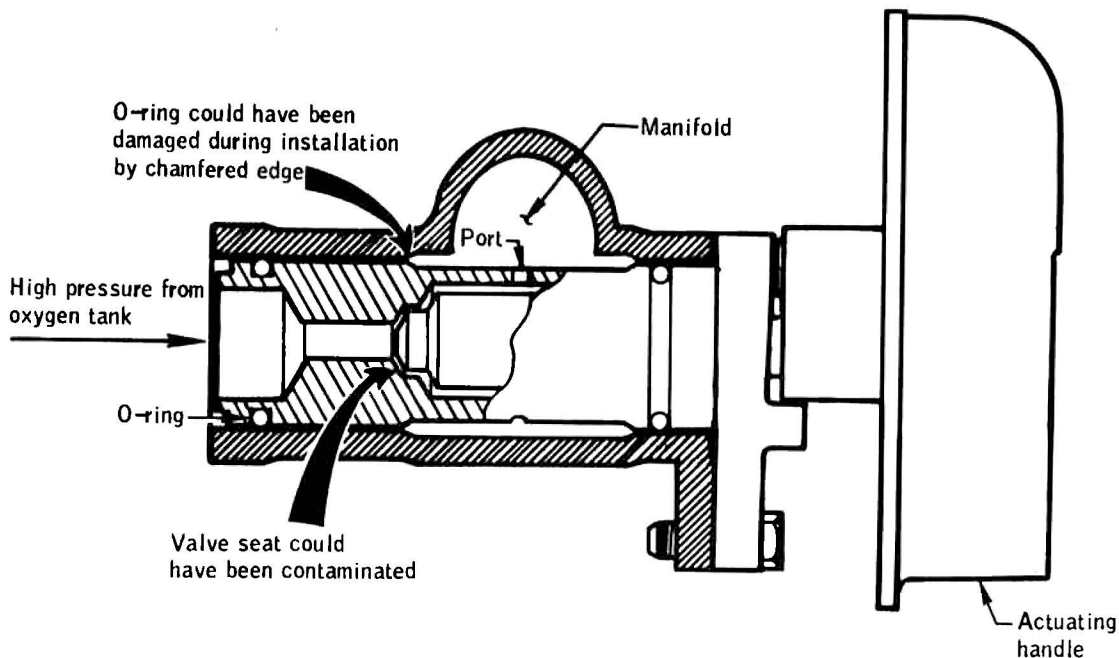
Figure 14-20.- Ascent stage tank shutoff valve.

(fig. 14-20) caused the leakage. When the valve is installed, the forward O-ring can be rolled and damaged when it passes the manifold port. In the other two valves, the cause was not identified and was assumed to be contamination.

compression allowed in the valve design would aggravate the tendency for the O-ring to roll during valve assembly.

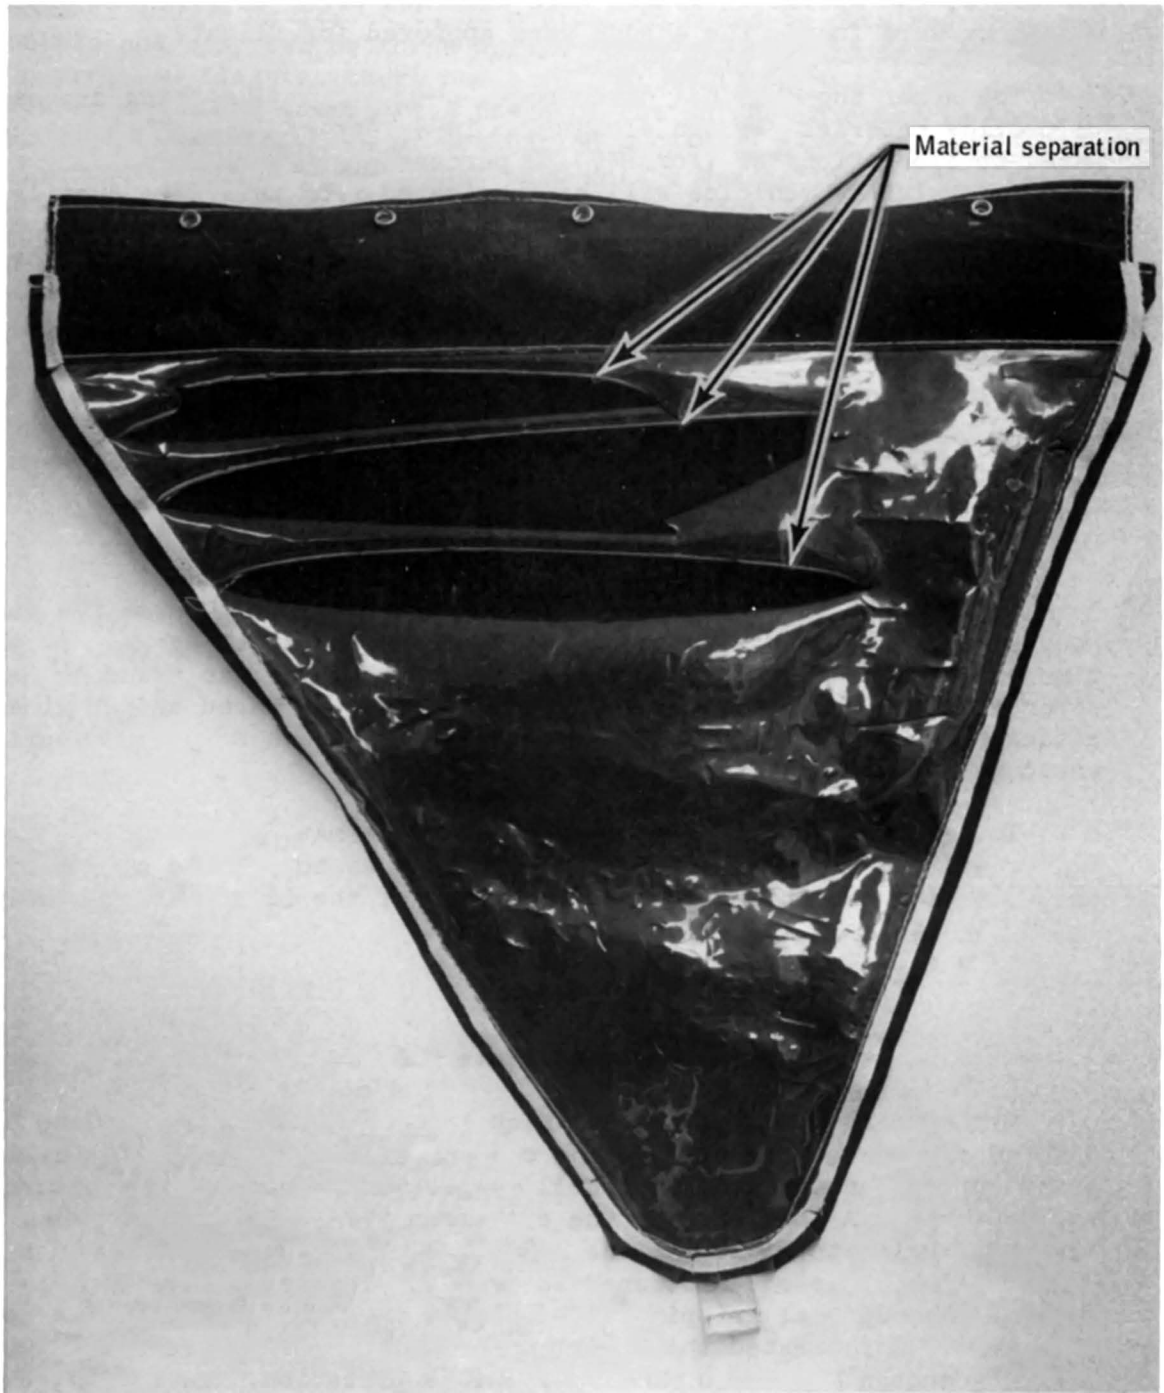
Figure 14-21.- Cracked left-hand window shade.

Cracking as a result of Aclar embrittlement has occurred before, therefore, the Apollo 13 shades were examined prior to flight. Since no cracks were found, the shades were approved for flight.
