**MSC APOLLO 13 INVESTIGATION TEAM**

## SPACECRAFT INCIDENT INVESTIGATION

### ANOMALY INVESTIGATION

June 10, 1970

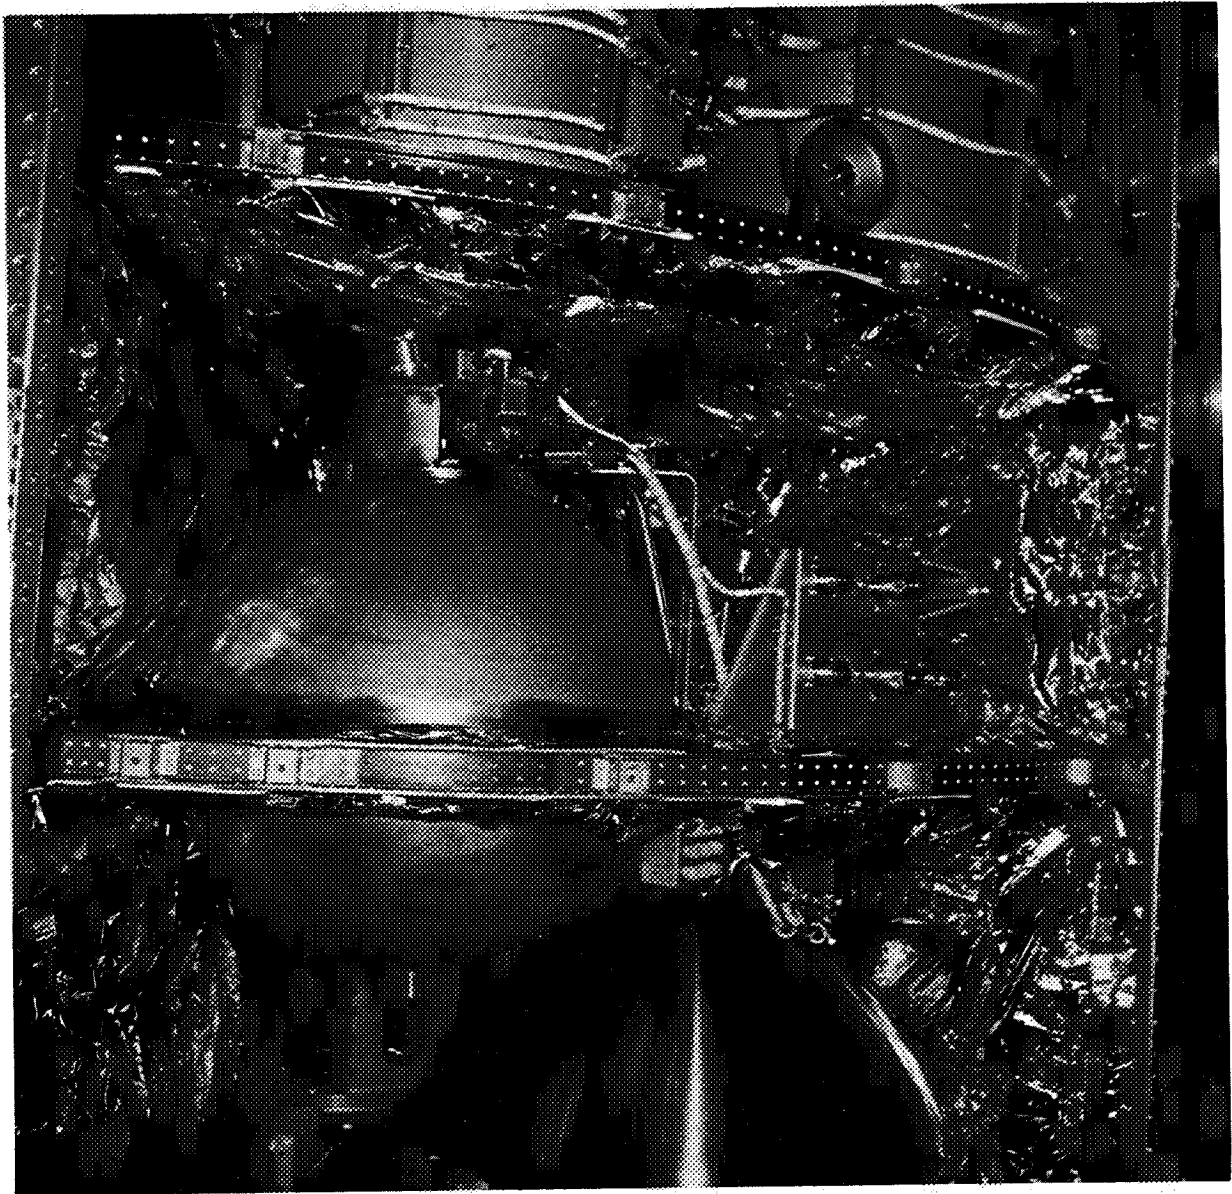
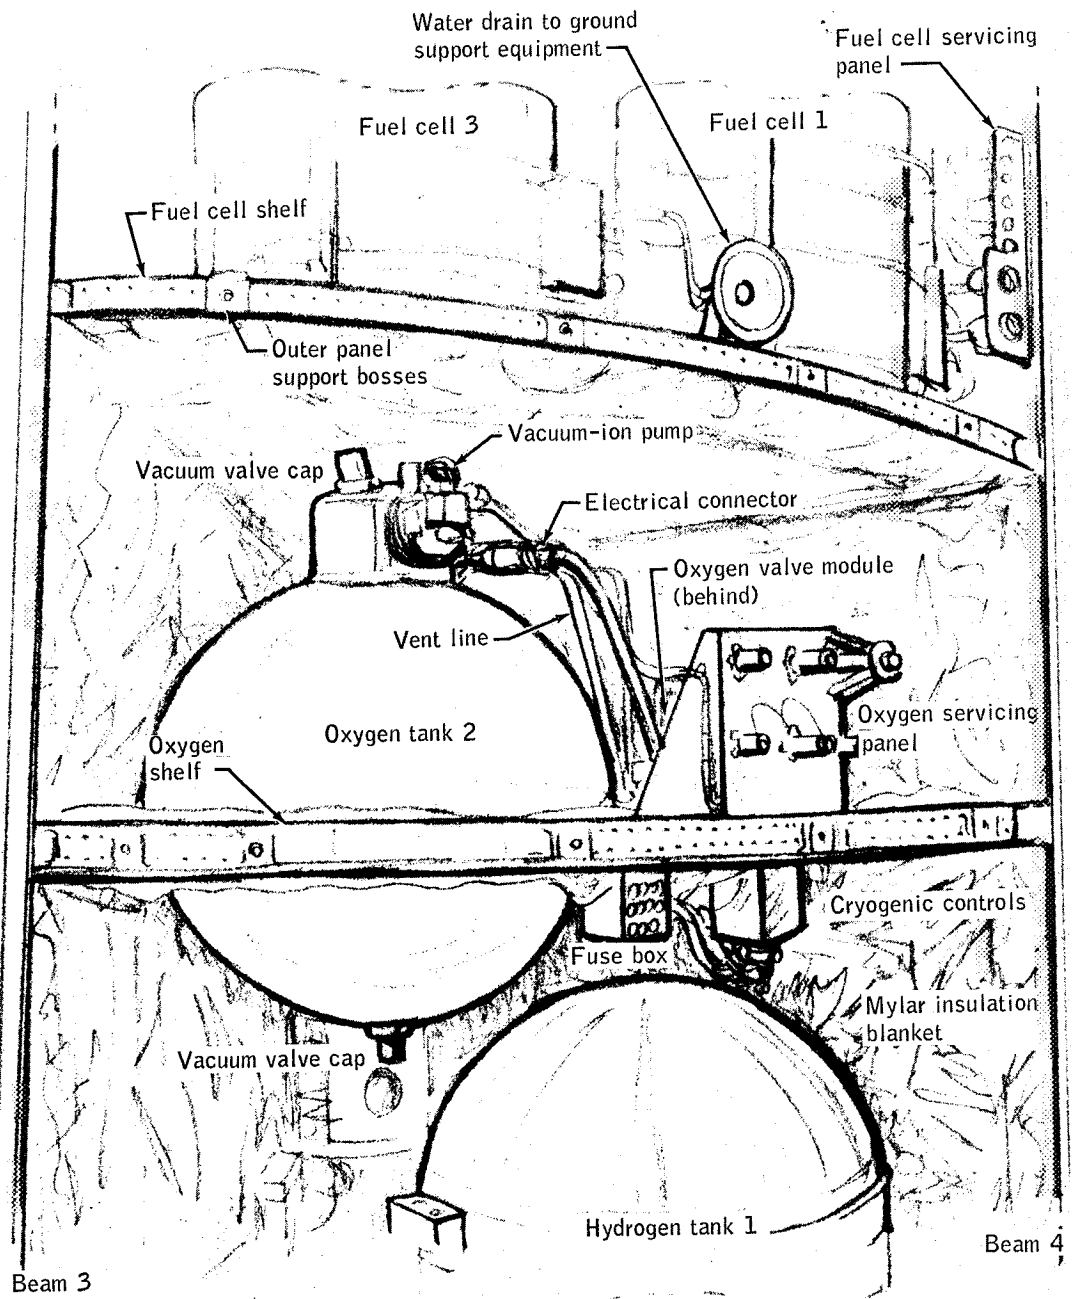
Figure 4-17.- Bay 4 closeout photography.

(a) Cryogenic oxygen tank 2.

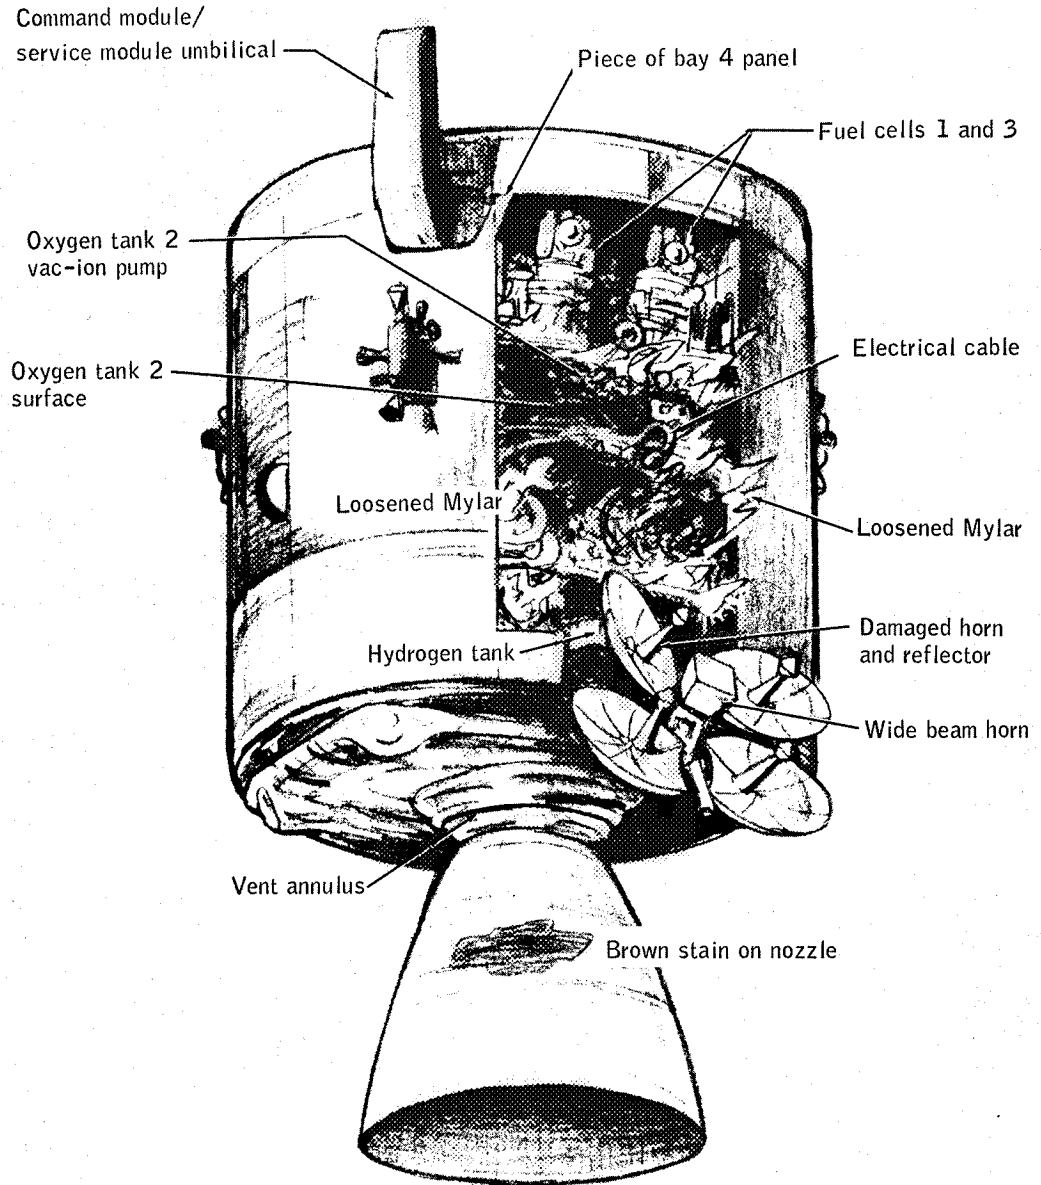
Figure 4-18.- 70-mm color film frame 8464.

- a. The fuel cells (1 and 3) are tipped slightly forward (outboard) so the rear of the fuel cell shelf apparently was raised.
- b. The insulation blanket was removed from the underside of the fuel cell shelf near radial beam 3 and above oxygen tank 2, since the color of the bare shelf is visible.
- c. Mylar and Kapton insulation blown, torn, and/or partially burned free from its initial fastening, now congest some areas of the bay and extend outside the service module from several places along the edges of shelves and beams.
- d. The oxygen tank 2 appears to be present and discolored. Because of the blackness of the non-illuminated remaining interior, aluminized Mylar and Kapton, and the discoloration of the oxygen tank 2, the blend

h. One of the four reflectors and feeder horns for the high-gain antenna was damaged. The attitude of the antenna, with the damaged reflector nearest the service module, had changed since the incident because the gimbals are free to rotate whenever the power is turned off.

(a) Onboard camera view.

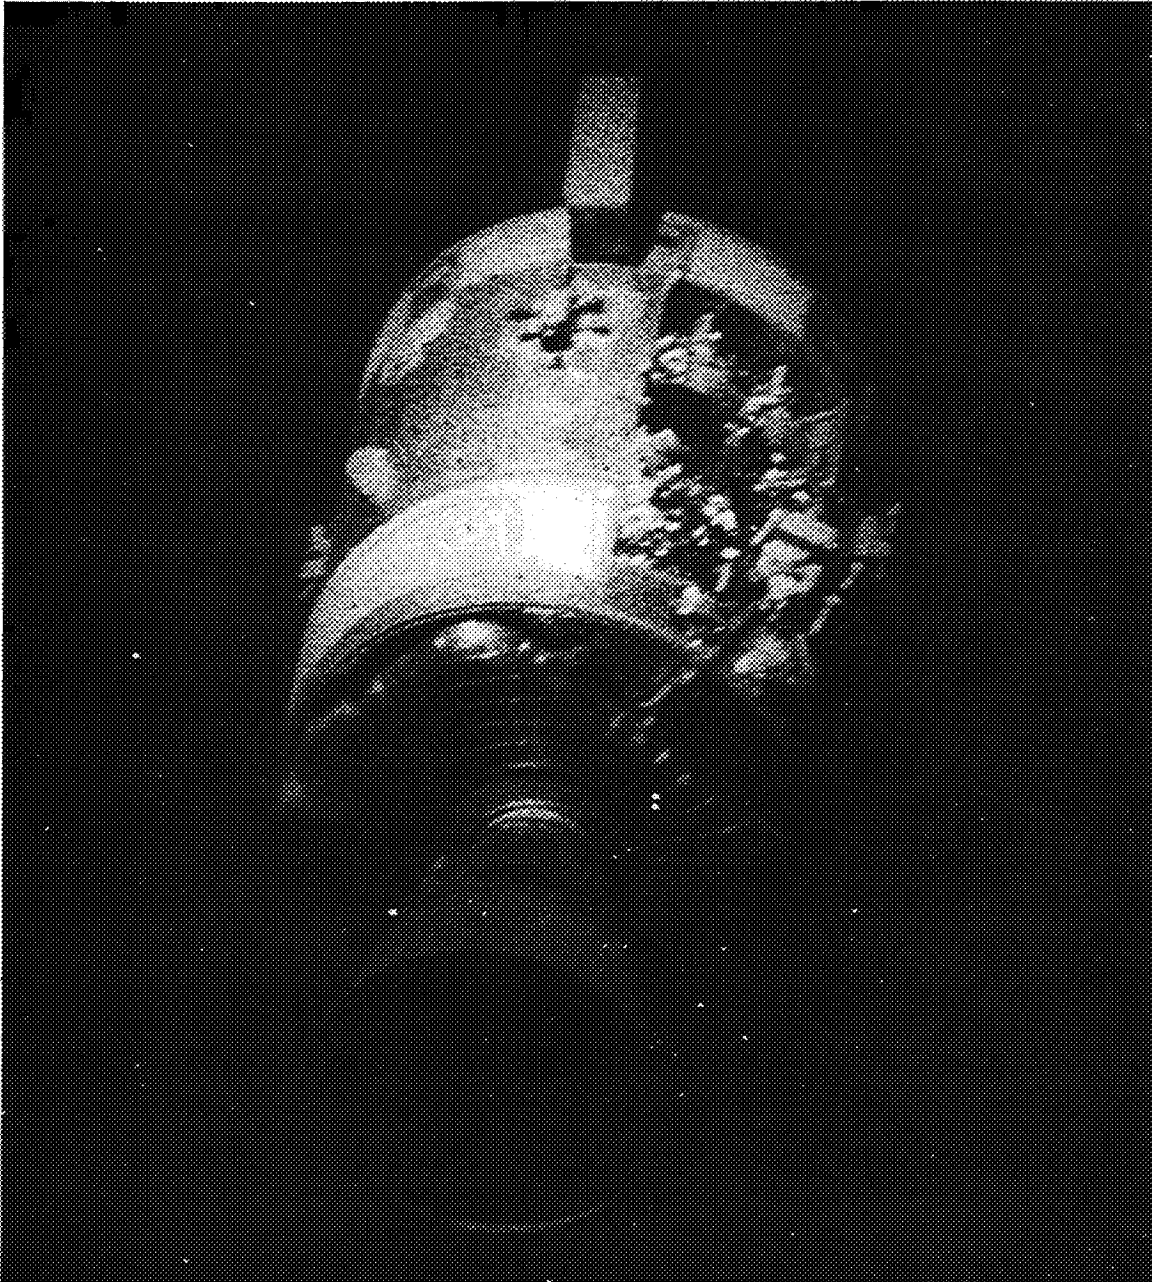
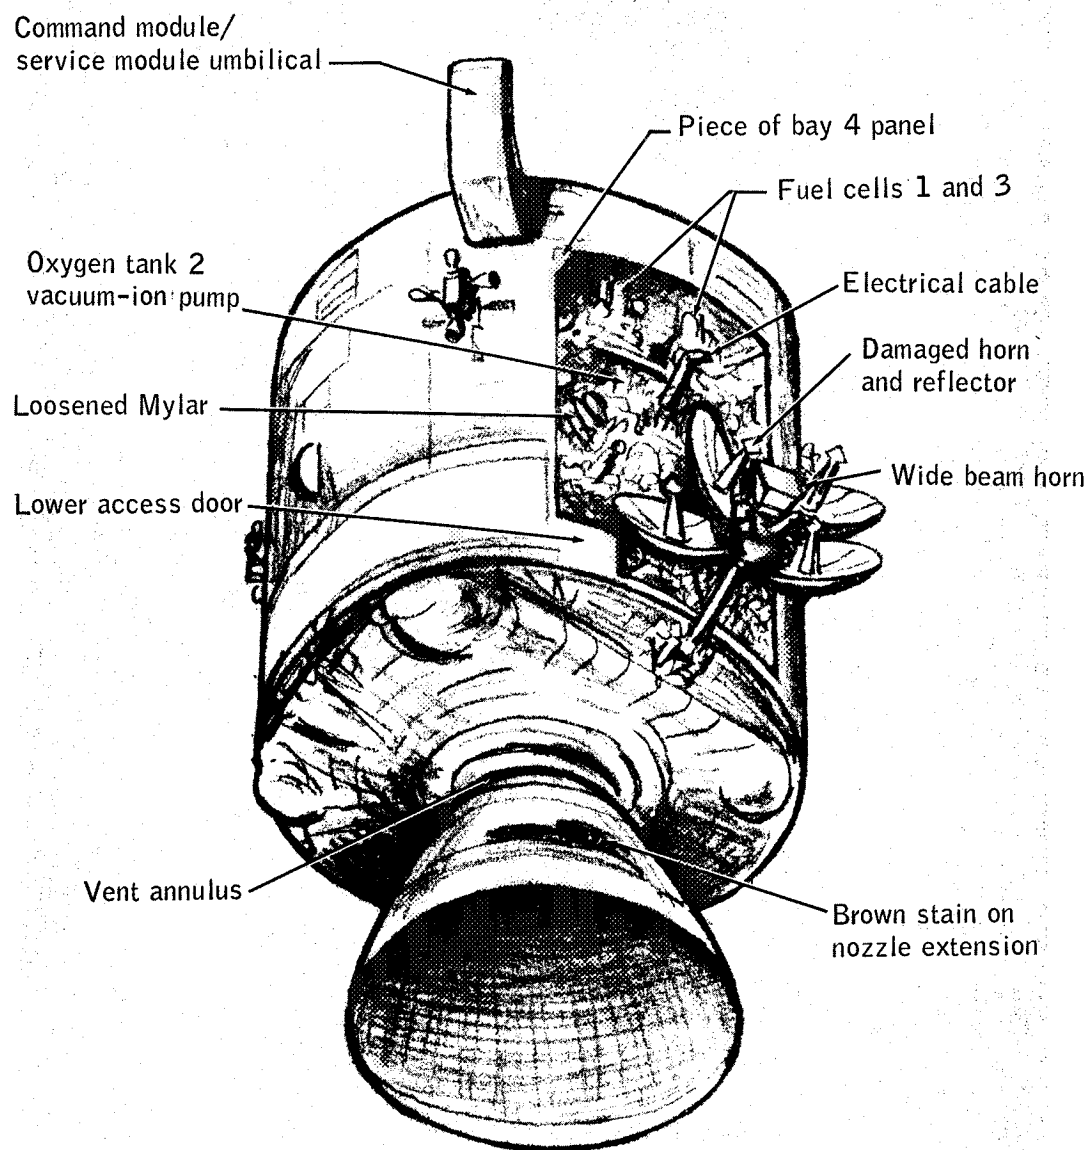
Figure 4-19.- 70-mm black and white film frame 8501.

(a) Onboard camera view.

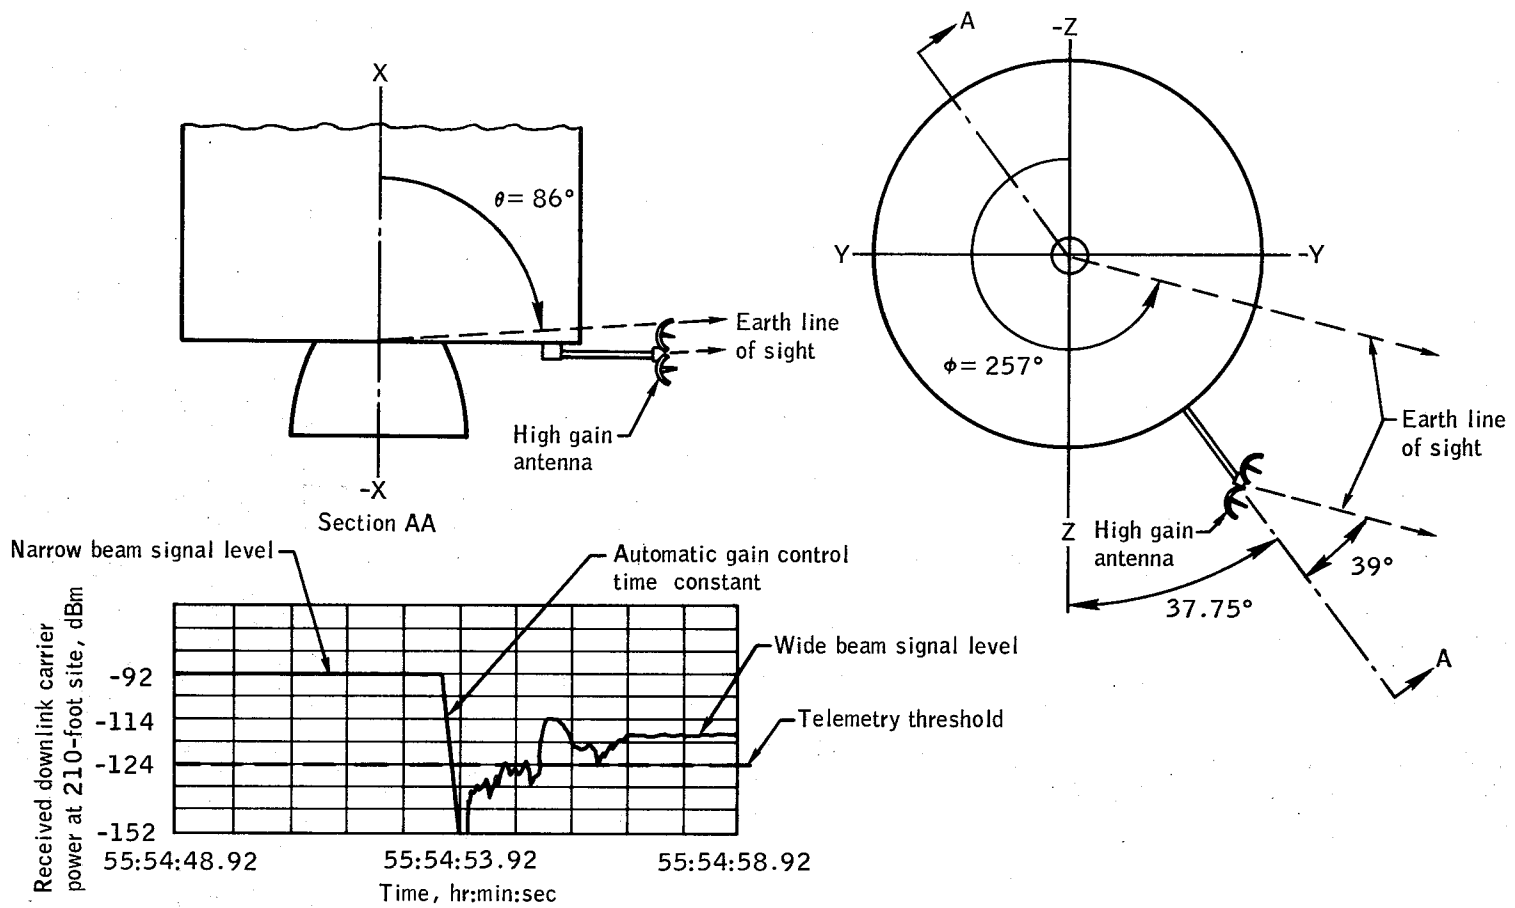
Figure 4-29.- Antenna configuration at the time of the incident.

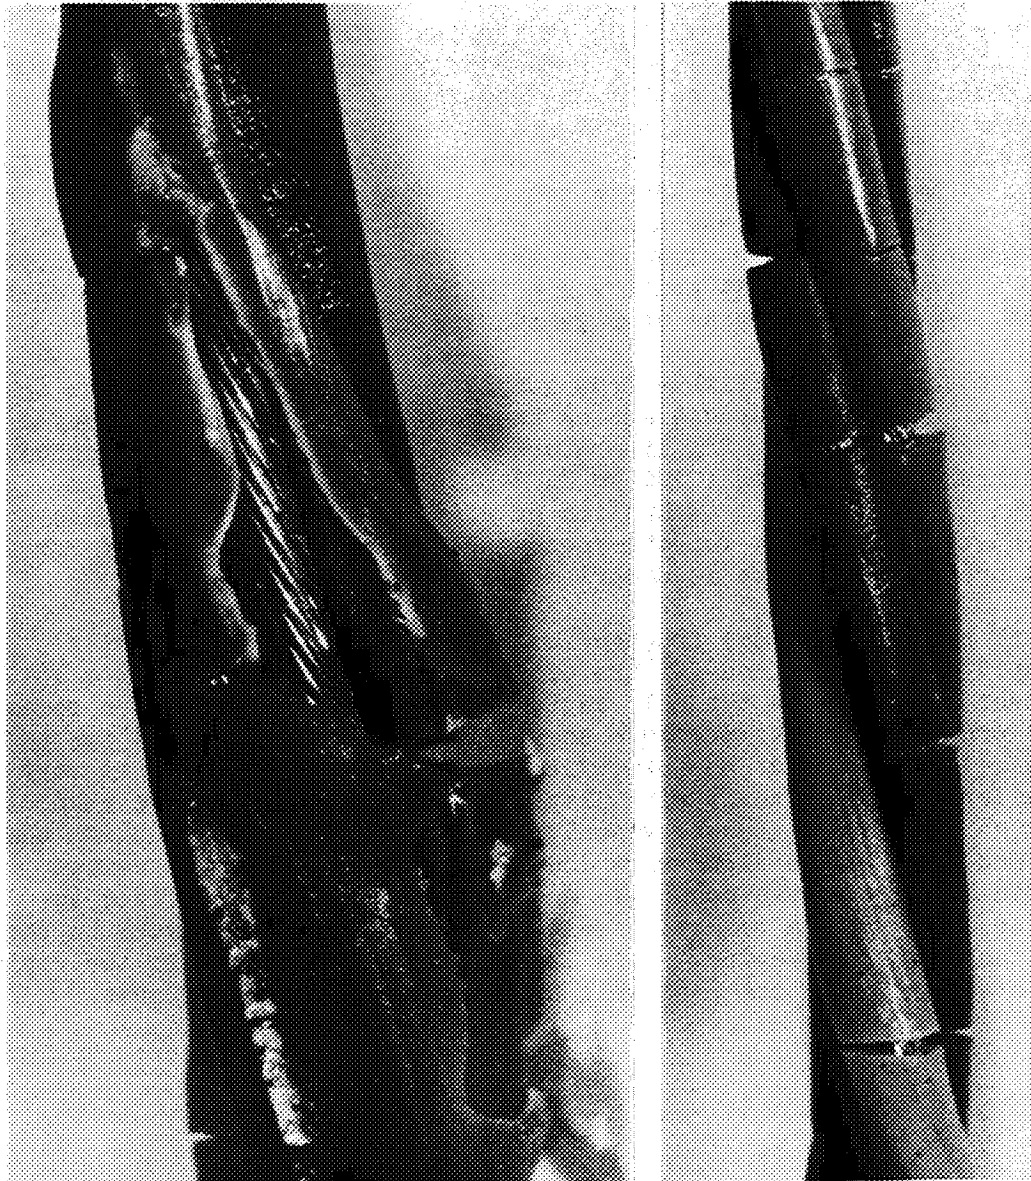
Figure 4-43. - Fan motor wire damage from heater tests.

This test showed that insulation will be severely damaged by the abnormal heater operation so that numerous locations for electrical shorts or arcs are available when the fan circuits are powered.

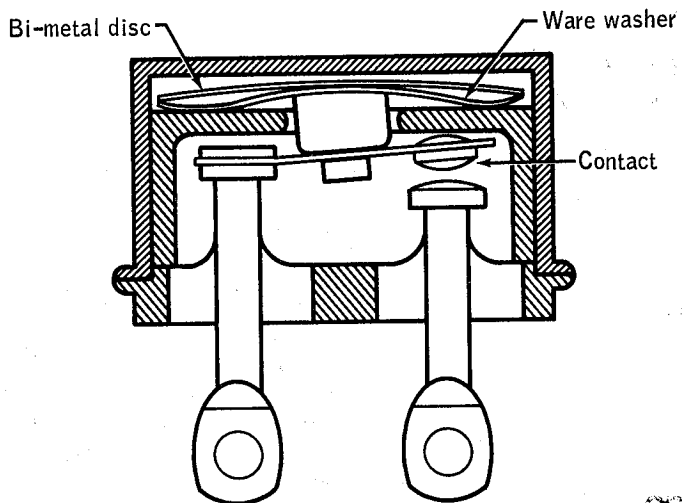
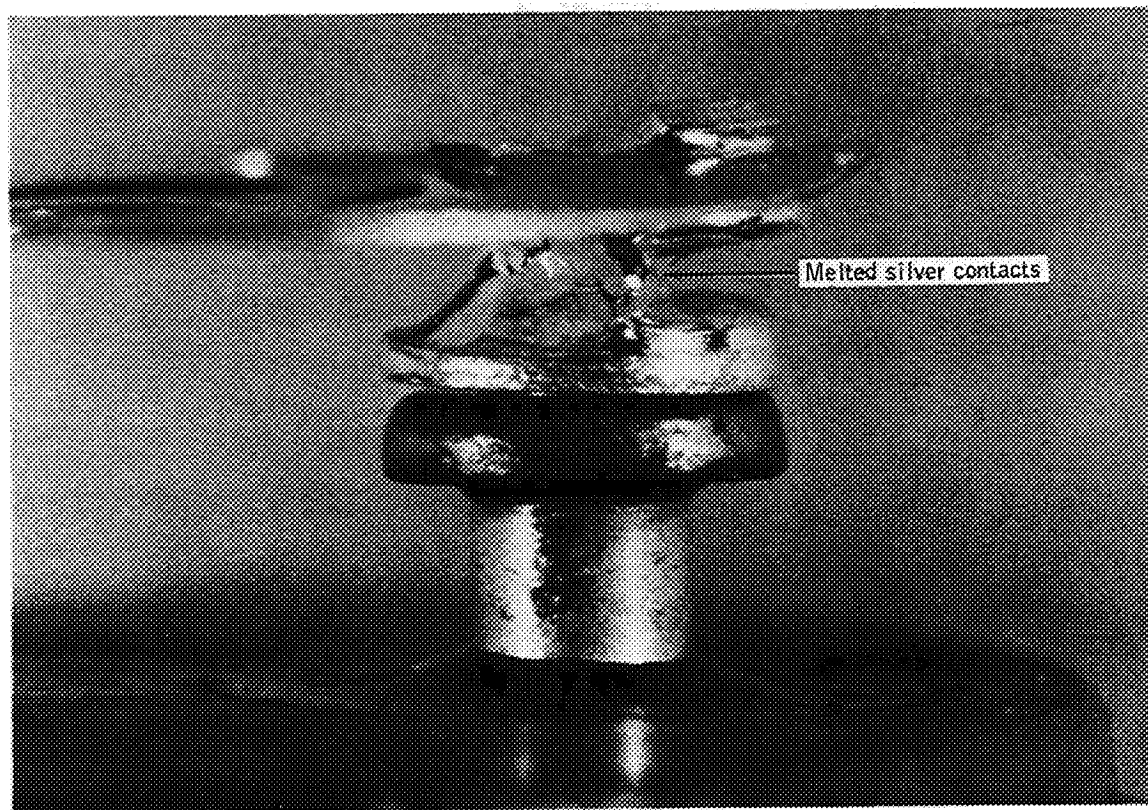
Figure 5-5.- Heater thermal switch.

The thermal switches, which normally open at about 80° F, show no sign of operation from the heater voltage data. Inflight, these switches have not operated due to the temperatures in the tank. Further, the switches in the past have not operated under a load on the ground, and they were not designed or tested for this condition.

(b) Welded contacts after test.

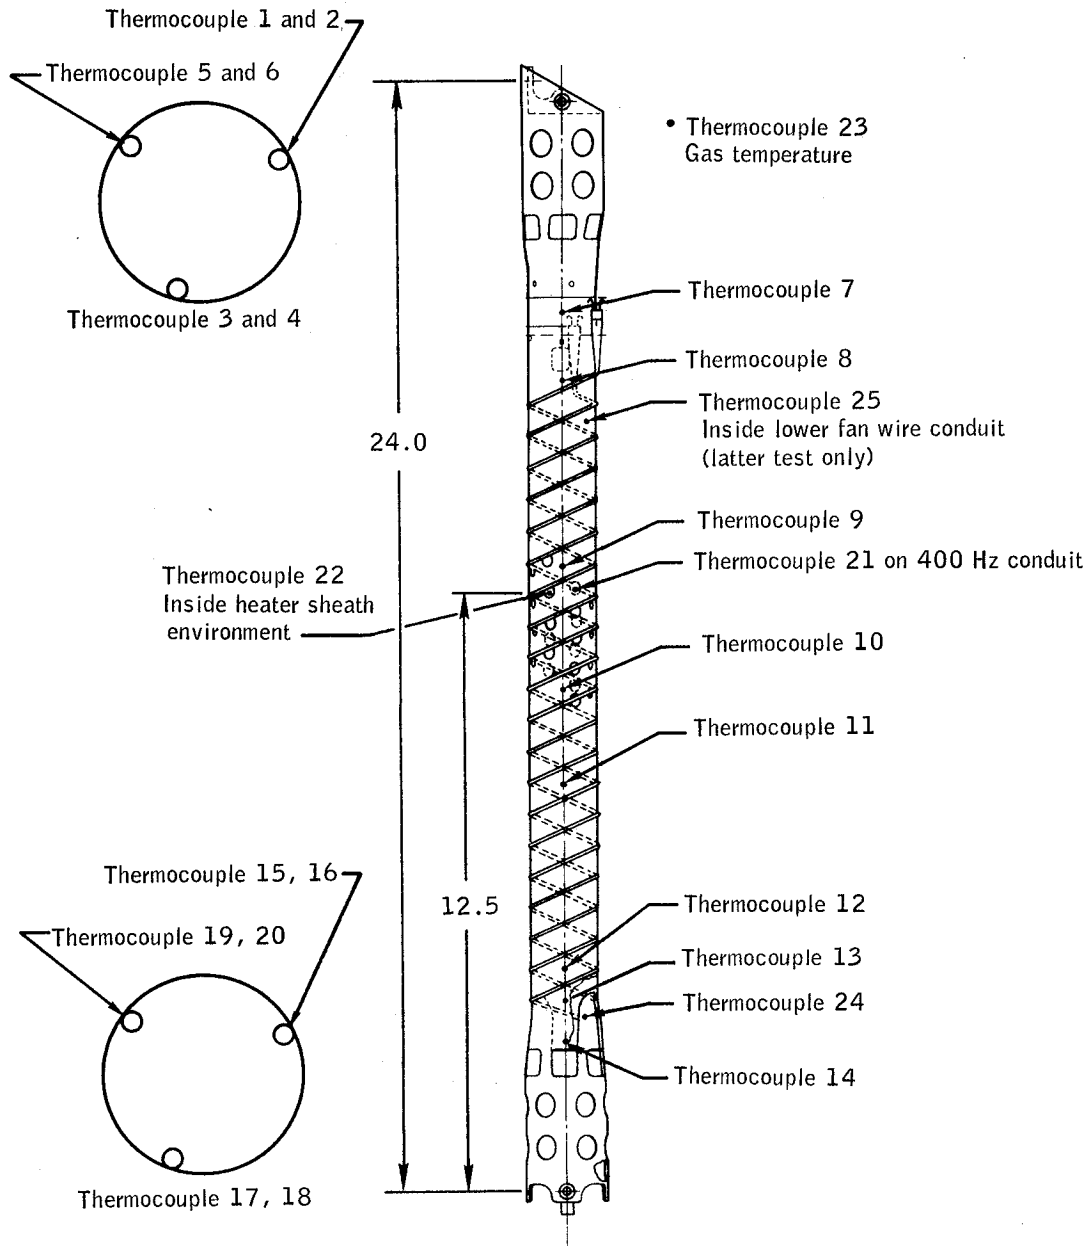
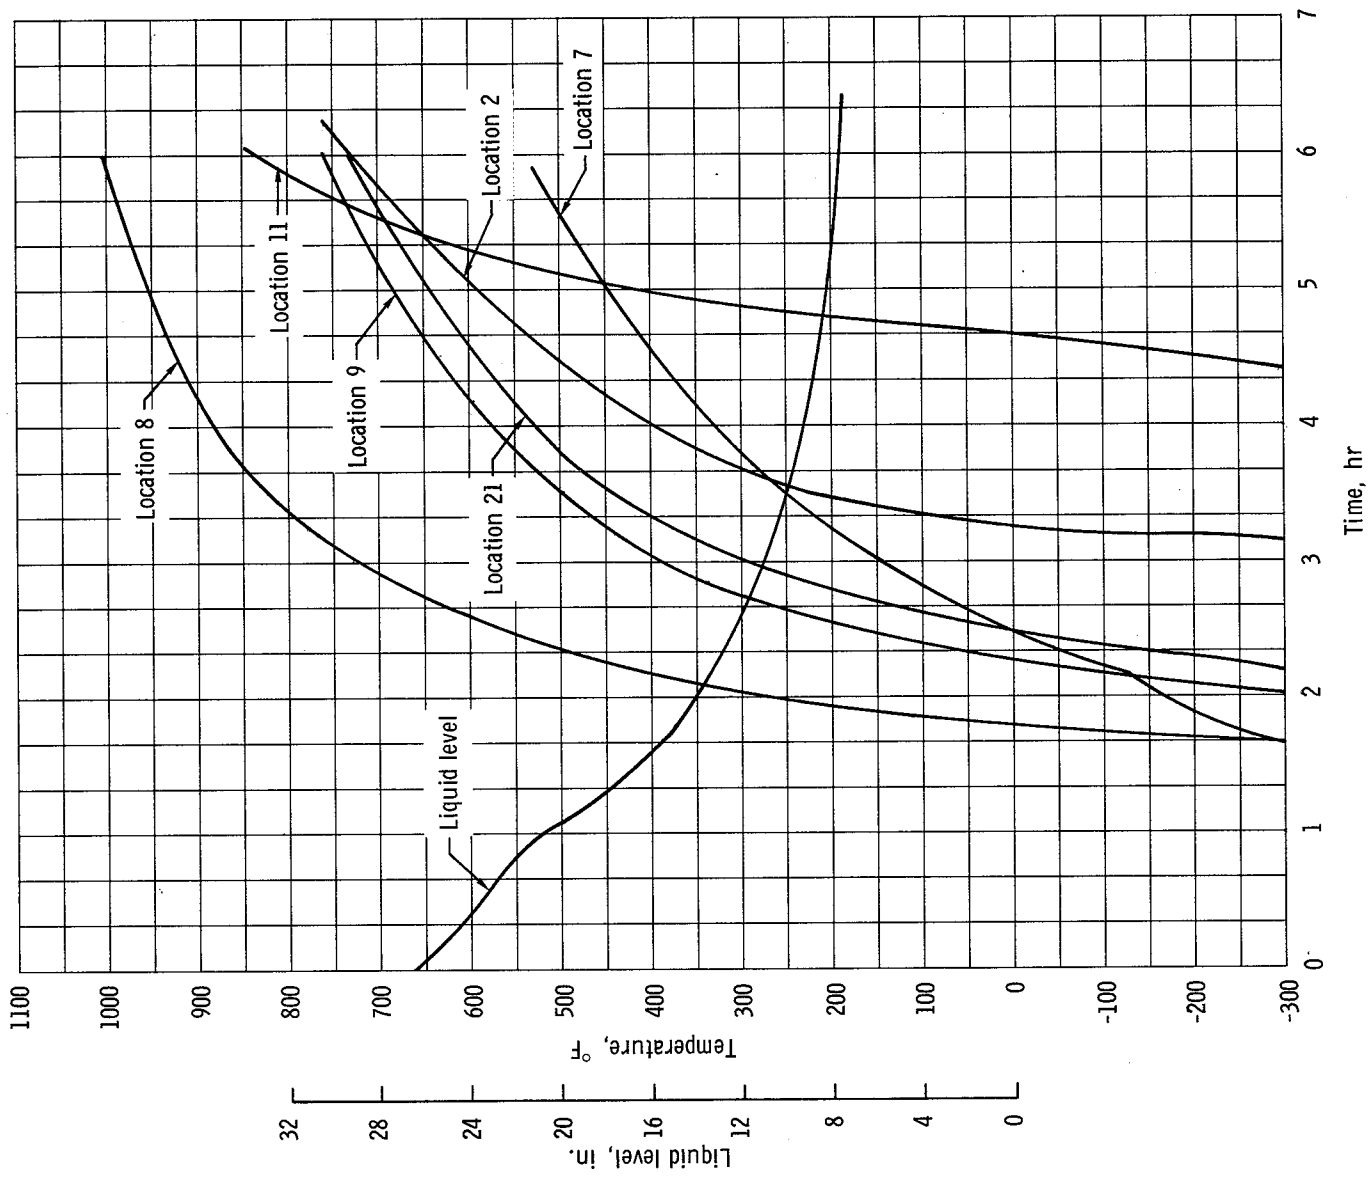
Wiring can be damaged within a couple of hours, with the heaters being "on" continuously as evidenced by the temperature on the heater assembly (figs. 5-6 and 5-7).
