MANNED SPACECRAFT CENTER INTERNAL NOTE

APOLLO 13 CRYOGENIC OXYGEN TANK 2 ANOMALY

ANOMALY REPORT NO. 1

APOLLO 13 MISSION
CRYOGENIC OXYGEN TANK 2 ANOMALY REPORT

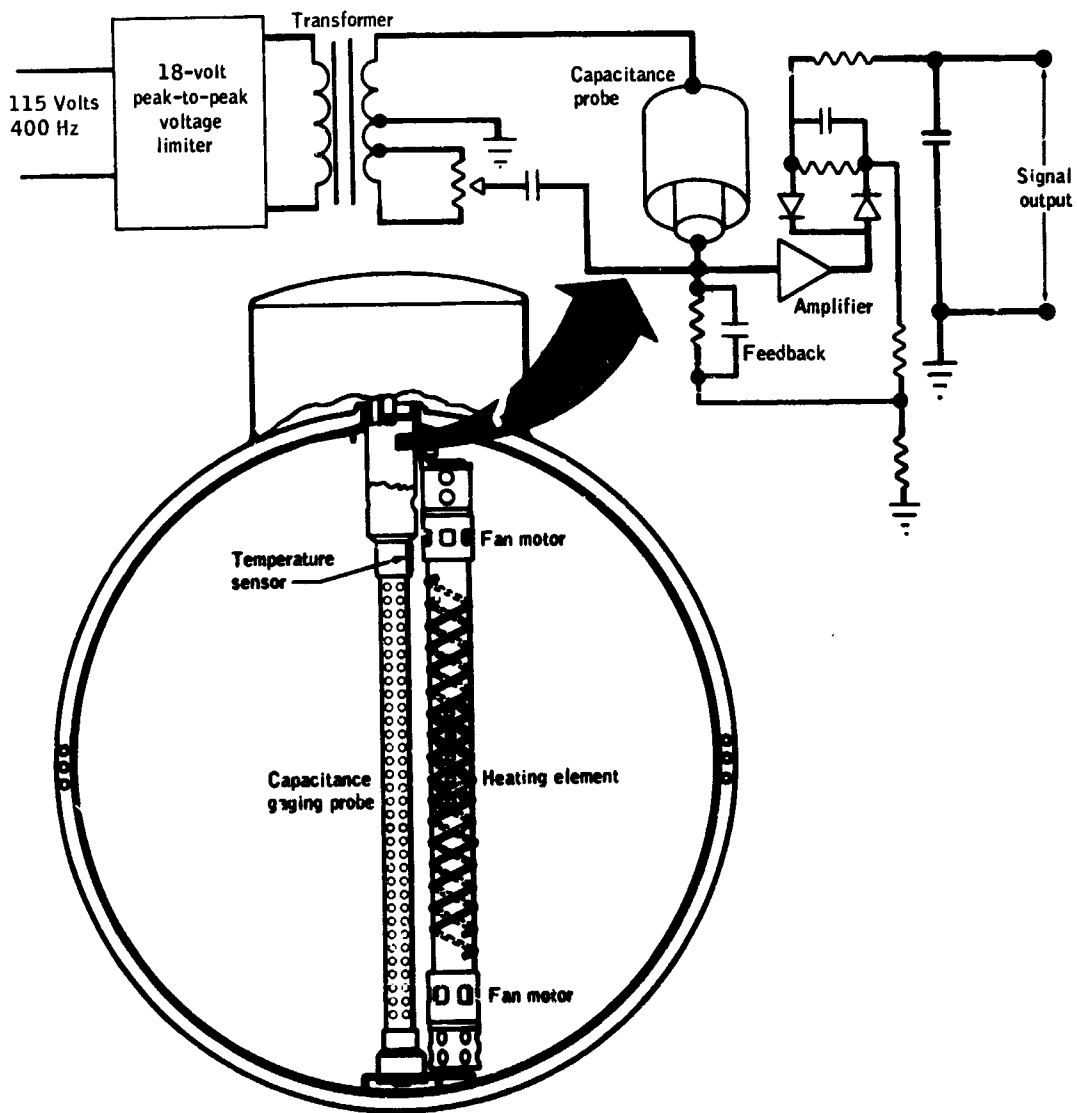
Figure 4-1.- Quantity gage.

The first anomalous inflight condition associated with the cryogenic oxygen tank 2 occurred at 46:40:06 when the ac-powered destratification fans in both cryogenic oxygen tanks were turned on. Within about 3 seconds after fan activation, the quantity measurement for cryogenic oxygen tank 2 abruptly indicated full-scale high. This system indicates density of the cryogenic oxygen by measuring its dielectric constant, which is a function of density. This instrument is a capacitor which consists of two concentric aluminum tubes inside the tank (fig. 4-1).

Tests have shown that an open-circuit in the leads to the capacitor assembly or a short across the capacitor or its leads will drive the output to full scale. If this short-circuit is removed, the output signal drops abruptly from full scale to zero, and then in about a second, it settles out to the proper reading, as noted in the data of figure 4-2. This agrees with the flight data from the quantity probe. Tests also show that if the inner tube is shorted to ground, the output may oscillate in a random manner. Such an oscillation was noted several minutes after data recovery following the incident. It should be noted that with a short-circuit in the quantity gaging system inside the tank, the maximum current that could be drawn is 15 milliamperes.

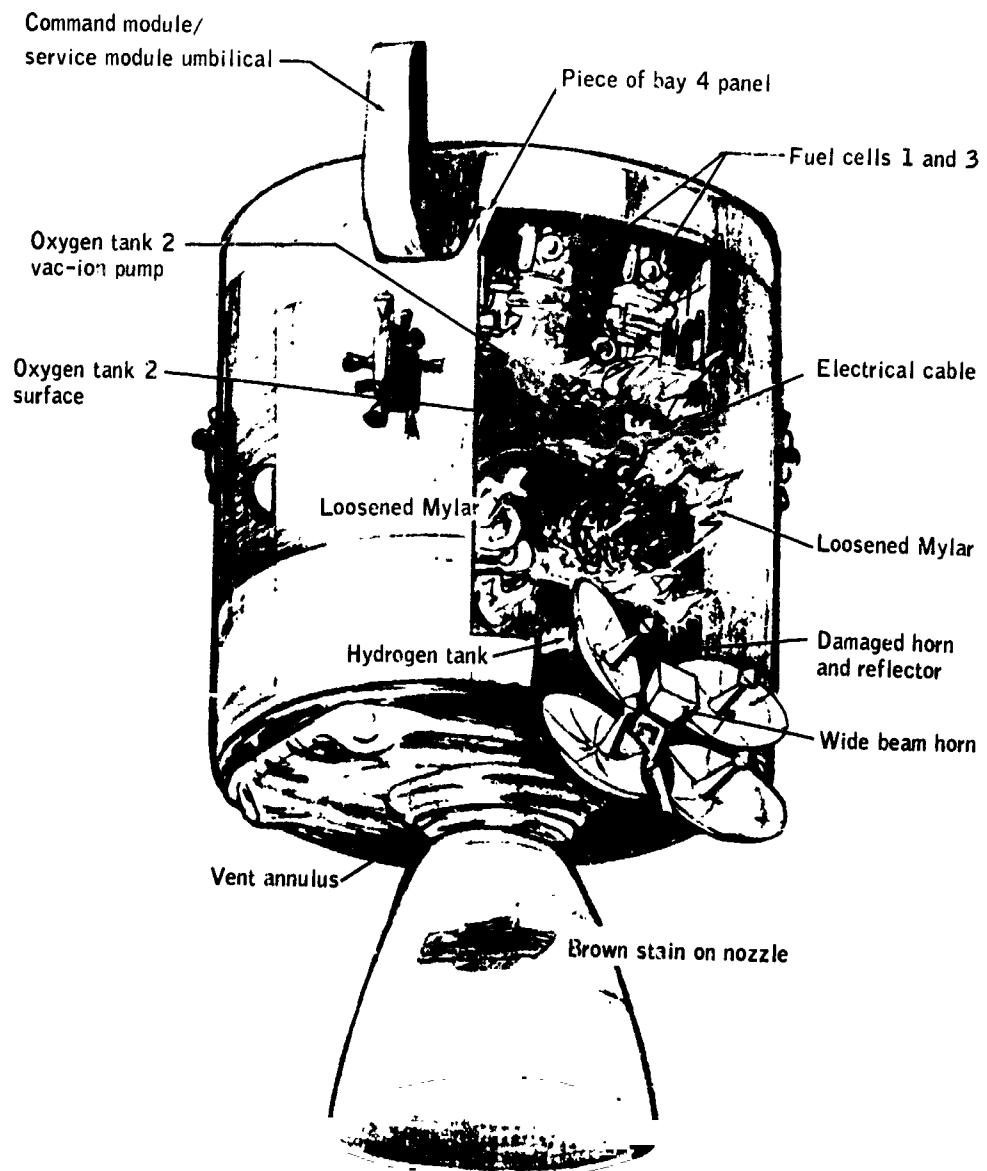
Figure 4-18.- 70-mm film frame 8464.

Photographs taken after service module separation showed that the bay 4 panel was missing and that one high-gain antenna horn was damaged.

h. One of the four reflectors and feeder horns for the high-gain antenna was damaged. The attitude of the antenna, with the damaged reflector nearest the service module, had changed since the incident because the gimbals are free to rotate whenever the power is turned off.

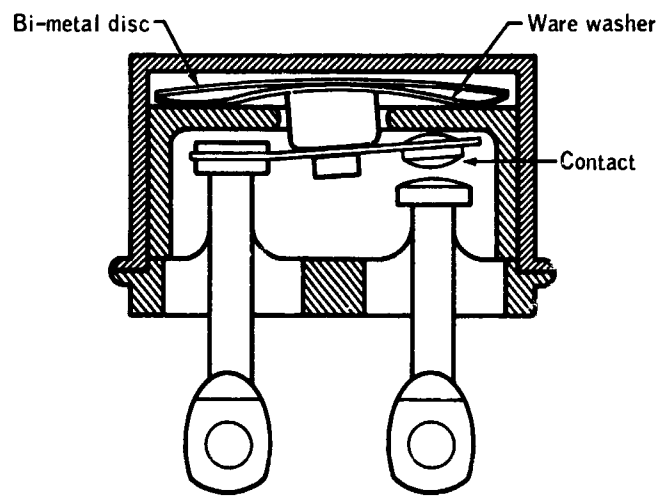
Figure 5-5.- Heater thermal switch.

The thermal switches, which normally open at about 80° F, show no sign of operation from the heater voltage data. Inflight, these switches have not operated due to the temperatures in the tank. Further, the switches in the past have not operated under a load on the ground, and they were not designed or tested for this condition.
