REPORT OF APOLLO 13 REVIEW BOARD

**APPENDIX B - REPORT OF MISSION
EVENTS PANEL**

**APPENDIX C - REPORT OF MANUFACTURING
AND TEST PANEL**

APPENDIX D - REPORT OF DESIGN PANEL

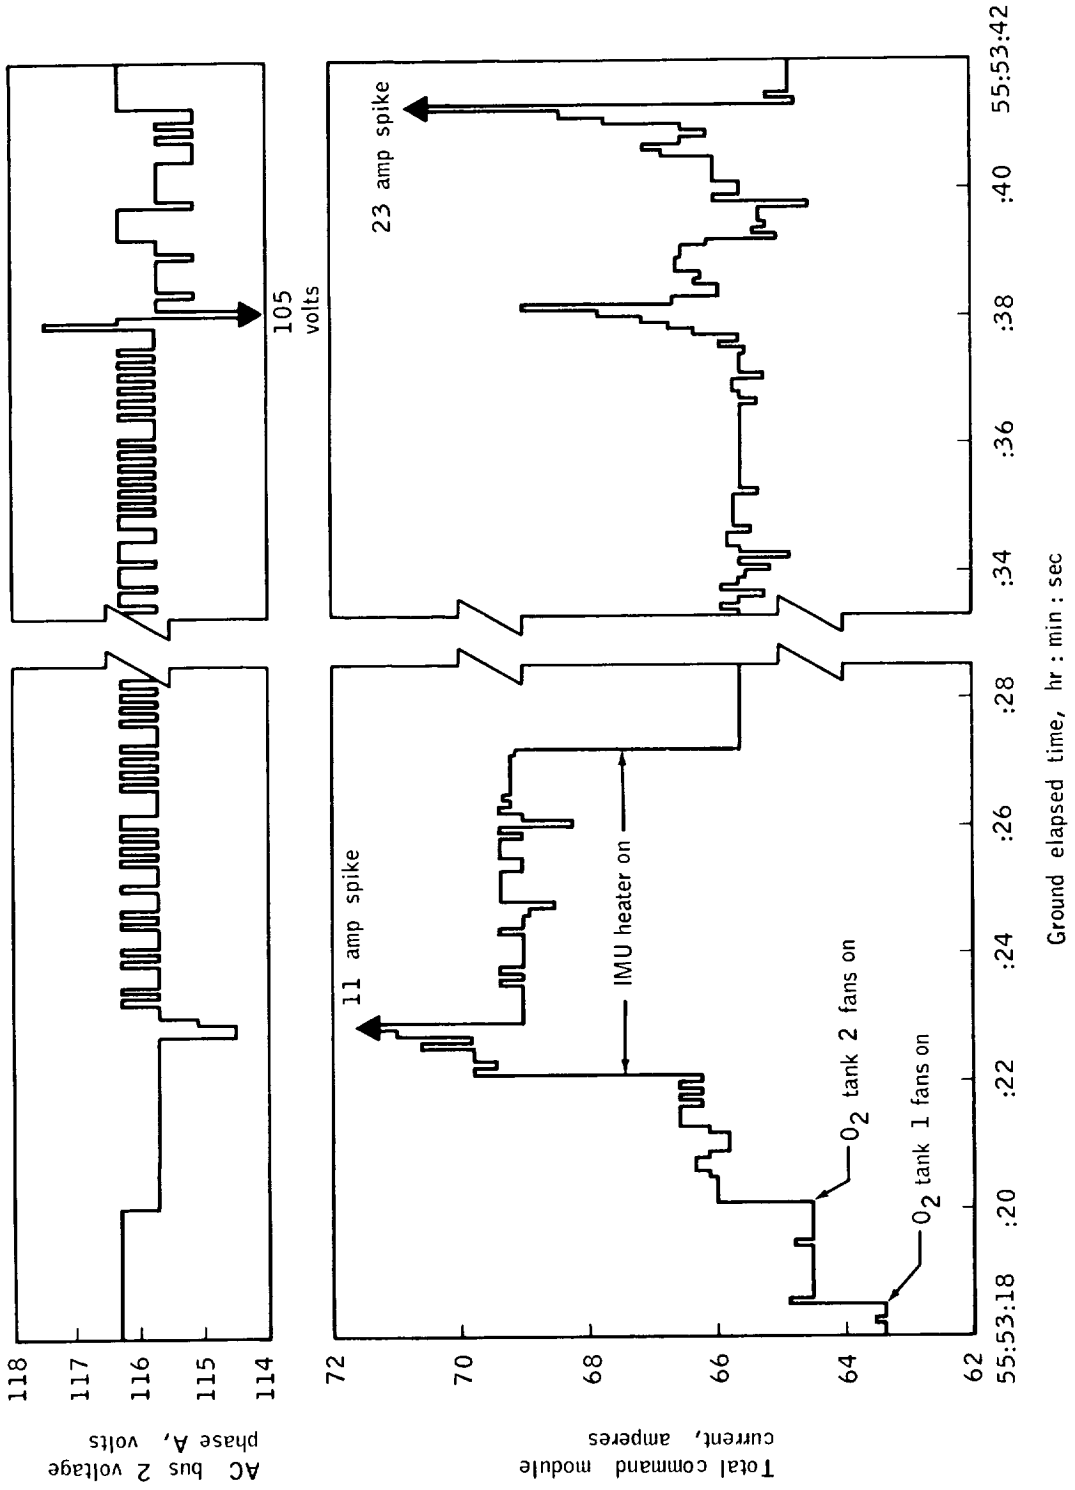
Figure B5-4.- Electrical anomalies.

The most probable cause of the electrical disturbances between 55:53:22 and 55:53:42 is that a short circuit occurred in the electrical

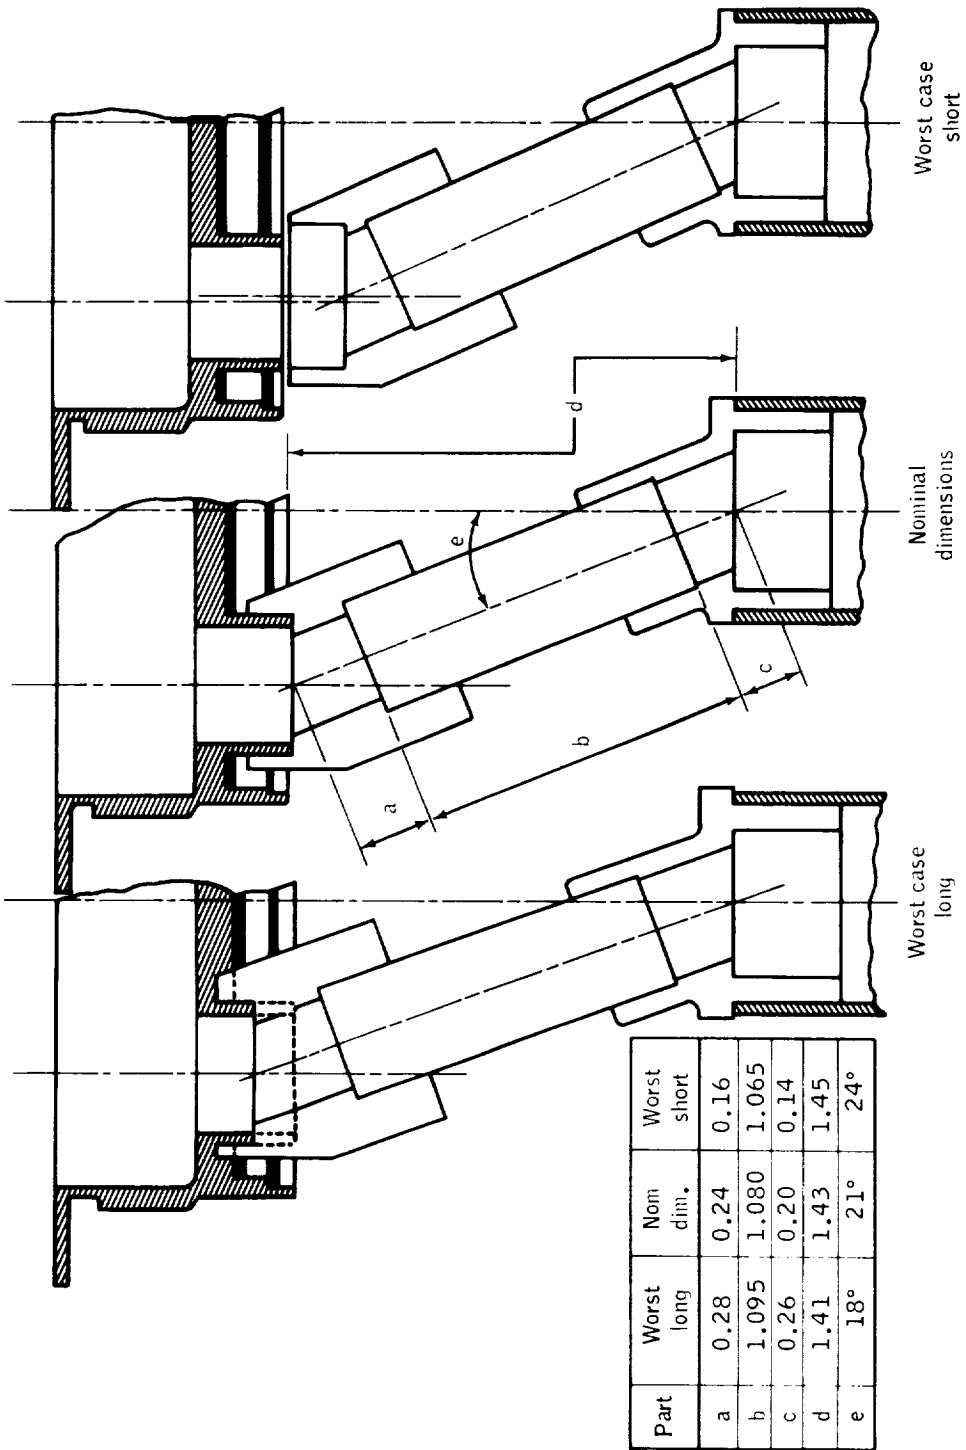
Table C4-II shows the range of diametral clearances that can exist at ambient conditions (73° F) and at a typical detanking condition (-278° F, which corresponds to the saturation temperature of liquid oxygen at 40 psia). The fit between the Teflon bushing and the tank adapter fitting can result in a maximum 0.003-inch interference. The only other clearance that results in an interference fit occurs if the minimum size holes are provided where the Teflon bushings slide on the 3/8-inch Inconel tube. Tests at liquid nitrogen temperature (-320° F) indicate that the Teflon is not overstressed and does not crack when subjected to interference fits of this type.

Figure C4-49.- Extreme and nominal tolerance cases for fill tube connection parts.
