14.4.3 Intermittent Lock of Universal Handling Tool In Suprathermal Ion Detector Fitting

14.5 GOVERNMENT FURNISHED EQUIPMENT

14.5.1 Television Control Unit Clutch Slippage

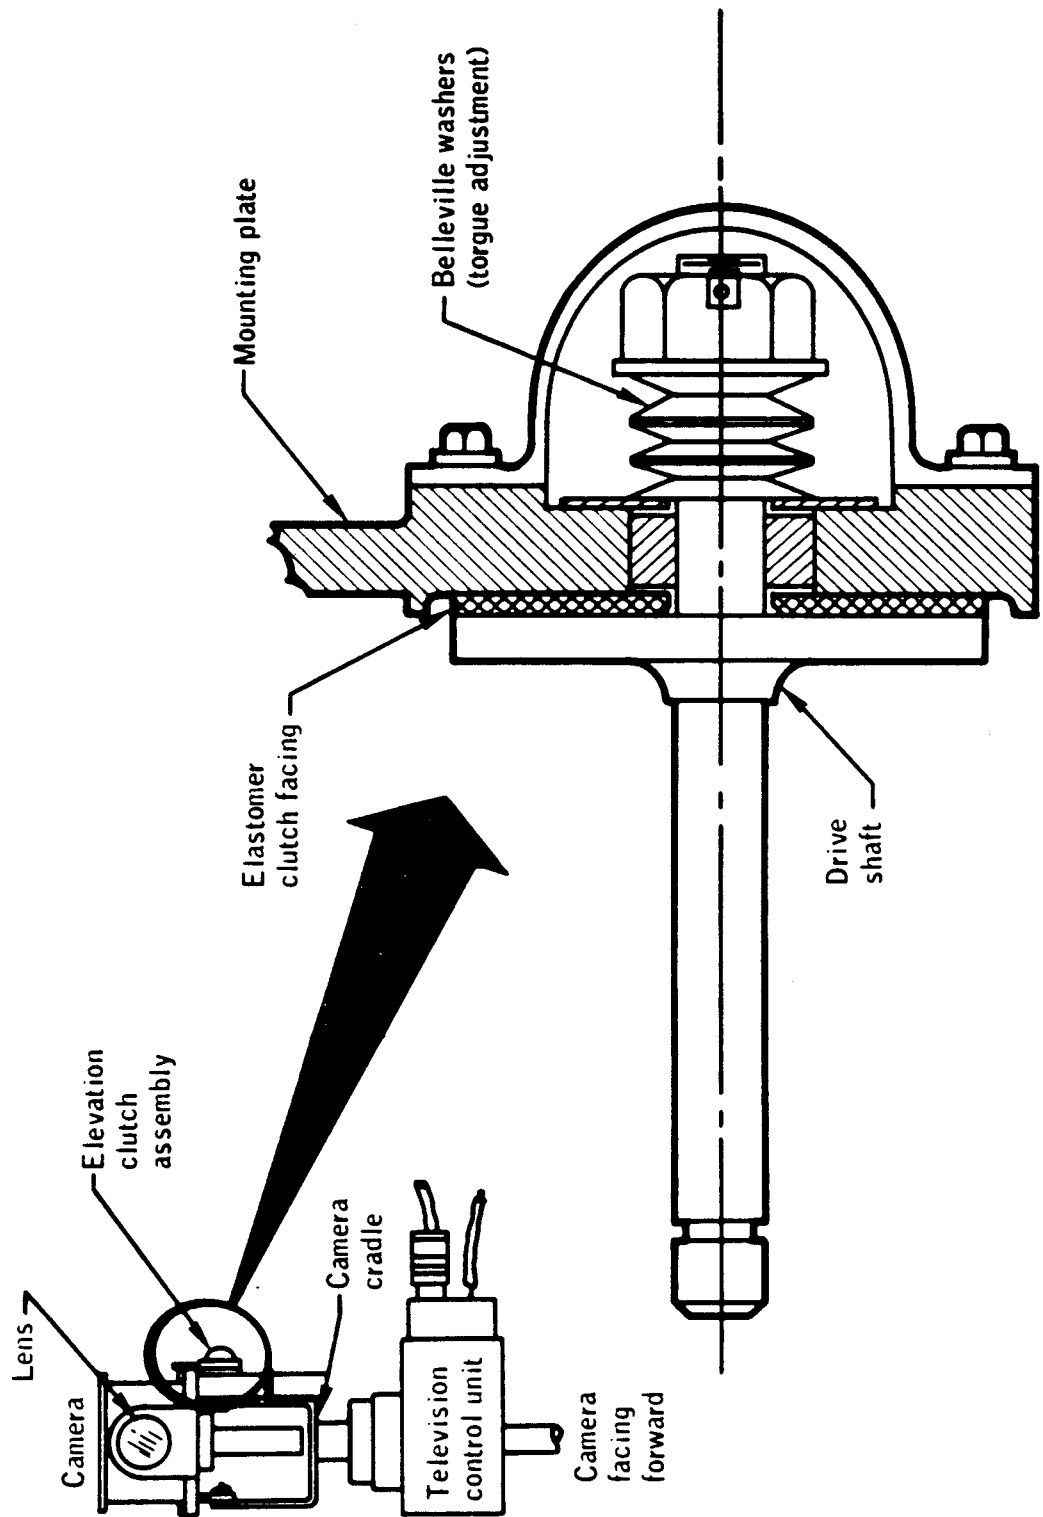
Figure 14-47.- Camera elevation control clutch.

During the second extravehicular activity, the camera could not be elevated as the unit approached the upper or lower limits of angular travel. The condition further deteriorated during the third extravehicular activity.

Elevation control is provided to the camera cradle through a friction clutch (fig. 14-47) which allows manual override of the ground-commanded camera positioning. The camera-cradle pivot point is approximately 3 inches below the center of gravity of the cradle with the camera mounted. As the camera moves away from the horizontal position, the unbalanced moment becomes progressively greater, and a higher torque load must be supported by the clutch mechanism.

The elastomer clutch-facing material provided the required stable friction properties in the specification and qualification test temperature range (122° F, maximum). However, the maximum temperature on the television control unit during the third extravehicular activity has been calculated as approximately 180° F. Materials specifications show that the compressive strength of the elastomer degrades rapidly at this temperature, and ground tests with flight unit 4 verify severely degraded performance with time at elevated temperature.

The clutch is being changed to a metal-to-metal spring ring design in place of the elastomer disc. The clutch torque for Apollo 15 was set at 16 inch-pounds for ease of manual adjustment. For greater stability on Apollo 16, the new clutch is being built with a torque of 30 inch-pounds, which is still comfortable for manual positioning and is within design limits of the system, including the gear train (35 inch-pounds).
