15.4.3 Lunar Ejecta And Meteorite Experiment Temperature High

15.4.4 Cask Dome Removal Was Difficult

15.4.5 Background Noise in the Lunar Atmospheric Composition Experiment Data

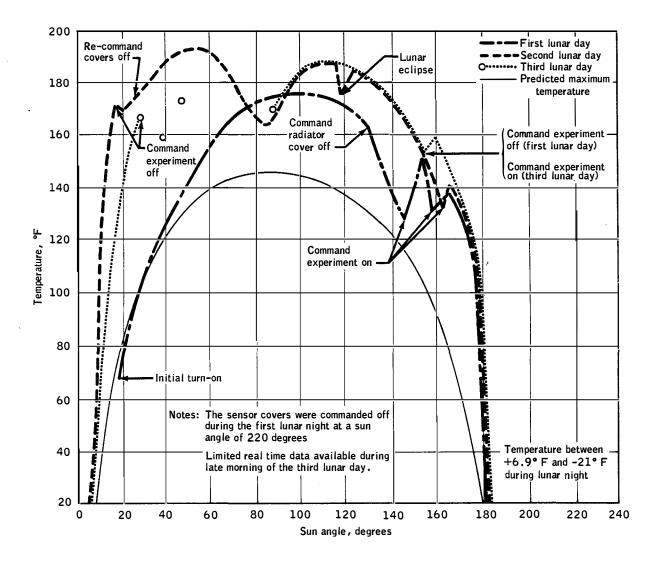
Figure 15-21.- Lunar ejecta and meteorites experiment temperature data.

The temperature of the lunar ejecta and meteorite experiment was higher than predicted during the first and second lunar days (fig. 15-21). The high temperatures occurred with all combinations of experiment modes: on, off, and standby, with all dust covers on, with only the sensor covers on, and with all covers off. Whenever the experiment was in the "operateon" mode, the science data indicated normal operation of the experiment. The maximum allowable temperature for survival of the electronic components has not been exceeded, however, it was necessary to command the experiment from "operate-on" to "off" at a sun angle of about 153 degrees during the first lunar day and at a sun angle of about 16 degrees during the second lunar day. Following sunrise of the second lunar day, the temperature rose from 0° F at 0° sun angle to about 168° F at 15° sun angle (fig. 15-21). The instrument was commanded to standby and then to off because the temperature continued to rise. In the off mode, with no power to the instrument, the temperature rise rate was lower.

The experiment temperature was cooler during the morning of the third lunar day as compared to the second. This could be attributed to the procedural change which turned the experiment off for 1 1/2 hours through sunrise and sunset. Data from the suprathermal ion detector and charged particle lunar environment experiments, deployed on previous Apollo missions, indicate that a flux of -100 to -750 volts can occur near the optical terminator (before optical sunrise and after optical sunset). During the lunar day, the surface is stable with photo electron layering at 15-30

+10 to +20 volts. It is postulated that when the experiment is on (sensor film at -3 volts and suppressor grid at -7 volts), the charge differential observed at these times may result in an accretion of lunar dust on the east and west sensors. Based on this, the experiment was turned off each sunset and sunrise after the second lunar day. The presence of dust on the sensor film and grid would degrade the thermal control system and result in higher experiment temperatures during the lunar day.

The current thermal profile permits experiment operation for 100-percent of the nighttime and 30 percent during the lunar day. If the thermal profile does not improve, consideration will be given to thermal testing on the qualification unit to ascertain whether or not the temperature limits can be raised to permit additional daytime operation. Preliminary results from an examination of the science data indicate that the instrument is operating properly.

Since the experiment is not scheduled for future missions, no corrective actions will be taken.
