**NATIONAL AERONAUTICS AND SPACE ADMINISTRATION**

**APOLLO 13 MISSION REPORT**

**SEPTEMBER 1970**

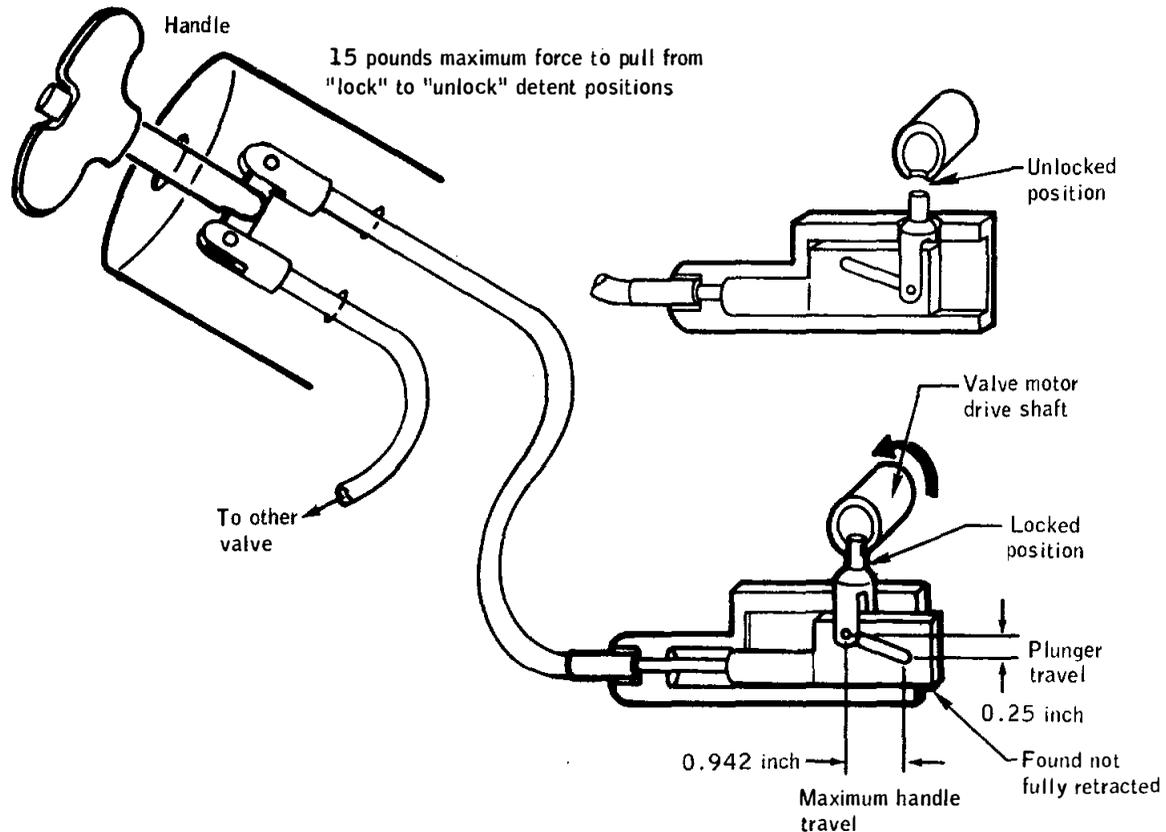
Figure 14-1.- Post-landing vent valve lock.

The valve-lock mechanism rigging tolerances were found to be within specifications. When reassembled in the spacecraft, the malfunction was duplicated with only partial travel of the handle.

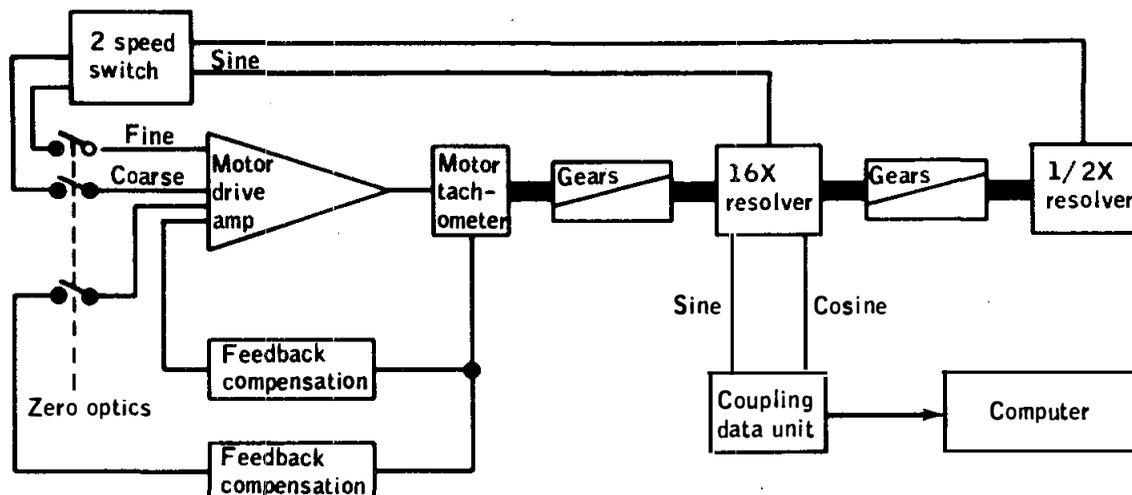
Figure 14-2.- Zero optics mode circuitry.

A simplified schematic of the optics shaft servo loop mechanization is shown in figure 14-2. In the zero optics mode, the sine outputs of

the half-speed and 16-speed resolvers are routed through a coarse/fine switching network to the motor drive amplifier and are used to null the system. Rate feedback from the motor tachometer is routed to the drive amplifier through a compensation network which removes any bias in the signal. When the zero optics mode is selected, the coupling-data-unit counter and the computer register which contains the shaft angle are zeroed for 15 seconds and then released to follow the 16-speed resolver. The half-speed resolver, the fine/coarse switching network, and the tachometer feedback compensation are used only in the zero optics mode.

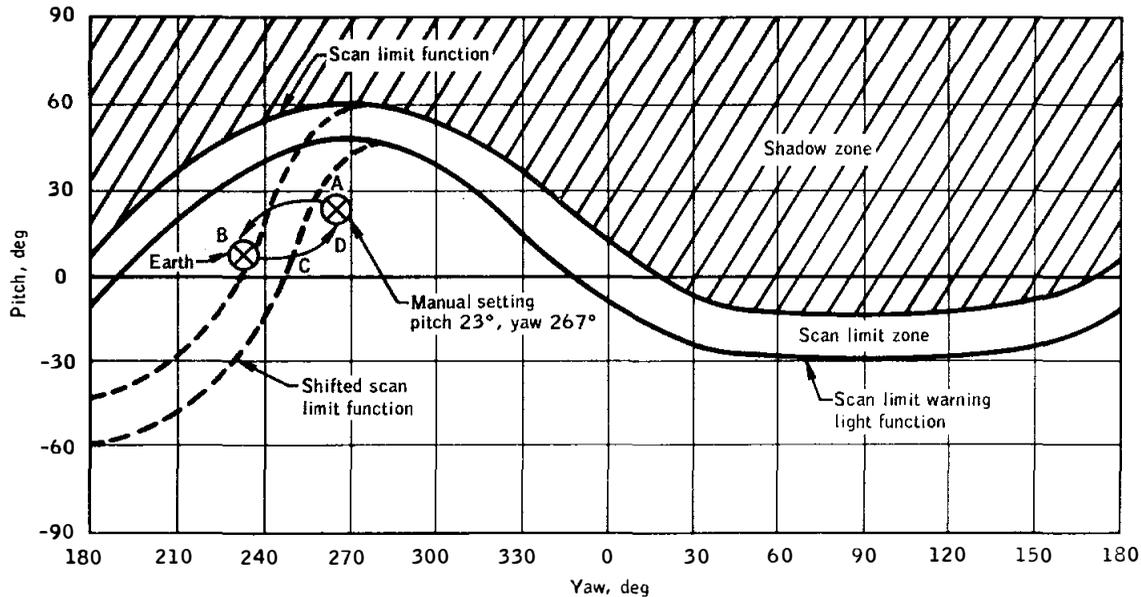
Figure 14-5.- Shift in scan-limit, scan-limit-warning illustrated.

mode and drive back toward the manual settings until the scan limit warning function line at point C was reached, thereby maintaining wide-beam operation. When the antenna reaches the scan limit warning function line, the system would automatically switch to the medium-beam mode and continue to drive in the manual mode until the manual setting error was nulled out at point A. The antenna would then switch to the auto-track mode and repeat the cycle. The most important feature of this cycle is that the antenna moves at the manual scan rate between points B and D, which is confirmed by the rapid changes in the downlink signal strength.

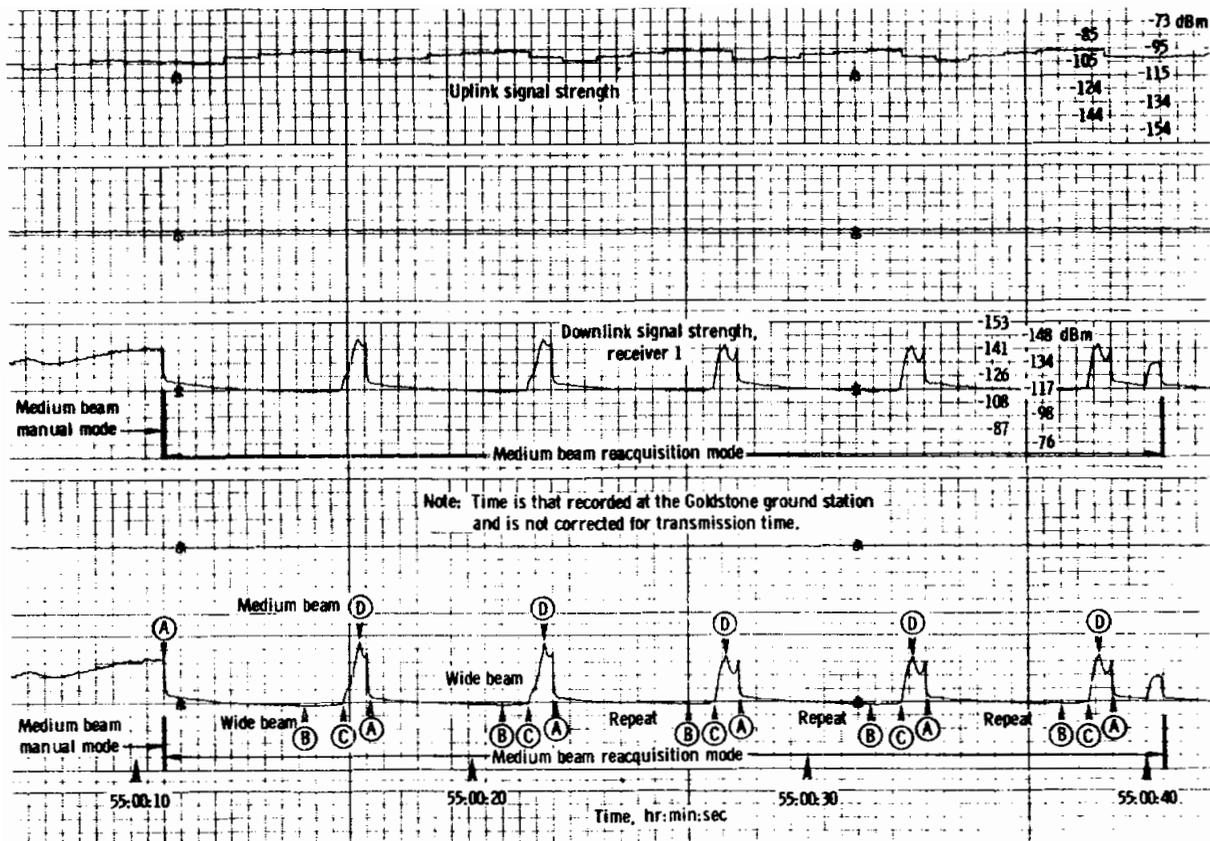
Figure 14-6.- Recorded signal strengths during high-gain antenna operation.

results of this test shifted the scan-limit functions but did not produce the necessary change in the scan-limit slope. Consequently, a failure in the electronic box is ruled out.

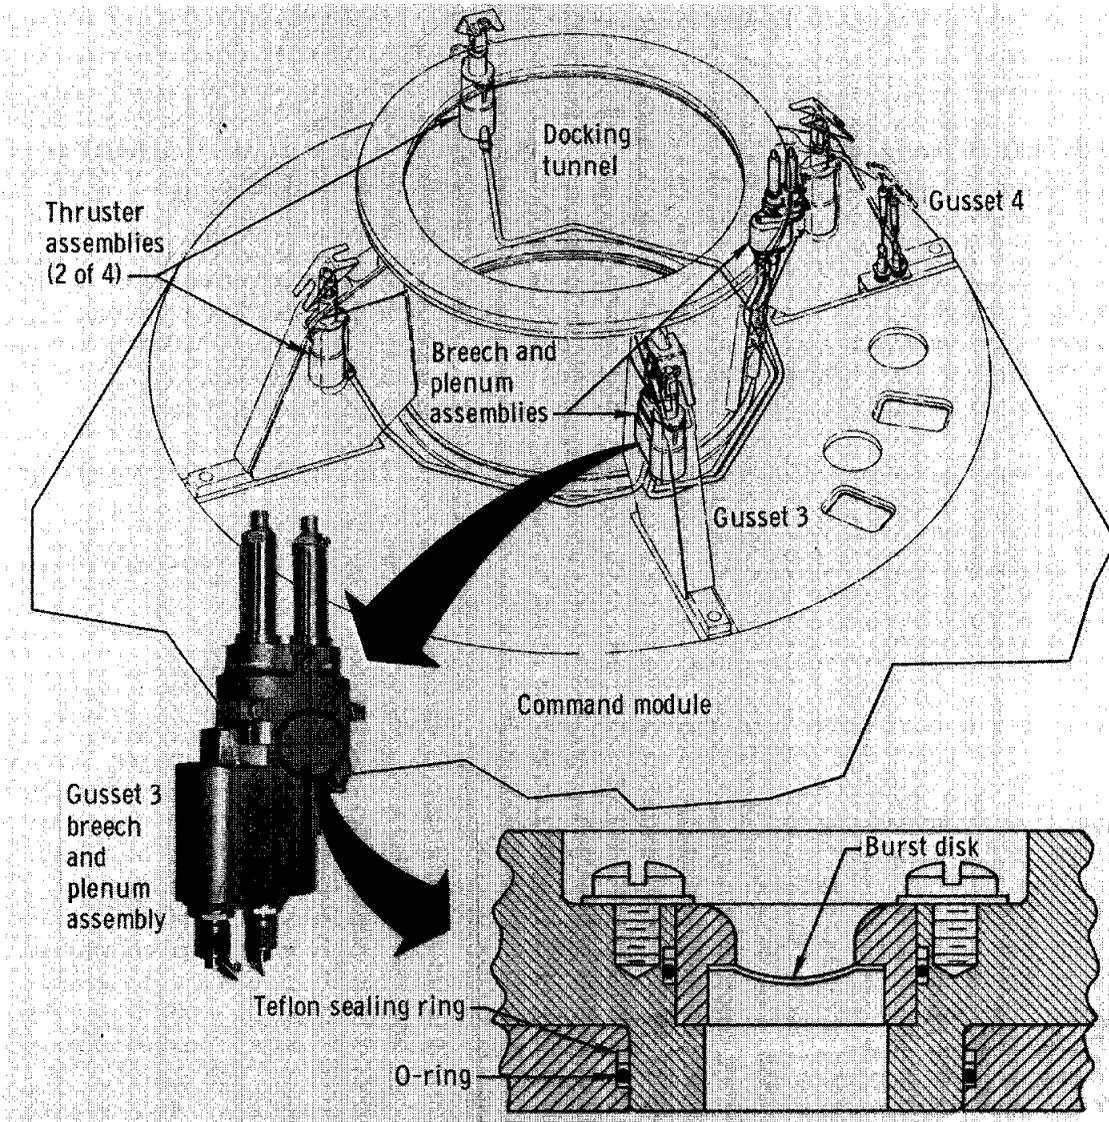
Figure 14-7.- Apex cover jettison system.

- a. Out of tolerance parts - Measurement of the failed parts indicate acceptable dimensions of the metal parts.
- b. Damaged O-rings - The 21 000-psi static proof-pressure test was successful.
- c. Gap in backup ring - The installation procedure specifies the backup ring may be trimmed on assembly to meet installation requirements,

but does not specify any dimensional control over the scarf joint. Since the gap portion was burned away, a gap in the backup ring could have caused the problem.

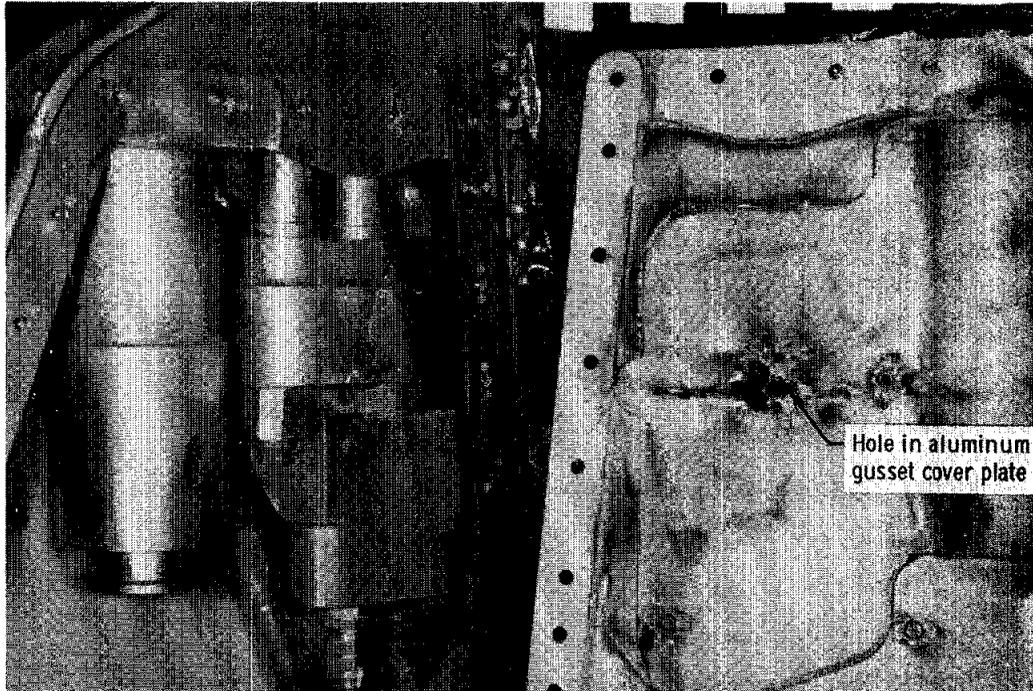
Figure 14-8.- Damage from apex jettison thruster.

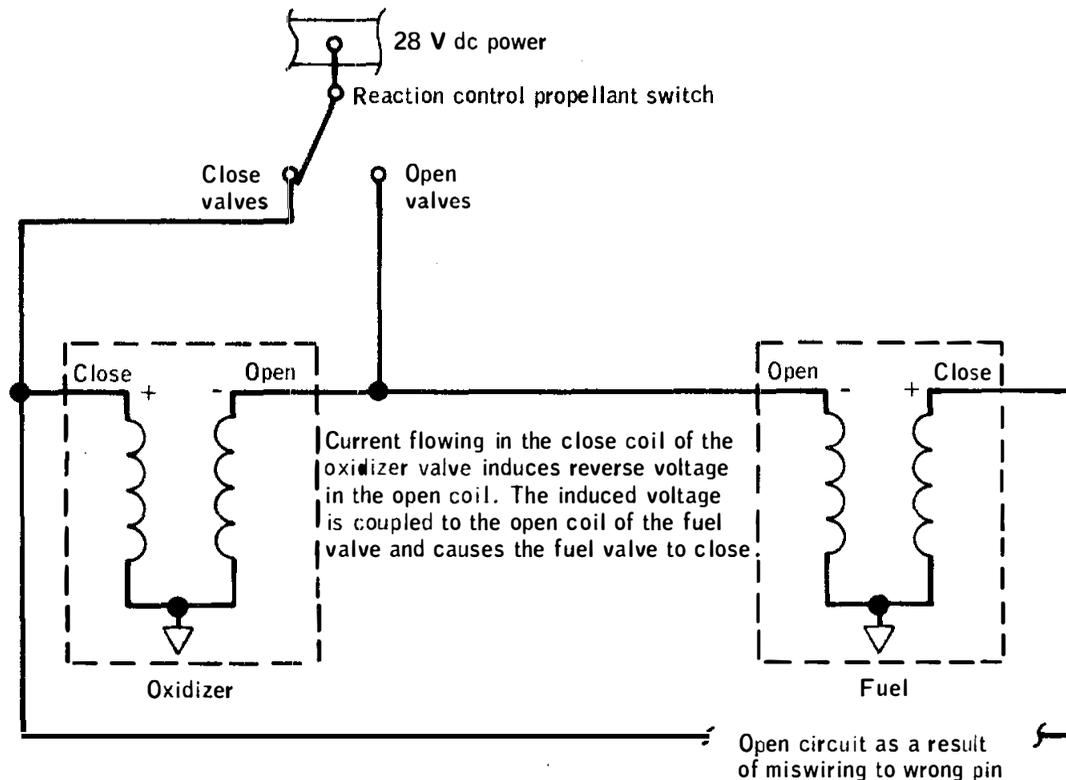
Figure 14-11.- Isolation valve circuit.

action. This voltage is applied to the fuel valve opening coil where it induces a magnetic field flux that closes the fuel valve. With 28 volts or more on the spacecraft bus, this phenomenon was consistently repeatable. With 24 to 28 volts on the bus, the valve would occasionally close, and with less than 24 volts, the valve would not close. Since preflight testing is accomplished at 28 volts, the functional tests did not disclose the miswiring. During the mission, the voltage was such that the valve did not close when commanded and therefore was found open after the flight.

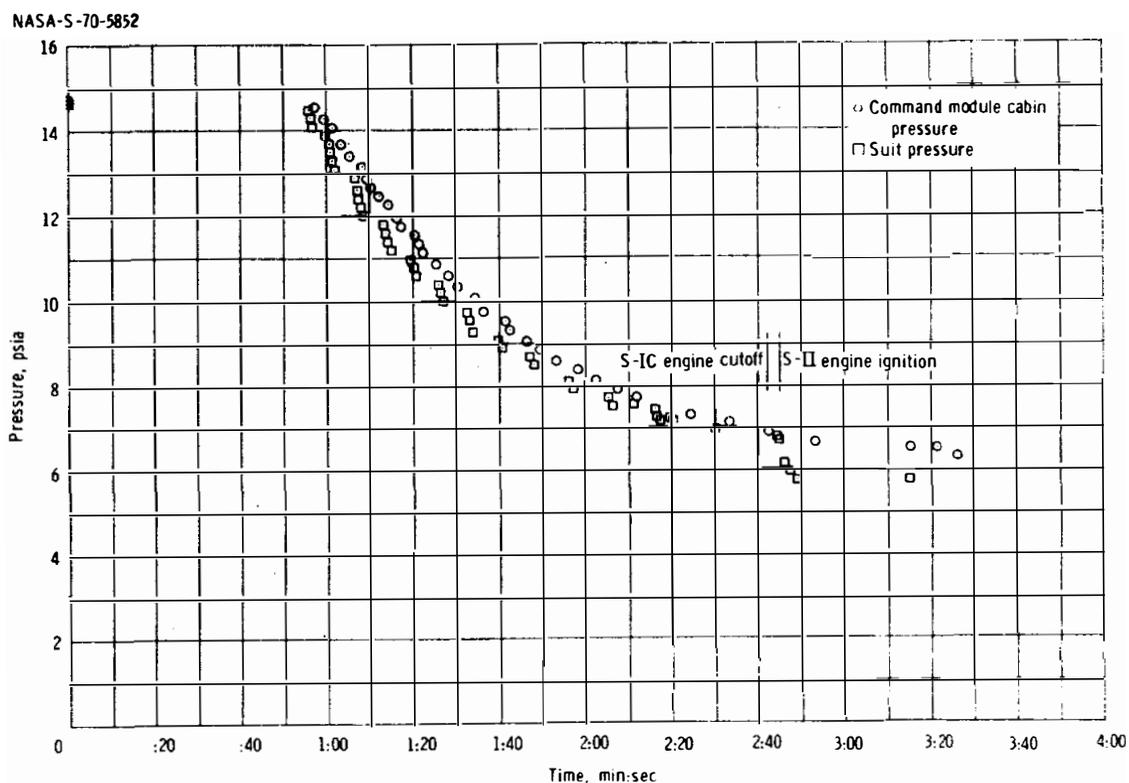
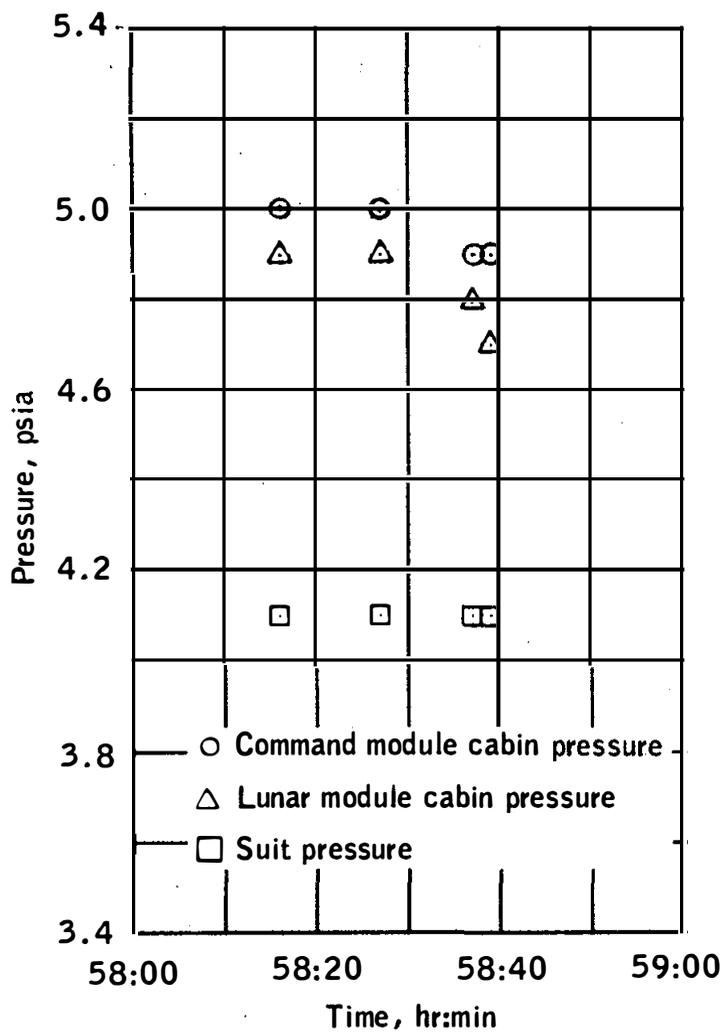
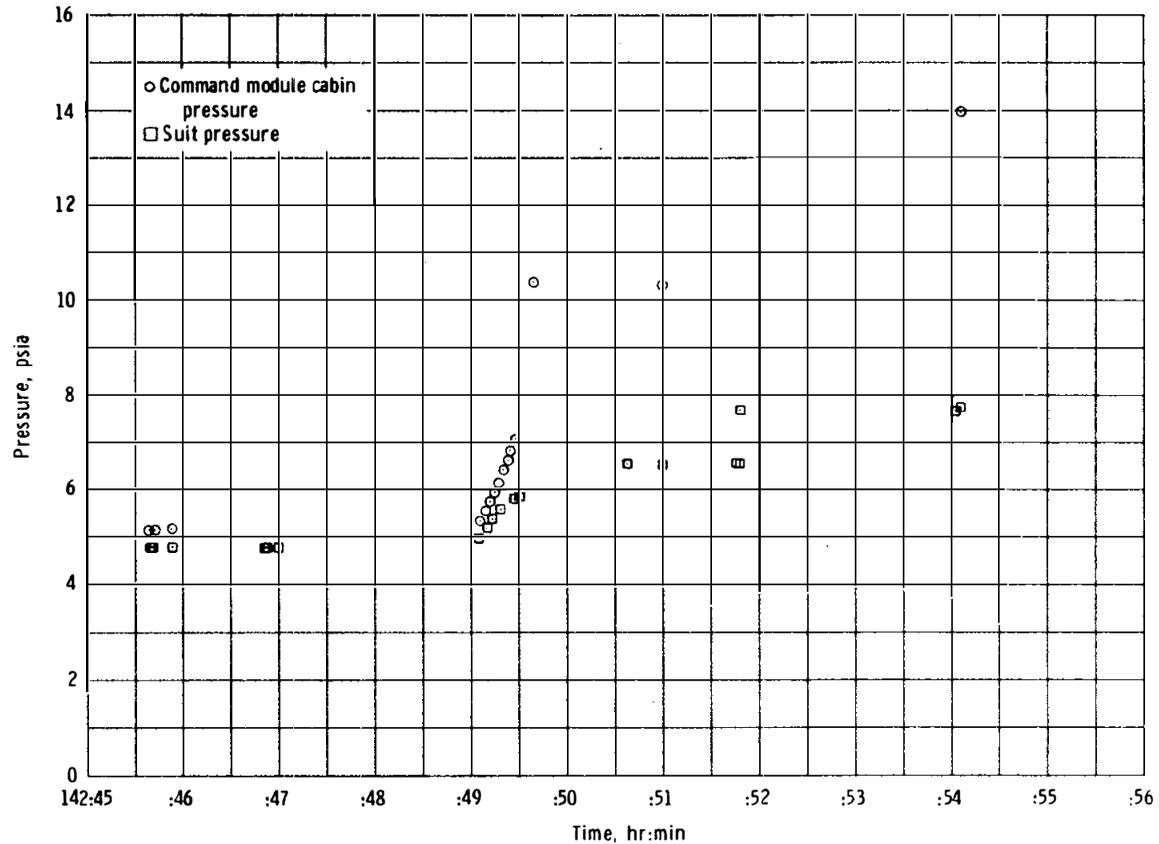
During launch the suit pressure transducer reading remained consistent with cabin pressure until 00:02:45, then suddenly dropped from 6.7 to 5.7 psia coincidentally with S-II engine ignition (fig. 14-12). The difference between the two measurements decreased to only 0.2 by 1-1/2 hours, when the cabin reached its nominal regulated pressure of 5.0 psia. For this shirtsleeve mode, the suit and cabin pressure readings should be nearly equal. During normal variations in the command module cabin pressure, the suit pressure measurement responded sluggishly and indicated as much as 1 psi low. Subsequently, the measurement output decayed and remained in the 4.1 to 4.3 psia range for a cabin pressure of 5.0 psia until system deactivation at about 59 hours (fig. 14-12).

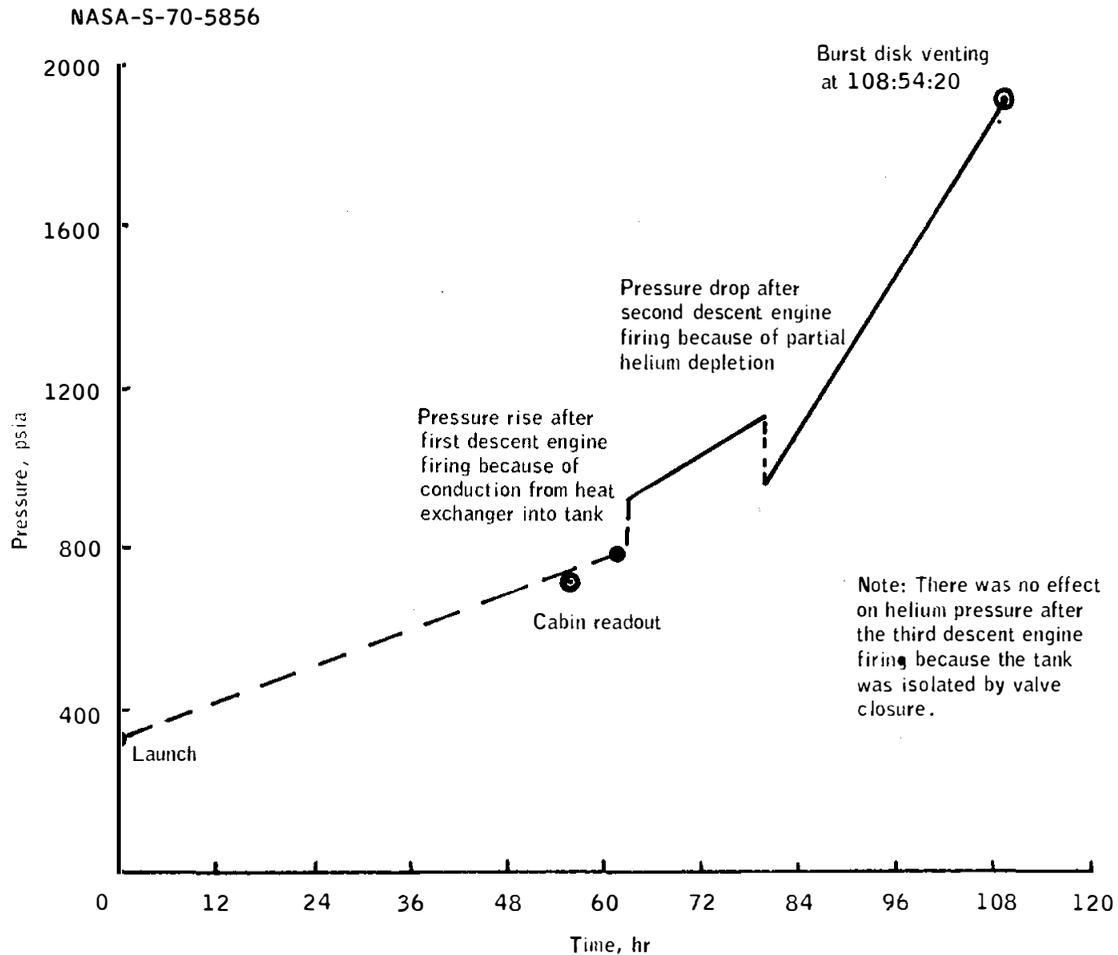
Figure 14-14.- Inflight profile of supercritical helium tank pressure.

The most likely cause of the anomaly is a tank-insulation degradation which would result in increased heat conduction to the helium. The insulating characteristics of the annular vacuum in tank was most likely degraded by the introduction of a contaminant (probably hydrogen) in extremely small concentrations (approximately  $10^{-6}$  pounds). These contaminants when vaporized can exponentially increase the thermal conductivity in proportion to their vapor pressure, as indicated by special tests. While loading helium into the tank, the contaminants would freeze upon the inner shell. In the frozen state, the pressure of the contaminant is too low to significantly affect the thermal conductivity. However, the flow check which preceded the cold-soak operation would vaporize the contaminants in the vicinity of the heat exchanger lines which pass through the annulus. The subsequent increase in thermal conductivity could cause the abnormally high pressure-rise rate observed during the cold soak. These vapors would slowly condense on the cold ( $10^{\circ}$  R) inner wall, resulting in the pressure rise rate dropping to the nominal level, as was observed. The rise rate would remain normal until the helium temperature increased above the vaporization temperature of the contaminant.

A screening test was devised for all future flight tanks to supplement normal helium tank testing. The purpose of this test is to determine the pressure rise rate for a wide range of helium temperatures from approximately  $9^{\circ}$  to  $123^{\circ}$  R. For a perfect tank, the steady-state rise rate should remain at approximately 8 psi/hour over the entire range of temperatures. The Apollo 14, 15, and 16 tanks have been subjected to the screening test, and each exhibit the same phenomena observed during Apollo 13, but to a lesser degree. For new tanks, the manufacturer will periodically analyze the gases removed from the vacuum jacket during pump down for possible contaminants. The pressure in the jacket will be measured 2 or 3 weeks after pumpdown to verify vacuum integrity.

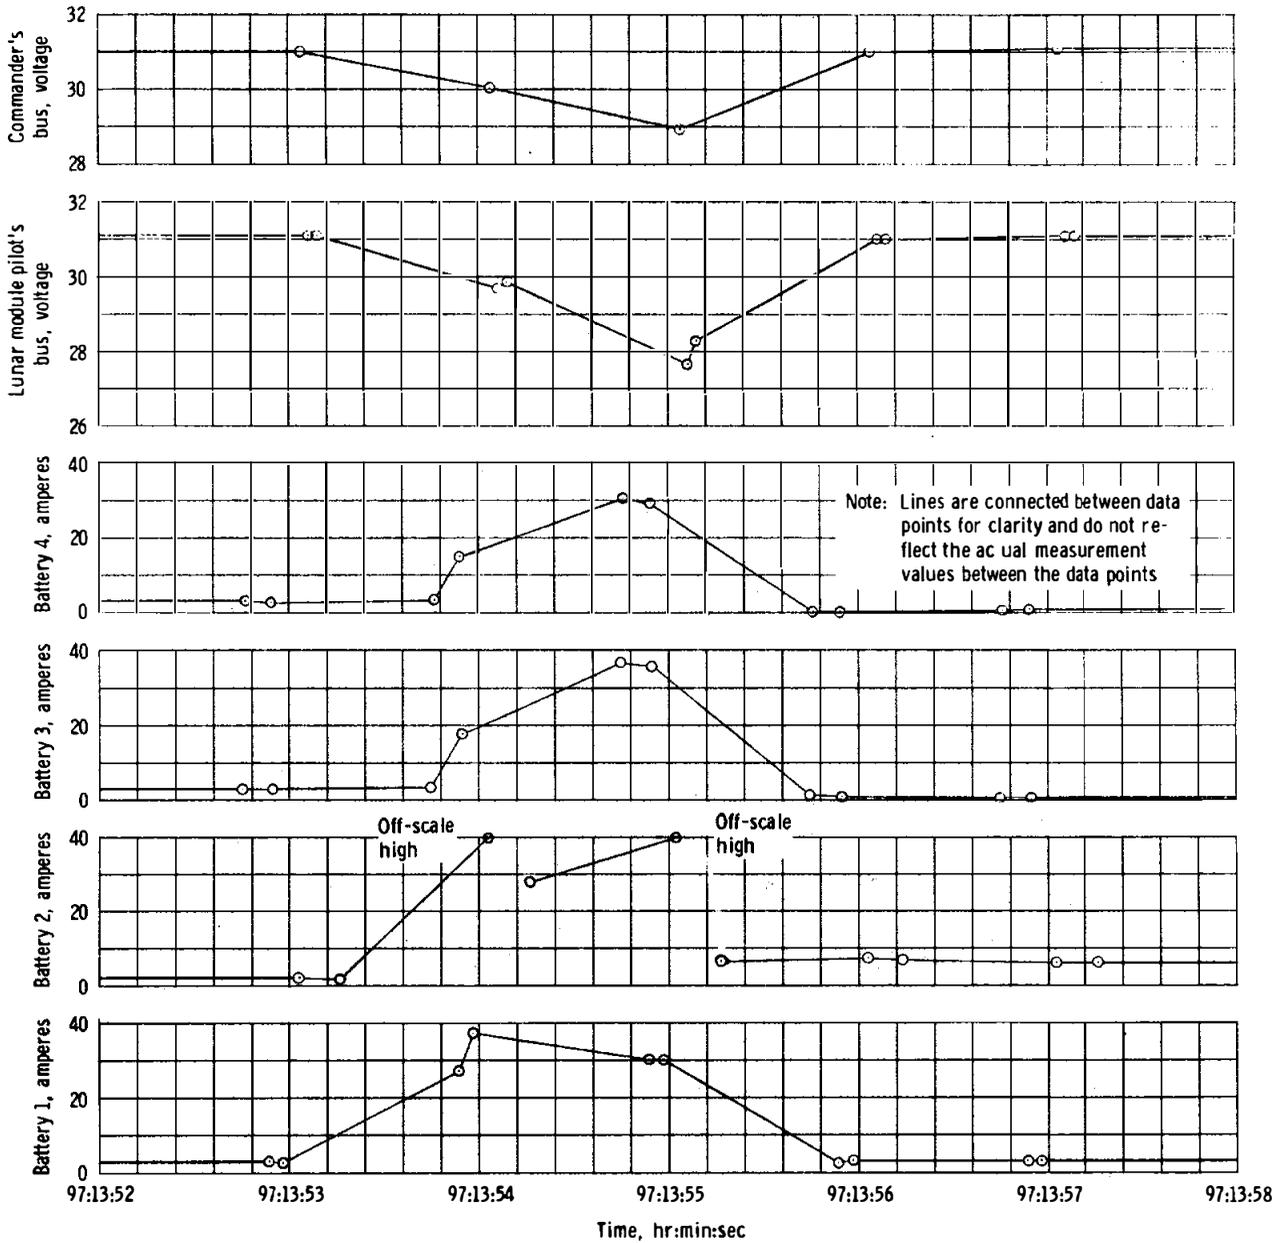
Figure 14-16.- Battery electrical transients.

The thumping noise occurred at about the same time as the current spikes. The current spikes show that a momentary short circuit existed in the Lunar-Module-Pilot side of the dc electrical system, which includes descent batteries 1 and 2 (fig. 14-16). The current surge was not of sufficient duration either to open the balance-load cross-tie circuit breakers, to display a reverse current indication, or to trip a battery-off relay as a result of an overcurrent condition.

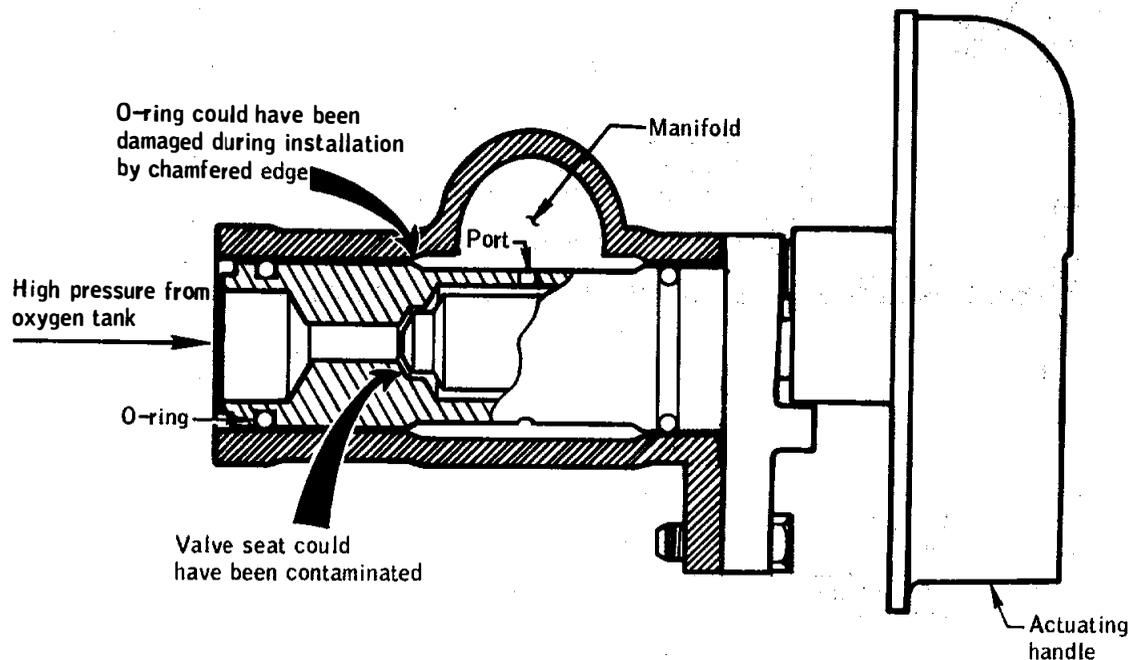
Figure 14-20.- Ascent stage tank shutoff valve.

(fig. 14-20) caused the leakage. When the valve is installed, the forward O-ring can be rolled and damaged when it passes the manifold port. In the other two valves, the cause was not identified and was assumed to be contamination.

compression allowed in the valve design would aggravate the tendency for the O-ring to roll during valve assembly.

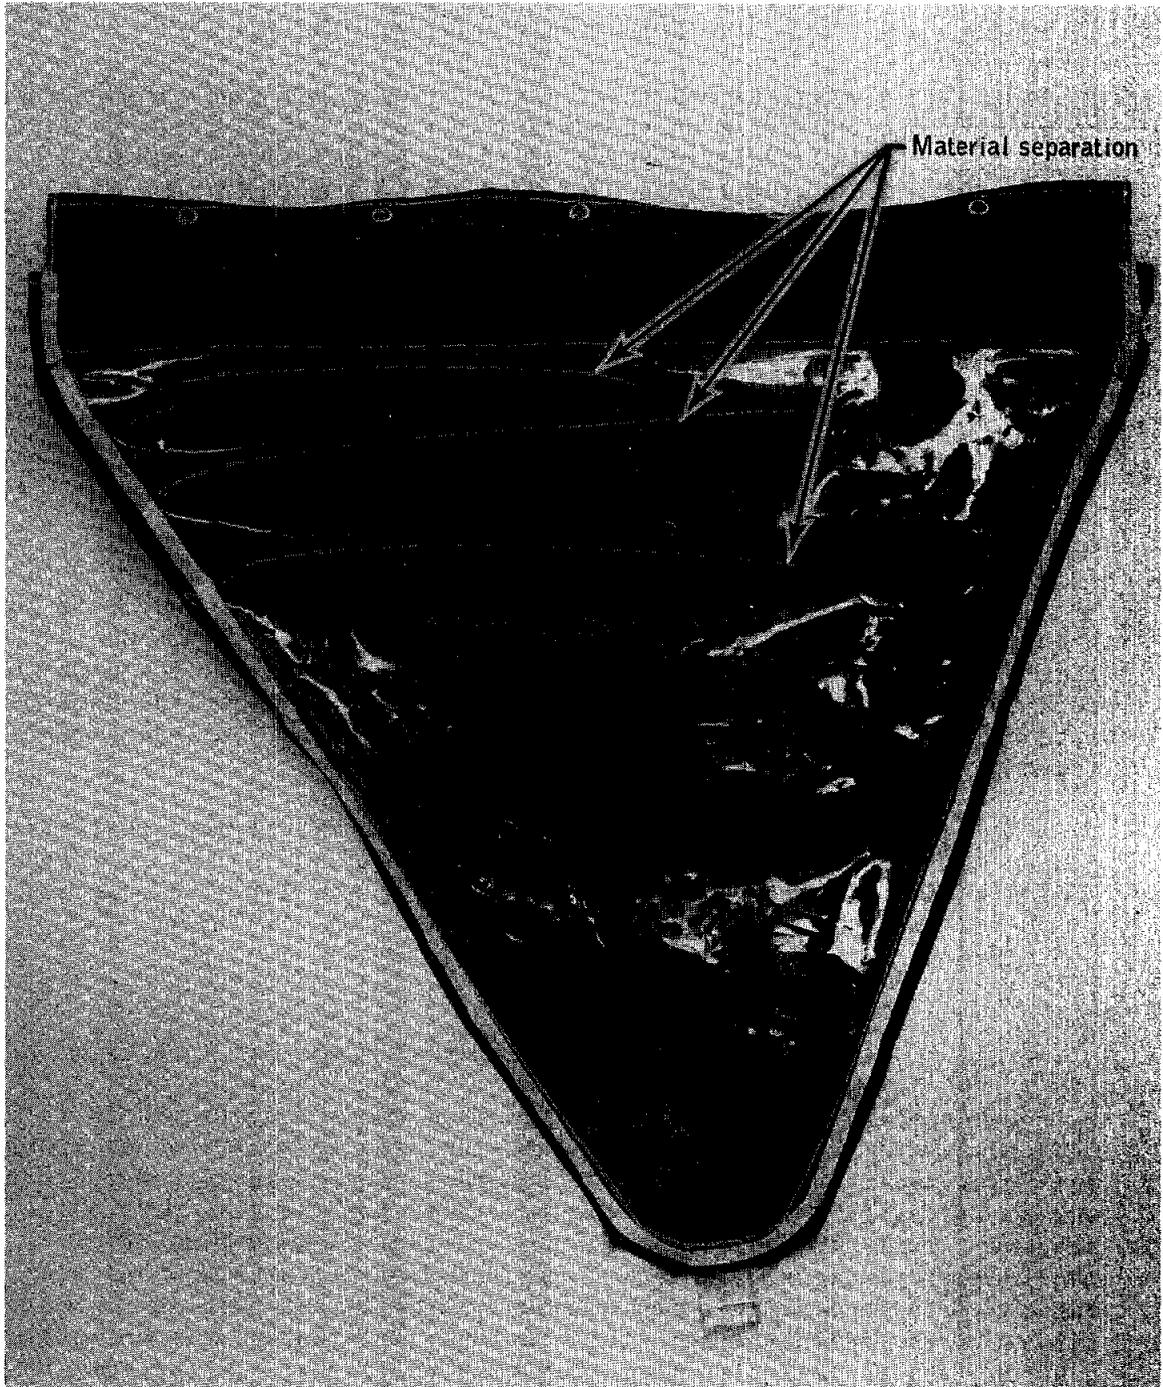
Figure 14-21.- Cracked left-hand window shade.

Cracking as a result of Aclar embrittlement has occurred before, therefore, the Apollo 13 shades were examined prior to flight. Since no cracks were found, the shades were approved for flight.
