14.1.10 Data Recorder Tape Deterioration

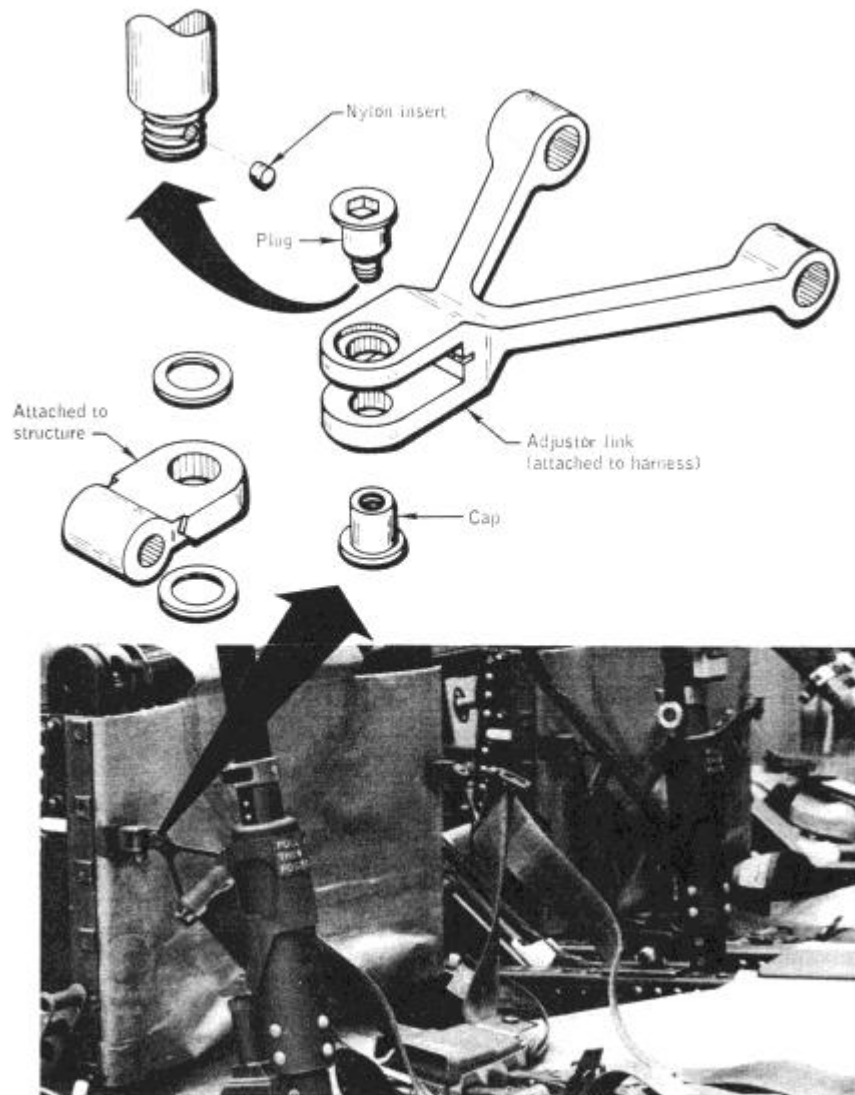
The plug-and-cap assembly (**Fig. 14-18**), which is part of the universal assembly that attaches the restraint harness to the couch seatpan, separated. (There are a total of six plug-and-cap assemblies on the crew couch, two per man.) The plug component (bolt) has a nylon insert in the threaded portion that acts as a locking device. Back-and-forth rotation of the adjuster link can cause the plug-and-cap assembly to unscrew from each other. Checks on the four other Apollo 15 assemblies showed zero torque on two of the units and minimum specification value (2.0 in-lb) on the others. The loss of torque is apparently due to cold flow of the plastic self-locking pellet, causing a loss of friction against the mating threads.

Figure 14-18.- Crew restraint harness connector.

A thread locking sealant will be used to prevent the problem on future missions.

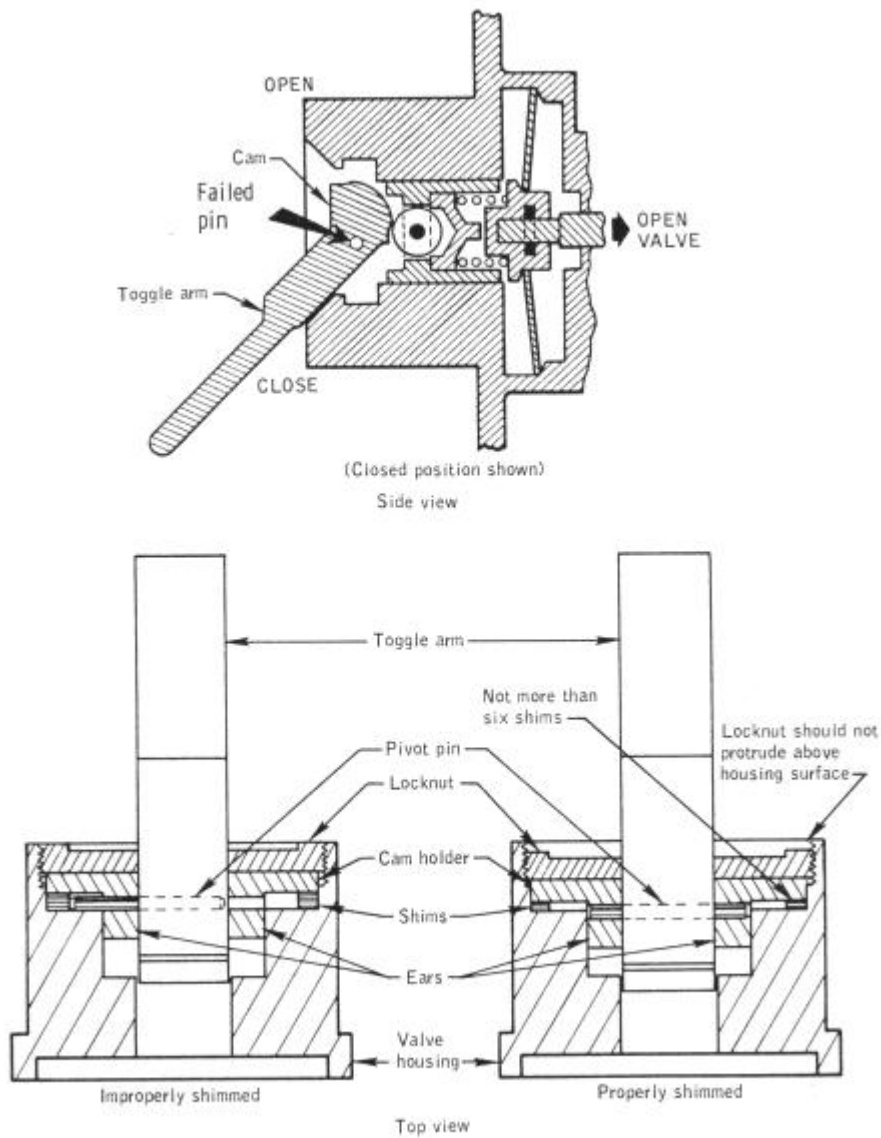
The pivot pin attaches the toggle arm to the cam holder and is retained in place by the valve housing when properly assembled (**Fig. 14-22**).

Figure 14-22.- Oxygen regulator shutoff valve.

Failure analysis showed that the pivot pin failed in single shear and bending. This failure resulted from improper shimming which allowed the pivot pin to come out of one side of the cam holder as shown in **Fig. 14-22**. Analysis and testing has shown that the pin strength is adequate in double shear, but will fail in single shear and bending with a force of about 70 pounds applied at the tip of the toggle arm when it is in the closed position. No marks were found on the toggle arm to indicate that it had been struck by some object.

Inspection criteria to assure that valves now installed in other spacecraft are properly assembled have been developed from a study of adverse tolerance buildups associated

with the valve components. These criteria are that the lock nut does not protrude and the number of shims does not exceed six (fig. 14-22).

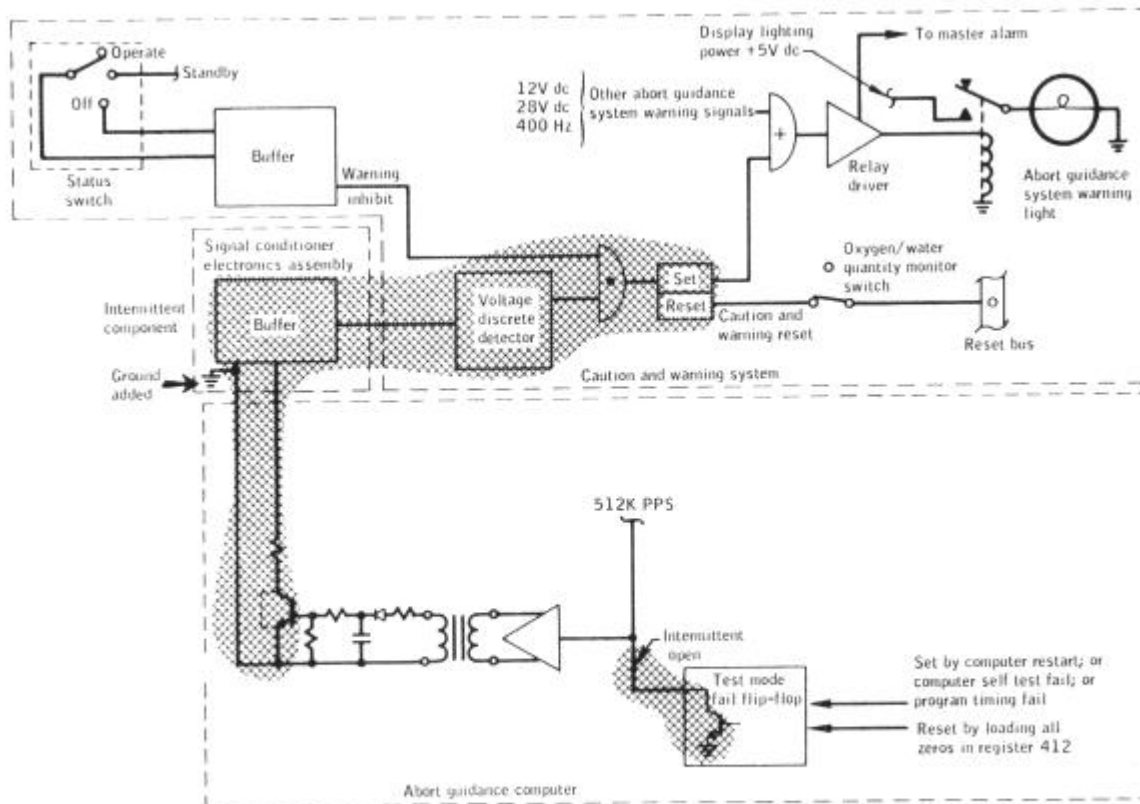
The abort electronics assembly test mode fail output drives a buffer (**Fig. 14-32**) in the signal conditioner electronics assembly which, in turn supplies the test mode fail signal to the caution and warning system. The test mode fail buffer is the only application in the lunar module where a transistor supplies the input signal to the buffer and where the low side of the input to the buffer is not grounded. Tests have shown that some buffers feed back 10-kHz and 600-kHz signals to the buffer input lines. These signals are completely suppressed when the low side of the buffer input is grounded.

Figure 14-32.- Abort guidance system test mode fail circuitry.

With the noise signal voltages present, the test mode fail driver is more susceptible to electromagnetic interference. An analysis indicates that, with worst-case noise signals present, an induced voltage spike of only about 3.5 volts will cause the test mode fail driver to momentarily turn on and latch the caution and warning system master alarm and abort guidance system warning light on.

For future spacecraft, the low side of the input to the buffer will be grounded.

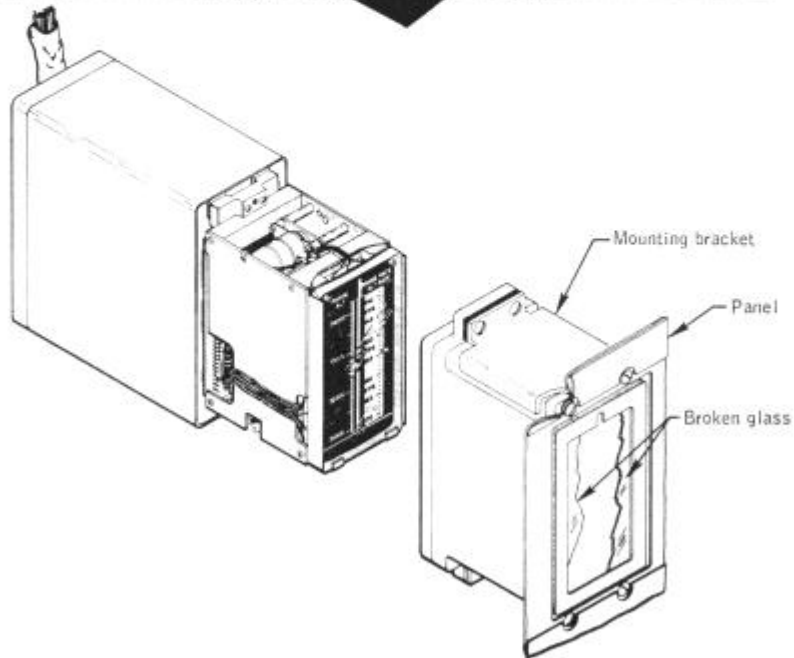
Sometime prior to ingress into the lunar module, the window of the range/range-rate meter broke (Fig. 14-34). Upon ingress, the crew saw many glass particles floating in the spacecraft, presenting a hazardous situation.

Figure 14-34.- Range/range rate meter mounting.

The window is an integral part of the meter case and is made of annealed soda-lime glass 0.085-inch thick. The meter case is hermetically sealed and pressurized with helium to 14.7 psia at ambient temperature. At the maximum meter operating temperature and with the cabin at vacuum, the pressure differential can be as high as 16.1 psi. This pressure differential is equivalent to a stress level of 6680 psi in the glass.

Glass will break when there is a surface flaw large enough to grow at the stress levels present. The threshold flaw size in a dry environment is about the same as the critical flaw size and immediate breakage occurs. The critical flaw size remains the same in a humid environment, but the threshold flaw is much smaller. For annealed soda-lime glass at a stress level of 6680 psi, the critical flaw depth is 0.0036 inch, and for a humid

For future missions, an exterior glass doubler will be added to the flaw depth to 0.0036 inch and the critical flaw depth to 0.032 inch. This should prevent future fatigue failures since there are no reported fatigue failures in soda-lime glass at stresses below 2000 psi. In addition, all similar glass applications in the lunar module and command module were reviewed and changes are being made. In the command module, transparent Teflon shields will be installed on the:
