14.3.2 Loss of Laser Altimeter Altitude Data

14.3.3 Slow Deployment Of Mapping Camera

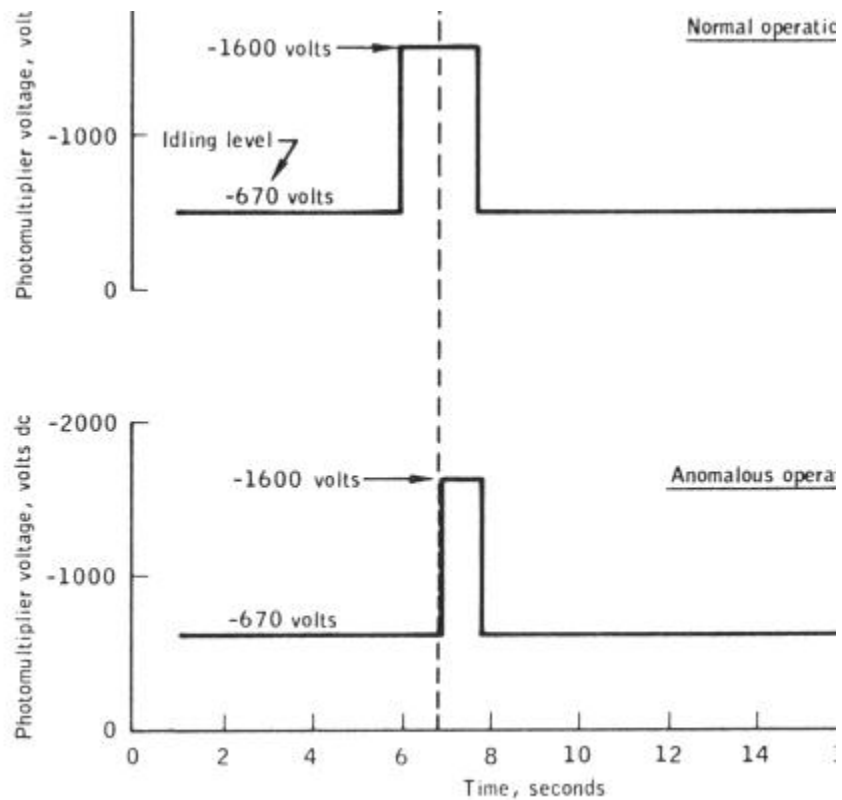
Figure 14-37.- Comparison of photomultiplier power supply volt.

- a. Altitude data became intermittent after revolution 24 as the result of a decrease in the laser output power.
- b. Beginning with revolution 38, the photomultiplier tube high-voltage power supply was held in the idling (minimum-voltage level) mode until after the laser fired, thereby causing the receiver to miss the return pulse from the lunar surface (**Fig. 14-37**). No altitude data were obtained after this anomaly occurred.

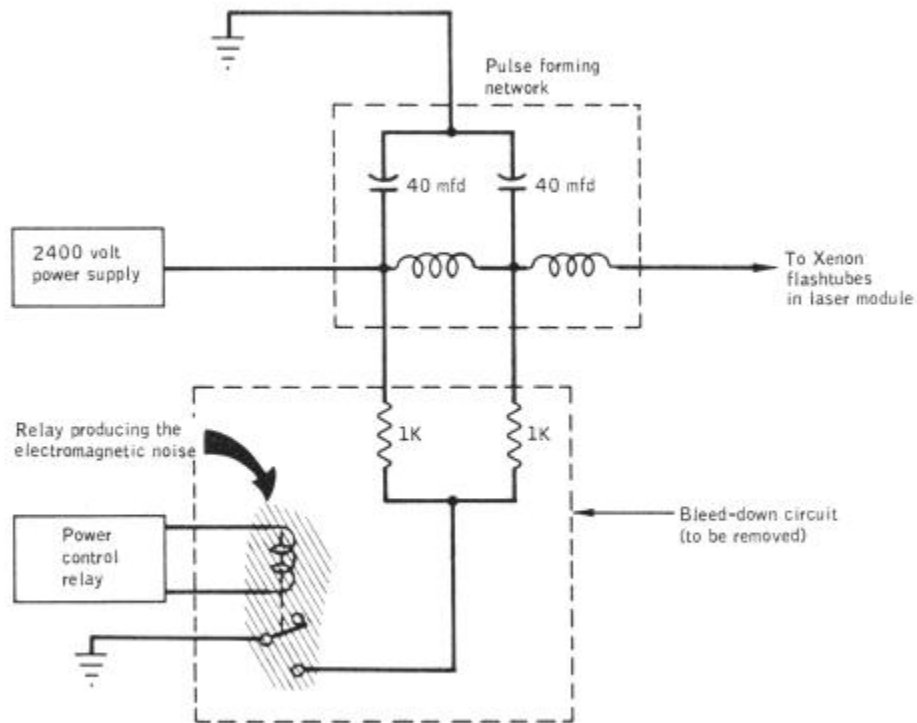
Figure 14-38.- Pulse forming network bleed-down circuit.

The photomultiplier tube power supply anomaly was duplicated when a relay which had been removed from a flight unit because it had an audible "buzz" was installed in the prototype altimeter. The relay serves no function in flight, but is a safety precaution for ground personnel working on the altimeter (**Fig. 14-38**). The relay contacts close when the altimeter is turned off, discharging the high voltage stored in the pulse forming network capacitors.

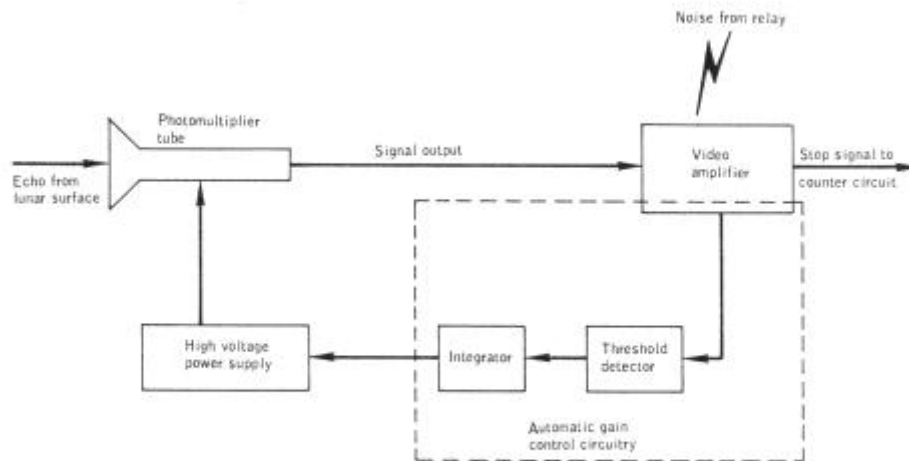
Figure 14-39.- Laser receiver circuitry.

It is suspected that the audible "buzz" is accompanied by electromagnetic interference that is coupled into the video amplifier in the laser receiver (**Fig. 14-39**). The video amplifier is a principal element in the automatic gain control circuit which controls the output of the photomultiplier tube power supply. The electromagnetic interference from the relay can thereby result in the automatic gain control holding the power supply in the idling mode until the pulse forming network is discharged in firing the laser. The relay and resistors that comprise the bleed-down circuit will be removed from the remaining flight altimeters.

An automatic power compensation circuit will be incorporated into the remaining flight units. The circuit will increase the pulse forming network voltage by about 50 volts each time the laser power falls below an established threshold value as sensed by a photodiode. Design feasibility tests have been completed on a breadboard circuit. The results show that the circuit will maintain the power output at a level sufficient to provide proper ranging.

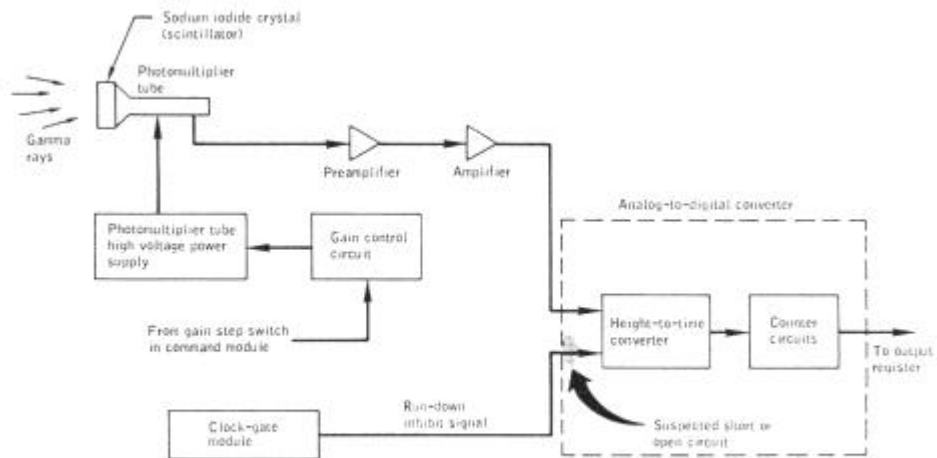
Figure 14-40.- Gamma ray spectrometer circuitry.

Tests conducted with the qualification unit verified that the change in gain was due to aging effects of the photomultiplier tube in the gamma ray detector assembly as a result of high cosmic ray flux rates in lunar operation. The zero shift appears to be associated with the run-down inhibit signal between the clock-gate module and the analog-to-digital converter (**Fig. 14-40**).

Absence of this signal at a particular point in the analog-to-digital converter removes a 3-microsecond offset in the pulse height analyzer. The resulting effect is an overall eight-channel offset in the spectrum. The qualification unit was partially disassembled and tests showed that either an open or a shorted wire within the pulse height analyzer can result in an eight-channel offset. An inspection of the circuit in the qualification unit disclosed no design deficiency which would cause this type of failure. Since the eight channel zero offset does not significantly impact overall data quality, no corrective action is contemplated.

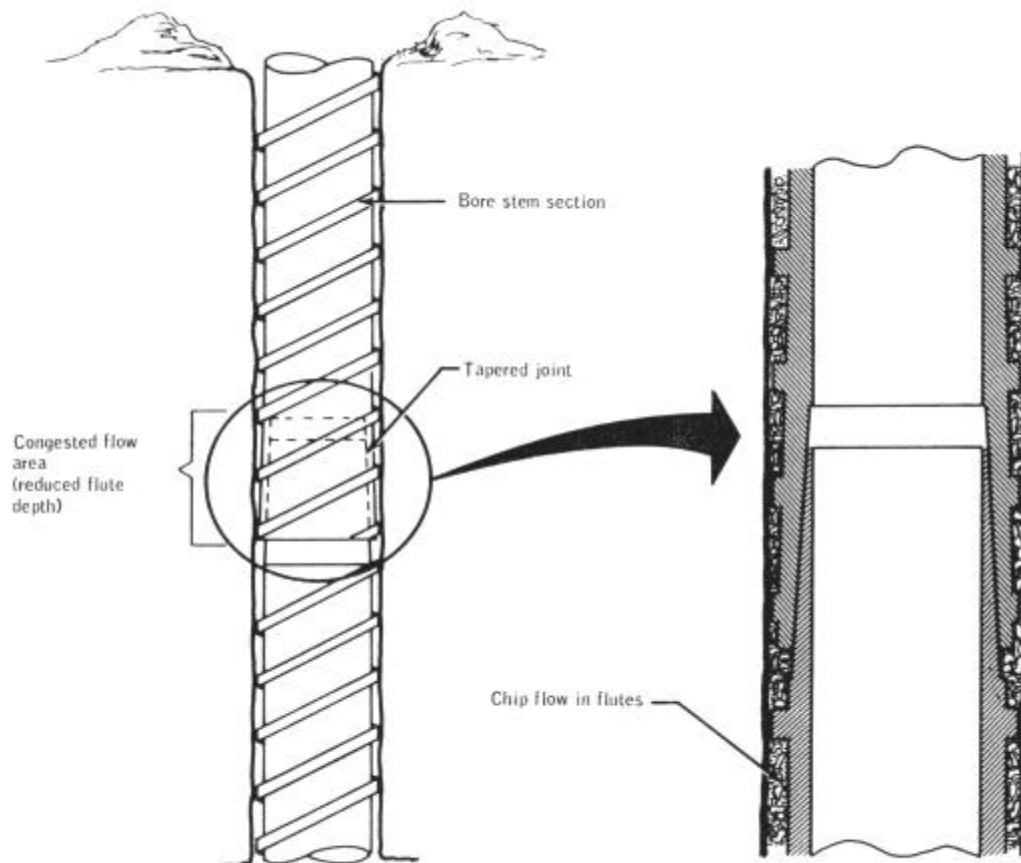
Figure 14-41.- Congestion at bore stem joints.

Although the average penetration rate for the two bore stem holes was reasonable (approximately 120 inches per minute for hole 1, and 18 inches per minute for hole 2), it was necessary to stop both holes at approximately 60 percent of the depth desired.

The bore stem sections are made of a fiberglass and boron filament laminate, chosen for its optimum thermal characteristics as a casing for the heat flow experiment probe. The sections are approximately 21 inches long with tapered male and female joints. One-inch double-thread spiral lead flutes are provided on the exterior surface to transport the soil chips from the drilled hole to the surface. The depth of the flutes is 0.050 inch for about 18 inches, but the flutes almost disappear at the joint area where the wall thickness must follow the taper of the joint (**Fig. 14-41**). As a result, the volume of chip flow to the surface is slowed considerably in looser soil formations, and stalled by the packing of the chips in high-density formations.

The bore stem joints will be changed from boron/fiberglass tapered joints to threaded titanium inserts which provide continuous flutes as do the core stems. The thread configuration also provides a more positive connection, precluding inadvertent separation of the joint in the hole.

The length of the first (bottom) bore stem section will be increased so that the 43-inch probe for the heat flow experiment is housed entirely in the boron/fiberglass material and the titanium joint is not in the probe region.

The length of the remaining sections will be increased by a small amount, which will reduce the number of joints for the crew to mate as well as keep the titanium away from the experiment thermocouples.

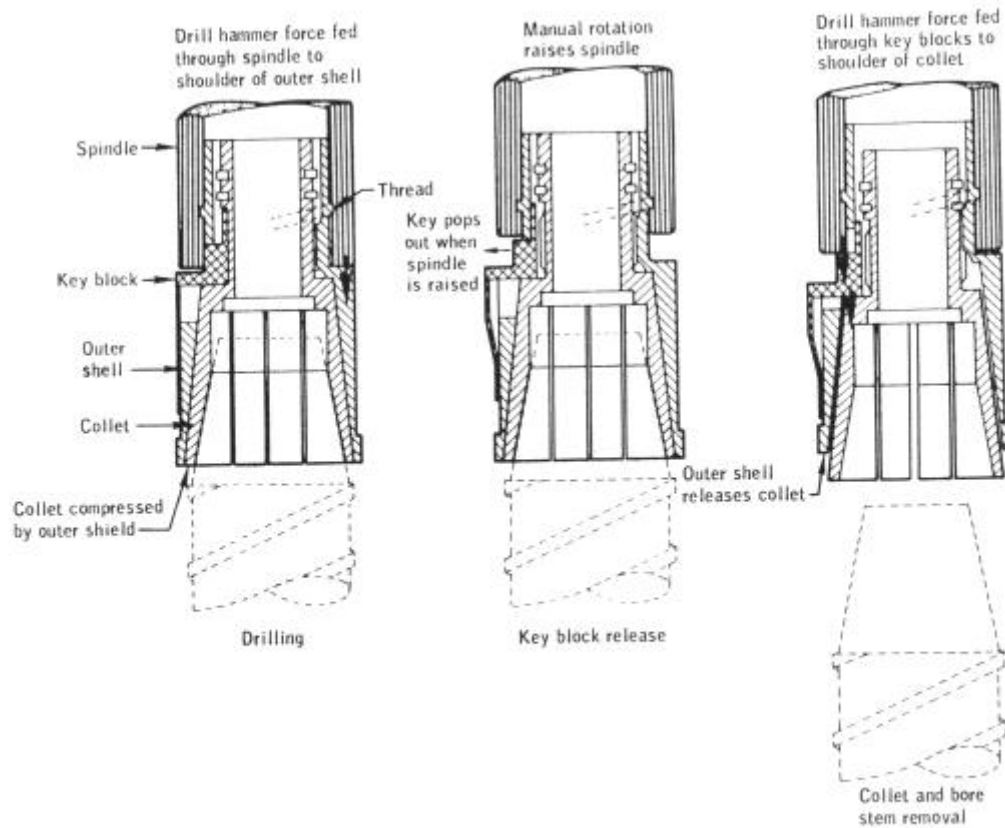
Figure 14-42.- Release of bore stem from drill.

In the bore stem drilling position, the key blocks are restrained inside, and the spindle drives against the shoulder of the adapter outer shell (**Fig. 14-42**). The operational sequence to release the bore stem from the adapter includes the following steps:

The single-purpose core stem wrench is fitted to the 0.983-inch- diameter titanium core stem, but the 1.088-inch throat will admit the 1.075-inch-diameter bore stem. The softer bore stem (boron-fiberglass laminate) can be deformed and present some difficulty in wrench removal, with possible damage to the bore stem. A wrench to fit both bore and core stems will be provided.

The change of the bore stem joint, discussed in the previous anomaly, will result in the elimination of the present bore stem drill adapter. The bore stem will thread into the power head spindle adapter in the same manner as the core stems on Apollo 15 and a spindle thread reducer will be provided to fit the core stems. In addition, the training models and procedures will be updated to reflect equipment changes.

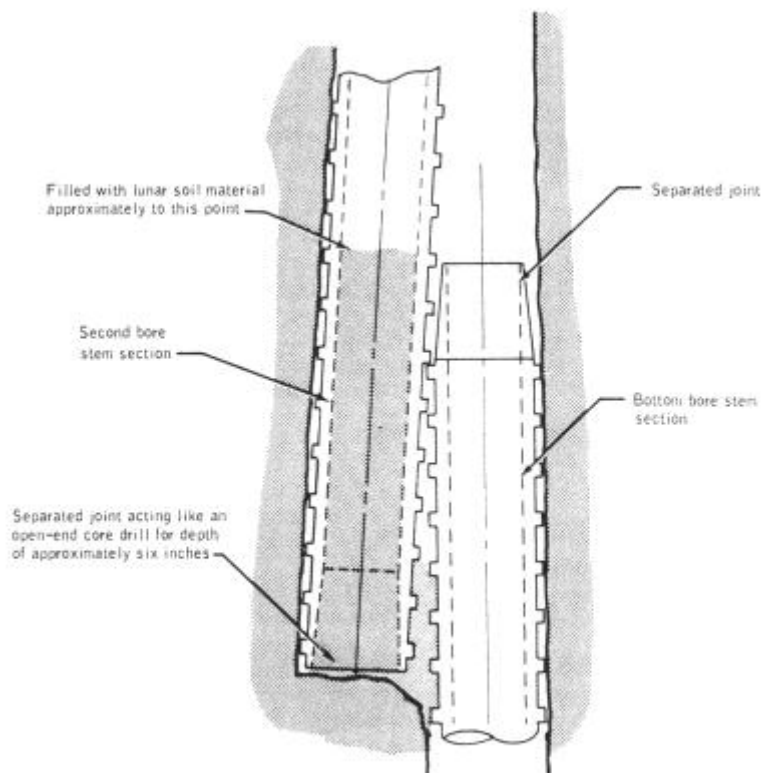
Figure 14-43.- Bore stem joint separation.

The probe would not go to the bottom plug of the bottom bore stem in hole 2, but stopped at a point about 6 inches above the first joint. Examination of photographs and heat flow probe data indicate that, near the end of the bore stem drilling operation, the first joint was separated when the drill and drill string were moved vertically (up and down) in an attempt to improve the drill penetration rate. Easier penetration (for approximately 6 inches) was reported by the crew, but it resulted from the bottom of the second section apparently performing more in a coring manner (**Fig. 14-43**) with the lunar soil entering the second section of the bore stem.

The change from boron/fiberglass to threaded titanium in the bore stem joint will prevent a repetition of such a separation.

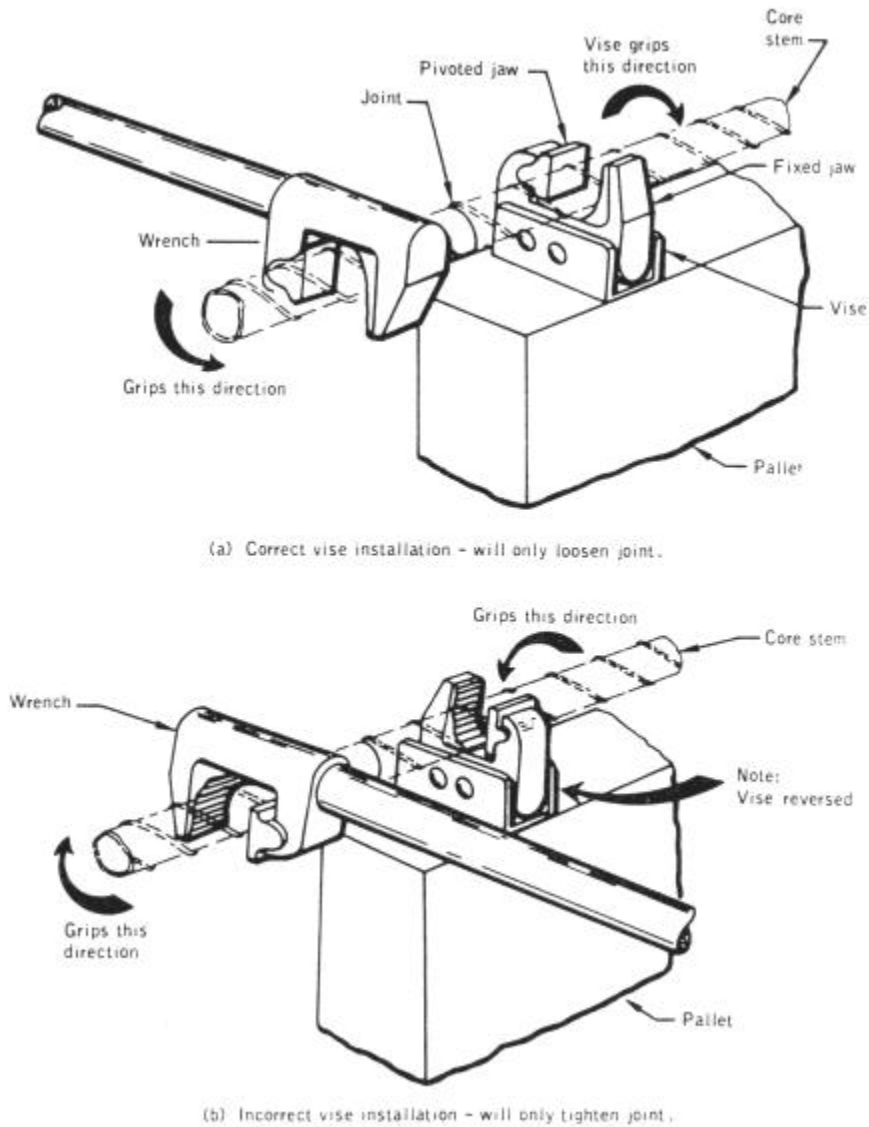
Figure 14-44.- Installation of core stem vise on rover pallet.

The sections of the core stem string could not be separated using the vise and wrench because the vise had been mounted on the pallet backward. The six section core stem string was removed from the core hole as a single unit and brought to the vise on the lunar roving vehicle. Three sections were separated individually with hand friction on one side of the joint and the wrench on the other side. The remaining three sections were returned to the earth in one piece.

As mounted, the vise would hold the core stem so that the joint could be tightened by rotating the wrench on the adjoining section. However, the vise would not hold in the opposite direction so that the joint could be loosened and separated (**Fig. 14-44**). Working on the inboard side of the vise, the core stem could have been held properly for loosening; however, there is insufficient clearance on the inboard side of the vise for

wrench rotation, and the distance to the other side of the lunar roving vehicle is greater than the length of a core stem section.

The installation drawing of the vise was in error and has been corrected to assure correct orientation of the vise for Apollo 16. The training vise was installed backward from the erroneous drawing, but correct for loosening the stems.

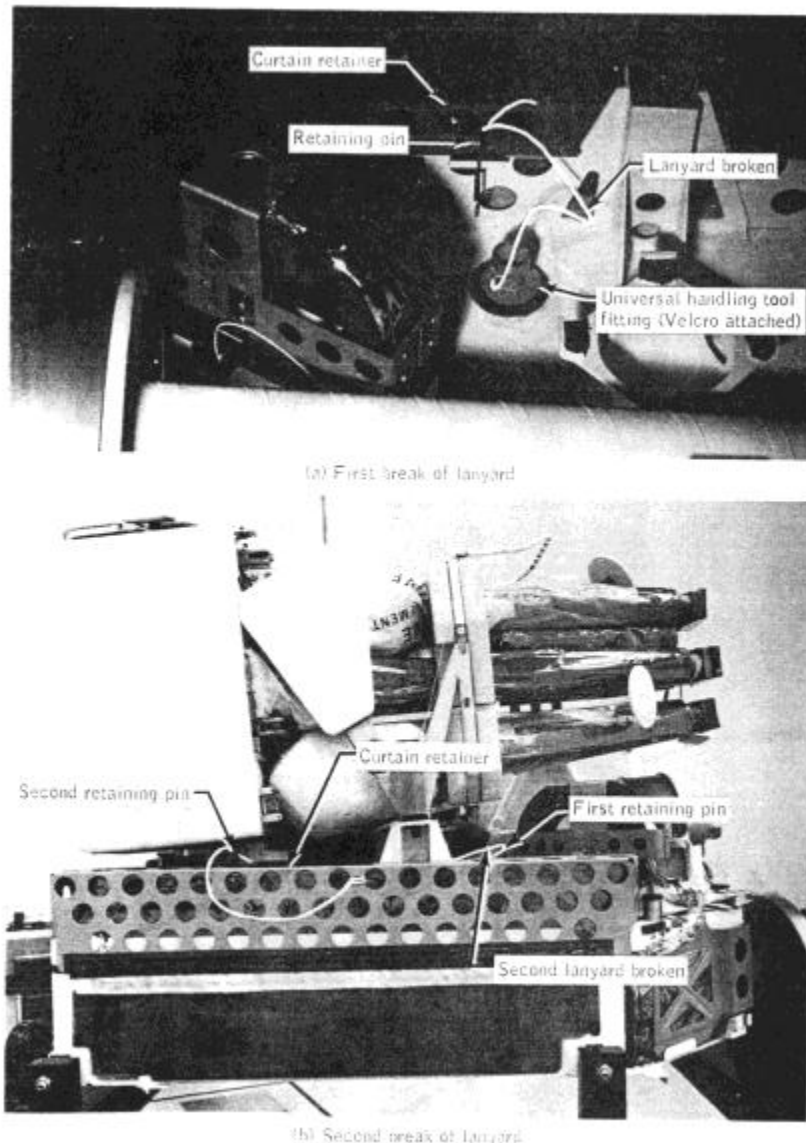
Figure 14-45.- Central station rear curtain retainer removal.

To remove the retainer for the central station rear curtain, added for Apollo 15, it was necessary to remove two retaining pins (**Fig. 14-45**). The two pins, a universal handling tool fitting, and the curtain retainer are joined by a three-section lanyard. When the universal handling tool was inserted in the fitting and raised to remove the first pin, that section of the lanyard broke. When an effort was made to remove both pins simultaneously by inserting the handle under the lanyard joining the two pins, that part of the lanyard broke. The pins and retainer were then removed by hand.

The Dacron lanyard is being changed from a 50-pound test rated material to a 180-pound test rated material with acceptance pull tests being increased to 20 pounds for

the entire system.

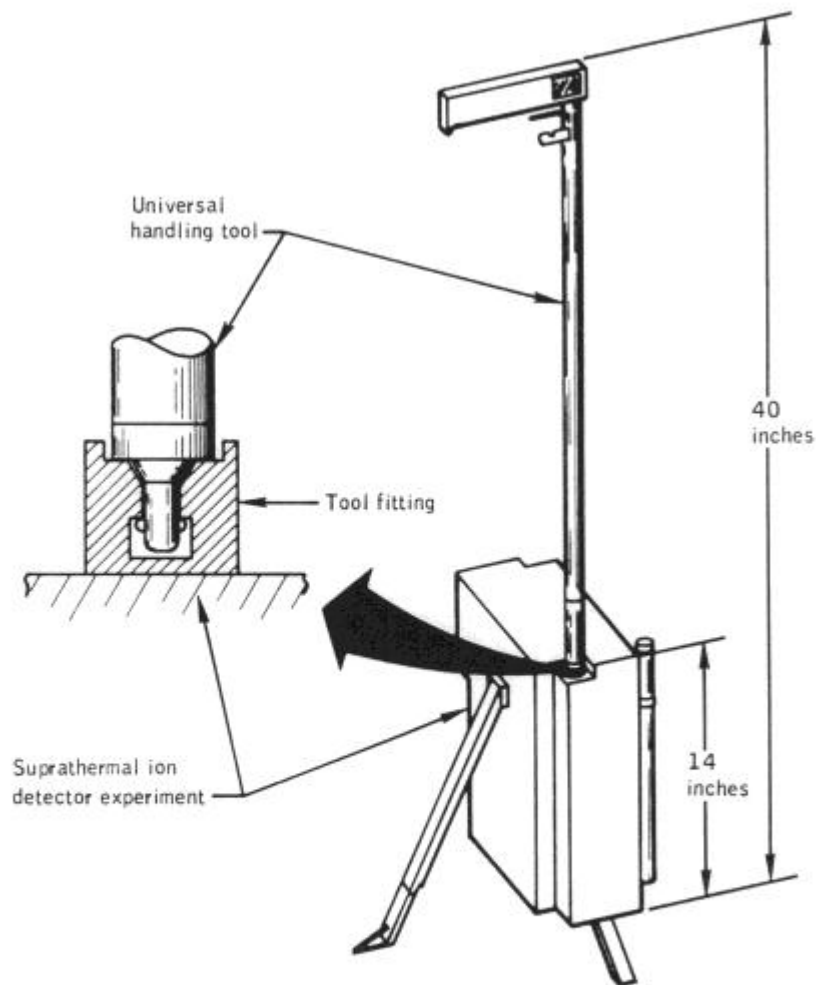
Figure 14-46.- Universal handling tool - suprathermal ion detector experiment interface.

While carrying the suprathermal ion detector experiment from the subpallet to the emplacement site, the experiment fell off the universal handling tool at least twice. The experiment sustained no visible damage and has been operating satisfactorily.

The universal handling tool fitting on this experiment is in the highest location above the lunar surface of any of the fittings and presents an awkward position of the tool for insertion, locking, and maintaining lock in the fitting (**Fig. 14-46**).

Corrective action includes training procedures to avoid inadvertent tool-release triggering because of the position of the tool. There are no present plans for the suprathreshold ion detector experiment to be carried on future missions, and no other scheduled experiments have a similarly located fitting.

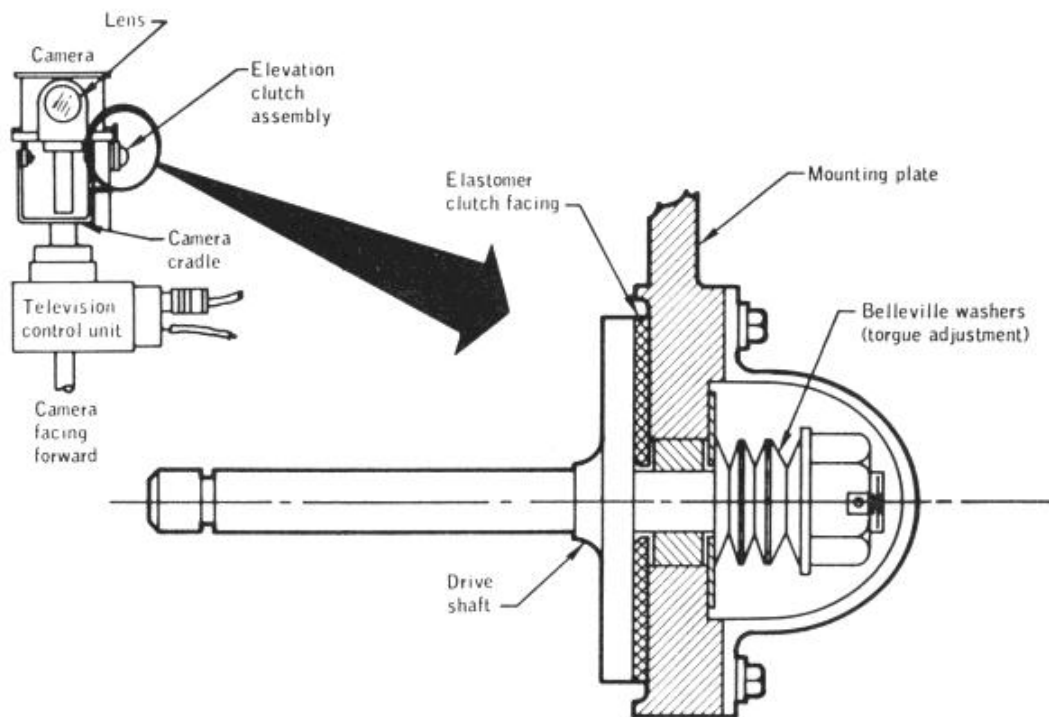
Figure 14-47.- Camera elevation control clutch.

Elevation control is provided to the camera cradle through a friction clutch (Fig. 14-47) which allows manual override of the ground-commanded camera positioning. The camera-cradle pivot point is approximately 3 inches below the center of gravity of the cradle with the camera mounted. As the camera moves away from the horizontal position, the unbalanced moment becomes progressively greater, and a higher torque load must be supported by the clutch mechanism.

The elastomer clutch-facing material provided the required stable friction properties in the specification and qualification test temperature range (122° F, maximum). However, the maximum temperature on the television control unit during the third extravehicular activity has been calculated as approximately 180° F. Materials specifications show that the compressive strength of the elastomer degrades rapidly at this temperature, and ground tests with flight unit 4 verify severely degraded performance with time at elevated temperature.

The clutch is being changed to a metal-to-metal spring ring design in place of the elastomer disc. The clutch torque for Apollo 15 was set at 16 inch-pounds for ease of manual adjustment. For greater stability on Apollo 16, the new clutch is being built with a torque of 30 inch-pounds, which is still comfortable for manual positioning and is within design limits of the system, including the gear train (35 inch-pounds).

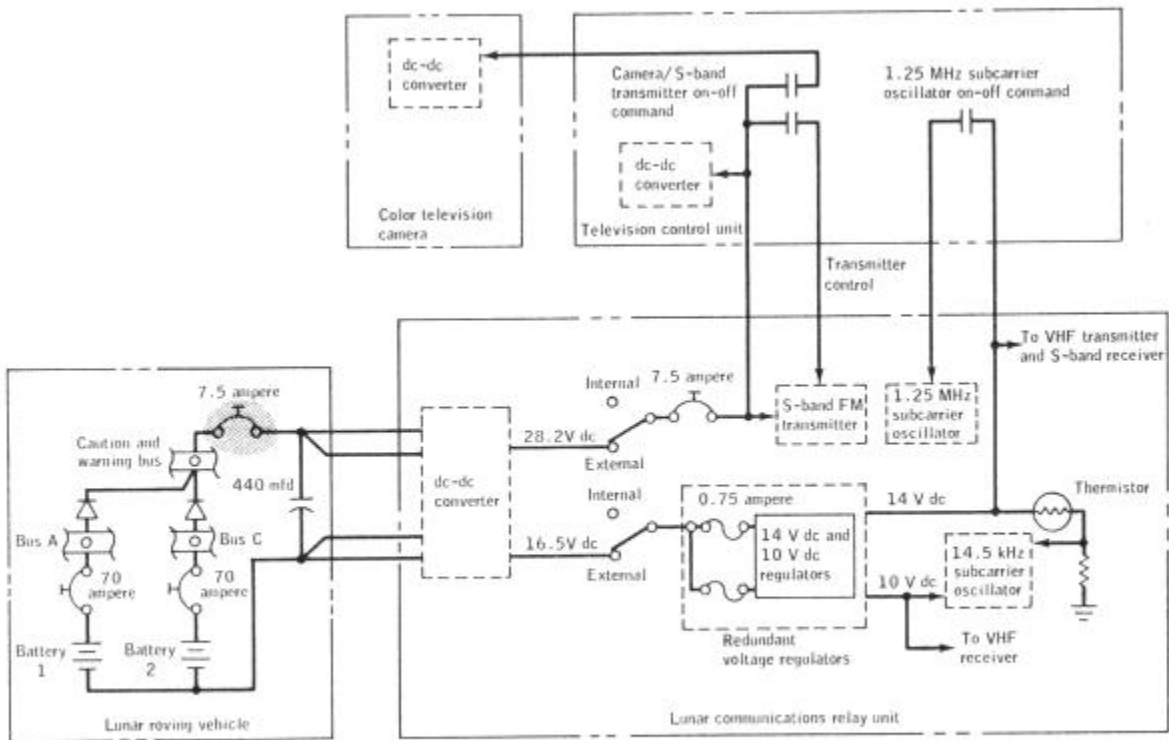
Figure 14-48.- Lunar roving vehicle/lunar communications relay unit/ground controlled television assembly power distribution.

In laboratory tests, the fault which duplicated the flight data was the opening of the lunar roving vehicle power line prior to the 440-microfarad capacitor (figs. 14-48 and 14-49). The tests show that the decay time of the lunar communications relay unit 28-volt and 14-volt power is increased by discharging the 440-microfarad capacitor. Other induced faults resulted in shorter power decay times, affecting the received signal accordingly. The temperature measurement output (see thermistor in fig. 14-48) is proportional to the decay in 14-volt power. Consequently, the 6-percent decay of the flight temperature measurement corresponds to a 1.4-volt decay. This characteristic was duplicated when the lunar roving vehicle power line was opened. The 28-volt power decayed to 21.8

The lunar roving vehicle power line has a 7.5-ampere circuit breaker forward of the 440-microfarad capacitor (fig. 14-48). Testing a 7.5-ampere circuit breaker under elevated temperatures (1800 F) and at vacuum conditions showed that the current capacity is also dependent on the connecting wire size because the wire provides a heat sink to the circuit breaker thermal element. The rover 7.5-ampere breaker used 20-gage connecting wire. Test results show that the breaker, with 20-gage connecting wire, at elevated temperatures and under vacuum conditions, will trip at 3.3 amperes. This corresponds to the calculated lunar communication relay unit load at the time of power failure.

A 10-ampere circuit breaker instead of the 7.5-ampere breaker and, in addition, a manual switch in the lunar rover circuit to override the circuit breaker after completion of vehicle activity are being provided for Apollo 16. Also, the lunar communications relay unit is being modified so that its internal 7.5-ampere circuit breaker is bypassed when operating in the external power mode.

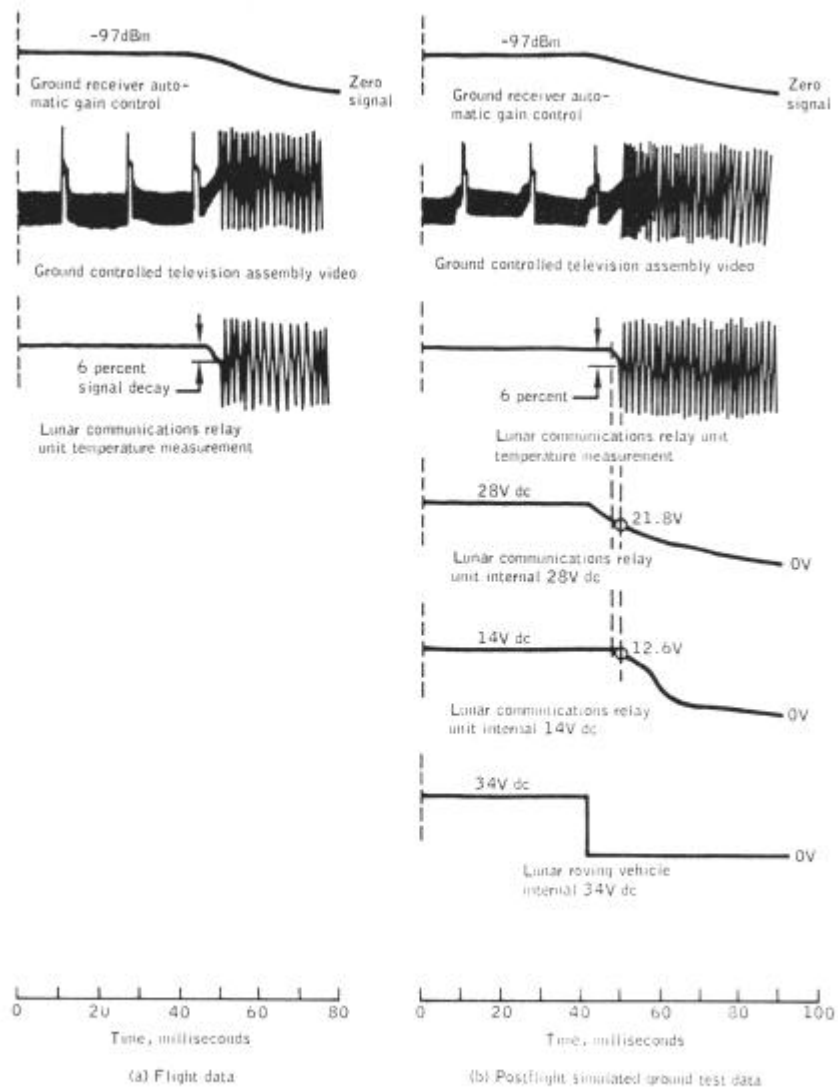
Figure 14-49.- Comparison of signal deterioration characteristics.

The flight data (**Fig. 14-49**) shows that the automatic gain control measurement began to fall followed by the video signal decay. This was followed by the decay of the lunar communications relay unit temperature measurement. The RF signal level then decreased below the ground receiver threshold as indicated by complete signal loss. The overall loss of the downlink signal within 5 milliseconds is indicative of 28-volt d-c power loss. Decay of the temperature measurement is indicative of 16.5 volt d-c power loss. The lunar communications relay unit dc-to-dc converter (**Fig. 14-48**) supplies both the 28-volt and 16.5-volt d-c power. To verify loss of 16.5-volt power, an uplink voice signal was transmitted to key the VHF transmitter on. No signal was received on the Stanford 150-foot VHF antenna which indicates that the VHF transmitter, powered from 16.5 volts dc, was inoperative.

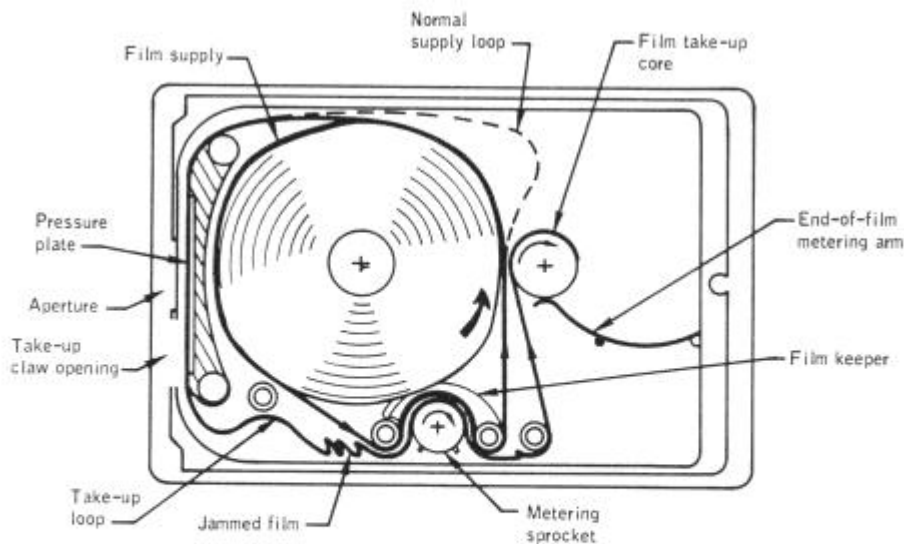
Figure 14-50.- Lunar surface 16mm camera magazine.

advancement varied from five to twenty-one frames in the jammed magazines. The film supply loop (**Fig. 14-50**) normally contains three to five excess frames. The normal procedure is to inspect the magazine for proper frame alignment in the aperture area, and manually advance the film not more than one frame, if required to obtain proper alignment. The excessive manual advancement depleted the film supply loops in all magazines.

Hardware analysis, air-to-ground voice tapes, and crew debriefing indicate that the lunar surface camera functioned properly, and the jammed magazines resulted from procedural errors. Corrective actions are to insure adequate crew training through scheduled prelaunch briefings, stress malfunction procedures and corrective actions, and put a removal flag on the tape.

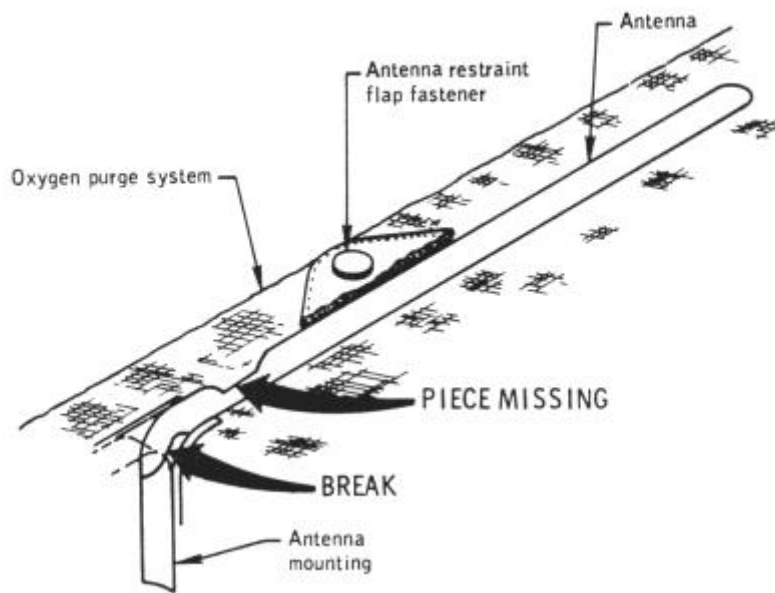
The crew reported that the Lunar Module Pilot's oxygen purge system antenna was broken off near the bottom during communications checkout prior to the second extravehicular activity. Previously, a notch had been observed in the antenna blade (see **Fig. 14-51**).

Antennas broken in training have shown similar flexure breaks. Observation of the notch edges of the returned antenna indicates that the notch started as a partial break in flexure, followed by material being torn out the rest of the way. Test results of the returned antenna indicated that the physical properties of the blade material were satisfactory with no excessive brittleness.

A flap which covers the entire antenna will be added for Apollo 16 to protect the antenna while the oxygen purge system is stowed and during unsuiting after extravehicular activities. The antenna will not be deployed until after egress to prevent it from being damaged inside the cabin or during egress.

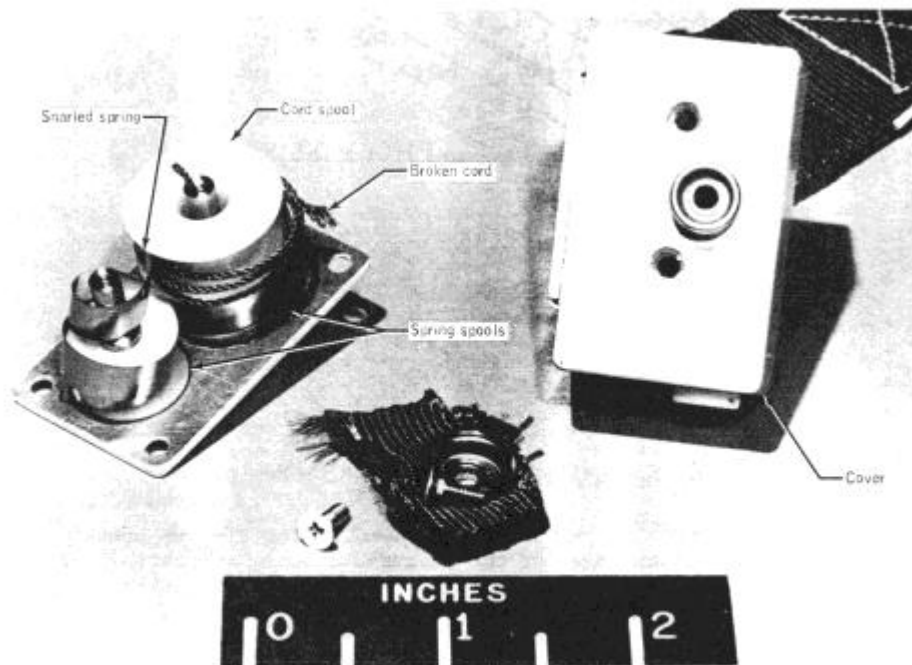
Figure 14-52.- Commander's tether (cover removed).

Both retractable tethers failed during lunar surface operations; the Commander's tether cord broke during the first extravehicular activity, and the tool clamp came off the end of the Lunar Module Pilot's tether. The Commander carried the standard 3/8-pound pull tether which consists of a case, a negator spring wound reel-to-reel on two spools, and a 30-pound cord wound on a spool mounted to one of the spring spools (**Fig. 14-52**).

The cord had broken against a sharp edge of the spring when an attempt was made to extend the tether after the jam. The failure mode with the release of the slack cord is repeatable. Disassembly of the Lunar Module Pilot's tether showed that both the bowline and the figure-eight knot attaching the cord to the clamp had untied (**Fig. 14-53**) and this allowed the cord to retract into the housing. Changing this knot to an improved clinch knot will provide a more secure and permanent attachment. Crew training will emphasize proper use of the tethers.

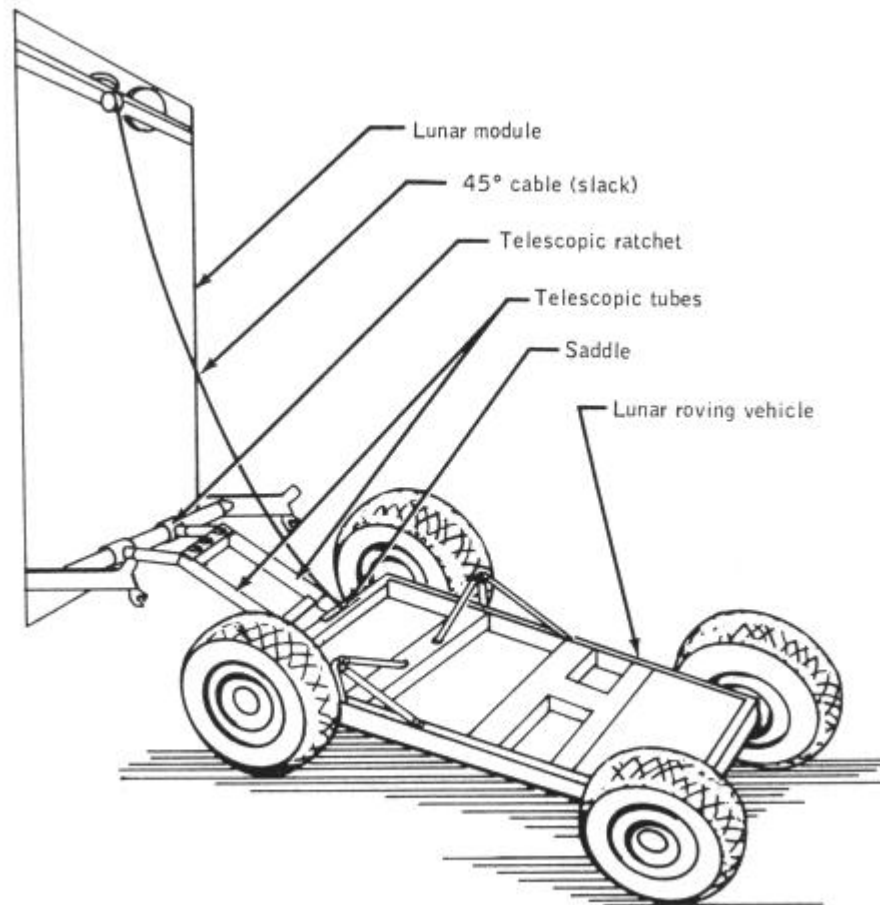
Figure 14-55.- Lunar roving vehicle deployment.

Ground tests have shown that if the partially deployed lunar roving vehicle resting on the surface but not yet detached from the saddle and lunar module, is rolled either to the left or right, the saddle/rover chassis interface will bind. The interface can be released, and the saddle dropped to the ground by one crewman adjusting the roll back to zero while the other taps the saddle with a hand tool. The corrective action is to insure adequate crew training.
