## Lunar Roving Vehicle (LRV) Missing Fender Extension Saga

### **Extracts From Apollo Mission Flight Evaluation Reports**

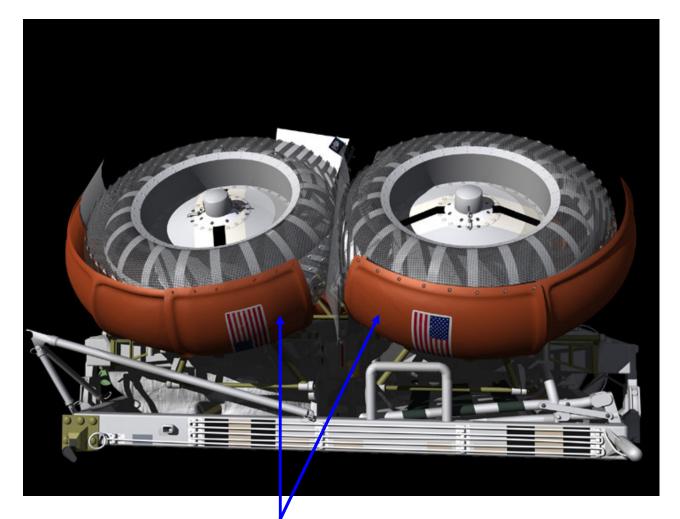
Retractable Fender Extensions Required For Folding of LRV Wheels

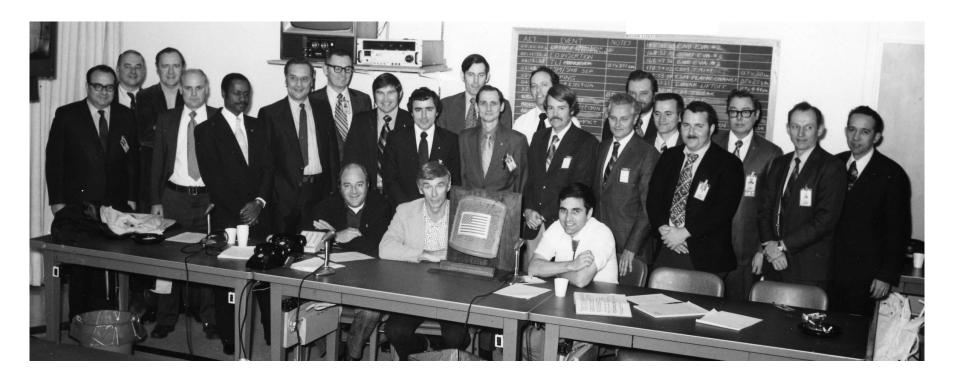
Astronauts Were Presented With Fender Extension From LRV Qualification Unit Autographed By MSFC Support Team

(This fender extension had been used to examine potential repair during the Apollo 17 mission. Crew did not indicate any status of fender extensions from LRV left on the moon at the conclusion of Apollo 17)

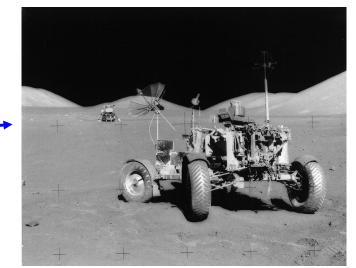
LRV Parked For Lunar Module Ascent Observation

In the process of preparing "Back to the Future" retrospective LRV thermal control experiences presentation, discovered picture of Apollo 17 in it's – last parked position that shows missing left front and left rear fender extensions, and missing right rear fender extension and fender map fix

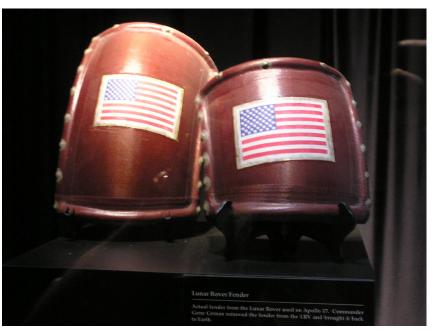
Picture of Apollo 17 Extensions Taken by Ben Nault

Fender extensions claimed to be: "Actual fender from the Lunar Rover used on Apollo 17" discovered on display at Kansas Cosmosphere museum.

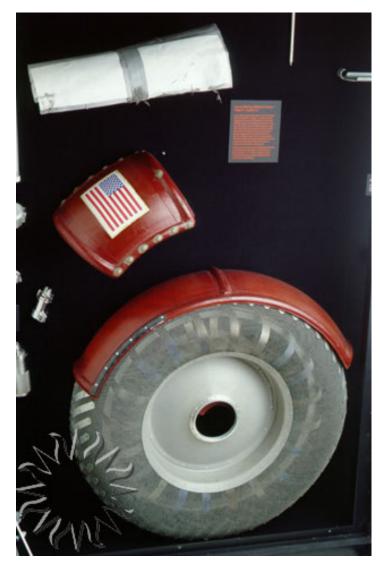
LRV Artifacts On Display at National Air and Space Museum ronald.a.creel@saic.com 4-16-05

### Apollo 17 Fender Extension and "Map Fix" Located at Smithsonian National Air and Space Museum (NASM)
