# STS-126/ULF2

## FD 05 Execute Package

MSG 037 - FD04 MMT SUMMARY

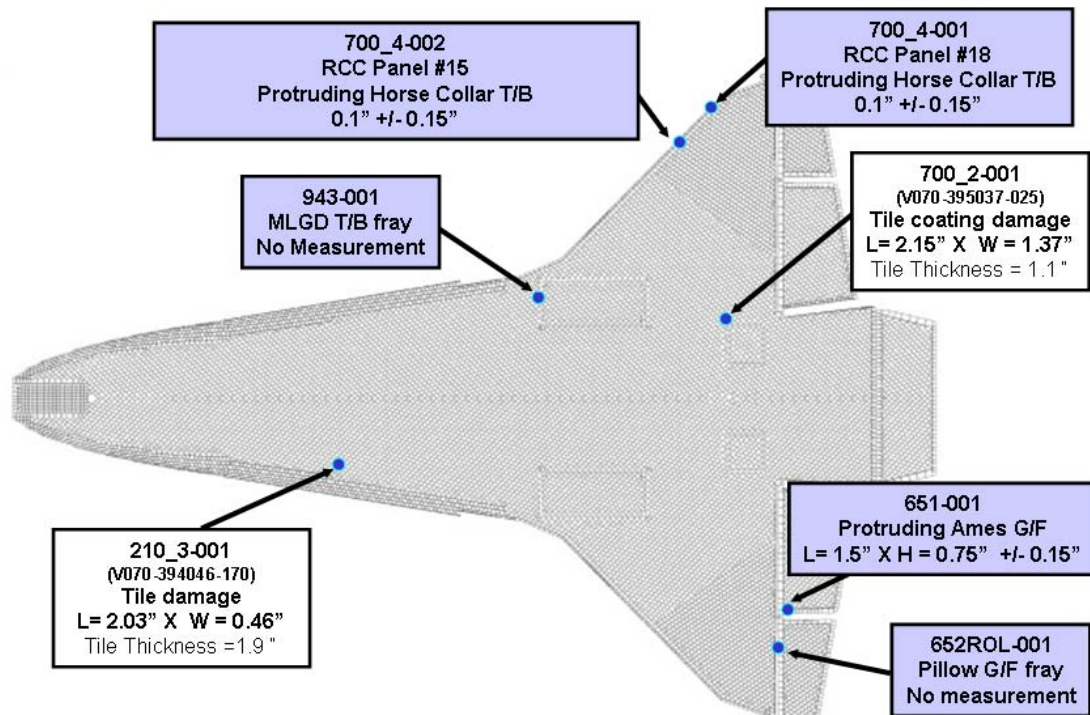
Figure 1 - Orbiter Lower Surface

11  
12 **Damage Assessment Team** - Analysis of the ascent imagery, FD02 inspection data and  
13 the RPM photos is nearly complete. For the RCC, the team has cleared all of the Regions  
14 of Interest; therefore, the RCC is considered clear for entry. For the rest of the TPS, there  
15 are 13 Regions of Interest identified. 5 of these ROIs are damage to tile, but none of the  
16 observed damage is significant and all is within our experience base. The team is still  
17 performing their rigorous analysis of these areas and expects to be complete with the  
18 damaged tile assessments by tomorrow's MMT. The other 8 ROIs are due to thermal  
19 barriers and gap fillers. 7 of these have already been cleared, but the 15" gap filler  
20 protrusion on the ROMS pod requires additional work. The team is not concerned about this  
21 gap filler, but wants to fully assess this longer than previously observed OMS pod gap filler.

22 Also, no Focused Inspection will be required for any of these ROIs.
