# APOLLO 13 MISSION CONTROL CONSOLE 7 - EECOM

O2 Tank 2 Loss Of Pressure

#### APOLLO 13 - O2 TANK 2 LOSS OF PRESSURE

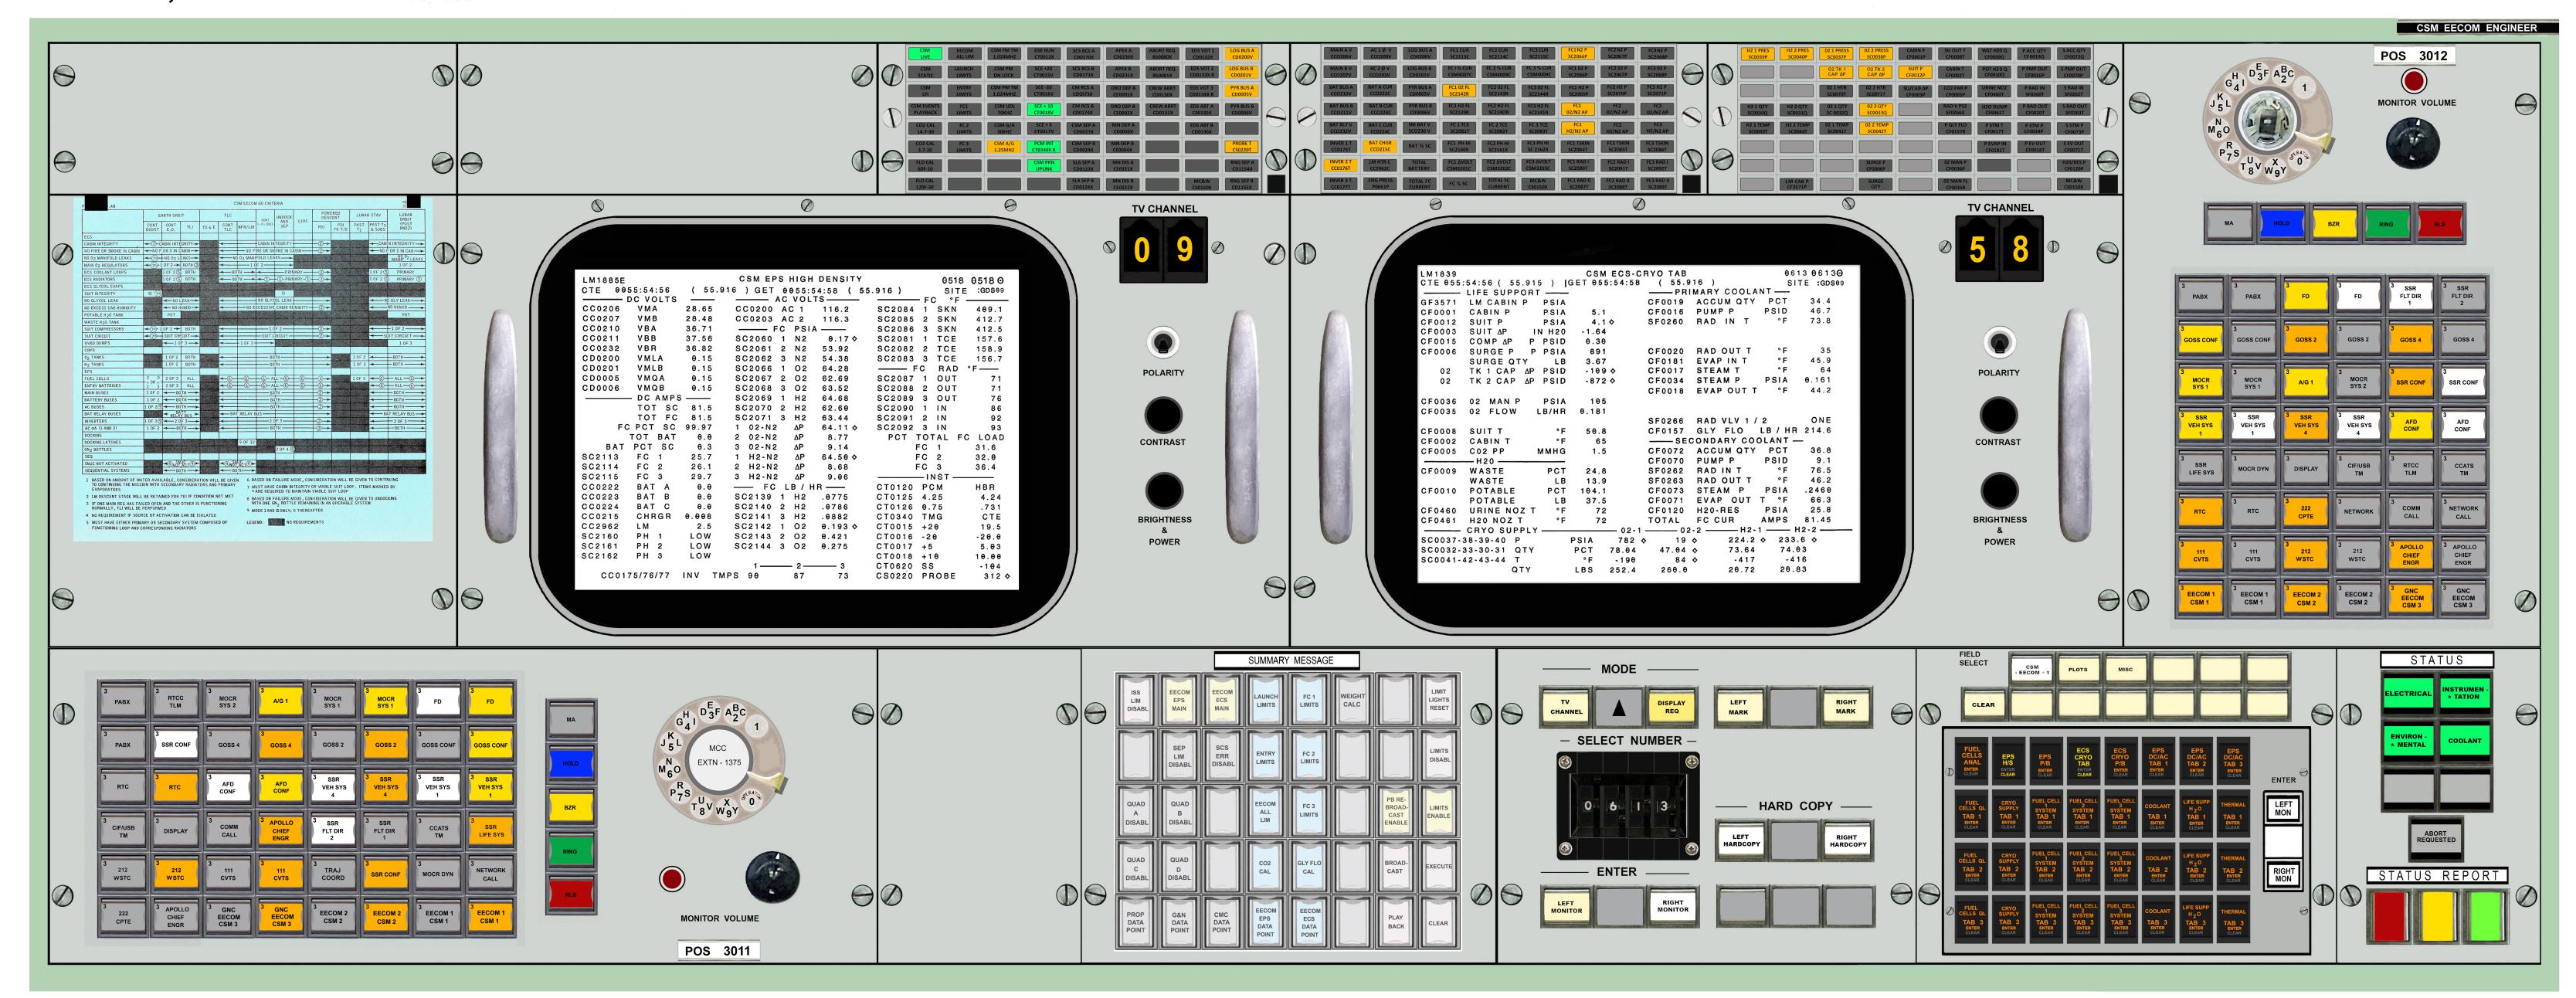
Just prior to a scheduled shift change, Flight Controller (EECOM) Sy Liebergot requested a procedural "stir" of the cryogenic tanks in the Swigert, a short circuit occured between wires or in the fans of O2 Tank 2 as a result of undetected pre-launch damage. This lead to a fire and a rapid rise in pressure that eventually caused the tank dome to fail, explosively releasing the O2 into the Serice Module bay. This resulted in the bay door covering that sector of the Service Module to be blown off hitting the nearby High Gain antenna causing a temporary

This graphic represents the situation displayed to Sy Liebergot when the telemetry resumed.

The first indication observed by Sy Liebergot was on the left screen - CSM EPS HIGH DENSITY, where Fuel Cell 1, N2 Pressure indicated 0.17 psi - effectively "0". However, as the related Fuel Cell O2 and H2 pressures were normal, this was correctly assumed to be due to a sensor malfunction. Fuel Cell 1 O2 flow also showed a drop in flow rate to 0.193 lbs/hr. Post mission, this was correlated to the "shocked" closure of the O2 Reactant Valve that permits O2 to flow to the Fuel Cell, but direct indication of this occurring, required both O2 and H2 Reactant Valves to be closed - an unprecedented occurrence during translunar coast. Closure of the Reactant Valve also affected Fuel Cell 3, but this was not yet evident. Fuel Cells 1 and 3 continued power generation for approximately three minutes with the O2 remaining in the supply lines downstream of the O2 Reactant Valve.

On the CSM ECS-CRYO TAB page on the right screen, O2 tank 2 pressure indicates 19 psi (off-scale low), quantity indicates 47% (indication had failed earlier in the mission) and temperature indicates 84 degrees (off-scale high).

The number of confusing telemetry indications were more indicative of a telemetry failure than a cascading multiple system failure. However, the failure of the O2 tank and the consequential failure of the Fuel Cells led to a mission termination due to loss of electrical power.
