APOLLO 16 MISSION

ANOMALY REPORT NO. 9

LUNAR ROVING VEHICLE ELECTRICAL SYSTEM METER ANOMALIES

MSC-07684

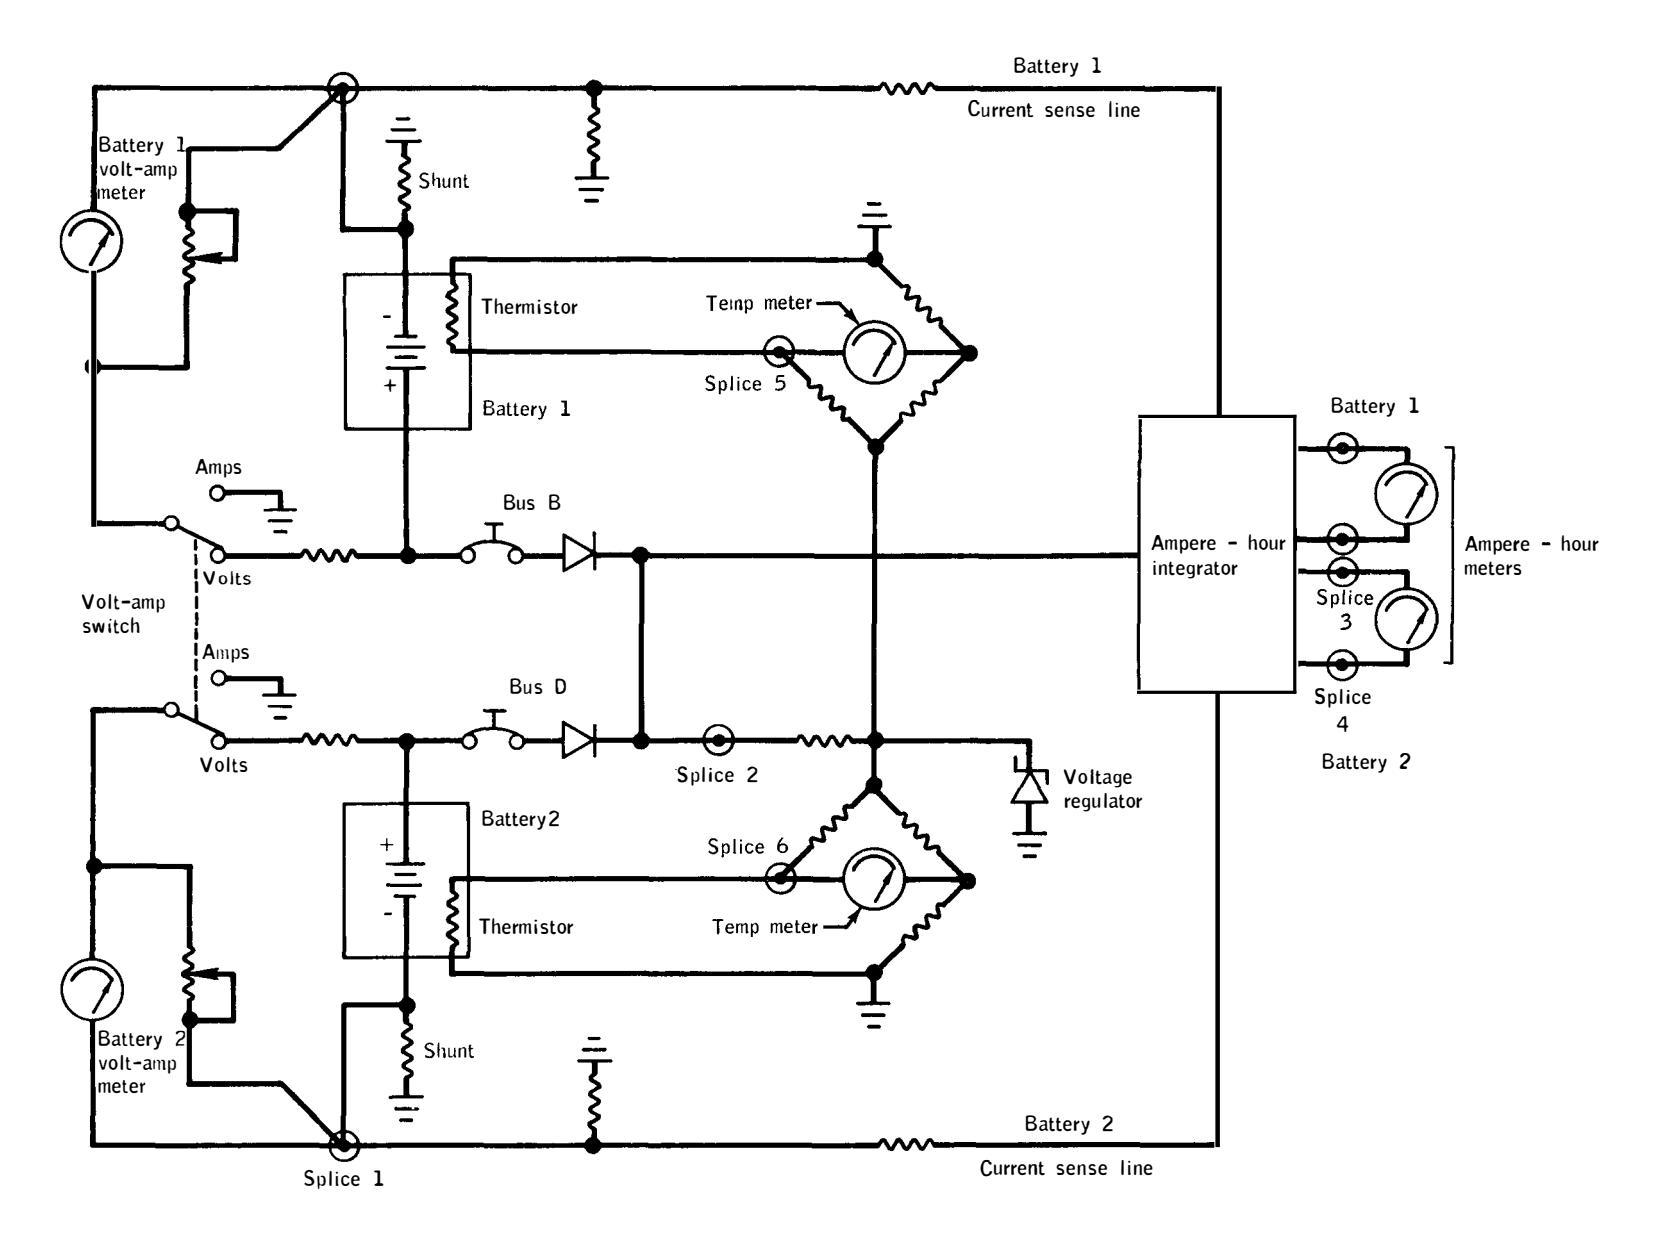
Figure 1.- Lunar roving vehicle electrical meters circuitry.

No single condition was found which would explain all anomalous meter indications. However, intermittent connections in some of the multiple wire crimp splices shown in figure 1 could explain the meter readings.

An intermittent connection in splice 1 could cause the battery 2 voltmeter to read off-scale low. Also, an intermittent connection in splice 3 or 4 would cause the battery 2 ampere-hour meter to read offscale low. To cause both temperature meters to read off-scale low would require intermittents in either splice 2 or in both splices 5 and 6. An intermittent in splice 1 would cause the ampere-hour integrator 1 to indicate increasing rather than decreasing ampere-hours remaining, since the polarity on the current sense line would be reversed as shown in figure 2. Finally, an intermittent connection in splice 5 would cause the battery 1 temperature meter to indicate off-scale low.

Splice fabrication, tooling, and procedures were reviewed and are considered adequate. No cause for the intermittent conditions in the splices was found.

Intermittent conditions must have existed in several of the multiple wire splices shown in figure 1.

No corrective action could be taken since the cause of the intermittents was not determined.

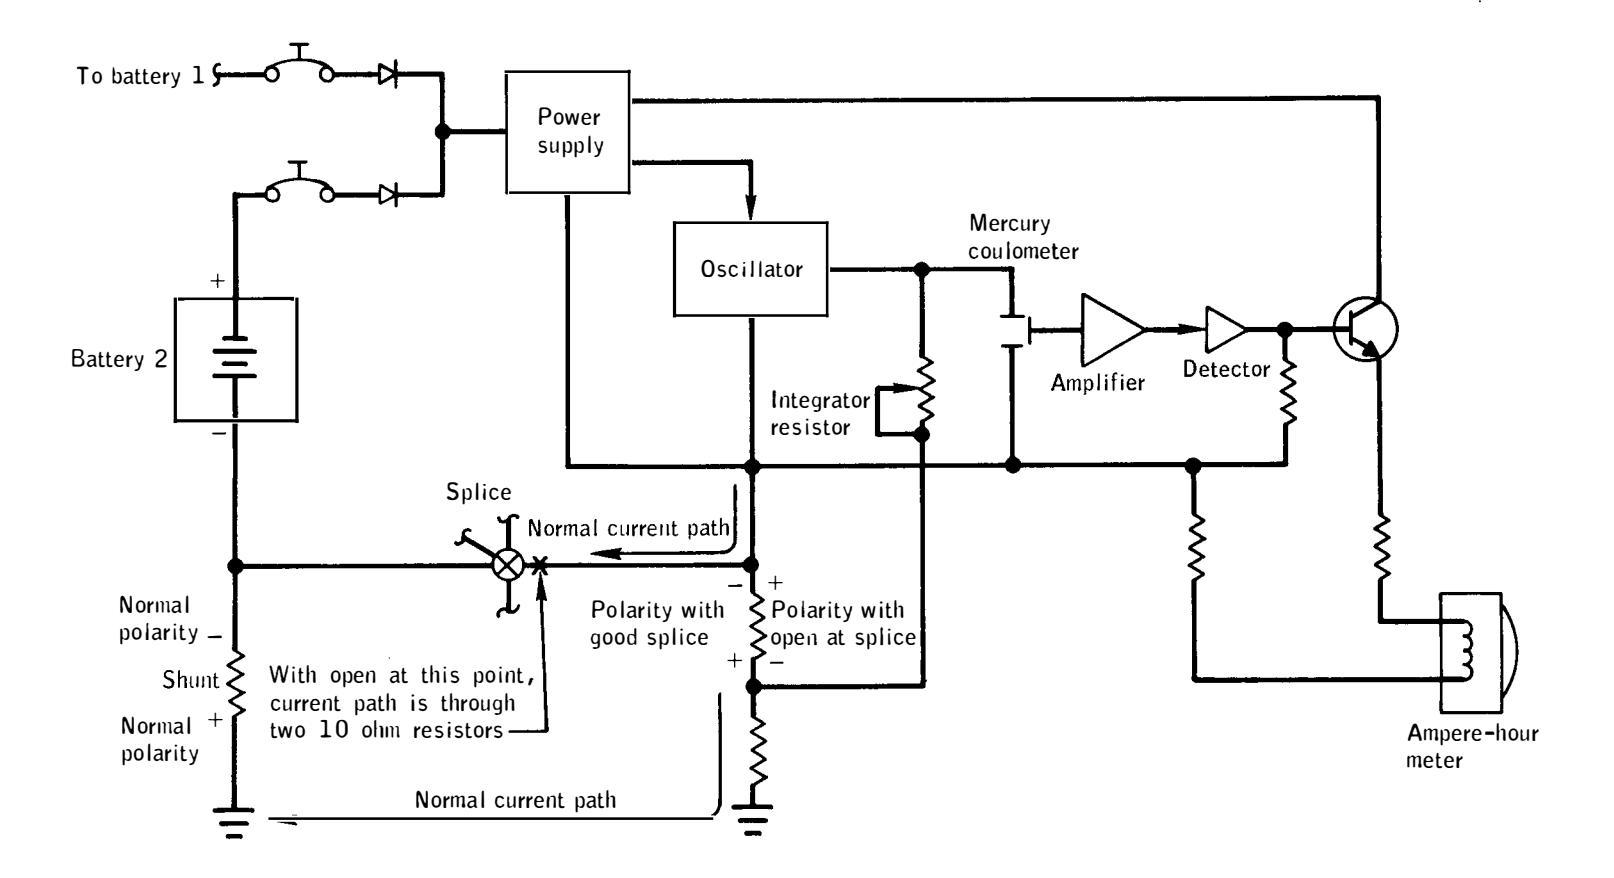
Figure 2.- Battery 2 amper-hour intergrator circuit.

The battery ampere-hour meter operates when either the bus B or the bus D circuit breaker is closed. The ampere-hour meter displays amperehours remaining in the batteries. This is accomplished as follows. A voltage, proportional to the battery current, is produced in the battery shunt (fig. 2). This voltage is applied through a resistor to an amperehour integrator. The resistor converts the shunt voltage into a current source.
