MSC-00171

APOLLO 11 MISSION REPORT

NATIONAL AERONAUTICS AND SPACE ADMINISTRATION MANNED SPACECRAFT CENTER HOUSTON, TEXAS November 1969

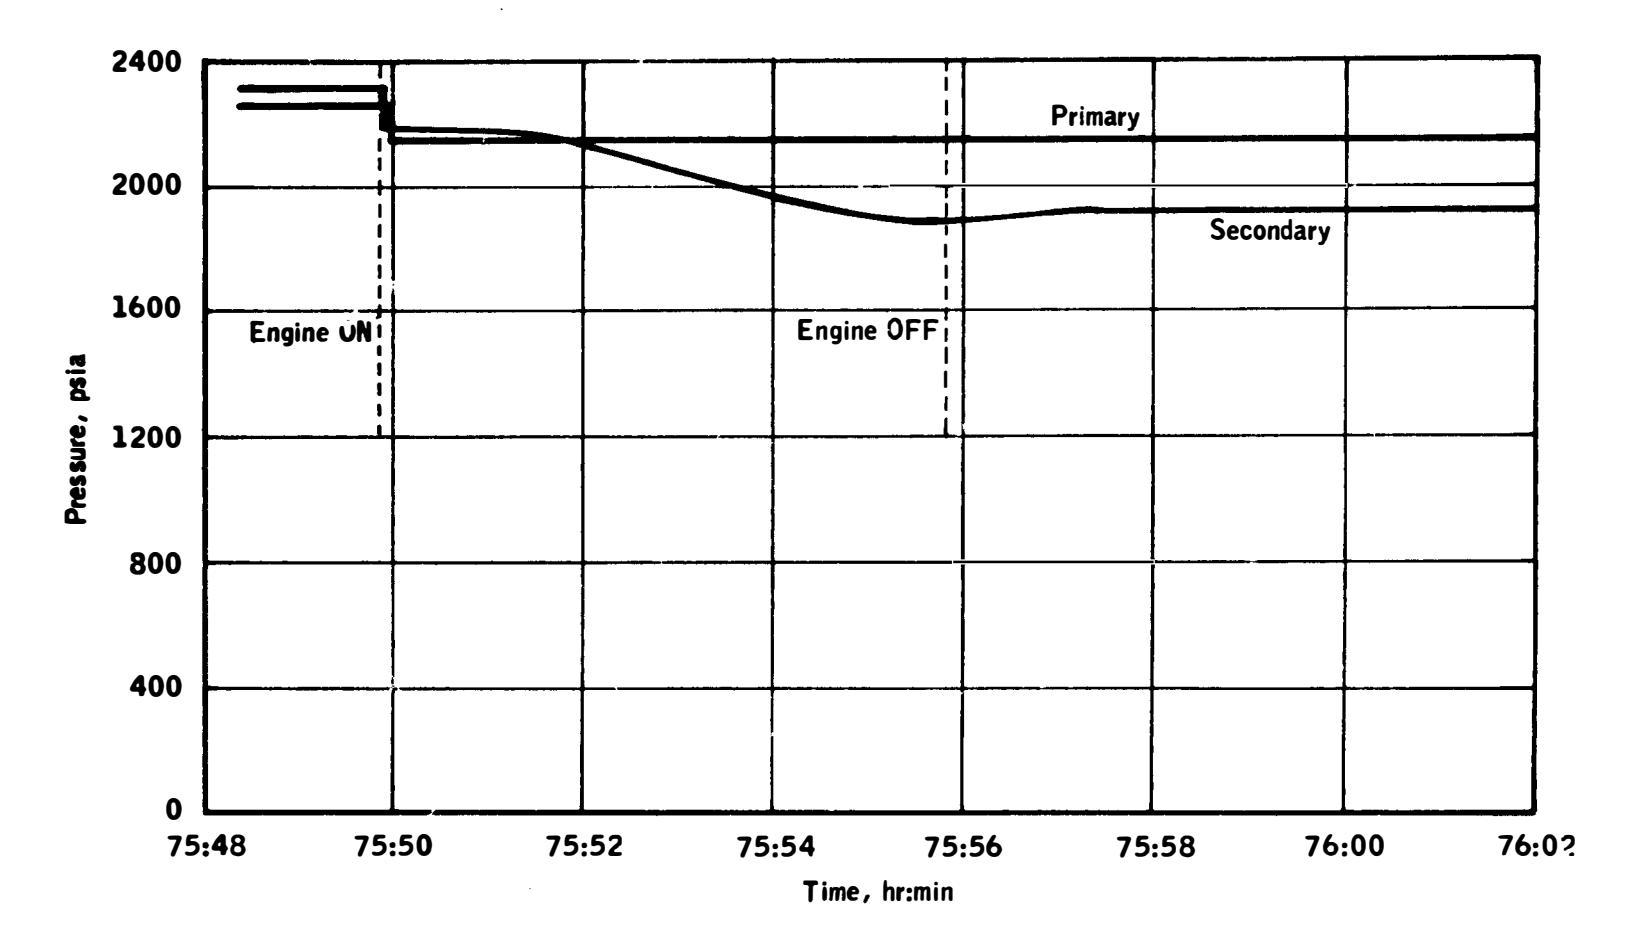
Figure 16-1.- Nitrogen pressure during initial lunar orbit insertion firing.

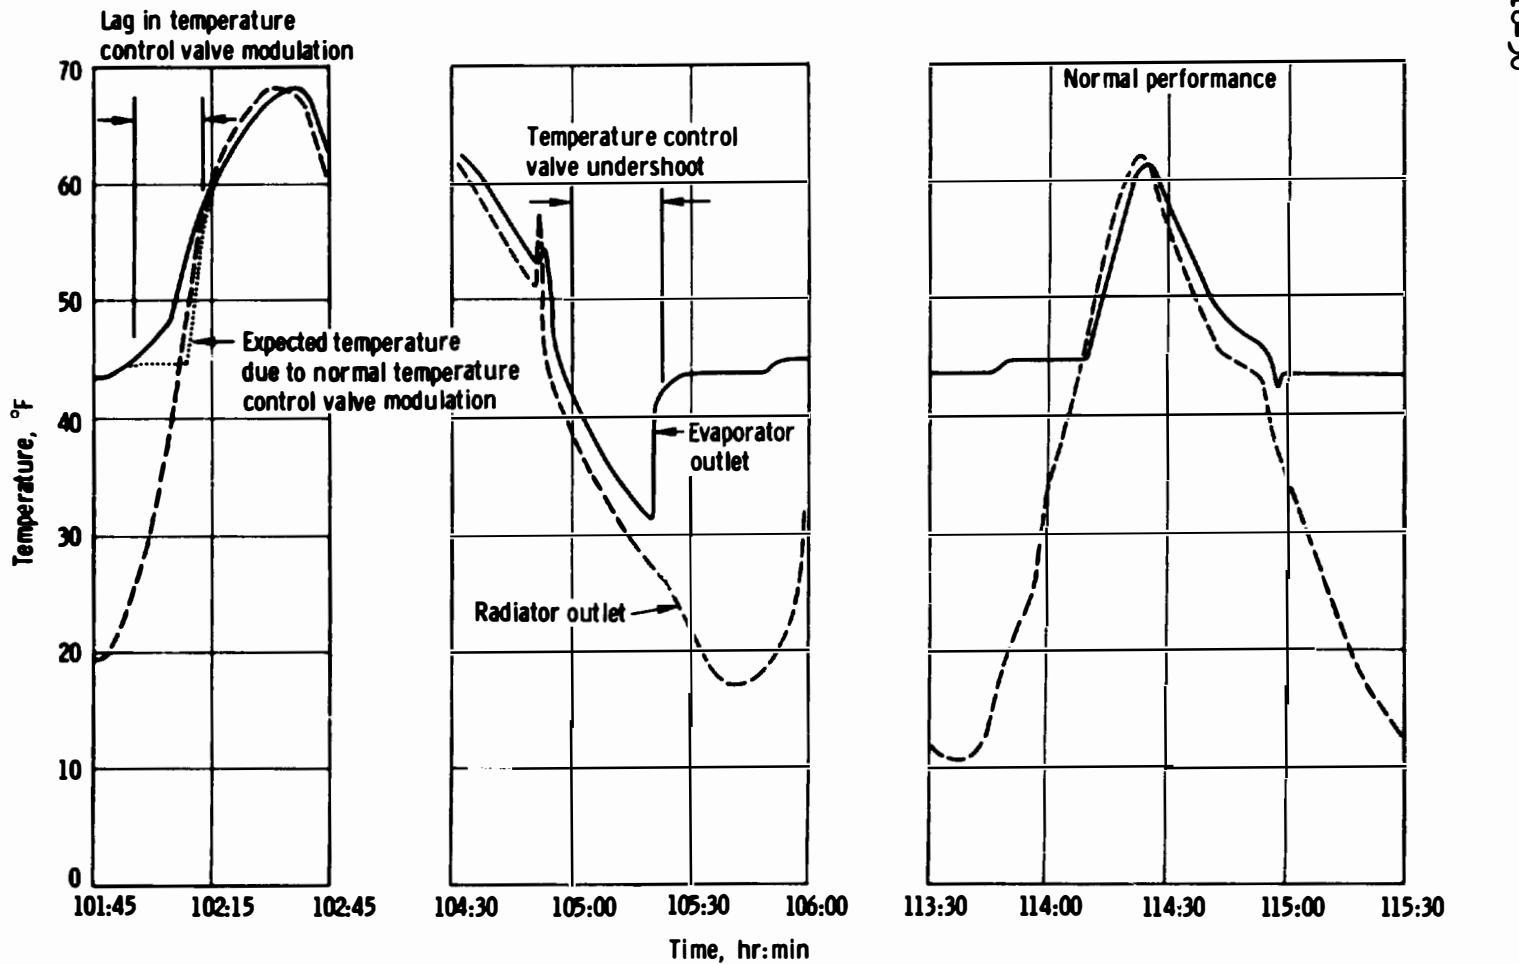
Figure 16-8. - Comparison of radiator and evaporator outlet temperatures.

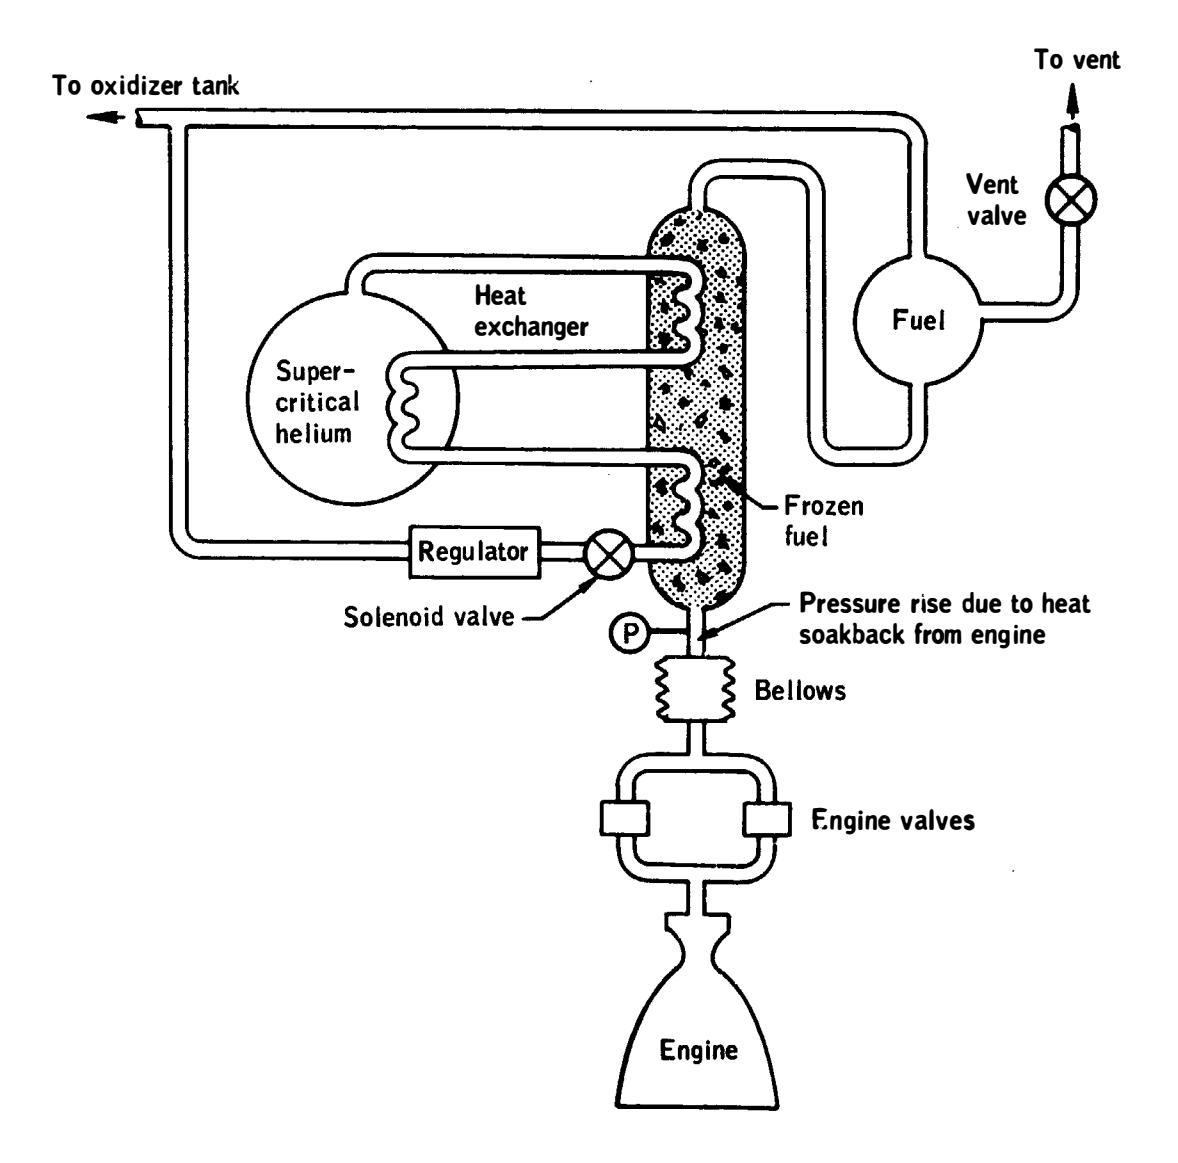
Figure 16-10.- Supercritical helium flow for descent propulsion system.

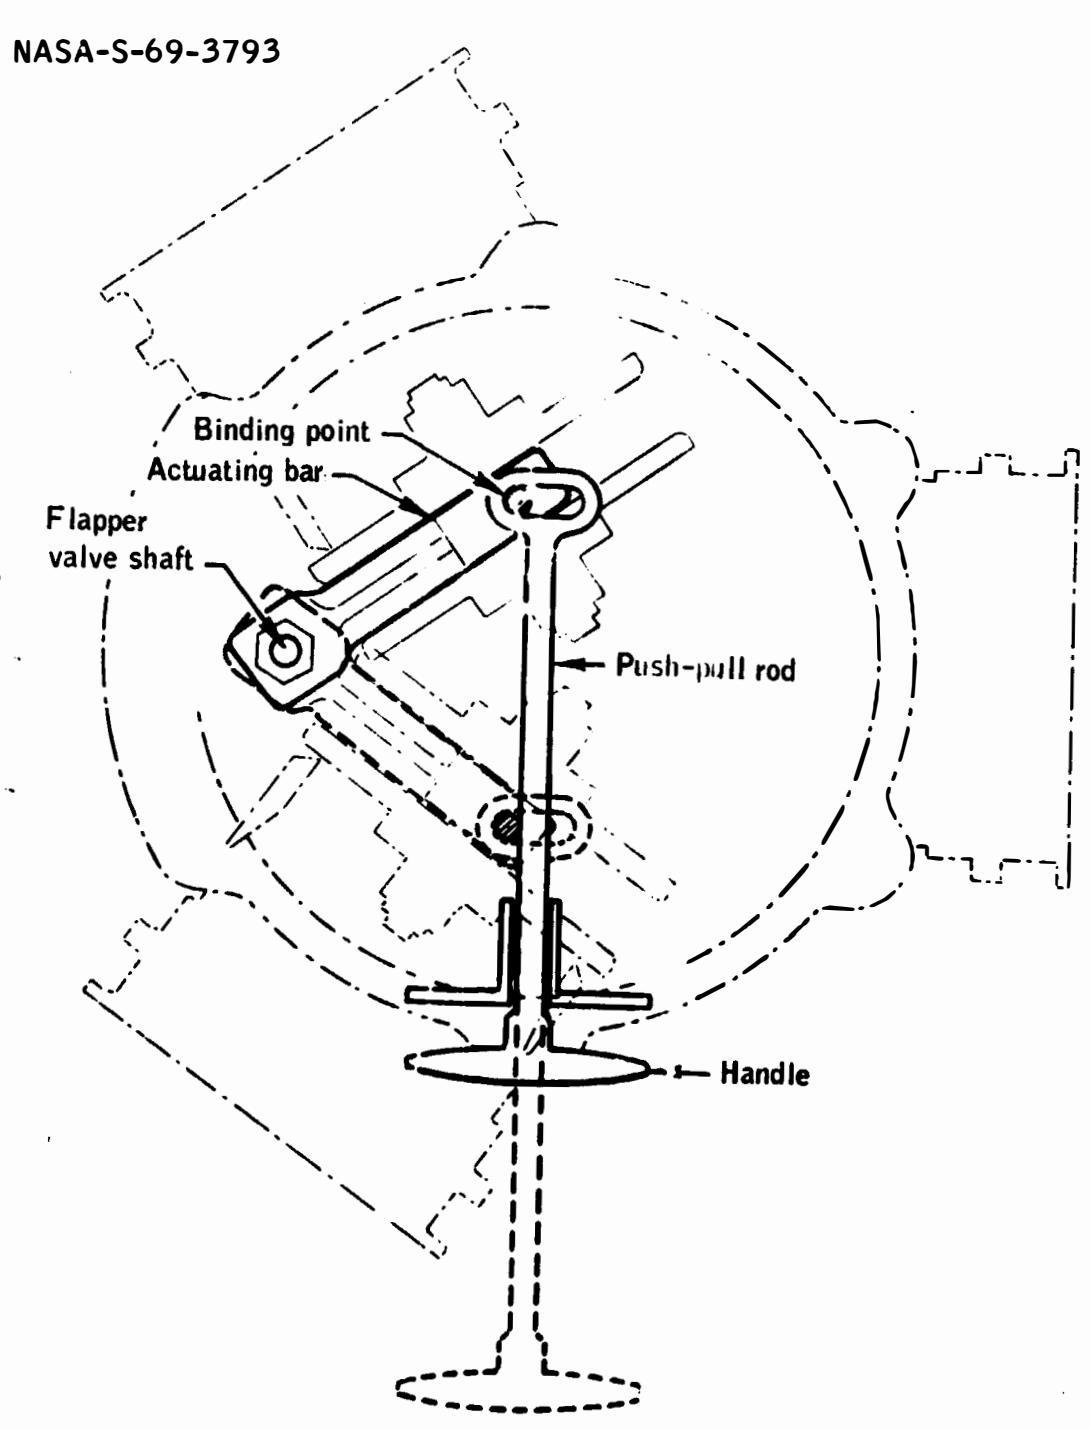
Figure 16-19.- Water separator selector valve.
