STS-115/12A

FD 04 Execute Package

MSG 035 (13-1195) - FD04 MISSION SUMMARY

13-1186 (MSG 027) CONTINGENCY P3/4 INSTALLATION WITH FAILED SSAS RTL

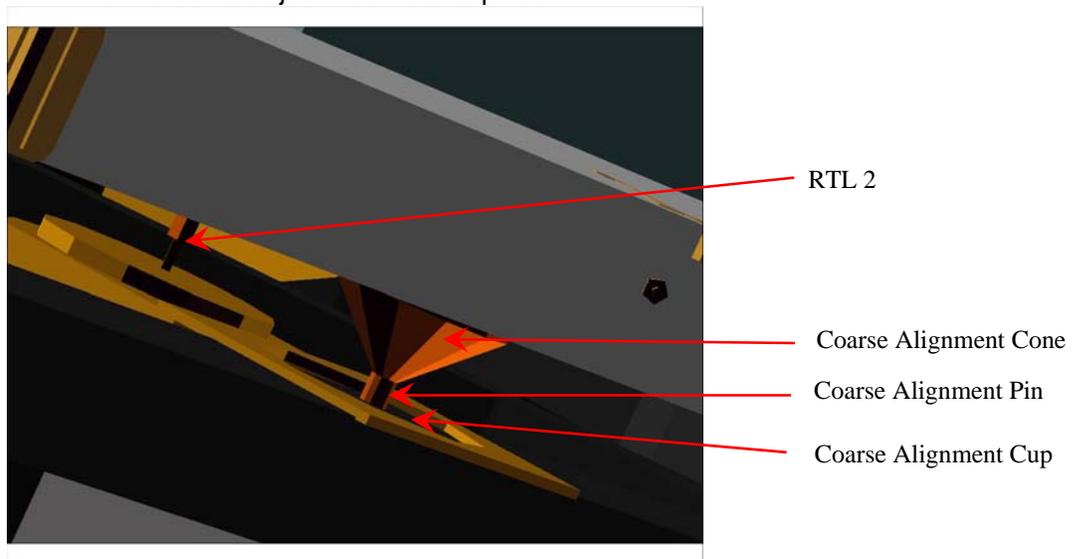
Figure 1.- 7cm Separation Reference View
(22: Base Elbow: -51, -10).

Route the SSRMS Base Elbow camera to one of the RWS monitors and adjust zoom as required.

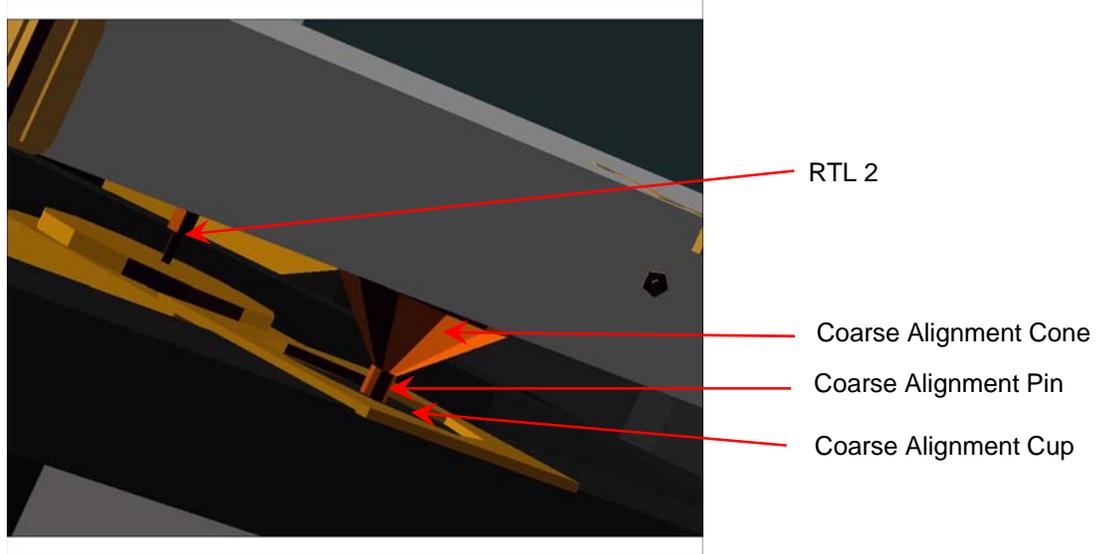
Figure 2.- RTL-2 7cm Separation Reference View
(22: Base Elbow: -51, -10).

Route the SSRMS Base Elbow camera to one of the RWS monitors and adjust zoom as required.

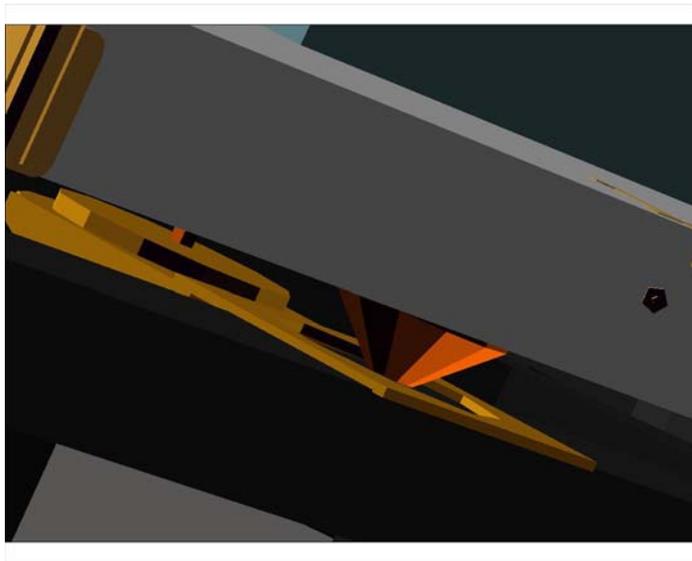
Figure 3.- RTL-2 4cm Separation
(22: Base Elbow: -51, -10).

Perform THC +X input until Coarse Alignment Pin 2 is no longer visible.
(Reference figure 3)

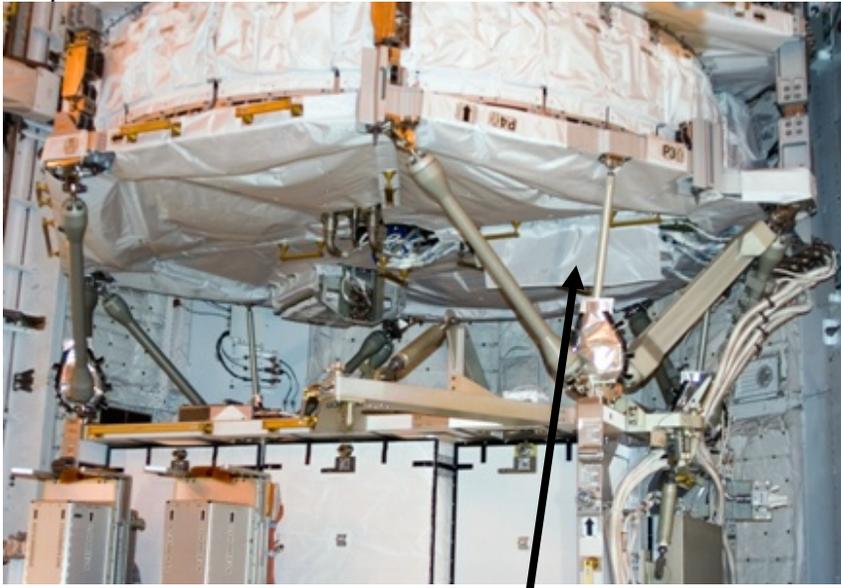
- During review of Flight Day 2 video, a thermal blanket on the P3 outboard bulkhead was observed to be loose. Review of payload bay walkdown photography revealed that this happened on the ground due to 1-G effects and the blanket was reattached.
- We will plan for you to reattach the thermal blanket during EVA 2 during SARJ Prep Tasks.
- Your best access to the protruding thermal blanket will be from face 1; this will avoid interference from struts and power cabling. Once inside the worksite, reattach the opened thermal blanket to the attached thermal blanket. There are three 1.5" wide Velcro strips on the open flap that must be mated to corresponding Velcro flaps on the attached thermal blanket. See the third photo below

MLI FLAP LOOSE

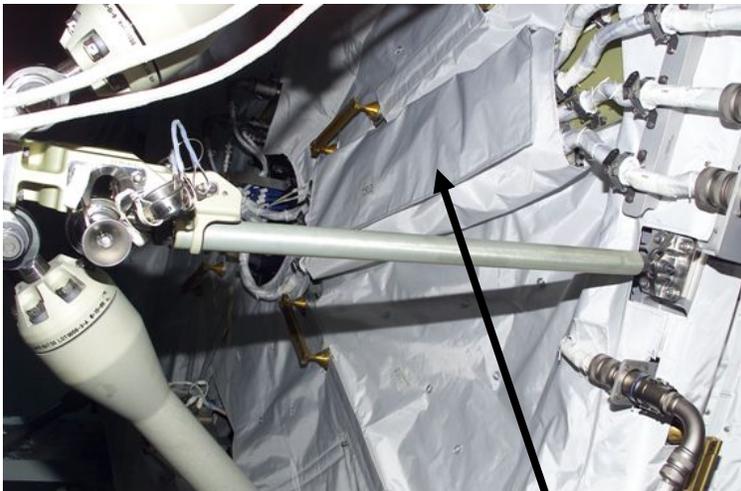
MLI FLAP SECURE

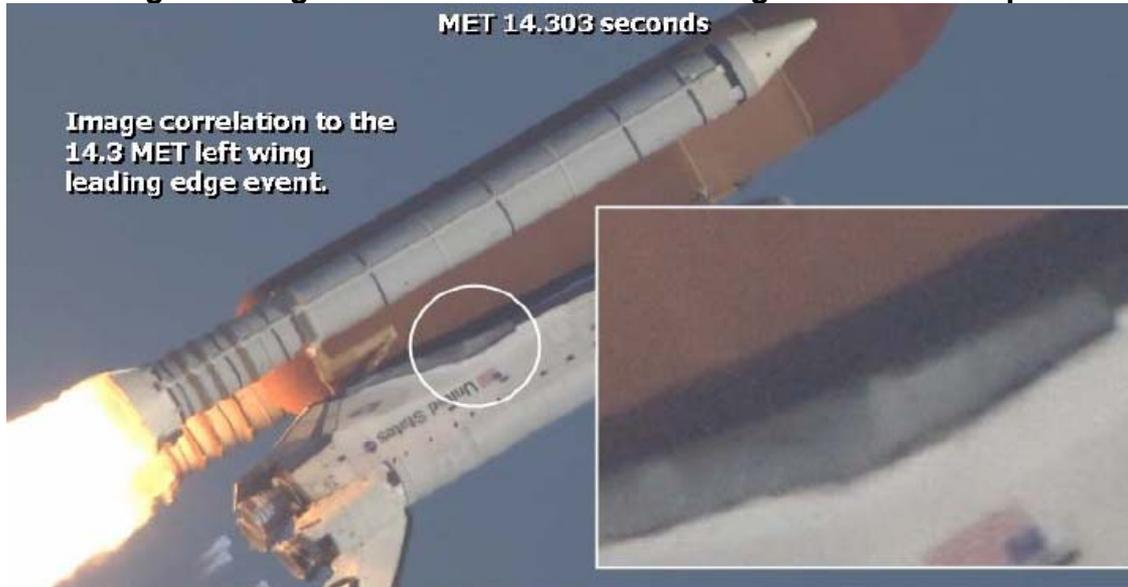
1 **Figure 1: High Definition Video of Port Wing indicates no impact**

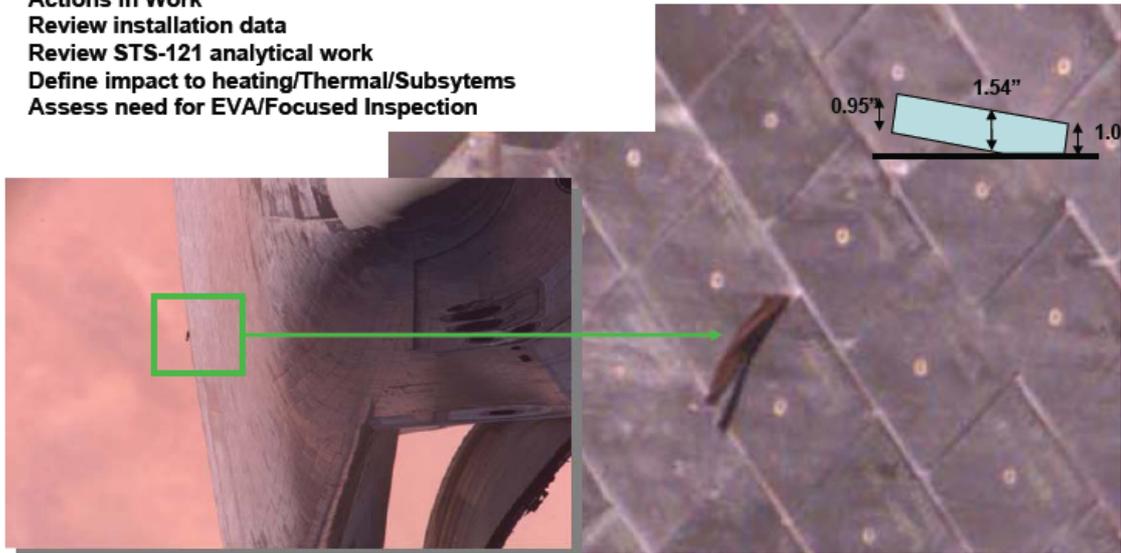
**Protruding approx. 1.7" between tiles V070-395025-020/395055-072
X0 1347 Y0 -72 tile thickness 1.6"**

- Actions in Work**
- Review installation data**
- Review STS-121 analytical work**
- Define impact to heating/Thermal/Subsystems**
- Assess need for EVA/Focused Inspection**

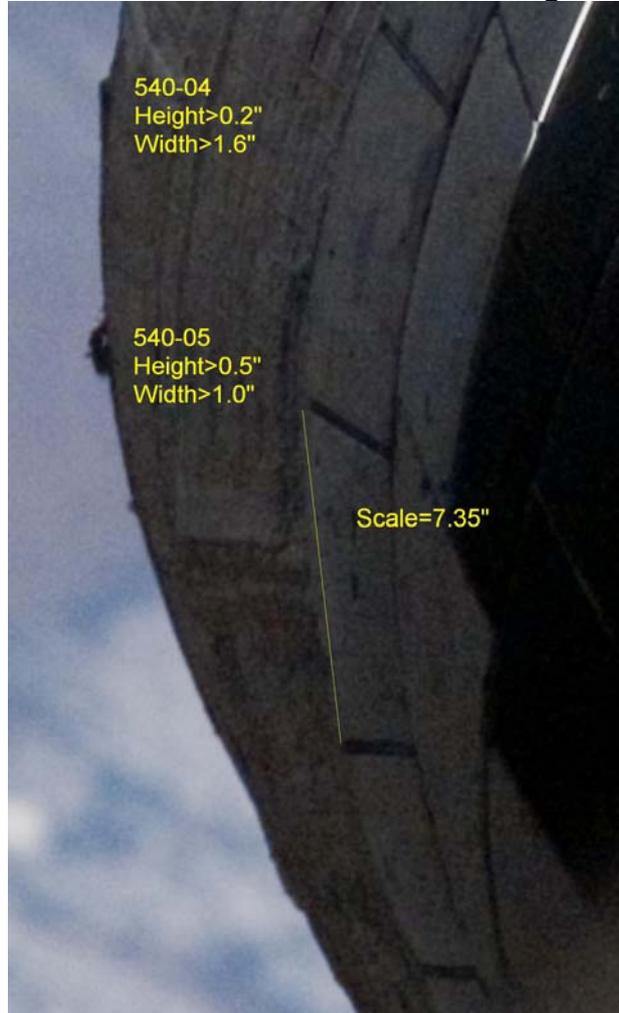
Figure 3: Starboard OMS Pod Protruding Blanket
