STS-129/ULF3

FD 05 Execute Package

MSG 029A - FD05 FLIGHT PLAN REVISION

MSG 041 - 4.007 HRF ULTRASOUND BOARD REPLACEMENT AND TEST

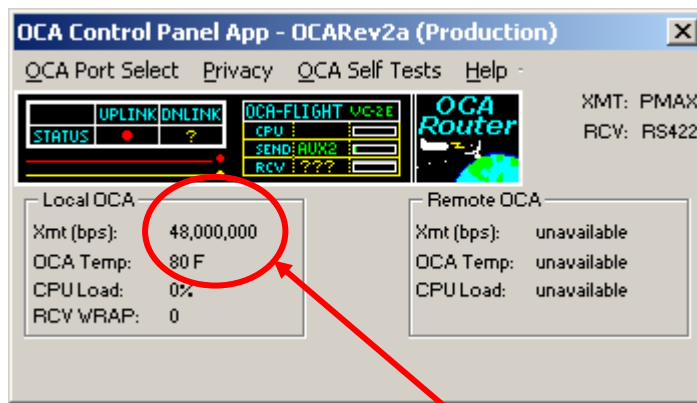
Figure 1

- A. In step 1.4, a reminder that the BYPASS switch is a 3 position switch
- B. Do not perform step 1.5 (do not turn MUX/VTR/CC - OFF)
- C. In step 3, after setting the OCA rate, verify on the OCA Control Panel App, bottom left side, that “Local OCA / Xmt (bps)” displays “48,000,000” (ref figure 1)

After reboot, verify OCA Xmt rate is still 48,000,000 (ref figure 1).

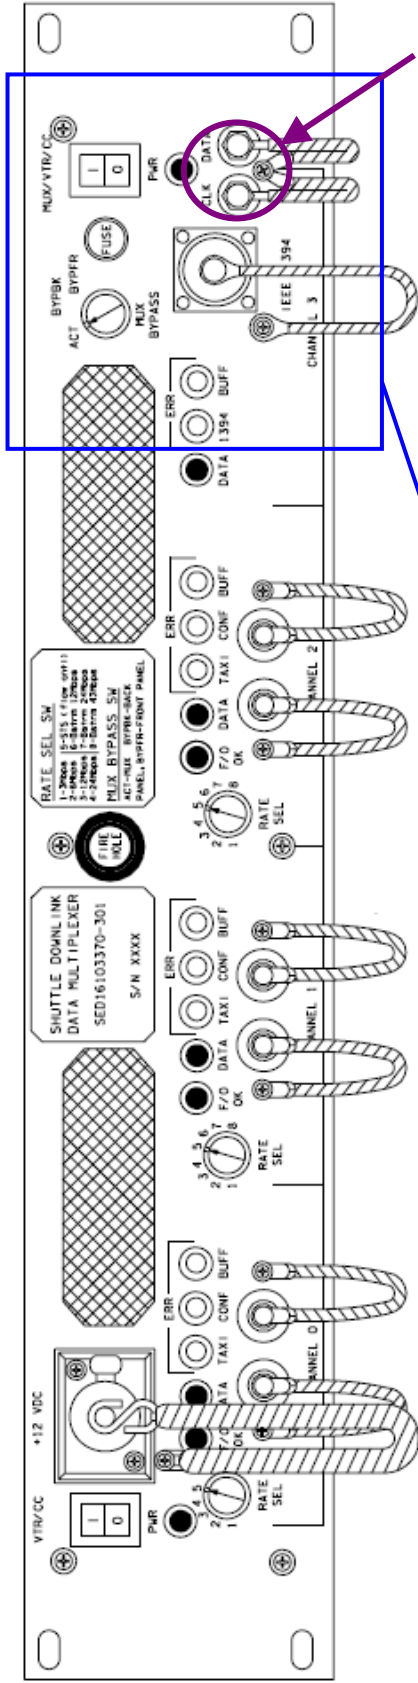
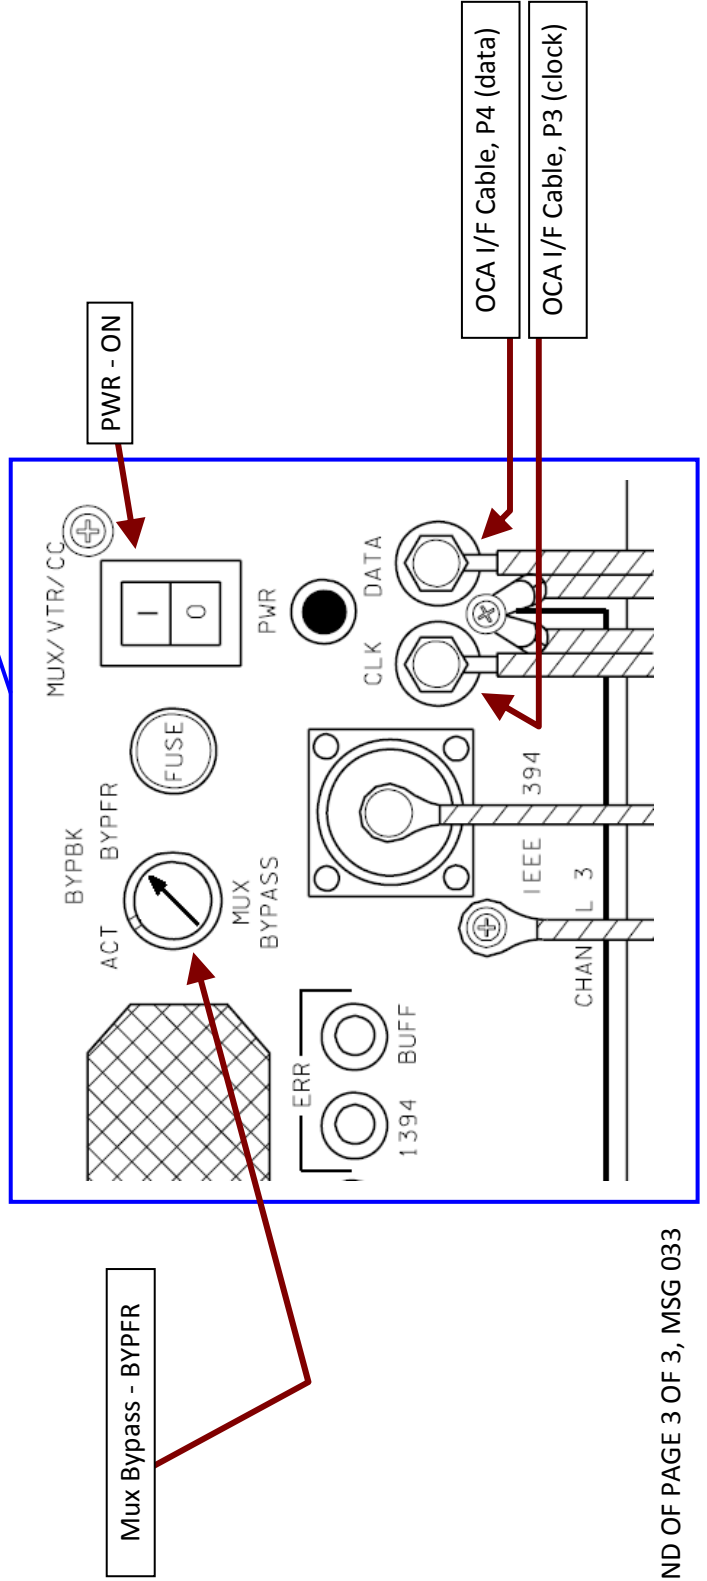
Figure 2 - DTV MUX Connection

OCA PL MAX Clock &
Data lines plug in here

Mux Bypass - BYPFR

PWR - ON

OCA I/F Cable, P4 (data)

OCA I/F Cable, P3 (clock)

Figure 2 is a diagram of the OCA connections to the DTV MUX.

If loopback test passes, perform step 4.2 to end the test and reconnect the P3, P4 cables to the MUX. Problem lies downstream of OCA connection to the MUX.

If loopback fails, the P3 or P4 legs of the OCA cable or the hi rate pins in the P1 connector are suspect. Perform the 1st step in 4.2 to end the test. √MCC to determine if spare OCA cable should be installed.

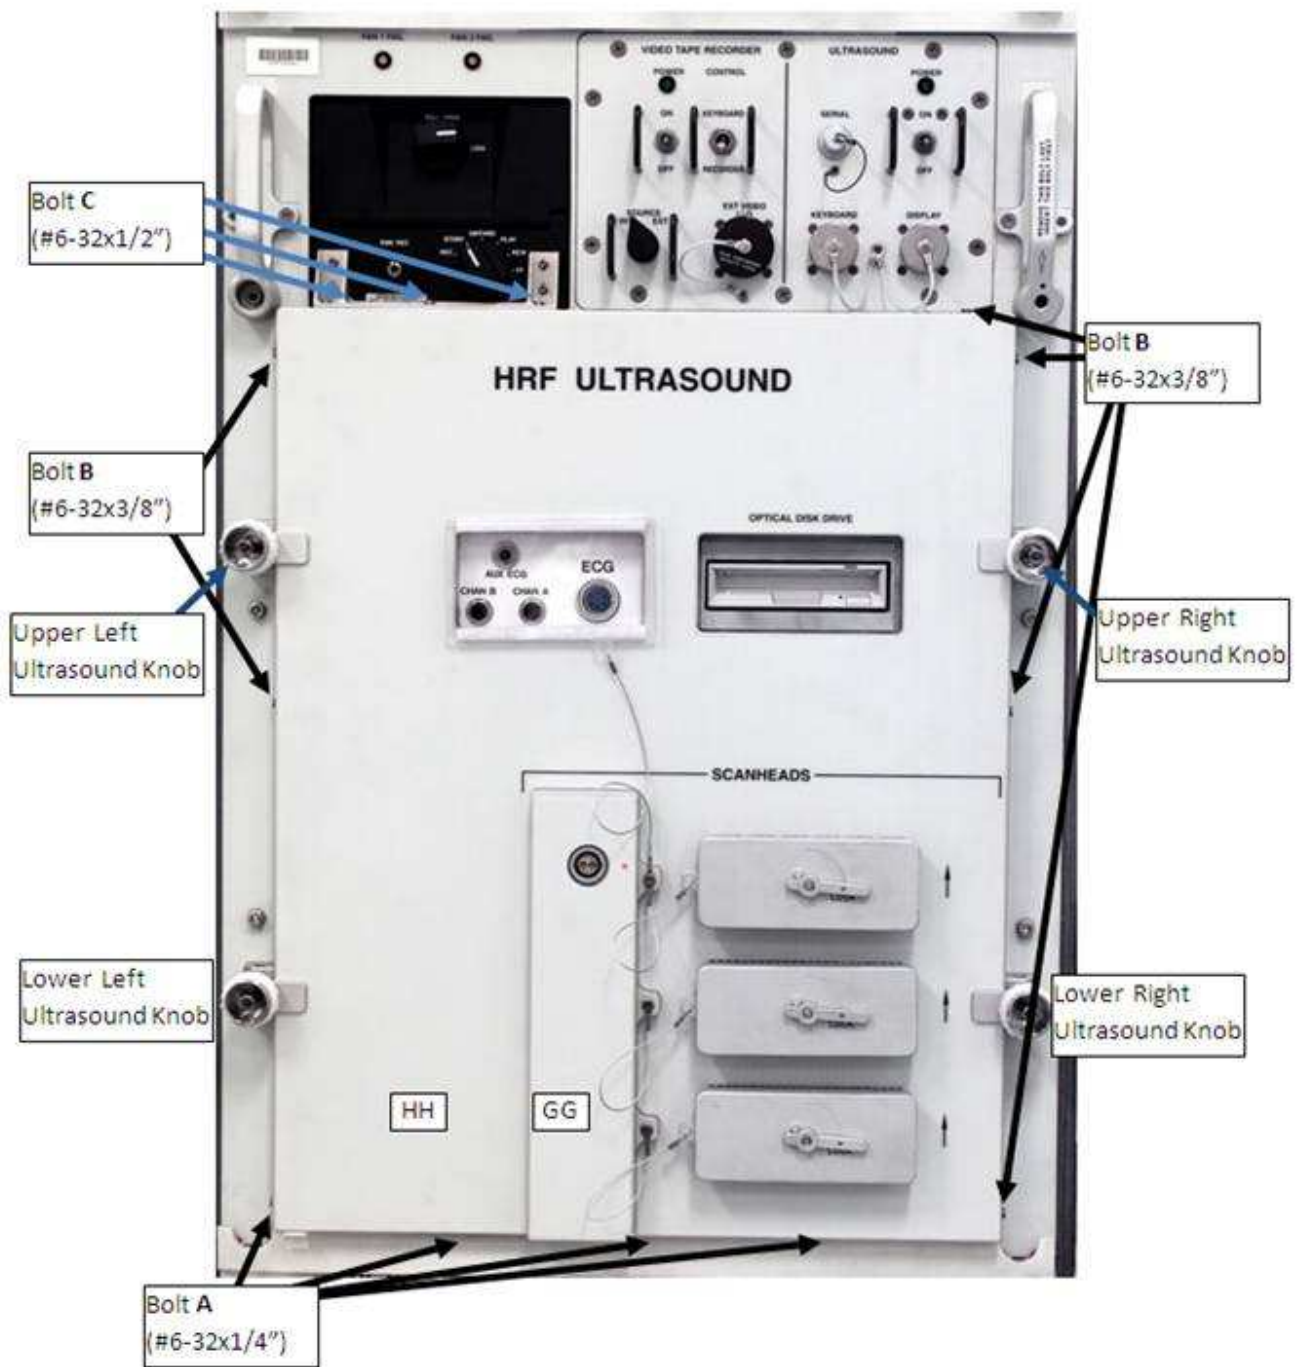
Figure 2. - HRF Ultrasound Front Panel Bolt Reference Guide.

1.2 Using Figure 2 as a guide for bolt location identification and tmpry stowage location into each labeled ziplock bag,

HRF Ultrasound Remove four non-captive bolts and washers (designated Bolt A) at bottom of HRF Ultrasound front panel using #6 Short Torq Bit with Ratchet, 3/8" Drive and 6" Extension 3/8" Drive. Stow bolts and washers in ziplock bag labeled 'Bolt A.'

Remove six non-captive bolts and washers (designated Bolt B) on sides of HRF Ultrasound front panel using #6 Short Torq Bit with Ratchet, 3/8" Drive and 6" Extension 3/8" Drive. Stow bolts and washers in ziplock bag labeled 'Bolt B.'

Remove three non-captive bolts and washers (designated Bolt C) at top of HRF Ultrasound front panel using #6 Short Torq Bit with Ratchet, 3/8" Drive and 6" Extension 3/8" Drive. Stow bolts and washers in ziplock bag labeled 'Bolt C.'

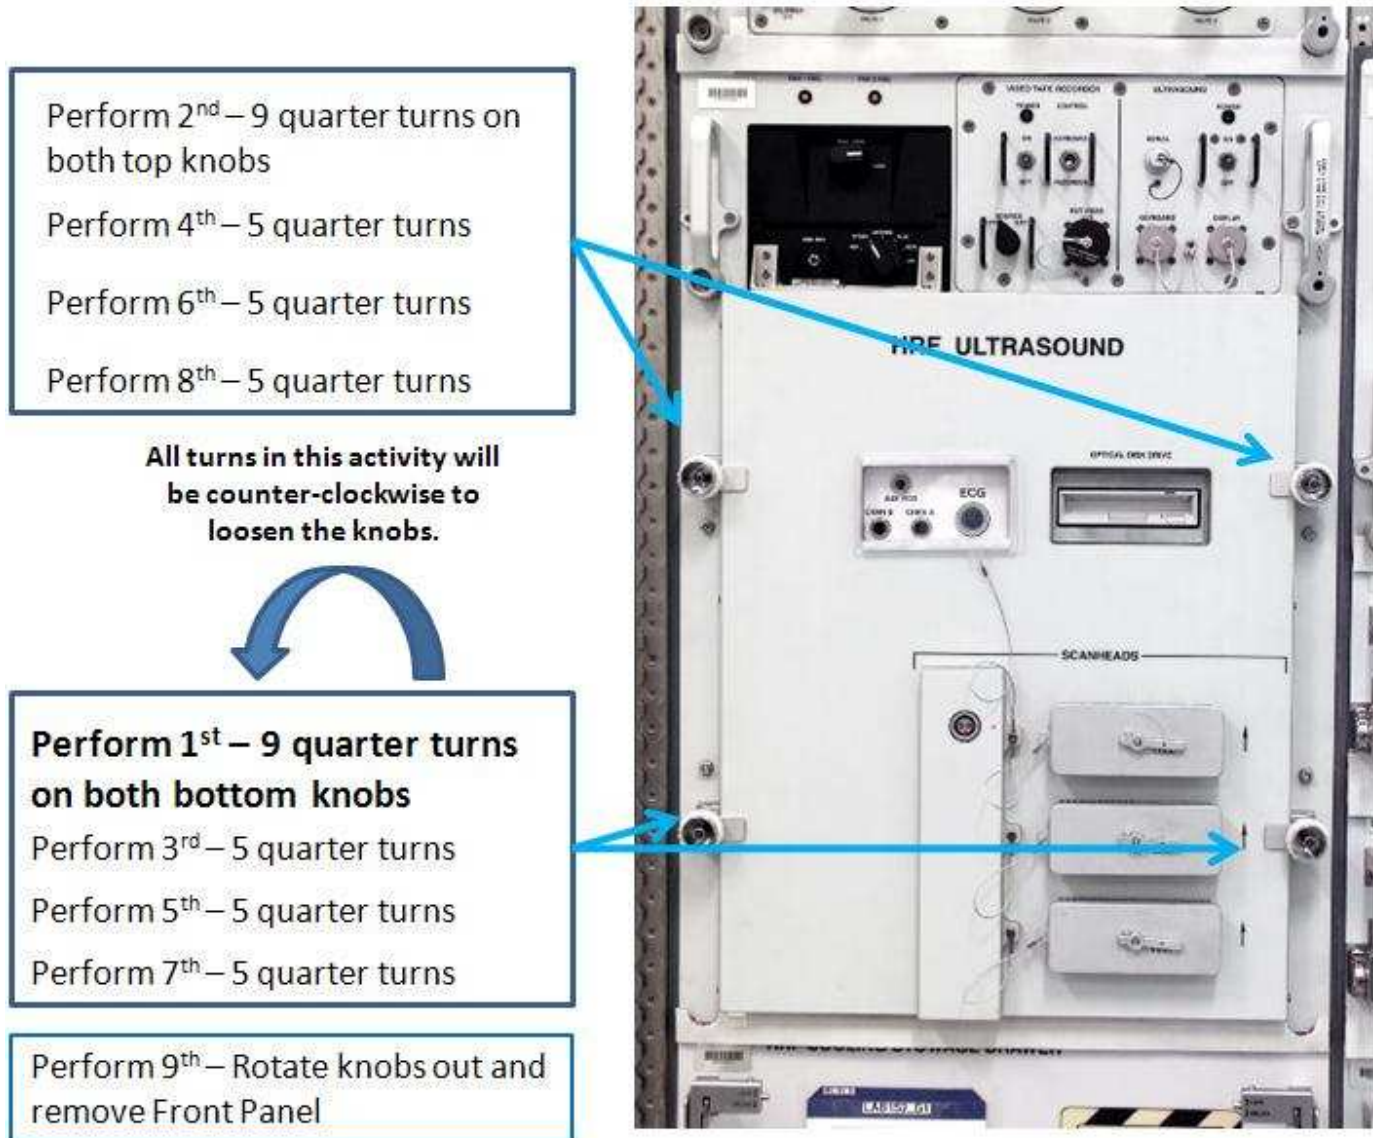
Figure 3. - HRF Ultrasound Front Panel Removal Guide.

- 1.6 Loosen HRF Ultrasound front panel knobs in this order as follows (see Figure 3 for further guidance if necessary):

Turn lower left and right knobs (two) together counterclockwise nine quarter turns.

Turn upper left and right knobs (two) together counterclockwise nine quarter turns.

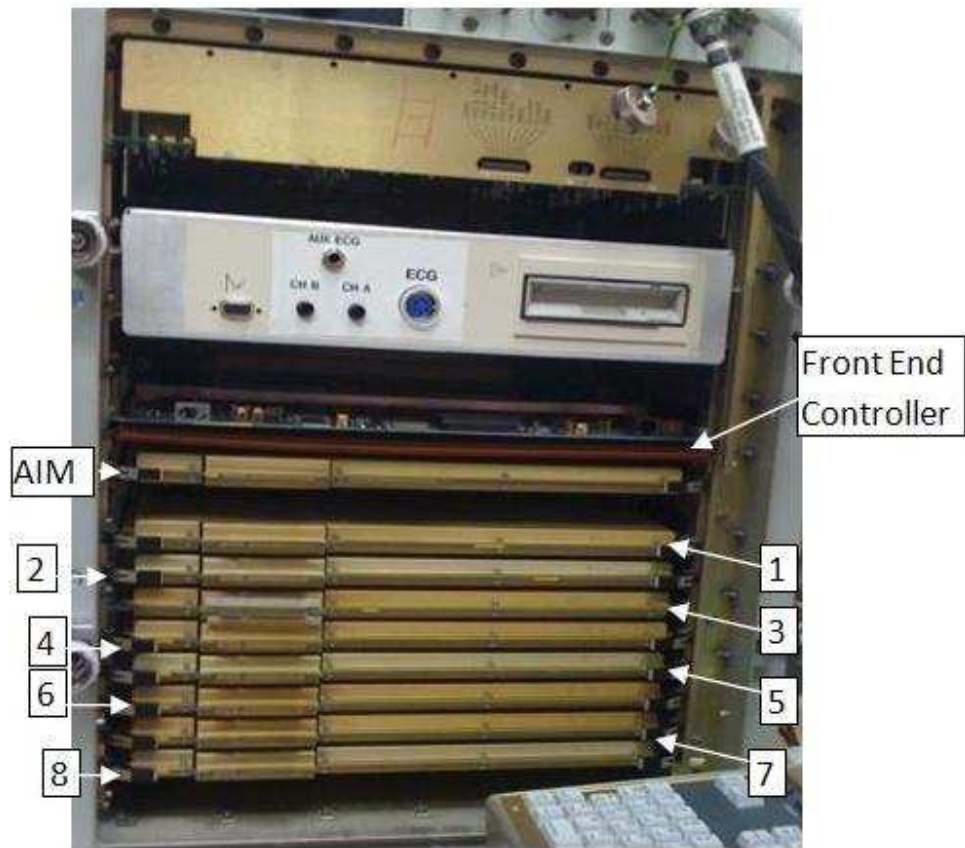
Figure 4. - Board Locations Inside HRF Ultrasound.

Printed Circuit Boards (PCB) contain sharp pins, sharp edges, and burrs. The PCBs must be handled by the edges and by using the extractor levers.

1.11 Using Figure 4 as a guide for board identification and location,

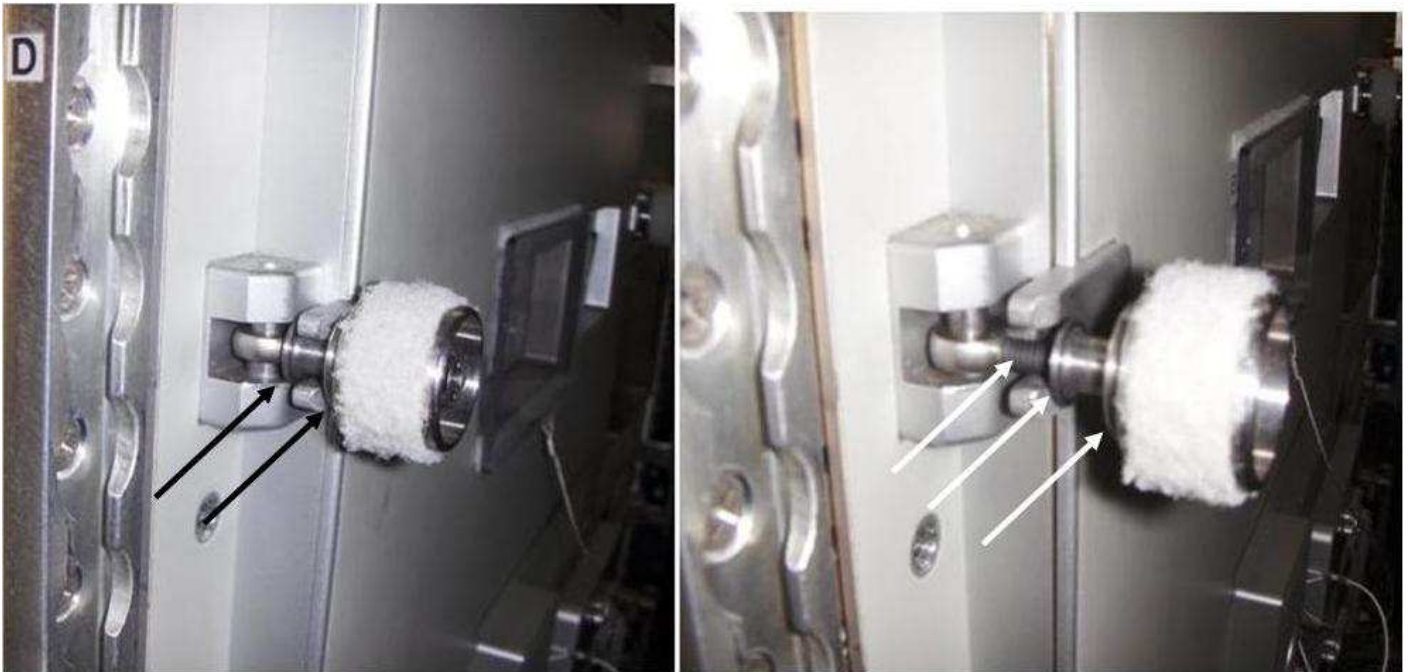
Correct Ultrasound Knob Lock

Incorrect Ultrasound Knob Lock

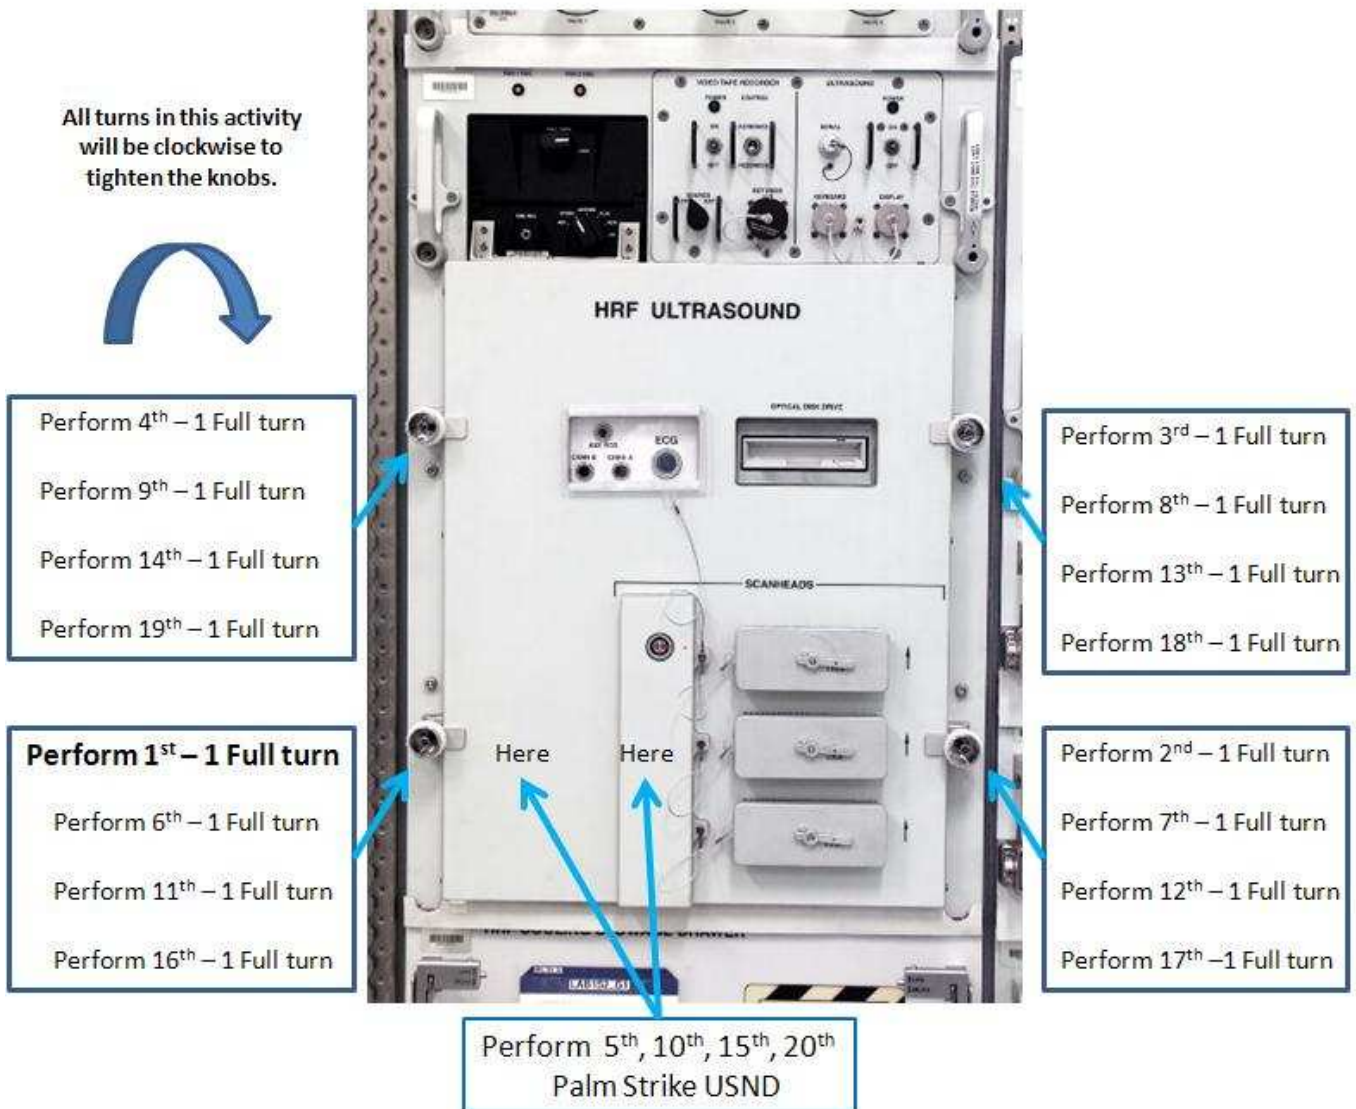
Figure 6. - HRF Ultrasound Front Panel Replacement Guide.

CAUTION	
	1. Failure to install HRF Ultrasound front panel correctly will result in broken channel boards.
	2. The lower left knob on HRF Ultrasound is the most critical to ensuring HRF Ultrasound front panel aligns properly.

HRF Ultrasound 1.17 Tighten HRF Ultrasound front panel upper and lower knobs in this order as follows (ensure gap is symmetric when progressing from knob to knob) (See Figure 6 for general guide to front panel replacement and Figure 7 for illustration of gap):

Once HRF Ultrasound front panel is determined to be seated properly, tighten upper left and upper right knobs to fully seat HRF Ultrasound front panel.

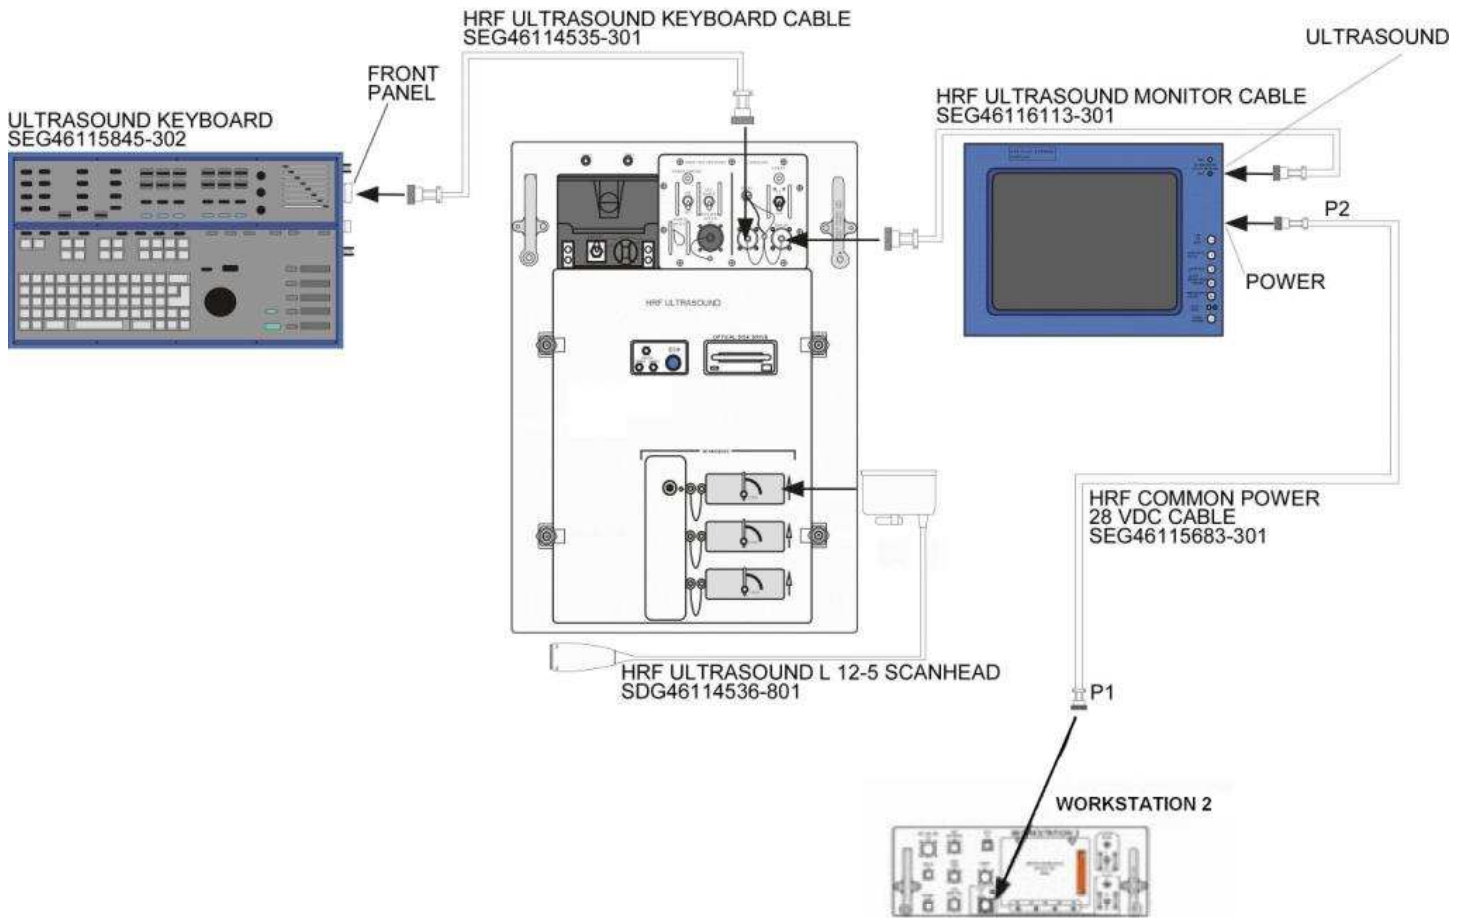
Figure 8. - Ultrasound Cabling Diagram.

Cabling Diagram below (Figure 8) can be referenced for the following steps.

- HRF Ultrasound 2.6 HRF Ultrasound Keyboard Cable →|← Keyboard
- Ultrasound Keyboard HRF Ultrasound Keyboard Cable →|← Front Panel (right side)
- HRF Workstation 2 2.7 ✓sw POWER 28VDC – OFF
✓POWER 28VDC Lt – Off
- HRF Ultrasound 2.8 HRF Ultrasound Monitor Cable →|← Display
- HRF FSD HRF Ultrasound Monitor Cable →|← Ultrasound (right side)
- HRF Workstation 2 2.9 HRF Common Power 28 VDC Cable (P1) →|← J11 28VDC
- HRF FSD 2.10 HRF Common Power 28 VDC Cable (P2) →|← POWER
- HRF Ultrasound L12-5 Scanhead 2.11 Remove L12-5 Scanhead Connector Cover and Tmpy stow.
Rotate HRF Ultrasound L12-5 Scanhead connector knob ↻

Male end of both HRF Ultrasound Keyboard Cable and HRF Ultrasound Monitor Cable can be inadvertently mated to another male connector resulting in pin-to-pin damage.
