# Ares I-X 30 Day Report

*Bob Ess, Mission Manager*  
*Marshall Smith, SE&I Chief*

*December 3, 2009*

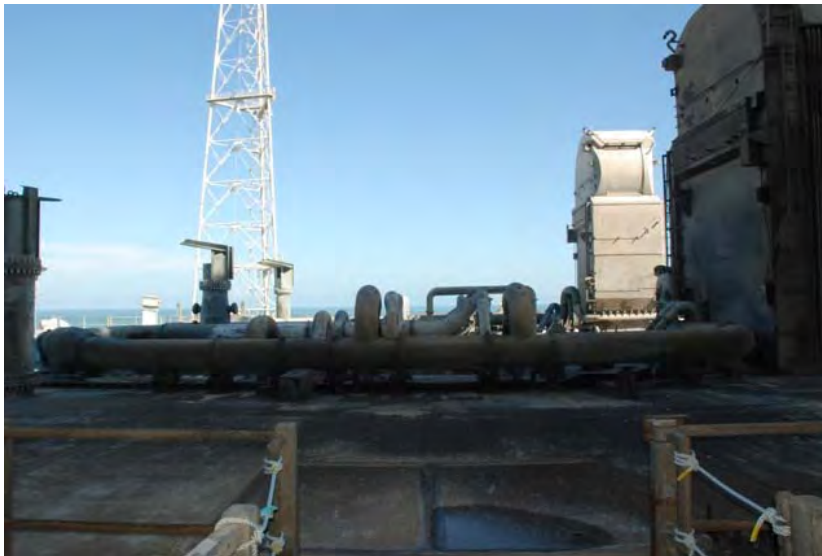
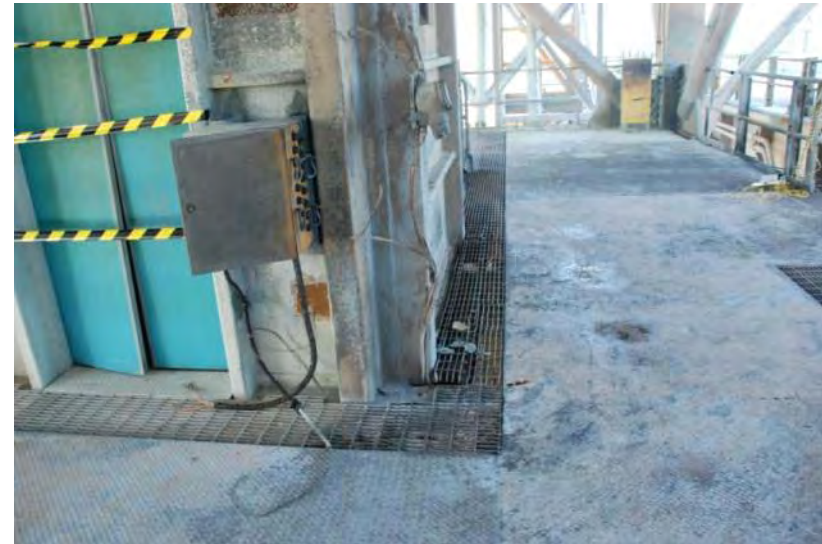
# GS

- ◆ PAD designers were very satisfied with results
- ◆ This flight will help Ares I structures designers as they design for an Ares I FAM

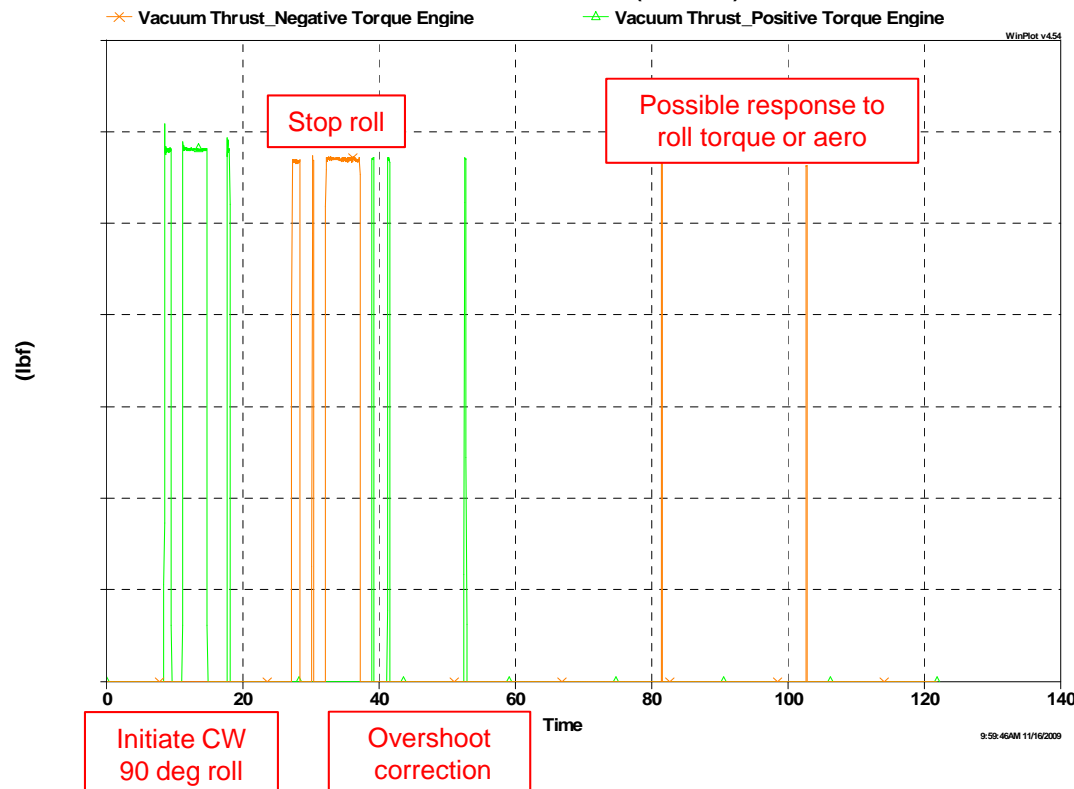
# Roll Torque Estimate

- ◆ **Primary Objective 5 intended to estimate roll torque**
  - Low roll torques observed
  - Estimate of roll torque assessed by the Roll Control System firings
    - Very few firings required. Only a couple that may be related to roll torque
  - Simulations show that roll torque may be primarily due to aero data as opposed to the motor

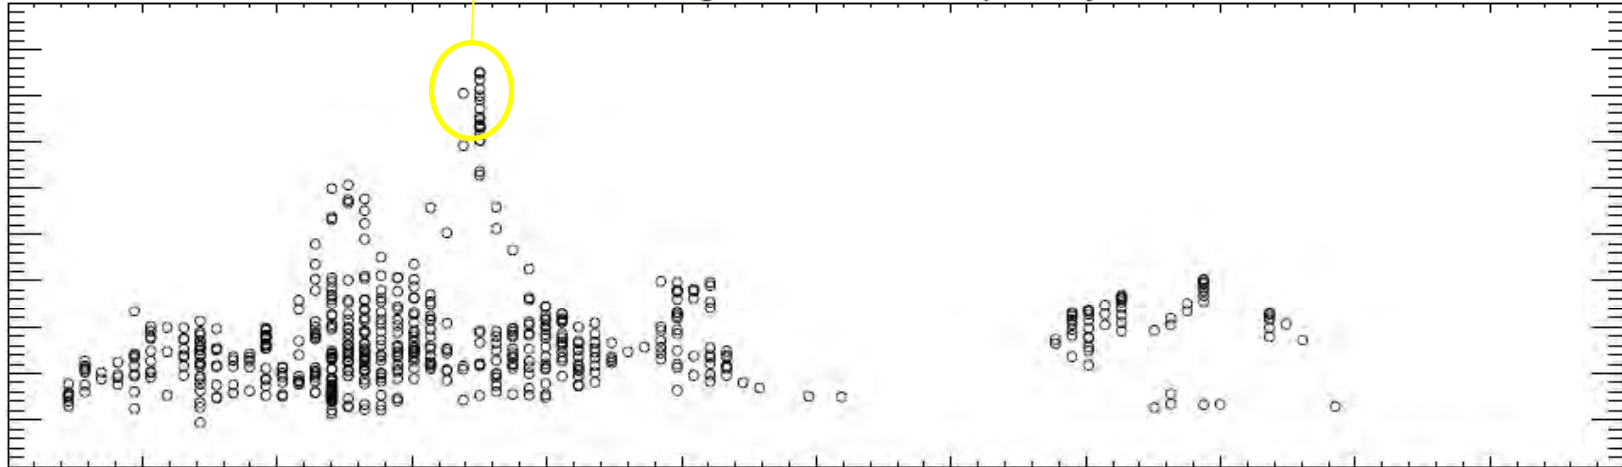
Peak Magnitude vs Frequency

- ◆ 1L thrust oscillation peaked between T+77 and T+79 seconds
- ◆ Substantial margin between recommended load and actual load
  - Peak pressure was about 1/3 of the predicted value
  - Frequency was ~15 Hz

77 to 79 seconds

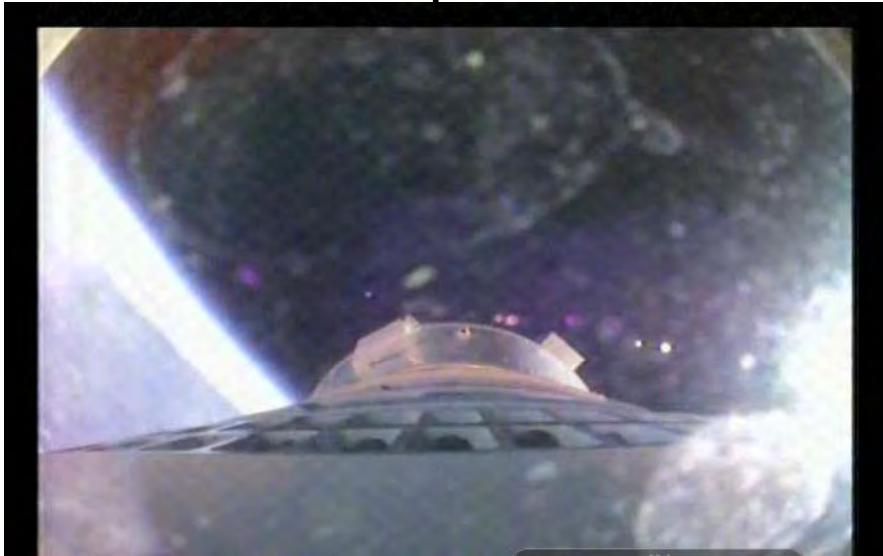
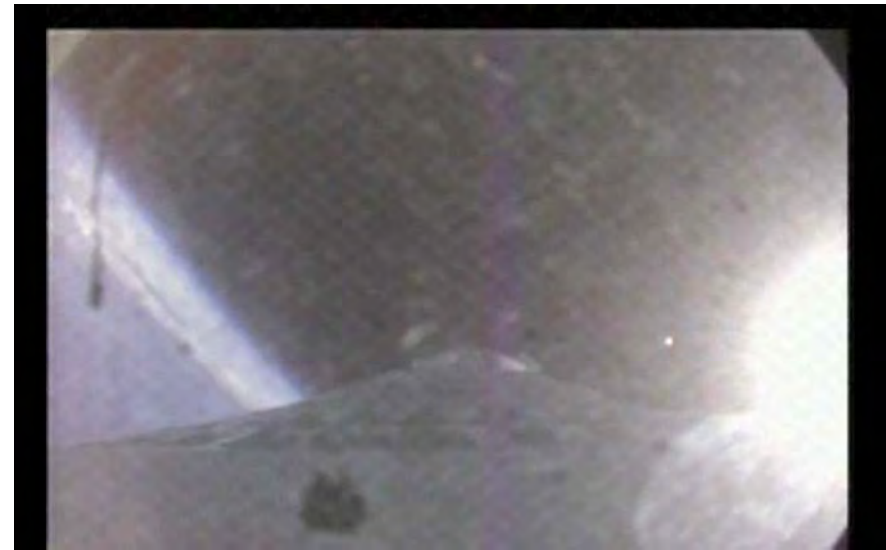
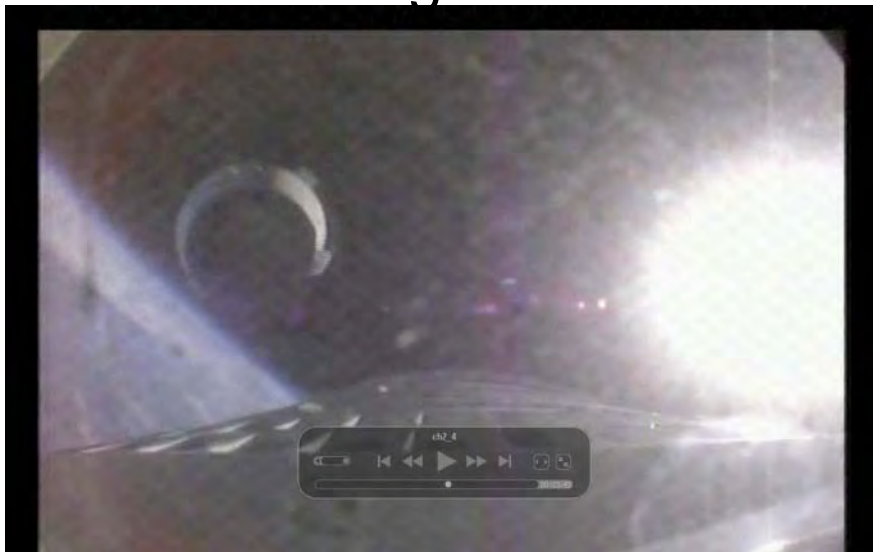
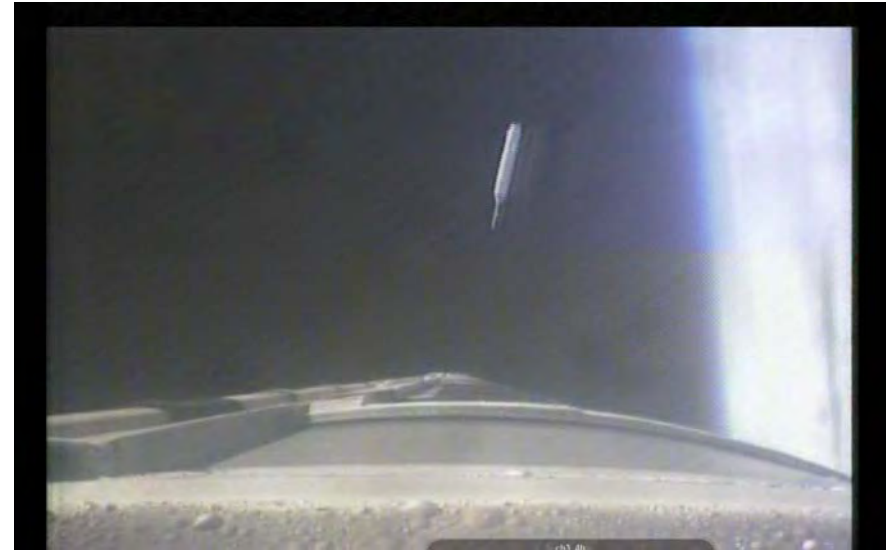
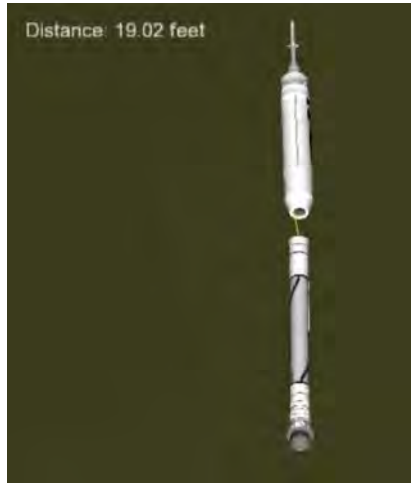
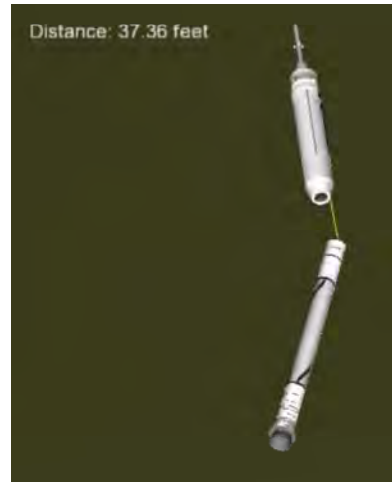
# Forward Looking Video

- ◆ **Post-separation tumble of the Upper Stage Simulator was expected due to mass properties and aerodynamic forces**

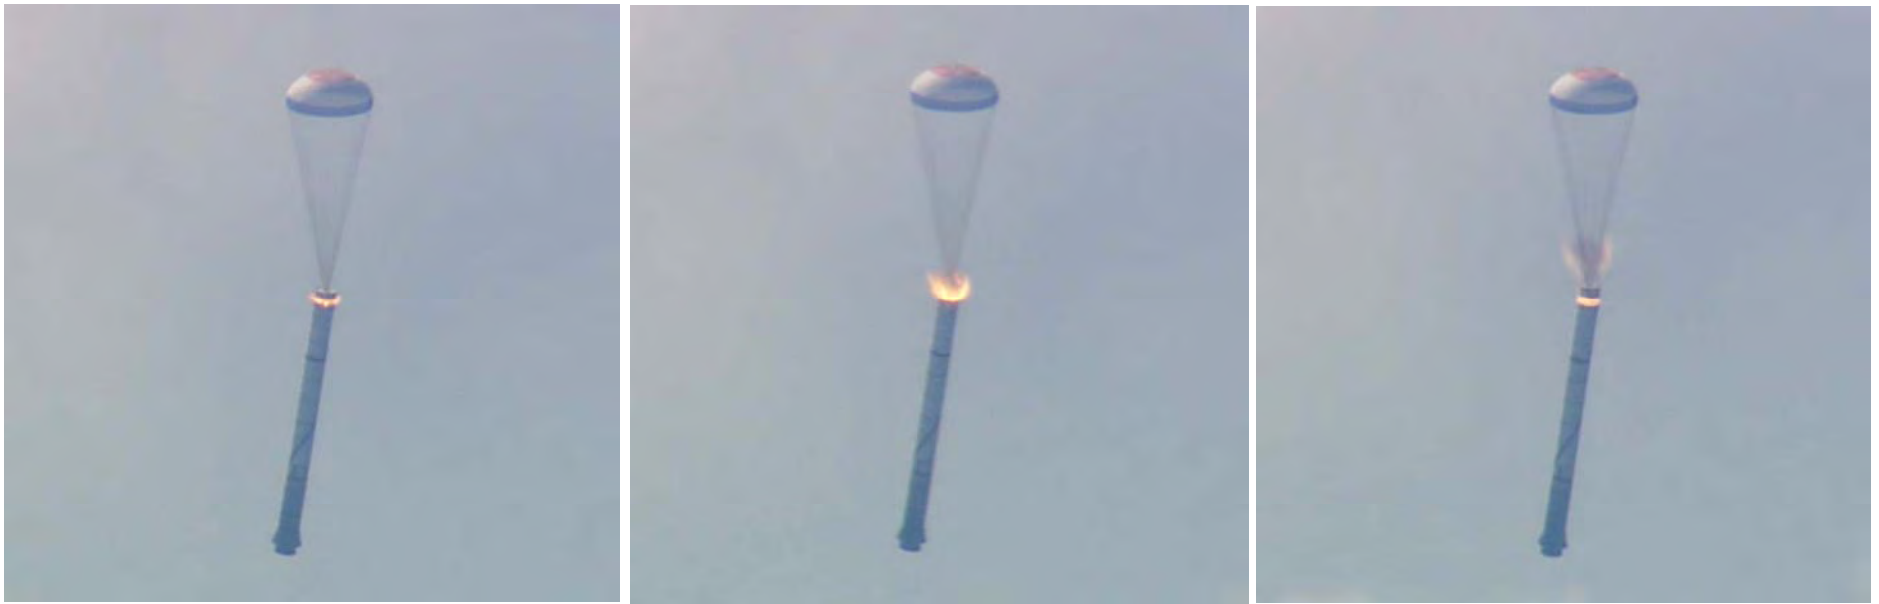
# Connector Assessment

- ◆ **Three separation connectors on the Forward Skirt dome did not separate**
  - Pendulum effect under the drogue chute may have caused an off center pull
  - A improper disconnect failure scenario was identified prior to launch and determined not to have any significant effects to the system
  - No loss of functionality of the connectors

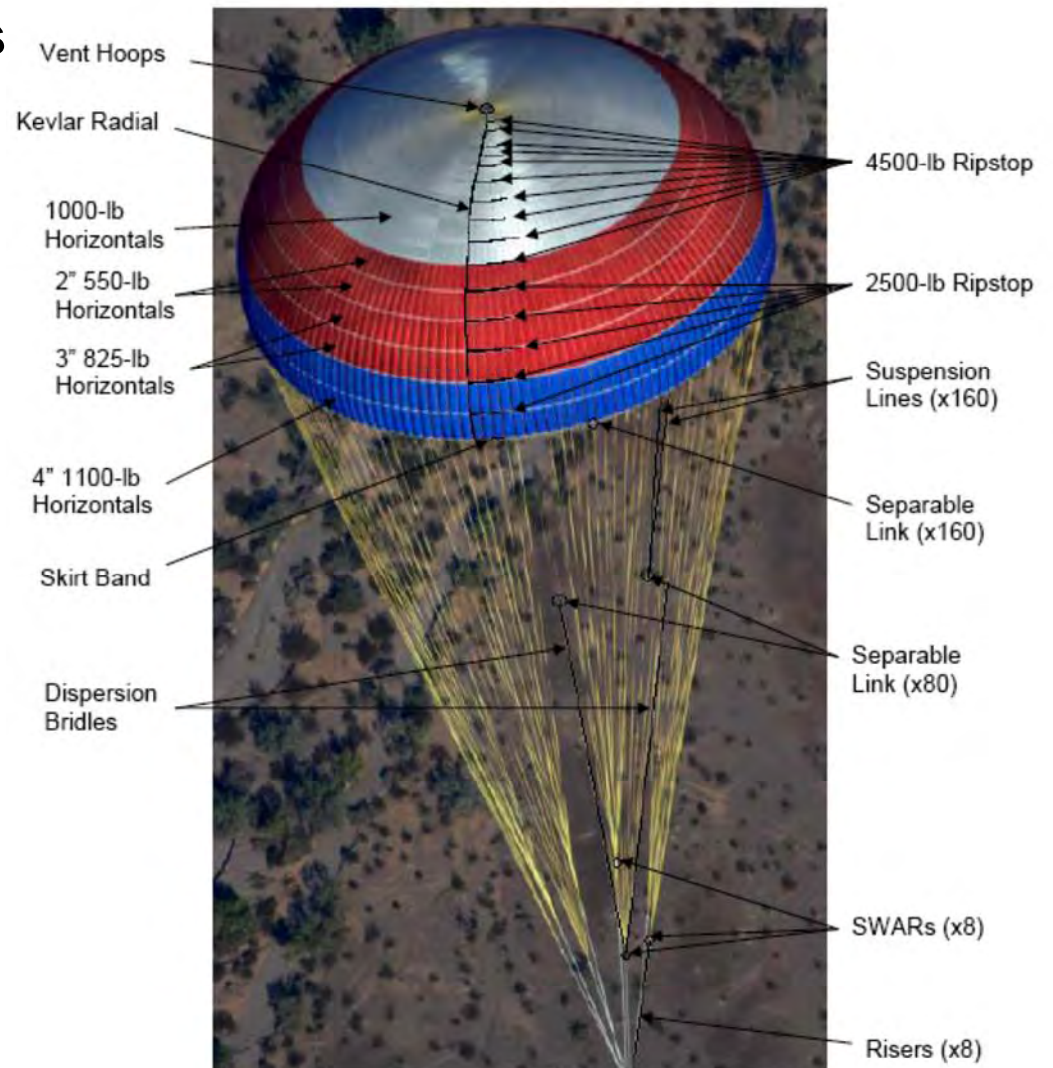
Major Components in a Main Parachute

- ◆ One of the main parachutes failed at initial inflation
- ◆ 1<sup>st</sup> parachute may have “dis-reefed” prematurely allowing parachute to inflate too quickly
  - Increased initial load on parachute and riser line system
  - Salt Water Activation Release (SWAR) hardware exhibits damage representative of an overload
- ◆ A second parachute then partially failed
  - Assessment underway
