# Ares I-X Flight Test Results

*April 2010*

# Ares I-X was extremely successful

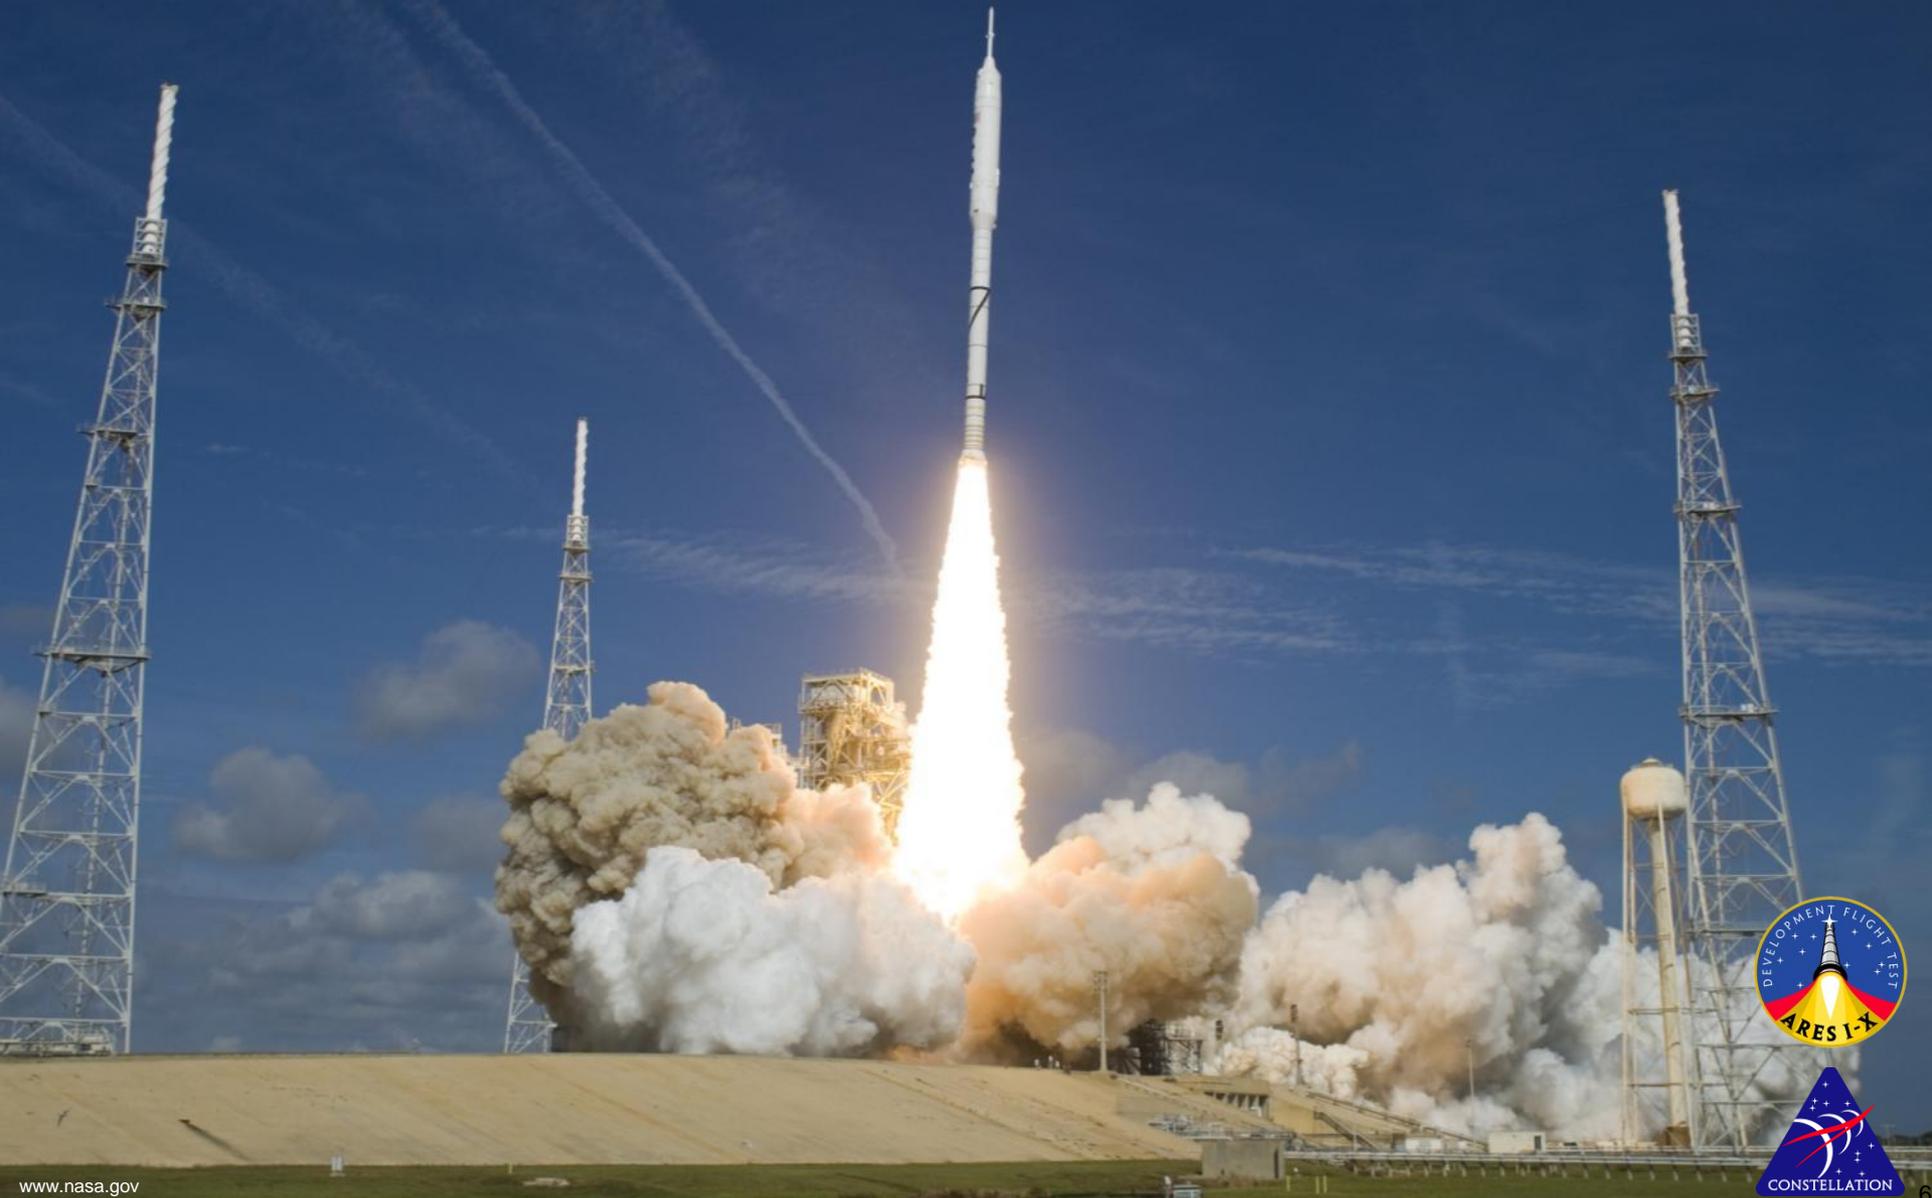
# Roll Control System

## ◆ Description

- Roll Control System provides rotational azimuth control for:
  - mitigation against adverse vehicle roll torques (self- and aero-induced).
  - antenna and simulated crew launch positioning.

## ◆ Salient Features

- The Roll Control System is an integral, modular, bi-propellant propulsion system installed in the Ares I-X Upper Stage Simulator Interstage.
- RoCS utilized off-the-shelf and Government-furnished components that have been harvested from USAF Peacekeeper Stage IV, then re-integrated into a system.

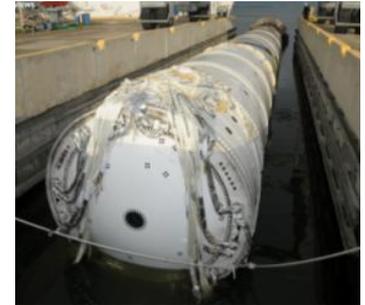
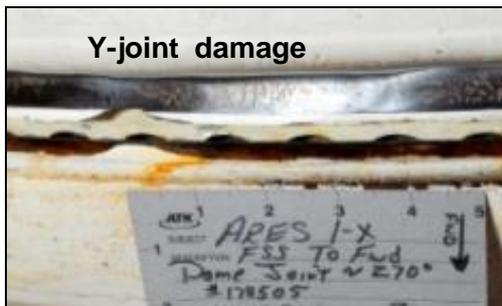
Aft Skirt Cracking

- **FSS/Forward Skirt is in good condition, however:**
  - Aft XL cylinder clevis joint has most likely yielded or fractured
- Forward dome has fractured or severely yielded Y-joint
- All four cylinders associated with the Center segments are damaged (buckled and/or flattened) and most likely not usable
- **Aft Segment**
  - ETA and both stiffener cylinders have combinations of inboard and outboard stub cracks as well as “shape” issues
- **Aft Skirt has significant cracking and “shape” issues**
- **TVC looks acceptable**
- **Hardware was not intended or needed for reuse**

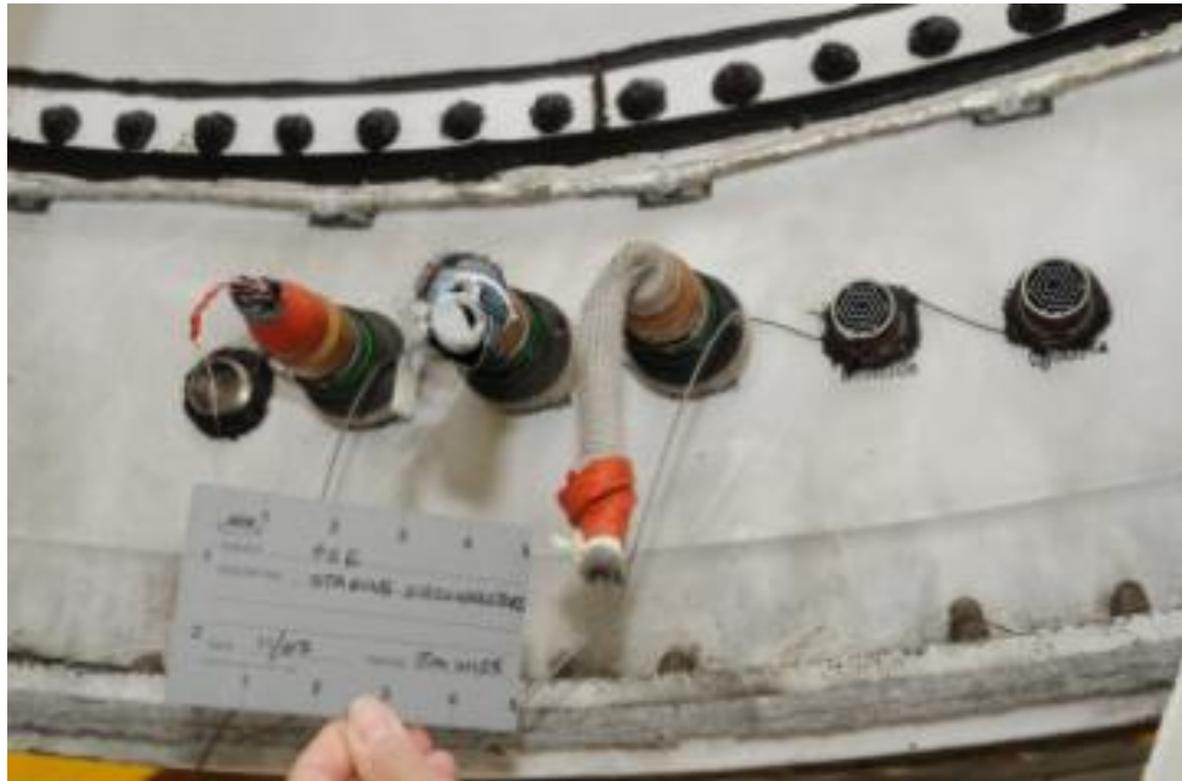
# Separation Connector Failure

## ◆ Failure of the Forward Skirt-to-FSE separation connectors

- The most probable cause of this failure is that connectors were pulled at an angle higher than their rated cone angle
- The cause of this higher angle is uncertain
  - Could have been a Pendulum Effect during the Drogue Chute phase

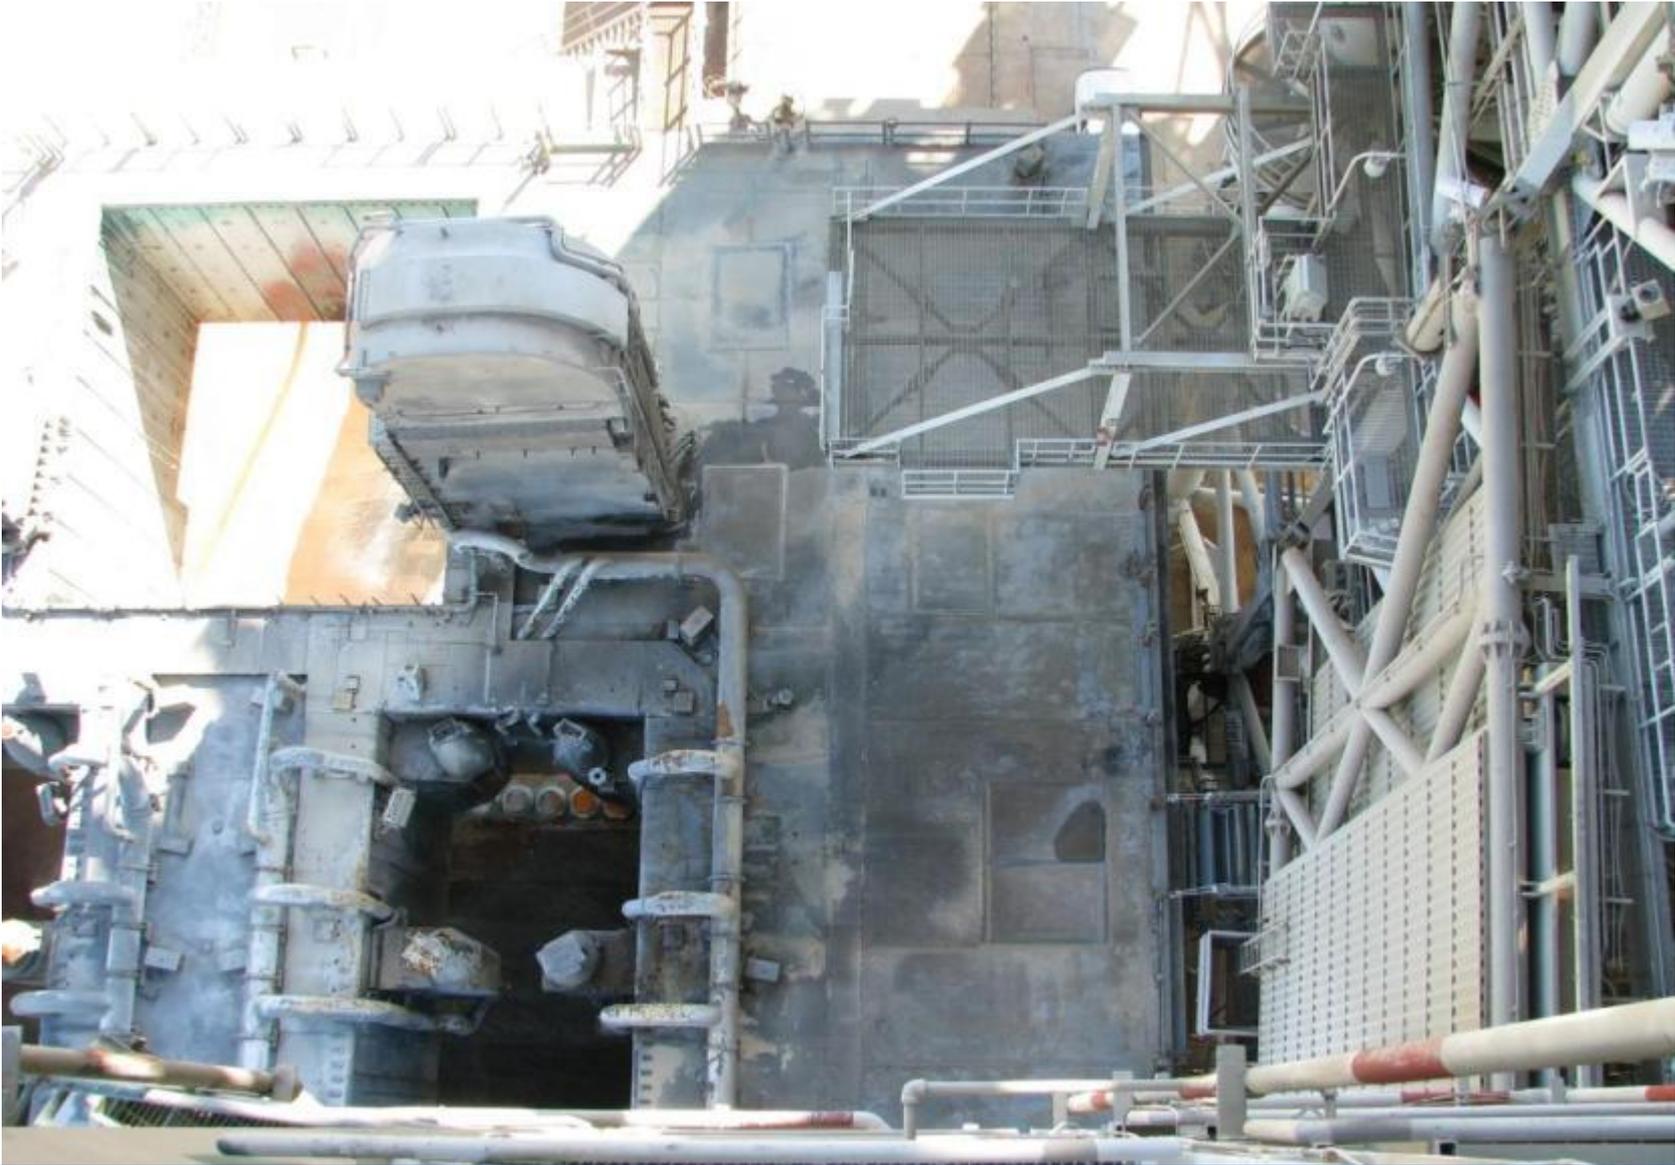
# MLP "0" Deck: Birdseye View

I-X causes more damage than Shuttle

- ◆ **Ares I-X launch damage greater than what has been seen on previous shuttle missions**
  - Launch pad was not hardened for Ares I-X plume impingement
  - More damage observed than Shuttle at 95' Level
    - Due to drift/fly-away maneuver & lack of Sound Suppression water coverage
  - No major damage observed at 115' Level
  - No damage at 135' Level & above

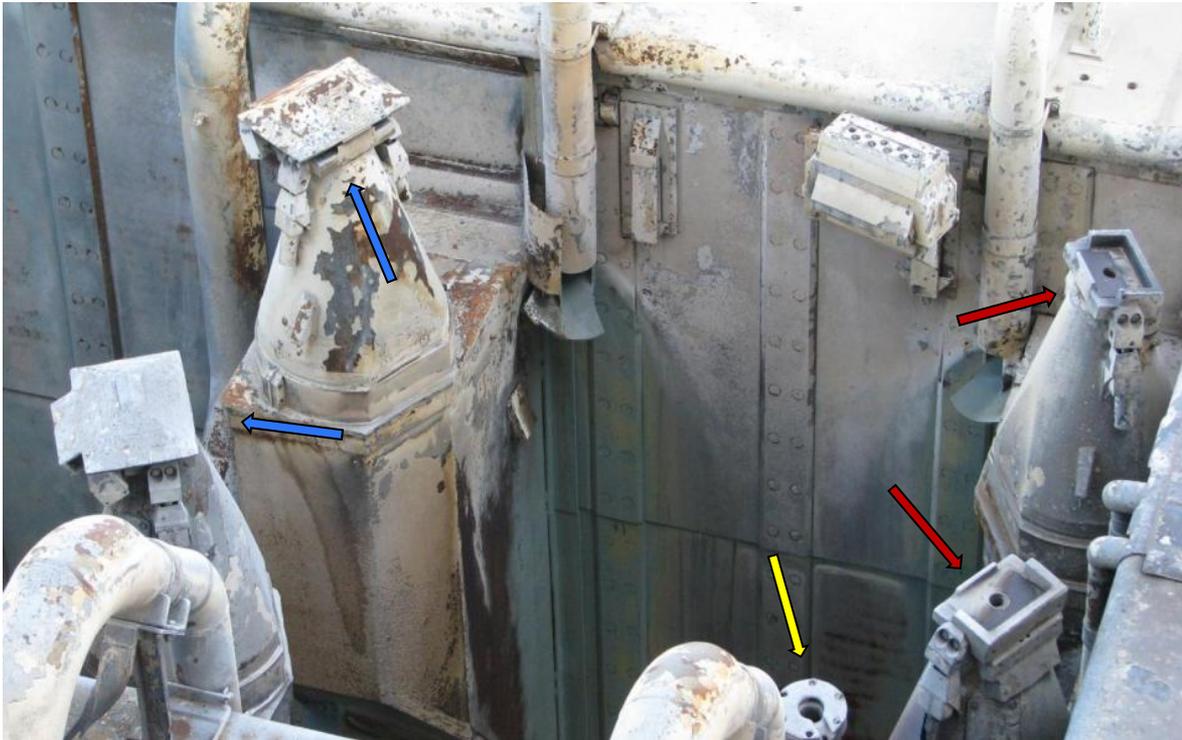
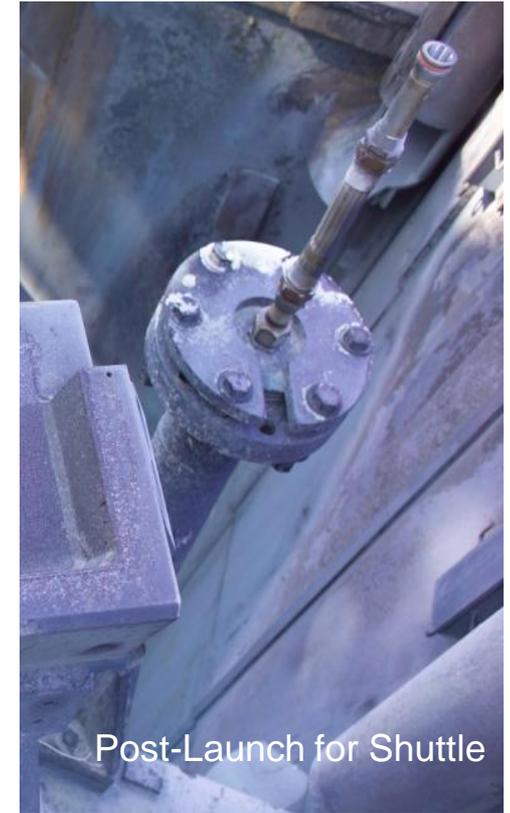
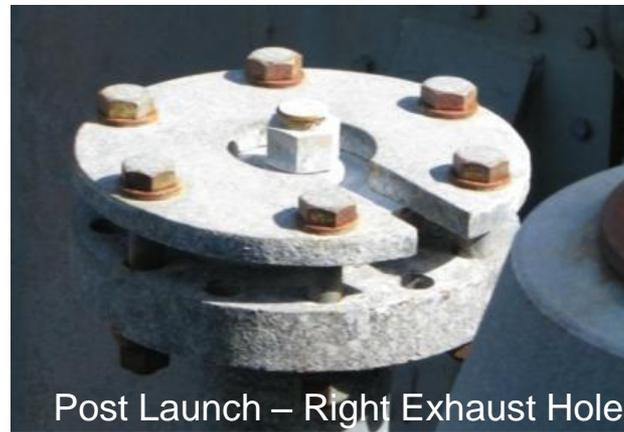
# Ares I-X Exhaust Hole Holddown Posts & GN2

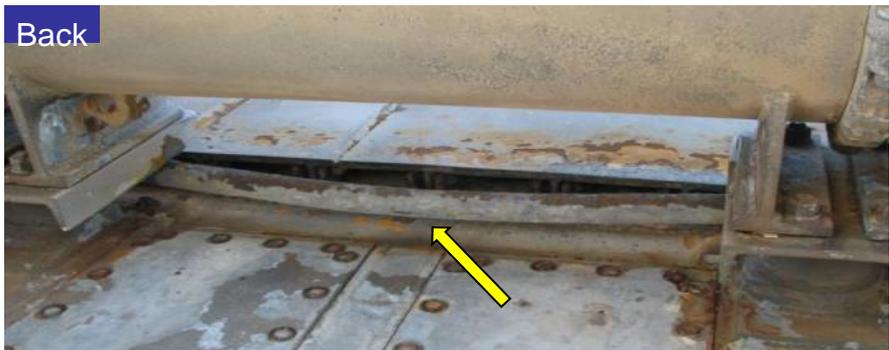
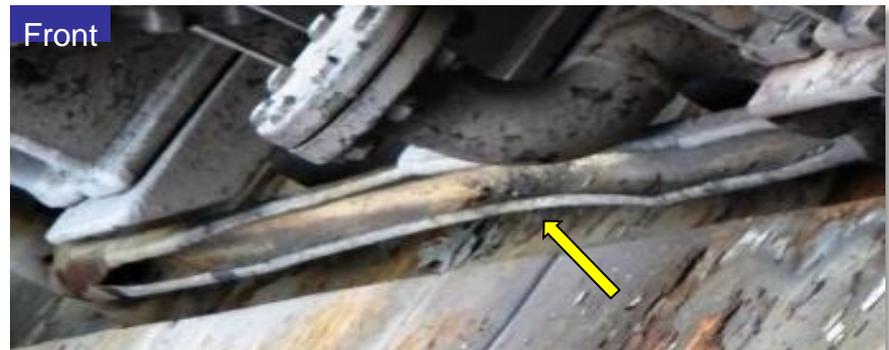
# MLP "0" Deck: Water System Damage

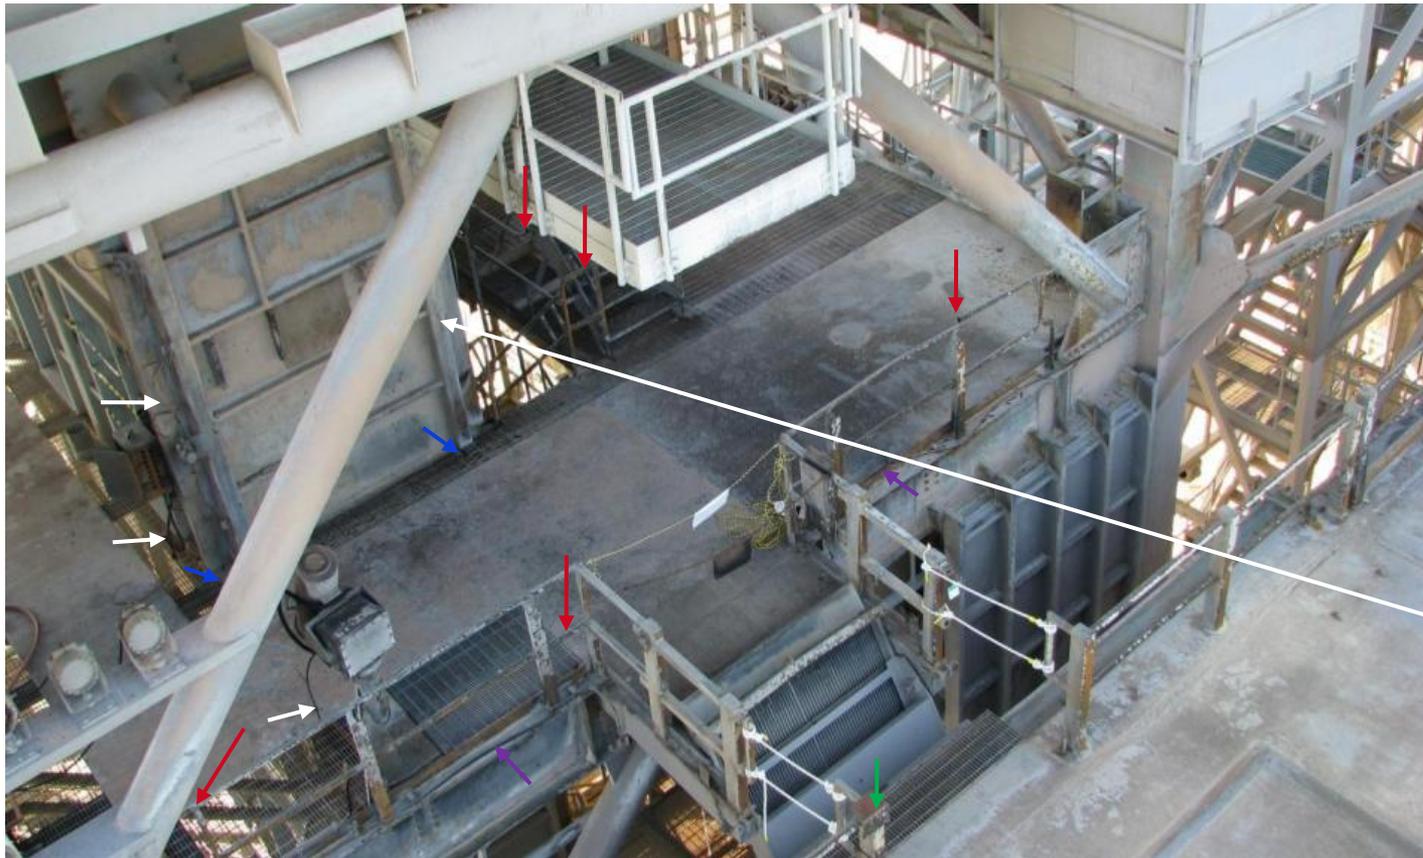
## FSS 95 Level

Color Key: ■ Hand Rails; ■ Tubing; ■ Gridding; ■ Sensors;  Cables

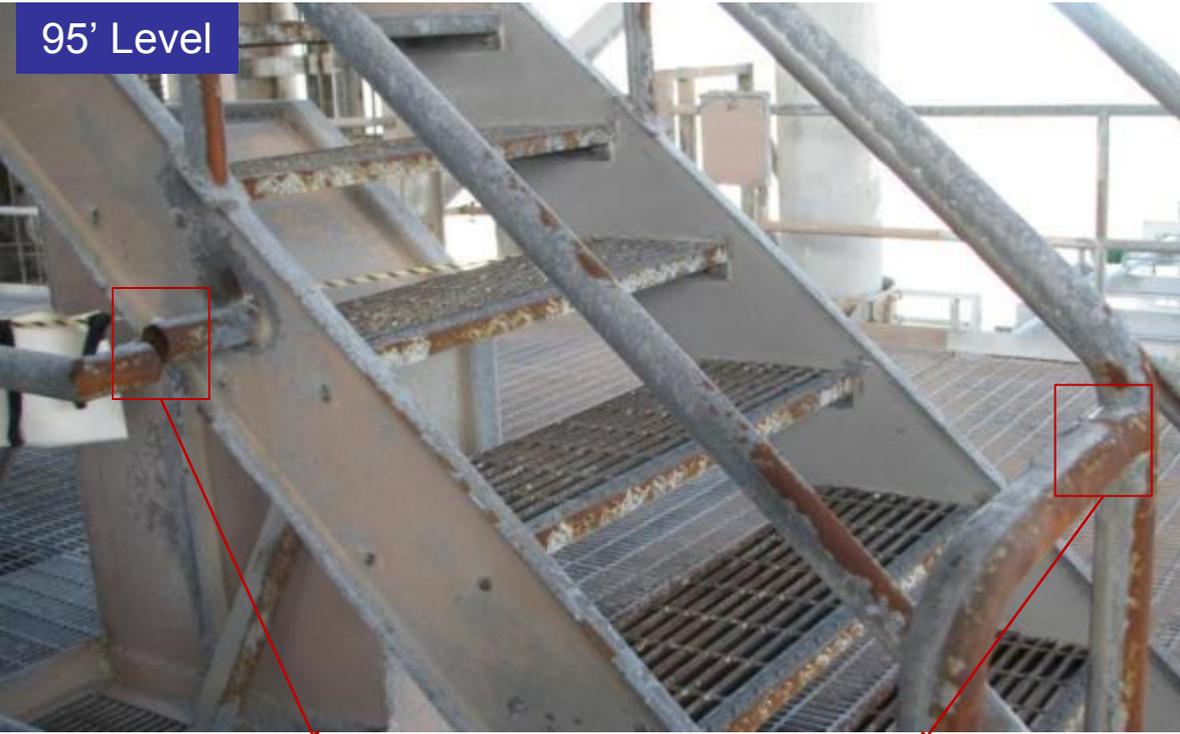
95' Level

# FSS 95' Level: Handrail Damage

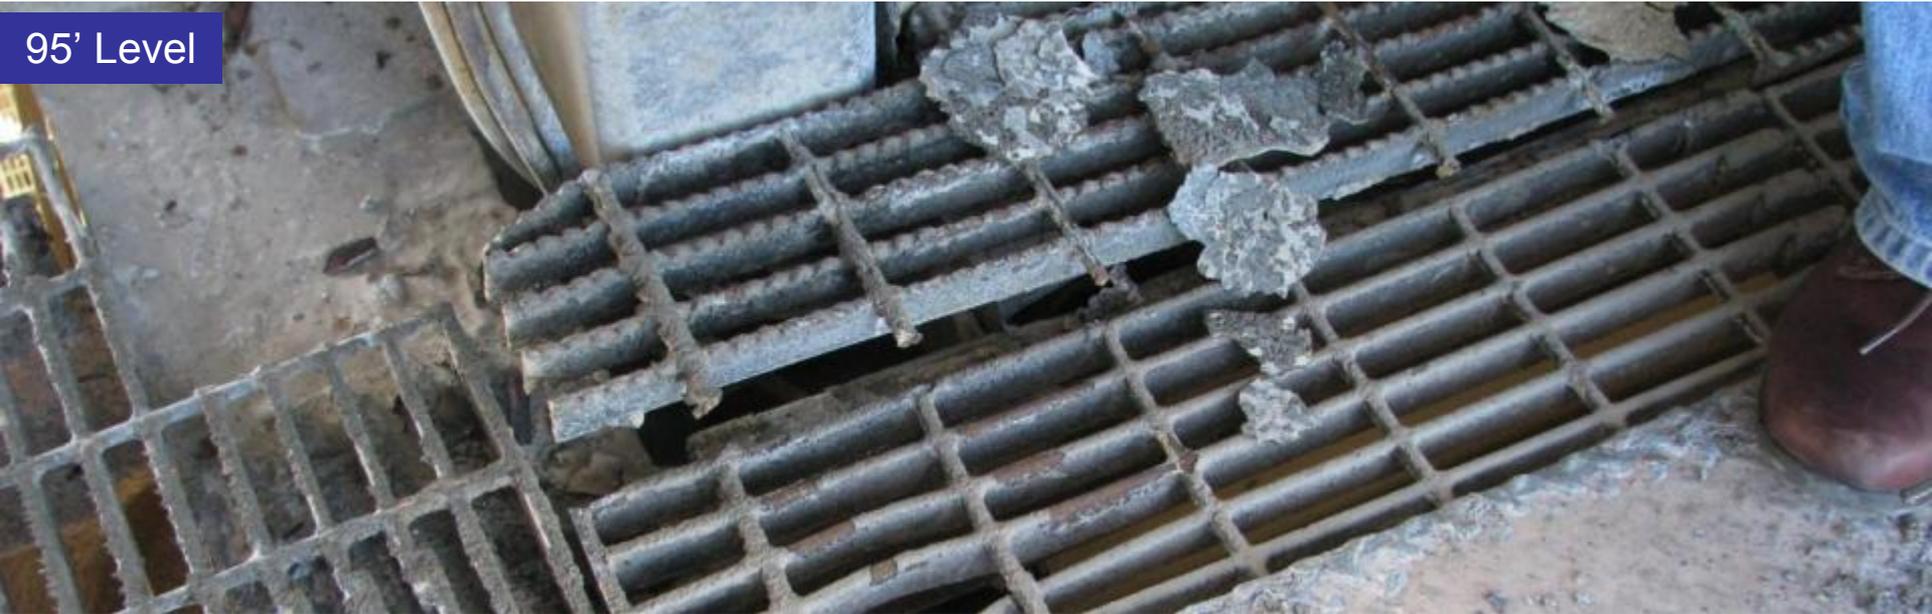
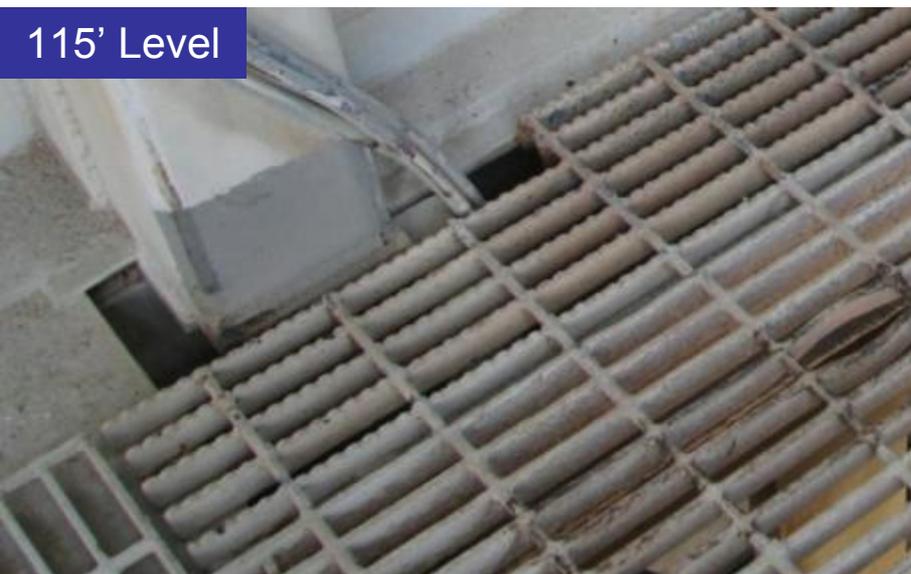
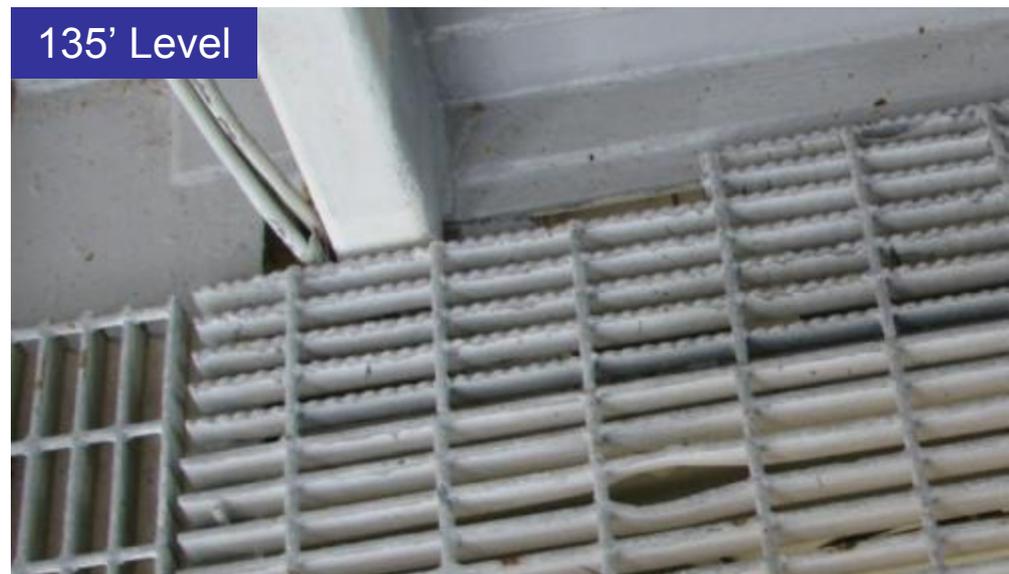
# FSS 95' Level : Grating Damage

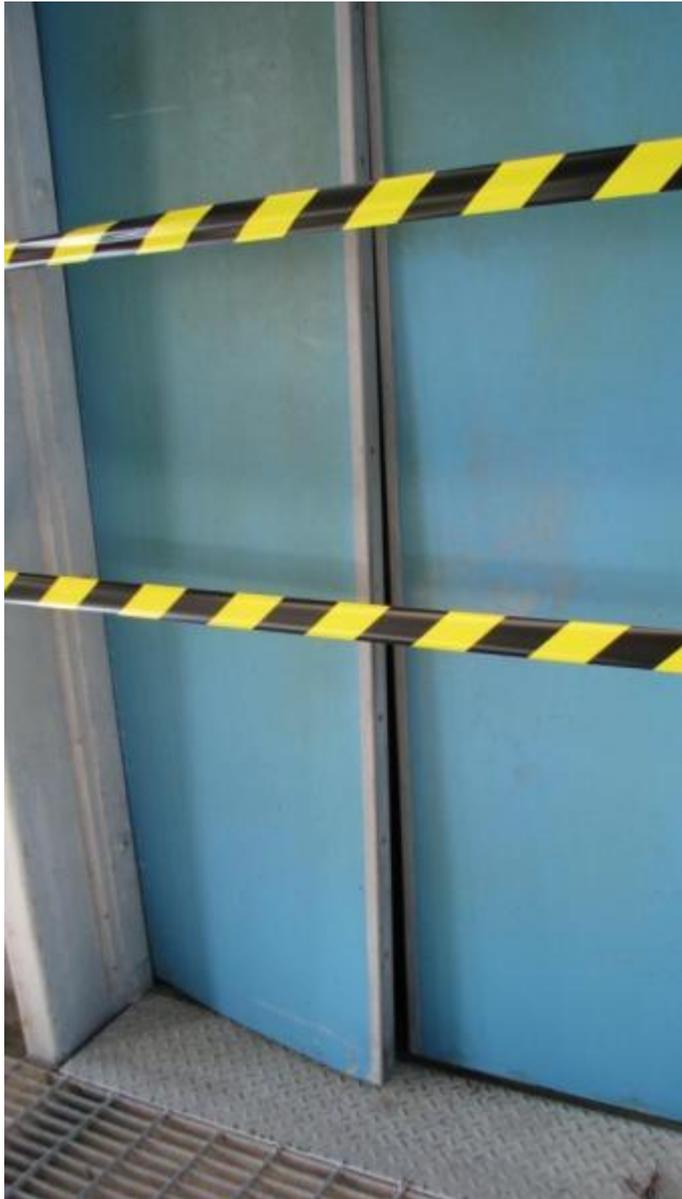
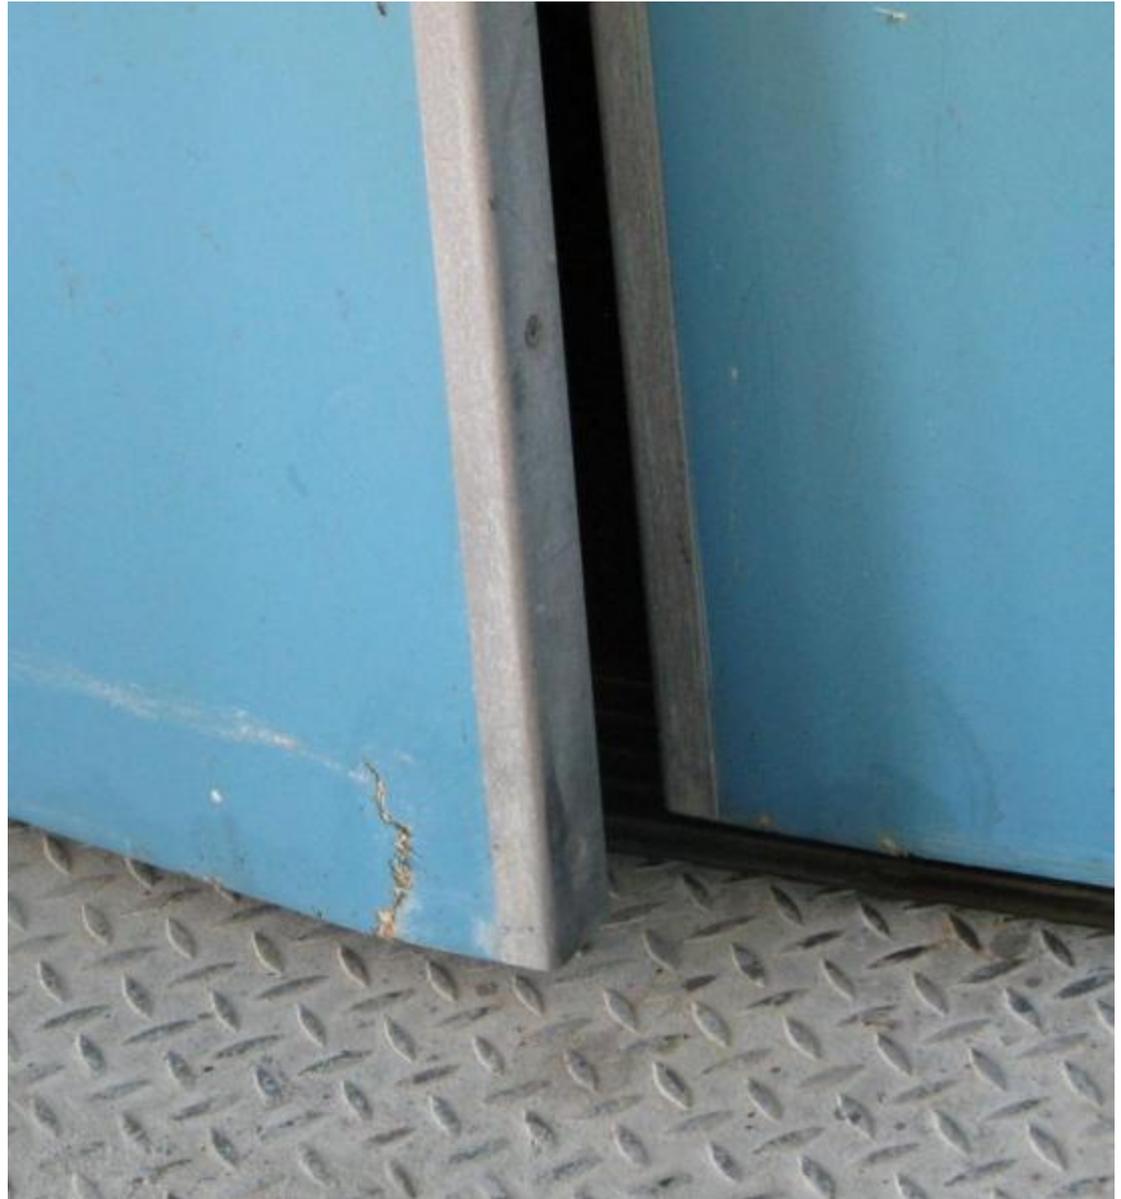
# FSS 95' Level : Elevator Door Damage

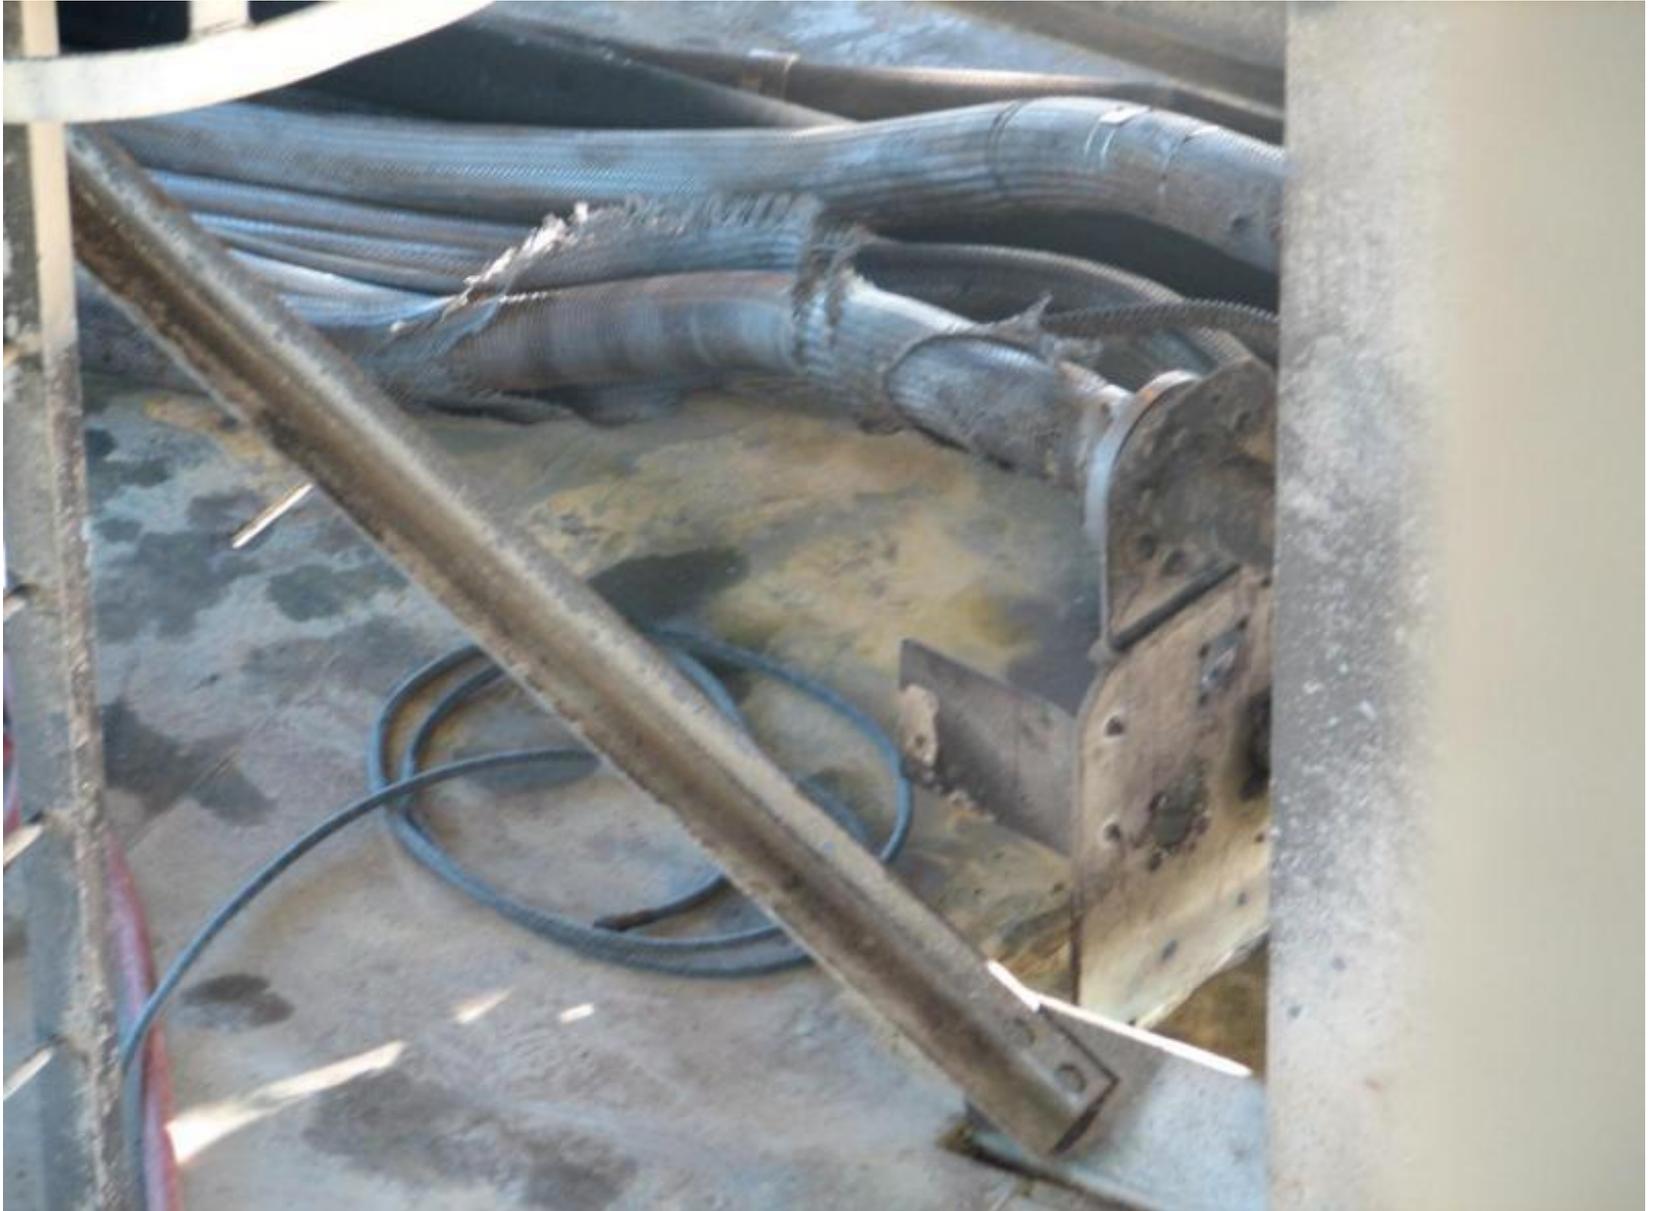
# RSS 95ft Level: Hypergol Flex Hose Damage

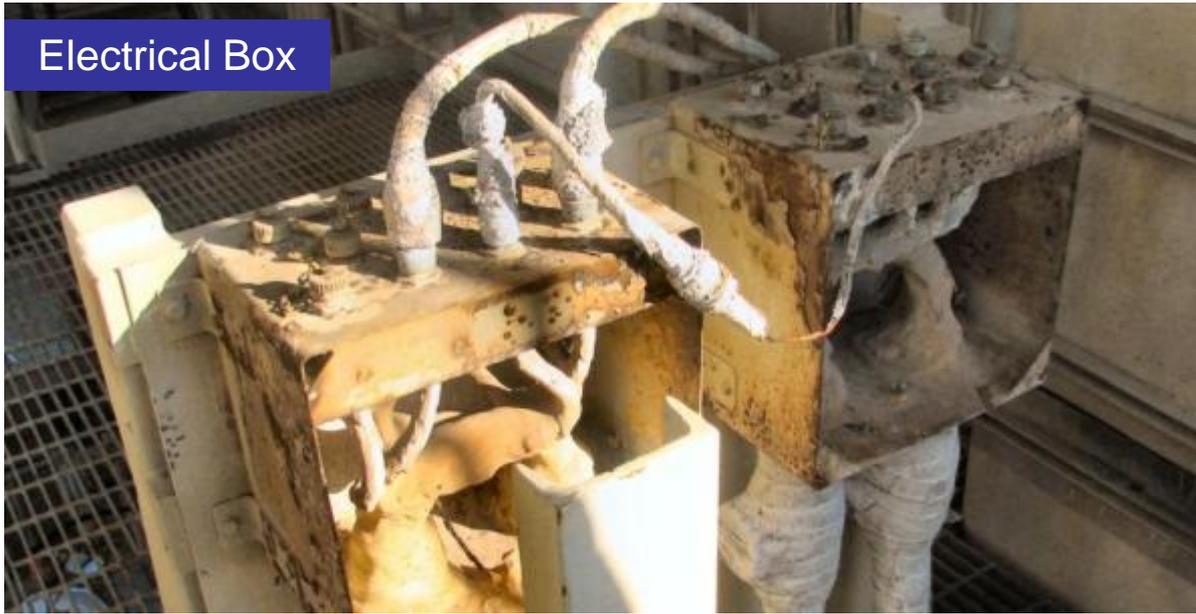
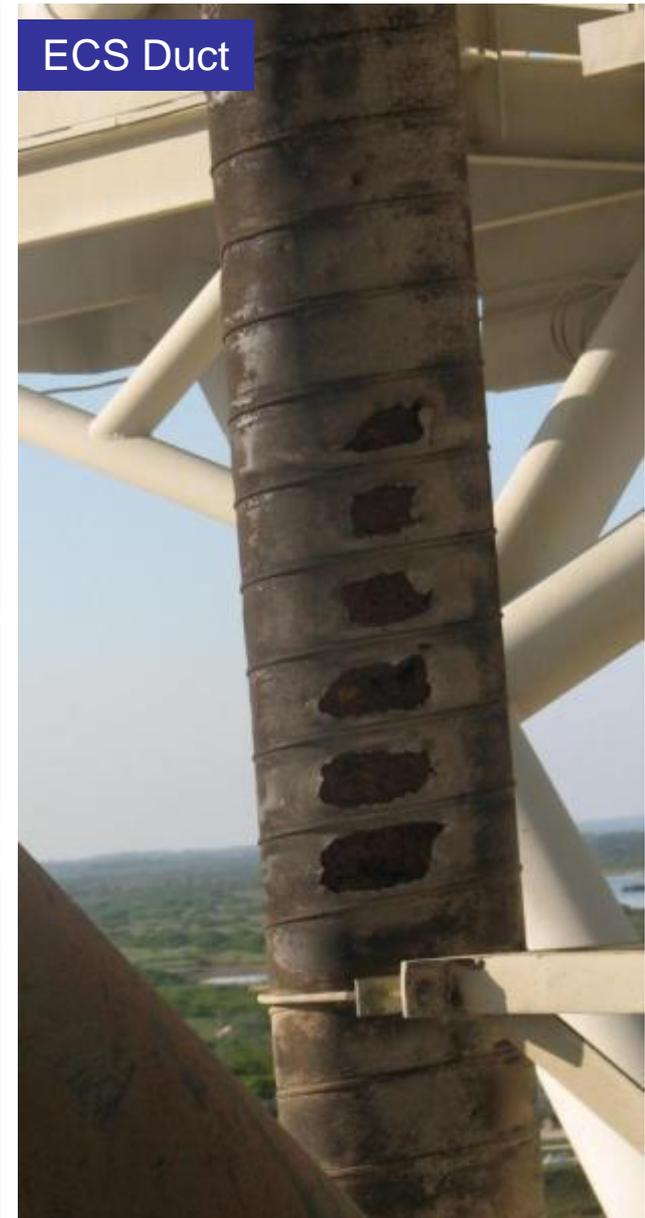
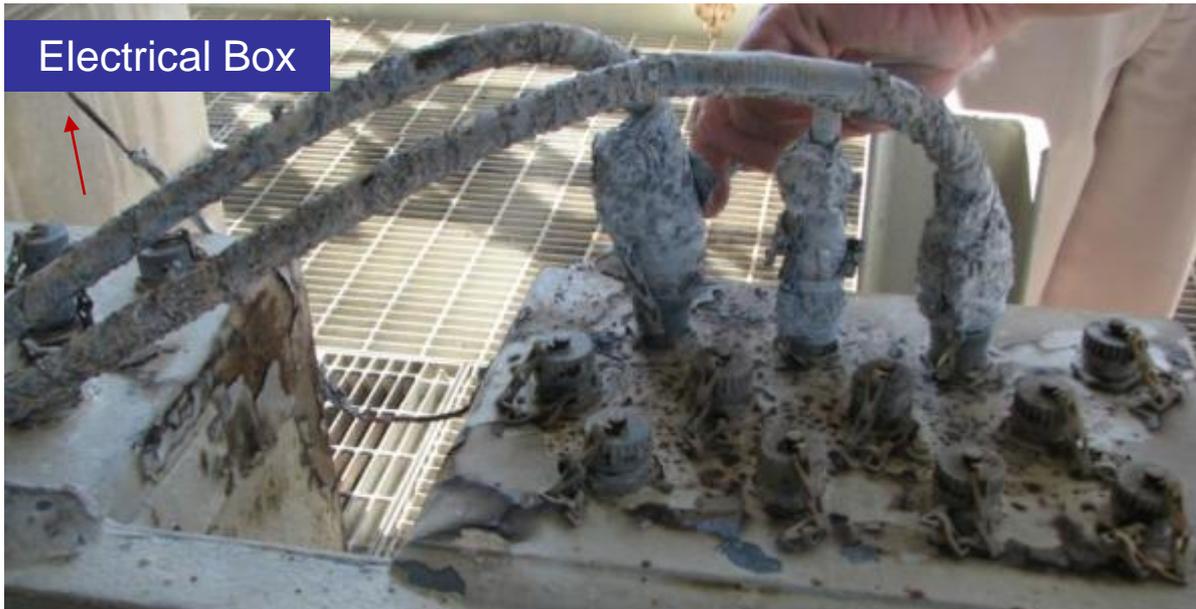
Electrical Box

ECS Duct

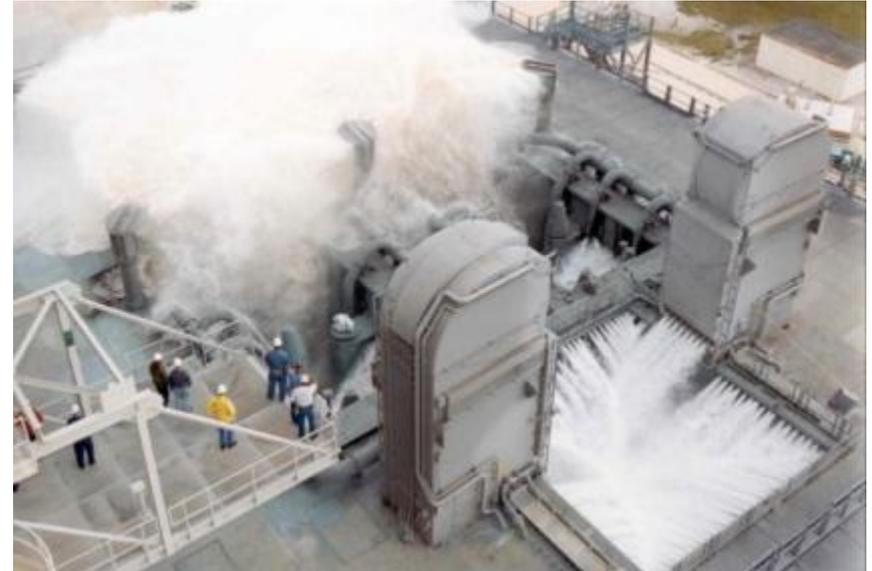
## ◆ I-X Sound Suppression System

- Not effective
  - 3-sides of deck surface uncovered
- Vulnerable to plume damage
  - Piping exterior to MLP deck

## ◆ Orion-I Sound Suppression System

- 60ft diameter coverage in all directions
- Piping interior to LM

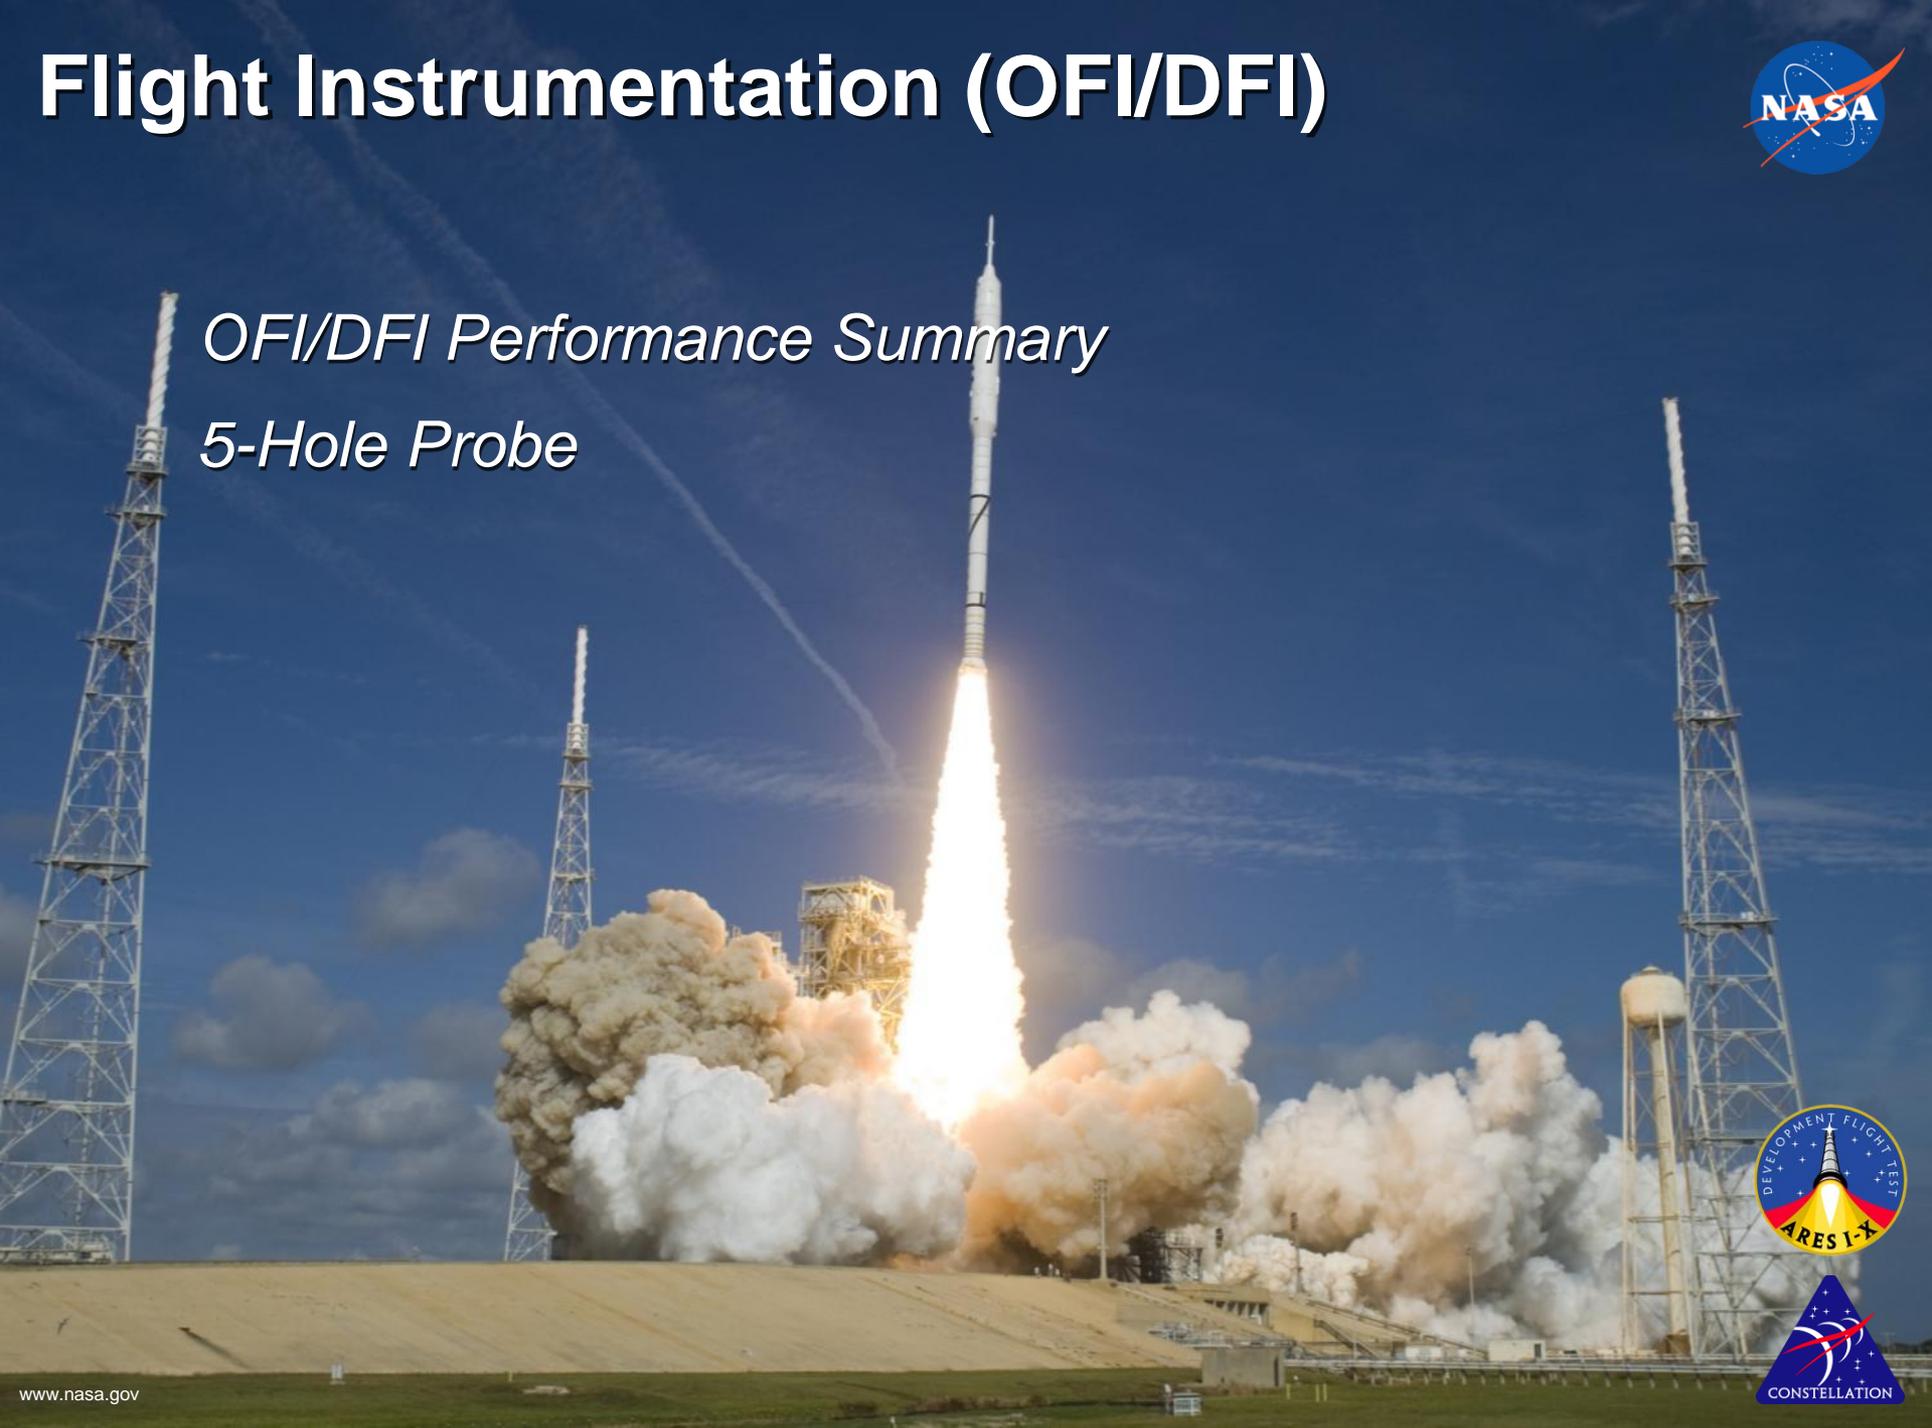
- ◆ **Operational Flight Instrumentation (OFI)**
  - 292 measurements; 285 Nominal, 7 Defective
- ◆ **Development Flight Instrumentation (DFI)**
  - 901 Measurements provided by 716 Sensors
  - 98% of DFI measurements functioned during the flight
    - ***Only*** 13 DFI measurements did not provide data
- ◆ **5HP and TAT covers were removed for 1st flight attempt**
  - Heavy Thunderstorms overnight
  - Probe data flawed
    - Water Intrusion (probable cause)
    - Oil Canning Effect of Sensor

Overall, less than 3% of sensors did not perform as expected during the mission  
All mandatory measurements were within LCC's/Limits throughout the countdown and flight

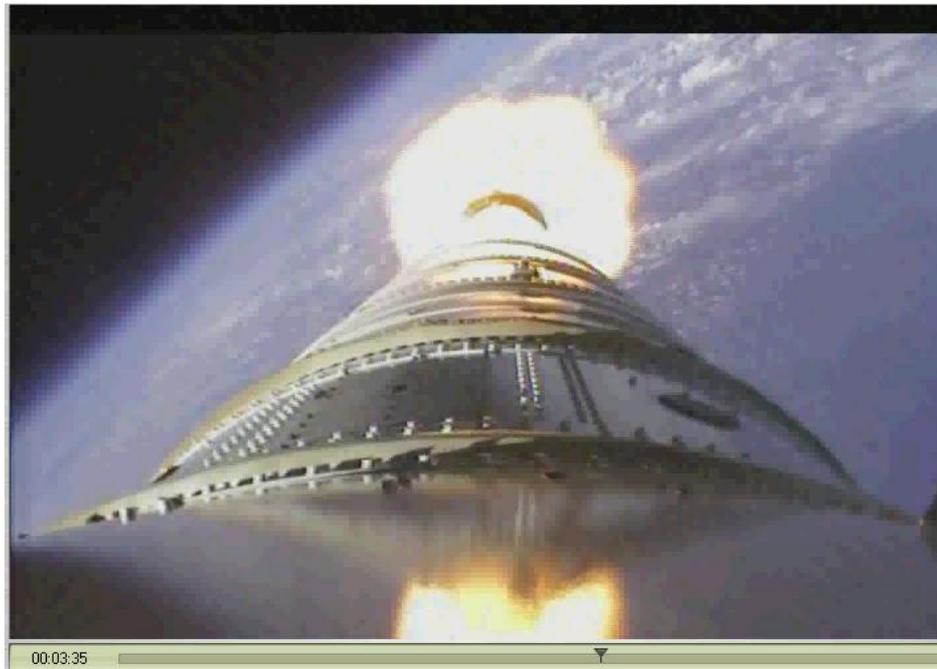
# Separation Data and Video – No Recontact

Time Stamp	Observation
3:37	Start of Separation with BDM Burn
3:38-3:39	FS Moves axially away from the US with little or no relative yaw between stages
3:40	BTMs fire and FS begins yaw tumble. No discontinuous change in US yaw is observed
3:43	Little US yaw rotation is detected, suggesting that the US yaw and yaw rate was not affected by the initiation of the FS tumble
3:44	US yaw begins to be noticeable, FS is well out of range
4:07	Next time US is seen in video, when it is much further away
