# Ares I-X Flight Test Results

*April 2010*

# Ares I-X was extremely successful

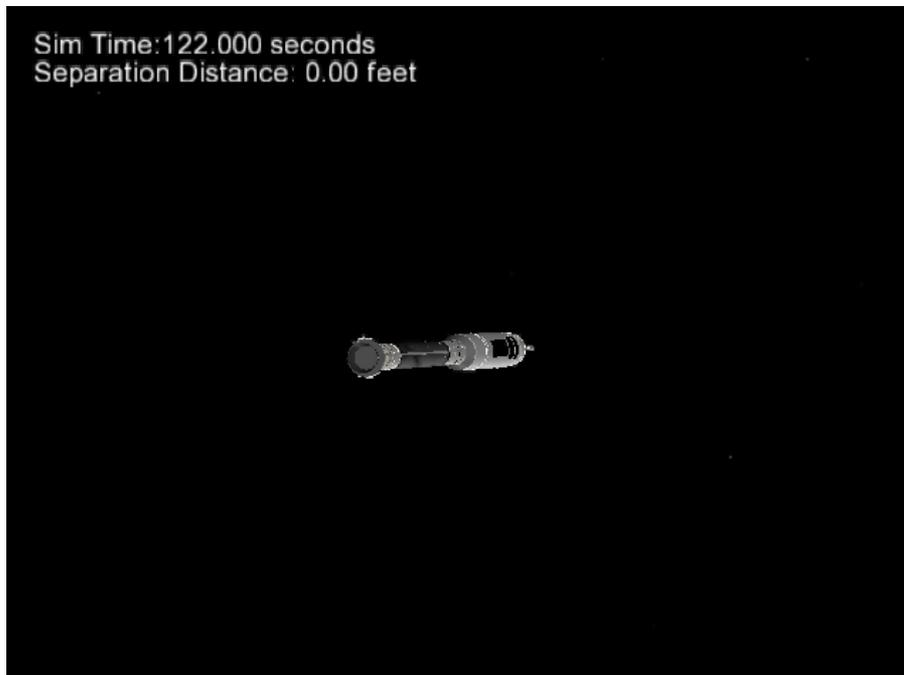
Simulated Ground View

- ◆ **Post-flight simulation, using flight data, demonstrates USS behavior**
- ◆ **Simulation predicts a successful separation.**
- ◆ **Simulation is consistent with ground video of flight.**

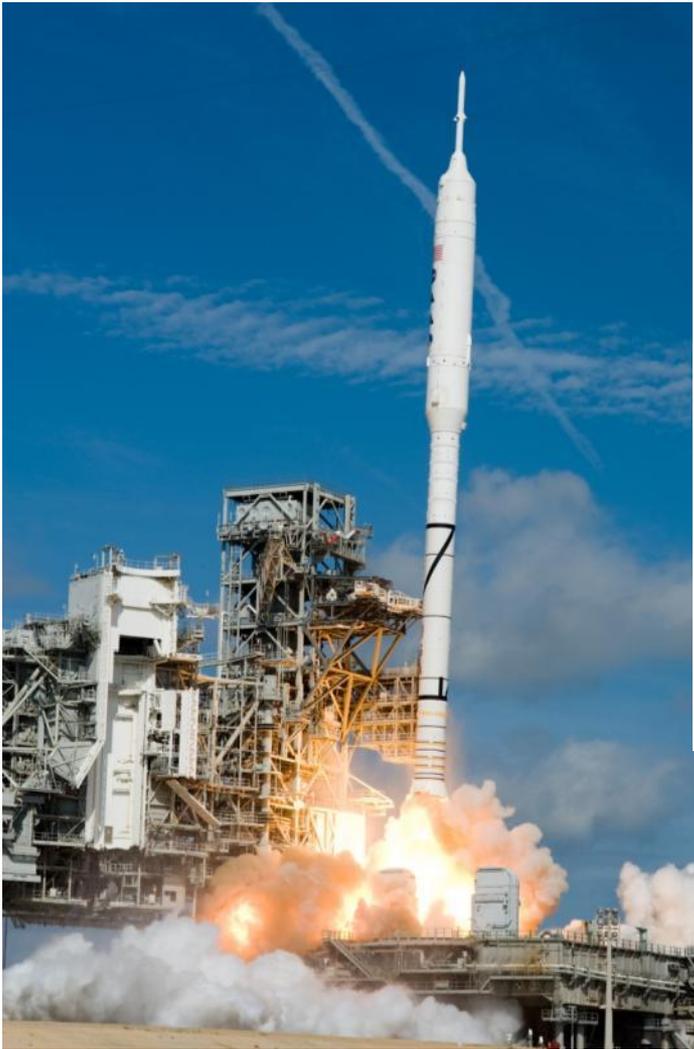
## ◆ Liftoff clearance as predicted

- Aggressive fly-away maneuver demonstrated
  - Protected the FSS from any major structural damage – no damage above 135 Level
  - “Plumed” lower levels to protect upper levels
- Data for design of pad for similar rockets obtained
