# EXPLOSIVE LESSONS IN HYDROGEN SAFETY

BY RUSSEL RHODES

## EXPLOSIVE LESSONS

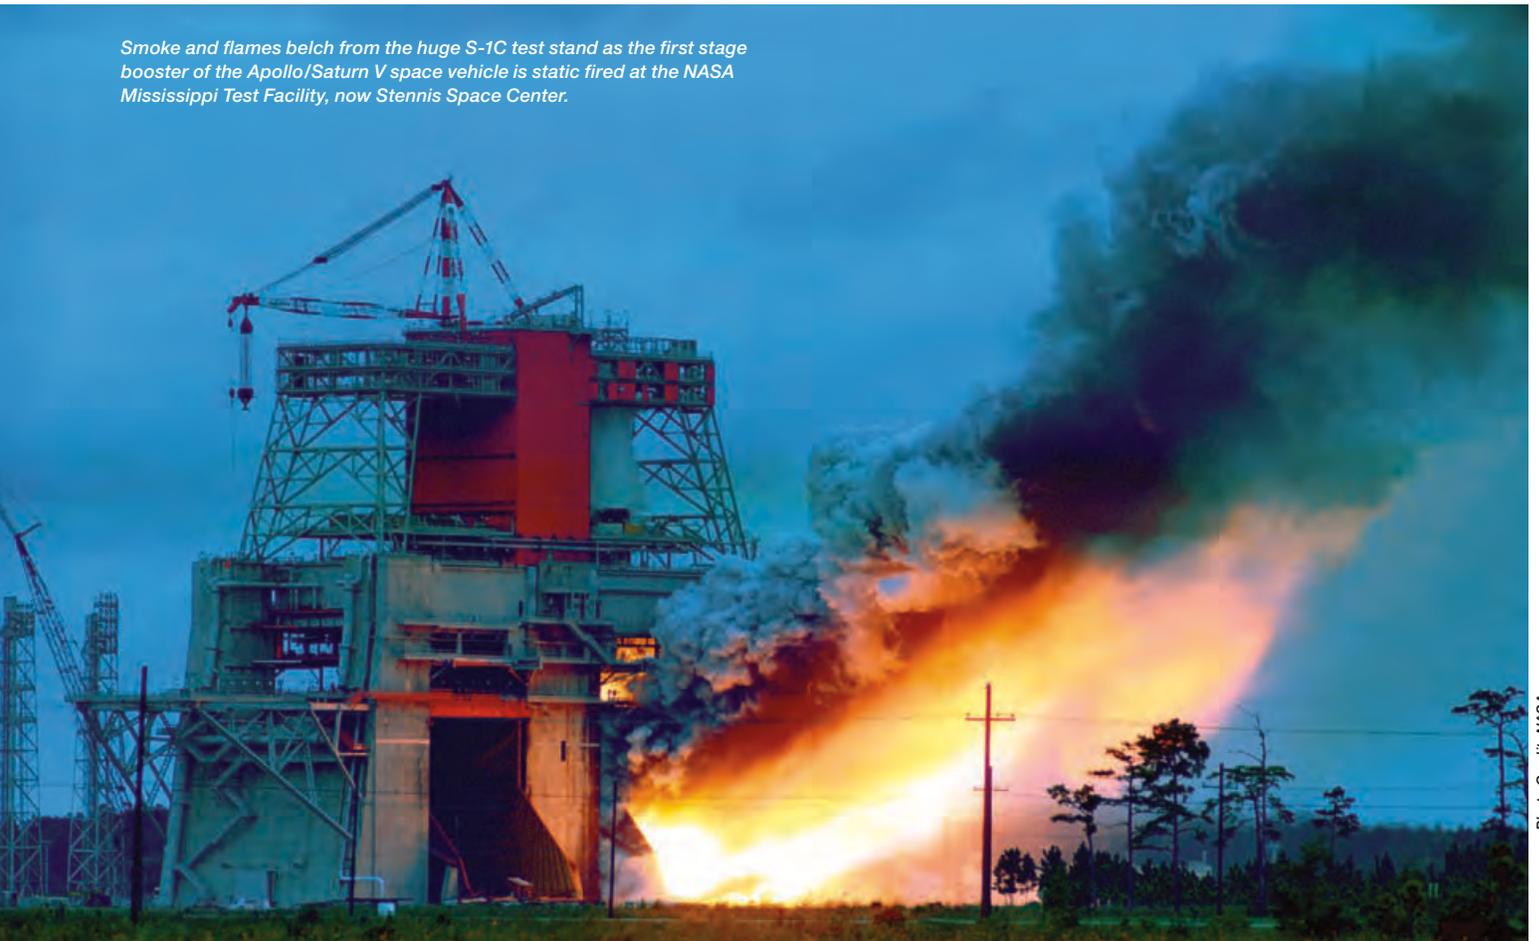
*Smoke and flames belch from the huge S-1C test stand as the first stage booster of the Apollo/Saturn V space vehicle is static fired at the NASA Mississippi Test Facility, now Stennis Space Center.*

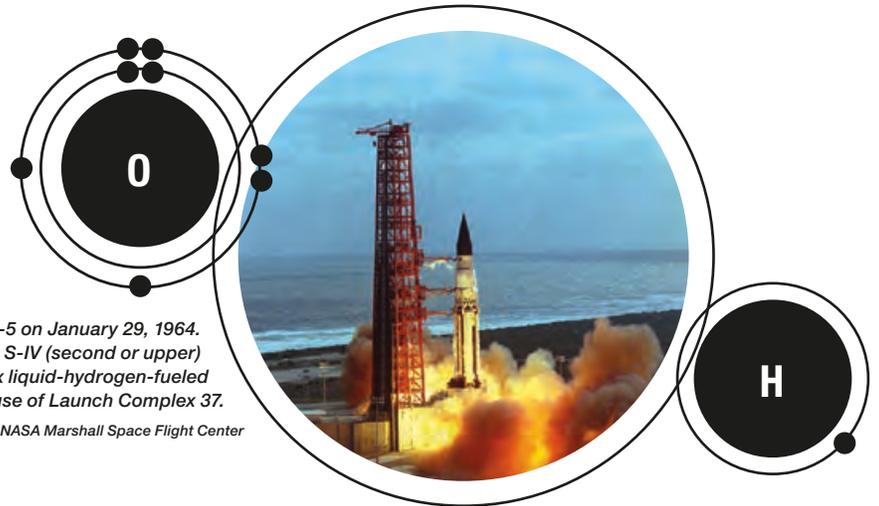
*Launch of the Saturn I SA-5 on January 29, 1964. This was the first flight of a live S-IV (second or upper) stage with the cluster of six liquid-hydrogen-fueled RL-10 engines and the first use of Launch Complex 37.*

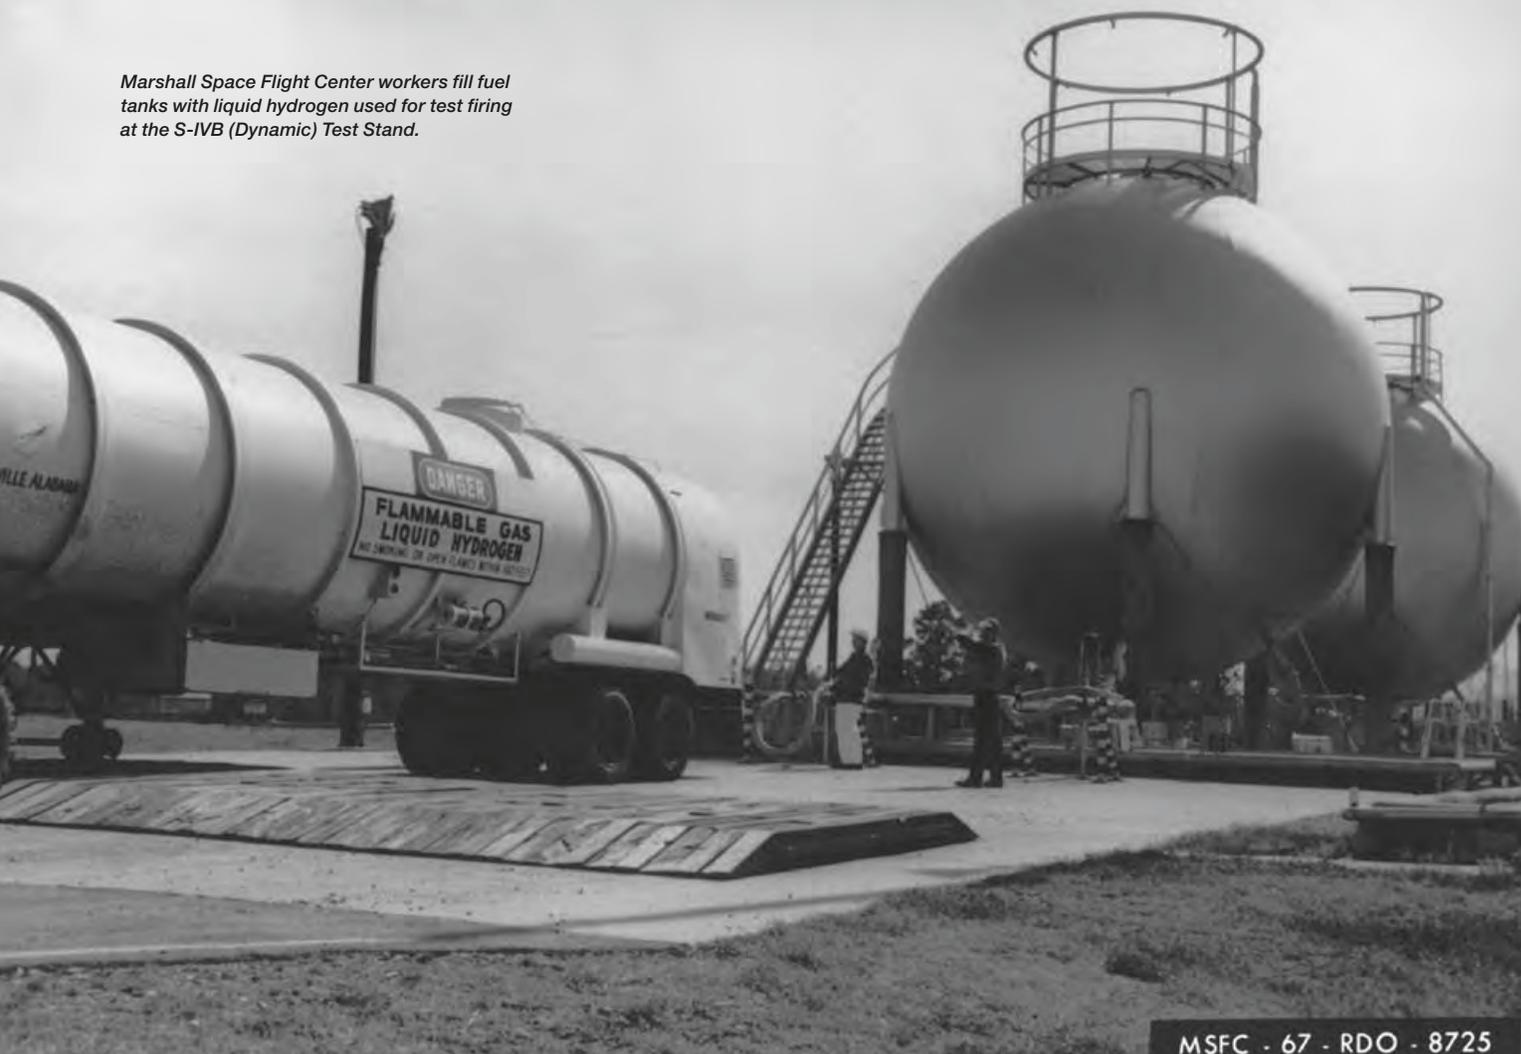
MSFC - 67 - RDO - 8725

**FUEL TRANSFER, S-IVB TEST STAND**

*Marshall Space Flight Center workers fill fuel tanks with liquid hydrogen used for test firing at the S-IVB (Dynamic) Test Stand.*
