So Close Yet So Far: The Jammed Airlock Hatch of STS-80

Overview

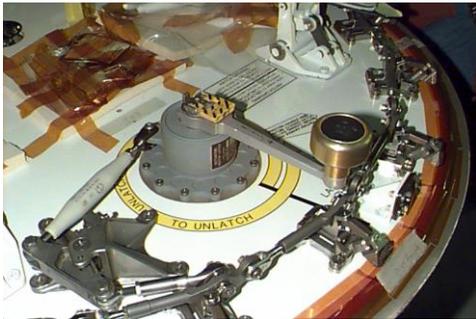
Figure 2: View of outer airlock handle and actuator assembly. NASA Image

Following the successful deployment of the ORFEUS-SPAS II and WSF satellites, preparations began for the two EVAs. After almost two hours of preparation, Tamara Jernigan attempted to open the outer hatch of the airlock only to discover the hatch was jammed.

“It smacked solidly into some obstacle at the 30-degree mark. After several grunting attempts to force the handle around, I could see... We were nowhere near turning the handle the one full circle required to retract the metal rollers that held the hatch against its seals. There was nothing obvious in the way, yet the handle felt like it was jamming against a hard metal stop [2].”

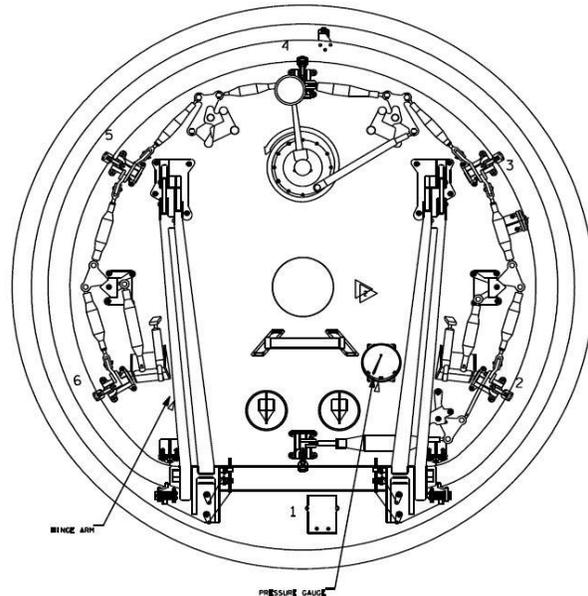
Figure 3: Schematic of aft view of outer airlock hatch. NASA Image

The airlock is 83 inches long with an inside diameter of 63 inches and can accommodate two fully-suited crew members at one time. It consists of two D-shaped pressure-sealing hatches. For Columbia, the inner airlock hatch is mounted to the front side of the airlock and opened into the middeck. The outer hatch is mounted to the aft bulkhead of the crew module. Both hatches have dual pressure seals to maintain pressure integrity and open in the direction of the primary pressure source: the crew cabin. Each hatch has six interconnected latches with a gearbox and actuator. Latches are interconnected with push/pull rods, as well as a bell crank for pivoting the rods [3]. The gearbox allows the crew to open or close the hatch during transfers and EVA operations. The gearbox and the latches are mounted on the low-pressure side of each hatch, and a gearbox handle is installed on both sides to permit operation from either side of the hatch.

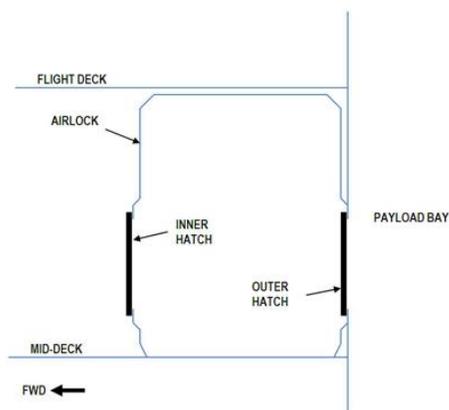
Figure 4: Illustration of the inner and outer hatch positions within the airlock . NASA Image
