Subject: Response to NMED Disapproval SWMU 49 (700 Area Landfill) Phase I Investigation Work Plan and Historical Information Summary

Comments for Disapproval of the 700 Area (SWMU 49) Landfill Phase I Investigation Work Plan

This investigation work plan (IWP) presents a planned Phase I field investigation at the National Aeronautics and Space Administration (NASA) White Sands Test Facility (WSTF) 700 Area landfill, listed as Solid Waste Management Unit (SWMU) 49 in the New Mexico Environment Department (NMED) Hazardous Waste Permit (Permit; NMED, 2016). The 700 Area landfill was operational at WSTF between 1965 and 1997. A Notice of Intent (NOI) to close the 700 Area landfill was placed in the Operating Record on February 3, 1998, and NASA submitted the final closure certification to NMED on August 5, 1998 (NASA, 1998a). A post-Closure care (PCC) Plan for the 700 Area landfill was implemented on July 31, 1998, and is in effect for 30 years. The plan includes requirements for groundwater monitoring, soil vapor monitoring, PCC quarterly inspections and maintenance for landfill cover integrity, adequate drainage, fencing for the landfill boundary, and vegetative cover (NASA, 1999).

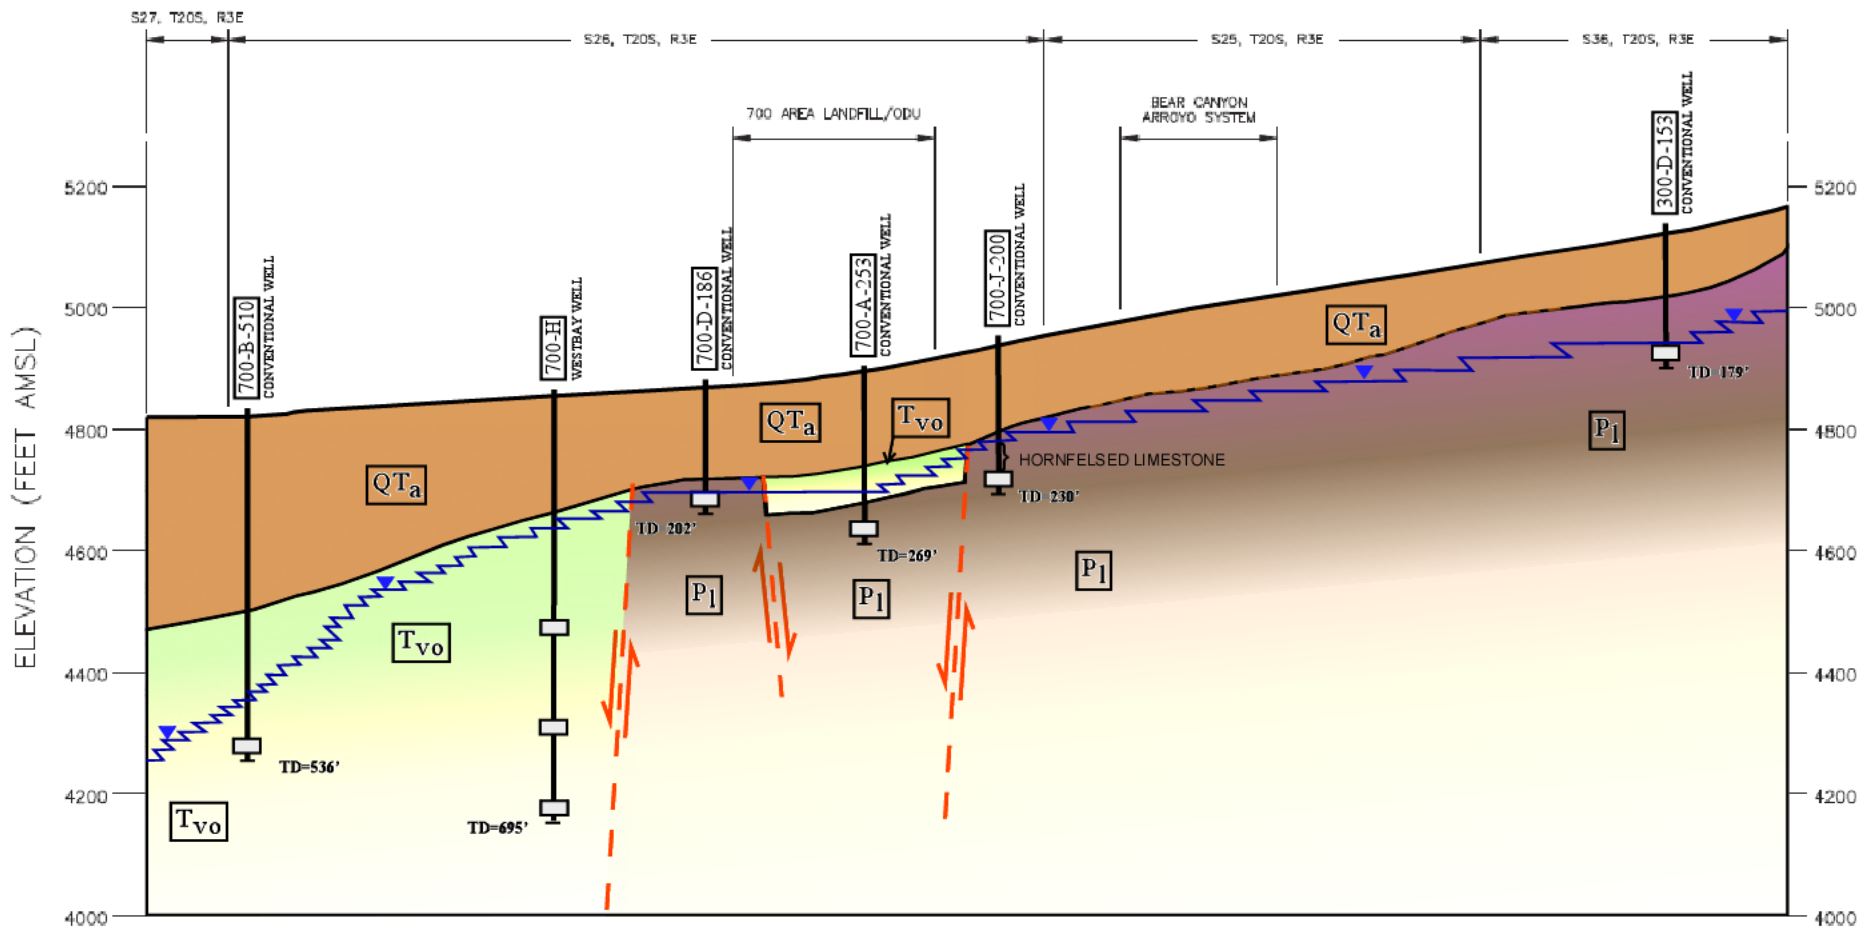
SOUTHEAST
A'

- QTa** QUATERNARY SANTA FE GROUP ALLUVIUM (COARSE-GRAINED PROXIMAL TO MID-FAN)
- Tvo** OLILOCENE OREJON ANDESITE
- P1** PALEOZOIC LIMESTONE (PRIMARILY HUECO FORMATION)

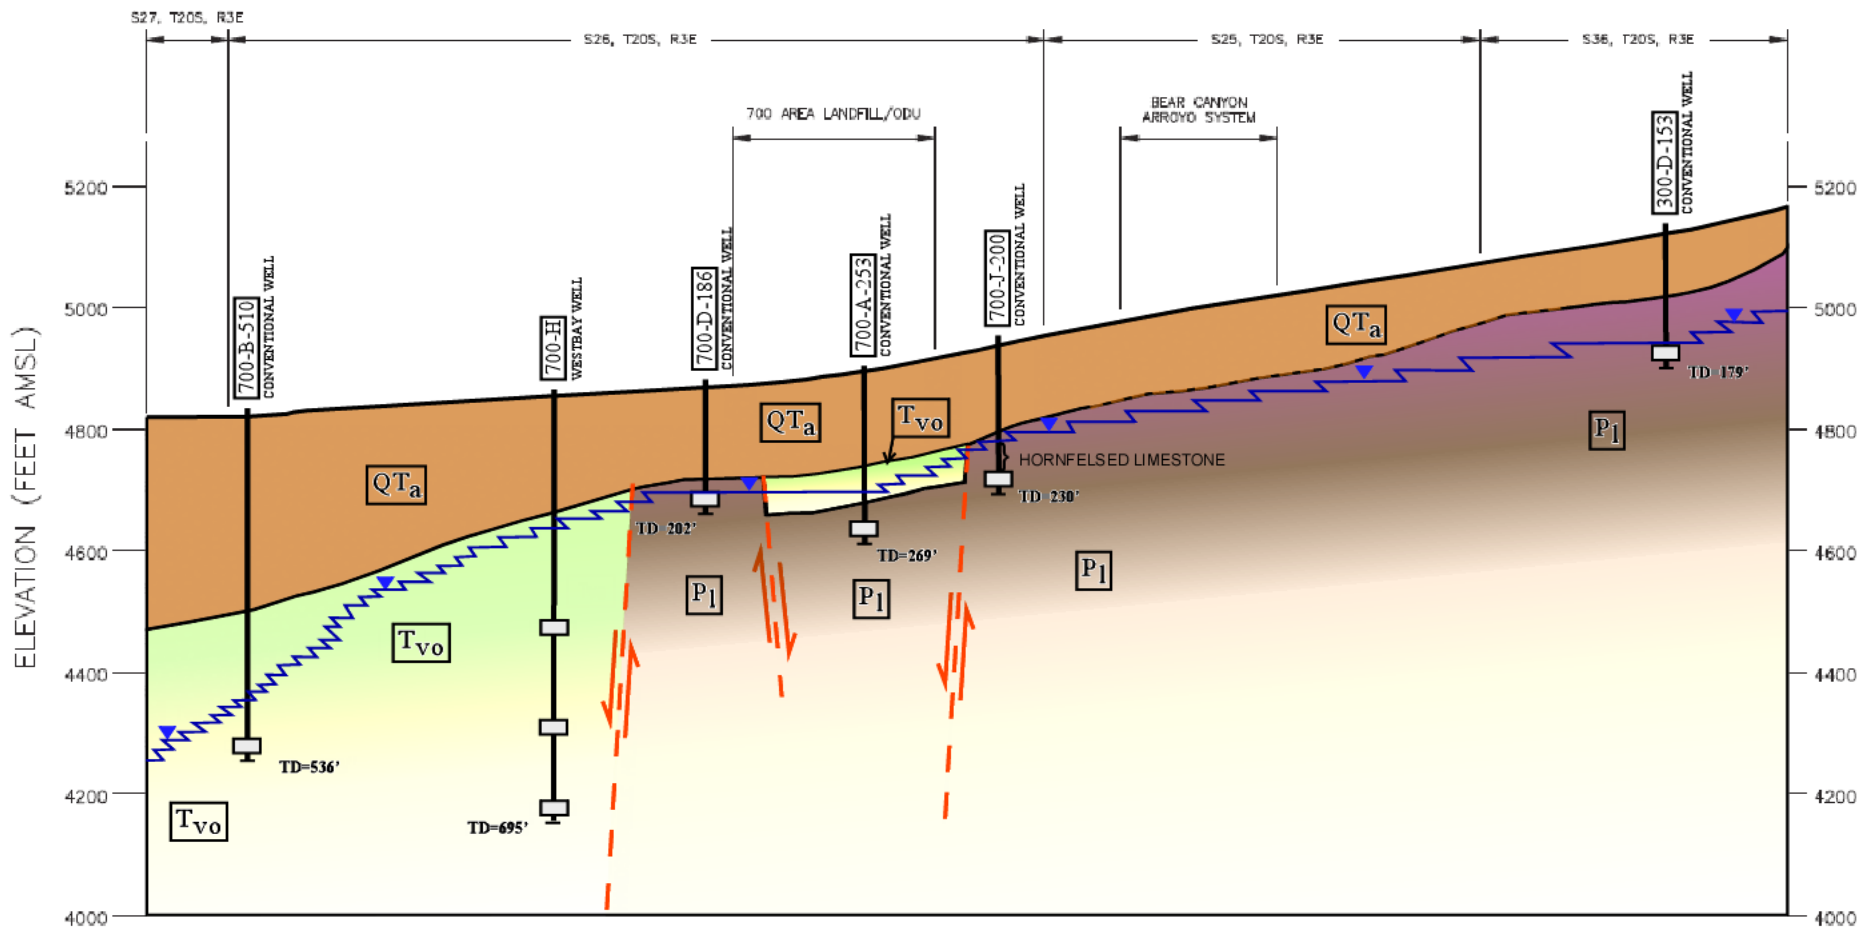
SOUTHEAST
A'

- GEOLOGY:**
- QTa QUATERNARY SANTA FE GROUP ALLUVIUM (COARSE-GRAINED PROXIMAL TO MID-FAN)
 - Tvo OLGIGENE OREJON ANDESITE
 - P1 PALEOZOIC LIMESTONE (PRIMARILY HUECO FORMATION)

- GROUND SURFACE
- FAULT WITH RELATIVE DISPLACEMENT (DASHED WHERE INFERRED)
- LITHOLOGIC CONTACT (DASHED WHERE INFERRED)

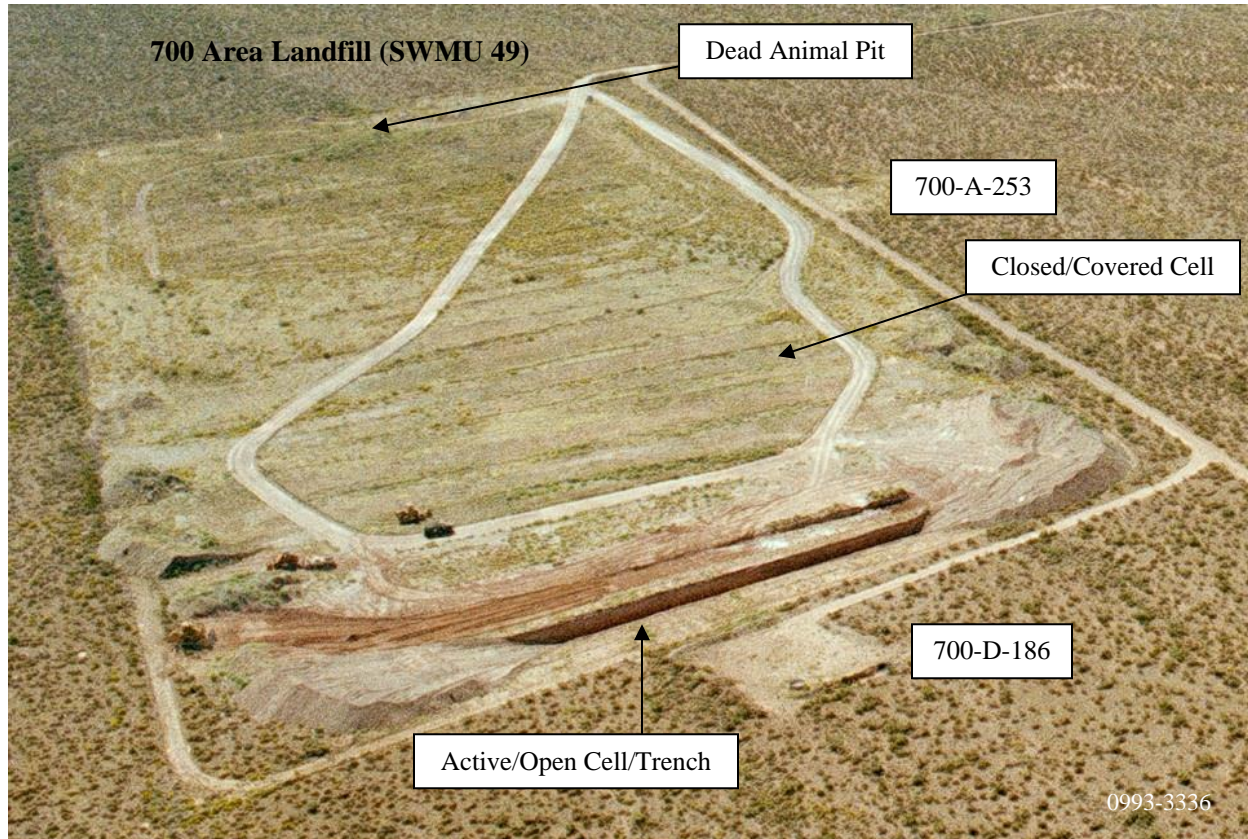
This photograph shows the WSTF landfill (SWMU 49) in September 1993, when the landfill was still in use at WSTF. Note that some closed and covered trenches are still visible due to some subsidence. The dead animal pit was located near the entrance to the landfill (shown at the top of this photograph), and groundwater monitoring wells 700-A-253 (cross-gradient) and 700-D-186 (downgradient) are present on the sides of the landfill.

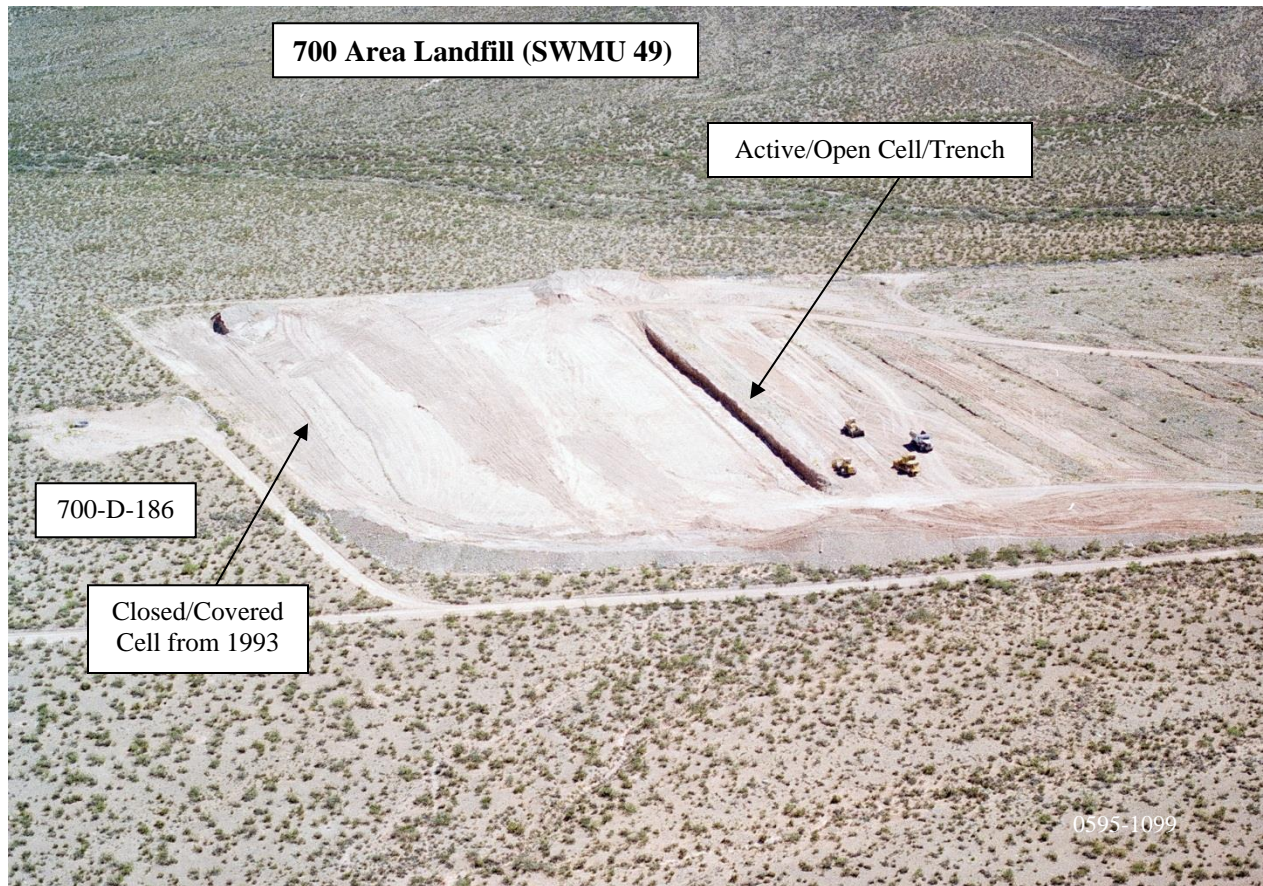
This photograph shows an aerial view of an open trench at the WSTF landfill (SWMU 49) in May 1995. Notice the location of the trench is not adjacent to the cell from 1993, and this cell is located between older previously existing closed/covered cells. (Refer to [Figure 6.3.](#))

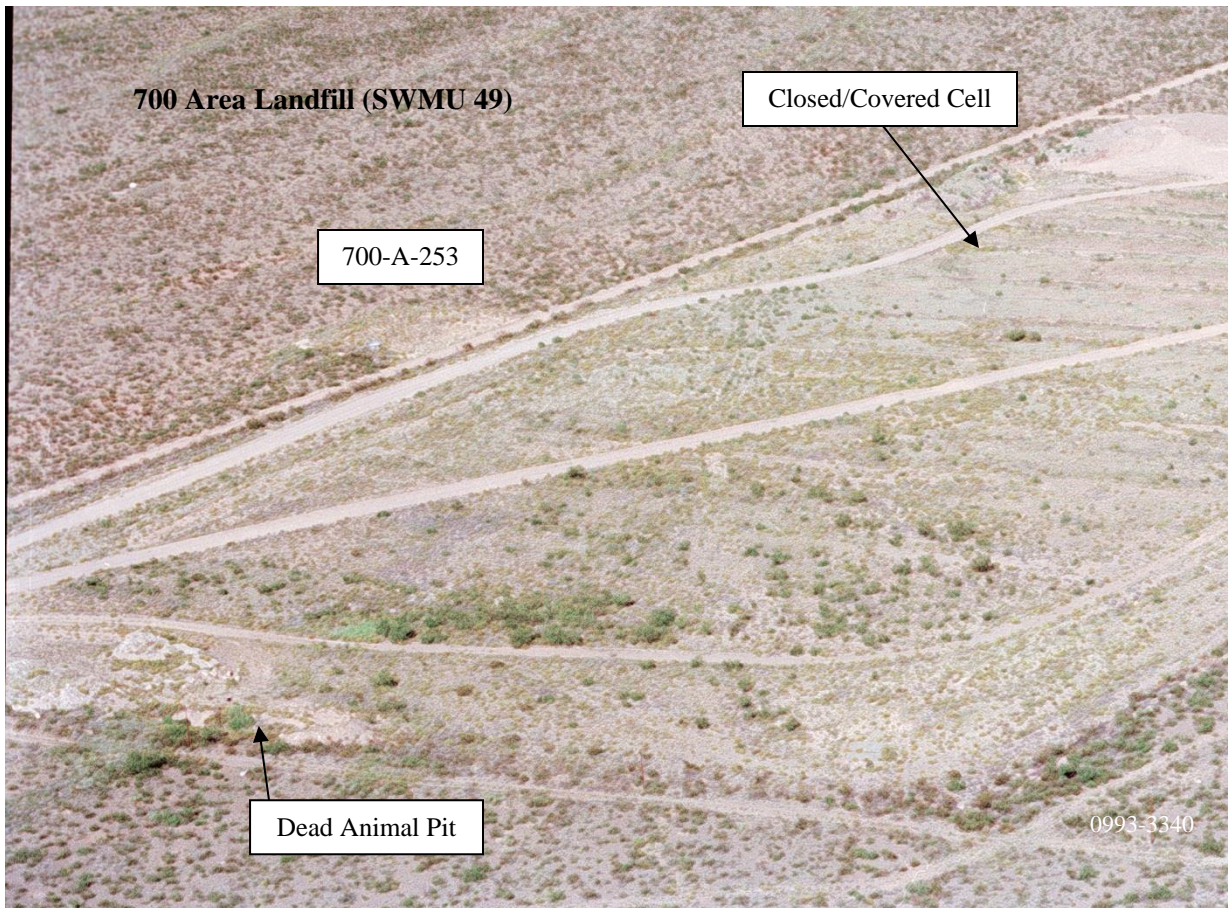
This photograph shows an aerial view of the dead animal pit at the WSTF landfill (SWMU 49) in September 1993. Note the white caliche layer around and within the dead animal pit. Groundwater monitoring well pad 700-A-253 and some previously closed and covered cells are visible as well.

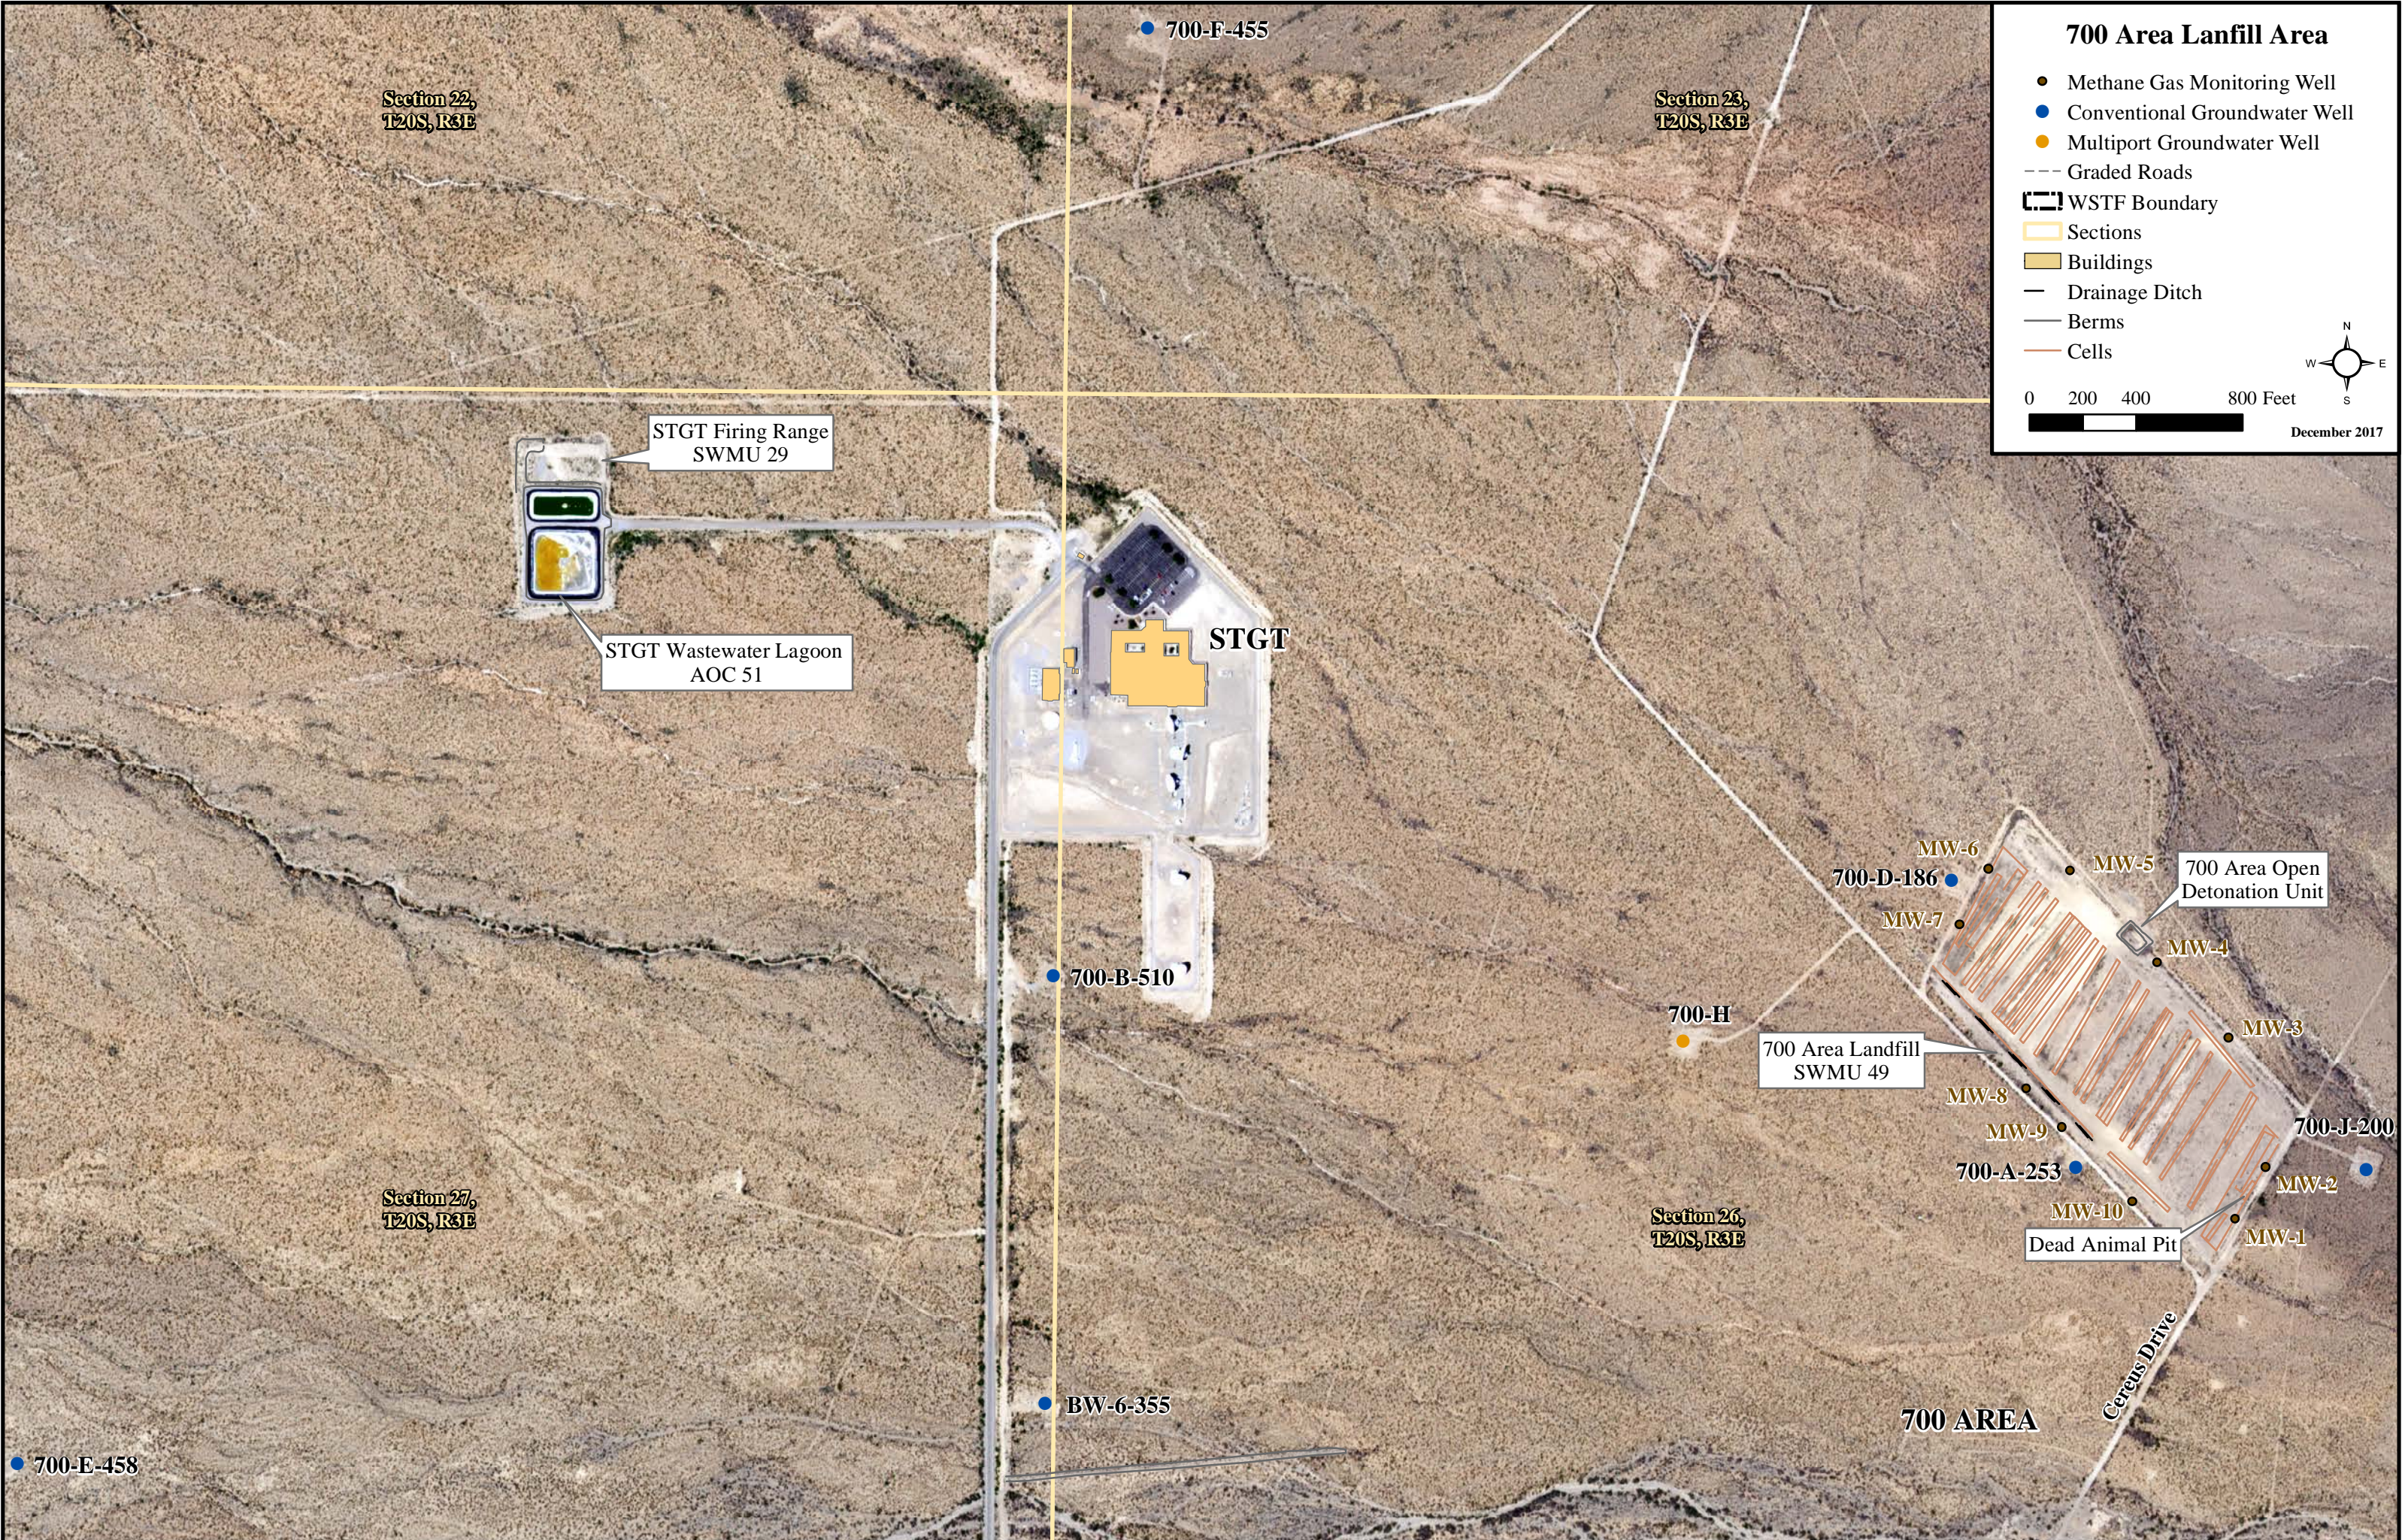
Figure 6.8

[Figure 6.8](#) shows a photograph of the installation of the GCL cover at the 700 Area landfill (SWMU 49). “...reseeding and the construction work were completed on June 12, 1998. NASA received the recorded plat, closure certification, and as-built drawings, and implemented the PCC care plan on July 31, 1998” (NASA, 1998i). [Figure 6.9](#) shows a final WSTF drawing of the landfill closure.

Geosynthetic Clay Liner Cover (1998)

[Figure 6.8](#) shows a photograph of the installation of the GCL cover at the 700 Area landfill (SWMU 49). “...reseeding and the construction work were completed on June 12, 1998. NASA received the recorded plat, closure certification, and as-built drawings, and implemented the PCC care plan on July 31, 1998” (NASA, 1998i). [Figure 6.9](#) shows a final WSTF drawing of the landfill closure.

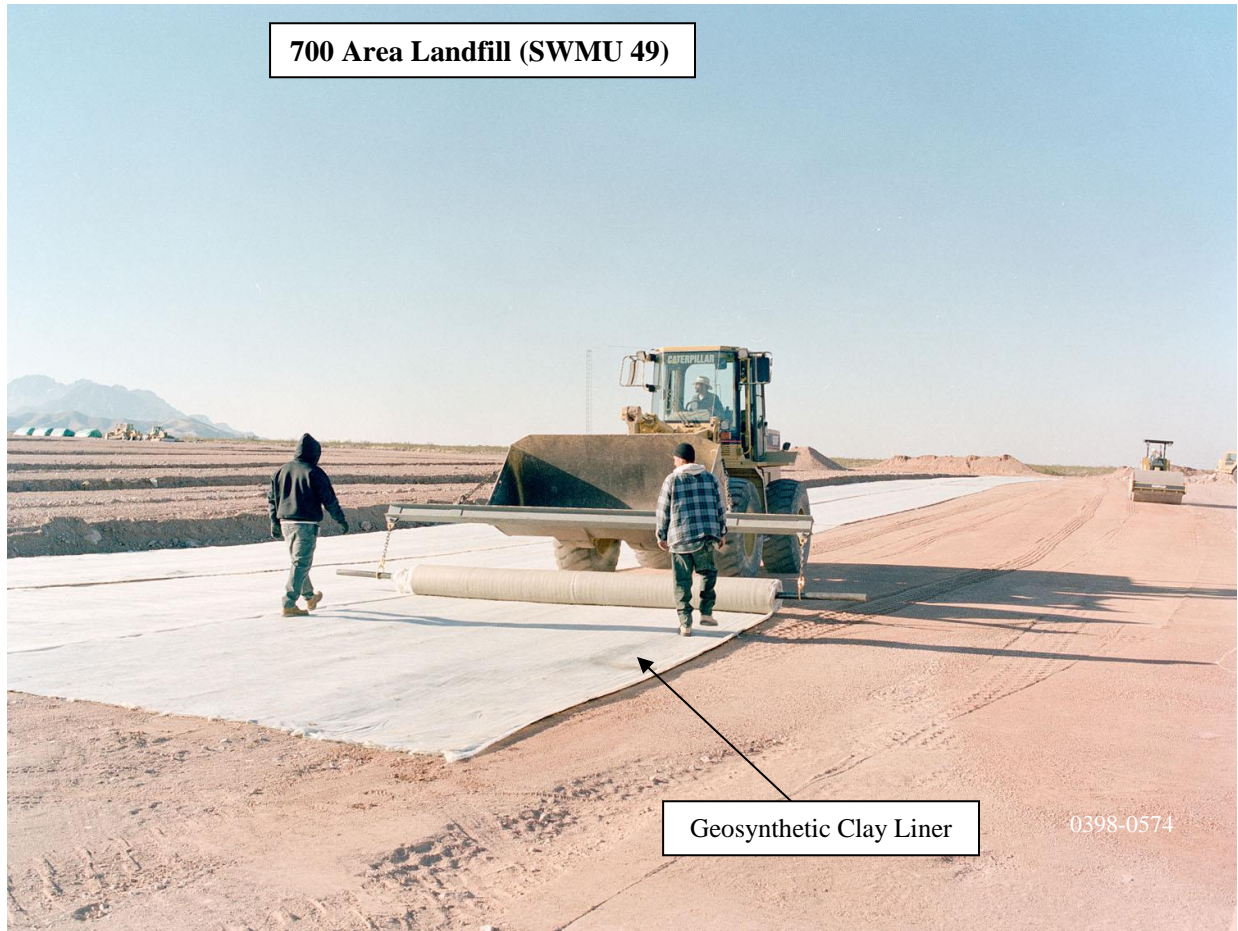
This photograph shows the installation of the Geosynthetic Clay Liner cover at the WSTF landfill (SWMU 49) in March 1998.

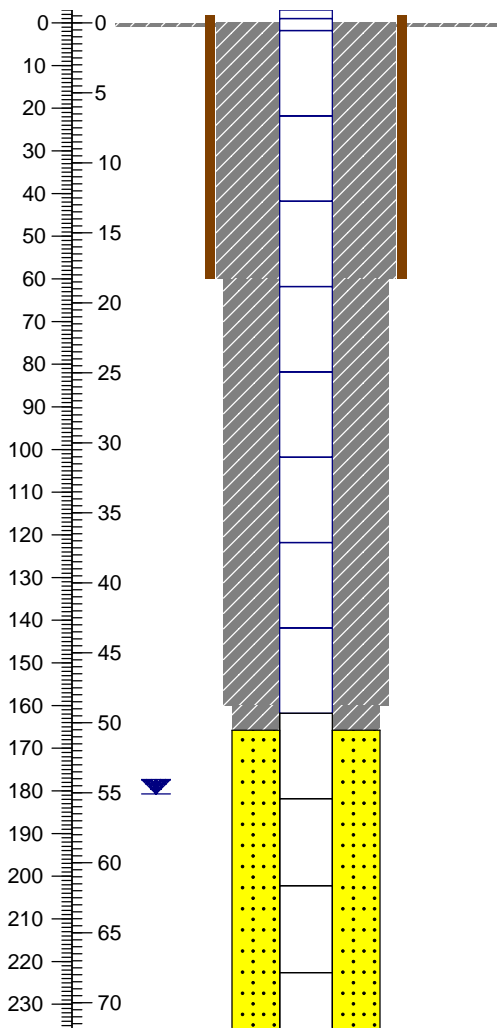
Conventional Well Stick-Up = 2.4' (0.73 m); 3' (0.9 m) at installation. 2.0' stainless steel riser and locking cap top casing

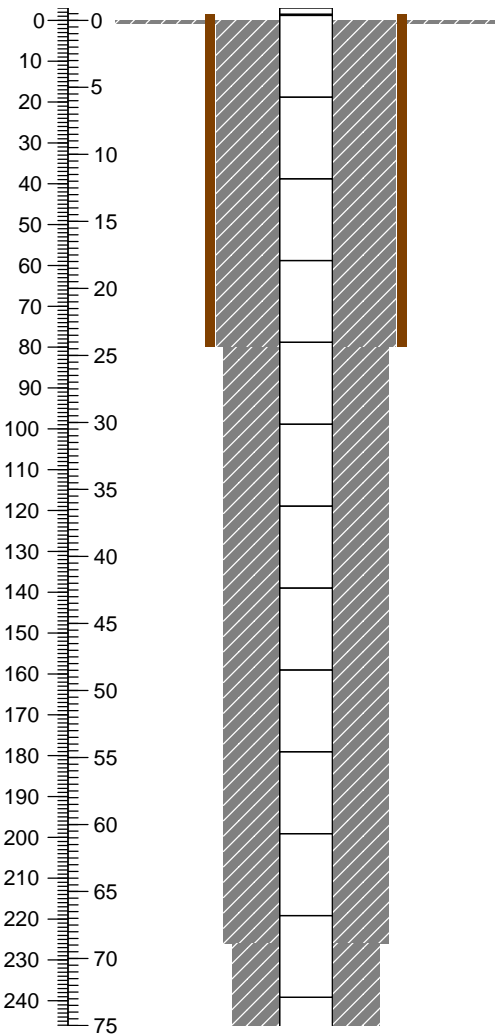
Conventional Well Stick-Up = 2.0' (0.61 m) (3.2' (1.0 m) measured at installation)
Stick-up consists of a 1.73' riser and 0.27' adapter plus 1.2' well casing stick-up.

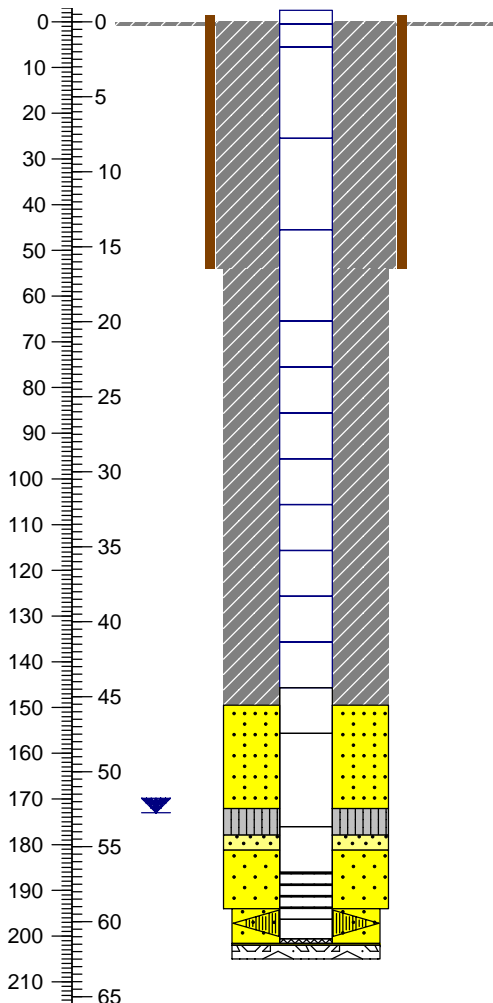
Conventional Well Stick-Up = 2.1' (0.64 m) (2.5' (0.8 m) at installation) 3.0' (0.91 m) Stainless steel riser and locking cap tops casing.
 Surface Casing Stick-Up = ~1.5' (0.5 m)
 Well completed with ~3' x ~3' cement pad, barrier posts, and locking steel well cap surrounding the casing at ground surface.

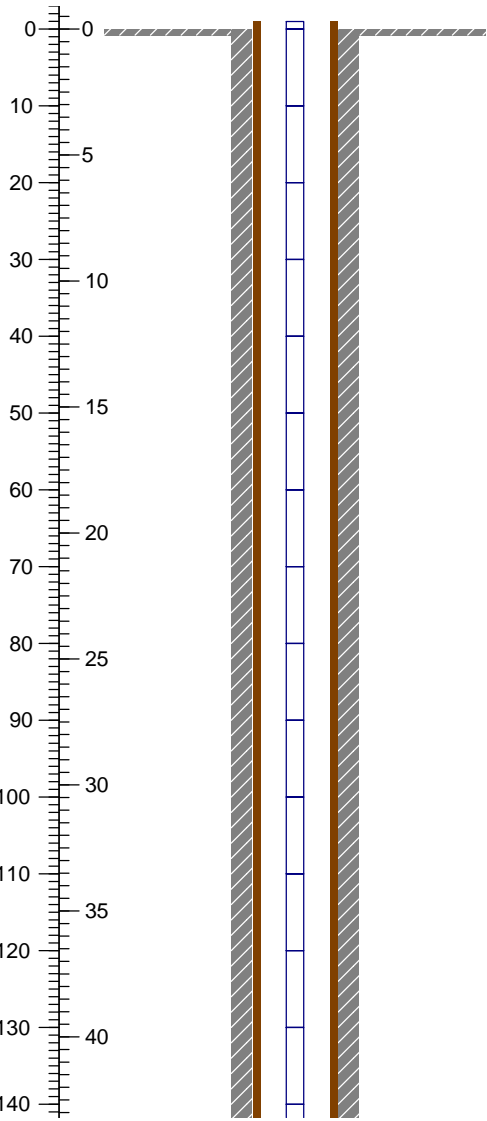
Westbay® Well Stick-Up = 1.0' (0.298 m)
Surface Casing Stick-Up = ~1.01' (0.3 m)
 Well completed with ~3' x ~3' cement pad, barrier posts, and locking steel well cap surrounding the casing at ground surface

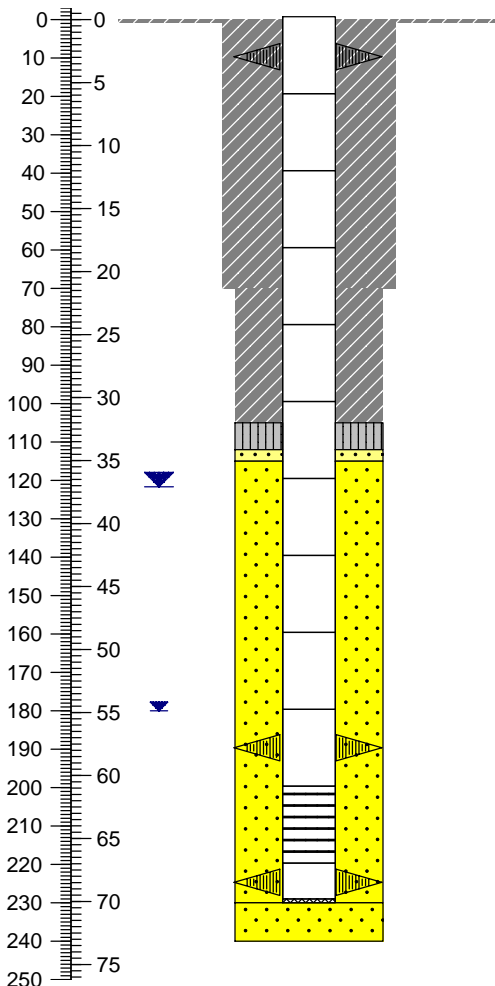
Conventional Well Stick-Up = 0.70' (0.21 m) (0.8' (0.2 m) at installation)
 Well completed with ~4' x ~4' cement pad, barrier posts, and locking steel well cap surrounding the casing at ground surface
 NOTE: Number and locations of centralizers were not recorded at installation. Locations and depths were taken from camera log.
 Three steel plates (centralizers) welded to casing at ~9.7' (~3.0 m)

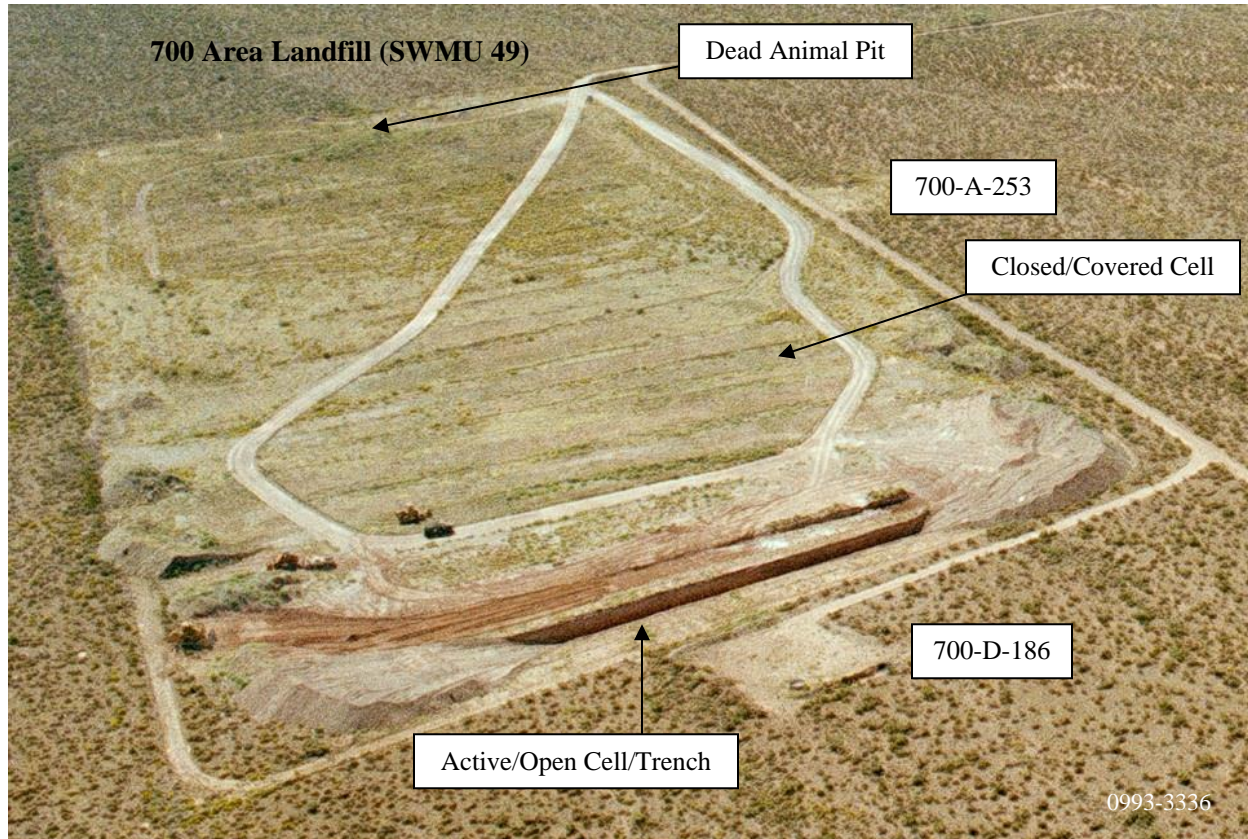
This photograph shows the WSTF landfill (SWMU 49) in September 1993, when the landfill was still in use at WSTF. Note that some closed and covered trenches are still visible due to some subsidence. The dead animal pit was located near the entrance to the landfill (shown at the top of this photograph), and groundwater monitoring wells 700-A-253 (cross-gradient) and 700-D-186 (downgradient) are present on the sides of the landfill.

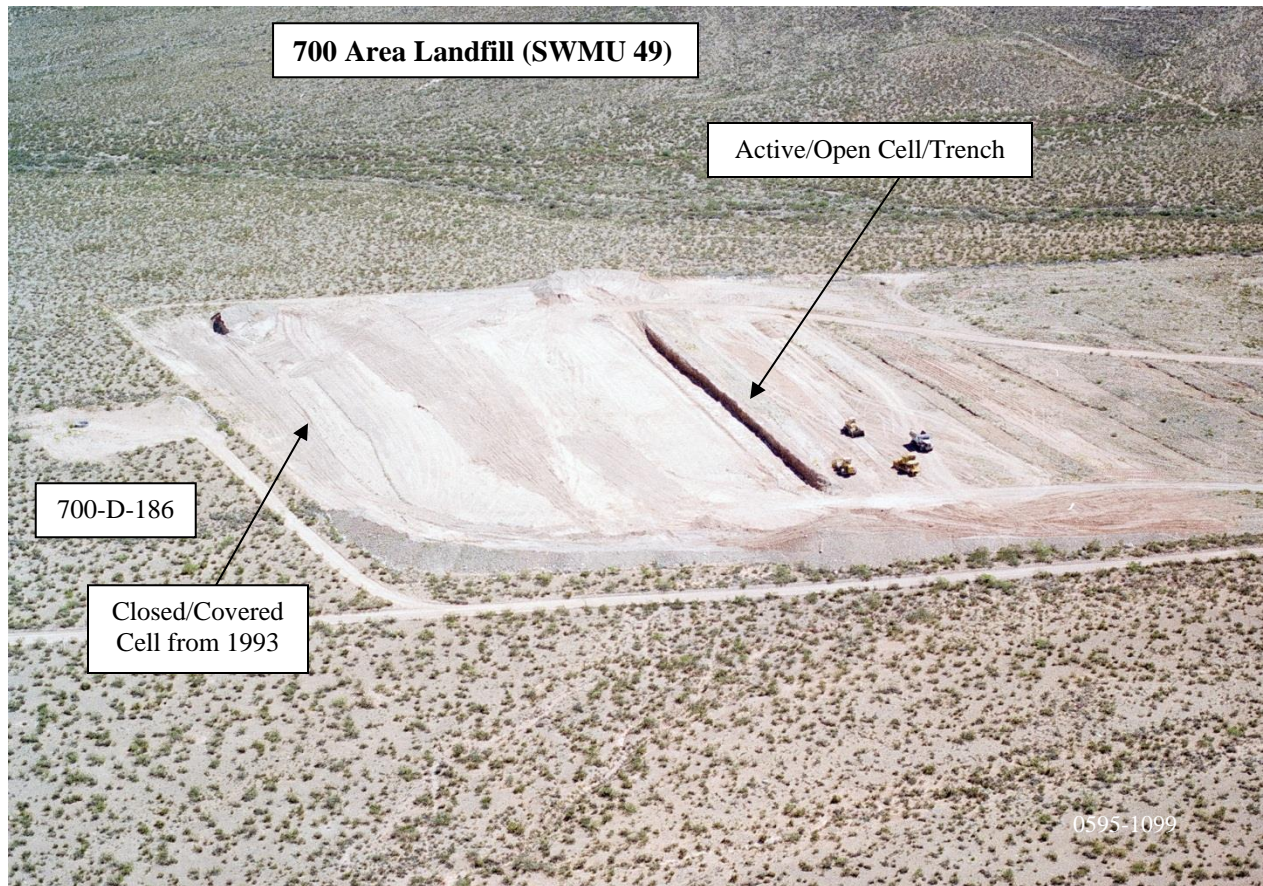
This photograph shows an aerial view of an open trench at the WSTF landfill (SWMU 49) in May 1995. Notice the location of the trench is not adjacent to the cell from 1993, and this cell is located between older previously existing closed/covered cells. (Refer to [Figure 6.3.](#))

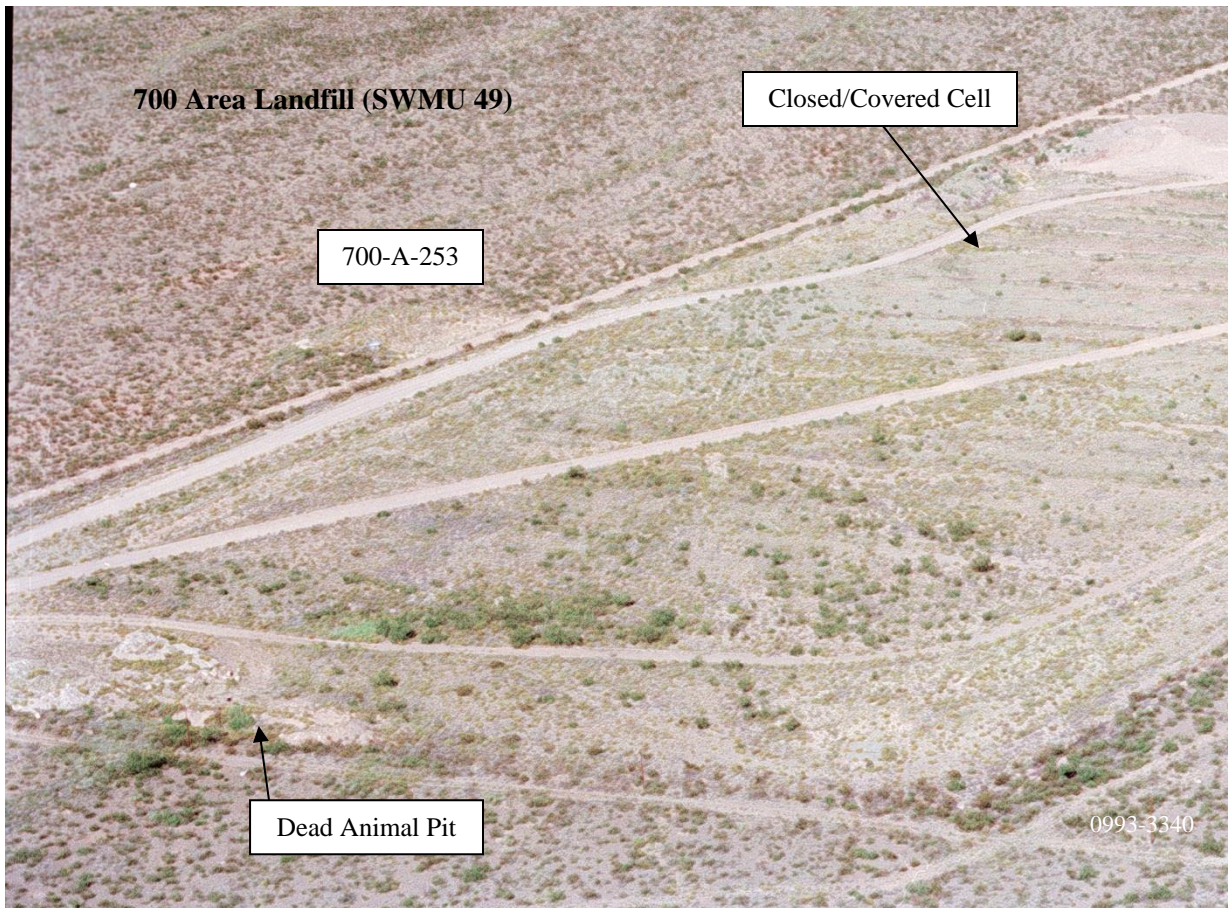
This photograph shows an aerial view of the dead animal pit at the WSTF landfill (SWMU 49) in September 1993. Note the white caliche layer around and within the dead animal pit. Groundwater monitoring well pad 700-A-253 and some previously closed and covered cells are visible as well.

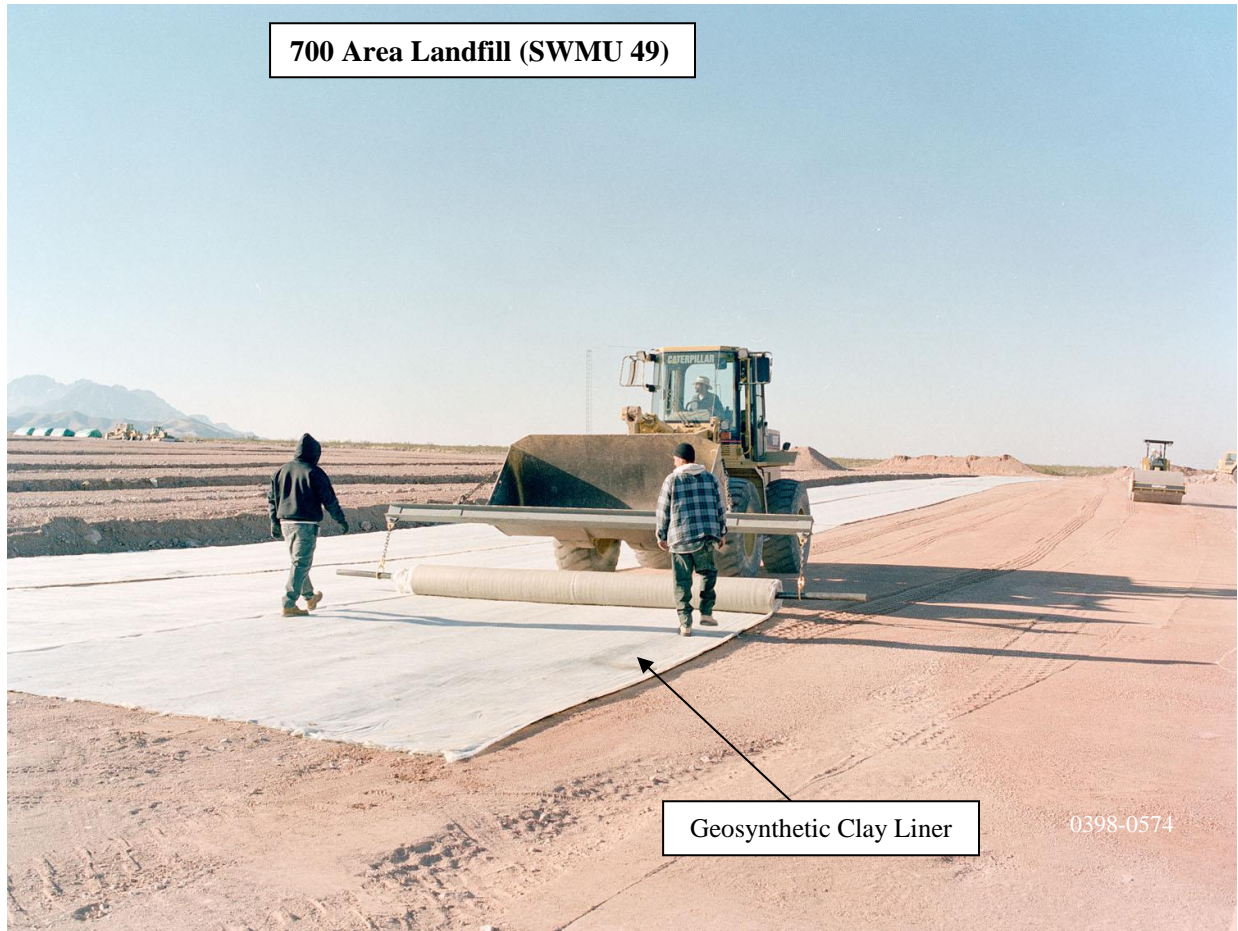
This photograph shows the installation of the Geosynthetic Clay Liner cover at the WSTF landfill (SWMU 49) in March 1998.

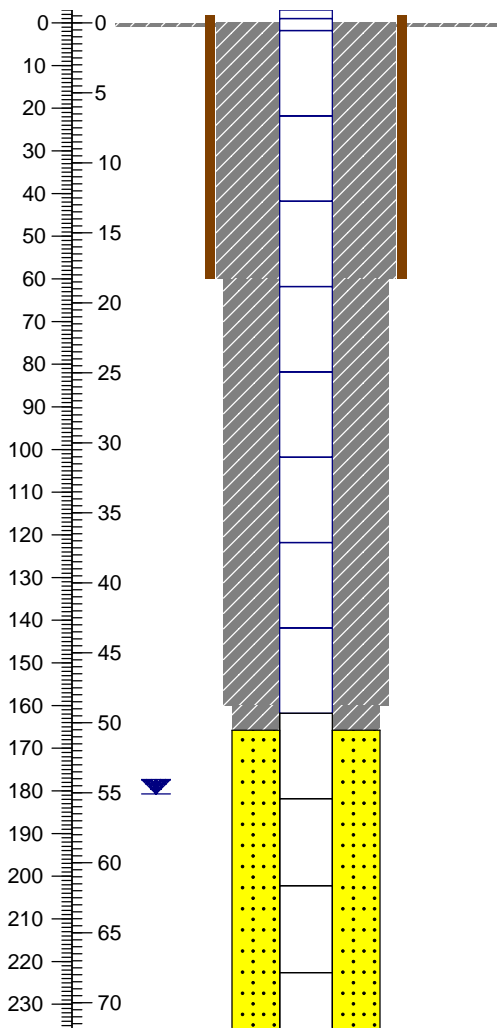
Conventional Well Stick-Up = 2.4' (0.73 m); 3' (0.9 m) at installation. 2.0' stainless steel riser and locking cap top casing

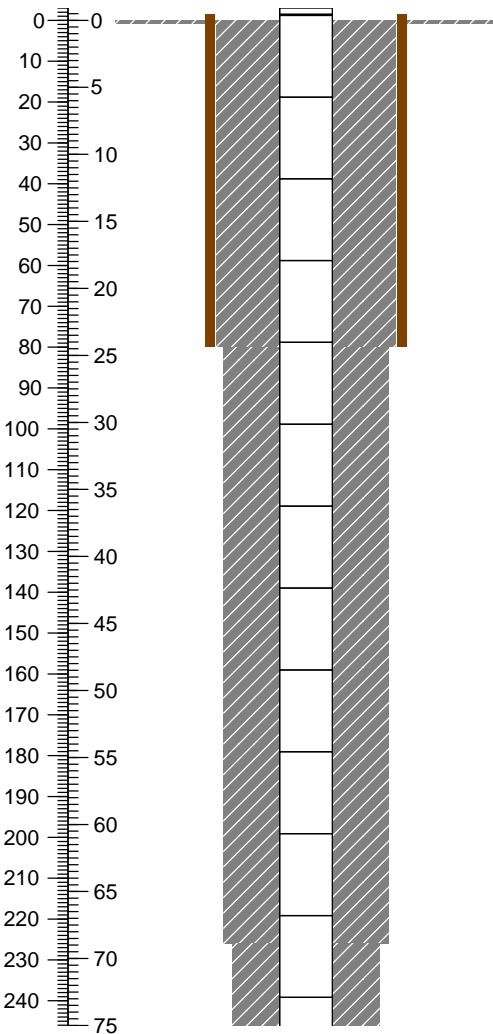
Conventional Well Stick-Up = 2.0' (0.61 m) (3.2' (1.0 m) measured at installation)
Stick-up consists of a 1.73' riser and 0.27' adapter plus 1.2' well casing stick-up.

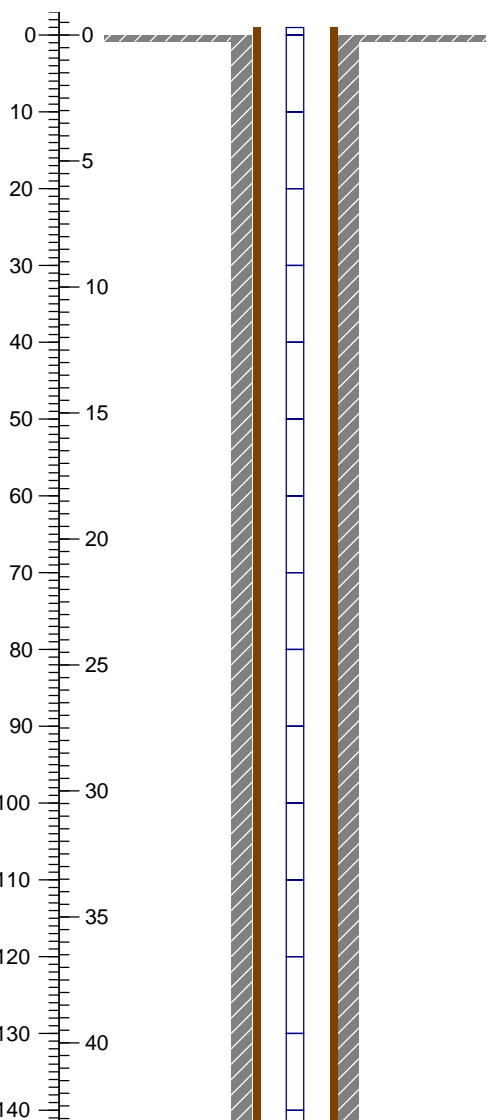
Westbay® Well Stick-Up = 1.0' (0.298 m)
Surface Casing Stick-Up = ~1.01' (0.3 m)
 Well completed with ~3' x ~3' cement pad, barrier posts, and locking steel well cap surrounding the casing at ground surface

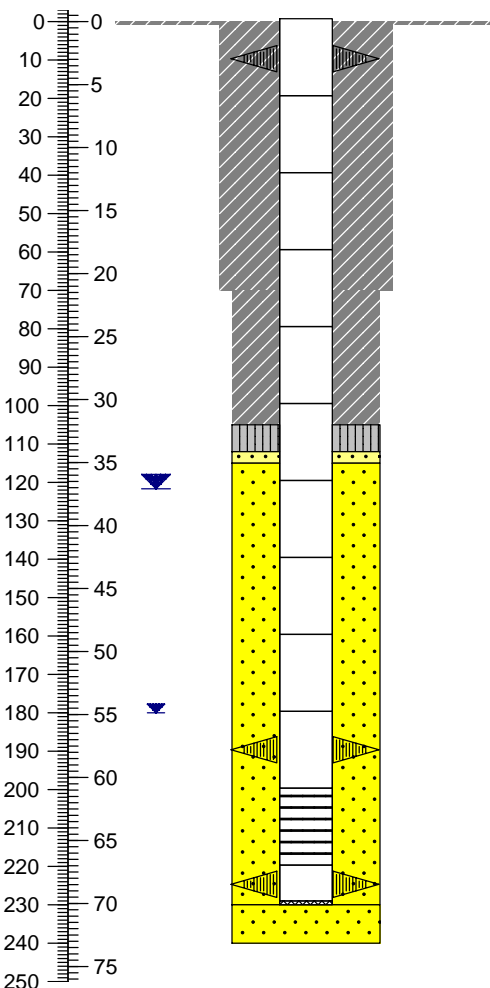
Conventional Well Stick-Up = 0.70' (0.21 m) (0.8' (0.2 m) at installation)
 Well completed with ~4' x ~4' cement pad, barrier posts, and locking steel well cap surrounding the casing at ground surface
