# **NASA's Recommendations to Space-Faring Entities: How to Protect and Preserve the Historic and Scientific Value of U.S. Government Lunar Artifacts**

**Release: July 20, 2011**

**NASA'S RECOMMENDATIONS TO SPACE-FARING ENTITIES: HOW TO PROTECT AND  
PRESERVE HISTORIC AND SCIENTIFIC VALUE OF U.S. GOVERNMENT ARTIFACTS**

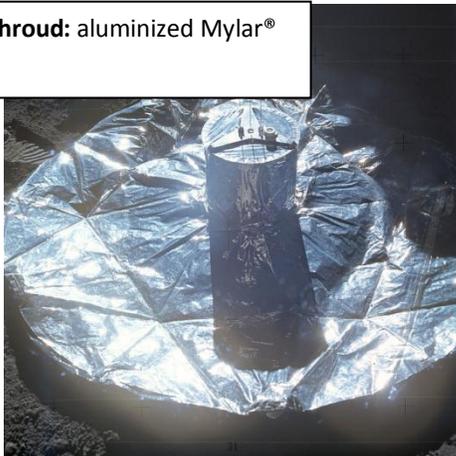
**Figure B3 – Passive Seismic Experiment**

**Thermal shroud:** aluminized Mylar®
