# Double Asteroid Redirection Test (DART) Lessons Learned

**Elena Adams**

DART Mission Systems Engineer  
Johns Hopkins University Applied Physics Laboratory

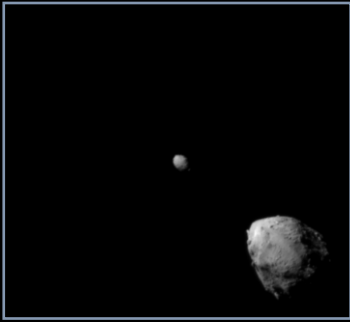
**920 kilometers**  
 Didymos – 180 pixel  
 Dimorphos – 38 pixel  
 Final downlinked images  
 to contain all of Didymos

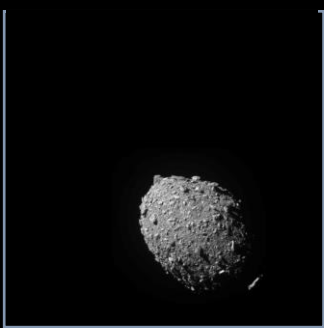
**76 kilometers**  
 Didymos – N/A  
 Dimorphos – 470 pixel  
 Final images to contain  
 all of Dimorphos

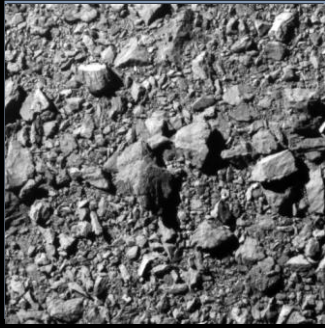
**12 kilometers**  
 Didymos – N/A  
 Dimorphos image – 31  
 meters across  
 Penultimate Image

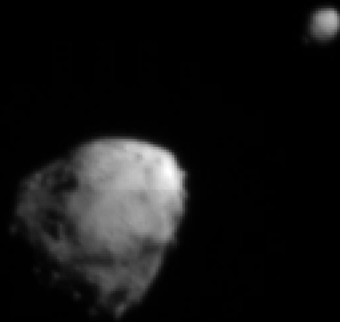
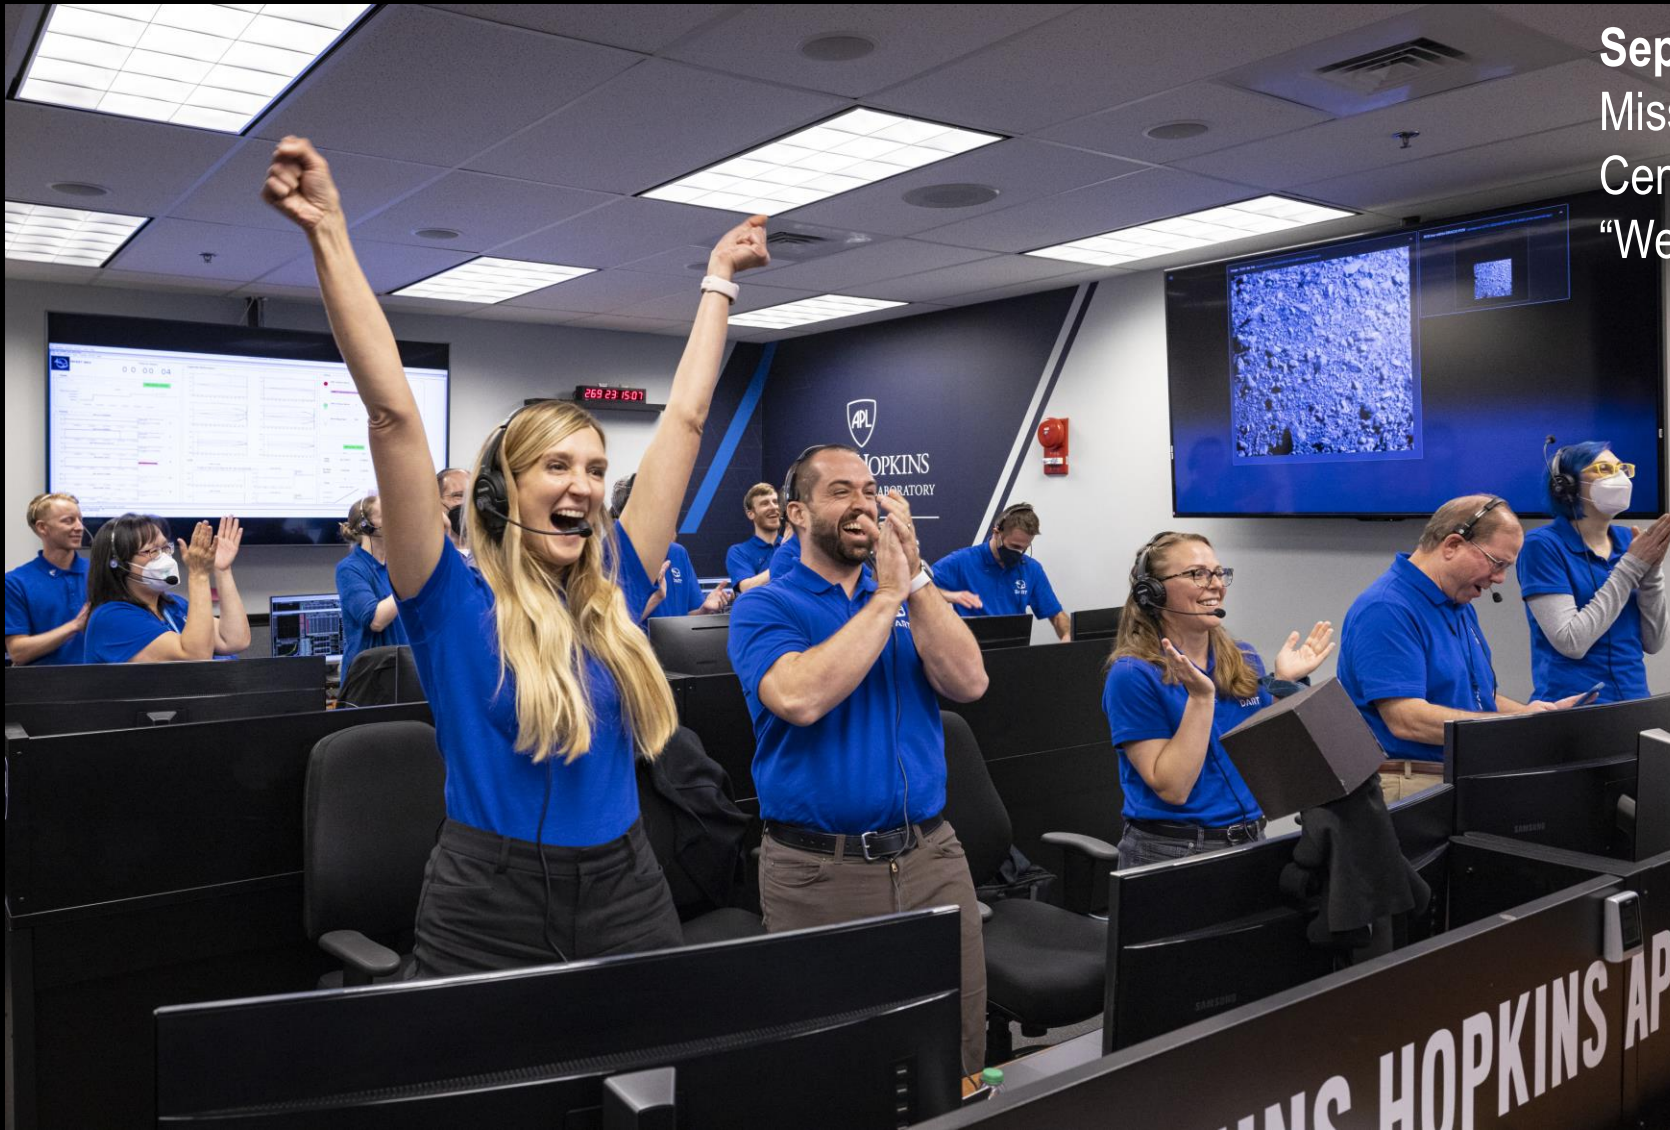
**Sept 26 7:10 -7:15 pm  
EST**

DRACO images  
streamed to Earth from  
7 million miles away  
10x speed

Sept 26 7:15 pm EST  
Mission Operations  
Center, Laurel MD  
“We have impact!”

DART impacted Didymos within 25m of the geometric center, and within 2m of the center of the illuminated figure

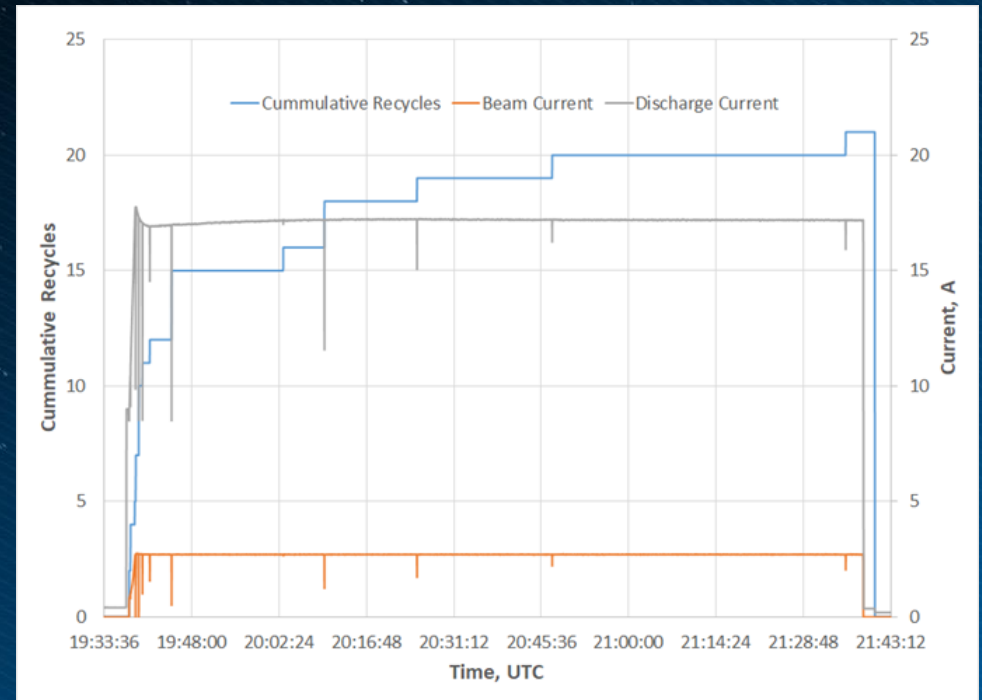
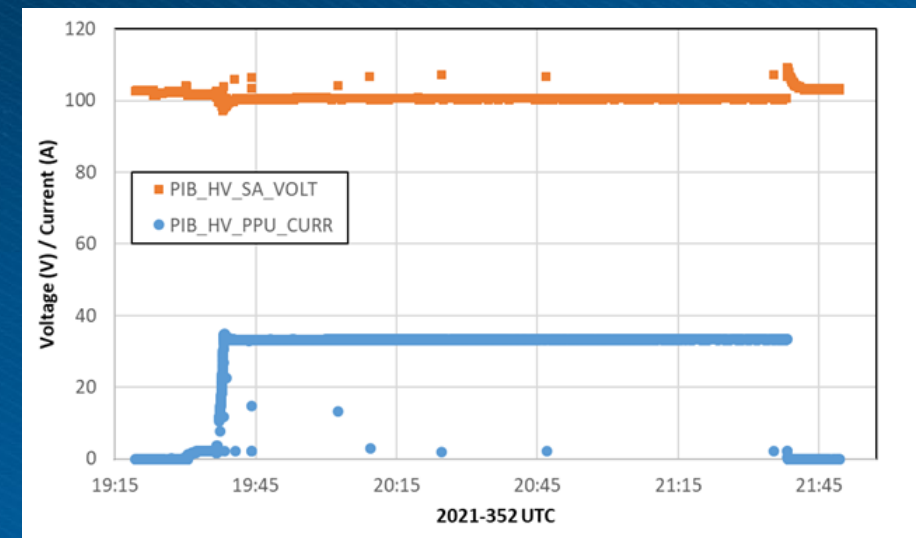
- During the operation time, the cathodes ignited nominally and the application of high voltage for beam extraction occurred nominally
- Spacecraft power response was consistent with the behavior observed in ground tests and was nominal during the operation time
- Thruster power was ramped up to the throttle level in less than 2 minutes and experienced several thruster recycles as expected
  - A recycle is a HV short at the thruster grid detected by the PPU as a high current condition. The PPU power cycles HV
  - Flight software controlled the ramp and performance was consistent with ground tests, including observing recycles
- Recycles continued intermittently through the operating period but did not impact NEXT-C performance, nor cause spacecraft resets or catastrophic faults
  - Recycles were observed both in the thruster data and spacecraft input power data
