NASA's Recommendations to Space-Faring Entities: How to Protect and Preserve the Historic and Scientific Value of U.S. Government Lunar Artifacts

Release: July 20, 2011

**NASA'S RECOMMENDATIONS TO SPACE-FARING ENTITIES: HOW TO
PROTECT AND PRESERVE HISTORIC AND SCIENTIFIC VALUE OF U.S.
GOVERNMENT ARTIFACTS**

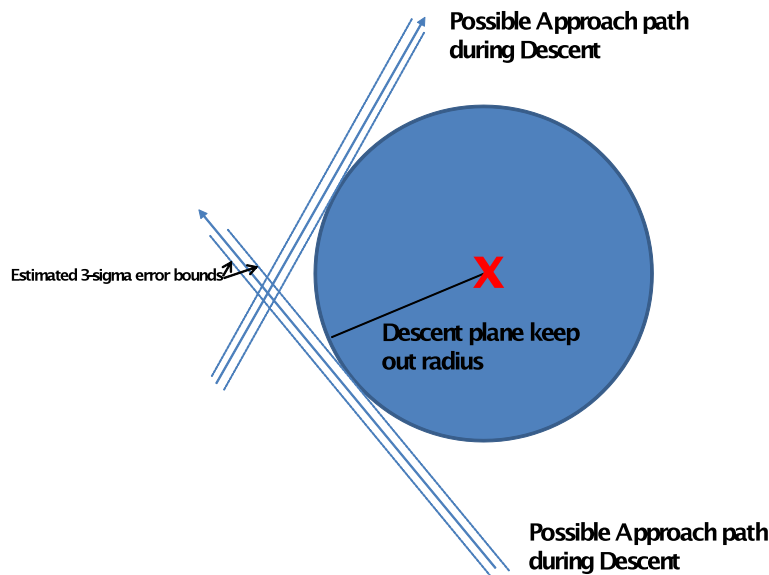
Figure 1: Possible Approach Path Scenarios

By specifying a exclusion radius for the approach plane, it would still permit a large number of different approach paths to the site. Mission designers could then design the descent trajectory geometry (inclination and ascending node combination) such that the plane does not cross within this exclusion radius. More specifically, it would be the plane with appropriate error bounds drawn to cover for anticipated dispersions.

A 0.5 km exclusion radius applies to the descent/landing path of the visiting vehicle to any of the USG heritage impact sites. This distance allows closer targeting (versus the heritage lander sites) for both lander/rover and hopper configuration landers.

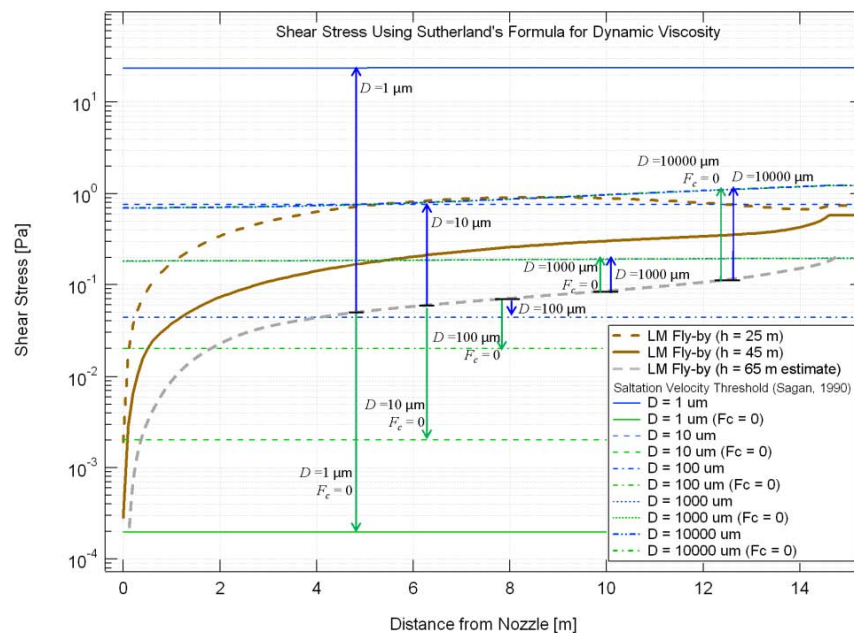
Figure 11: Shear stress generated by a rocket exhaust plume and shear stress levels required to mobilize various sizes of lunar soil particles.

With a spacecraft that has much smaller thrust than the LM, the altitude of initial dust blowing will be lower than these reported values, but it is difficult to predict analytically. Forty meters is chosen as a reasonable estimate until further analysis is performed.

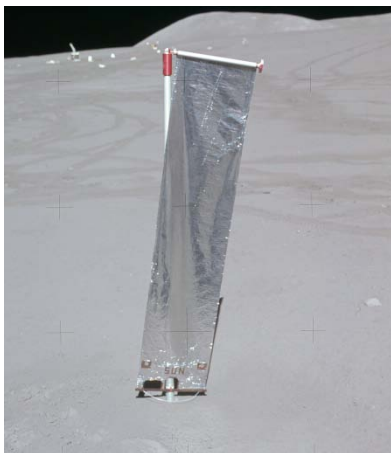
Figure B9 – Solar Wind Composition Experiment (Only Support Pole Remained on Moon)
