Battery Incident Root Cause Analysis and Review the Certifications

Nov. 14, 2017

PCTEST Engineering Laboratory

2. Galaxy Note 7 Battery Incident History, Root Cause Analysis and Corrective Action

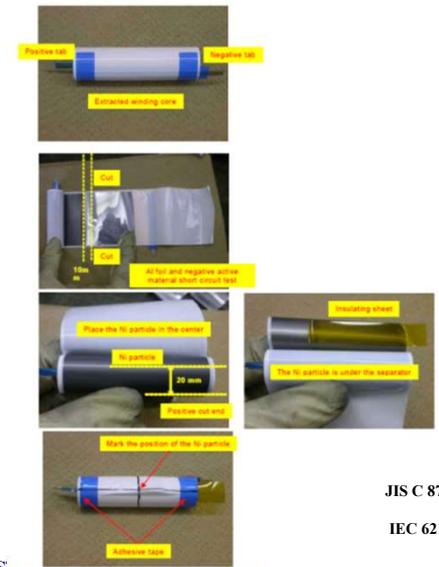
Cylindrical Cell

Corrective Action-2_Japan_Forced Internal Short_JIS C 8714

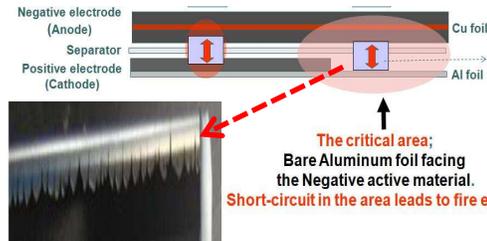
Internal Short Avoidance :IEEE 1625/1725

The critical area; Bare Aluminum foil facing the Negative active material. Short-circuit in the area leads to fire easily

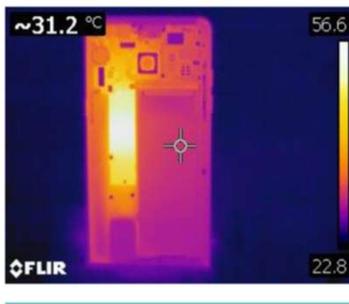
Battery System Analysis by UL

- Note 7 components do not increase the battery cell temperature to a level higher than the specified threshold

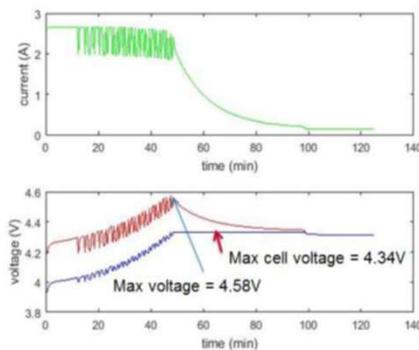
- Note 7 maximum current drain meets the specifications provided by Samsung
- The maximum charging current, the maximum temperatures and the maximum cell voltage are within the specifications with the standard adapter provided by Samsung

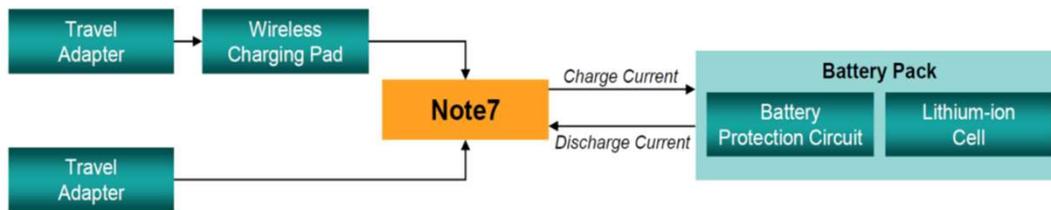
Note7 Battery System Architecture

- Analysis of the Note7 battery system design indicated that the system is designed with multiple levels of protection for the Li-ion cell
- The testing and analysis performed did not identify a fault in the Note7 battery system that could have triggered the observed battery failures in the field
- Testing performed with several third party wireless charging pads available for use with the Note7 device showed that the Note7 device is designed to prevent a failure of these charging pads from causing the Li-ion cell to operate outside its specifications

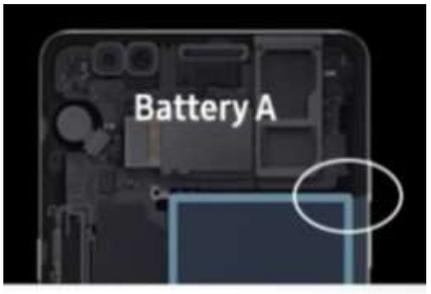
Battery A

The negative electrode is not deflected

Main Cause

- Based on the results of analysis and testing, the most likely root cause for the thermal failure of certain Manufacturer A cells was determined to be unintended damage to the negative electrode windings consistently in the corner of the cell closest to the negative tab

- The unintended damage was present in all of the cells examined by Samsung and Exponent
 - The damage was caused by a cell pouch design that provided inadequate volume to accommodate the electrode assembly

- The observed damage provides multiple potential routes to internal cell faulting and thermal failure with normal cycling, including compromise of the separator and lithium plating

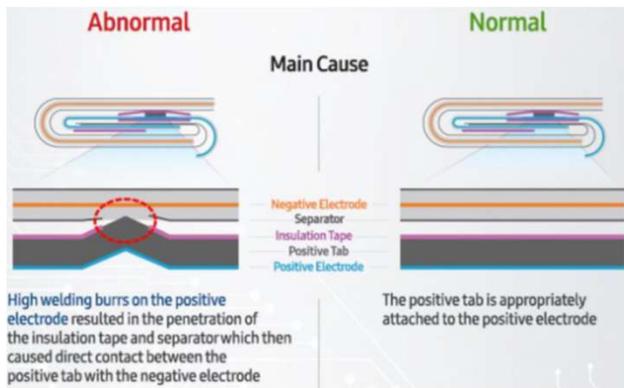
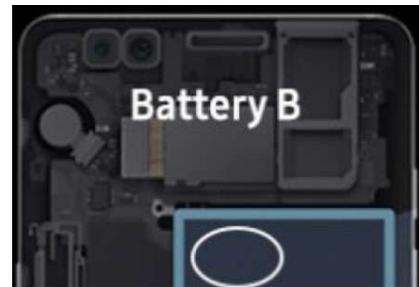
Manufacturing B: QC Issue

- Based on the results of analysis and testing, the most likely root cause for the thermal failure of Manufacturer B cells was determined to be internal cell faulting between positive electrode tab welding defects and the copper foil of the negative electrode directly opposite the defective welds
 - Welding defects in some incident cells were found to be tall enough to bridge the distance to the negative electrode foil
 - Some cells examined were assembled without protective tape over the positive electrode tab, increasing the likelihood of an internal cell fault

- Poorly controlled welding of the positive tab in Manufacturer B cells creates sharp, relatively tall welding defect features
- Normal swelling and contraction of the electrodes during charge and discharge forces the weld defect features into the opposing negative electrode
- Short circuit between the weld defect feature on the positive tab and the copper of the negative electrode results in heating of the cell
- At high states of charge, the cell heating results in thermal run away.

Check insulation tape status 100% vision check is mandatory during the manufacturing process. QC checks it every batch and many inspections.

* IEEE 1725 and CTIA Certification Requirement :Regularly Check the operating condition of the ultrasonic welding machine and evaluate the Welding position of Electrode:

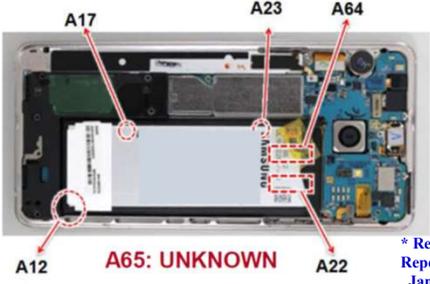
UL

- Signs of internal short circuit (ISC) at different locations of the cells from 5 of the damaged devices
- Signs of ISC at the tab locations of swollen cells
- Missing insulation tape on the cathode of swollen cells
- Sharp-edged protrusions on the tab welding spots of swollen cells

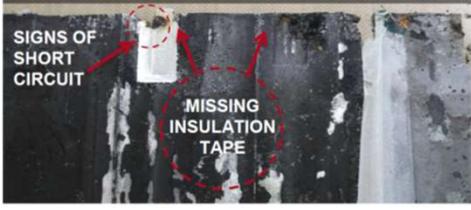
CELLS WITH MISSING INSULATION TAPE

NORMAL CELL WITH INSULATION TAPES

- a) Missing insulation tape on tab could result in higher possibility of ISC
- b) Bigger protrusion of welding points in tab could lead to higher possibility of separator puncture
- c) Misalignment of insulation tape and/or tab could bring more risk of ISC

The combination of **(a) missing insulation tape + (b) sharp edged protrusions on tab + (c) thin separator**, all leading to a high possibility of an ISC between cathode tab and anode, subsequently resulting in heating and fire.

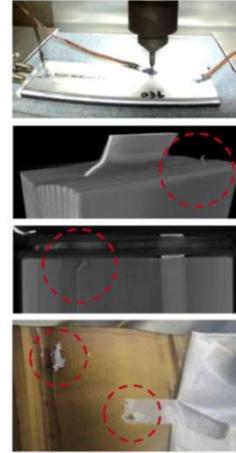
- Uneven charge status on multiple samples
- Signs of internal short circuit
- Poor alignment and inconsistent shape and dimension of tabs and insulation tapes
- Sharp edge protrusion of welding joints

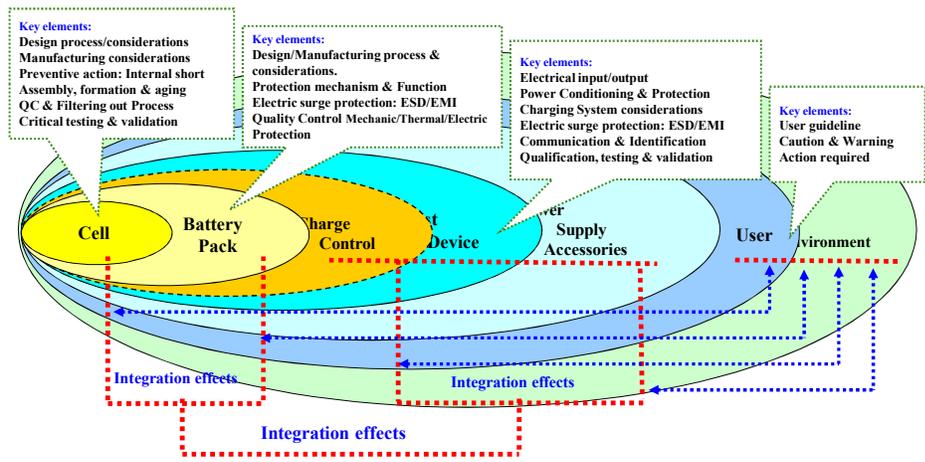
Verification of System Integration effects on IEEE 1625/1725

Key elements:
 Design process/considerations
 Manufacturing considerations
 Preventive action; Internal short
 Assembly, formation & aging
 QC & Filtering out Process
 Critical testing & validation

Key elements:
 Design/Manufacturing process & considerations.
 Protection mechanism & Function
 Electric surge protection: ESD/EMI
 Quality Control Mechanic/Thermal/Electric Protection

Key elements:
 Electrical input/output
 Power Conditioning & Protection
 Charging System considerations
 Electric surge protection: ESD/EMI
 Communication & Identification
 Qualification, testing & validation
