# International Space Station Lithium-Ion Main Battery Thermal Runaway Propagation Test

NASA Battery Workshop November 14-16, 2017

Penni J. Dalton, NASA Glenn Research Center
Tim North, The Boeing Company

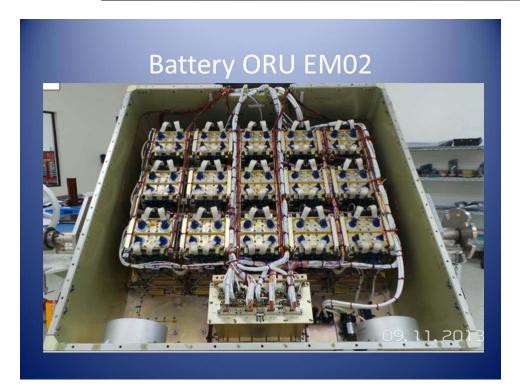
## ISS Li-Ion ORU

- 30 GS Yuasa LSE134-101 cells in series
  - Arranged in three "10 packs"
- •3.95 V/cell End of Charge Voltage
- ~15 Kwh
- Low Earth Orbit ~35 min discharge
   & 55 min charge
- 10 year (60,000 cycles) life

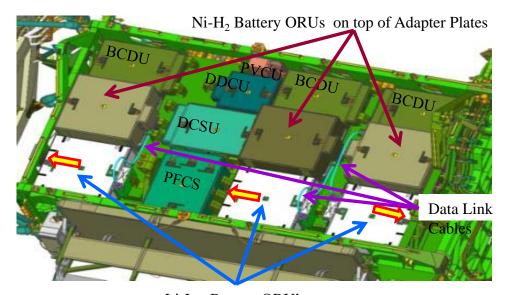
Note: Cell vents face up toward MMOD shielding – away from cold plate, adjacent cells, and IEA hardware

Li-Ion Battery ORU's
Li-Ion Battery ORU Vent Direction

- Allows ORU vent gas pressure relief
- Prevent Flames from escaping the ORU
- Baffles made of 300 series CRES (Stainless Steel)
- Directs vent effluent away from EVA crew member during Installation
- Once installed on ISS, vent ports face structure or adjacent ORUs, thus limiting effluent flow to EVA accessible areas

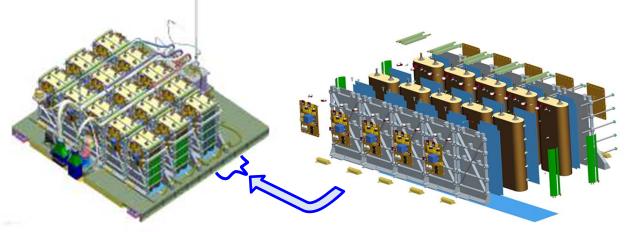
ORU Layout – three Cell "10-Packs" and 12 Radiant Barriers

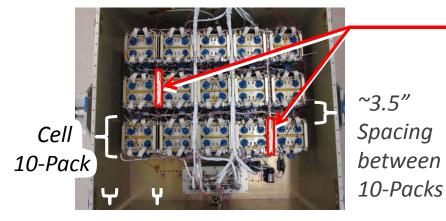
~2" ~1" Spacing Spacing between Cells

#### Radiant Heat Barrier (12 per ORU)

- Higher margin against thermal runaway propagation
- One barrier between each cell pair
- Reflects 787 reach-back safety additions

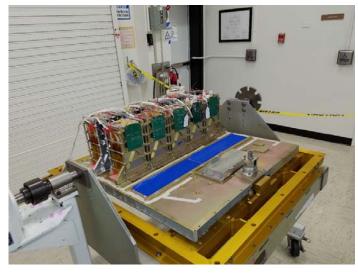
First two rows of cells on baseplate

- As Flight Like as possible within cost and schedule constraints
  - Finned baseplate, enclosure, MMOD shield, flame trap vent assemblies, cell holding fixtures, thermal gaskets, radiant barriers, insulation, etc.
- Six live cells, 24 cell mass simulators
  - Live cells at and adjacent to initiating TR cell locations.
- Battery Interface Unit mass simulator
- Cable runs similar to flight configuration
- Additional Thermal Couple Instrumentation
- Enclosure modified to accommodate drill penetration apparatus

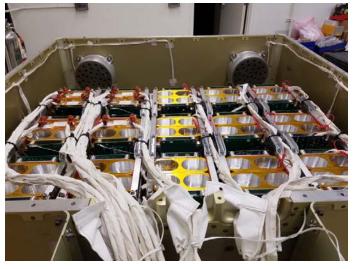
Six live cells, 24 cell simulators

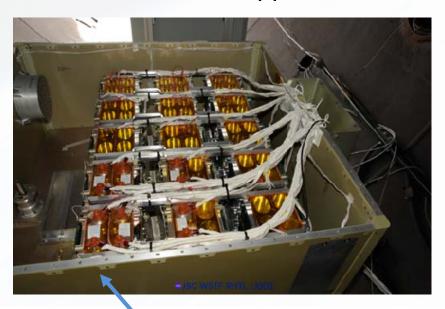
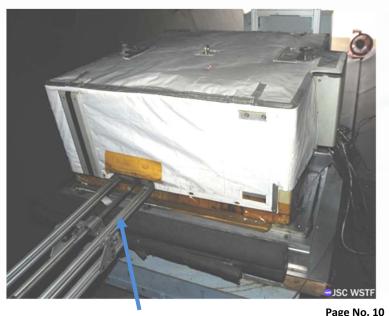
#### White Sands Thermal Runaway Propagation Test Bed

- Flight-like finned active cooling loop from ORU manufacturer, painted black over anodized gold coating for proper emissivity
- Affinity chiller selected for circulation of cooling fluid
  - Dynalene HC-10 fluid, on-orbit uses ammonia
  - Thermal analysis determined that differences were acceptable
- Two cameras, one inside test article, one inside chamber
- Drill Penetration Apparatus installed

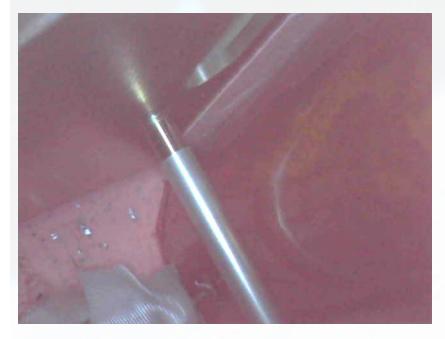
#### **USB Camera inside Test Article**

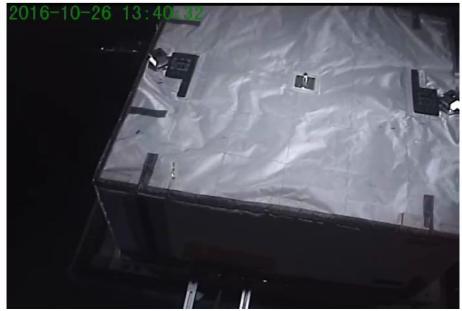
#### **USB** Camera outside Test Article

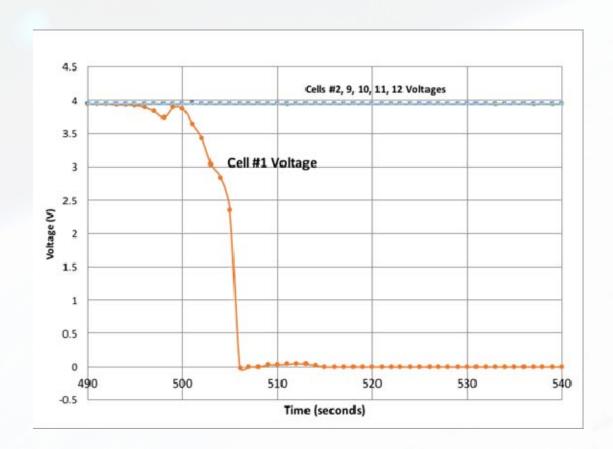
Test Summary – Cell Voltages

- Trigger cell vented, achieved TR, followed by cell winding ejection
- Battery enclosure contained TR products, including flames
  - Minimal damage to enclosure, MMOD shield, or radiant barriers
  - Gases vented and exited from enclosure
- No propagation to neighboring cells
  - All 5 live cells maintained their pre-test Open Circuit Voltages

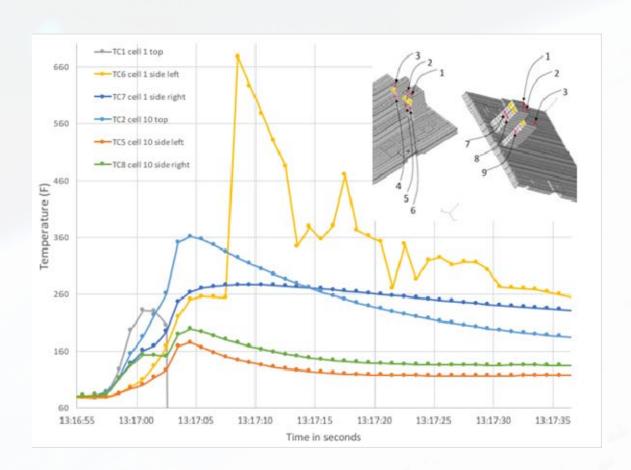
Test Summary – Cell 1 and Cell 10 Temperatures

Note: TC 1 failure, erratic readings on TC6 due to intermittent contact with the cell case

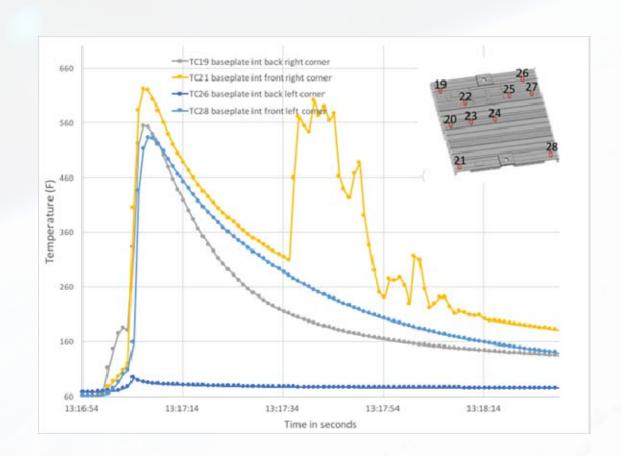
Test Summary – Baseplate Corner Temperatures

**Note:** Erratic readings on TC21 due to intermittent contact with the cell case

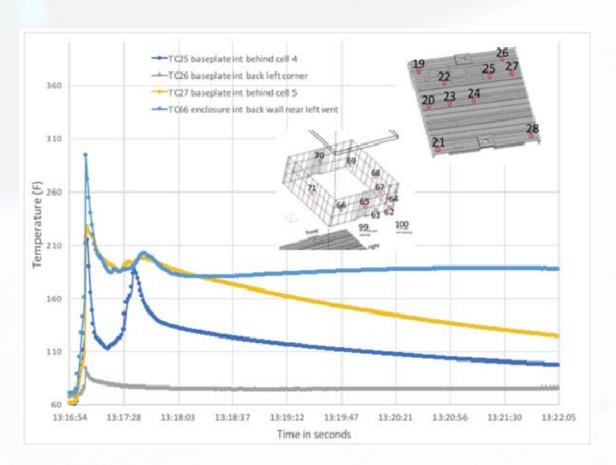
Test Summary – Baseplate Corner near jelly roll winding final location

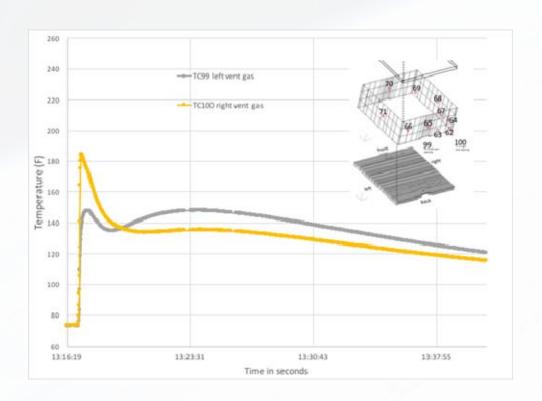
Test Summary – Flame Trap Exit Temperatures

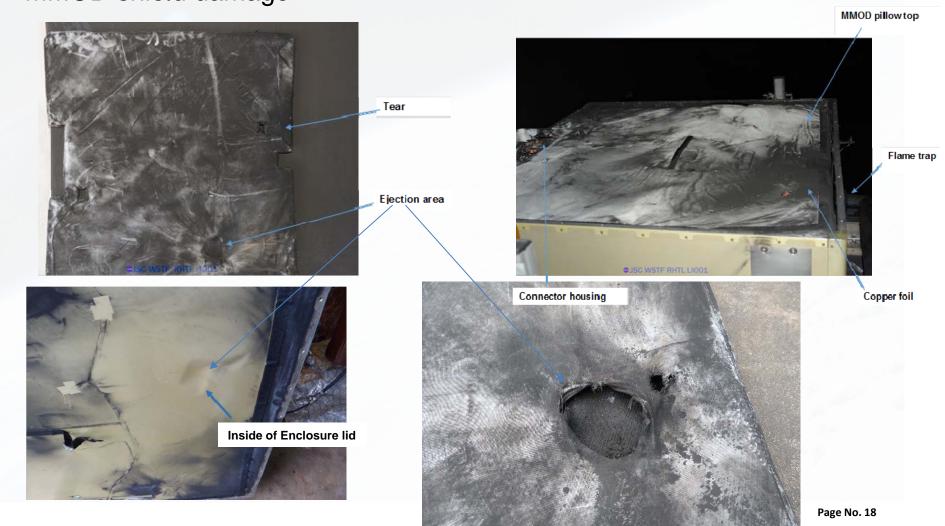
Post-test Destructive Physical Analysis at JSC

MMOD shield damage

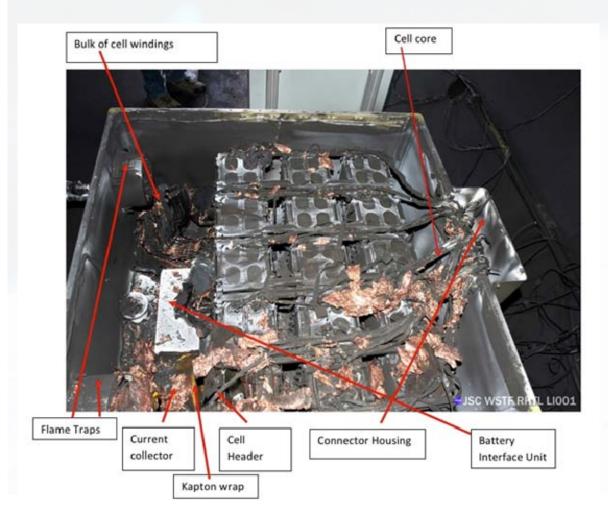
Post-test Destructive Physical Analysis at JSC

Location	Mass (g)
Cell Winding	470
Cell #1 remains	328
Front corner near cell 1	165
Front corner near cell 5	157
Cell Header	157
Baseplate cell 30 row	128
Top of live cells	86
Current collector	44
Top of mass simulator plus	
doghouse	31
In Flame Trap near cell 1	30
Between Cell Rows 1-2	28
Between Cell Rows 2-3	18
Cell Core	16
Cell 5 and 6 area	10
Outside ORU under doghouse	3
TOTAL	1671
Pretest Mass	3526
Missing Mass	1855

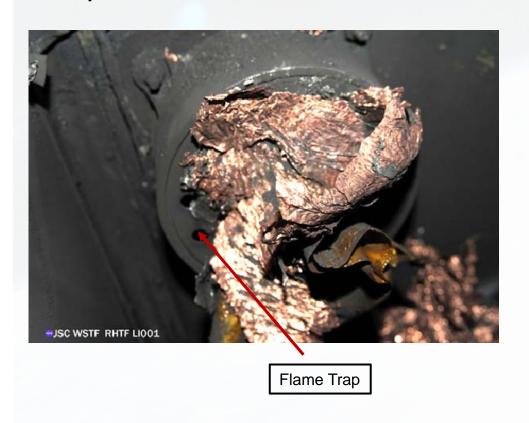
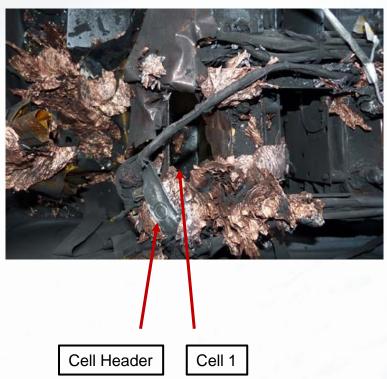
Post-test Destructive Physical Analysis at JSC – Flame Trap, Cell 1, and Header
