The Martian Landscape

By The Viking Lander Imaging Team

Scientific and Technical Information Office
NATIONAL AERONAUTICS AND SPACE ADMINISTRATION
Washington, D.C. 1978

The Viking Lander Imaging Investigation: An Anecdotal Account

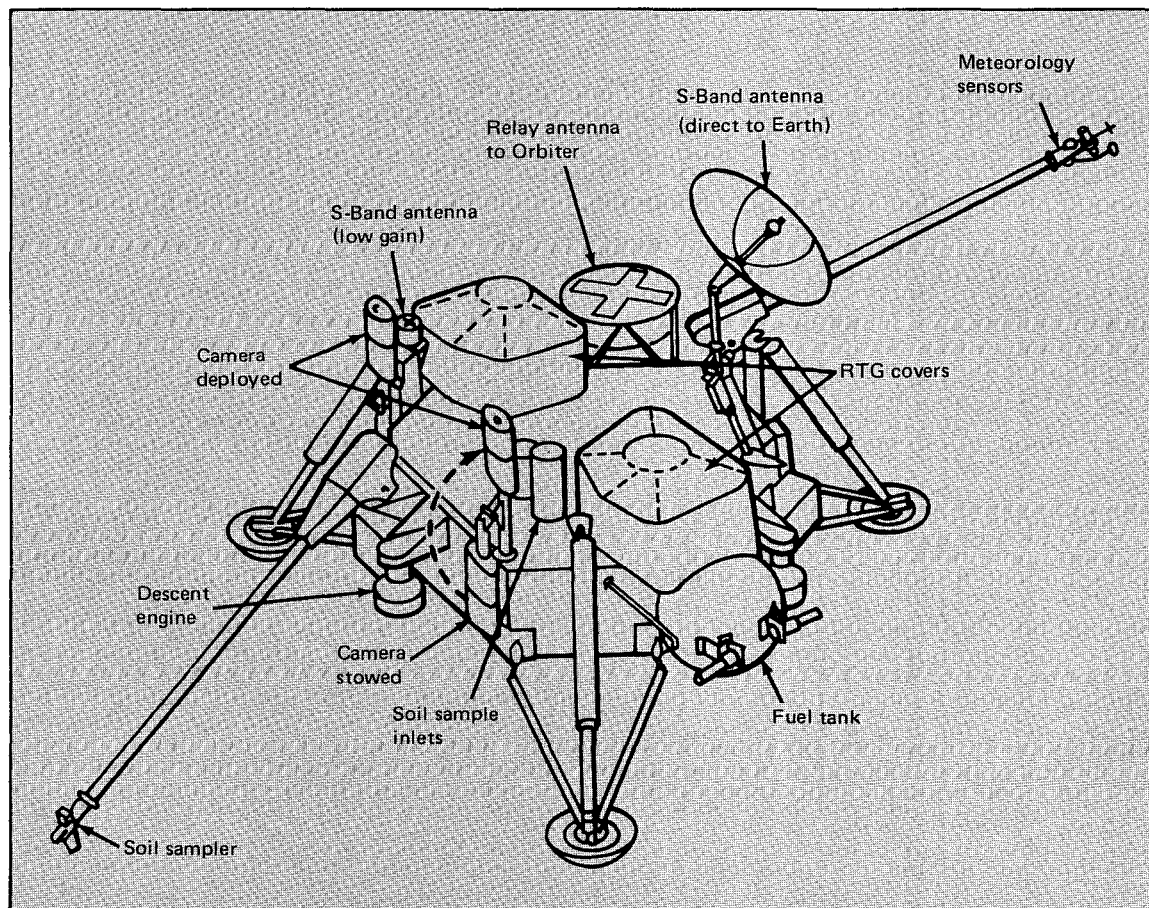
Figure 8. An intermediate design of the Viking Lander showing two cameras on hinged masts.

A compromise design was pursued for the better part of a year. The cameras would be mounted on hinged masts (fig. 8). During the trip to Mars they would be folded down; after landing they would be swung up, rotating through 180°. In retrospect it is difficult to see how this design concept survived for as long as it did. It introduced undesirable complexity and serious risk. During landing the sensitive camera electronics would be situated close to the base of the spacecraft, susceptible to collision with a boulder. If the swing mechanism failed to operate the cameras would remain in an inoperative position. If dust coated the exposed upper plate and base of the two mast sections, the deployed camera might be slightly tilted, introducing an unknown error in topographic analysis. Finally, if the cameras were not securely connected to the body of the spacecraft, they would not benefit from heat conducted from radioisotope energy sources. Isolated on the top of articulated masts, they might freeze to death. When all the liabilities were spelled out, the swing-up masts were discarded.

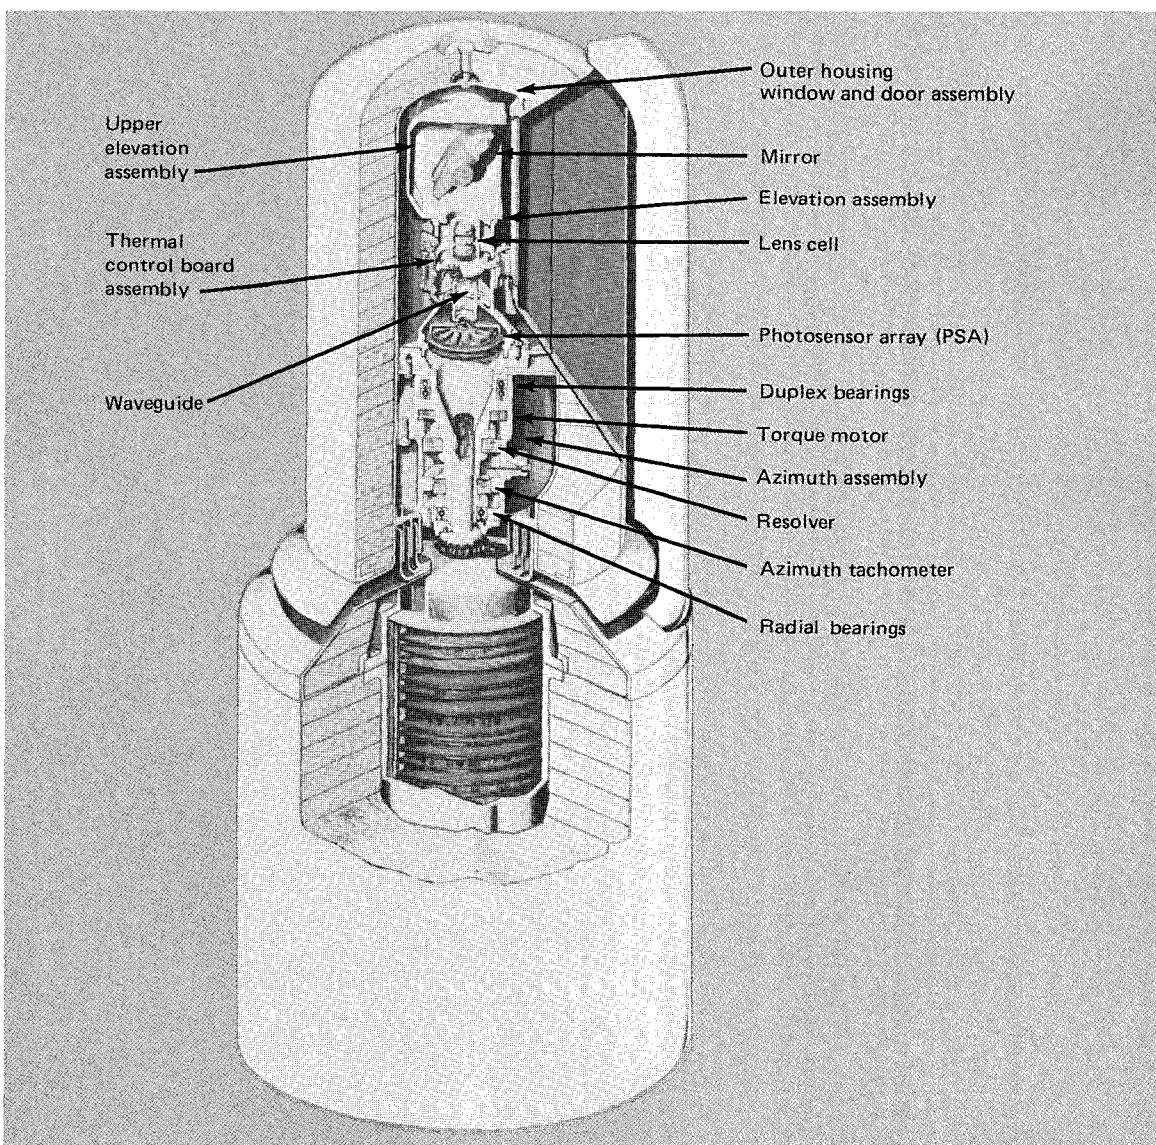
Figure 11. A cutaway drawing showing arrangement of components in the Viking Lander camera.

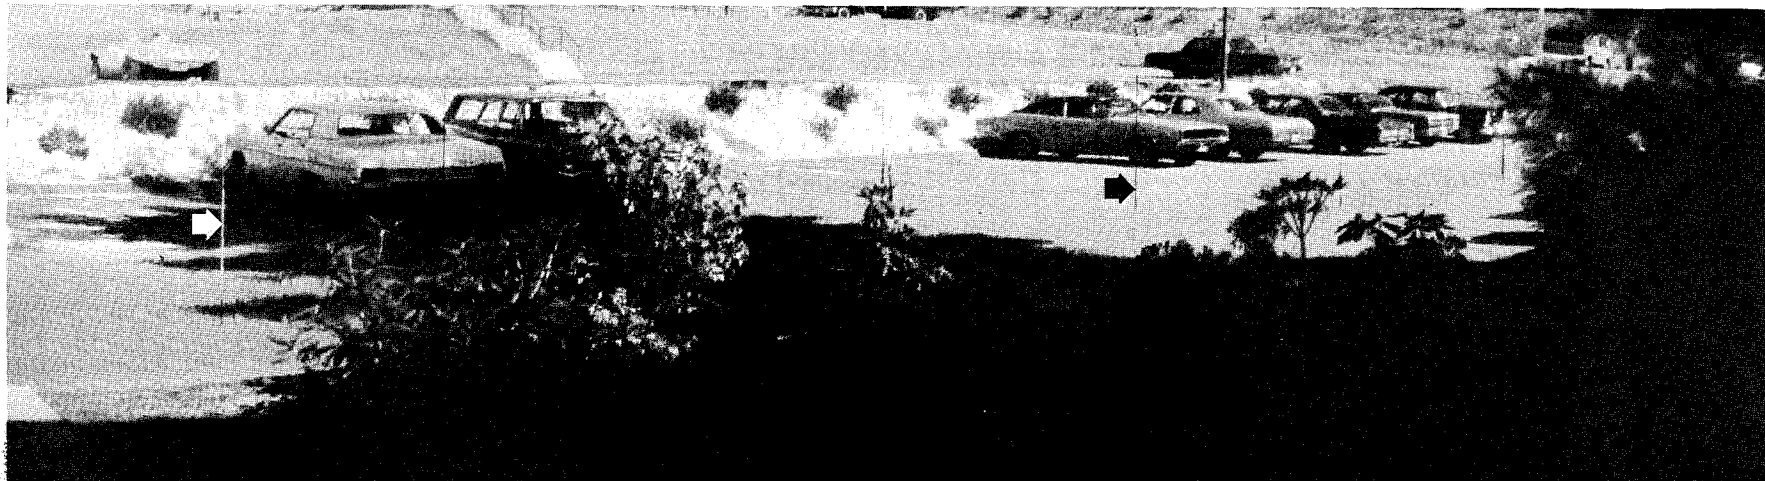
Figure 13. The first panorama taken with the Viking camera, a view of the ITEK parking lot in Lexington, Mass. The several vertical streaks, indicated by arrows, are not defects. They are the greatly distorted images of cars that drove by while the picture was being taken.

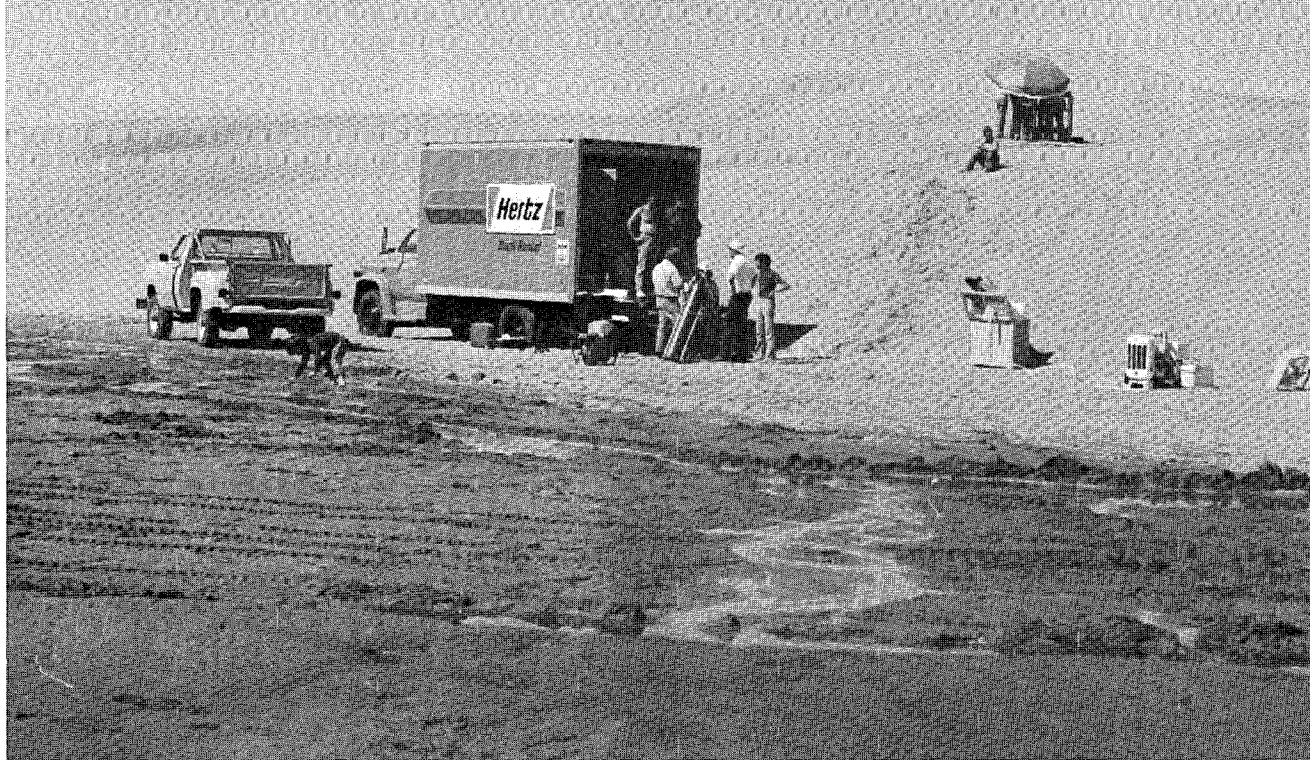
Figure 15. Operating the Viking camera at Great Sand Dunes National Monument, Colo. The camera is situated beneath the umbrella which protects it from the heat of the Sun. The supporting electronic equipment is in the rental truck.

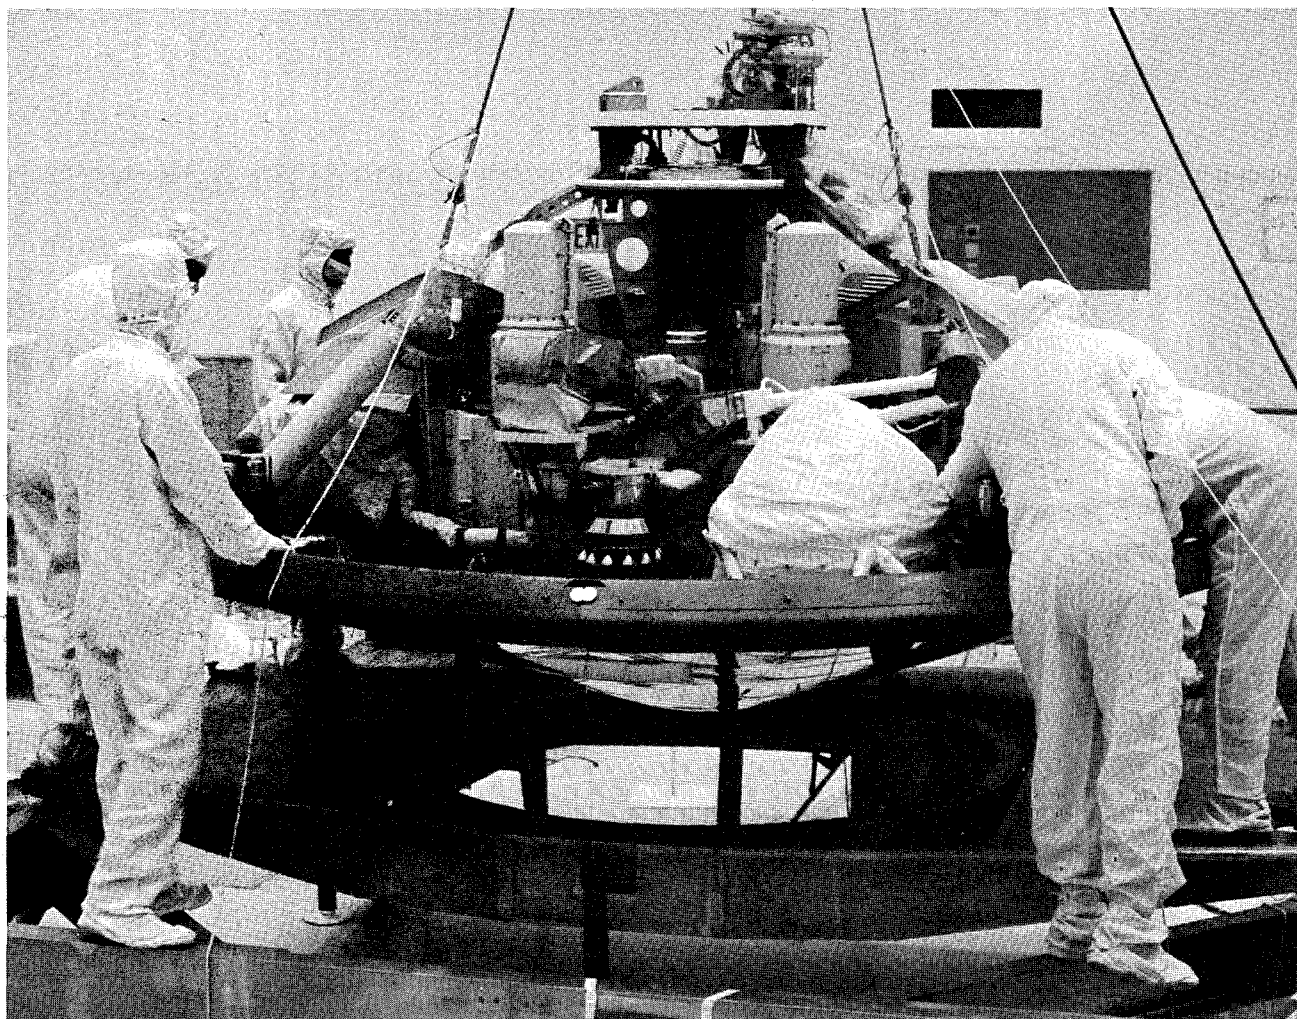
Figure 18. Encapsulating the Viking Lander in its protective aeroshell. The two Lander cameras are visible.

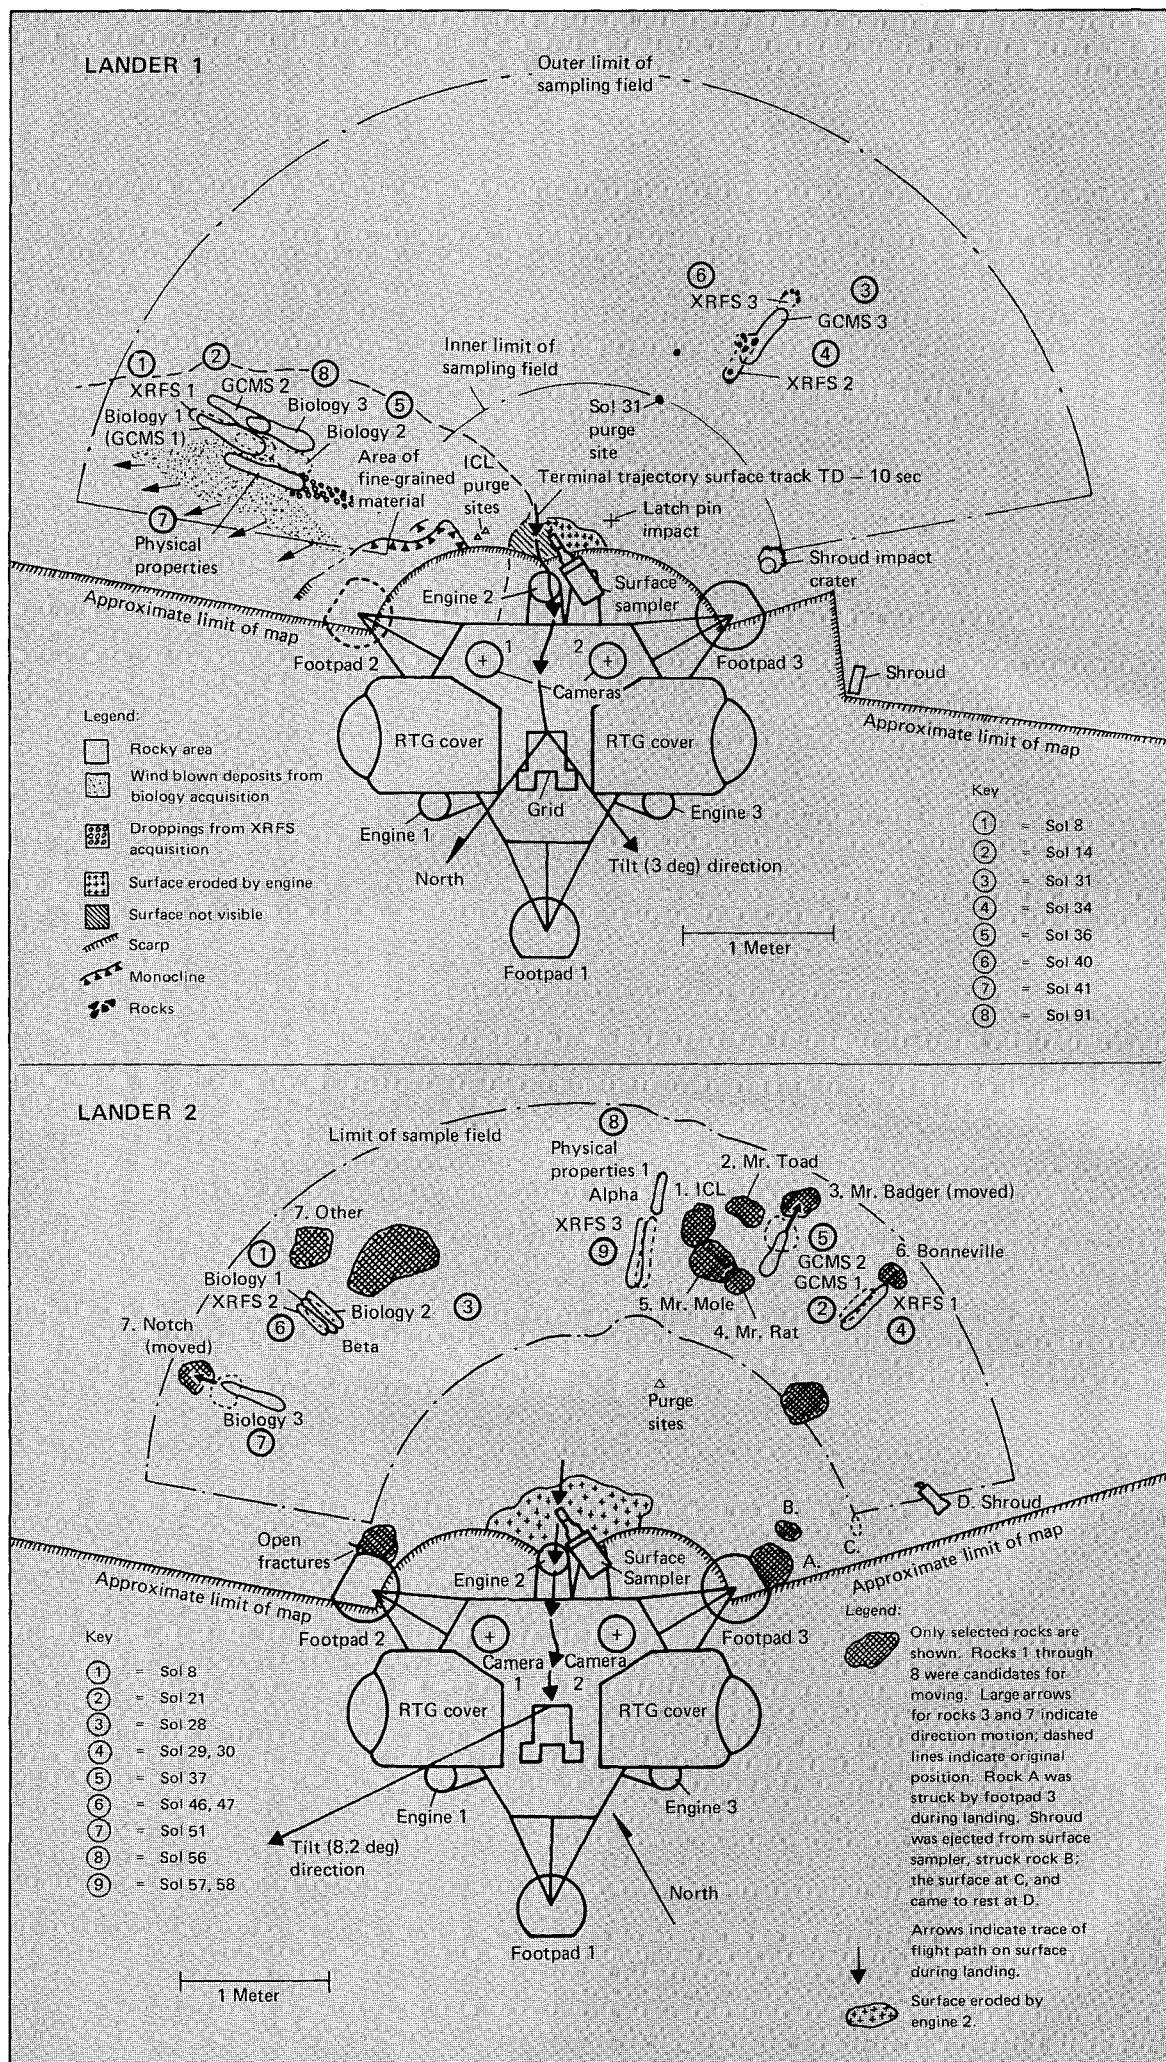
Figure 23. Schematic drawings of Lander 1 and 2 sampling areas summarizing surface sampler activities during the primary mission. The numbered circles indicate, in sequence, the sample acquisitions. The key indicates the sol (martian day) on which each acquisition occurred.

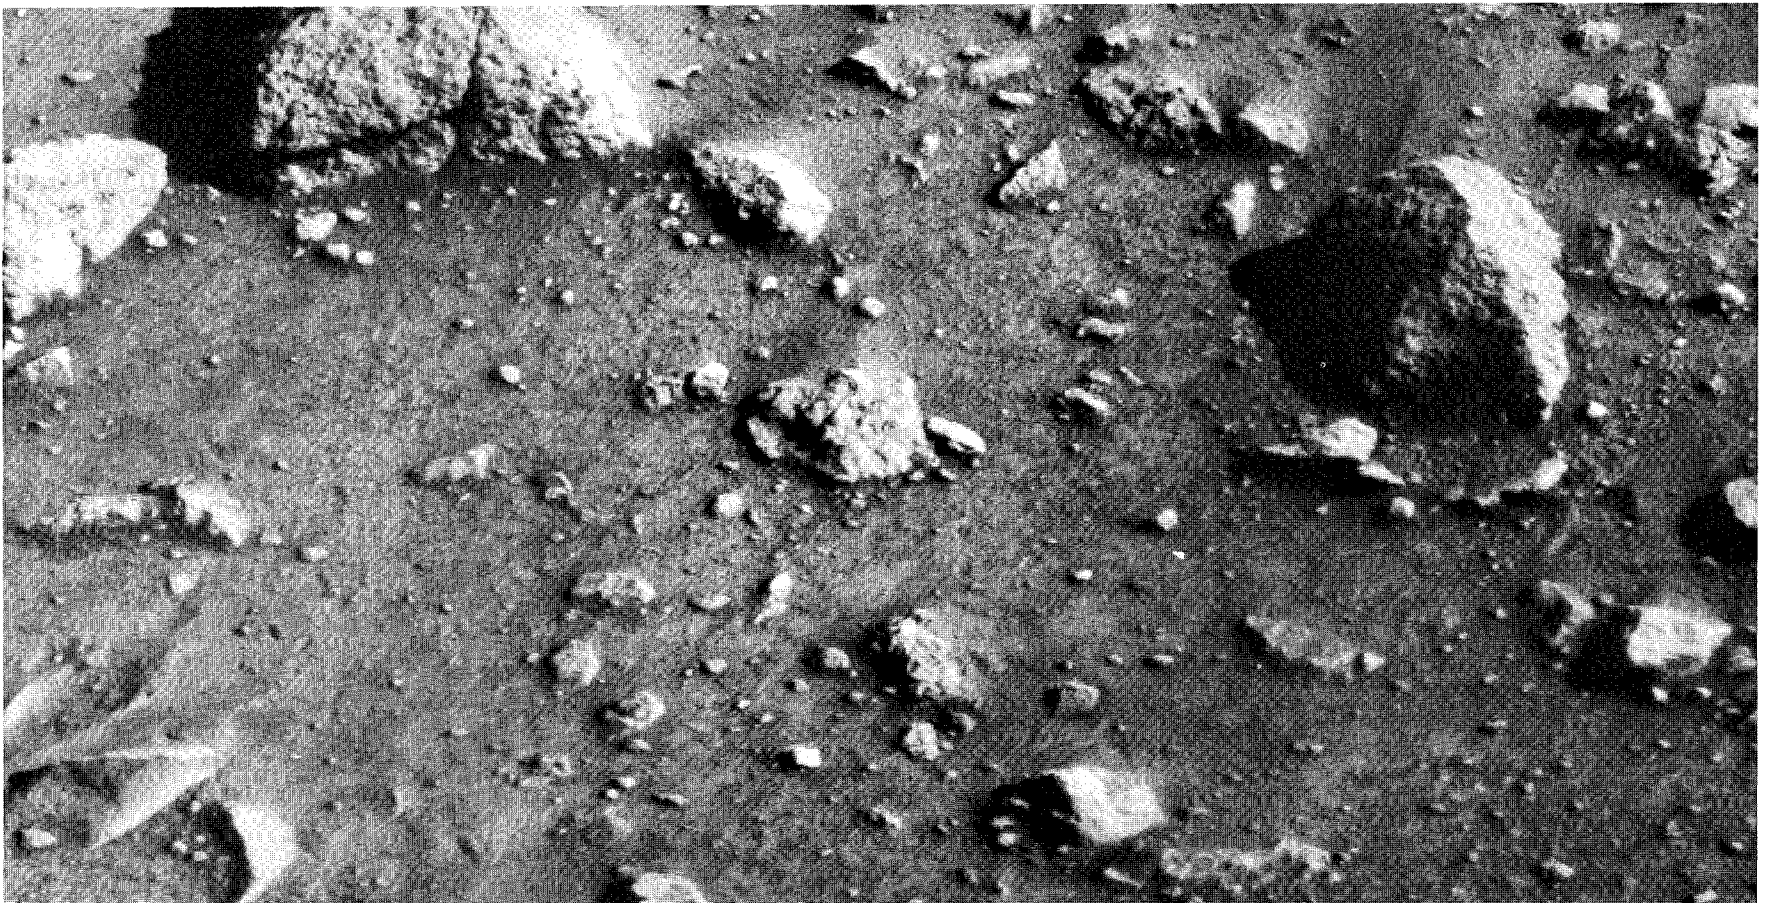
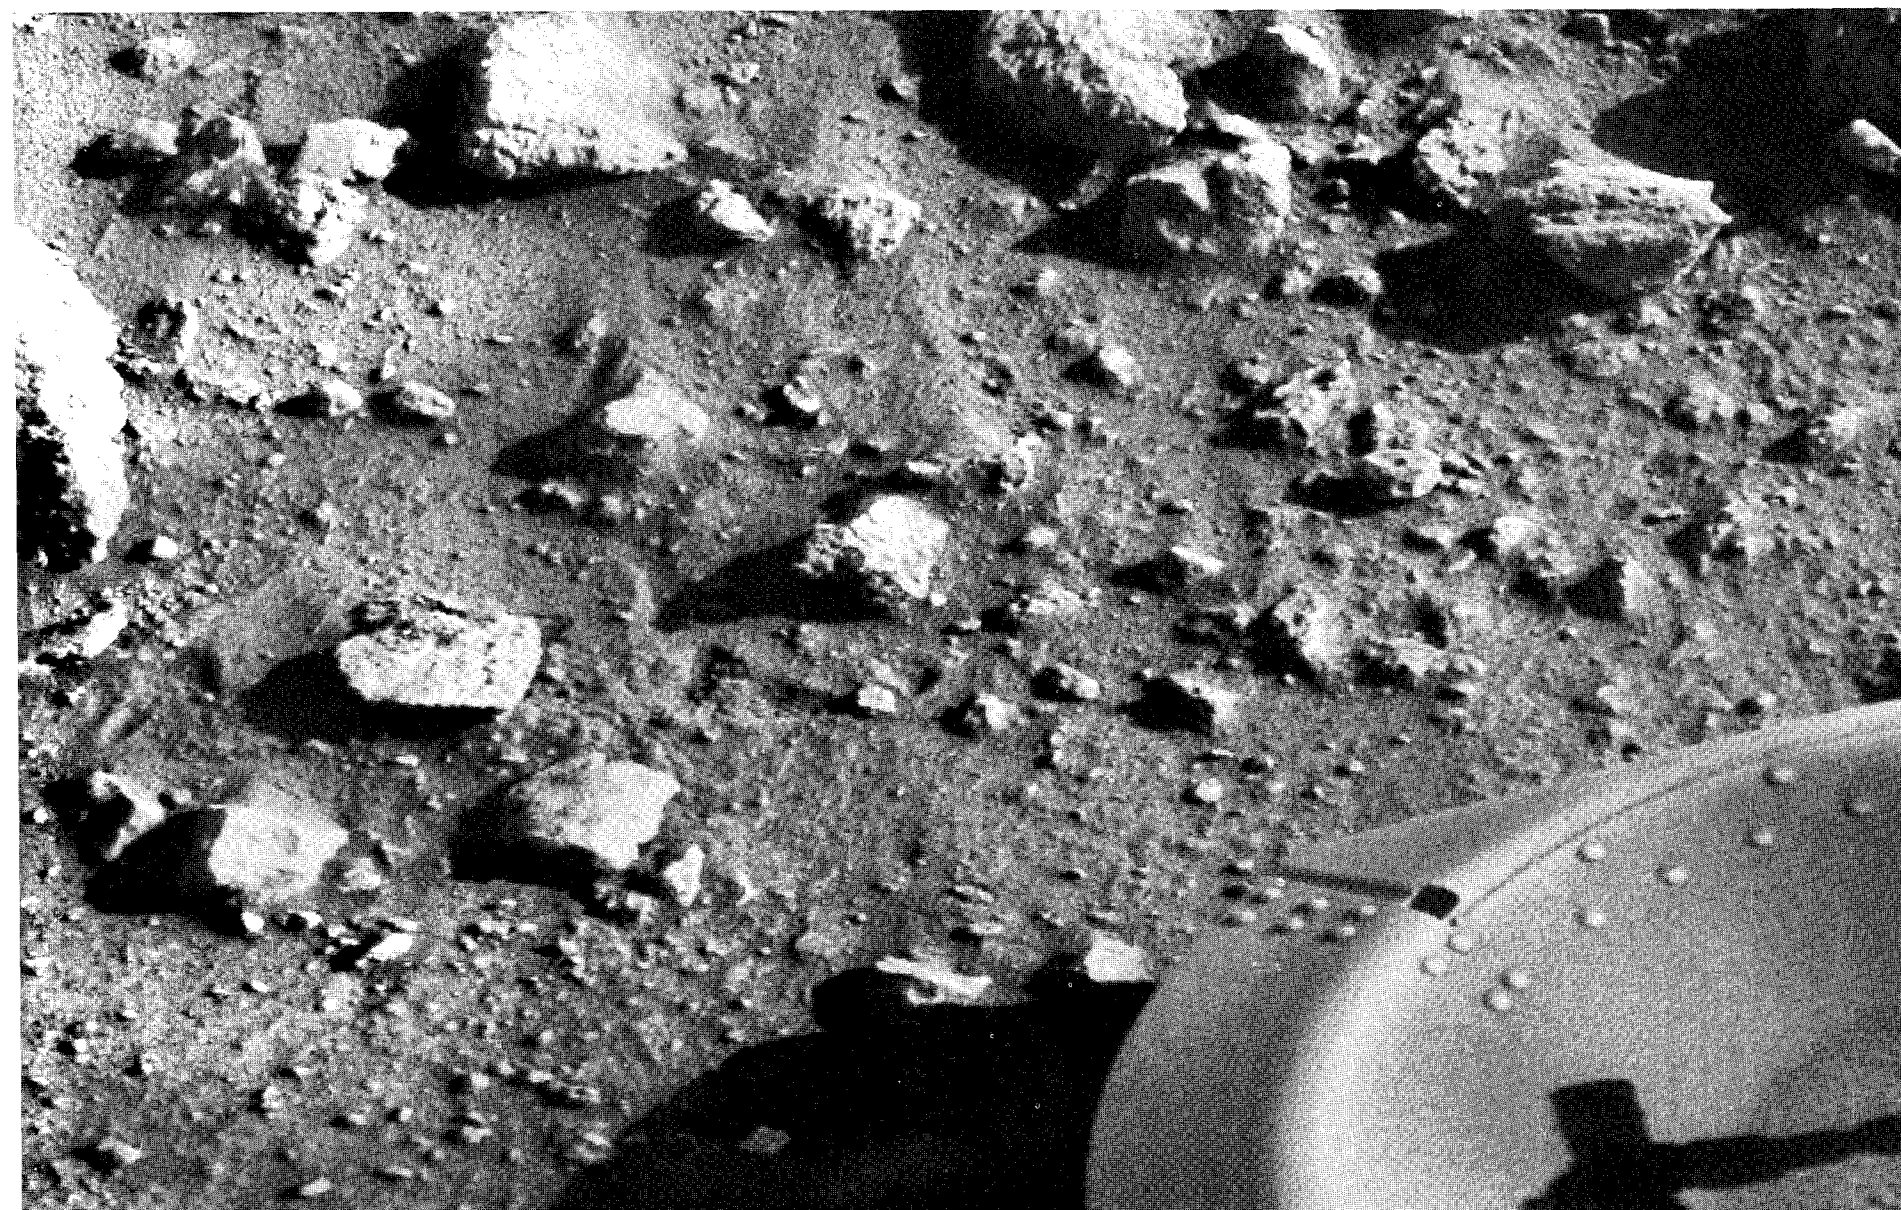
FIGURE 25

Figure 24 comprises the first picture taken on the surface of Mars. The camera began scanning the scene 25 sec after touchdown and continued to scan for five min. The picture was assembled from left to right during the 20 min it took to transmit the data from the Orbiter relay station to Earth. The first segment to be displayed was a narrow strip at the far left. About all that could be determined was the presence of bright and dark areas in the scene, but even that was cause for elation. Ironically, some viewers were more impressed by the picture of the footpad than by the view of the martian surface, marveling at the fidelity with which the rivets were displayed.
