Testing of Thermal Runaway Tolerant Designs Utilizing High Energy Density 18650 Lithium Ion Cells

Energys Advanced Systems / ABSL
Longmont, Colorado

NASA Aerospace Battery Workshop
November 27-29, 2018

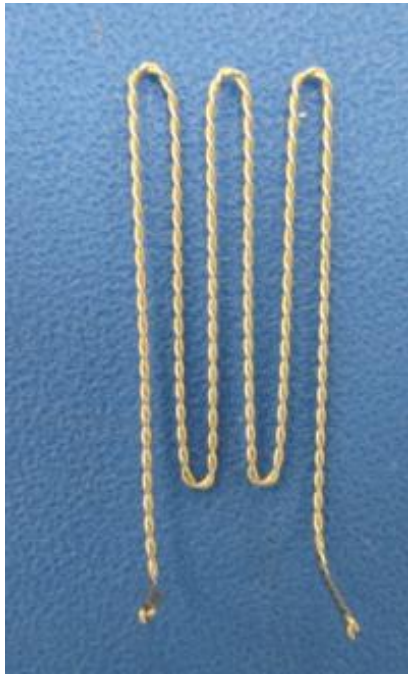
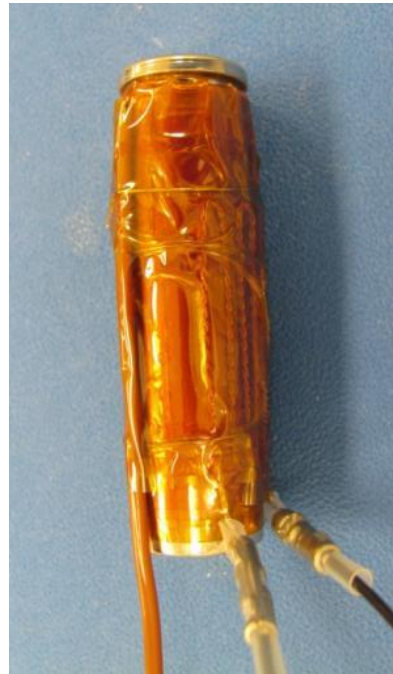
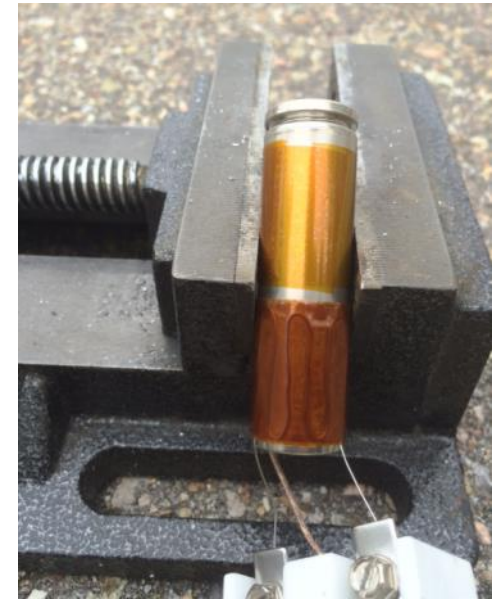
Single Cell Test Method

- Single cell tests used nichrome heater attached with Kapton tape, driven at 30-50W

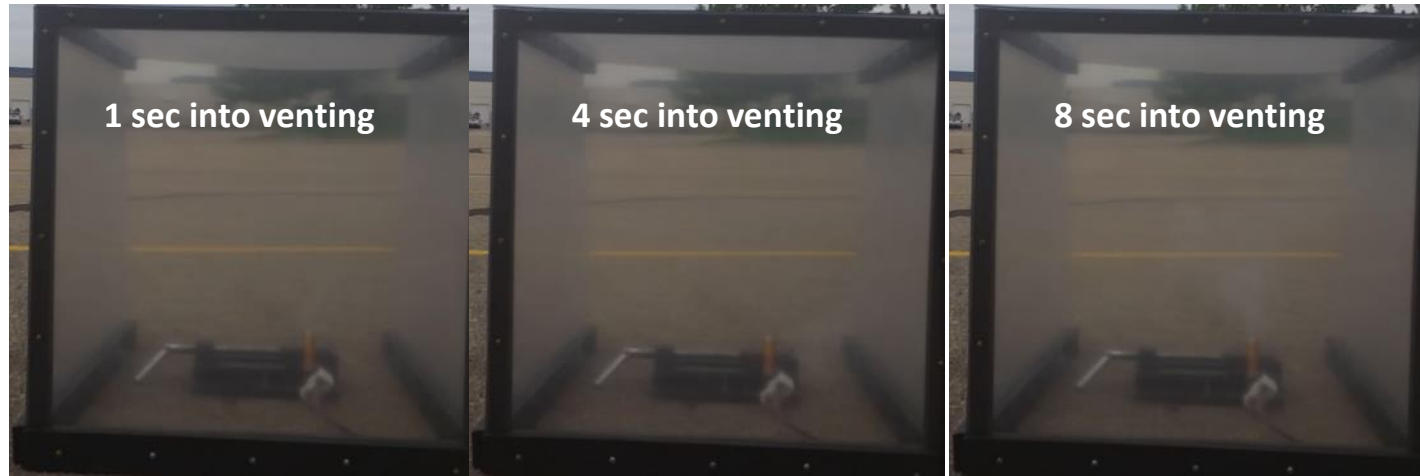
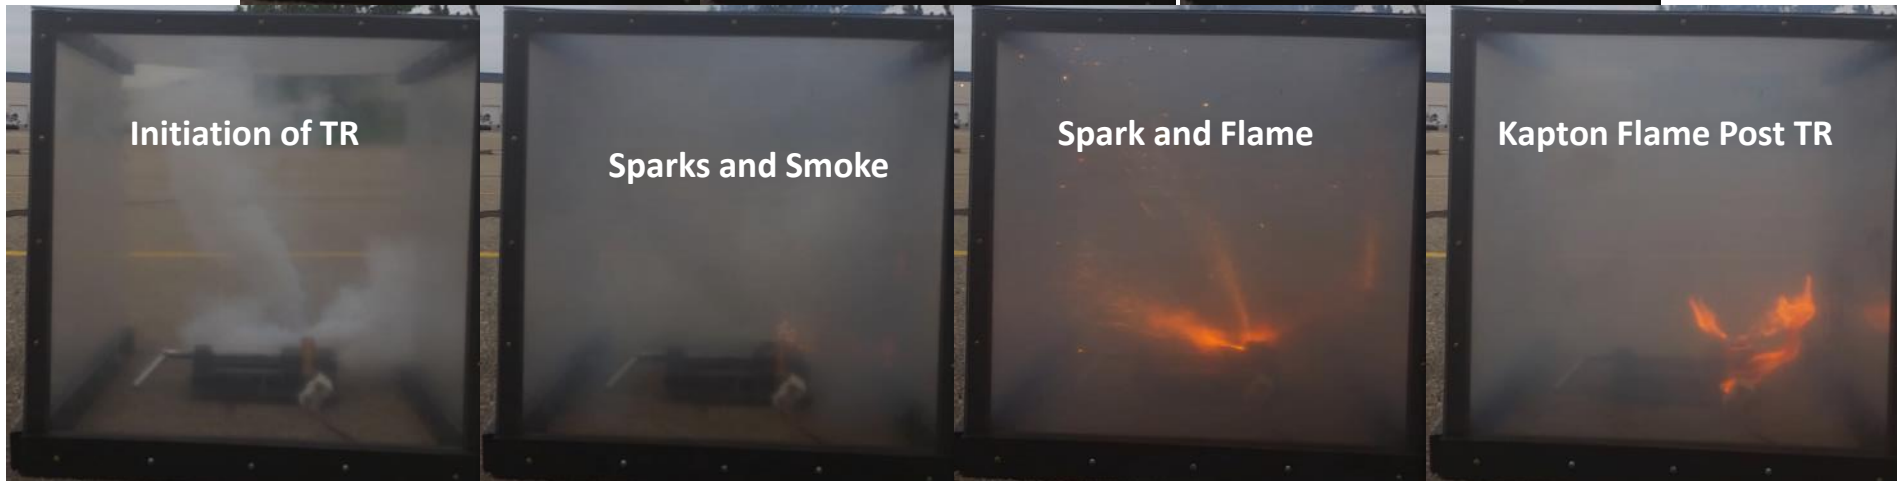
HCM (1.5 Ah) Single Cell TR Test Results

- As the HCM approaches thermal runaway, it begins to vent a small amount of smoke
 - Typically lasted 10-15 seconds before full TR
- At the time of TR initiation, a jet of flames, sparks and smoke are emitted through the center of the cathode assembly
 - Typically lasted 2-3 seconds

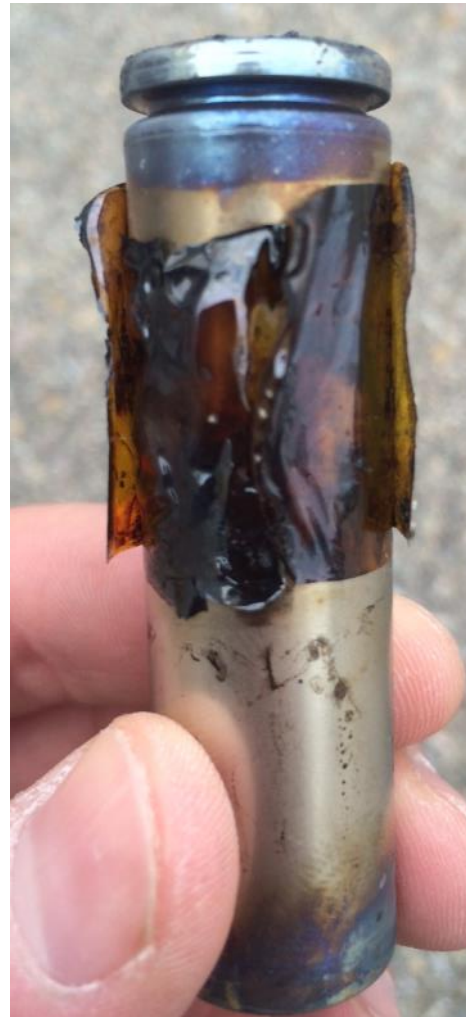
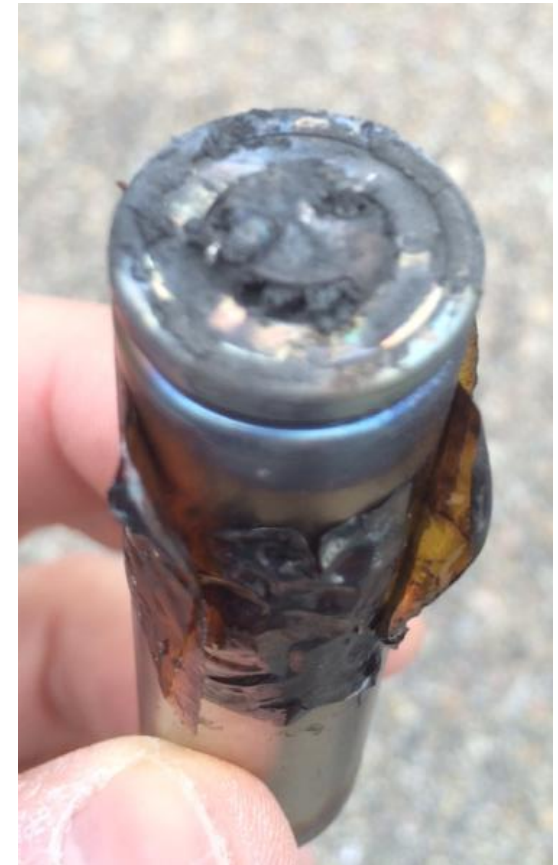
HCM (1.5 Ah) Single Cell TR Test Results

- Cathode assembly remained intact
 - TR jet pierced burst disk and cathode top cap
- No signs of side wall rupture
- Heat discoloration of the cell can

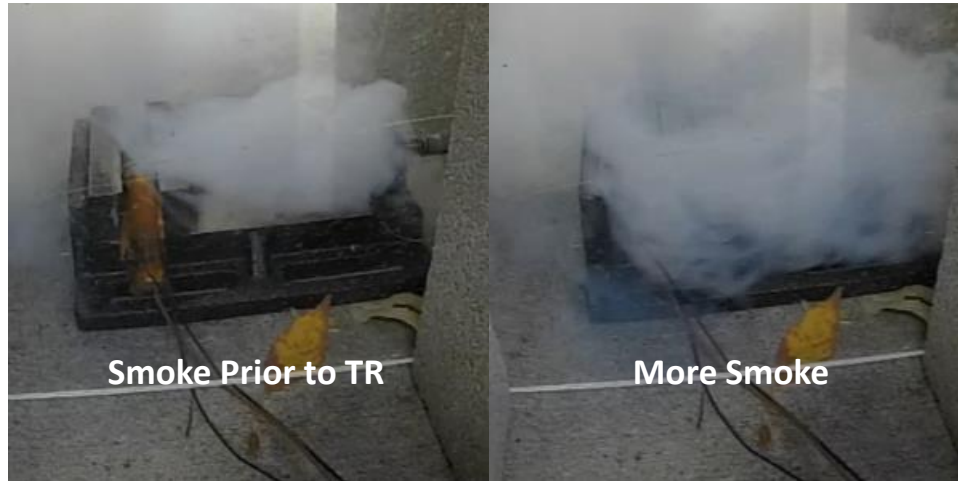
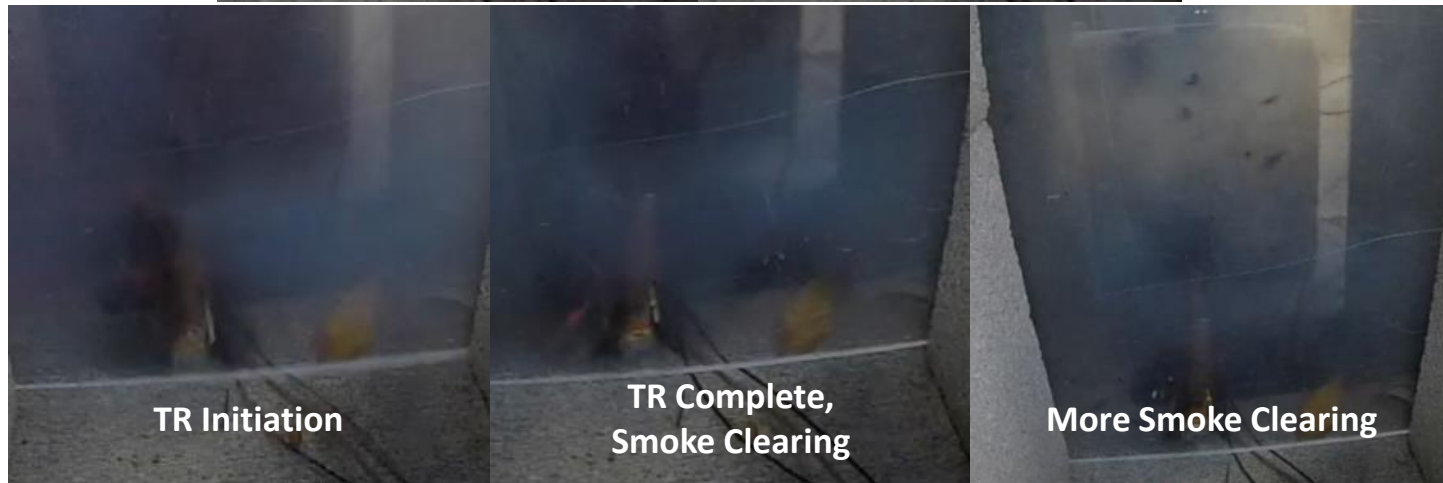
Moli C (2.0 Ah) Single Cell Test Results

- As the Moli C approaches TR initiation, it is much less consistent than the HCM cell
 - Some cells would vent a significant amount of smoke, others would vent no smoke
- TR failure mode was failure of the cathode assembly
 - Cathode assembly blown out of the cell entirely, along with jelly roll
- Fundamentally different TR event
 - Duration is much shorter than HCM
 - No flames observed coming out of cell

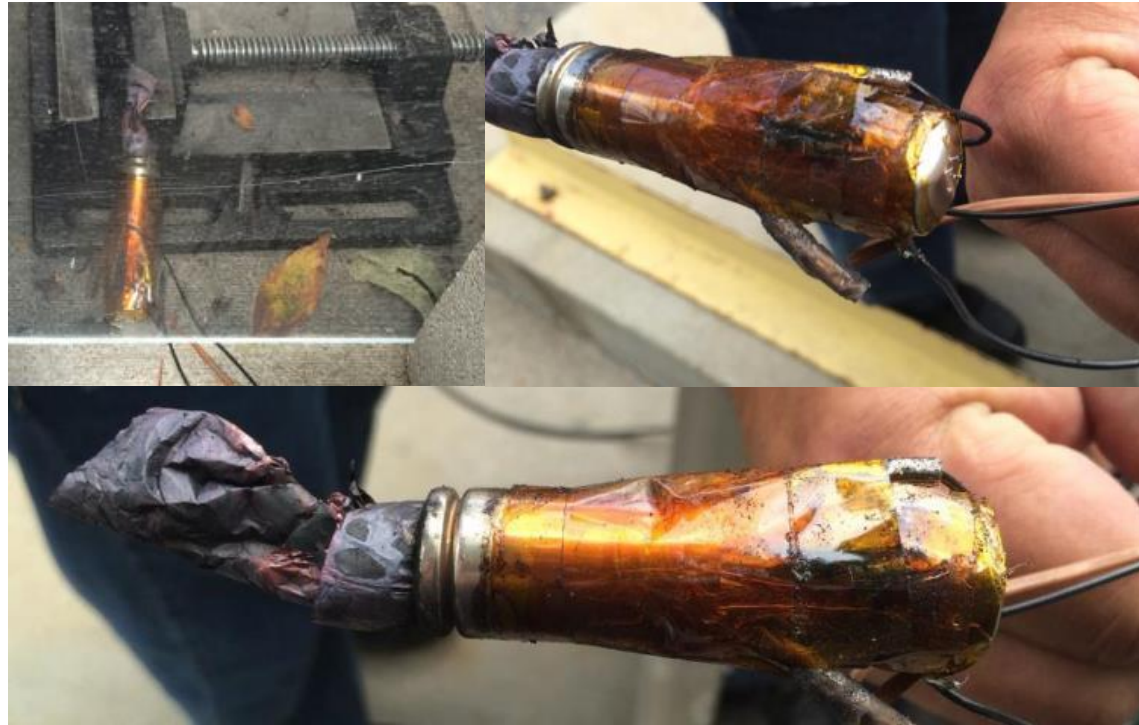
Moli C (2.0 Ah) Single Cell Test Results

- Cathode and jelly roll ejected
- No signs of side wall rupture in the anode, but significant bulging from internal pressure
- Cell can heat discoloration

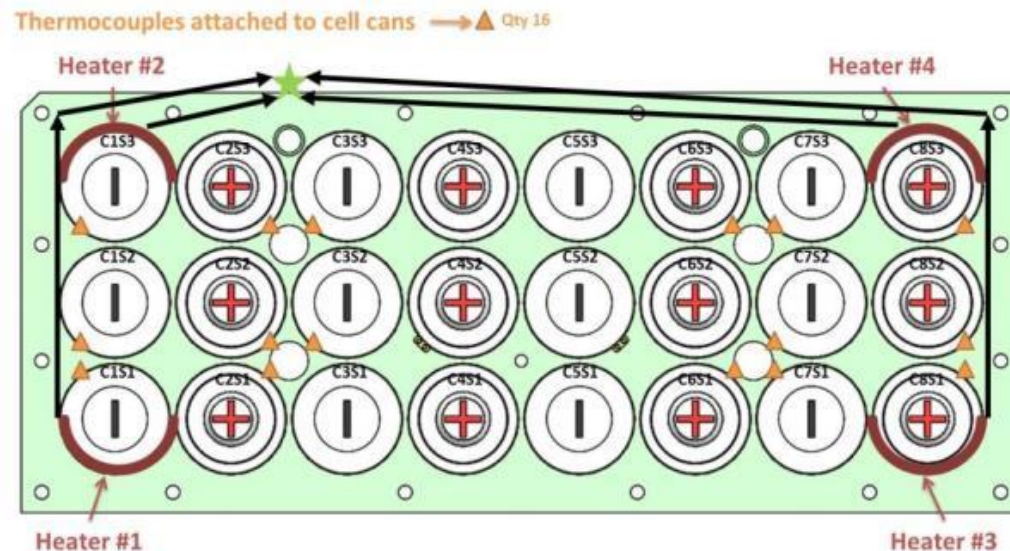
HCM Battery-Level Test Method

- Flight-like 3p8s was built, with integrated heaters and additional thermocouples
 - Heaters installed on four corner cells

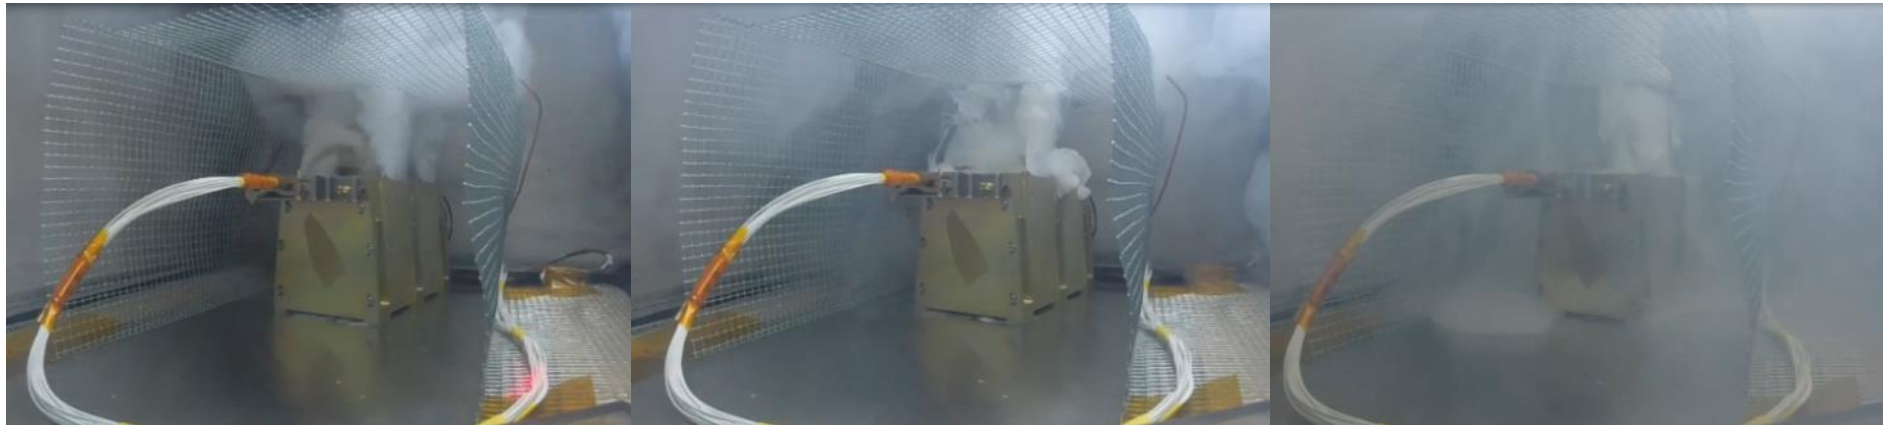
HCM Battery-Level TR Test #1

- Trigger cell went into TR as expected, $\sim 160^{\circ}\text{C}$
- No propagation of TR
- Battery maintained structural integrity
 - No signs of structural damage on the outside of the housing

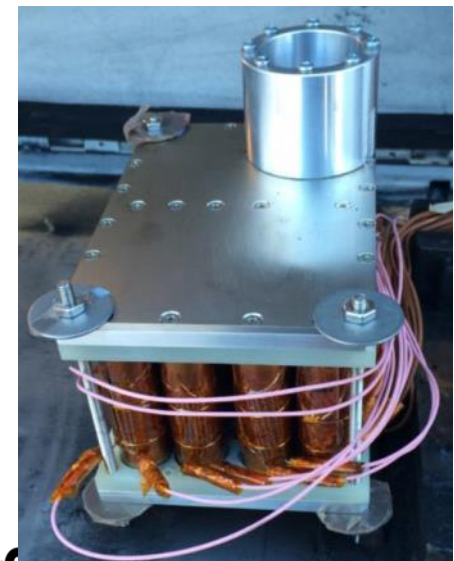
Moli C Battery-Level Test Method

- **Configuration 1:** 24 individual cells in chassis similar to HCM
 - Cells not connected electrically
- **Configuration 2:** Four 6p1s virtual cells
 - No chassis, but added deflector plate and vent chimney

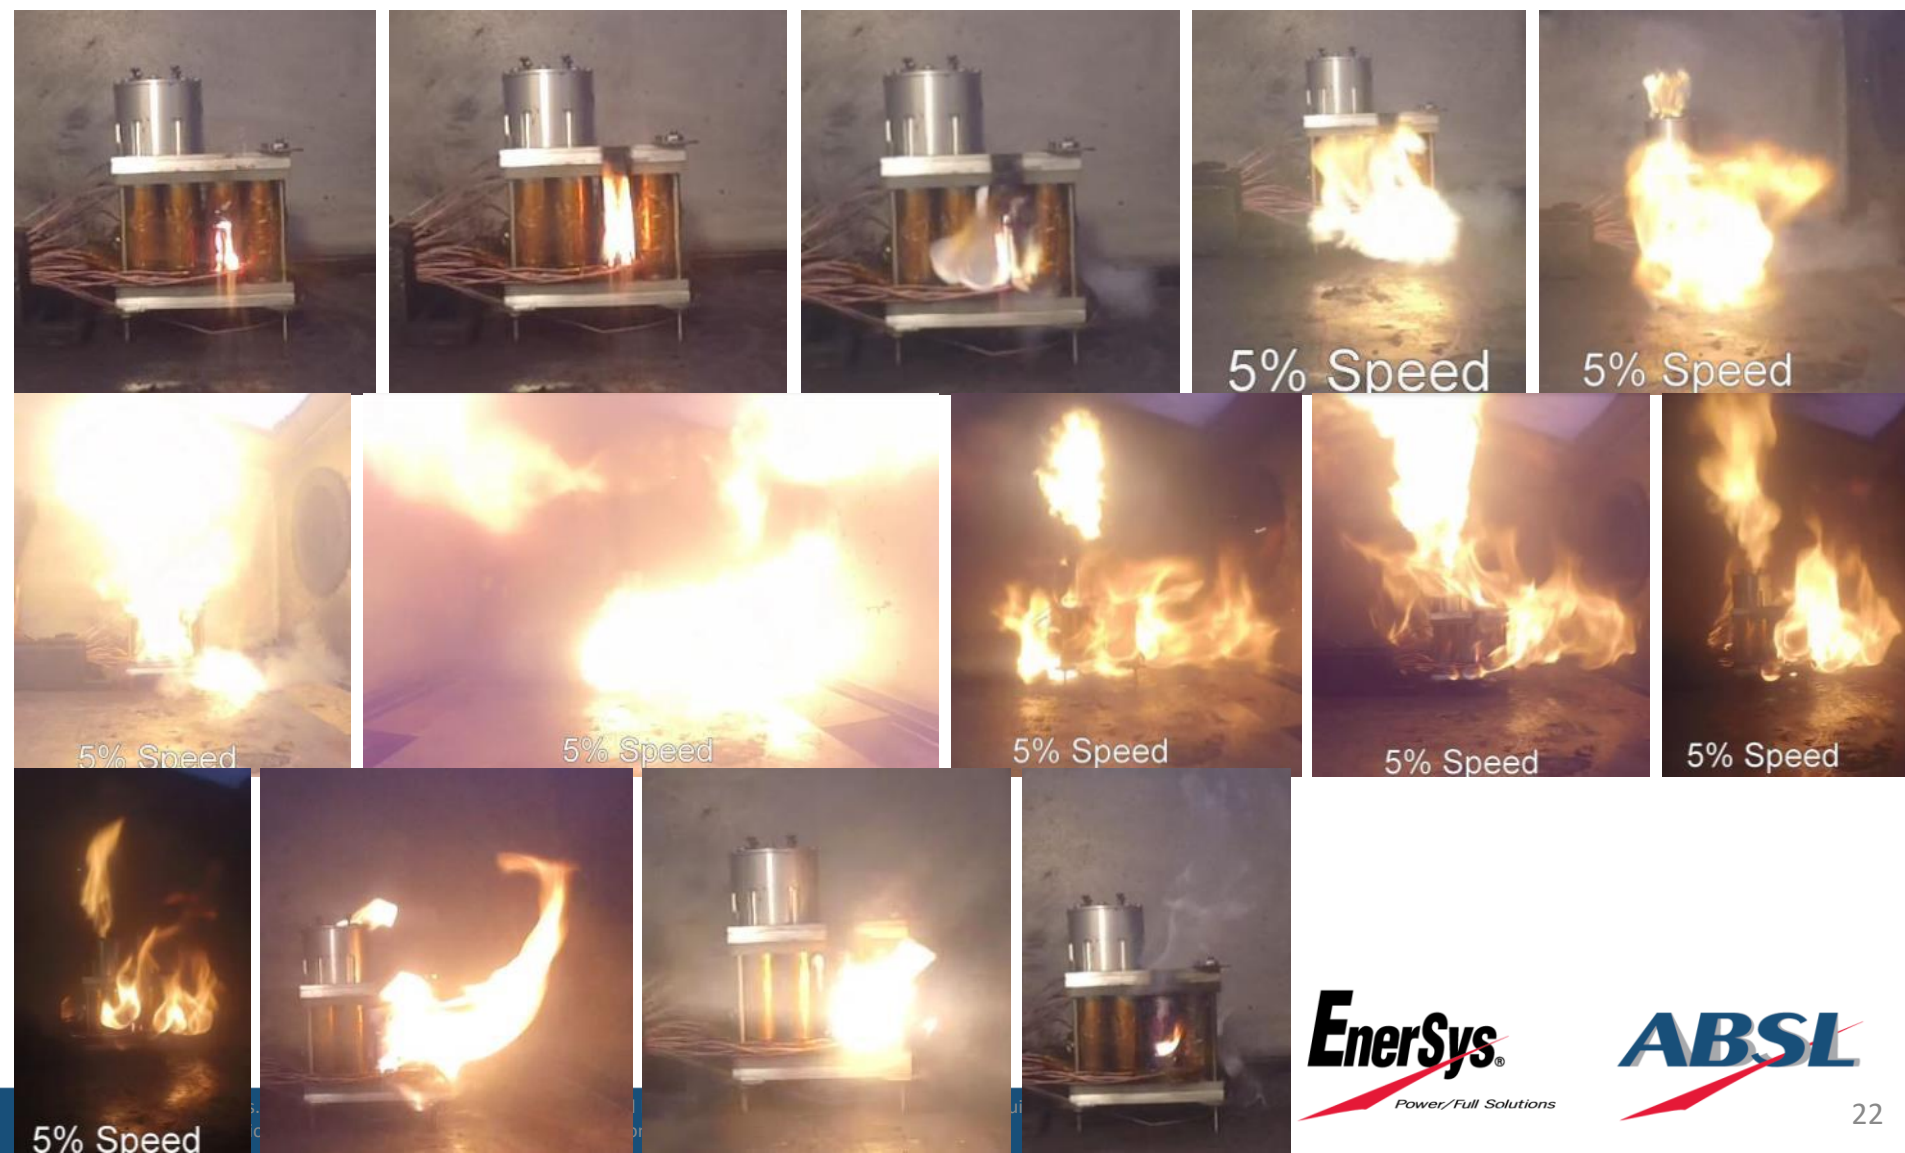
Moli C Battery-Level TR Test #2

- TR initiated on the trigger cell at approximately 170°C
- Maximum temperature of neighbor cells was approximately 160°C

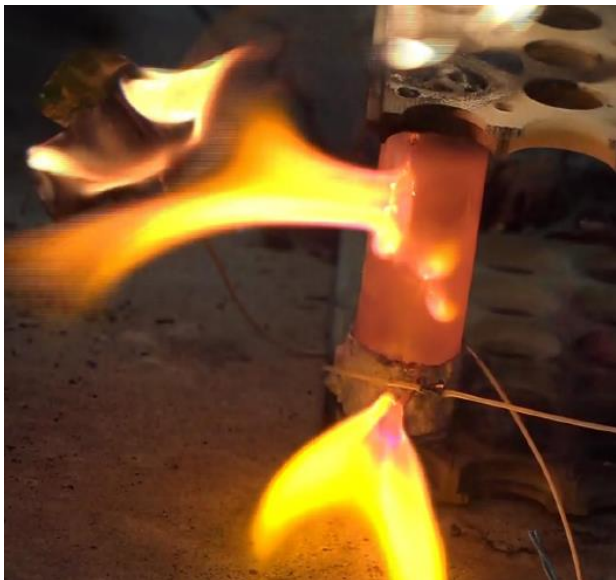
Increasing Energy Density

- Increased risk of sidewall ruptures
 - Some manufacturers increase energy density by reducing can wall thickness

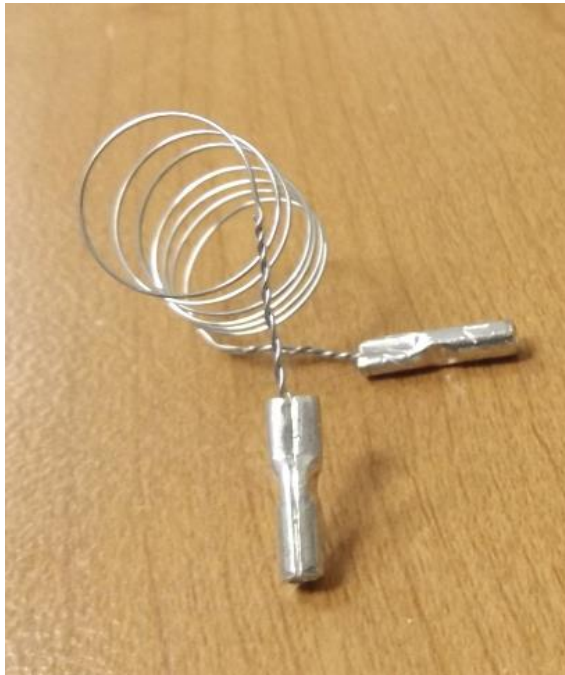
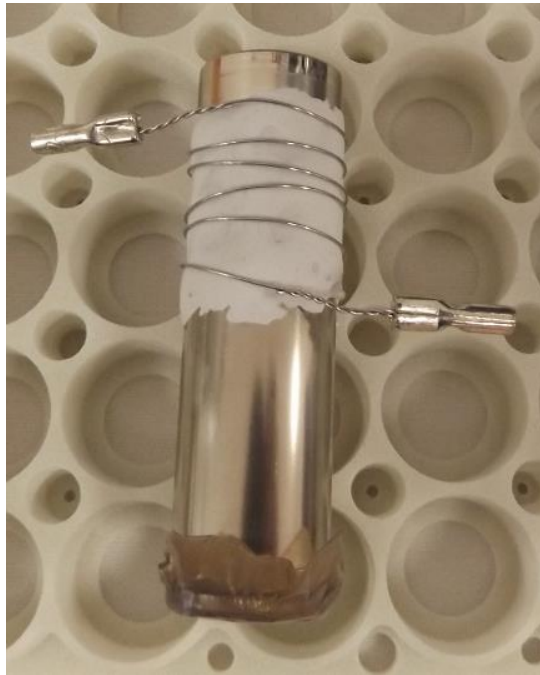
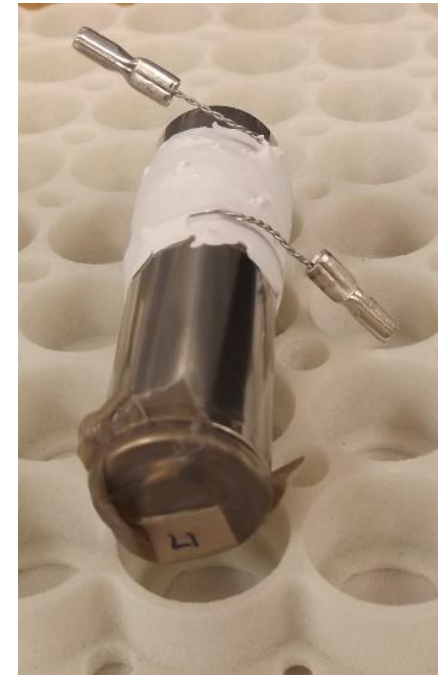
MJ1 Single Cell Testing

- New heater design – eliminate Kapton burning during test, more evenly heat can circumference

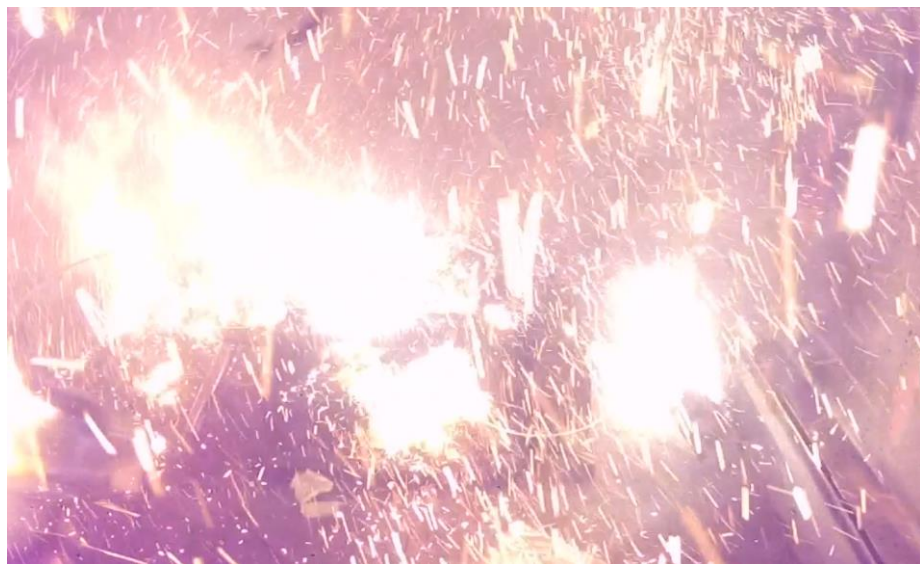
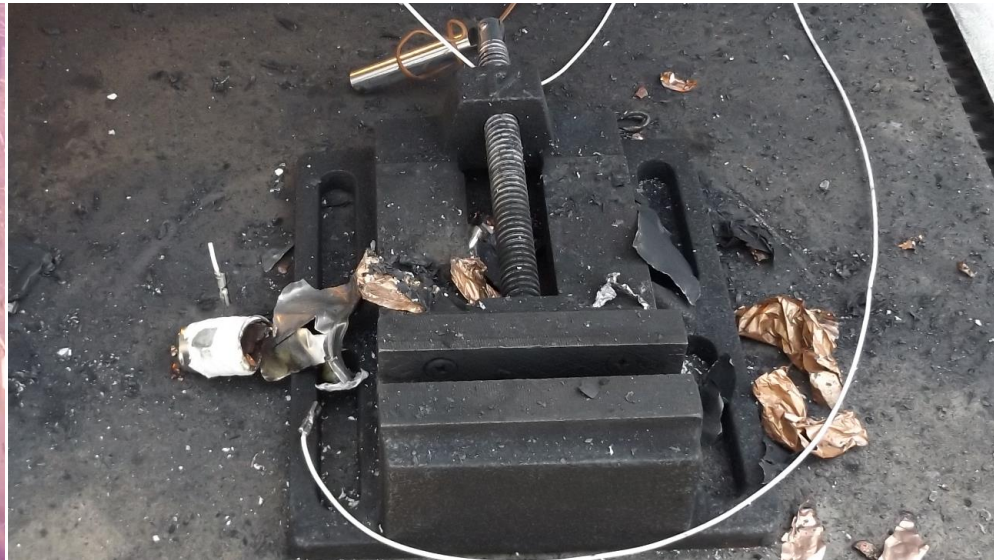
MJ1 Single Cell – Unsupported

- 1/7 “explosion” failure mode

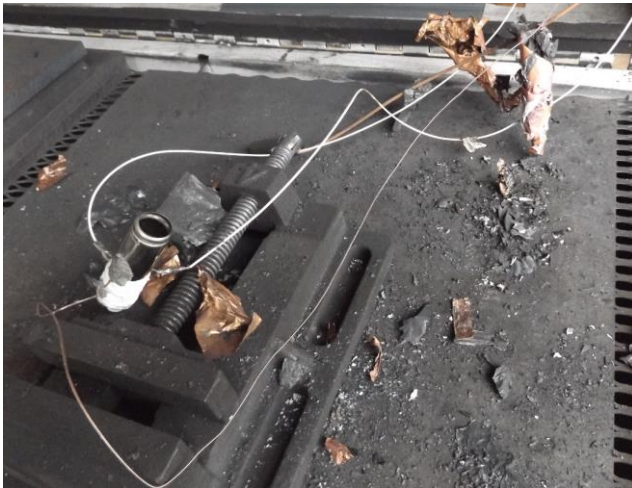
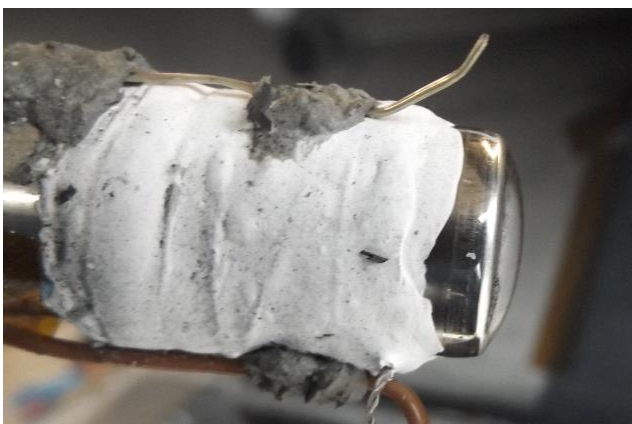
MJ1 Single Cell – Unsupported

- 1/7 “crimp unfurl” failure mode

- “Blast through” failure mode was most consistent
- Other failure modes may be related to unsupported configuration
 - Unfurl – no capture plate restraint at cathode crimp
 - Anode hole – physically sitting on vise edge, and pressed into edge during TR event

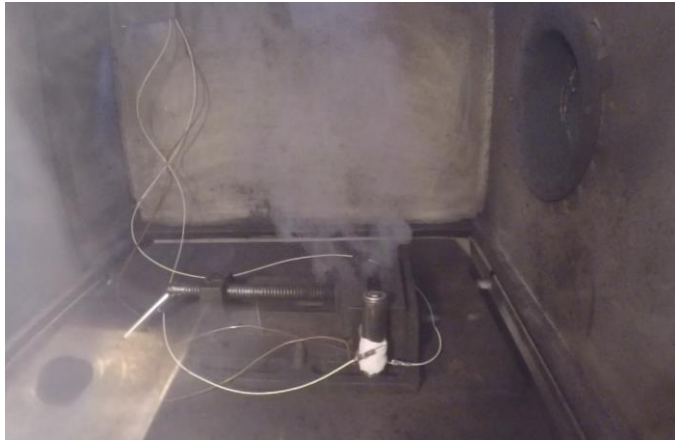
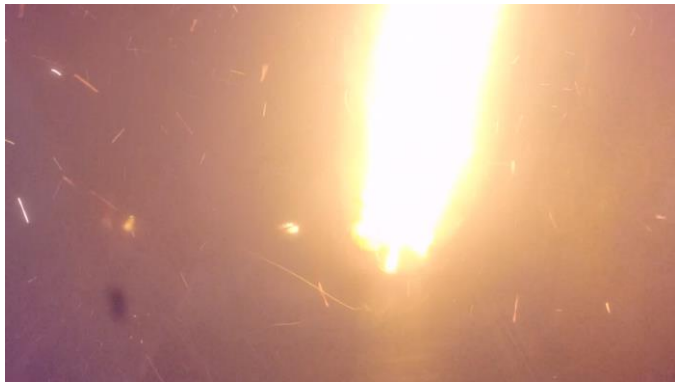
MJ1 Single Cell – Unsupported

- 5/7 “blast through” failure mode...

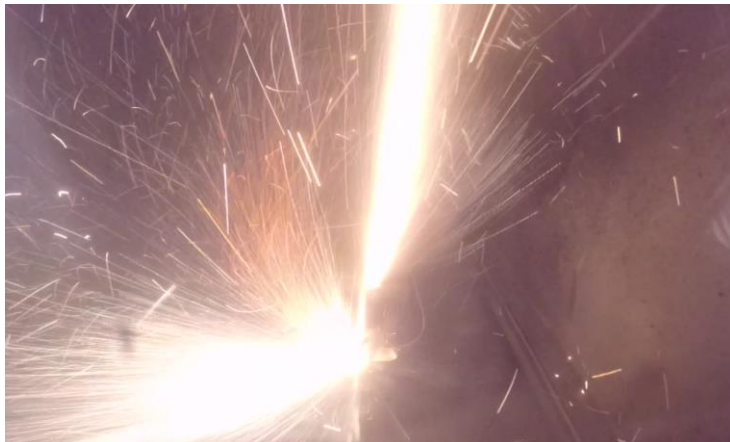
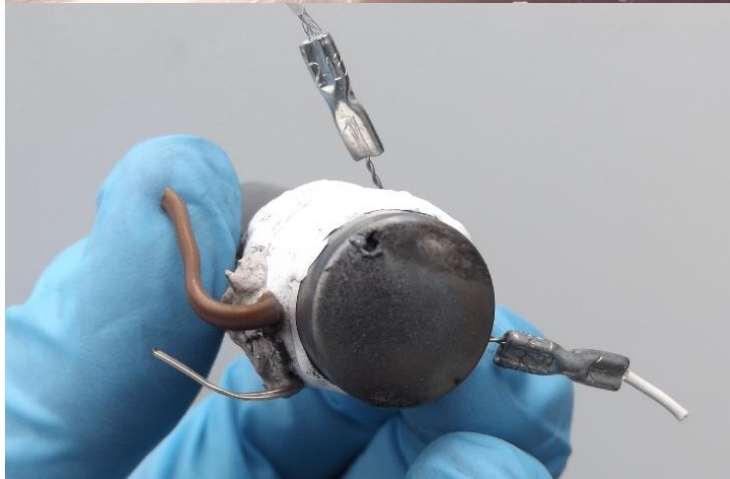
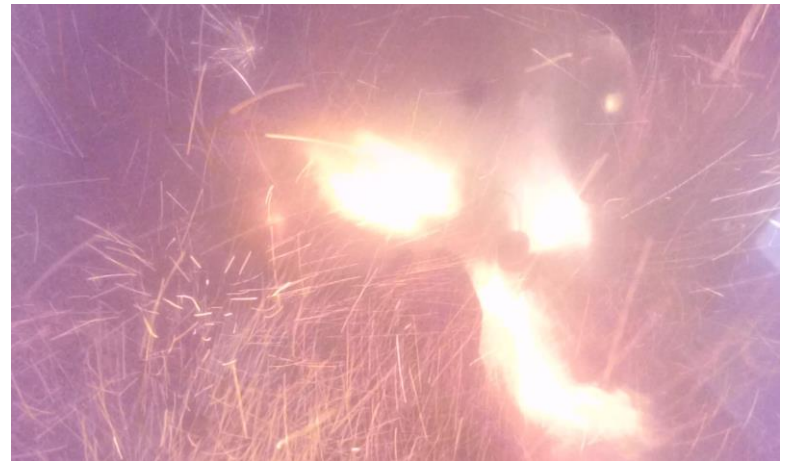
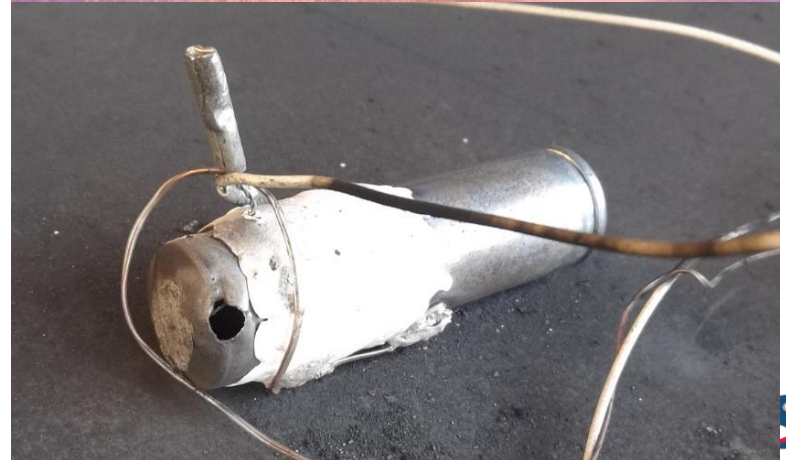
MJ1 Single Cell – Unsupported

- ... but two of these also had anode breaches

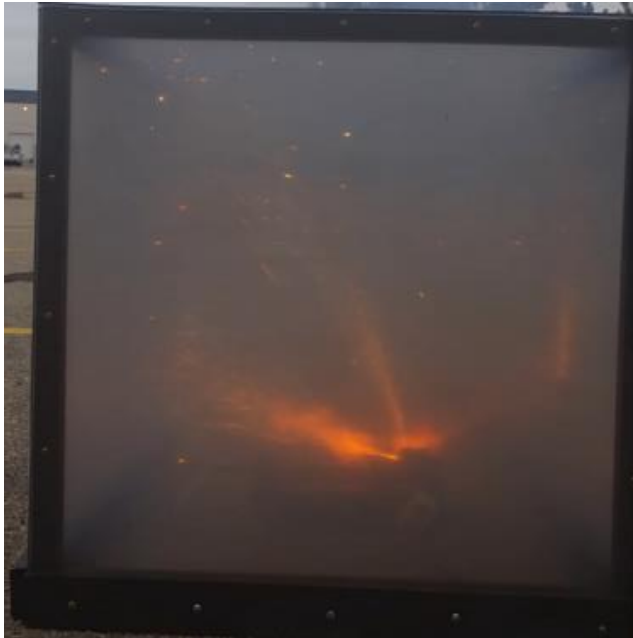
- Empirically, MJ1 single cell TR more energetic than HCM or Moli C

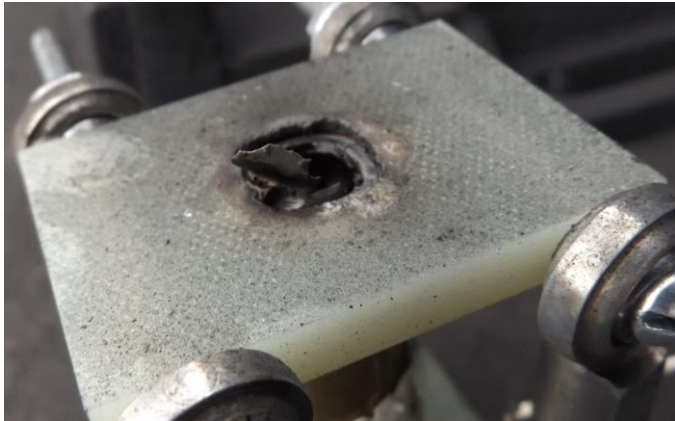
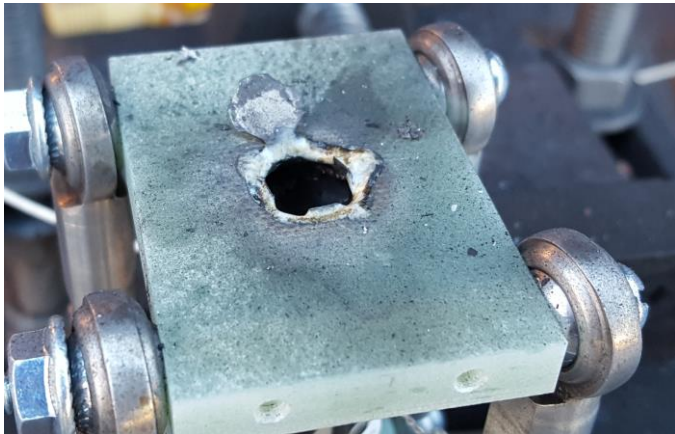
MJ1 Single Cell – Supported

- 4/8 “blast through” failure mode

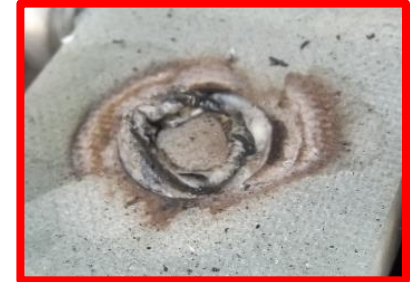
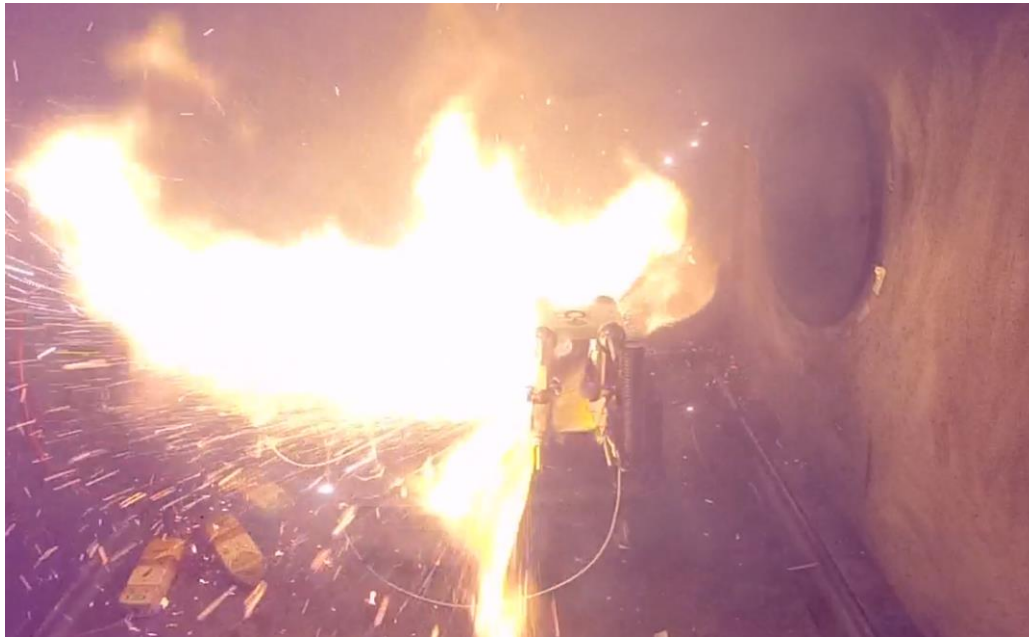
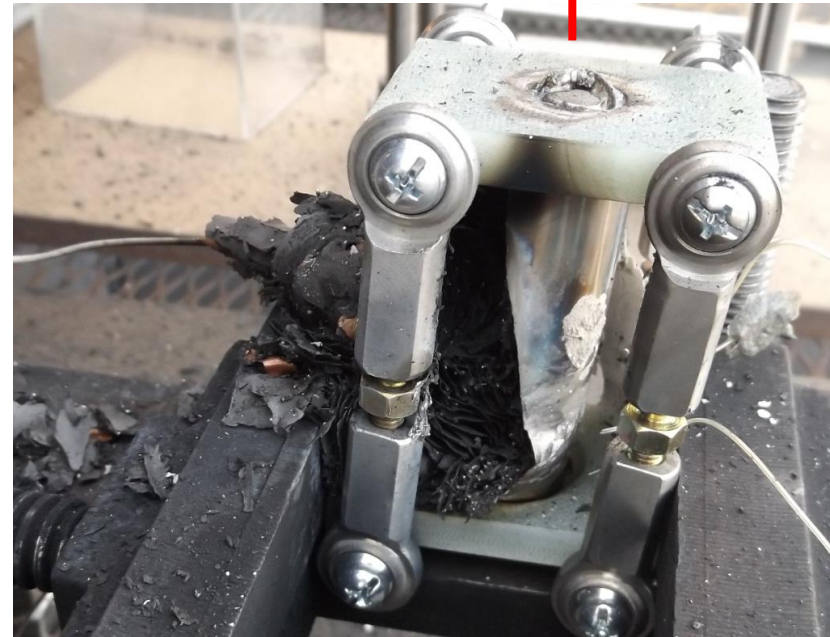
MJ1 Single Cell – Supported

- 4/8 “stuck in GRP” failure mode

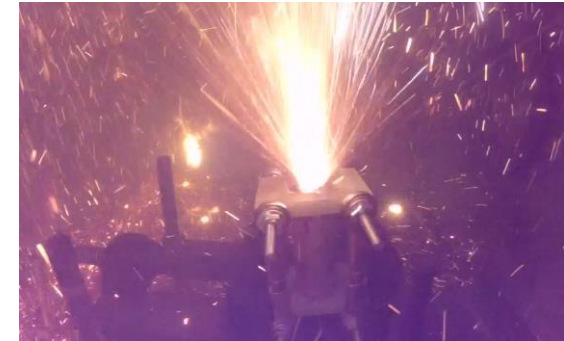
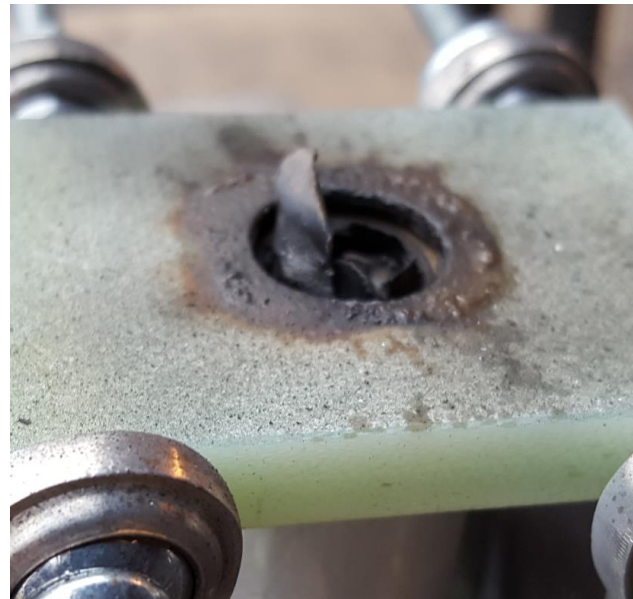
MJ1 Single Cell – Reinforced

- 3/3 “blast through” failure mode
 - Video and post-test evidence of insulator melting through vent holes

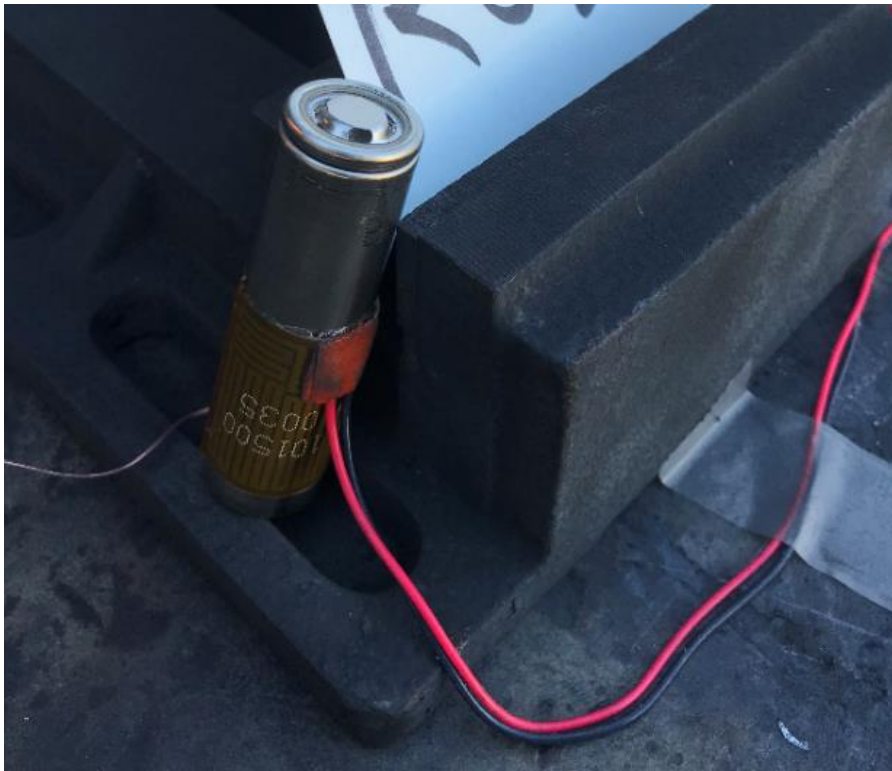
MJ1 Single Cell – Patch Heater

- Three unsupported, three in GRP

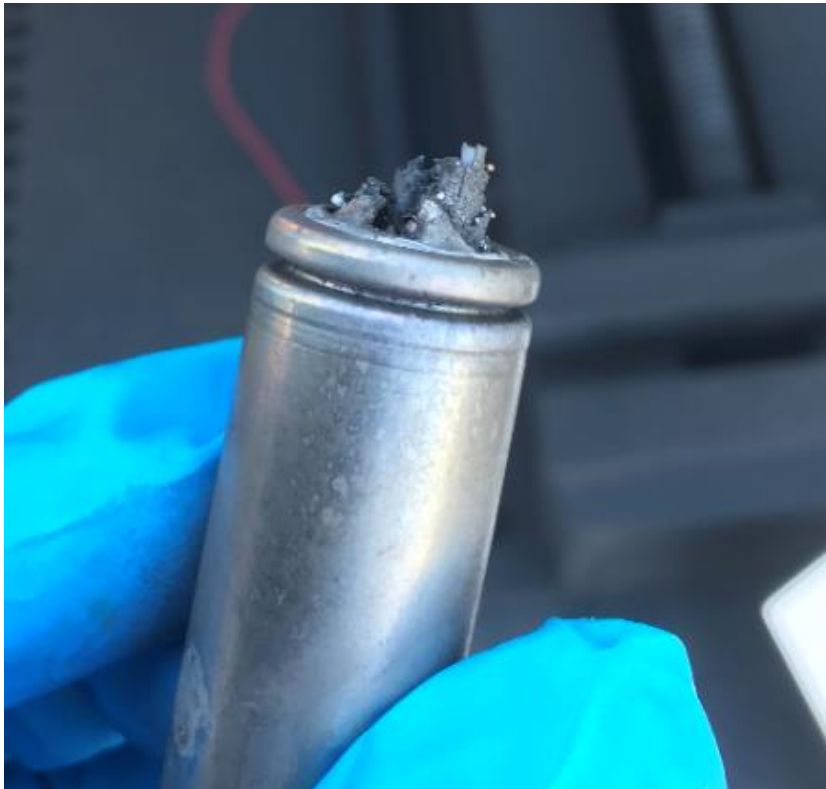
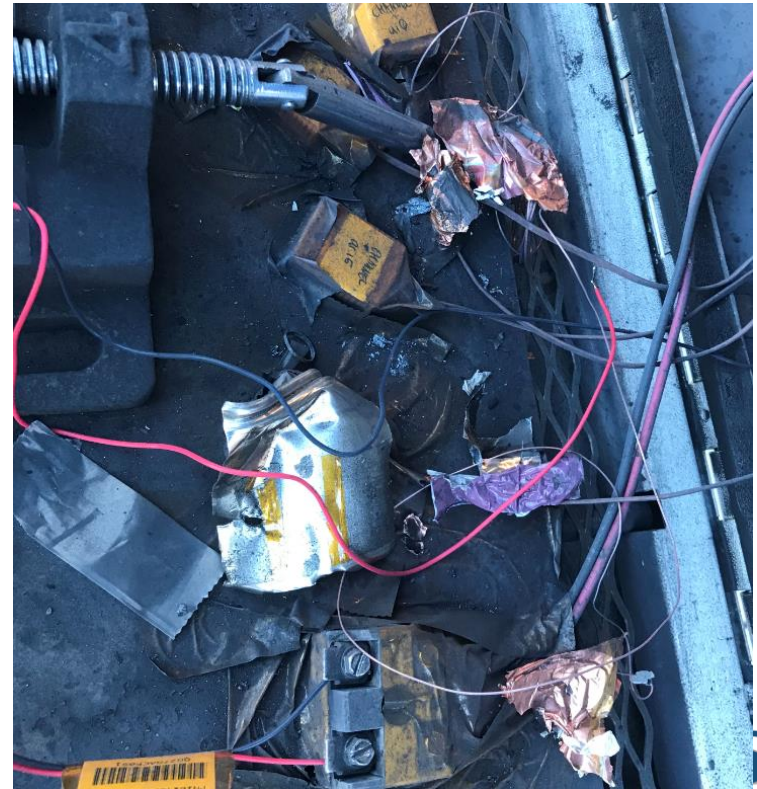
Patch Heater, Unsupported

- 1/3 “blast through” failure mode
- 2/3 “explode” failure mode

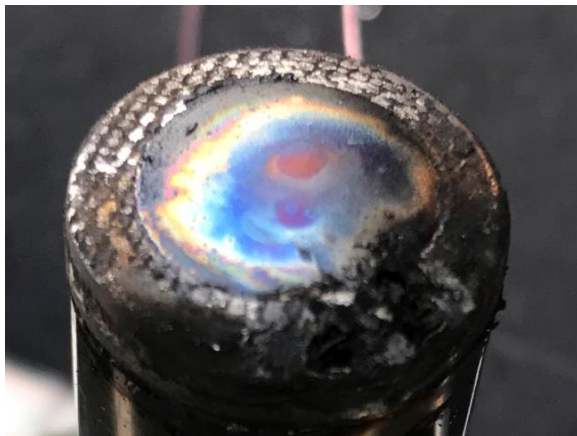
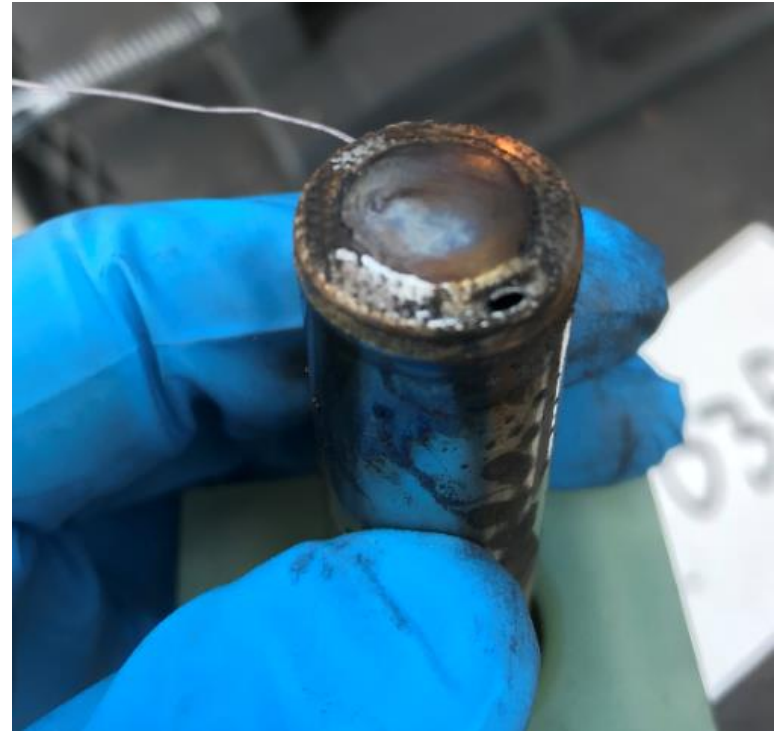
Patch Heater, Supported

- ... but 2/3 with anode hole

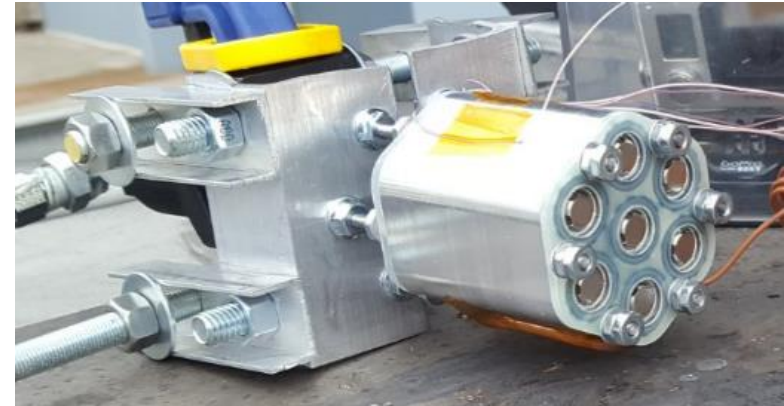
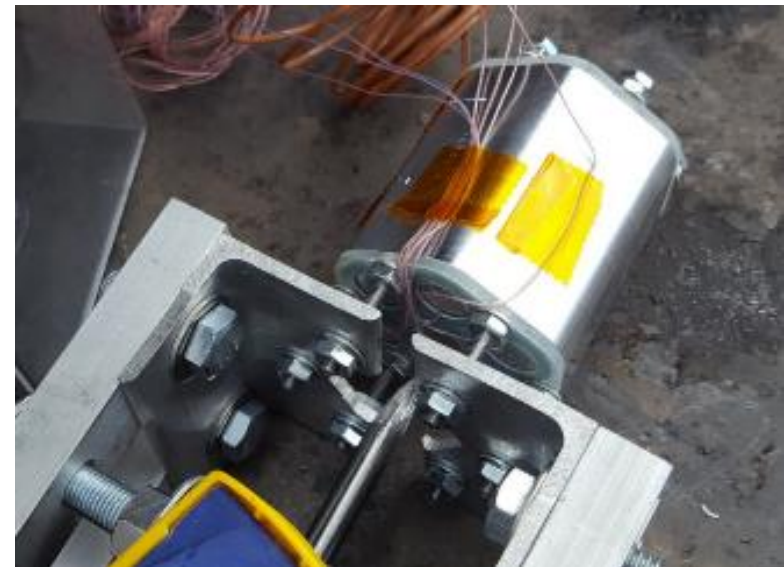
MJ1 7X Submodule – Test Setup

- Tried anode heater, but found temperatures in neighbor cells would be biased to $>100^{\circ}\text{C}$ by the initiation of TR
 - Unacceptable – creates unrealistic risk of propagation
- Nail penetration gives advantages beyond avoiding neighbor cell temperature bias
 - More closely represents internal short failure mode
 - Avoids insulator melting by TR initiation temp and clogging vents
