Testing of Thermal Runaway Tolerant Designs Utilizing High Energy Density 18650 Lithium Ion Cells

Energys Advanced Systems / ABSL
Longmont, Colorado

NASA Aerospace Battery Workshop
November 27-29, 2018

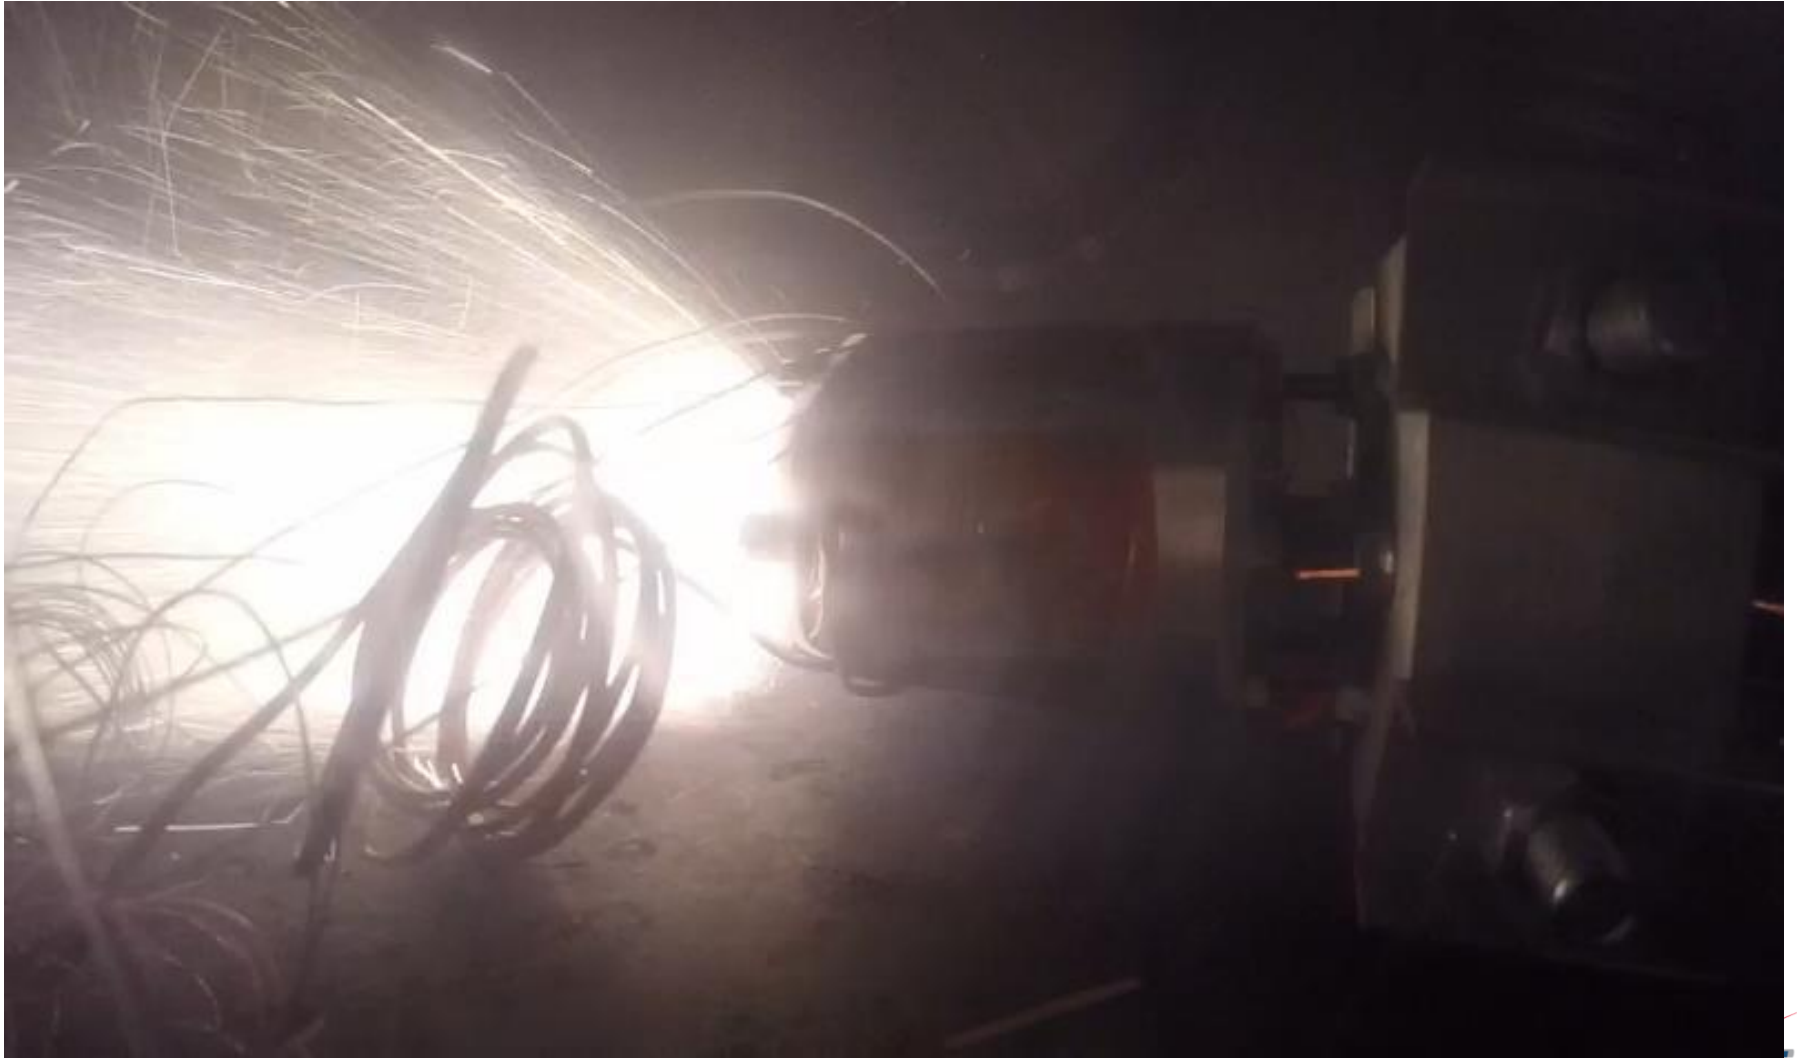
MJ1 7X Submodule – Typical Result

- Seven tests completed successfully
 - 7/7 “blast through” failure mode with ~4 seconds of sparks
 - No evidence of cell can failures, but submodules could not be disassembled due to epoxy bond

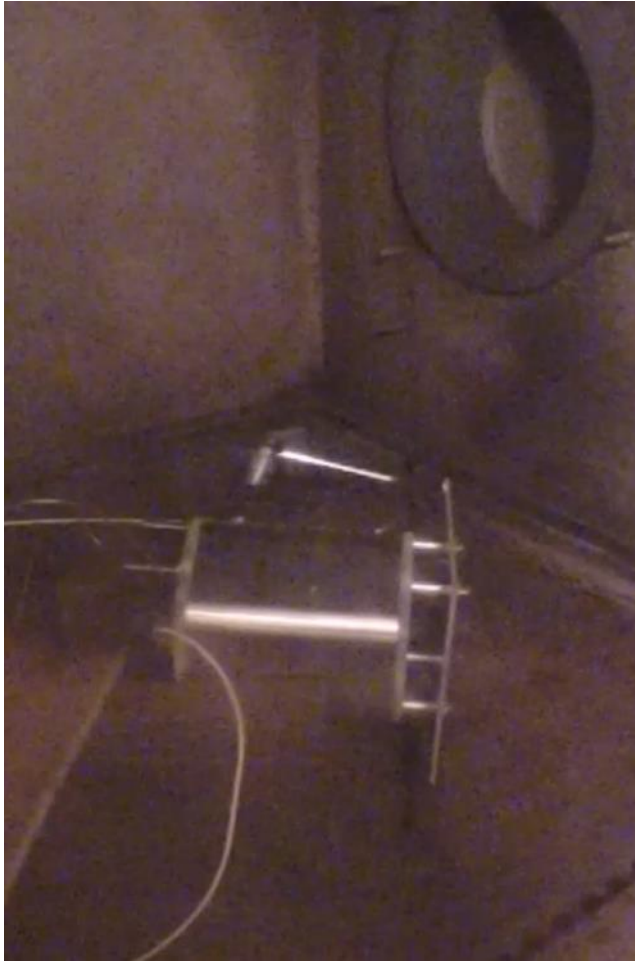
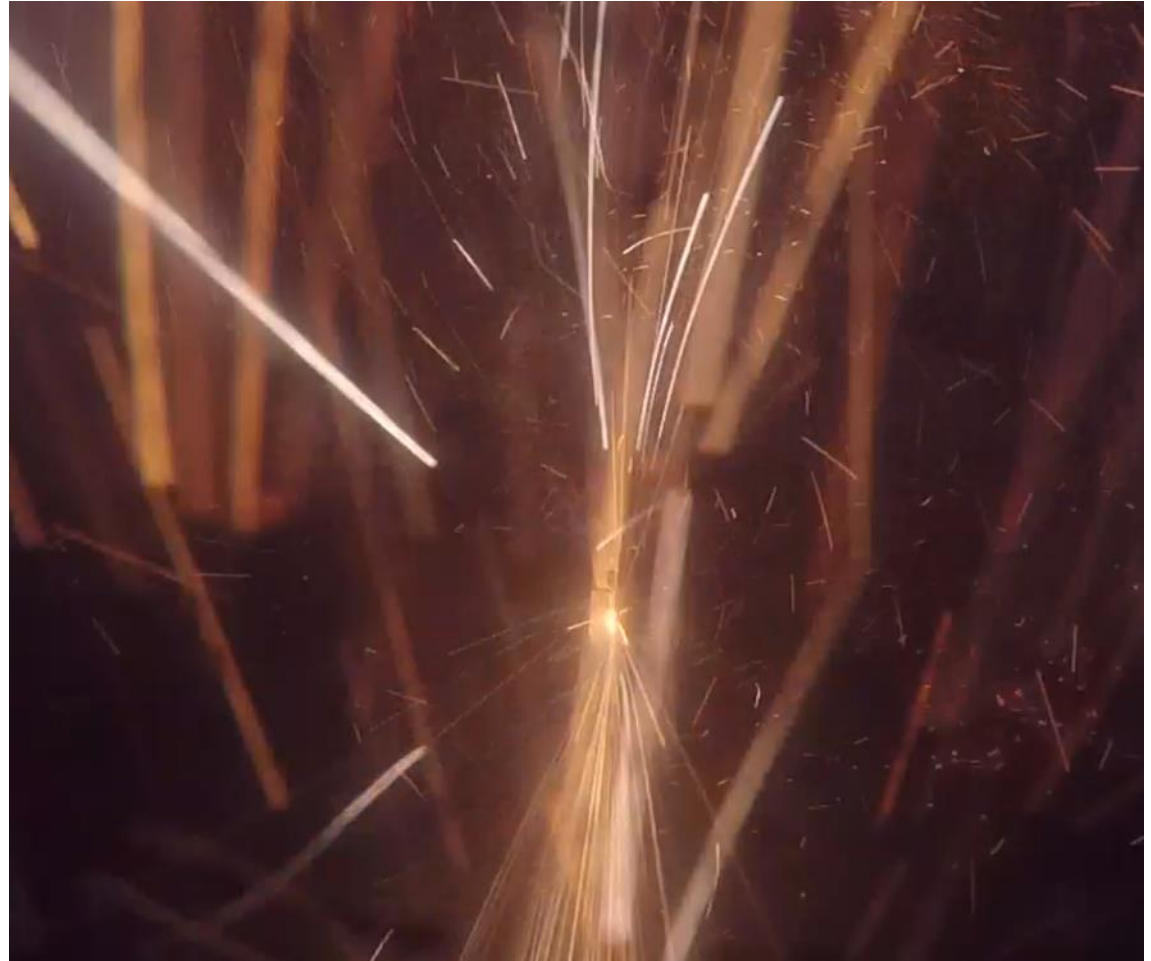
7X Submodule – M36 Trigger Cell

- 7X test hardware was used to perform validation run of M36 ISC trigger cell – goals:
 - Verify anode heater triggers ISC appropriately
 - Minimal neighbor cell bias due to anode heater
 - M36 ISC temperature response and failure mode consistent with MJ1 nail penetration
- Also added flight-like blast plate

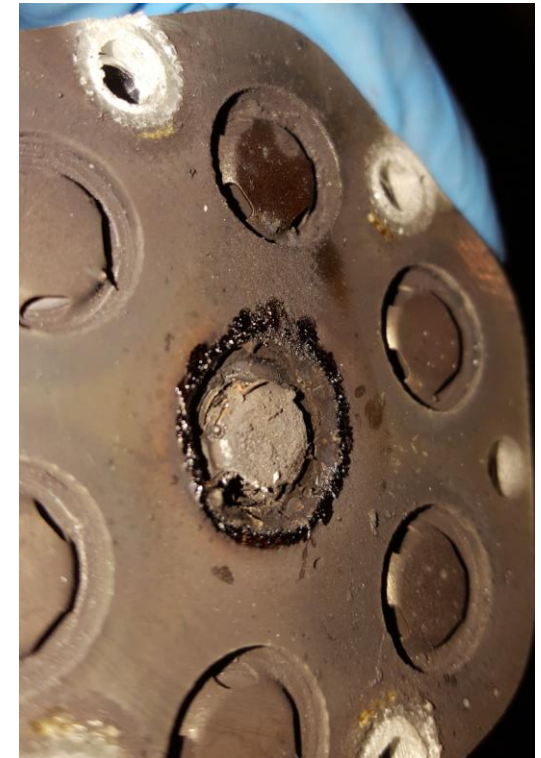
7X Submodule – M36 Trigger Cell

- Confirmed “blast through” failure mode (like MJ1)
 - Ejecta deposited on blast plate, GRP

- Blast plate deformed, but contained TR
