Third Five-Year Review Report

Goddard Space Flight Center
Wallops Flight Facility
Wallops Island, Virginia

February 2024

FFTA - FIVE-YEAR REVIEW PHOTOGRAPHIC LOG

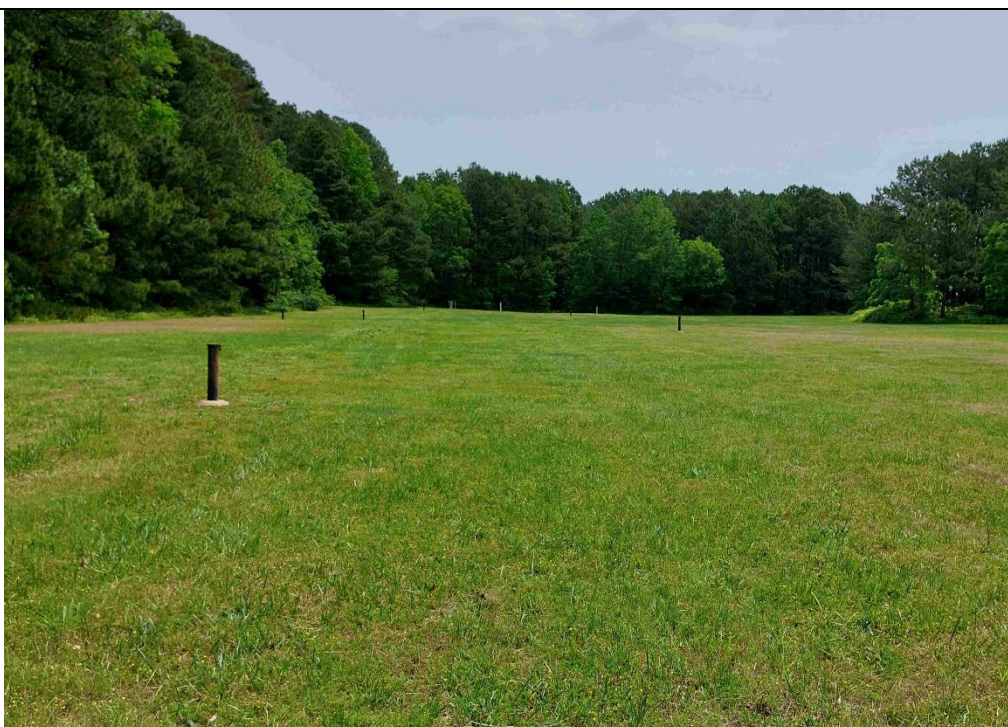
| Standing west of monitoring well FFTA-MW106 looking across the site. Several other FFTA monitoring wells are visible in the distance. | | |

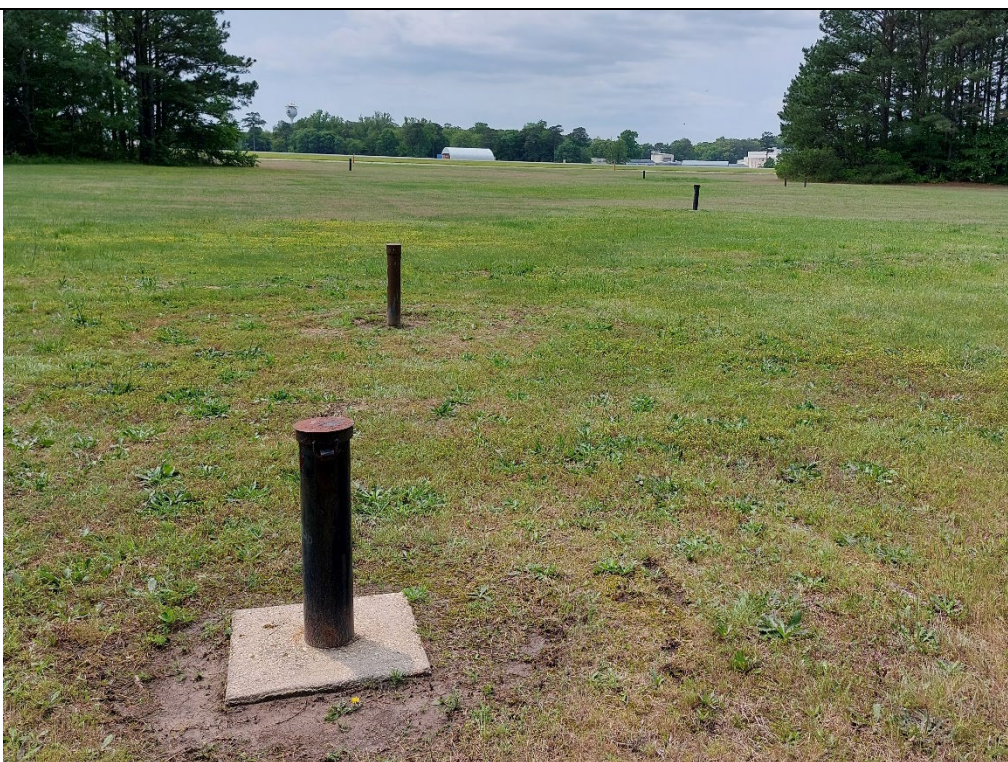
| Standing adjacent to FFTA-MW102D looking across the site back towards the abandoned taxiway. Several other FFTA monitoring well are visible in the distance. | | |

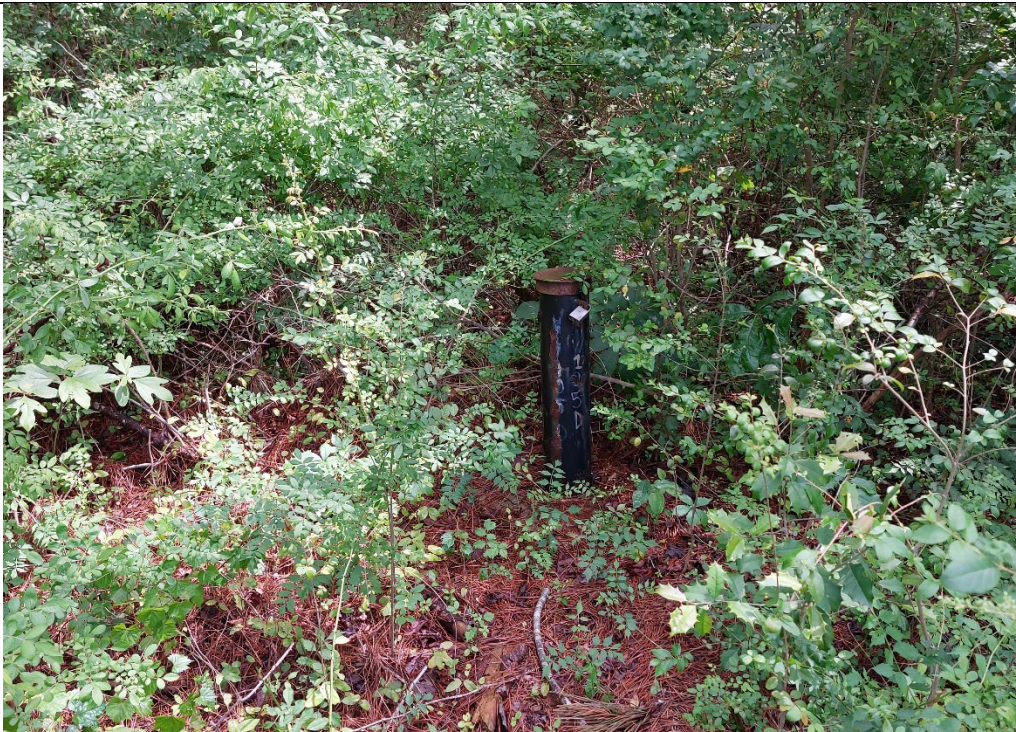
Standing near FFTA-MW105D. The brush has encroached on FFTA-MW105D and needs to be cleared/cut back.

During the FYR site inspection in May 2023, protective casings and covers for certain monitoring wells included in LTM program were noted as needing maintenance. This was also documented in the September 2022 LTM Event Report that recommended certain wells be rehabilitated or abandoned and reinstalled. These deficiencies were addressed in September 2023 and the details will be documented in the December 2023 LTM Event Report.

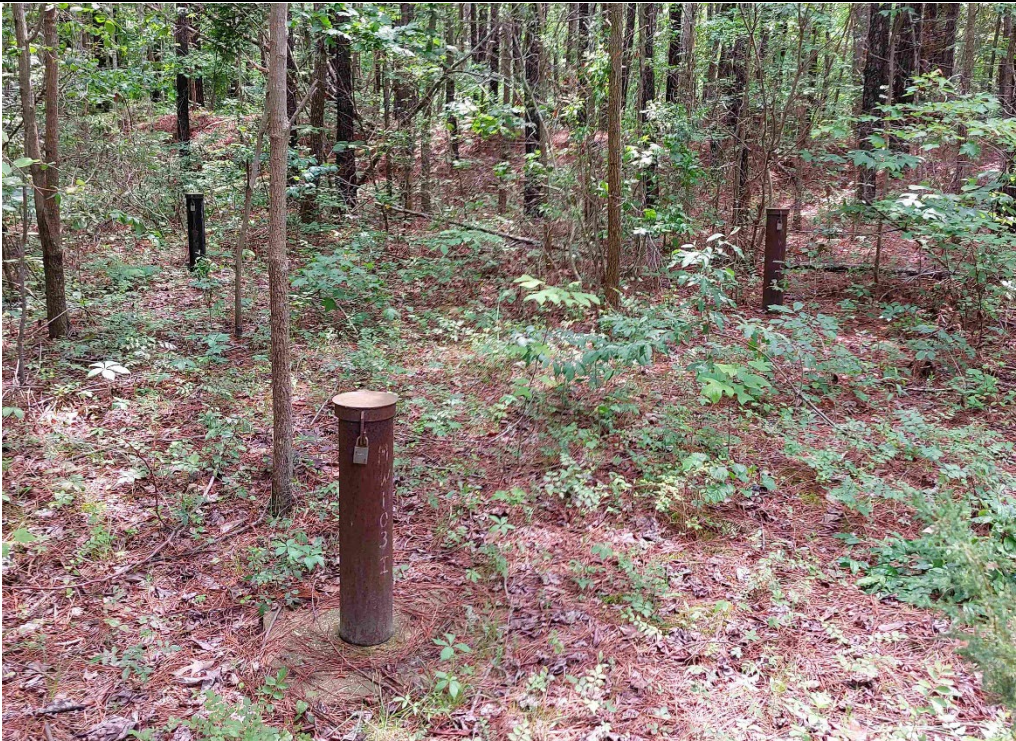
View of the FFTA-MW103 monitoring well cluster.

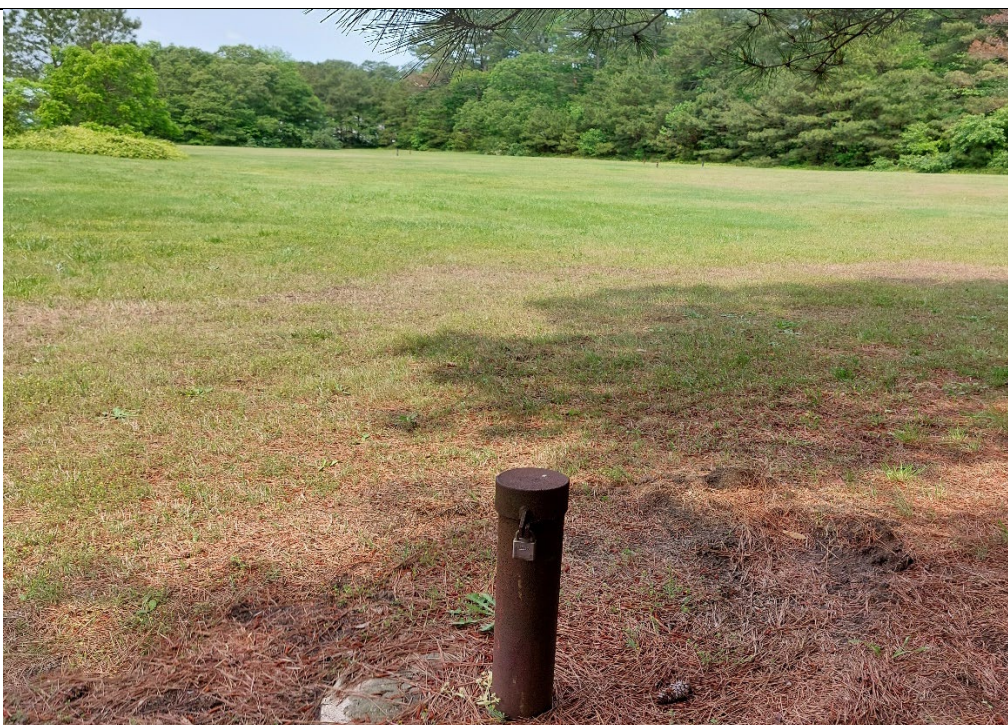
Standing southeast of FFTA-MW059S looking across site. Several FFTA monitoring wells are visible in the distance.

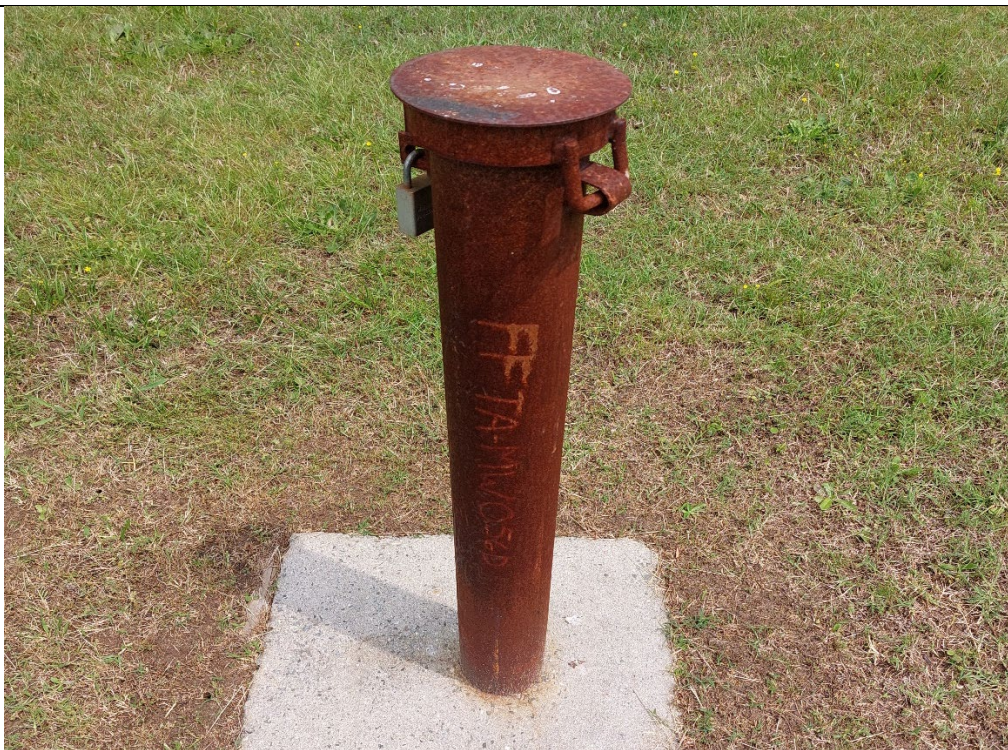
View of FFTA-MW056D. The well is in good condition other than some rust.

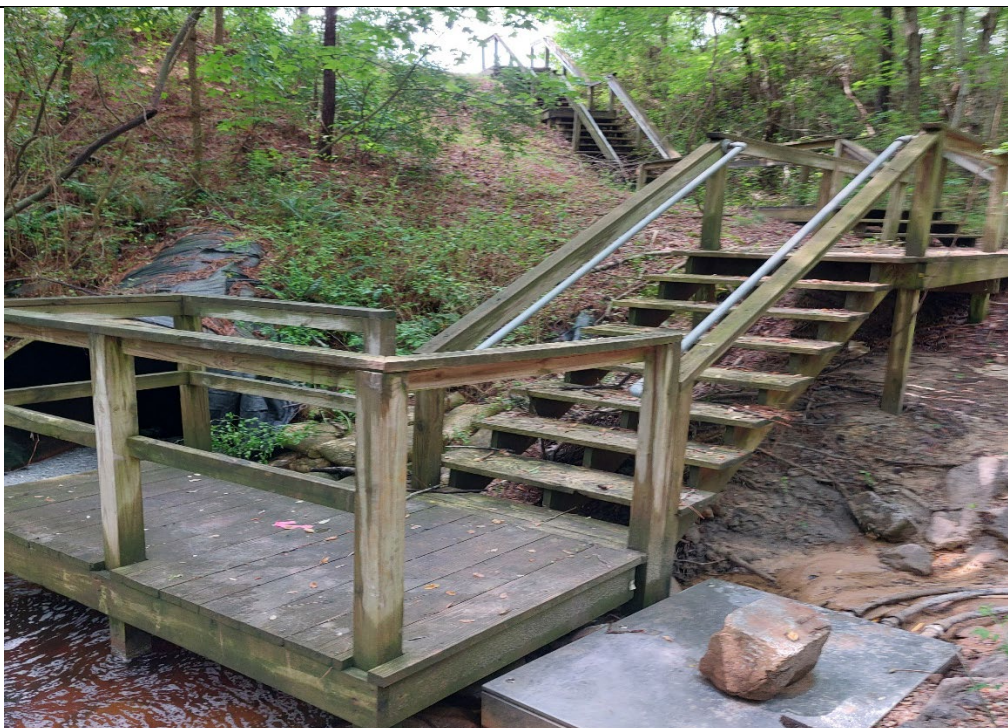
Stairway to access to the two monitoring wells (14-MW004 and 14-MW005) by the creek on the east side of FFTA. A PFAS treatability study system associated with Seep003 is also located in this area.

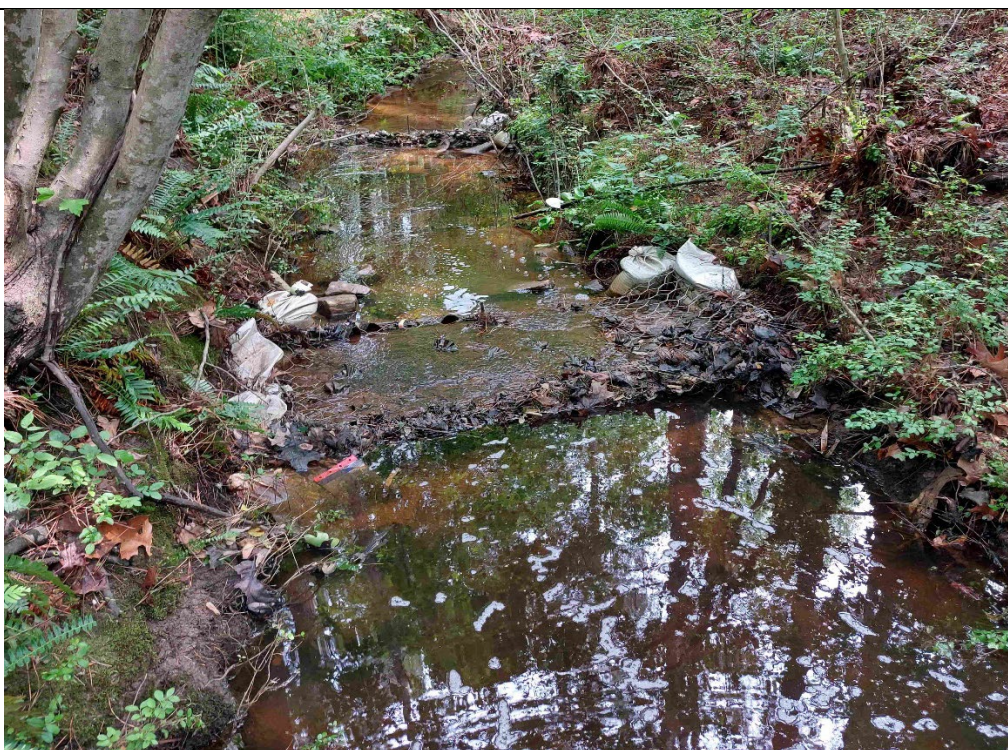
View of creek on the east side of FFTA near well 14-MW005.

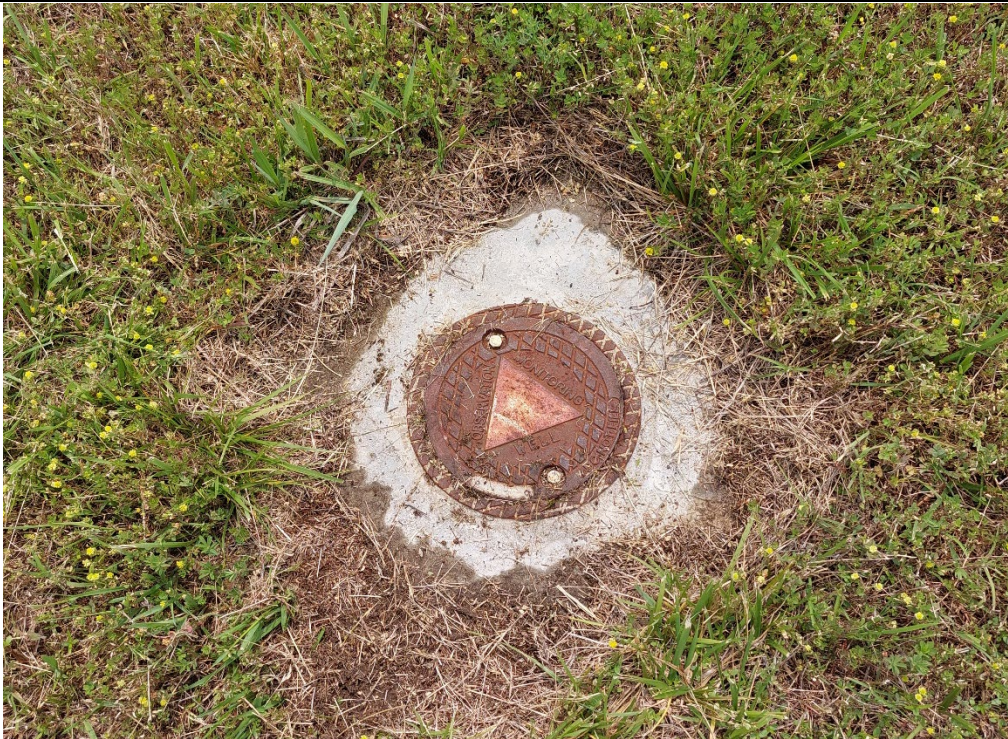
View of FFTA-MW109. Flush mount completion in grass on south side of abandoned taxiway.

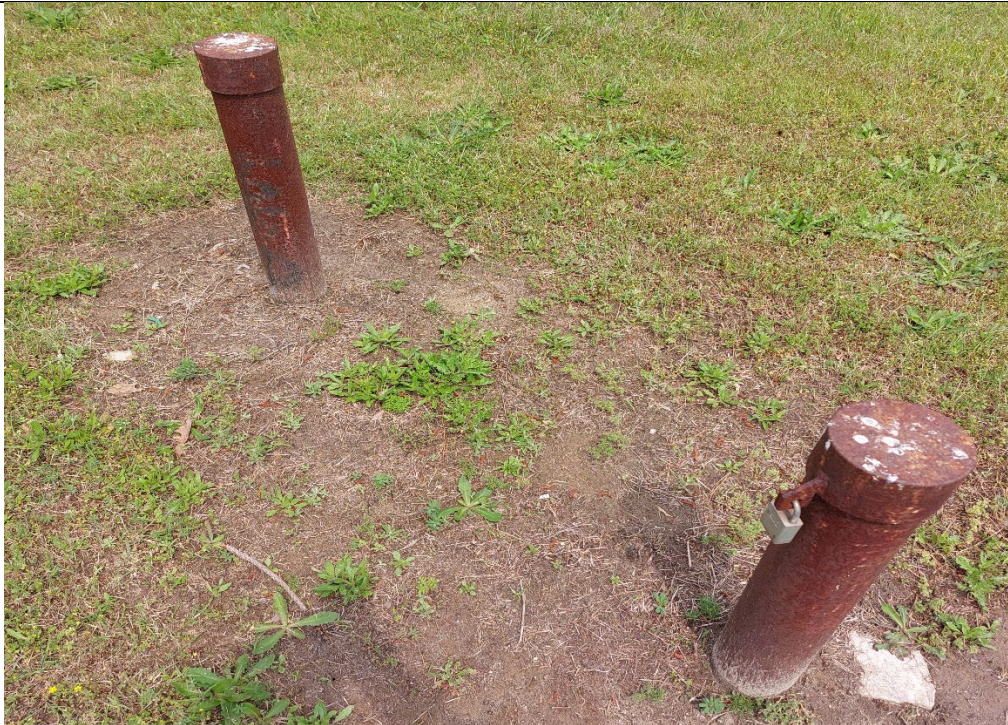
View of FFTA-MW055S and FFTA-MW055D. Other than some rust the well are in good condition.

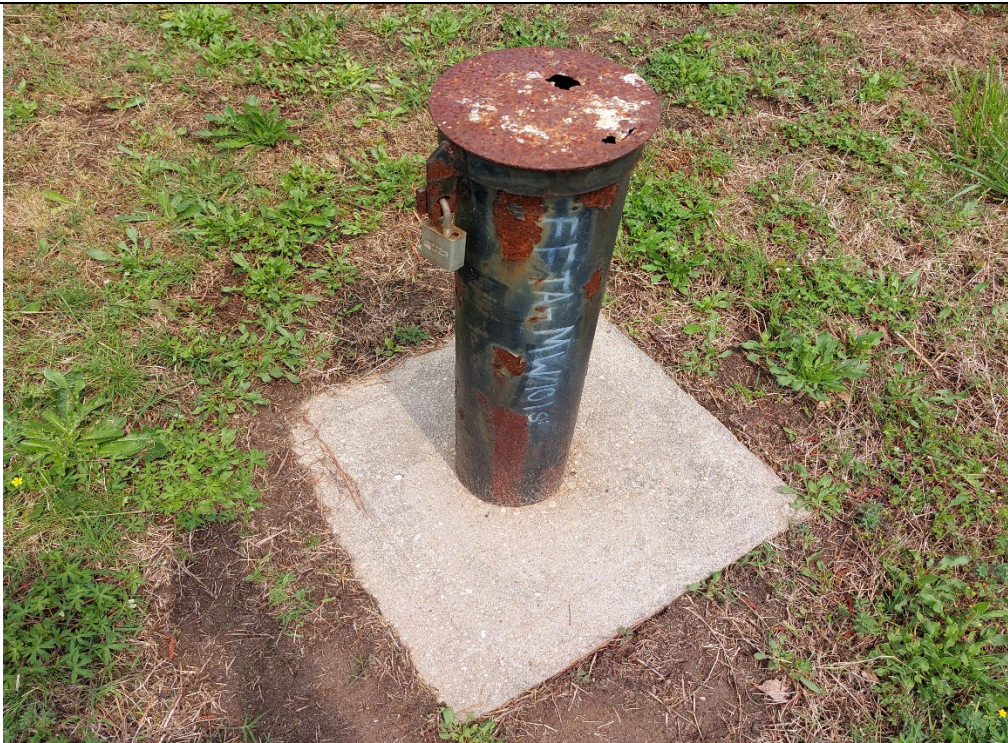
Free product was detected in MW055S (0.13 feet thick) and MW101S (0.76 feet thick) during the October 2022 follow-up LTM event reported in the September 2022 LTM Event Report. December 2015 was the last LTM event that free product was detected (in well MW101S). Free product at the FFTA does not appear to be mobile and is thought to have only accumulated in MW055S and MW101S during periods when the groundwater table is unusually low or experiencing a significant and sustained drop. The report recommended free product monitoring and recovery in these wells and evaluating natural source zone depletion (NSZD) to determine whether the criteria provided in VDEQ's (2012) Case Closure Evaluation of Sites with Free Product memorandum has been achieved.

View of FFTA-MW101S. The protective casing's cap has rusted through and needs replaced.

The September 2022 LTM Event Report (NASA, 2023c) identified the presence of petroleum free product in wells MW055S and MW101S. It recommended performing free product recovery and evaluating NSZD to determine whether the criteria provided in VDEQ (2012) has been achieved. The report also recommended rehabilitating or abandoning and reinstalling certain LTM wells to improve metals data quality due to excessive aquifer sediments in the wells. The RPM Team agreed that these recommendations should be pursued as part of LTM and O&M.

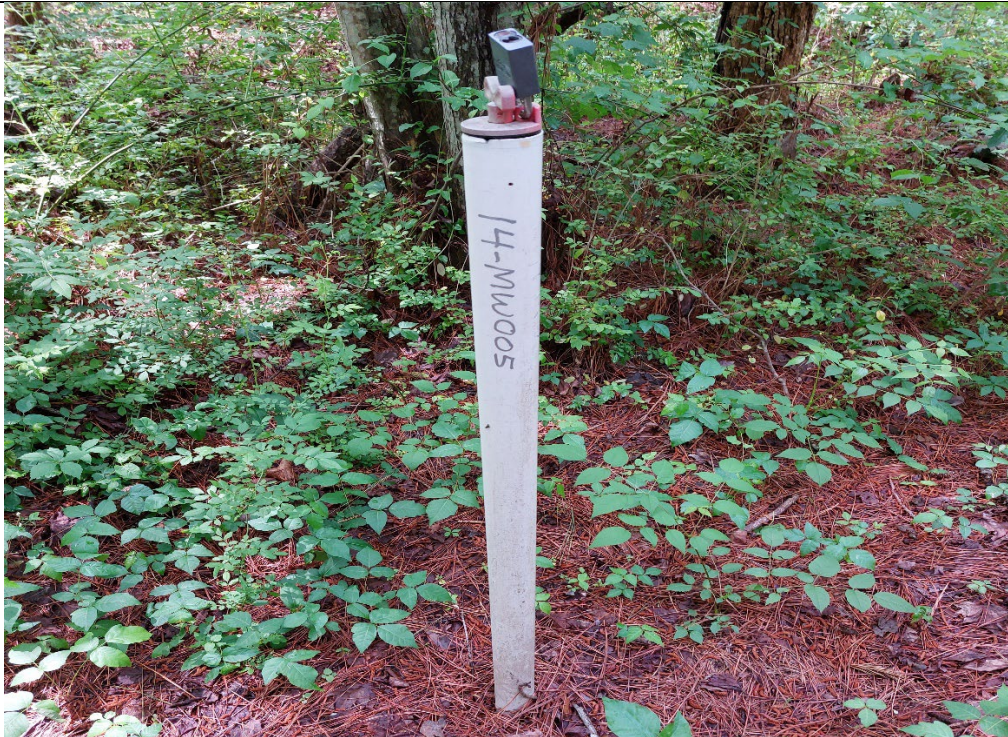
View of 14-MW005. There is no protective casing installed for this well due to the location.

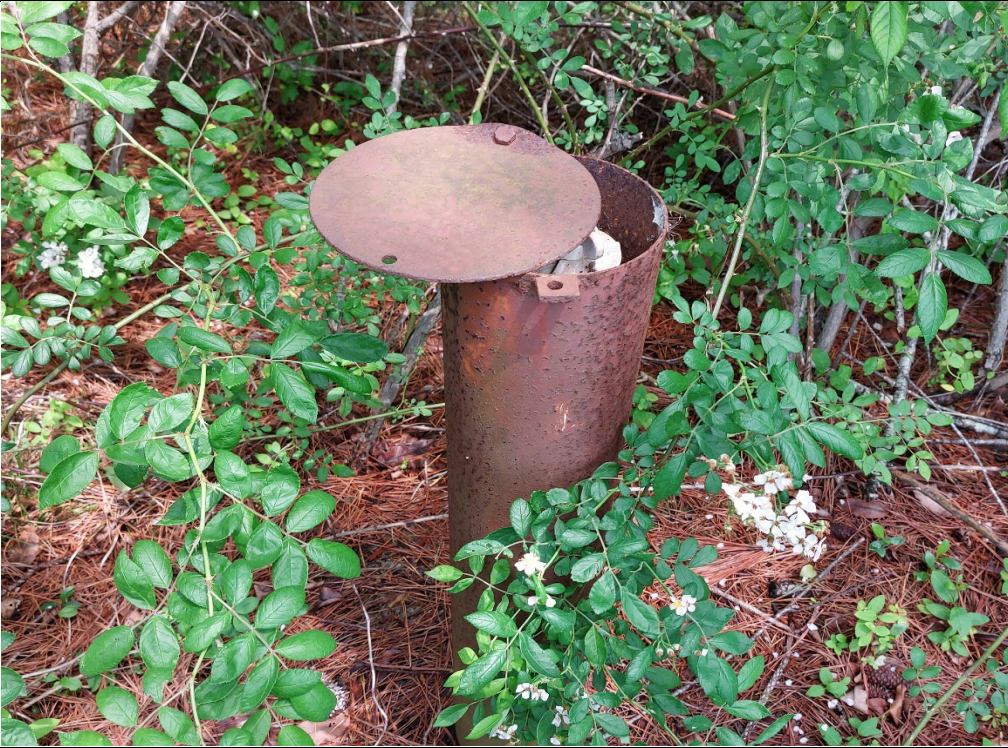
View of 14-MW001. The protective casing's cap has rusted, is no longer attached to well casing, and needs replaced. Brush has encroached on 14-MW001 and needs to be cleared/cut back.

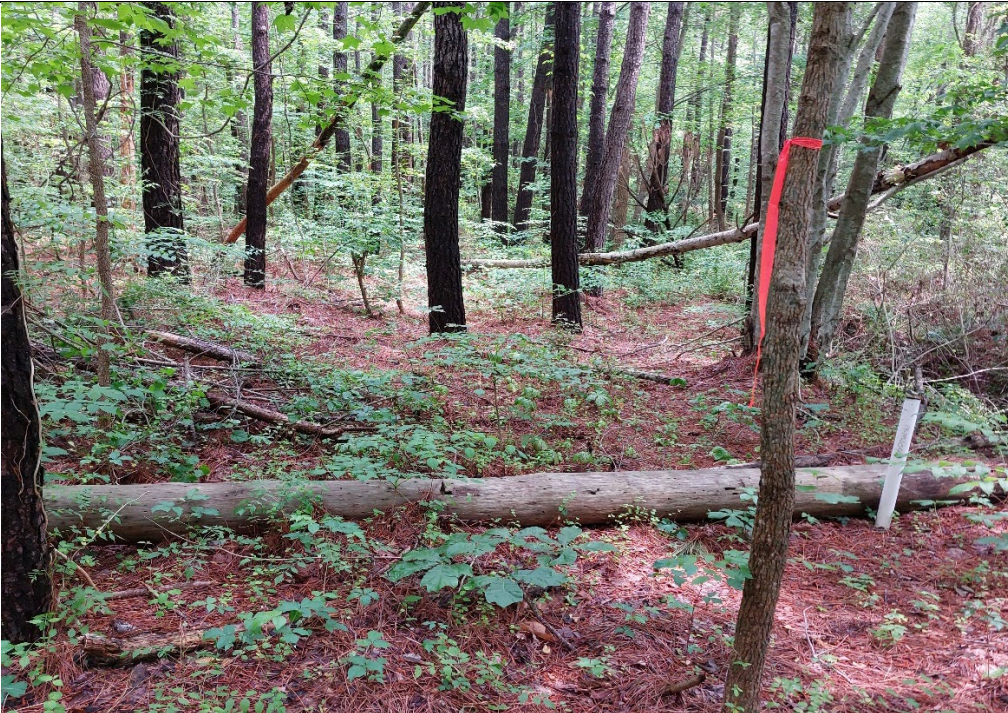
View of path to near 14-MW004 and 14-MW005. Several trees have fallen over and may need to be cleared in the future.

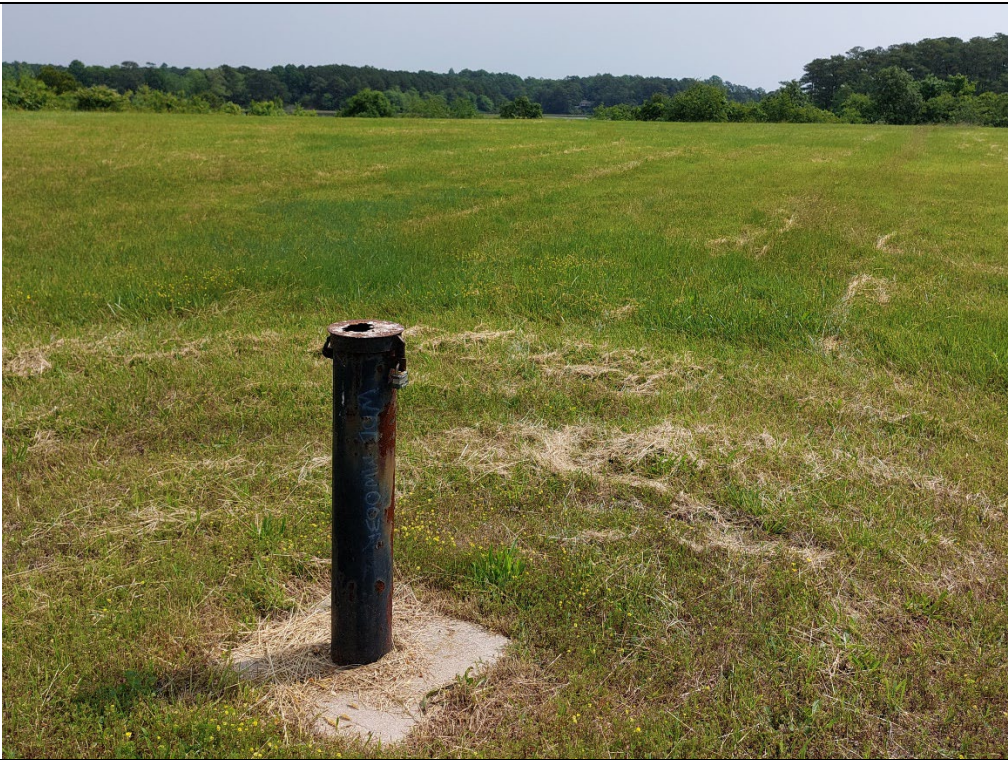
Standing near WOD-MW003R looking across the site.

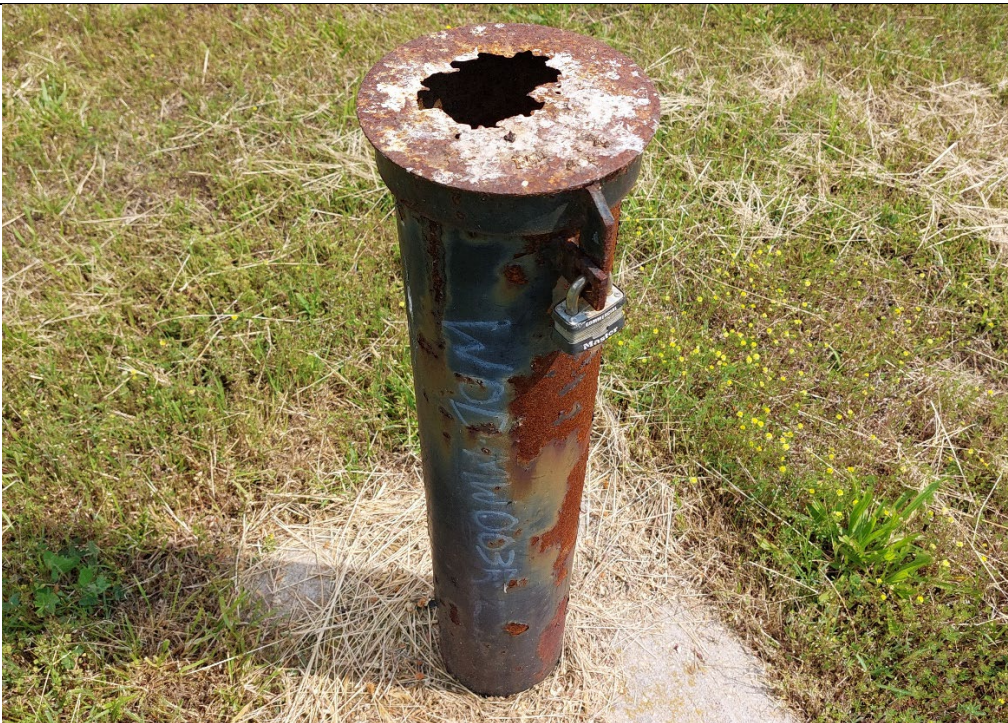
View of WOD-MW003R. The protective casing's cap has rusted through and needs replaced.

During the FYR site inspection in May 2023, protective casings and covers for certain monitoring wells included in the LTM program were noted as needing maintenance (e.g., redevelopment or abandonment and reinstallation). These deficiencies were addressed in September 2023 and the details will be documented in the report for the next monitoring event.

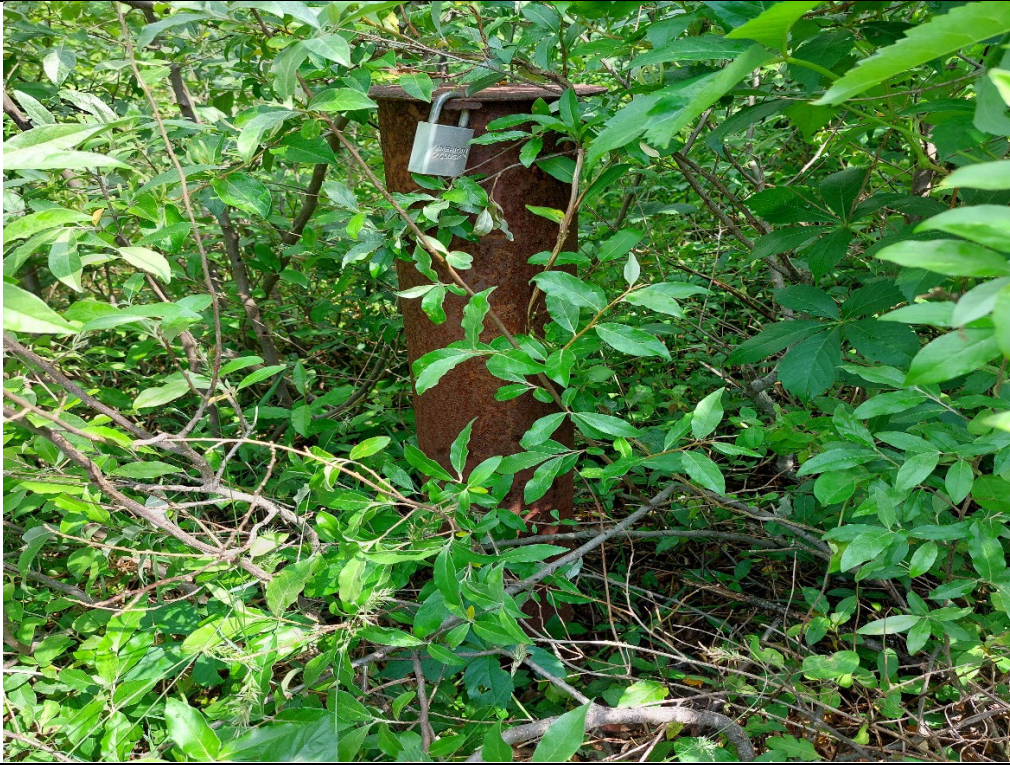
Standing next to 15-MW007 looking at brushy fringe. The brush has encroached on 15-MW007 and needs to be cleared/cut back.

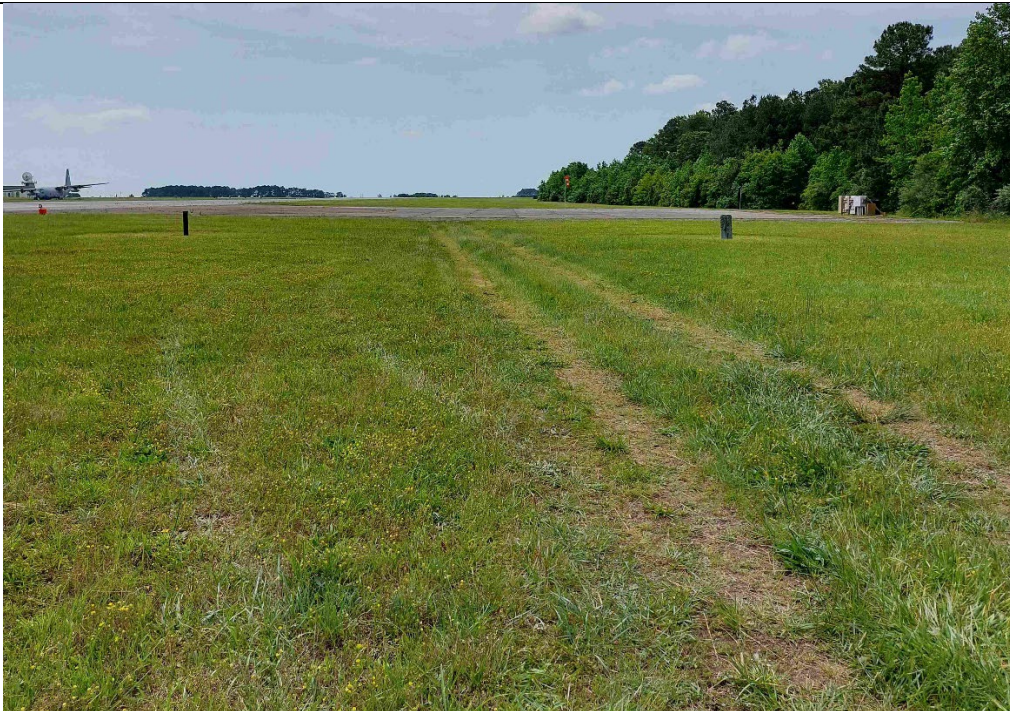
Standing along dirt access back towards Runway 17-35 and Hot Pad area. The former asphalt/cement plant which used to be located on the north side of the runway was removed.

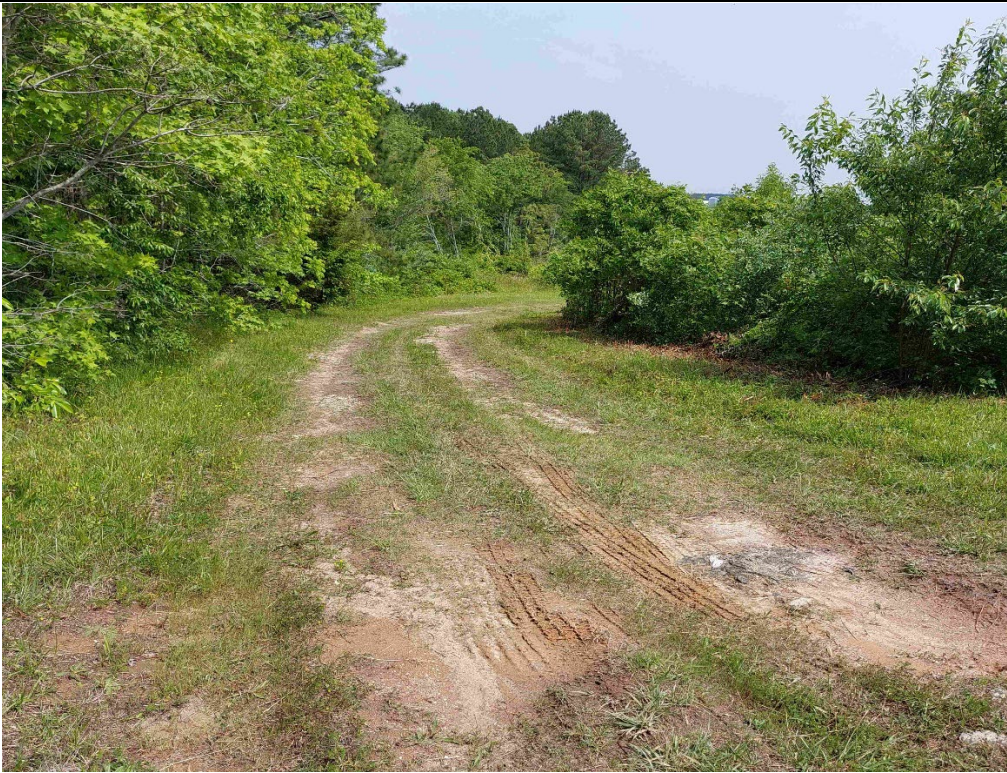
| Date: 5/17/2023 | View: North | Photographer: J. Martone (Tetra Tech; contractor for NASA) |

Standing along dirt access road that leads to perimeter gate (Gate 11).

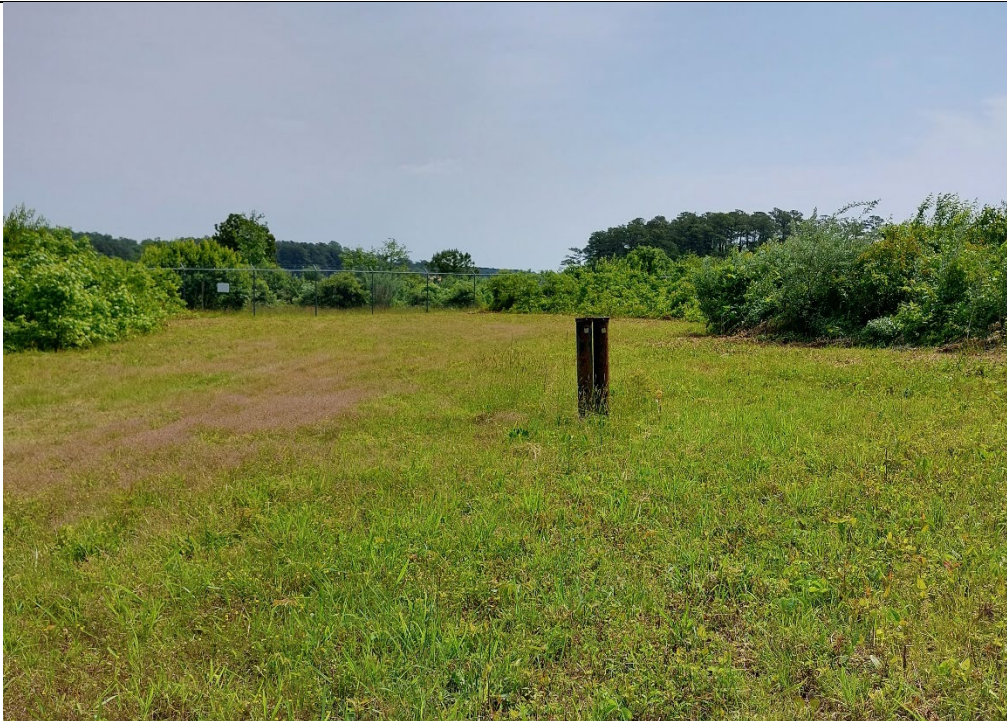
Standing along dirt access road looking at WOD-MW002S and WOD-MW002D and perimeter fence.

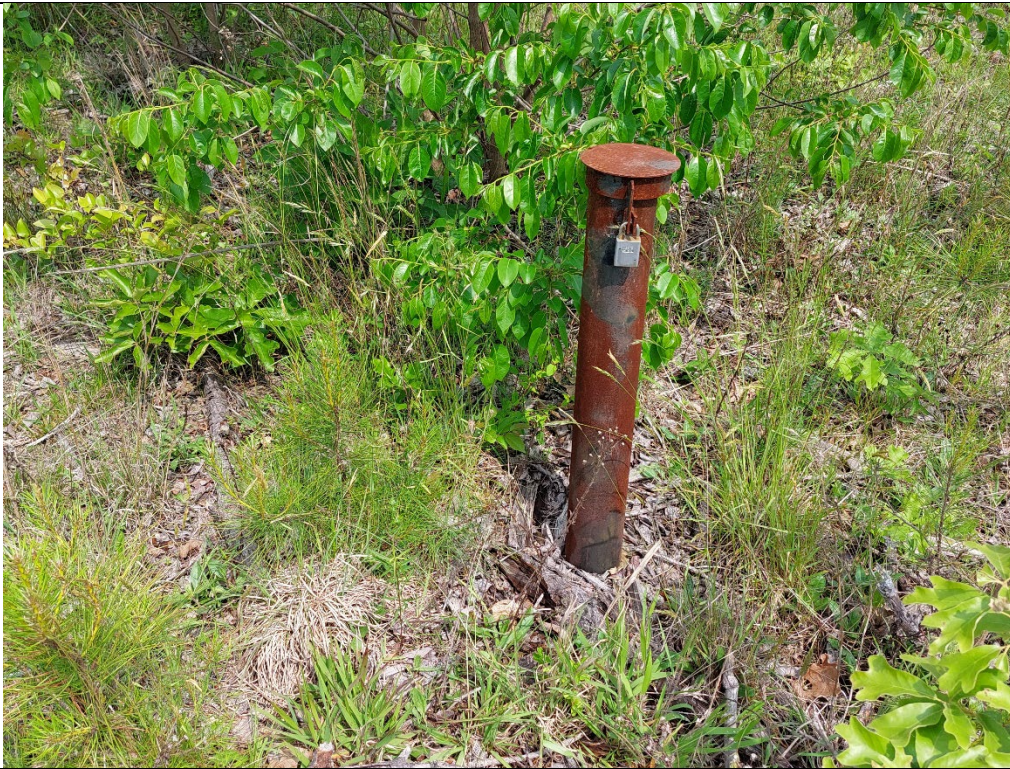
View of WOD-MW008. Other than some rust the well appeared to be in good condition. Picture depicts typical rusty conditions of most of the wells in the area.

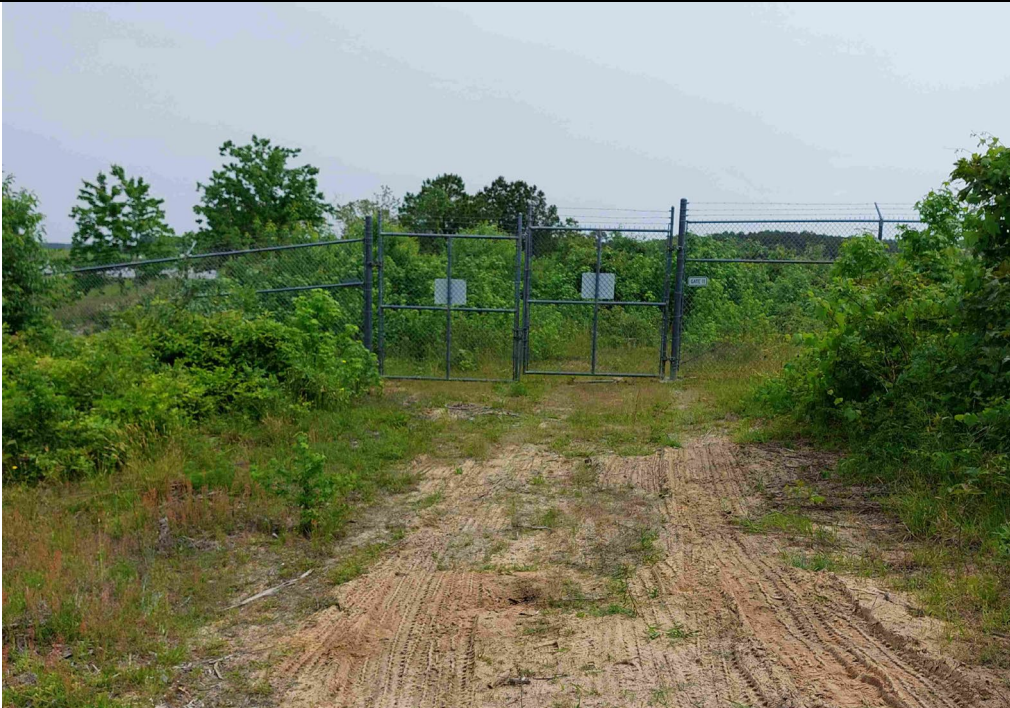
| Date: 5/17/2023 | View: North | Photographer: J. Martone (Tetra Tech; contractor for NASA) |

View of the dirt access road and facility perimeter gate (Gate 11).

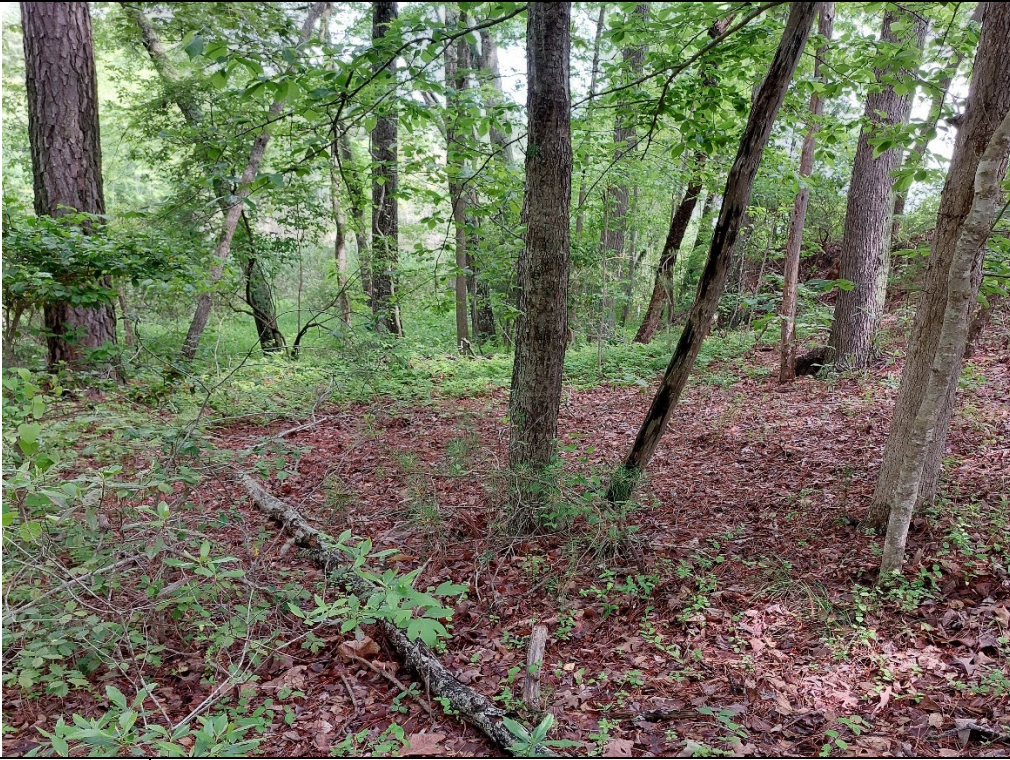
Standing in woods near 15-MW002 looking at the drop off towards the creek. No unusual erosion was noted.

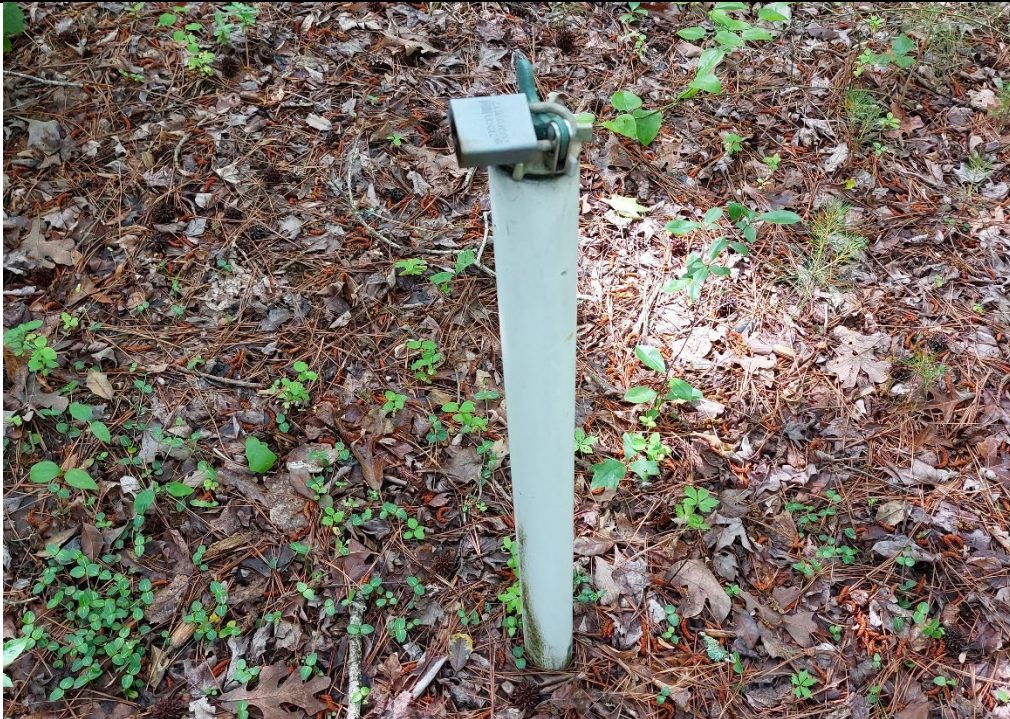
View of 15-MW002. Well Identification has faded/worn off and there is no protective casing due to the location of the well.

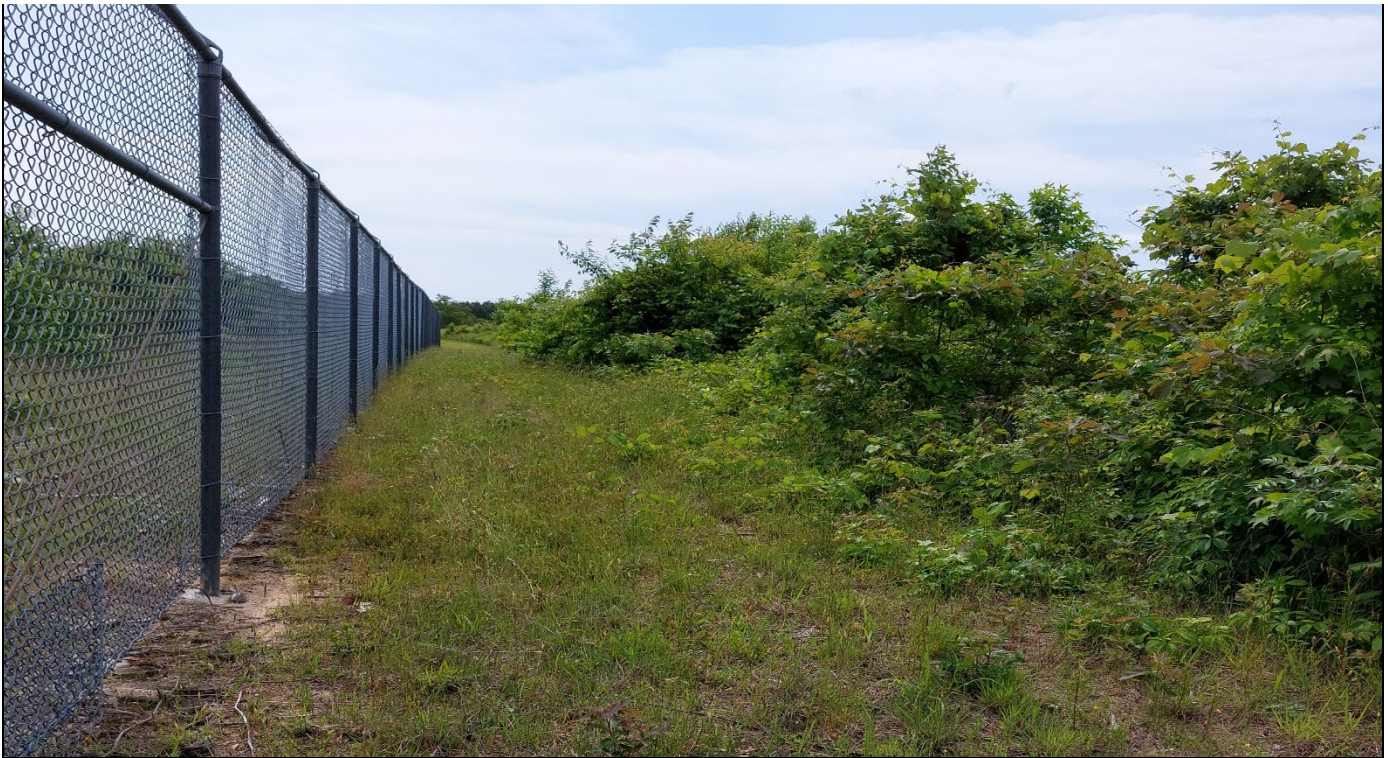
| Date: 5/17/2023 | View: East | Photographer: J. Martone (Tetra Tech; contractor for NASA) |

Standing next to Gate 11 looking down the facility perimeter fence from inside the facility.

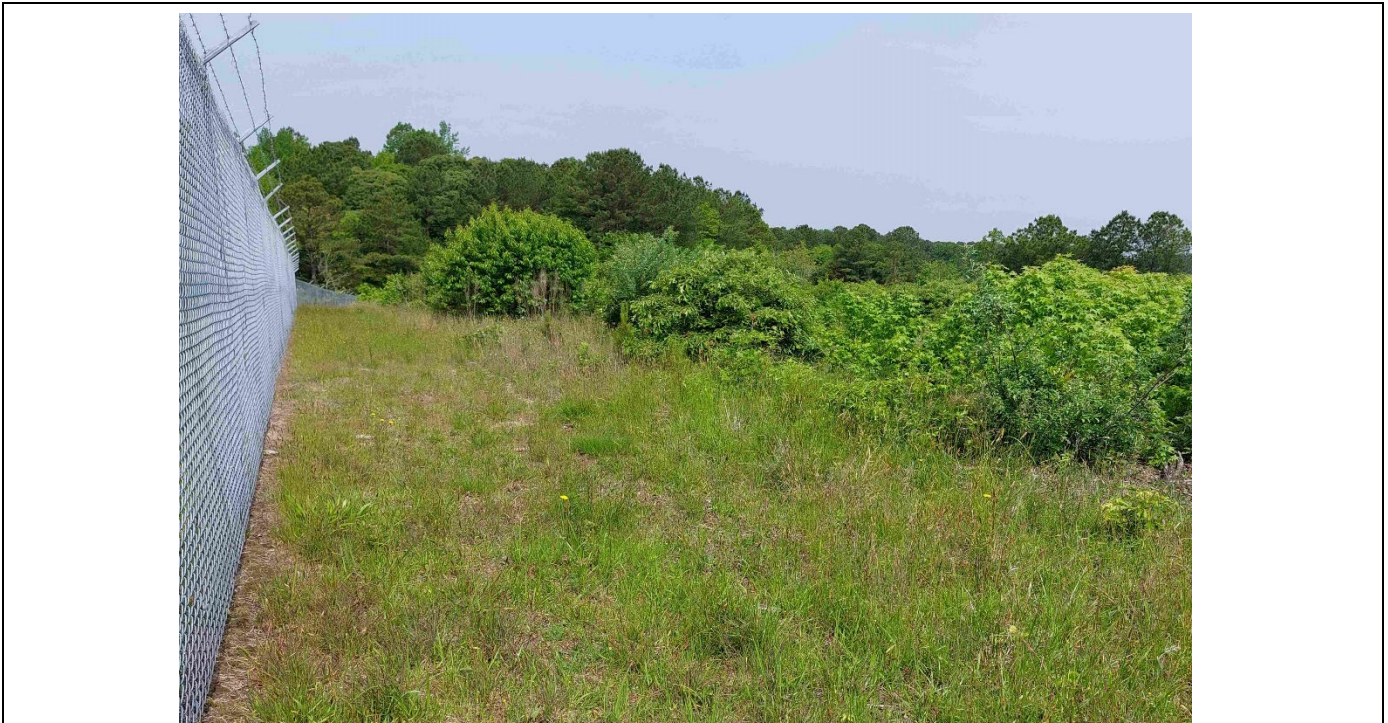
| Date: 5/17/23 | View: West | Photographer: J. Martone (Tetra Tech; contractor for NASA) |

Looking down the facility perimeter fence towards Gate 11 from outside the facility.

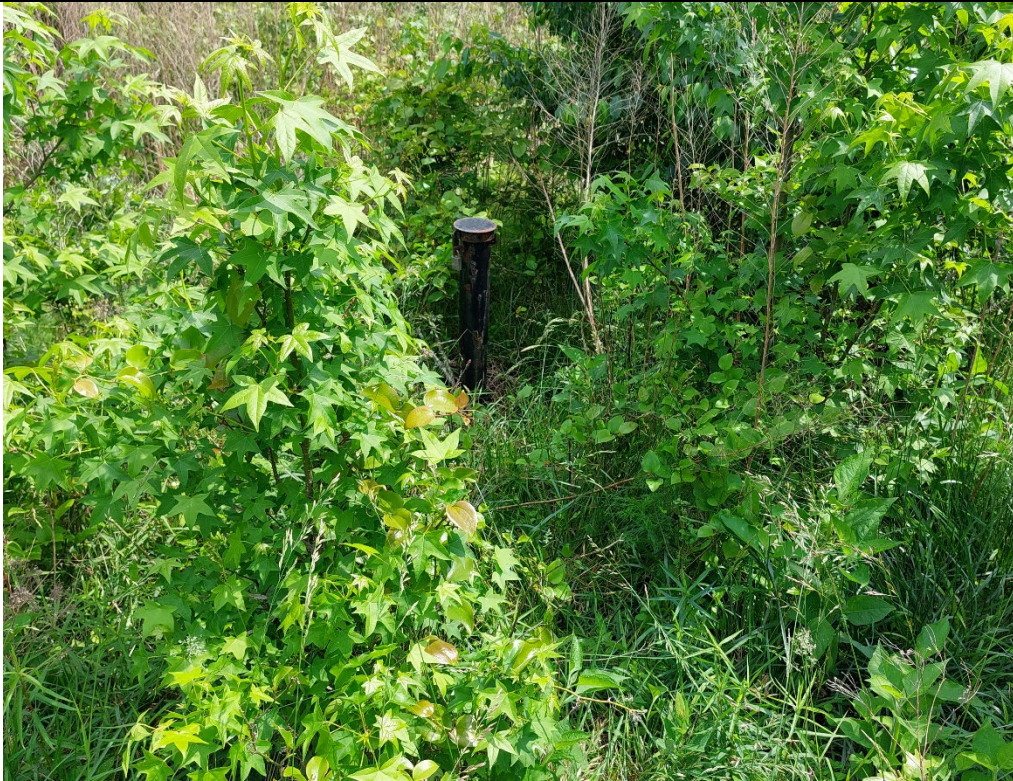
View of WOD-MW006. The brush has encroached on WOD-MW006 and needs to be cleared/cut back.
