# Conquering Frontiers: A New Era Contamination Control Mirrors, First Contact Polymers, LIGO, Keck & NASA's Starshade Telescope

**James P. Hamilton, PhD**  
**Wisconsin Distinguished Professor**

# First Contact Polymer End Game: Routinely Maintain Mirrors at Max Reflectivity, Extend Coating & Optic Lifetime, Eliminate Scatter, & make Zero Defect Coatings.

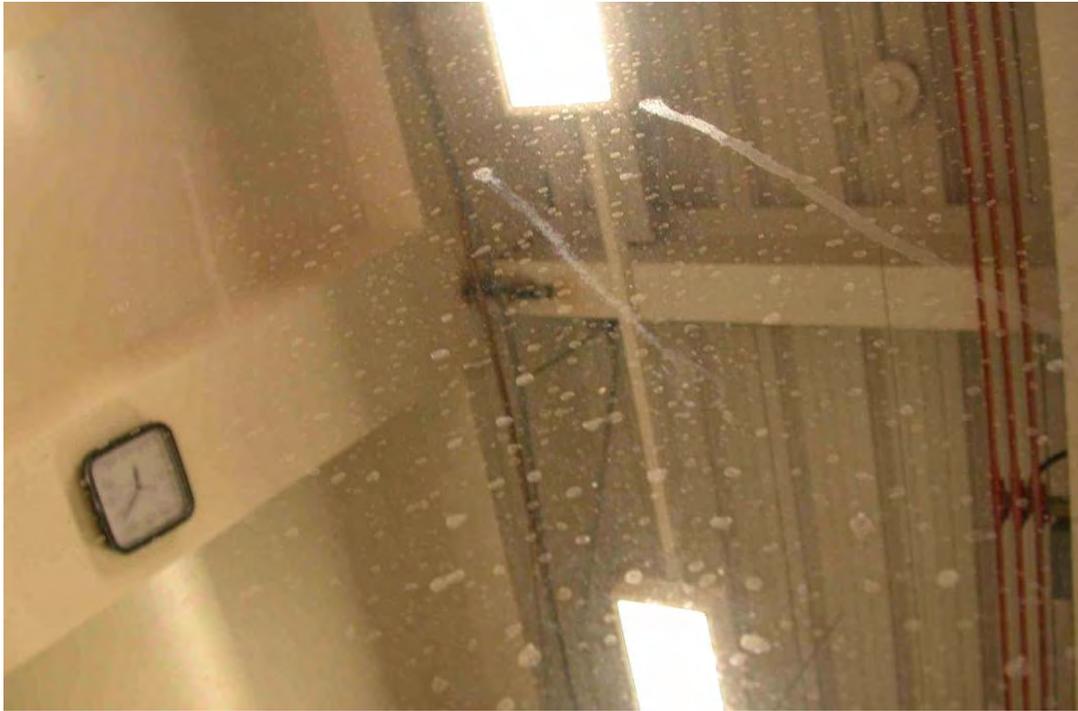
Operating  
Surface- 10 m  
Keck Telescope  
Hawaii.

Some surfaces are “uncleanable”.  
Nanoparticles **very** hard to remove

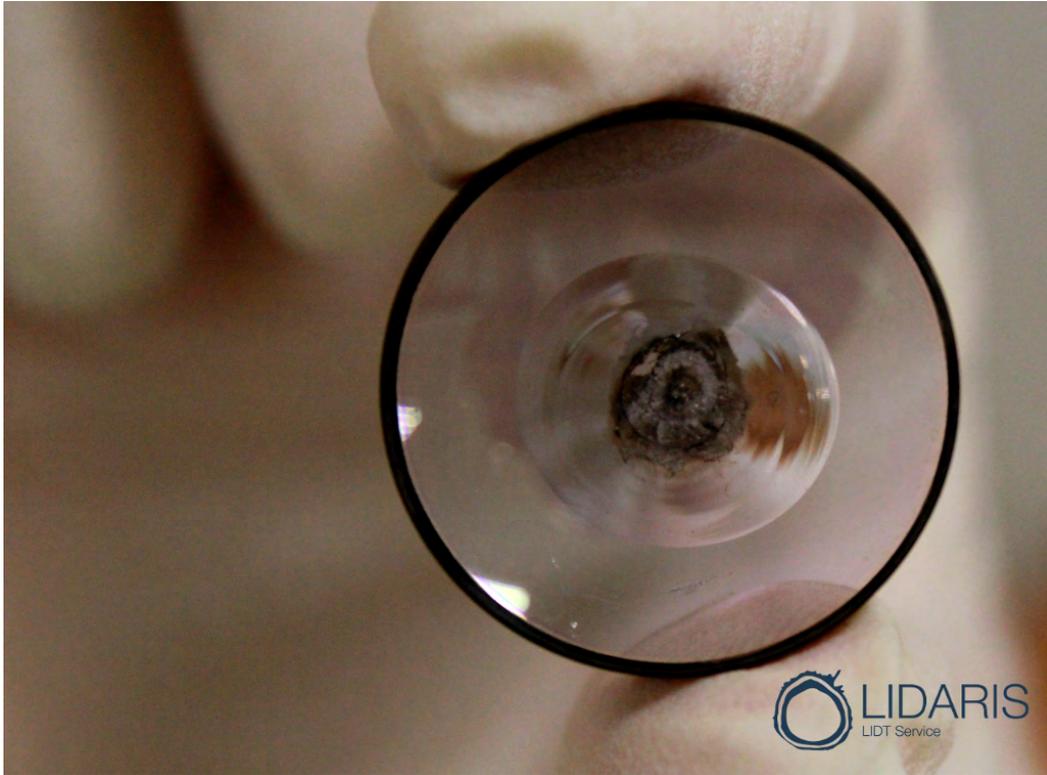
Laser Induced  
Damage:  
Optics & Optical  
Coatings

Some surfaces are “uncleanable”.  
Nanoparticles **very** hard to remove.

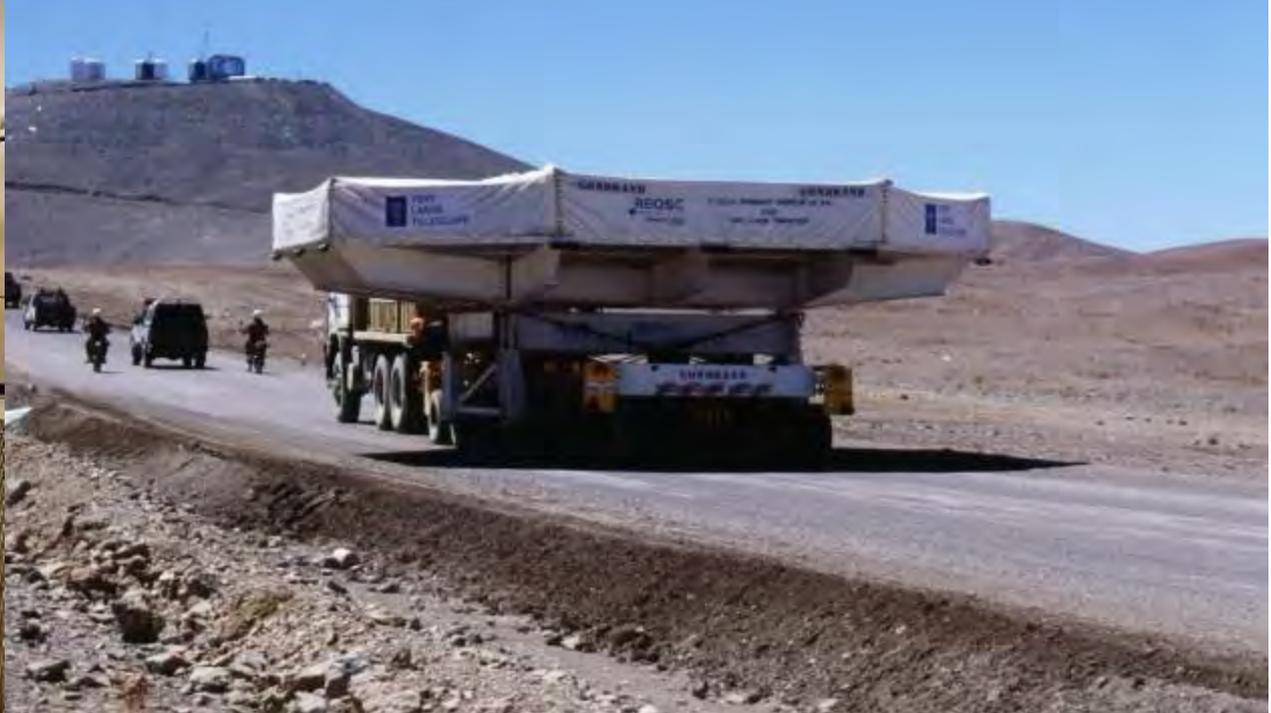
**8.2m Mirror driven for cleaning & recoating: Atacama desert in Chile.**

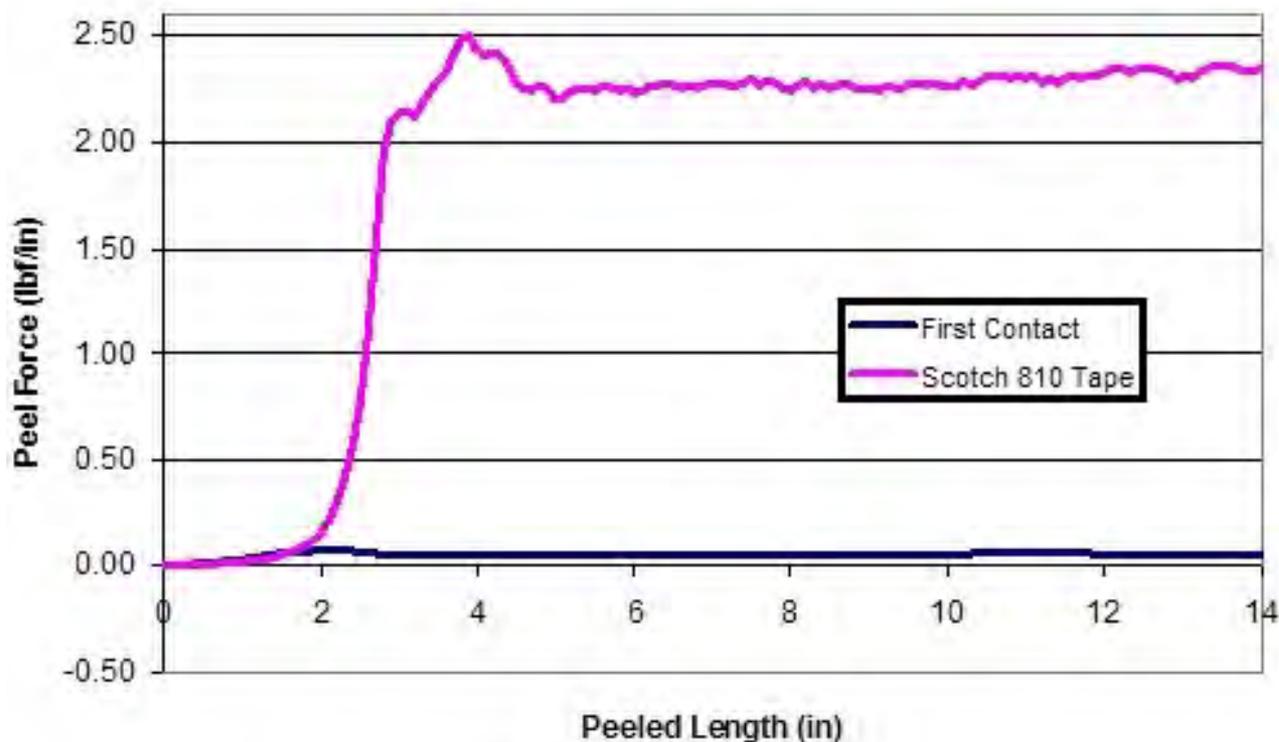
1/20<sup>th</sup> the adhesion of Scotch Tape on Al - SAFE

First Contact vs Scotch Tape (810) Peel  
from Borofloat Glass First Surface Aluminum Mirror

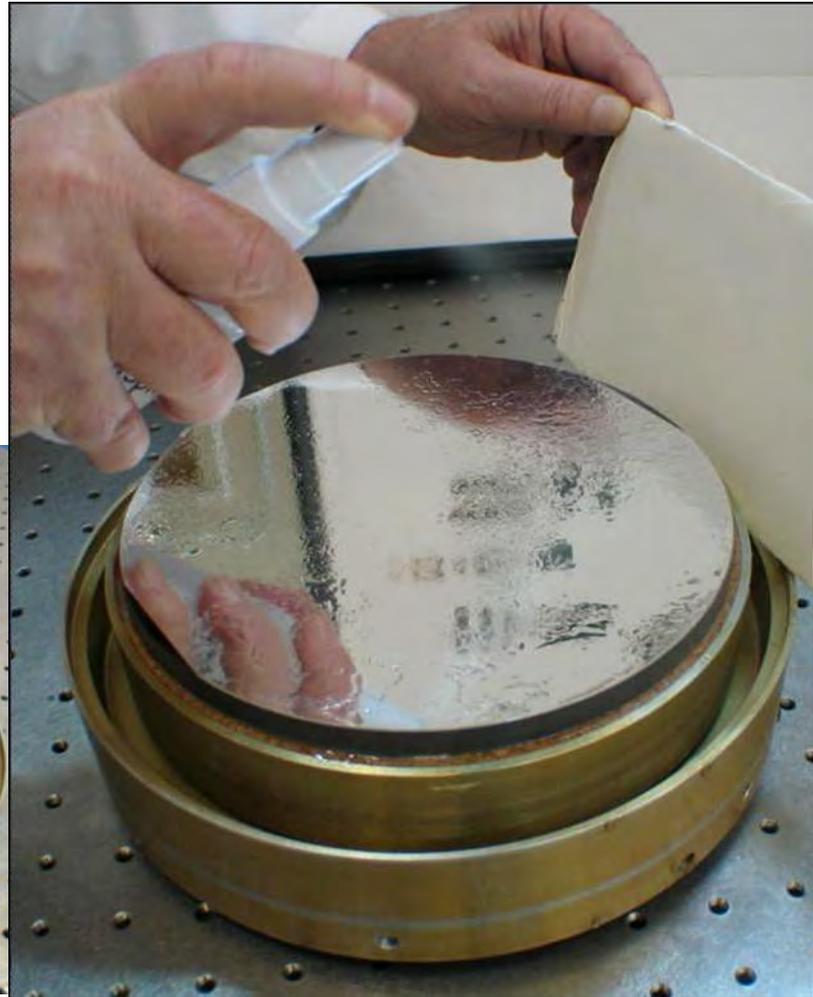
Fingerprints intentionally placed on mirror to demonstrate cleaning effectiveness

Polymer Applied with A Pump Spray Developed with the WR Optics Lab

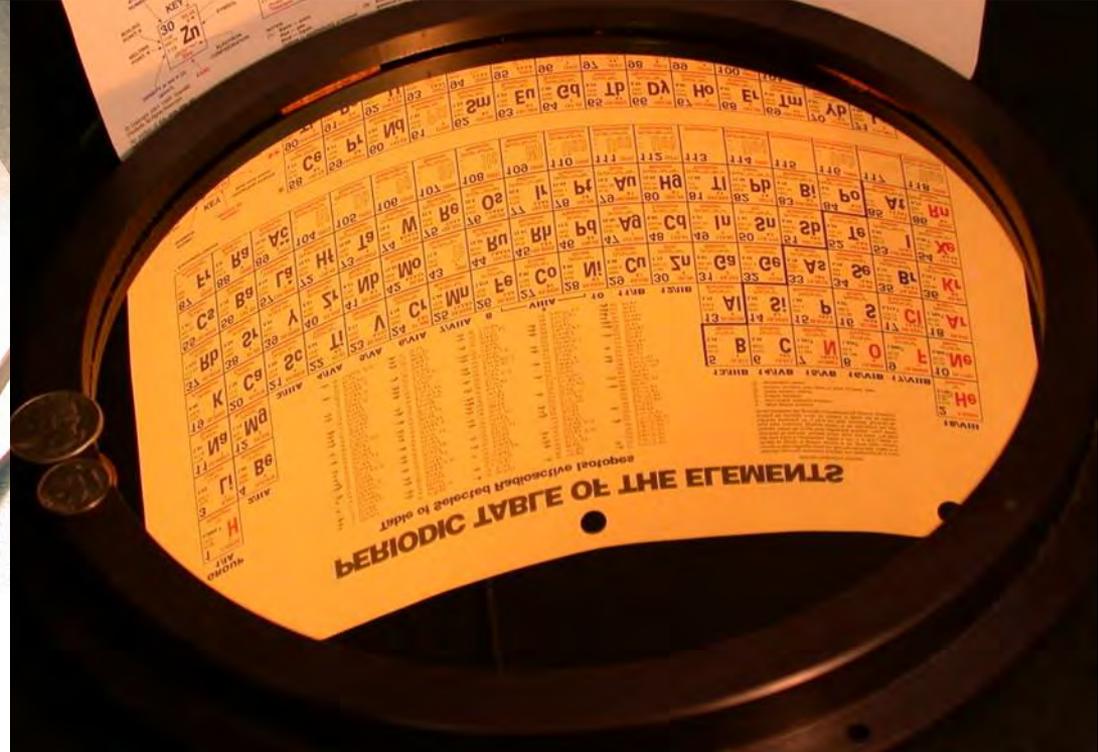
Unprotected Gold mirror. 400mm

After treatment with First Contact™

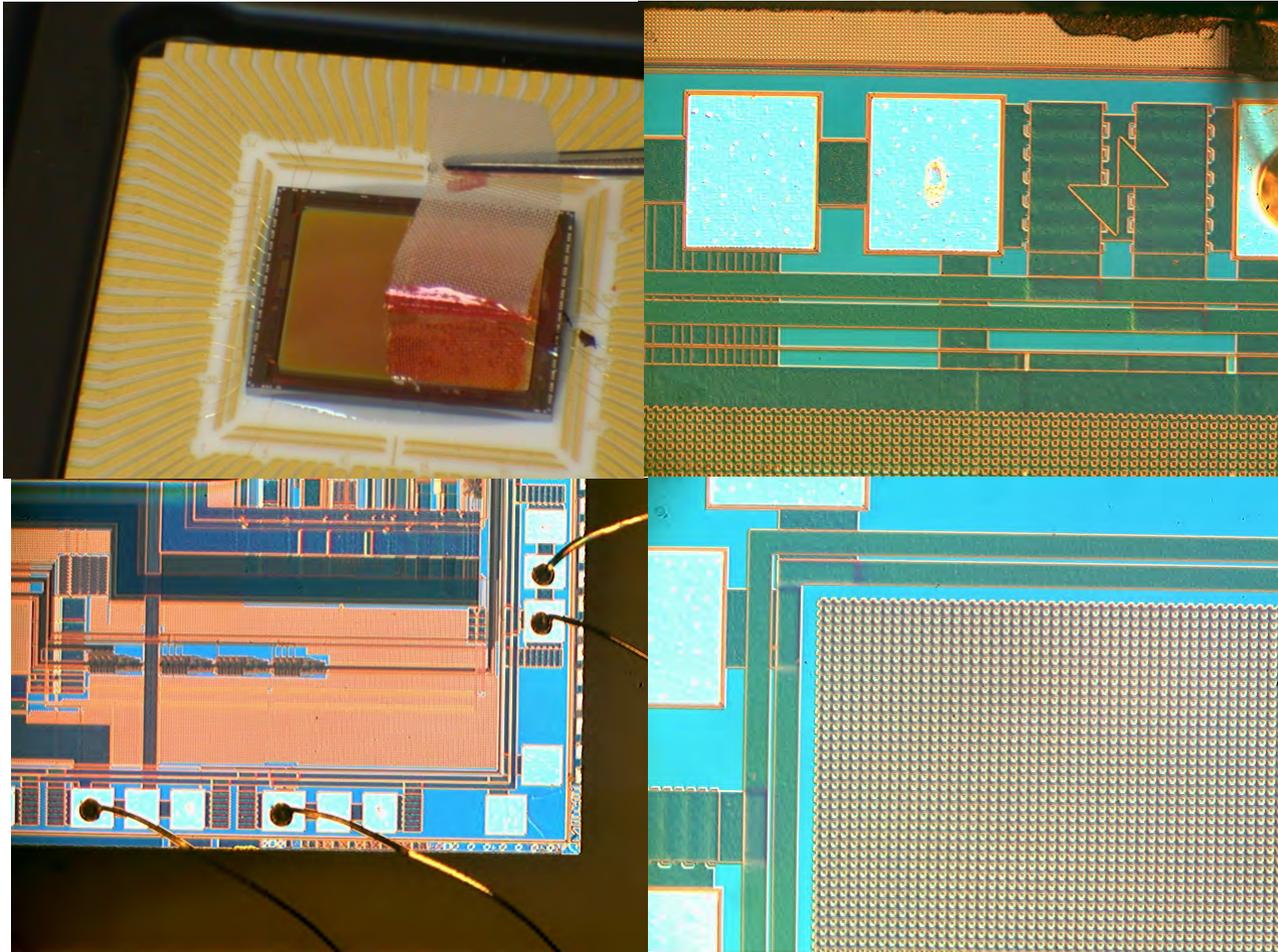
Cleaning the Uncleanable.

Nomarski Microscopy Images, PCT

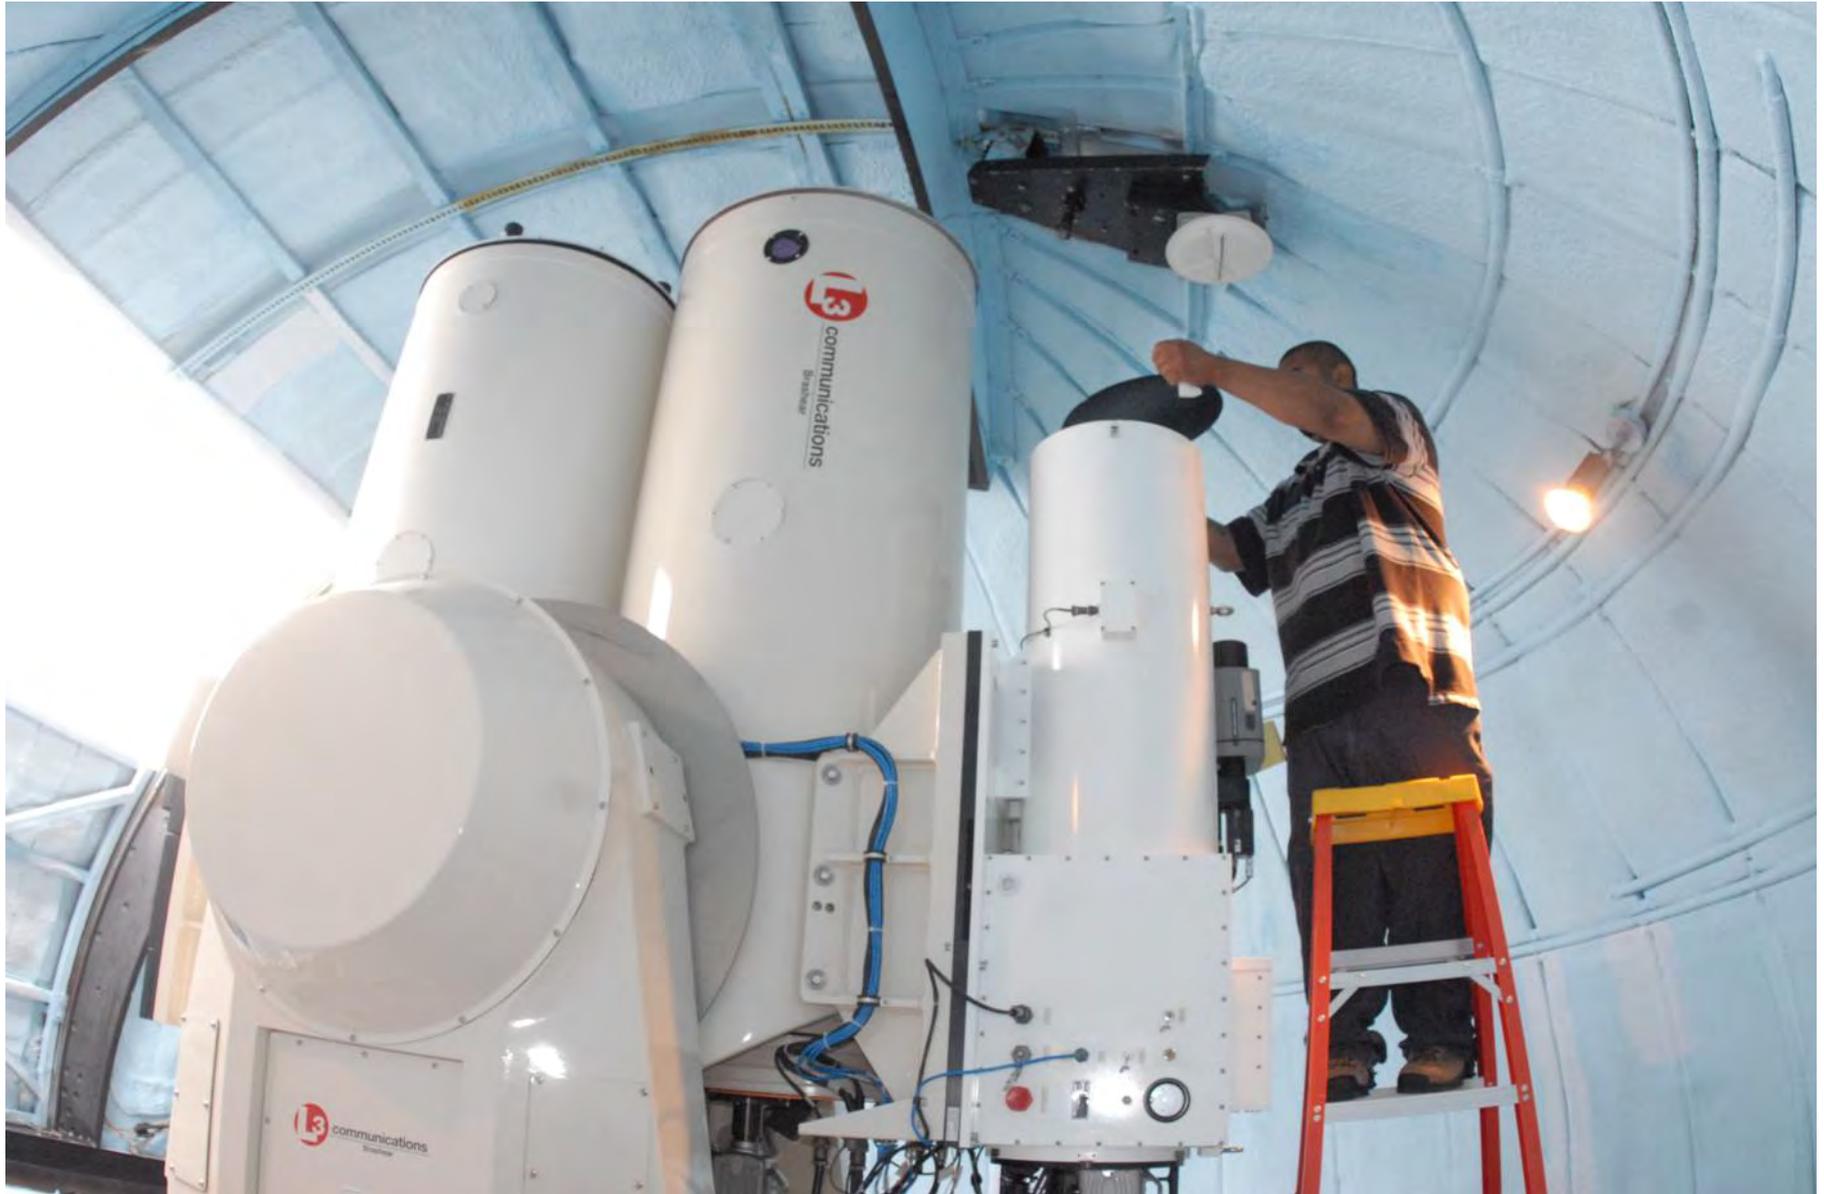
Preparing to Apply the *First Contact* Polymer Protective Coating

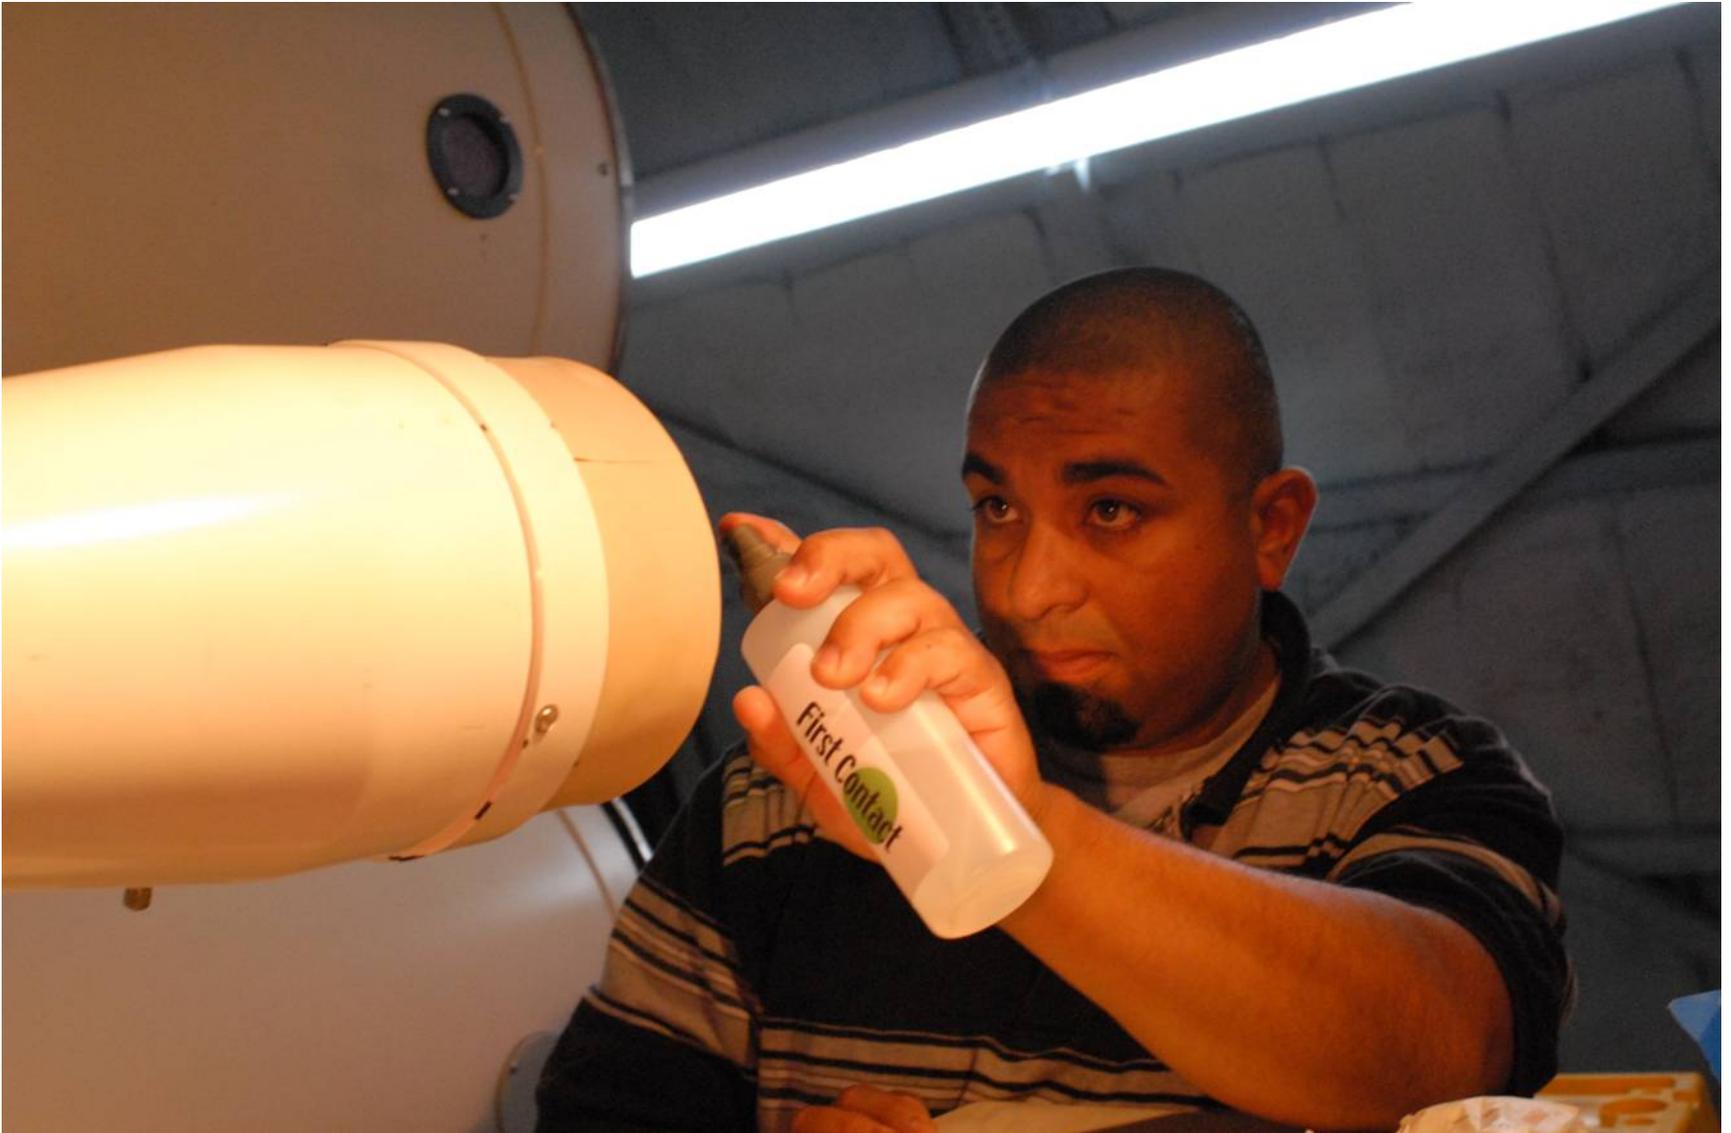
***First Contact Polymer Protection Applied with a Spray***  
**Apply – Seconds to Remove – Years of Protection**

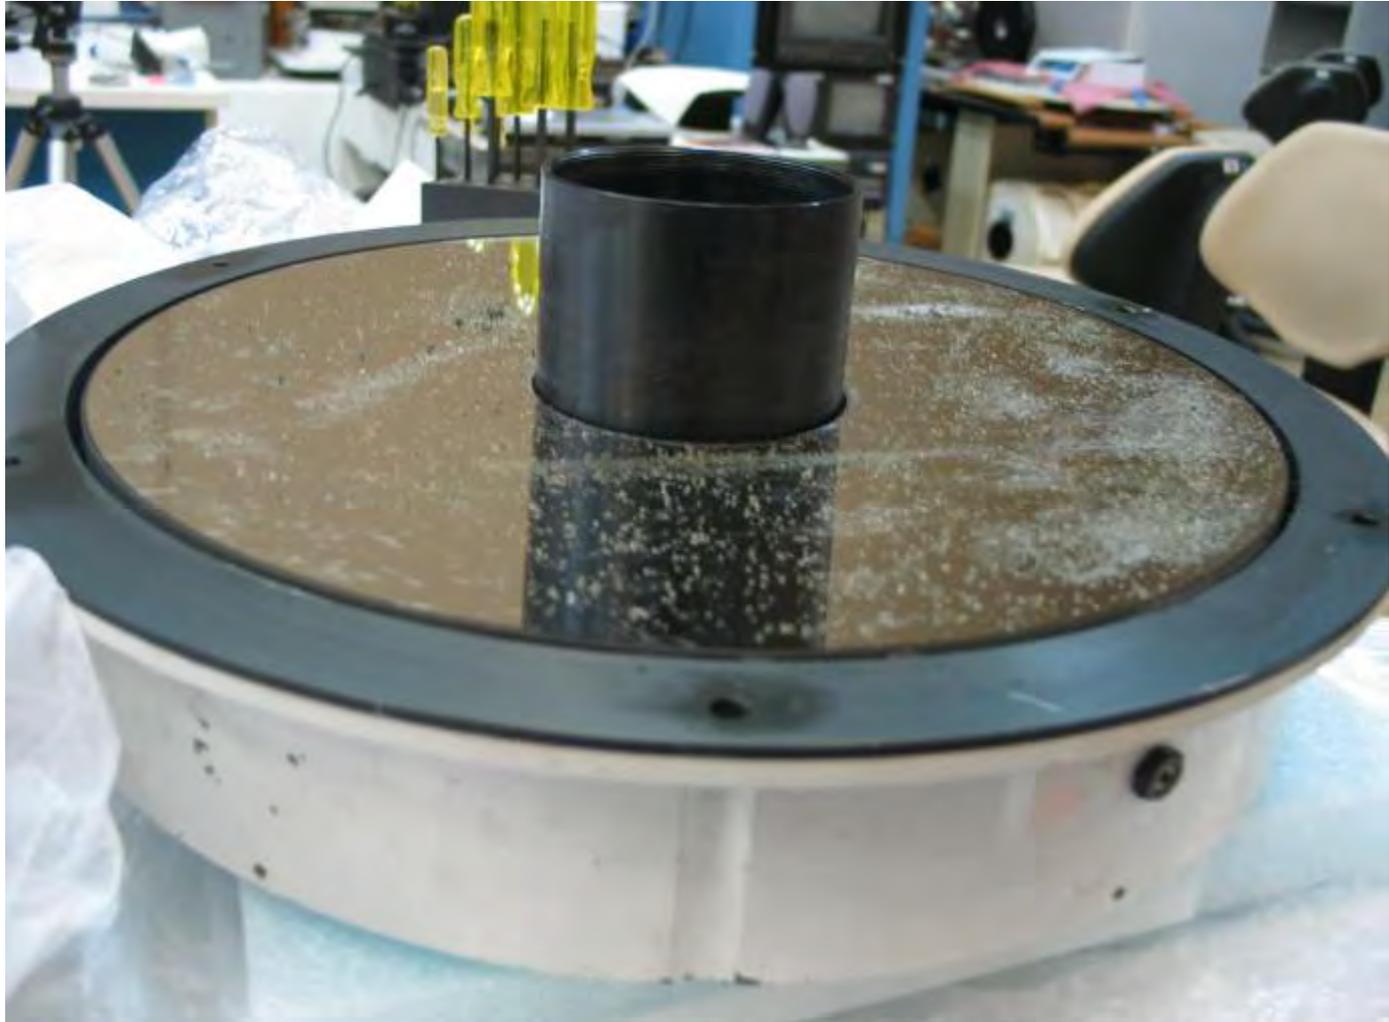
## The Heavily Contaminated Primary Mirror - An Optical Engineer's Nightmare ...

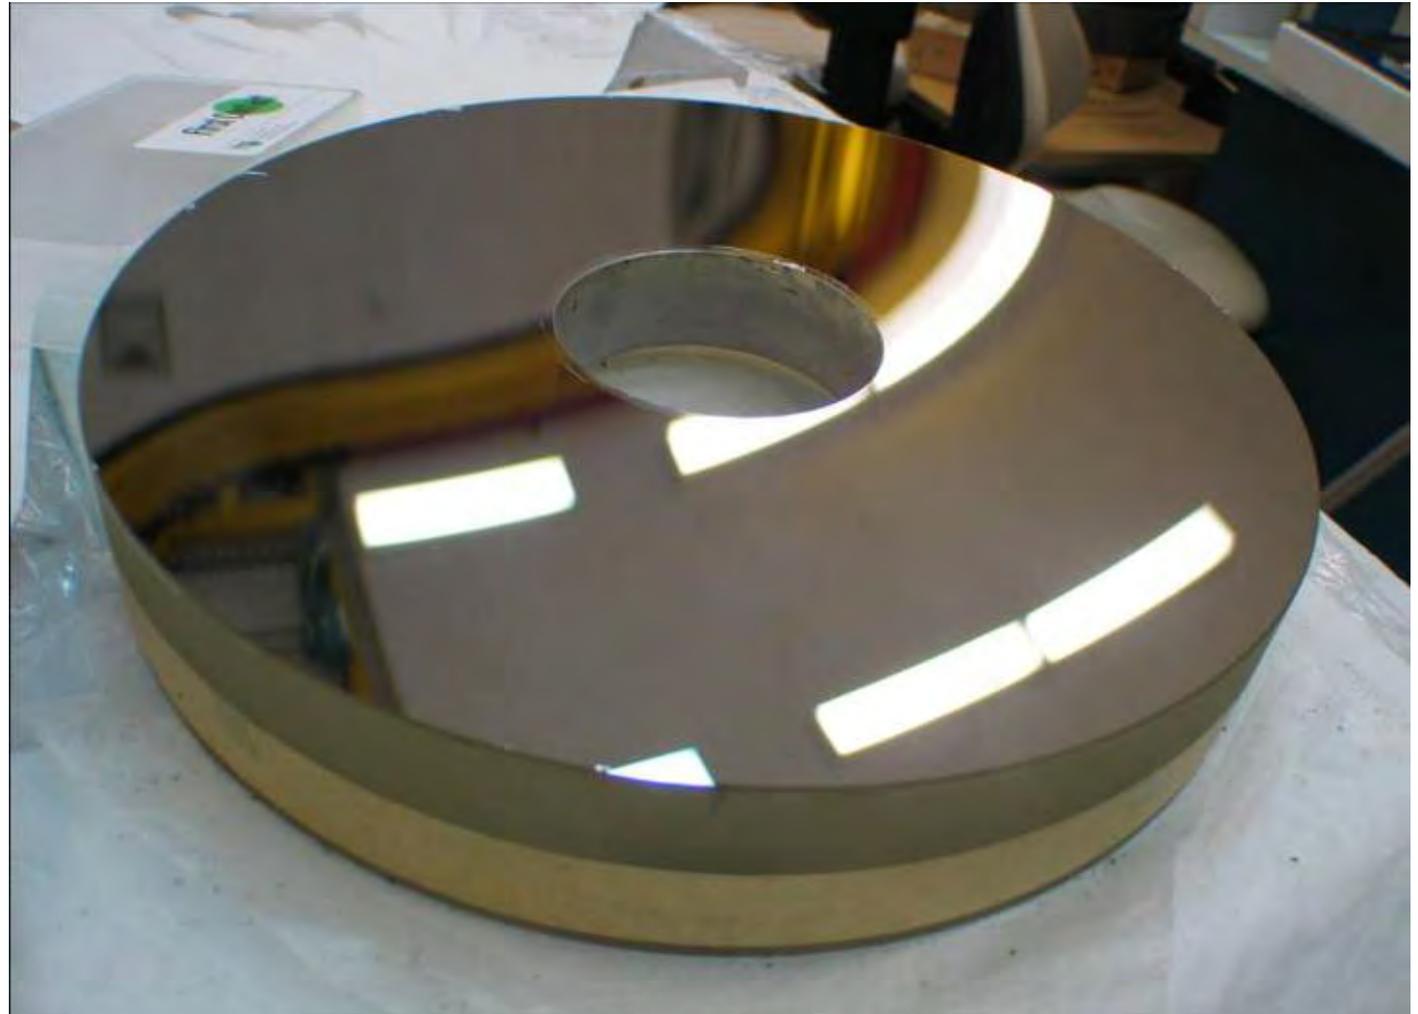
Restored to Pristine Condition - An Optical Engineer's Dream ...

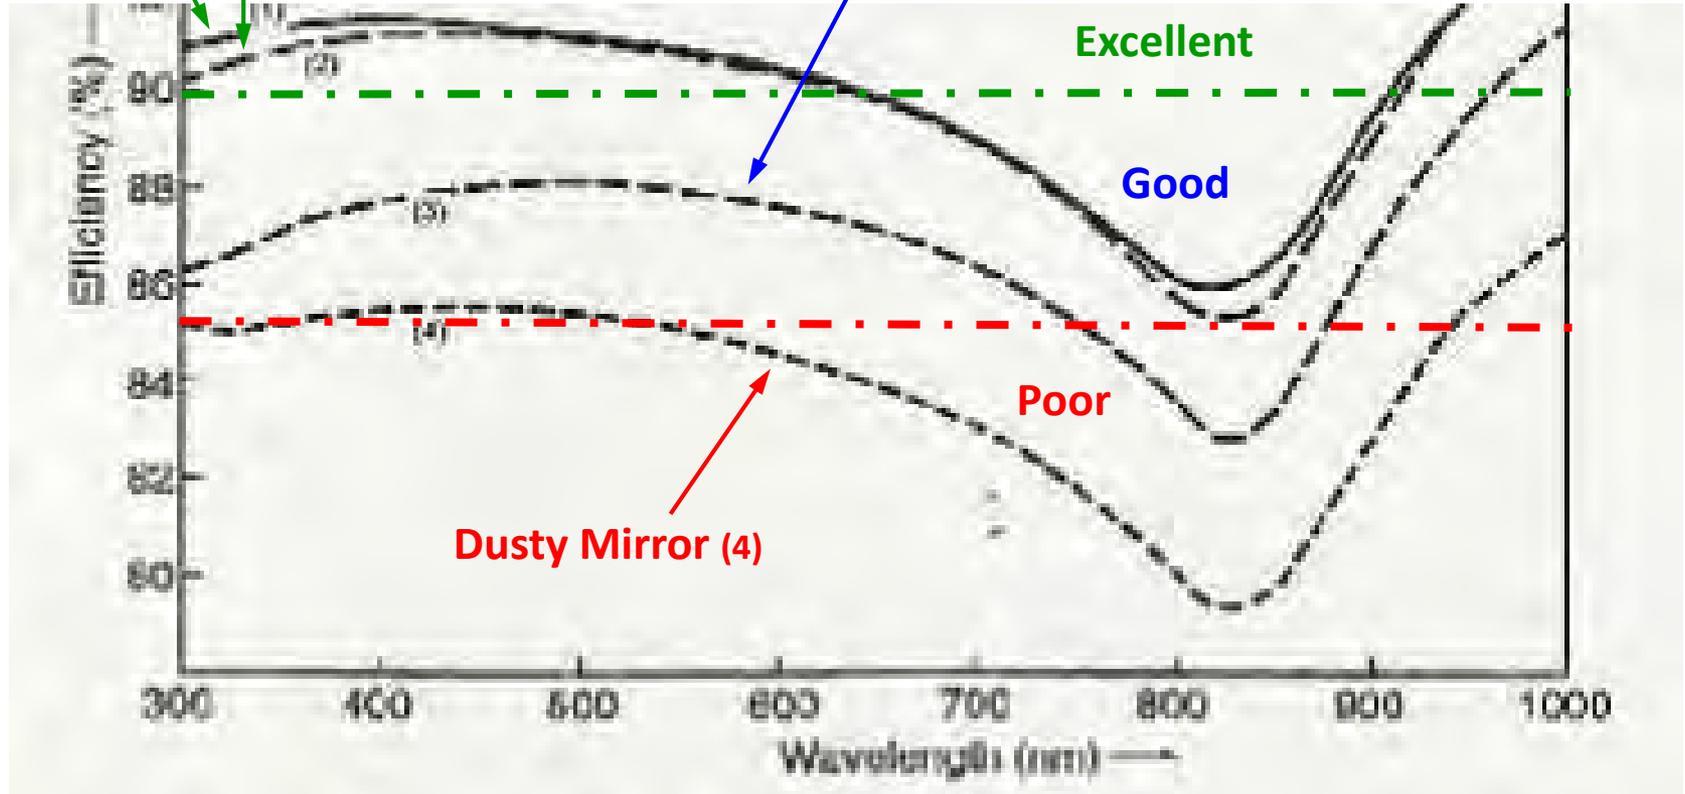
# First Surface Mirror Efficiency Curve

Newly Coated Mirror (1)

Dusty La Silla Chile Mirror Cleaned Using this Liquid Polymer (2)

Dusty Mirror Cleaned Using the Traditional Method CO<sub>2</sub> (3)

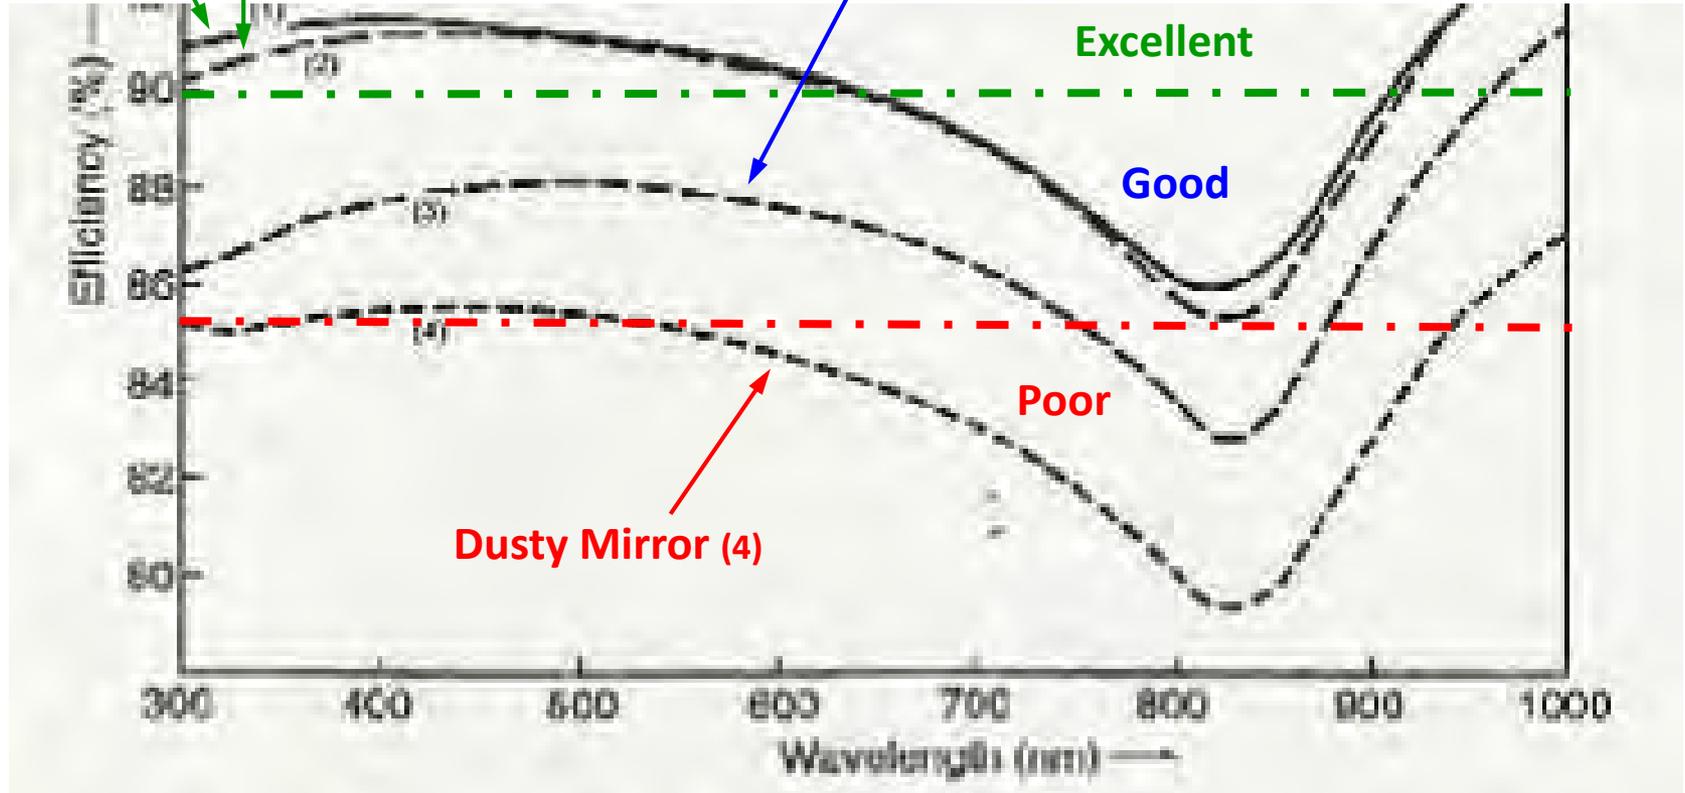
Newly Coated Mirror (1)

Mirror Cleaned Using this Liquid Polymer (2)

Dusty Mirror Cleaned Using the Traditional Method CO<sub>2</sub> (3)

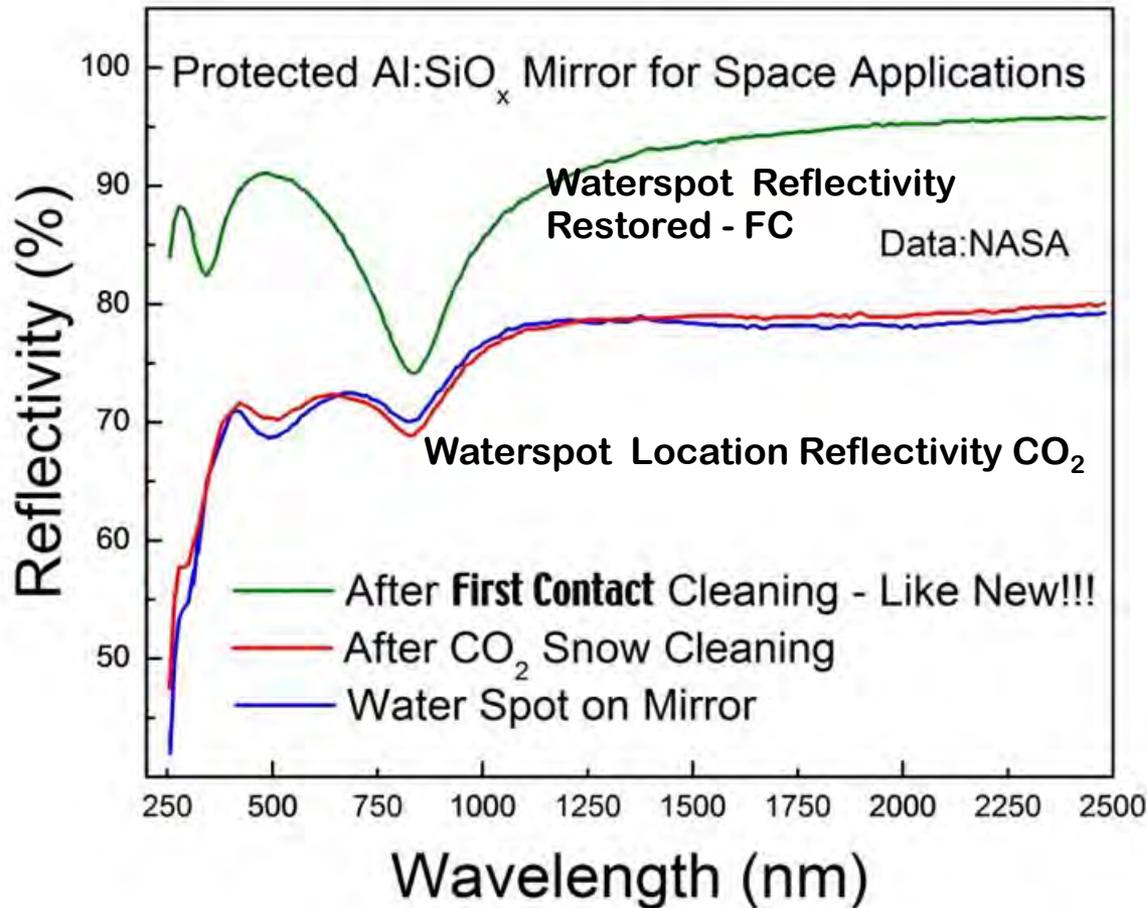
# First Contact™ - Cleans Waterspots CO<sub>2</sub> can't - NASA

Data: NASA/Goddard, Greenbelt, MD

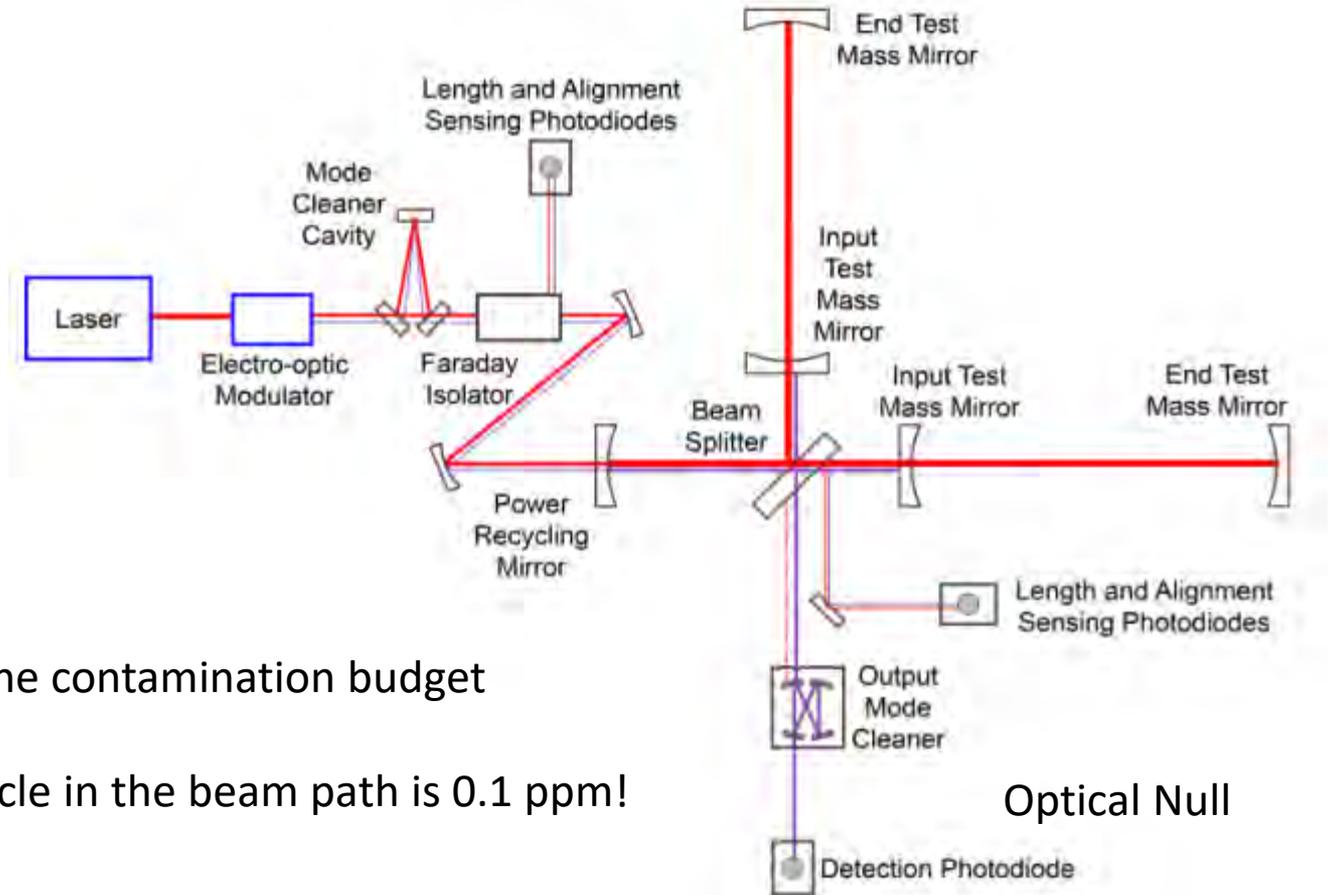
LIGO Laser Intensities at optical surface: 200 kW/cm<sup>2</sup>,  
Absorption specification 0.1ppm on optics & coatings  
Total cavity loss budget in operation= 70 ppm  
Allowable each cavity surface = strict at 0.5 ppm per surface

0.1 ppm set aside for the contamination budget

One single 30  $\mu\text{m}$  particle in the beam path is 0.1 ppm!

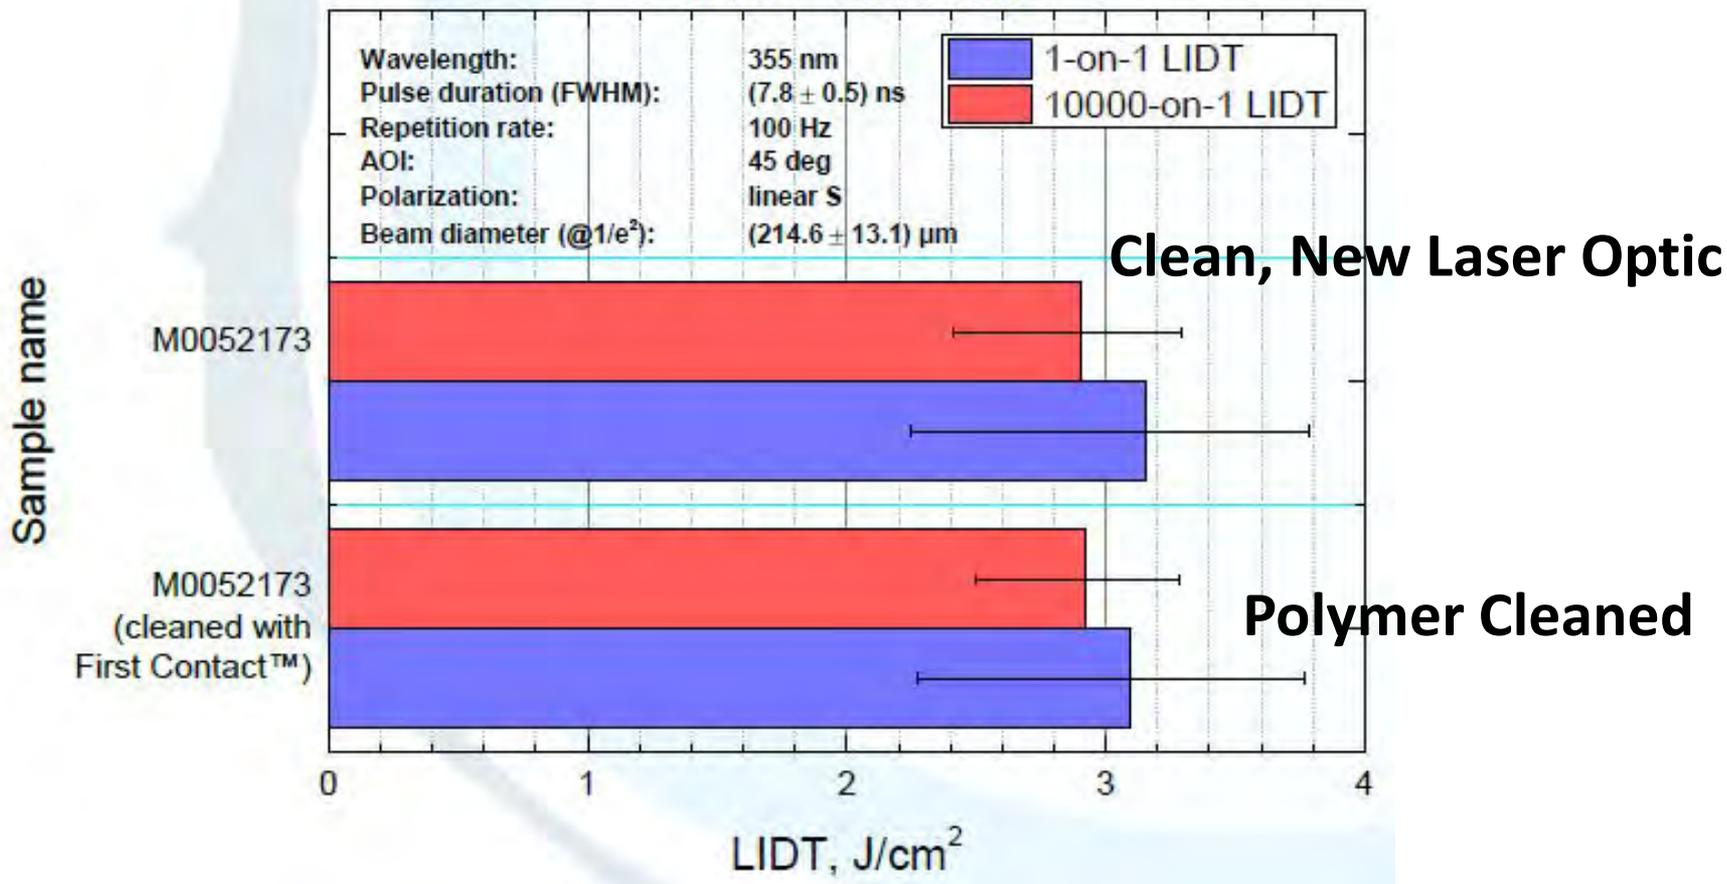
# High Power Laser Damage Threshold (LIDT) – 355nm

Measured at LIDARIS 2016-05-26

**No Change in LIDT = No residue = No Damage**

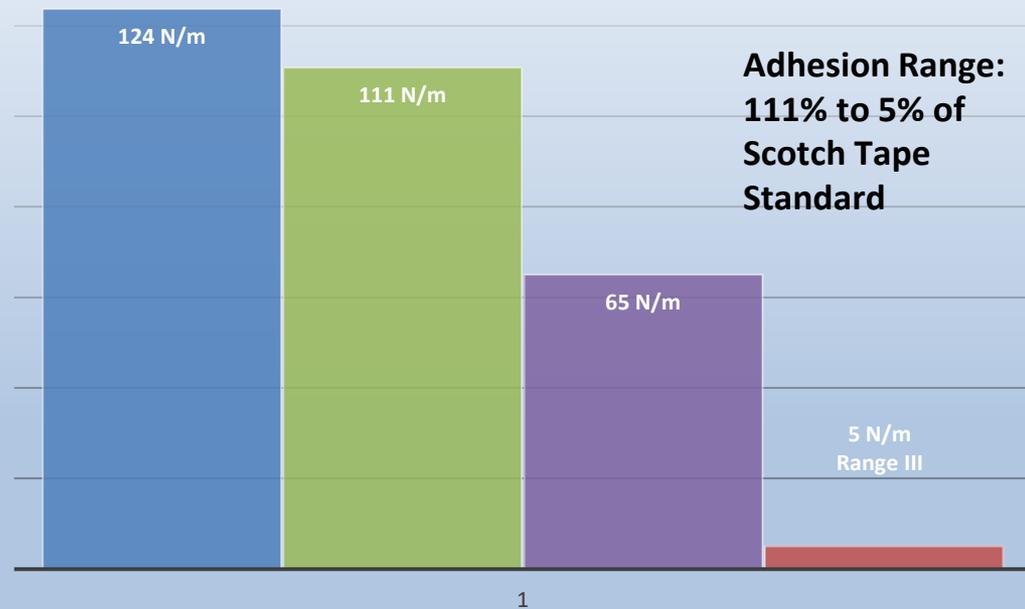
Maximum Observed Adhesion Differences  
on Proposed Starshade Alloy
