# Conquering Frontiers: A New Era Contamination Control Mirrors, First Contact Polymers, LIGO, Keck & NASA's Starshade Telescope

**James P. Hamilton, PhD**  
**Wisconsin Distinguished Professor**

# First Contact Polymer End Game: Routinely Maintain Mirrors at Max Reflectivity, Extend Coating & Optic Lifetime, Eliminate Scatter, & make Zero Defect Coatings.

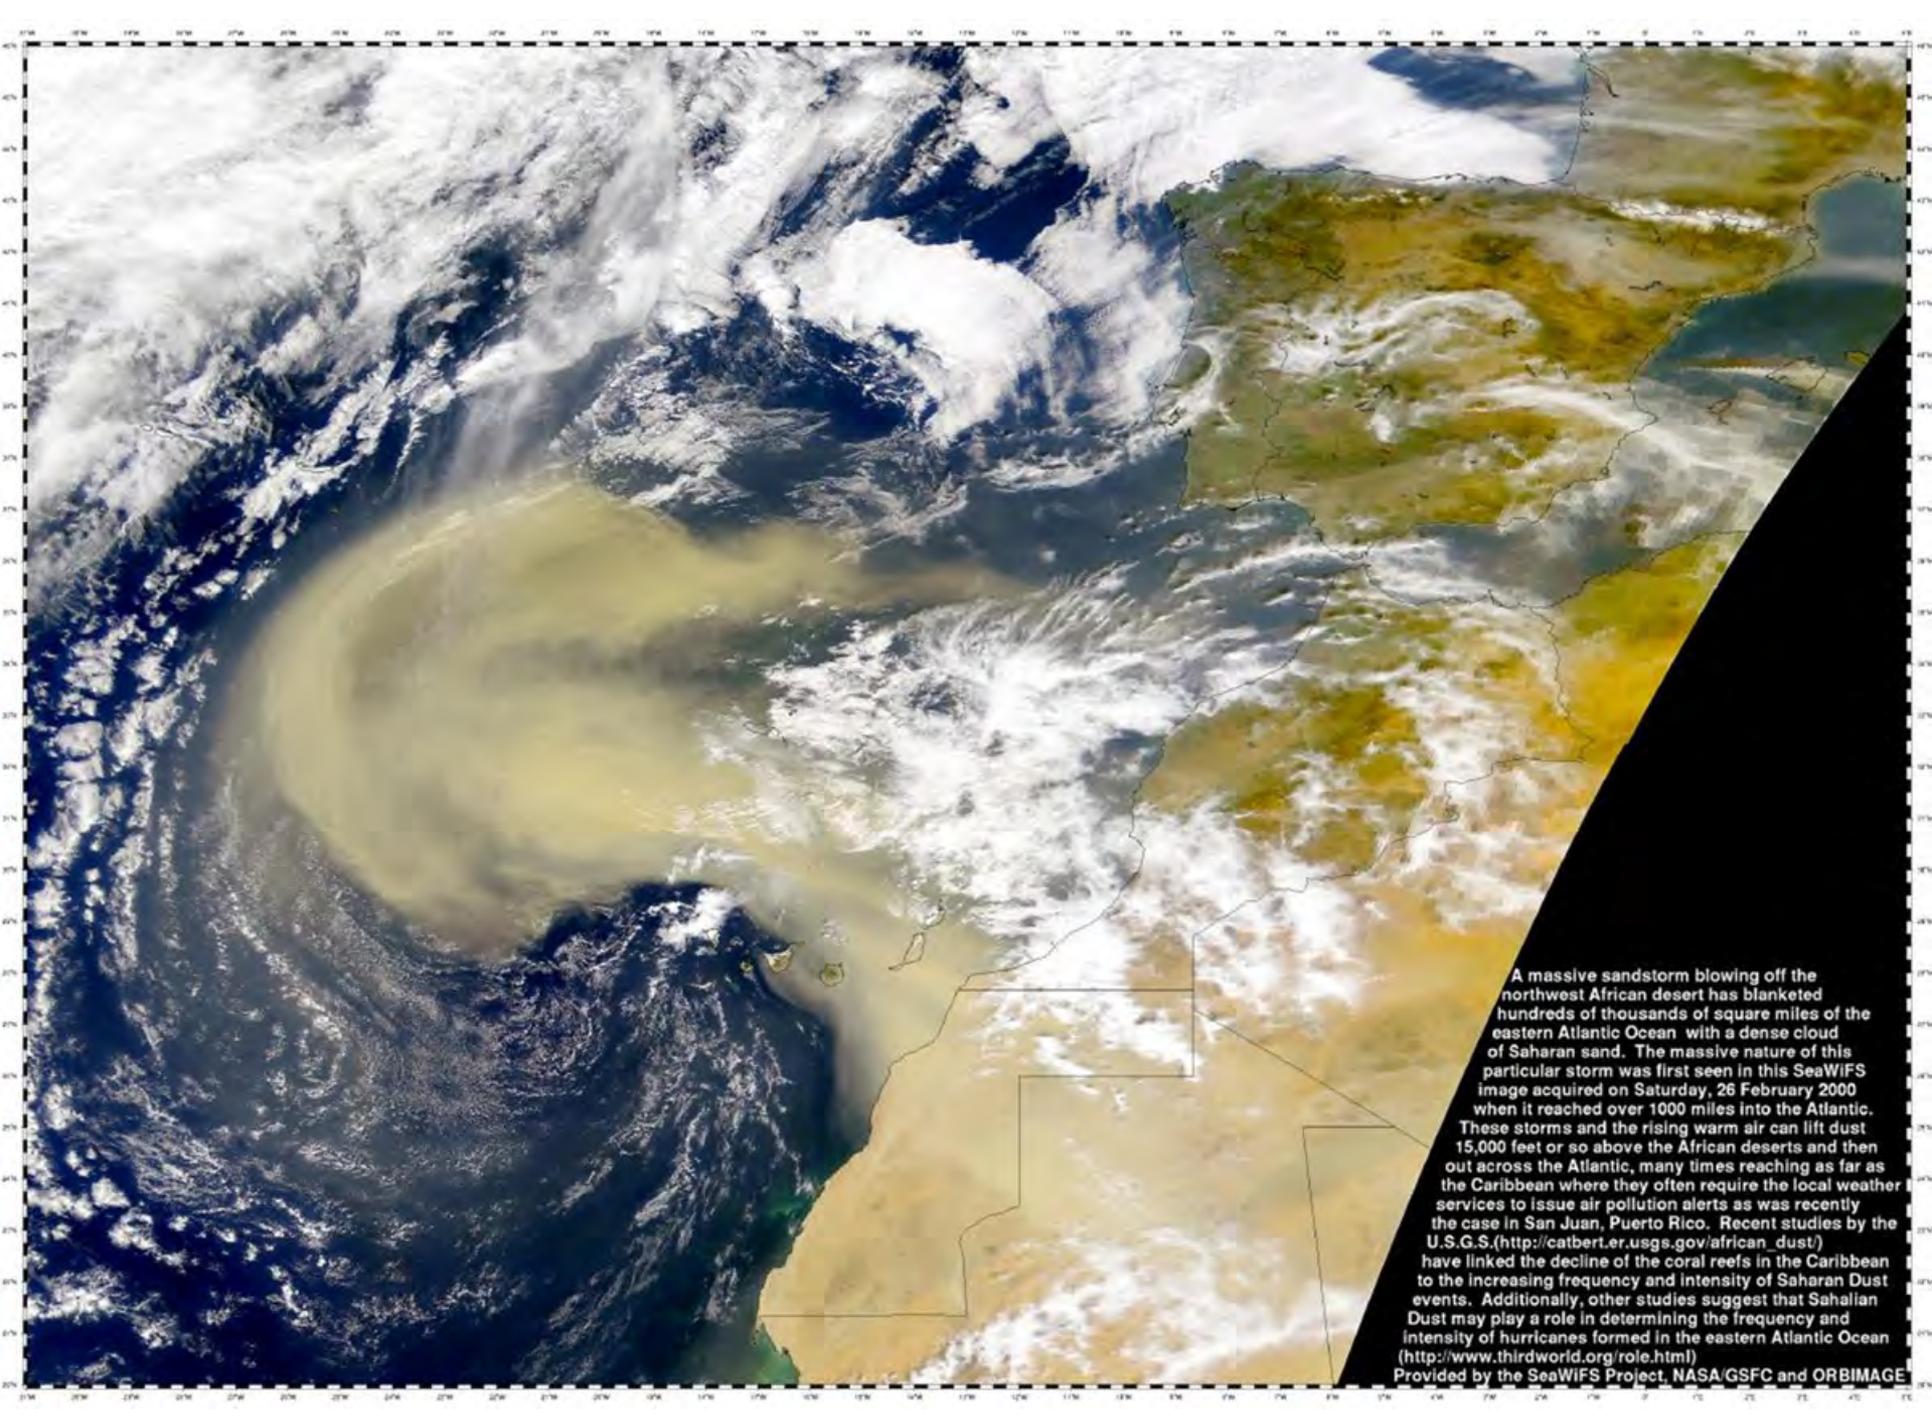
A massive sandstorm blowing off the northwest African desert has blanketed hundreds of thousands of square miles of the eastern Atlantic Ocean with a dense cloud of Saharan sand. The massive nature of this particular storm was first seen in this SeaWiFS image acquired on Saturday, 26 February 2000 when it reached over 1000 miles into the Atlantic. These storms and the rising warm air can lift dust 15,000 feet or so above the African deserts and then out across the Atlantic, many times reaching as far as the Caribbean where they often require the local weather services to issue air pollution alerts as was recently the case in San Juan, Puerto Rico. Recent studies by the U.S.G.S. ([http://catbert.er.usgs.gov/african\\_dust/](http://catbert.er.usgs.gov/african_dust/)) have linked the decline of the coral reefs in the Caribbean to the increasing frequency and intensity of Saharan Dust events. Additionally, other studies suggest that Sahelian Dust may play a role in determining the frequency and intensity of hurricanes formed in the eastern Atlantic Ocean (<http://www.thirdworld.org/role.html>)

Provided by the SeaWiFS Project, NASA/GSFC and ORBIMAGE

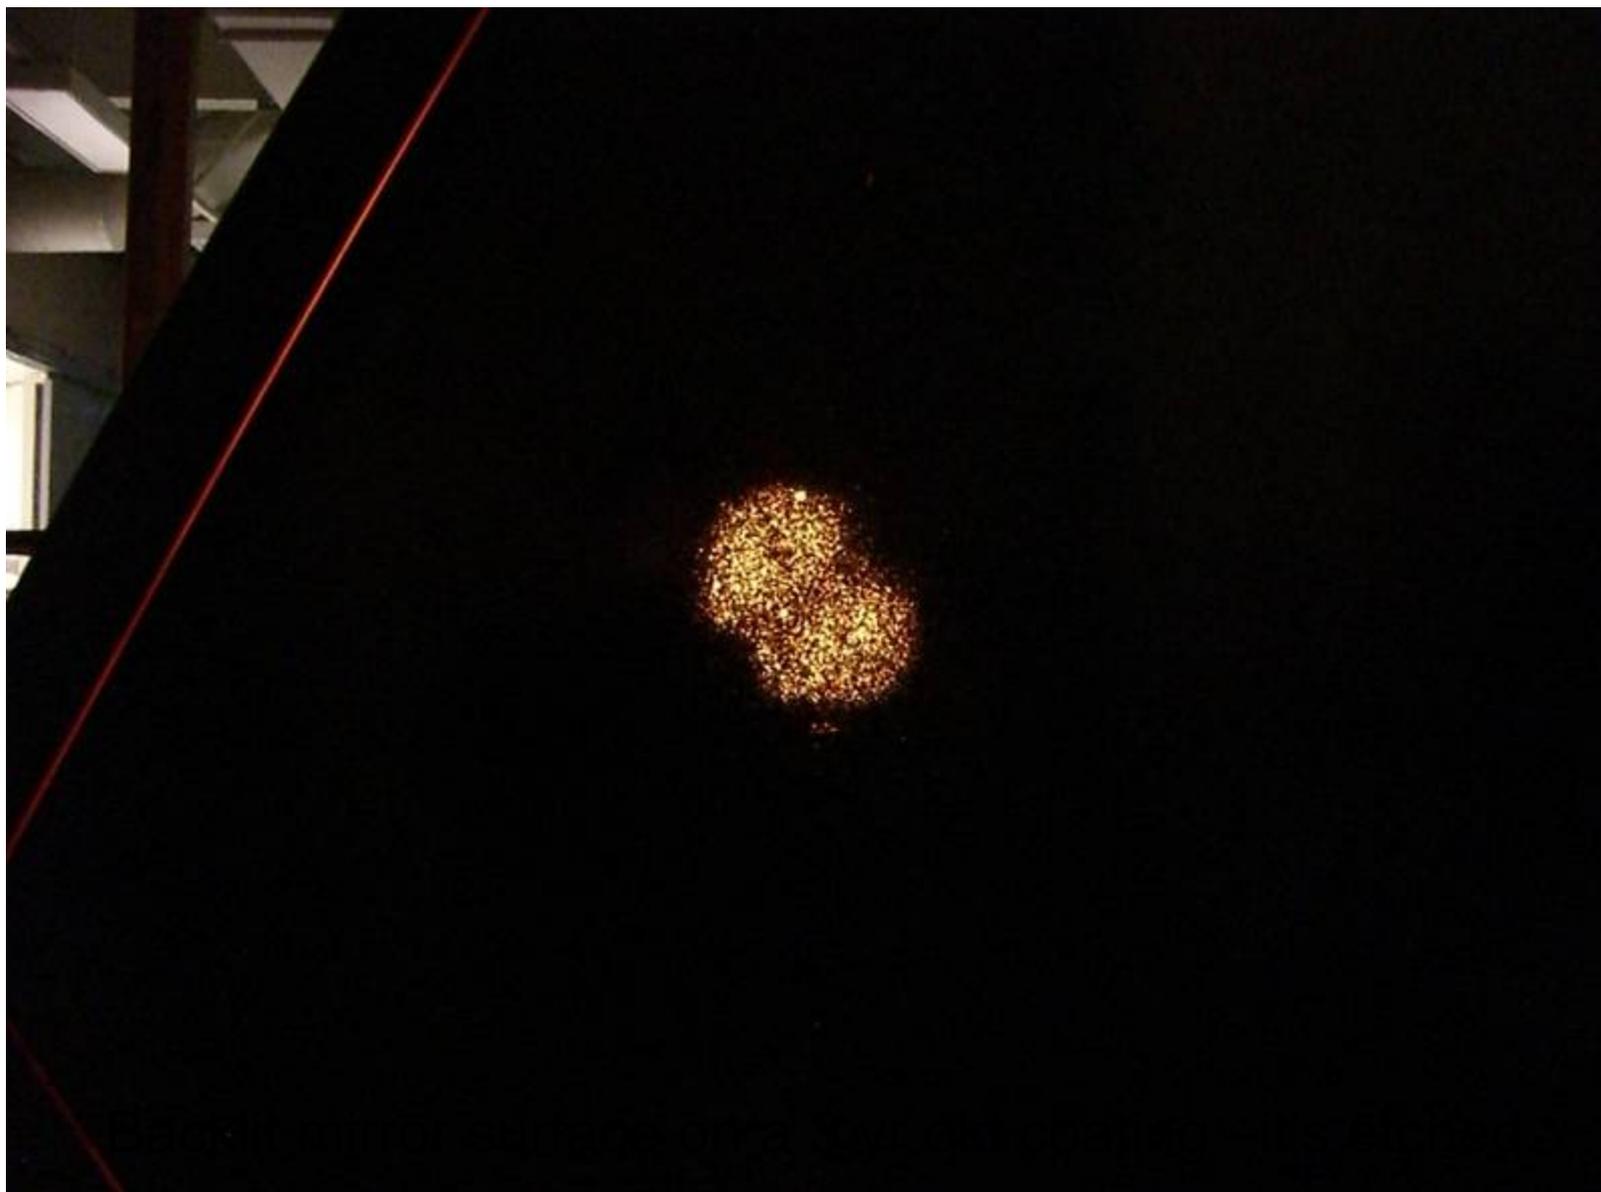
**Flashlight Shining through Keck Primary Mirror**

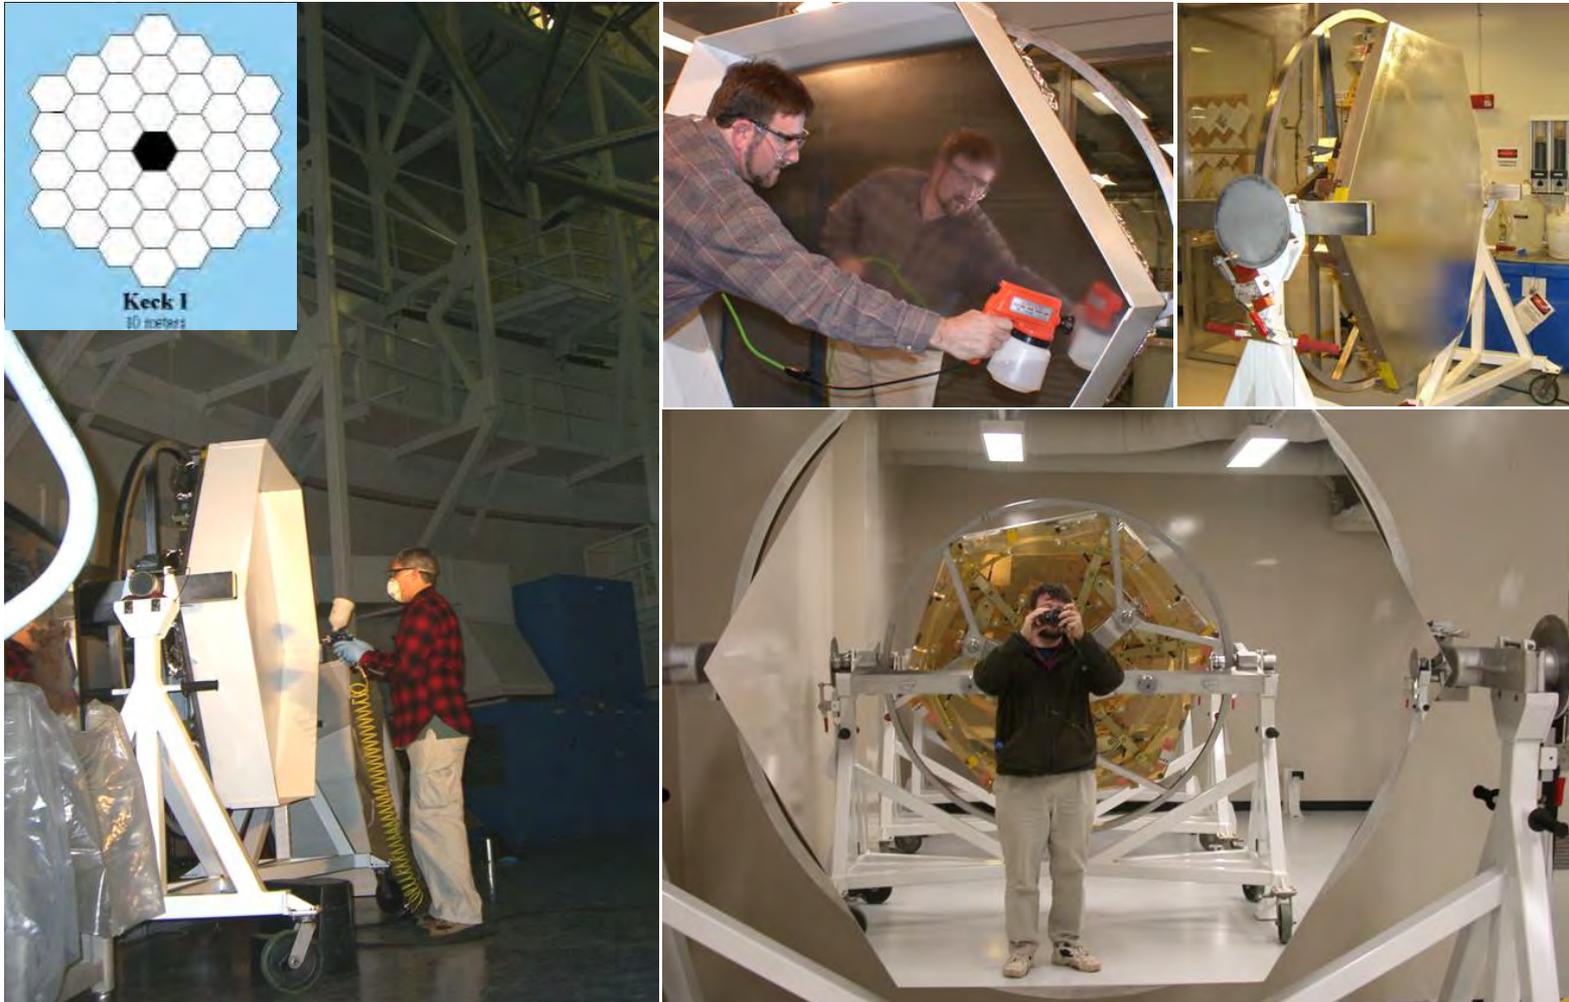
Cleaning one of the 36 segments of the Keck Telescope with Liquid Polymer. When implemented by Keck Observatory management, this polymer cleaning process will open the window on a revolutionary method for cleaning astronomical telescopes.

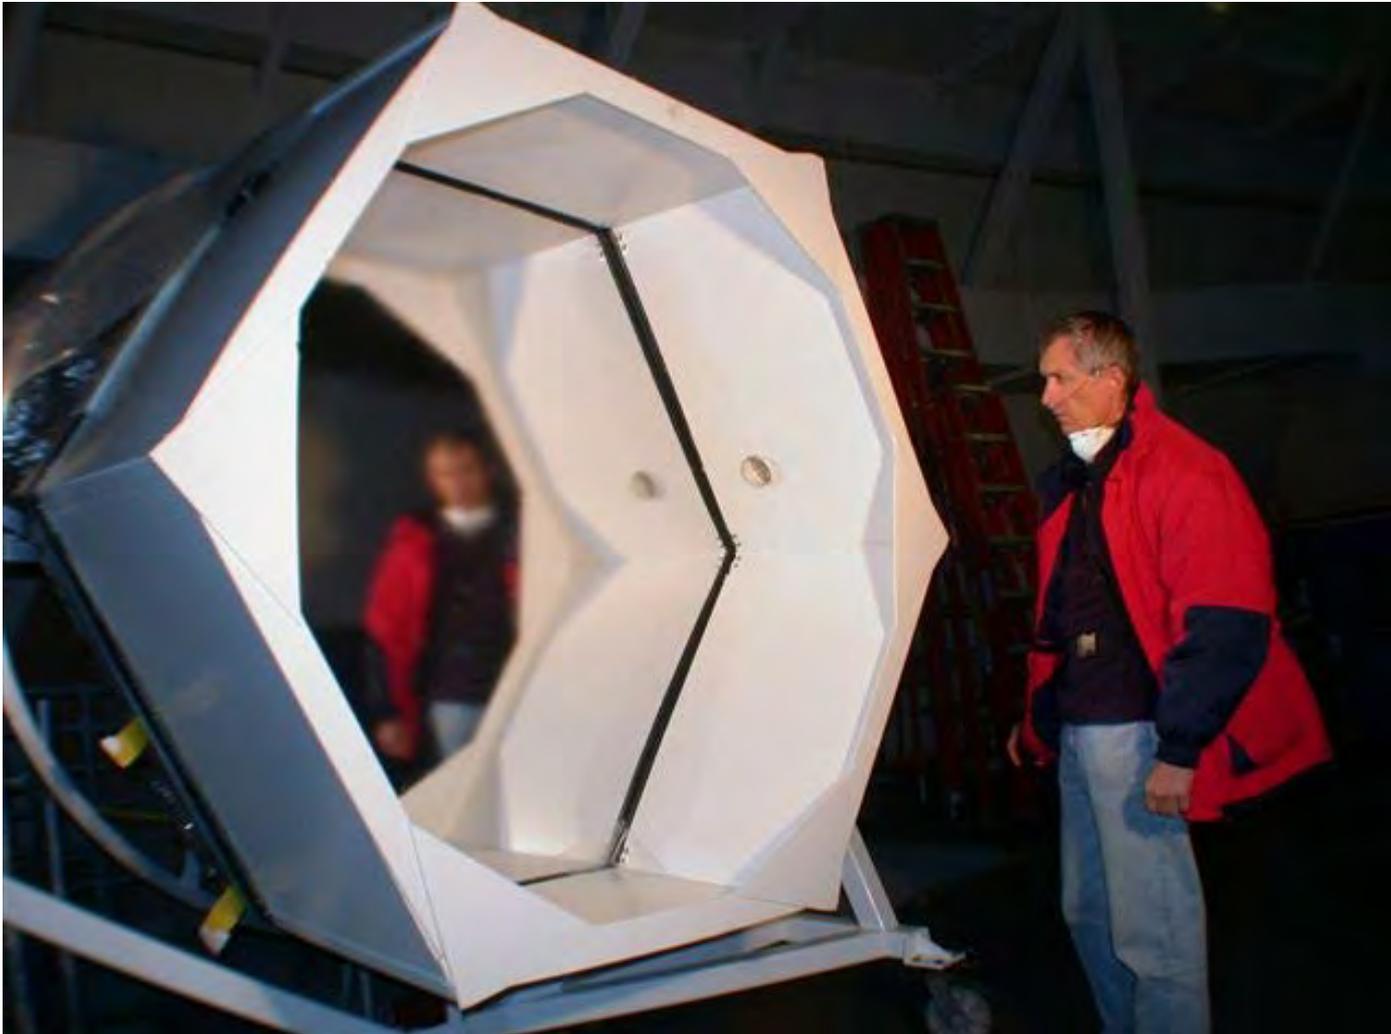
Spray  
Application of  
First Contact  
Polymer to  
Keck 6ft  
hexagonal  
mirror.

In the Dome: 0° C  
and 13,800 ft.

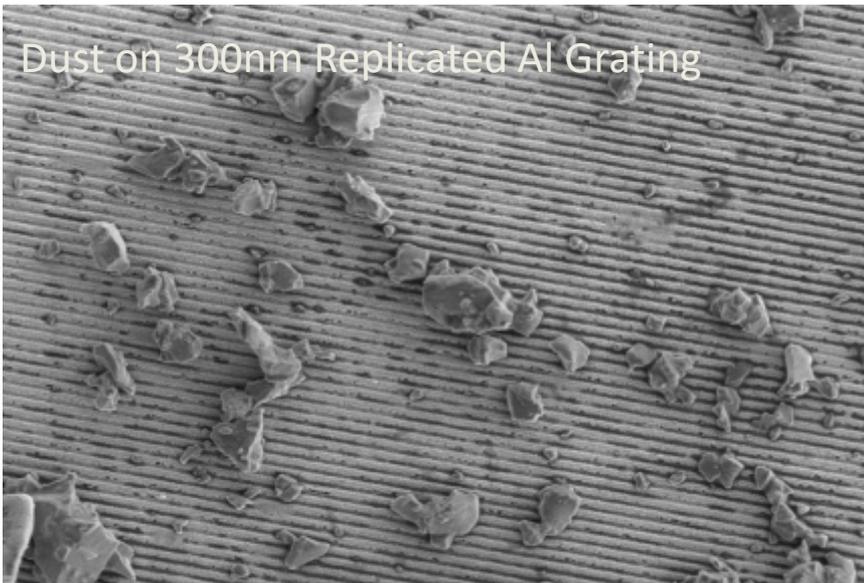
Dust on 300nm Replicated Al Grating

SE 10-Mar-04 S4300N WD 4.9mm 1.3kV x6.0k 5um

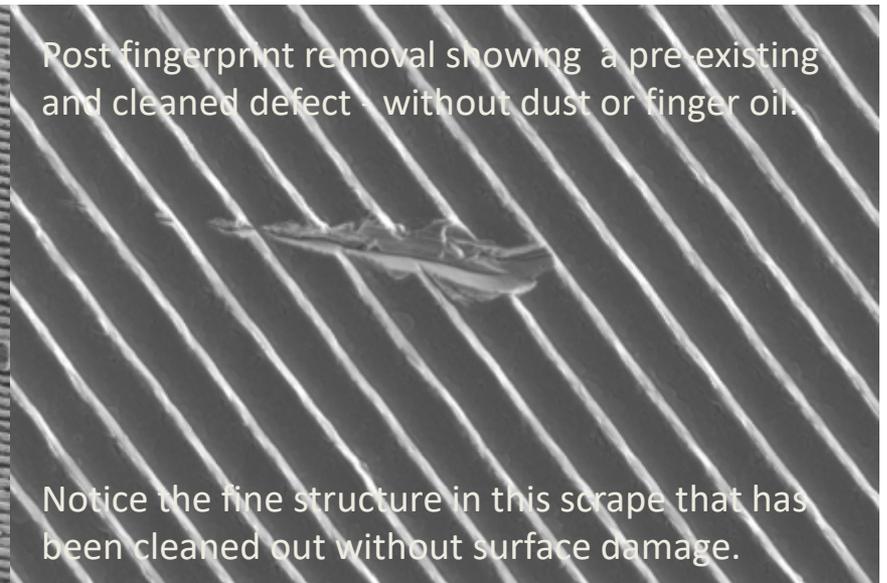
Post fingerprint removal showing a pre-existing and cleaned defect - without dust or finger oil.

Notice the fine structure in this scrape that has been cleaned out without surface damage.

SE 10-Mar-04 S4300N WD20.5mm 3.0kV x5.0k 10um

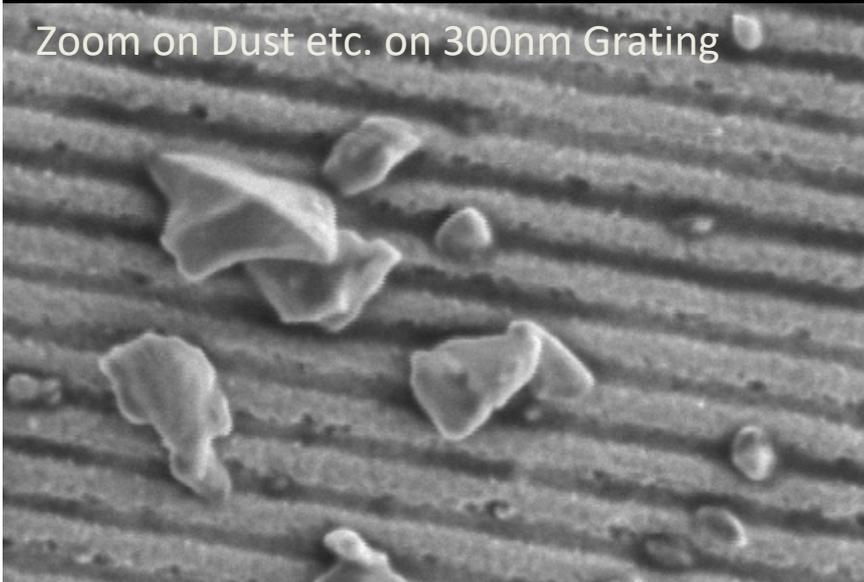
Zoom on Dust etc. on 300nm Grating

SE 10-Mar-04 S4300N WD 4.9mm 1.3kV x30k 1um

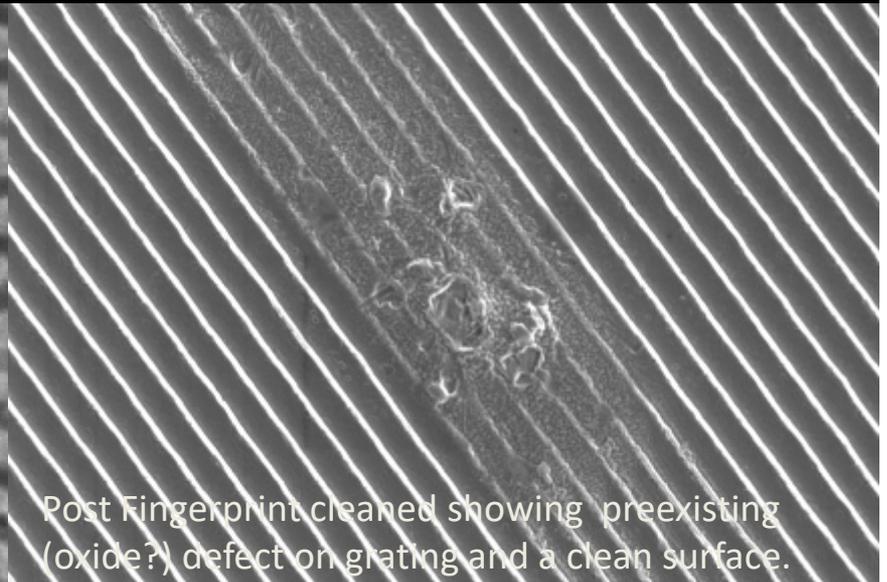
Post Fingerprint cleaned showing preexisting (oxide?) defect on grating and a clean surface.

SE 10-Mar-04 S4300N WD20.5mm 3.0kV x3.0k 10um

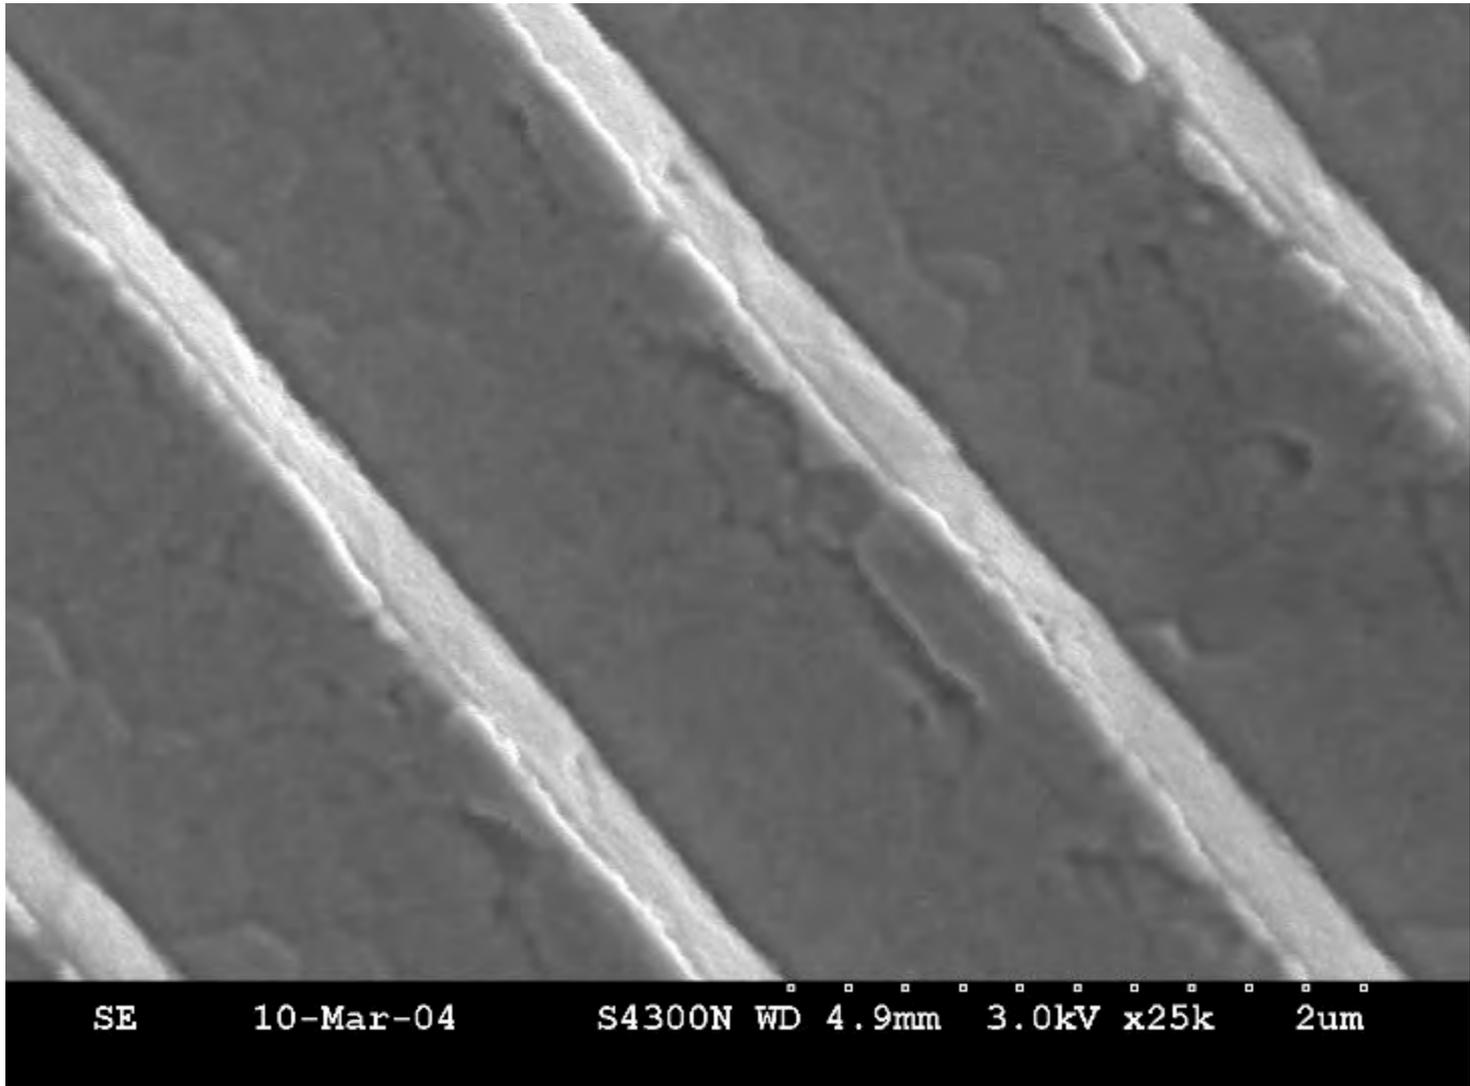
Post Fingerprint, Cleaned Surface on Hitachi S-4300 Cold FE-SEM

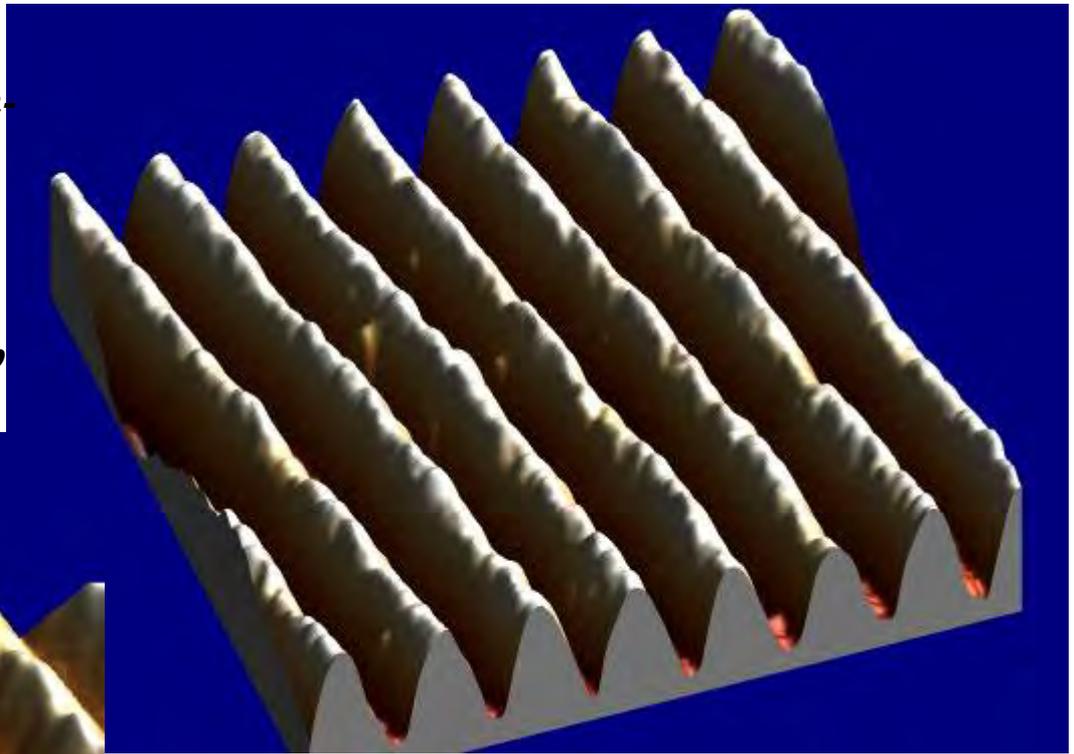
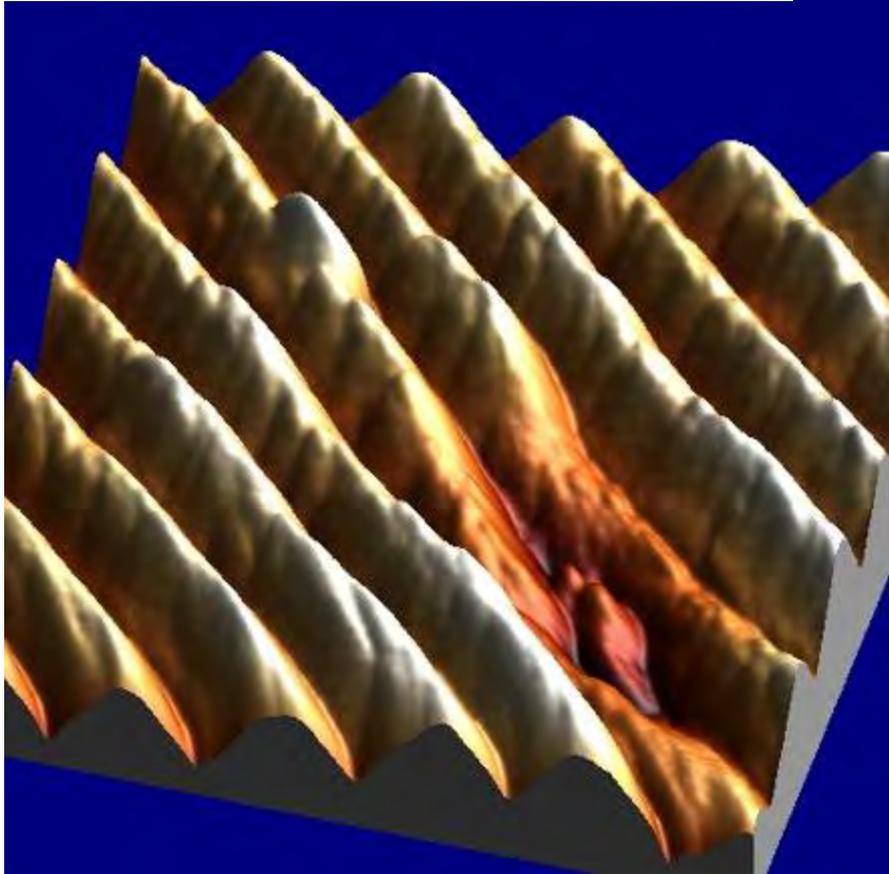
*Images on this poster are from a TopoMetrix Explorer AFM operated in non-contact mode using high resonance frequency cantilever (Si cantilever Model 1650, resonance frequency ~229.6 kHz, Scan size 2.5x2.5  $\mu\text{m}$ , scan rate 2.5  $\mu\text{m}/\text{sec}$ . Images taken with high aspect ratio FIB tip did not show a noticeable difference.*

*False color images obtained after applying a fingerprint to the 300nm grating, applying polymer & removing the film after allowing it to dry. Notice preexisting defect at left. Some of these gratings were “seconds” from the manufacture.*

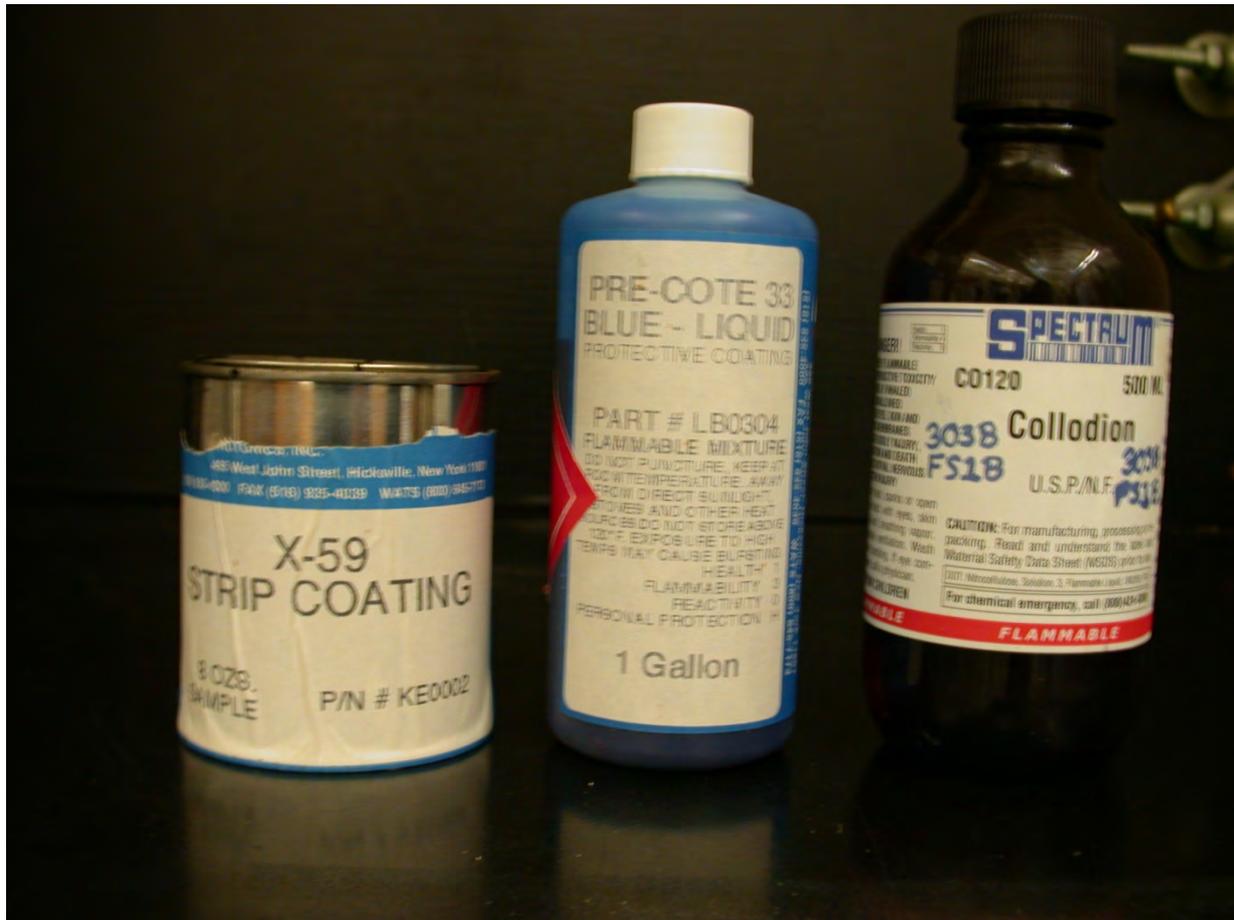
# Comparison of some Commercial Strip Coatings

Protection while grinding. Not Cleaning.

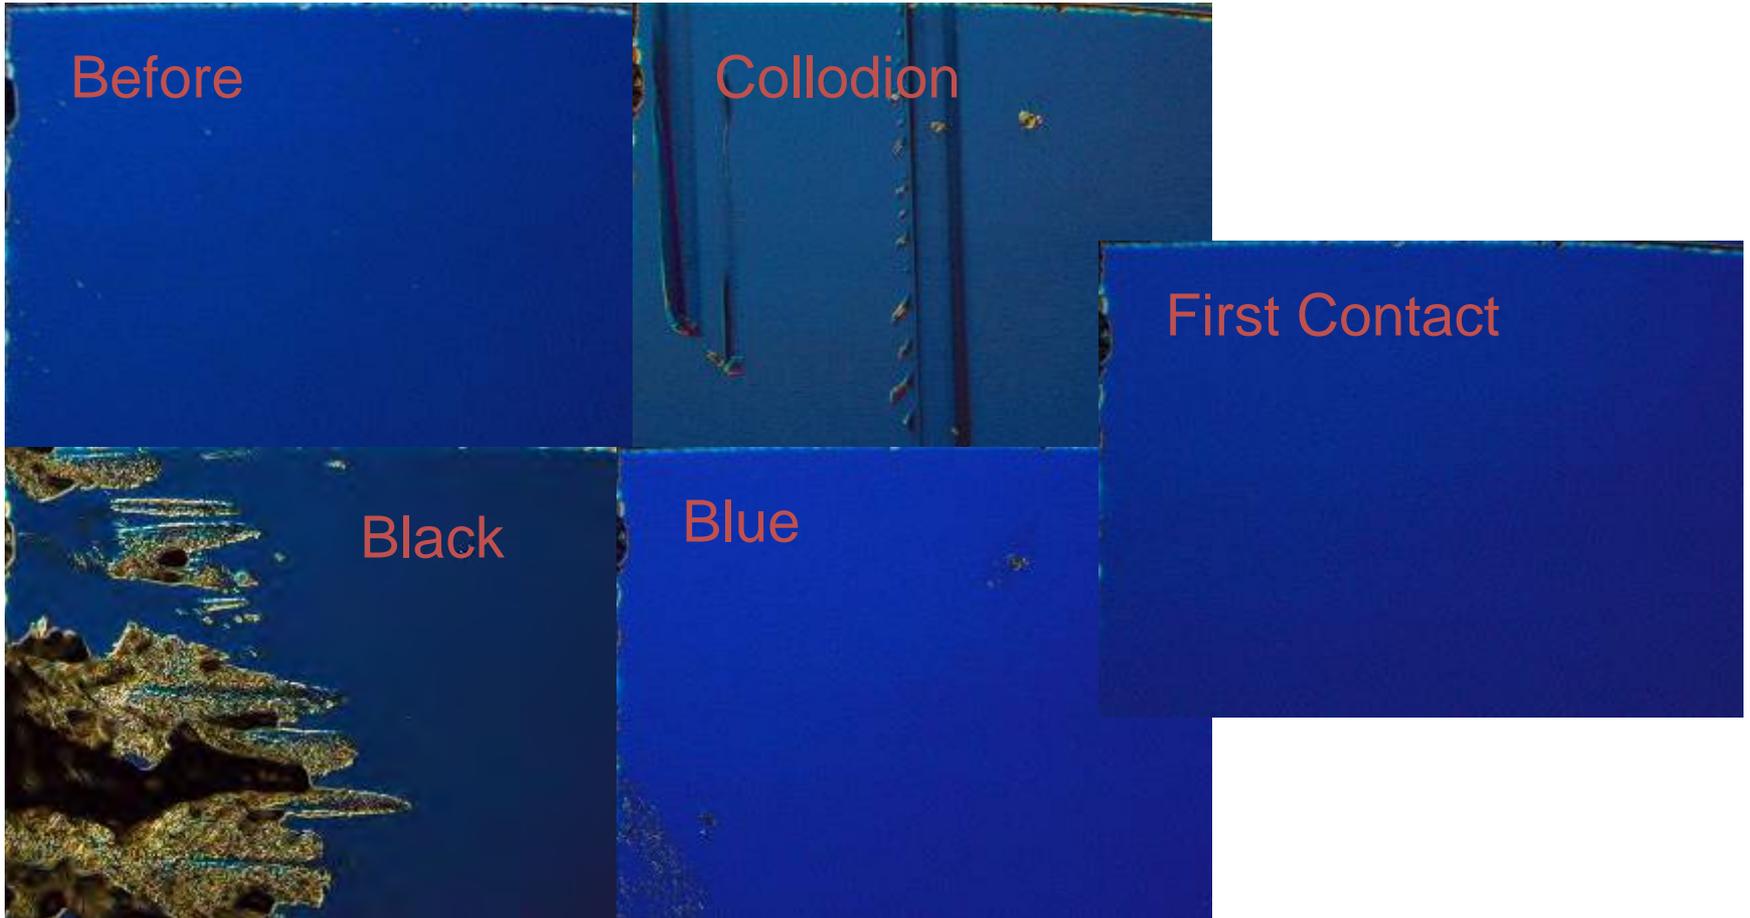
# 50X Nomarski Images

First Contact Polymer:  
Completely Clean using  
Nomarski Interference  
Microscopy
