Subject: NASA White Sands Test Facility (WSTF) Septic Tanks (SWMU 21 – 27) Investigation
Work Plan and WSTF Septic Tanks Historical Information Summary

WSTF Septic Tanks (SWMU 21 – 27) Investigation Work Plan

NASA Johnson Space Center White Sands Test Facility
WSTF Septic Tanks (SWMU 21 – 27) Investigation Work Plan

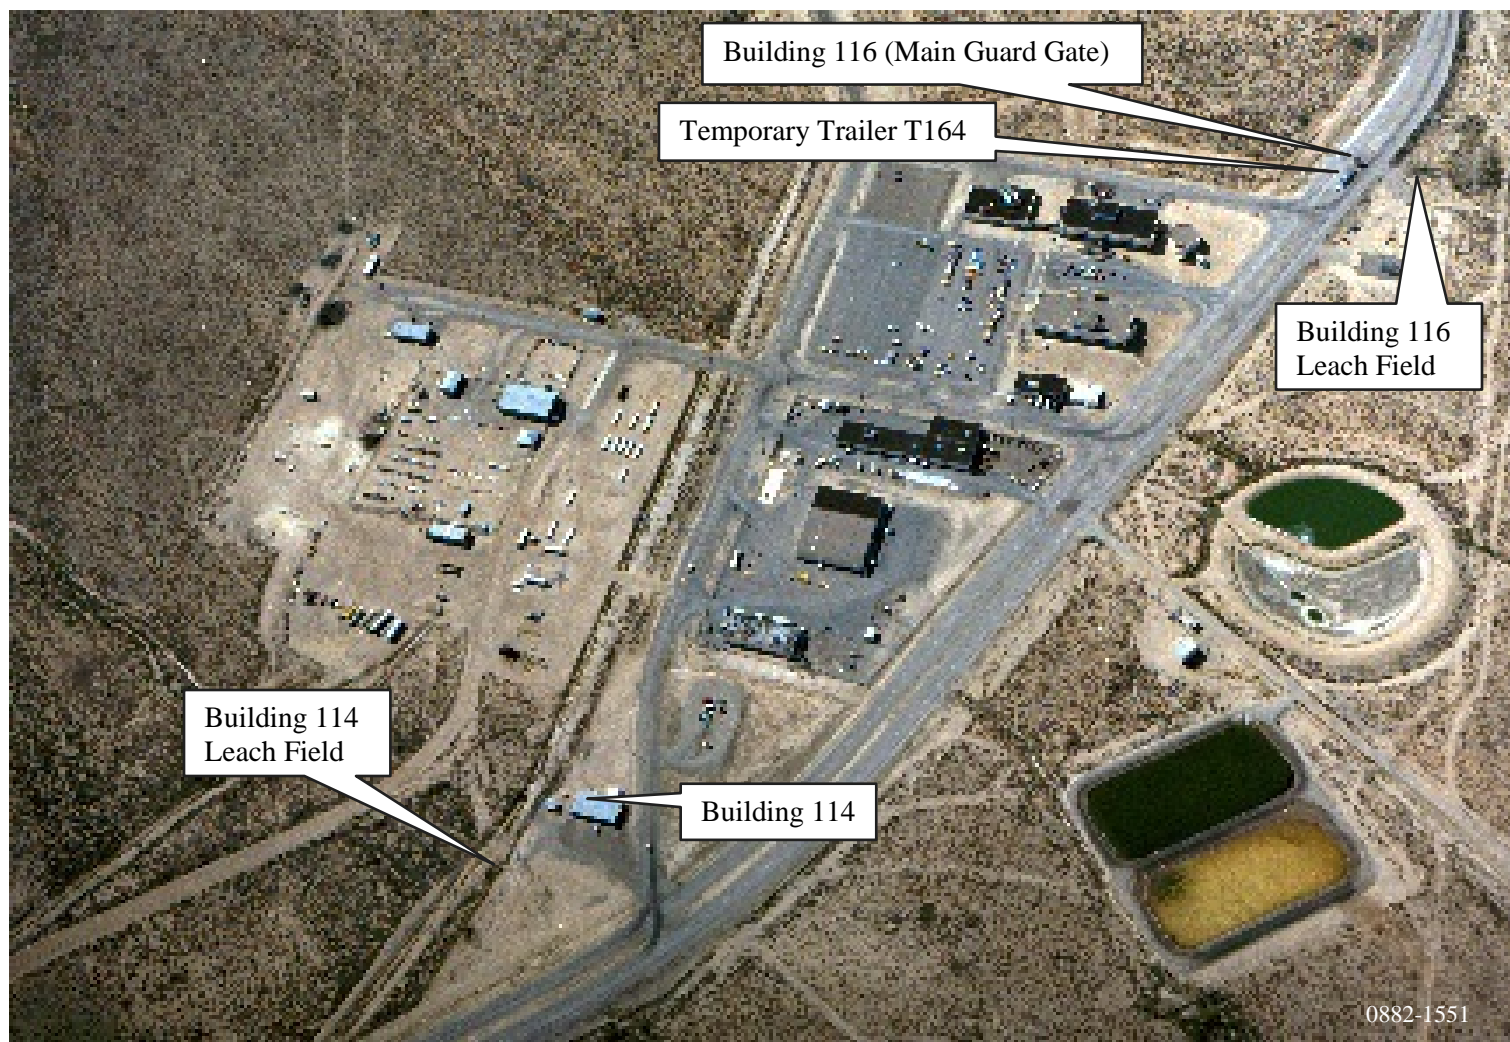
WSTF 100 Area (1982) – view to the south

This photograph shows the WSTF 100 Area, Building 114, and Building 116 Areas in August 1982. It was taken during the time the plate-maker machine chemicals were being discharged to the Building 114 septic tank. Building 119 is not present.

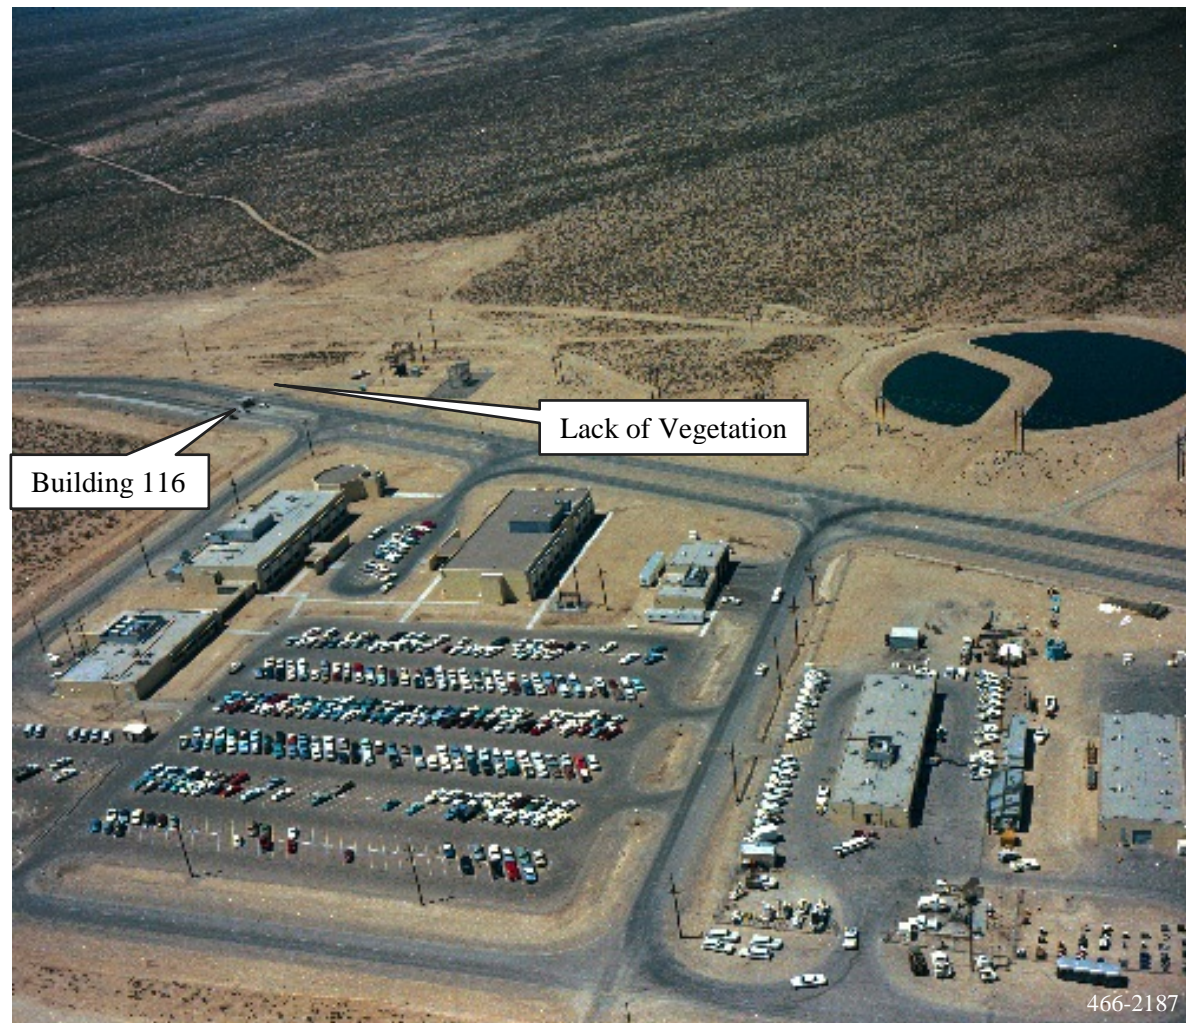
Figure B.4

WSTF 100 Area Showing Building 116 (Main Guard Gate) Area (1966) – view to the west

This photograph shows the WSTF 100 Area (and Building 116, the Main Guard Gate) in April 1966. The temporary trailer T164 and the Building 116 (Main Guard Gate) septic tank were not yet installed.

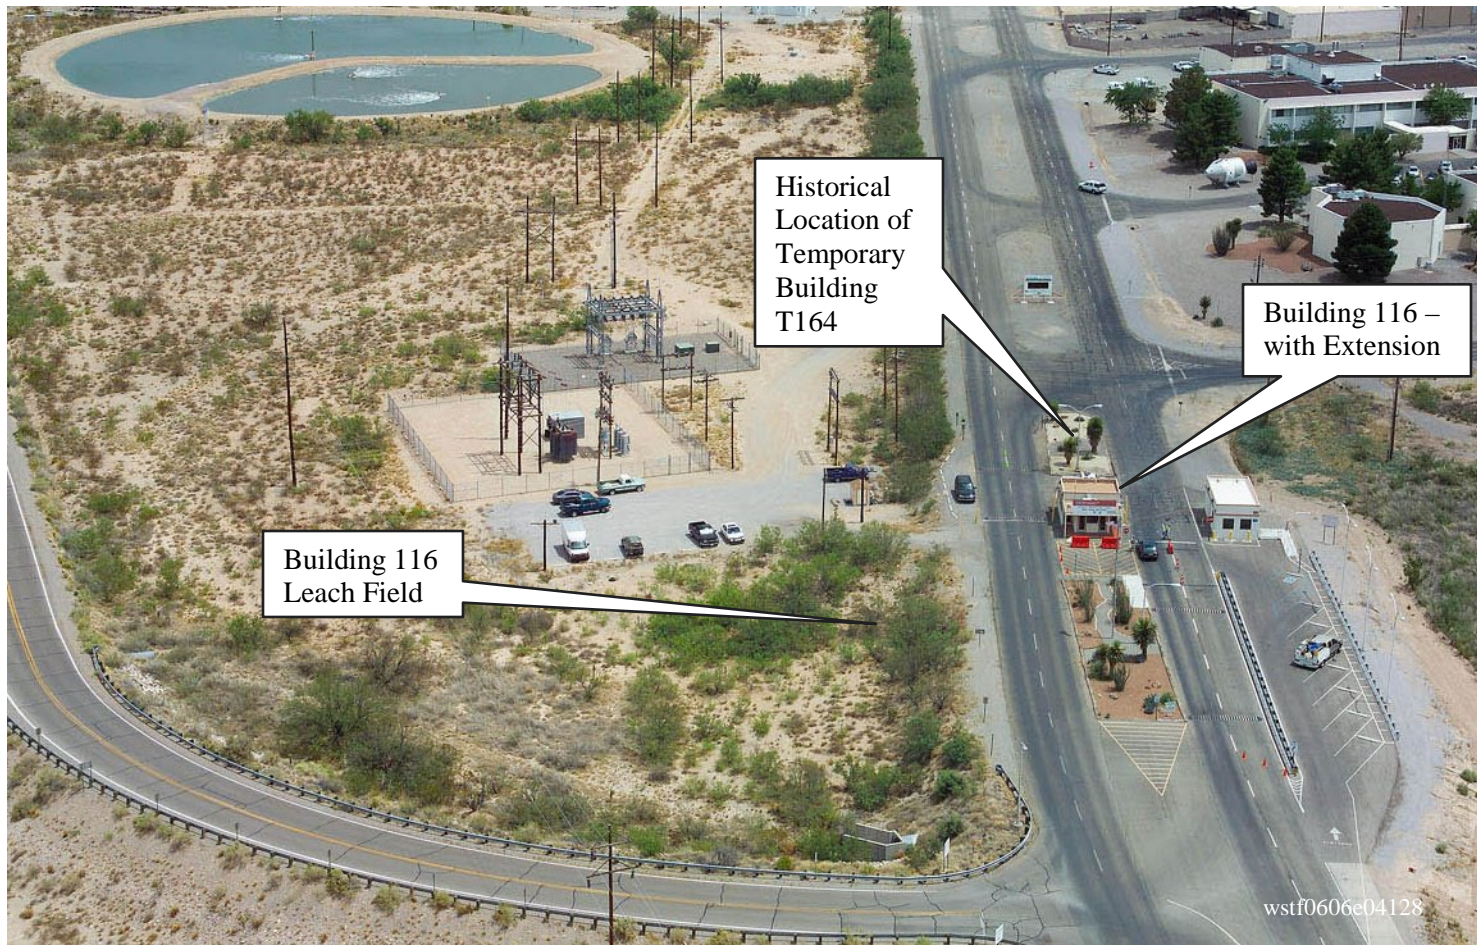
Figure B.8 WSTF Building 116 (Main Guard Gate) Area (2006) – view to the north

This photograph shows the Building 116 (Main Guard Gate) Area in June 2006. The large size of the vegetation in the septic tank/leach field area may indicate this tank has likely never been pumped out.

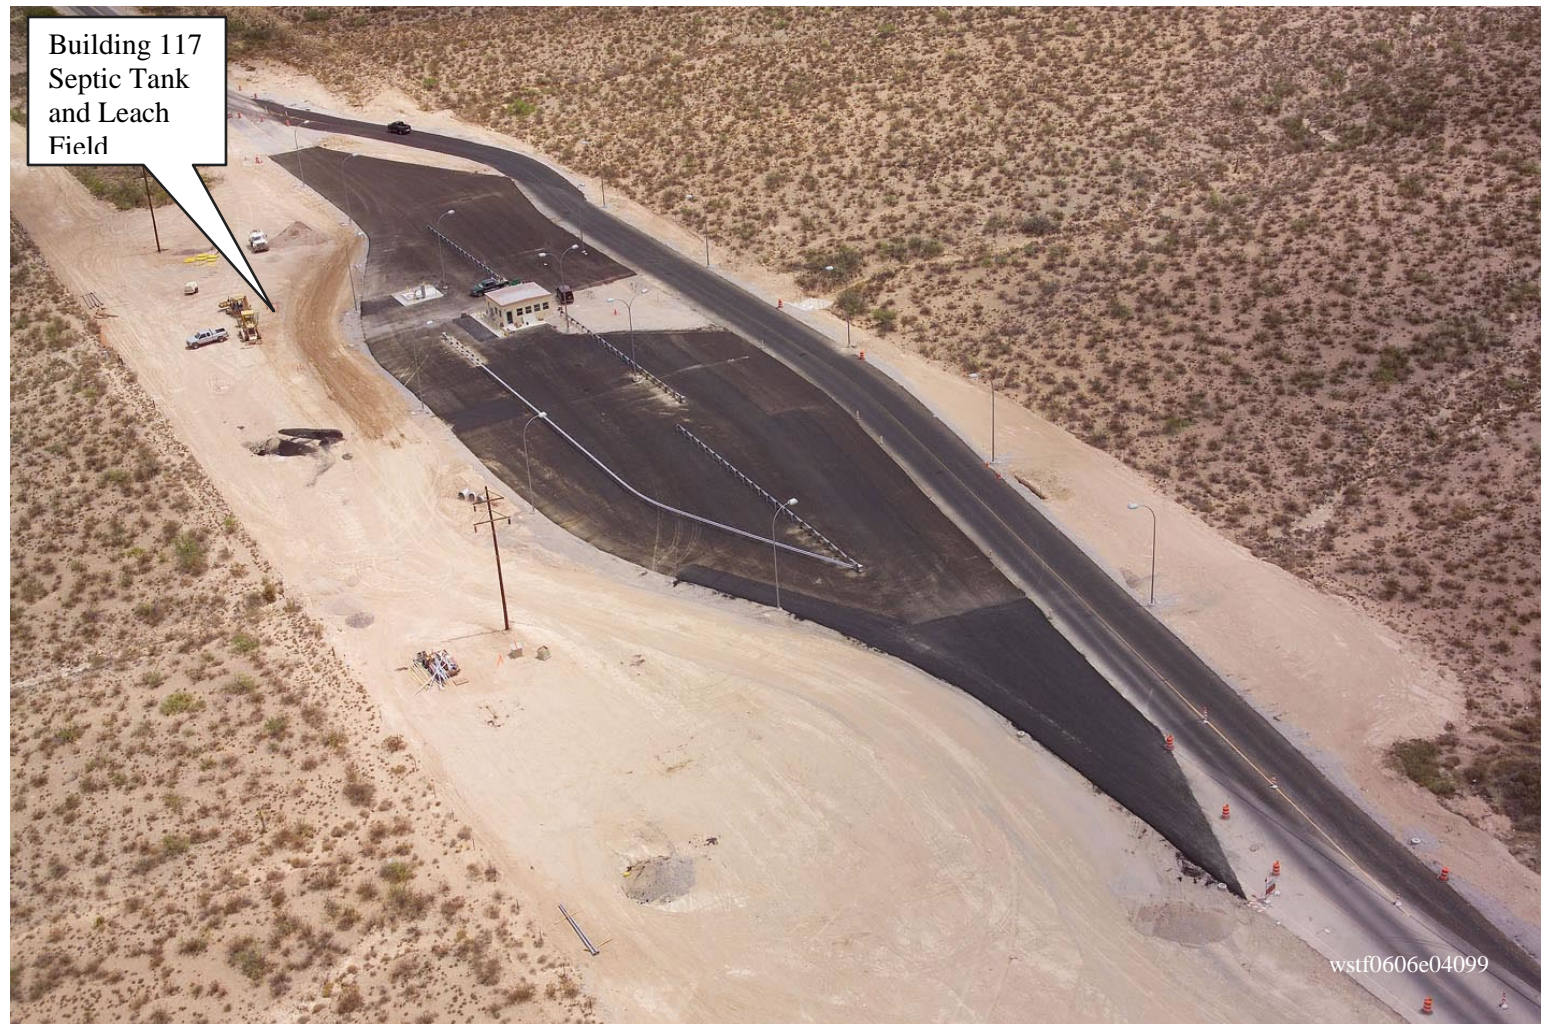
Figure B.9

WSTF Building 117 (Forward Guard Gate) Area (2006) – view to the northeast

This photograph shows the WSTF Building 117 (Forward Guard Gate) Area in June 2006, during construction of the area. The Building 117 septic tank and leach field were installed adjacent to the road under construction in this photograph.

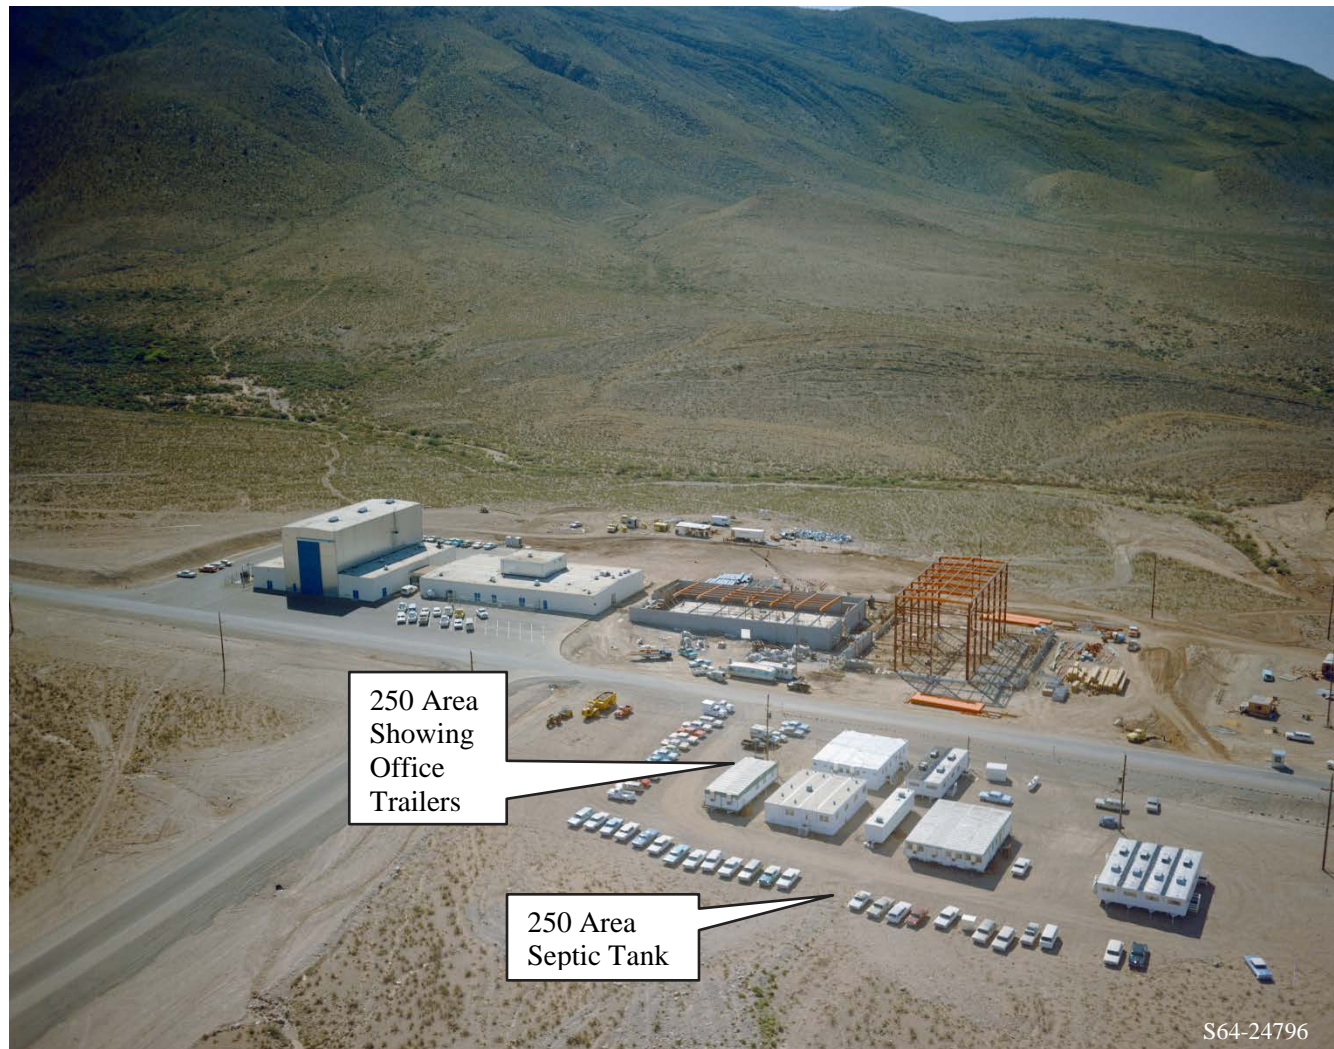
Figure B.10

WSTF 200 Area in Construction (1964) – view to the east

This photograph shows the WSTF 200 Area circa 1964, prior to completion of Building 201 and the South Highbay. There are temporary trailers located in the 250 Area.

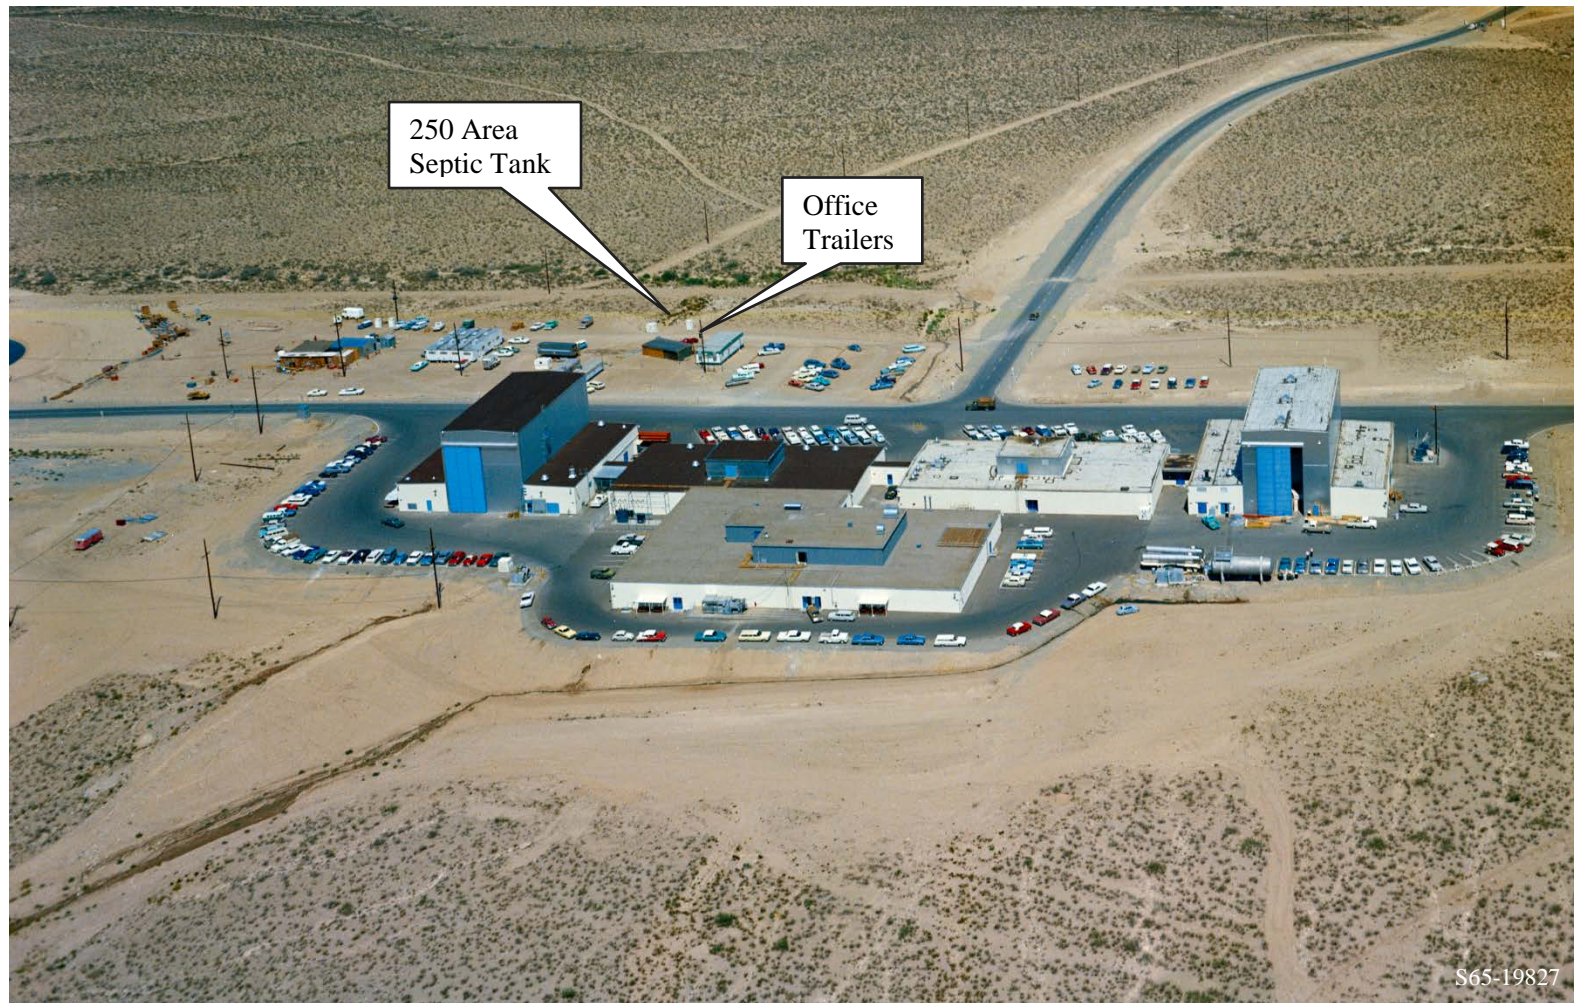
Figure B.13

WSTF 200 Area (1965) – view to the west

This photograph shows the 200 Area circa 1965. Building 201, the South Highbay, and Building 203 have been completed and there are fewer trailers located in the 250 Area.

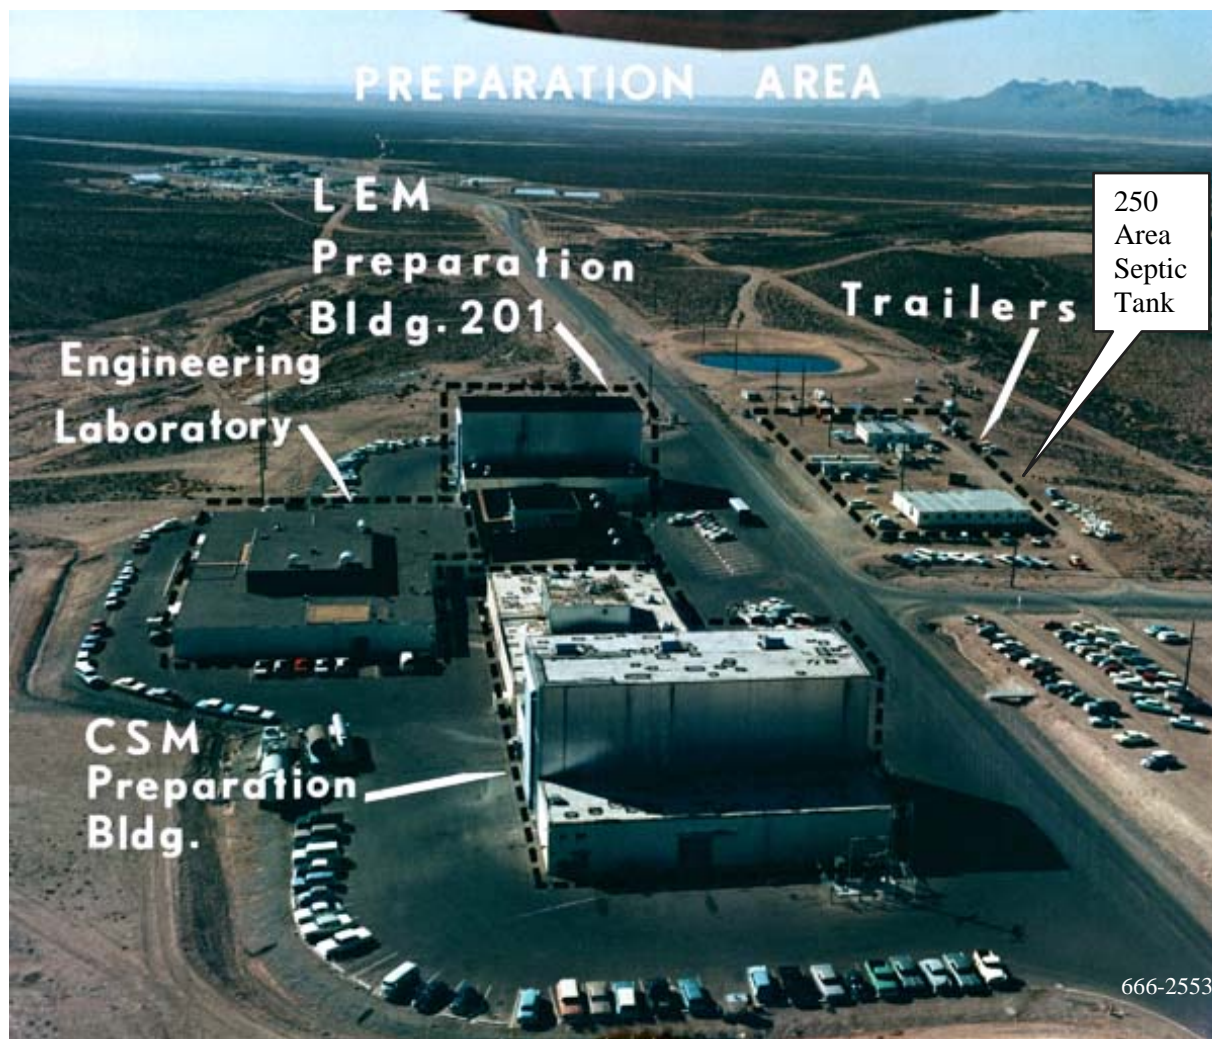
Figure B.14

WSTF 200 Area (June 1966) – view to the southwest

This photograph shows the 200 Area in June 1966. The 250 Area is at the right of the photograph. The number of office trailers located in the 250 Area has increased again compared to the 1965 photograph, indicating that use of the 250 Area continued after completion of the 200 Area main complex.

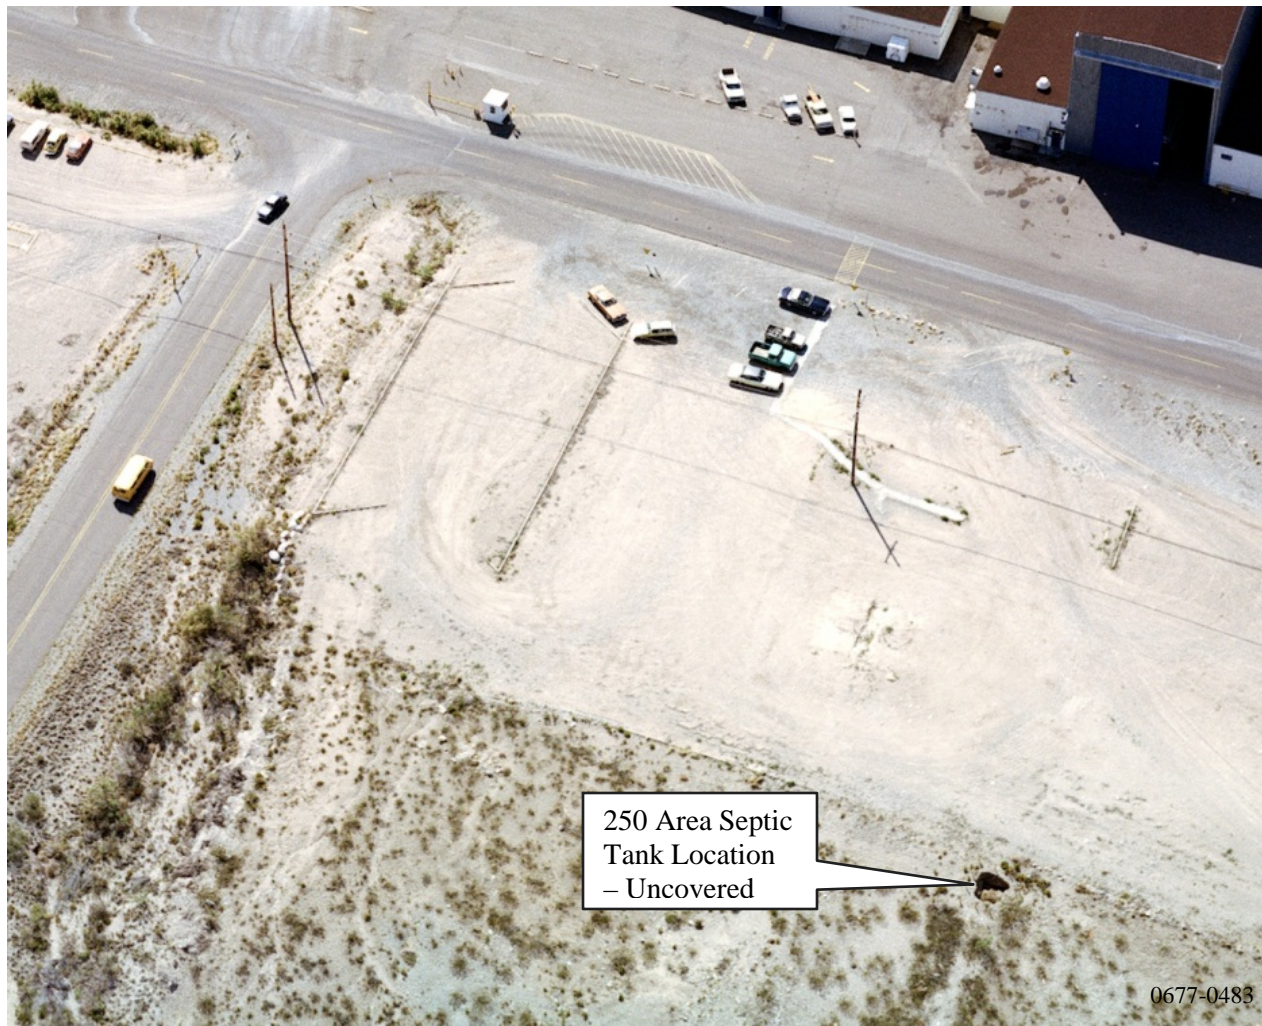
WSTF 250 Area (June 1977) – view to the east

This photograph shows the 250 Area in June 1977. The 250 Area septic tank appears to be uncovered. It is unknown if this tank was excavated or if the soil collapsed above the tank. Also notice Building 251 has been removed. This building was later moved between Buildings 250 and 252.

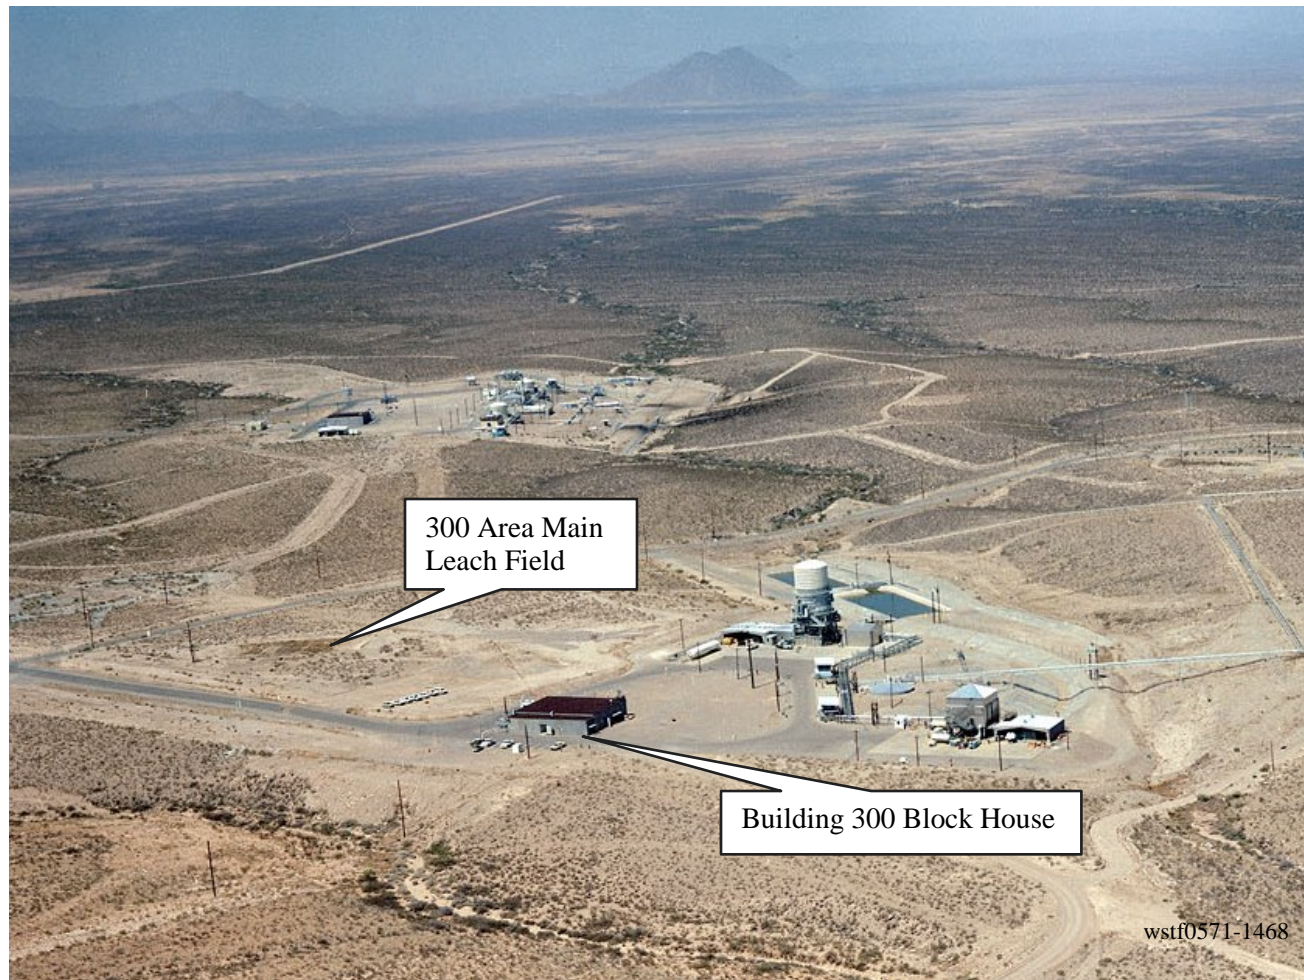
Figure B.19 **WSTF 300 Area Main Septic Tank Area (1971) – view to the west**

This photograph shows the WSTF 300 Area in May 1971. The rectangular area with increased vegetation growth illustrates the location of the 300 Area main septic tank leach field.

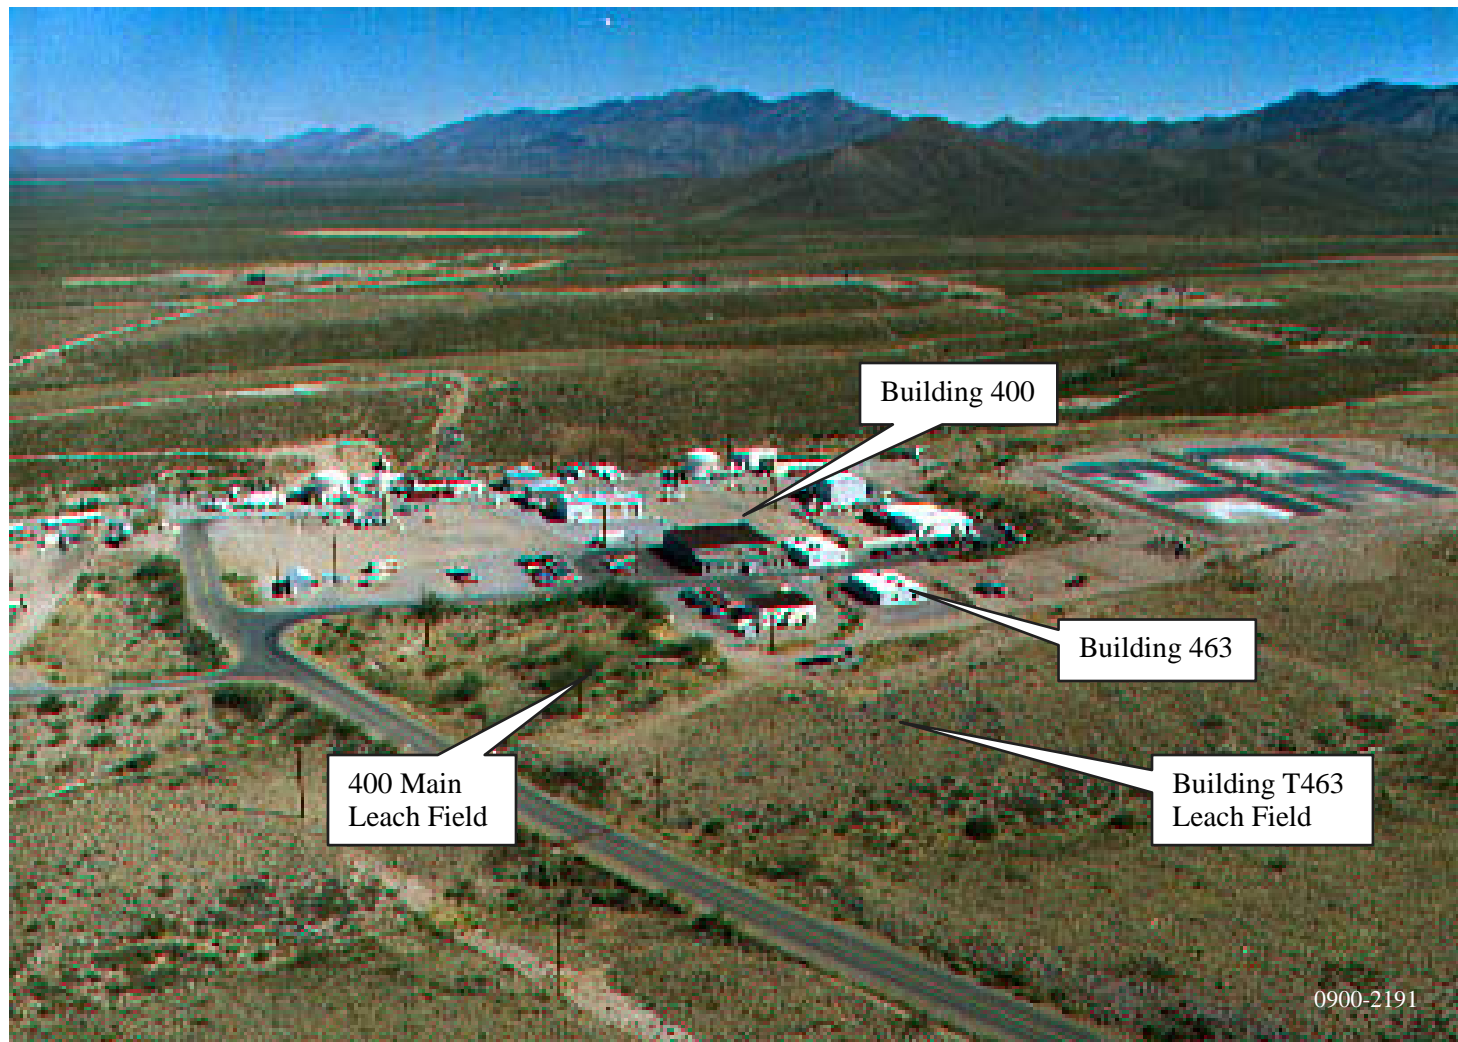
Figure B.29

WSTF 400 Area (2000) – view to the north

This photograph shows the 400 Area main and the temporary Building T463 septic tank systems in September 2000. Building T463 (not shown in this photograph) was in use from June 1992 to April 1994, when the temporary trailer was removed.

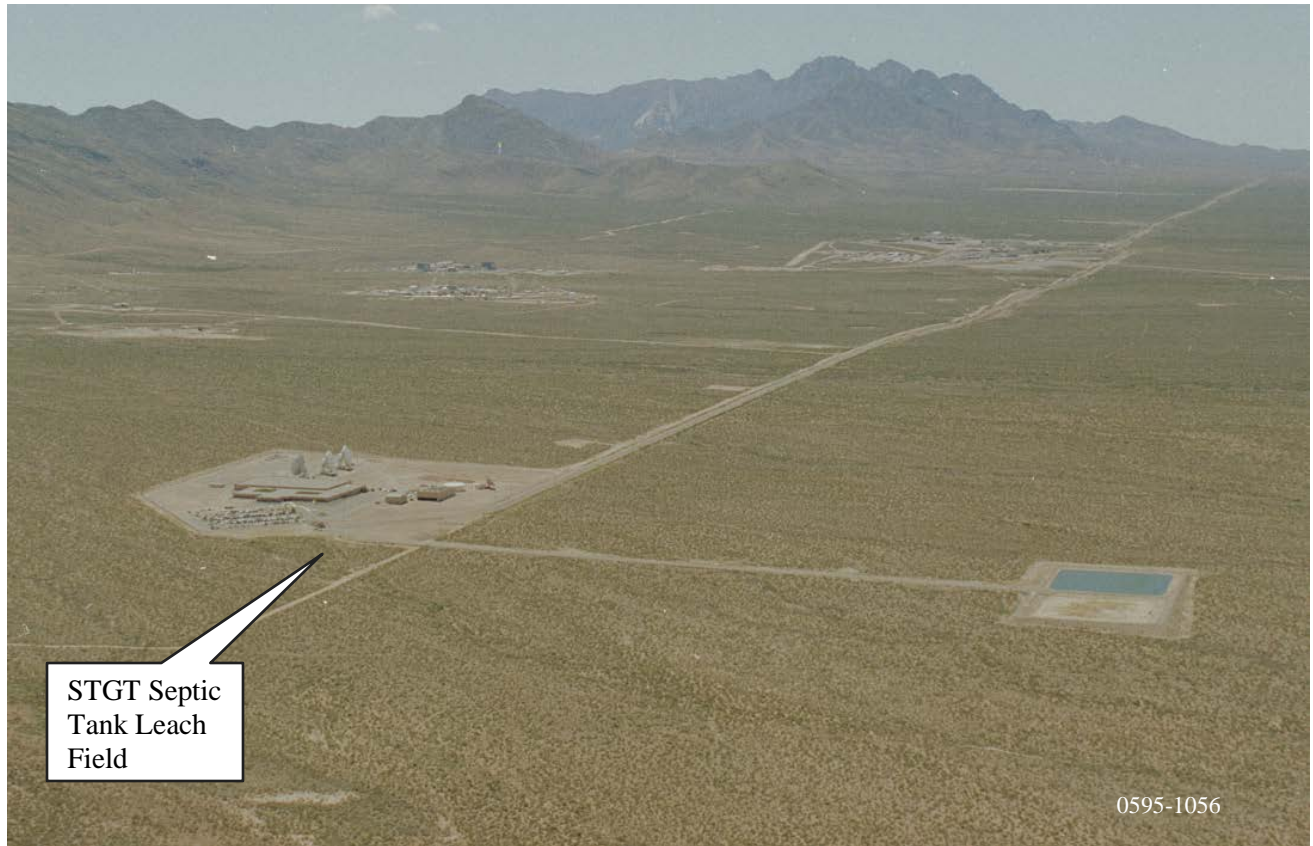
Figure B.32

STGT Area (1995) – view to the southeast

This photograph shows the STGT area in May 1995. A photograph could not be located of the STGT septic tank area during use of the septic tank system. (The STGT septic system was in use from 1989 to 1991).
