Subject: Response to Approval with Modifications Revised WSTF Septic Tanks  
(SWMUs 21-27) Investigation Report

## Comments for Approval with Modifications of the Revised WSTF Septic Tanks (SWMUs 21-27) Investigation Report

# **White Sands Test Facility Industrial Areas and Septic Tanks**

# Building 114 Septic Tank (SWMU 22) Site Conceptual Exposure Model

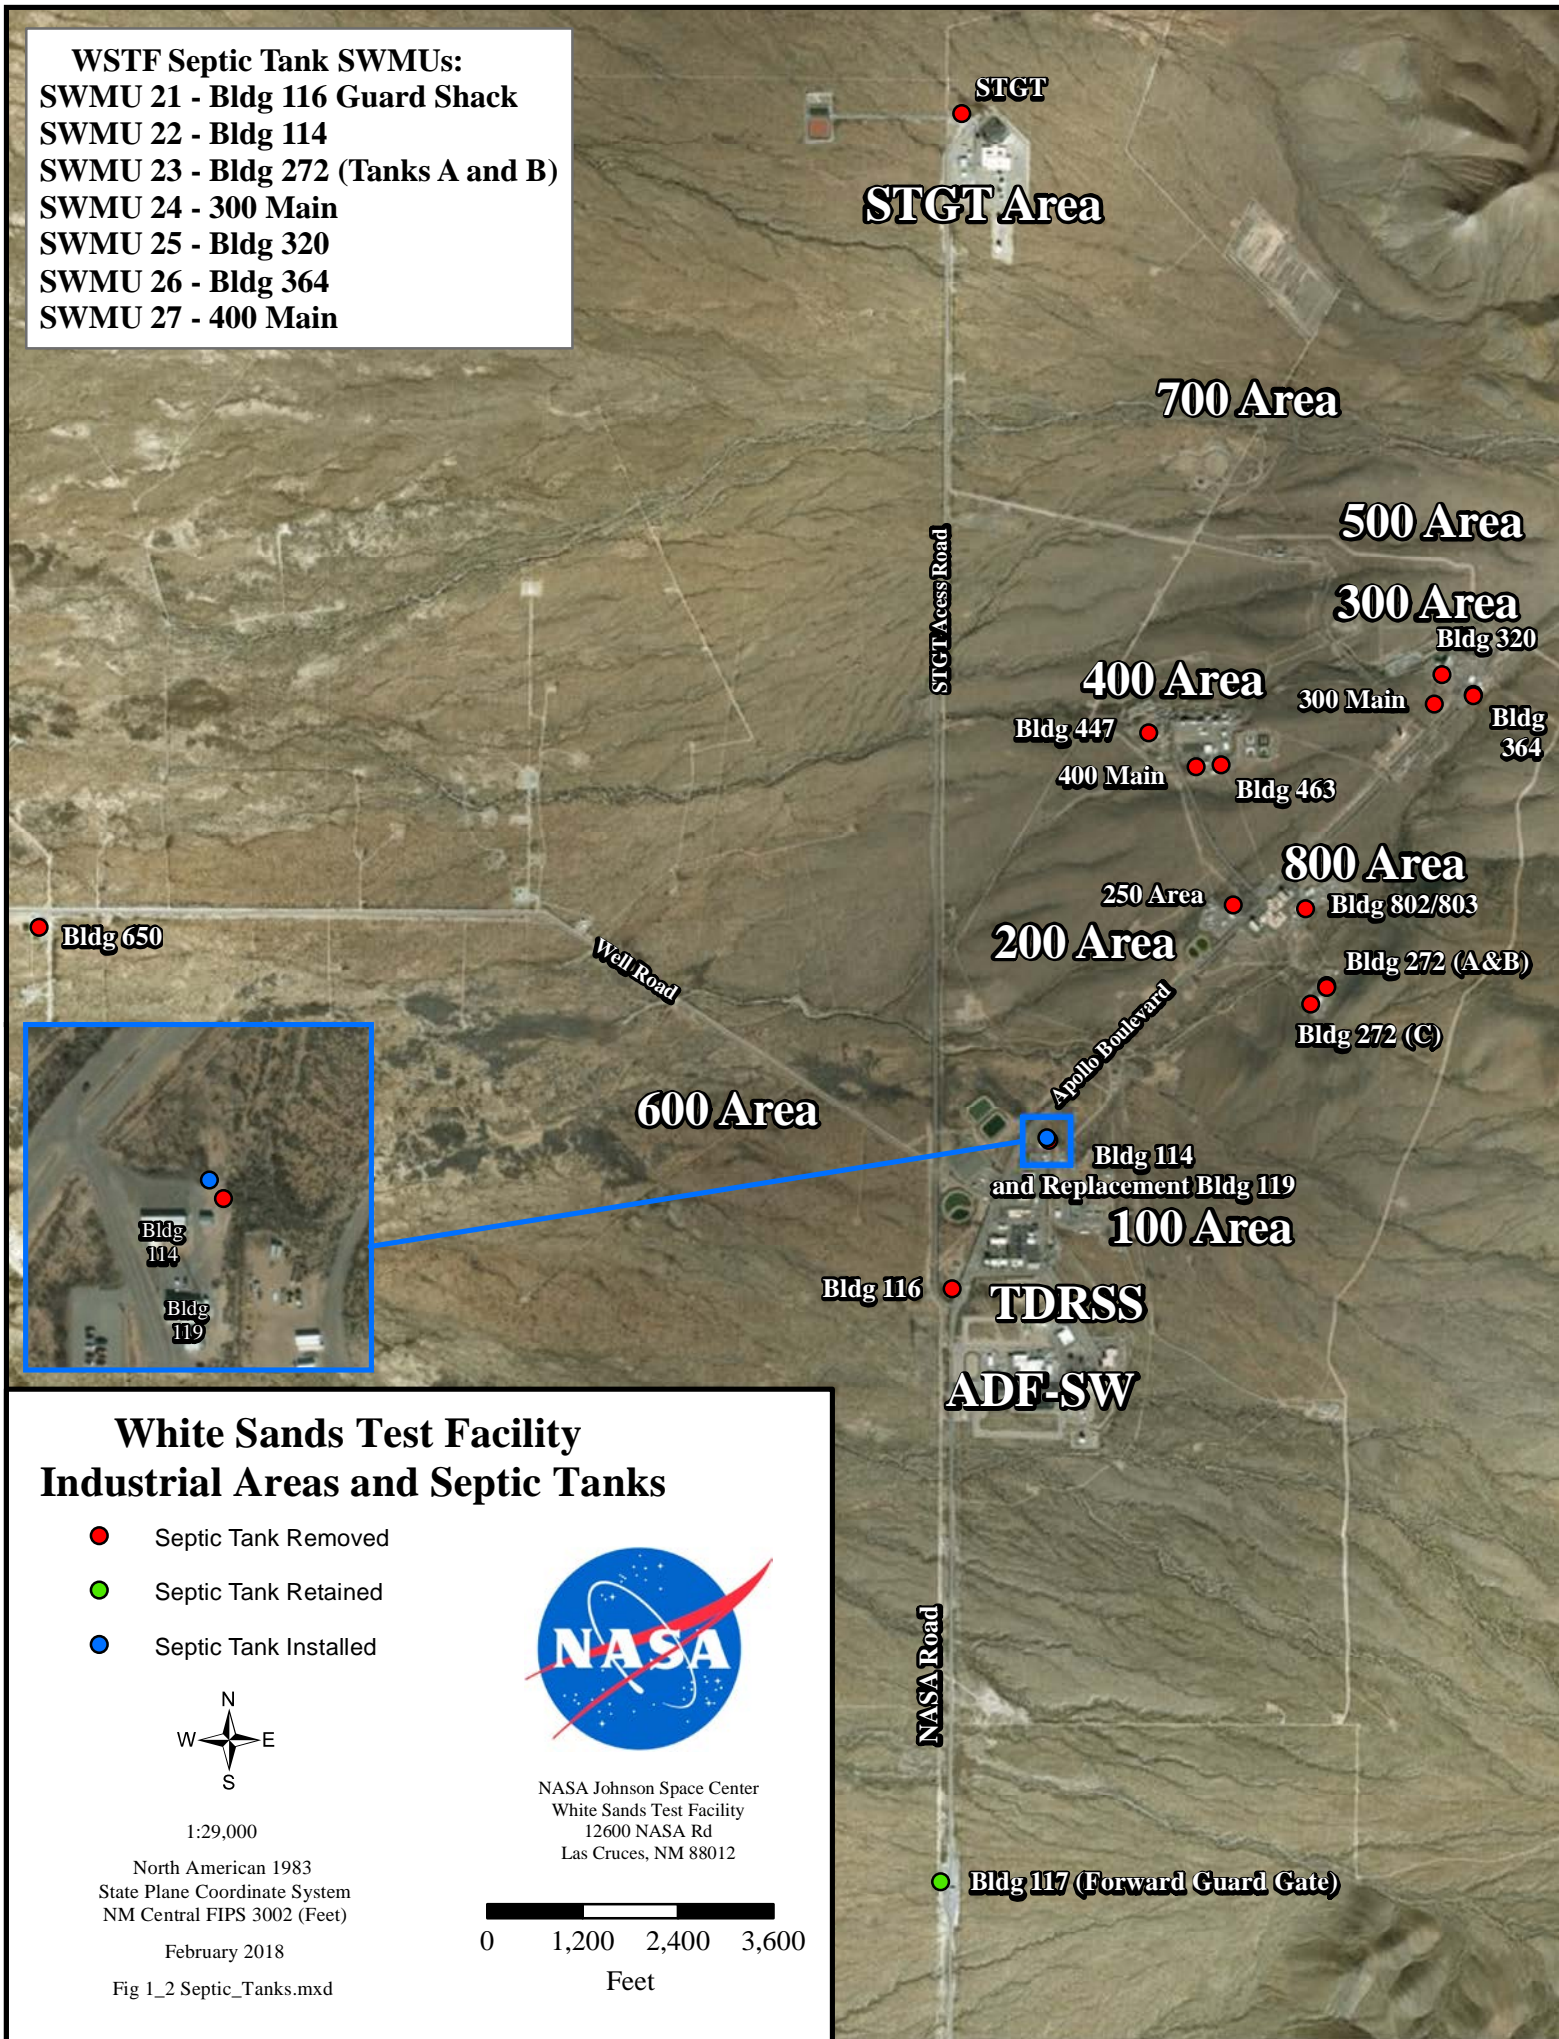
- Septic Tank Removed
- Septic Tank Retained
- Septic Tank Installed

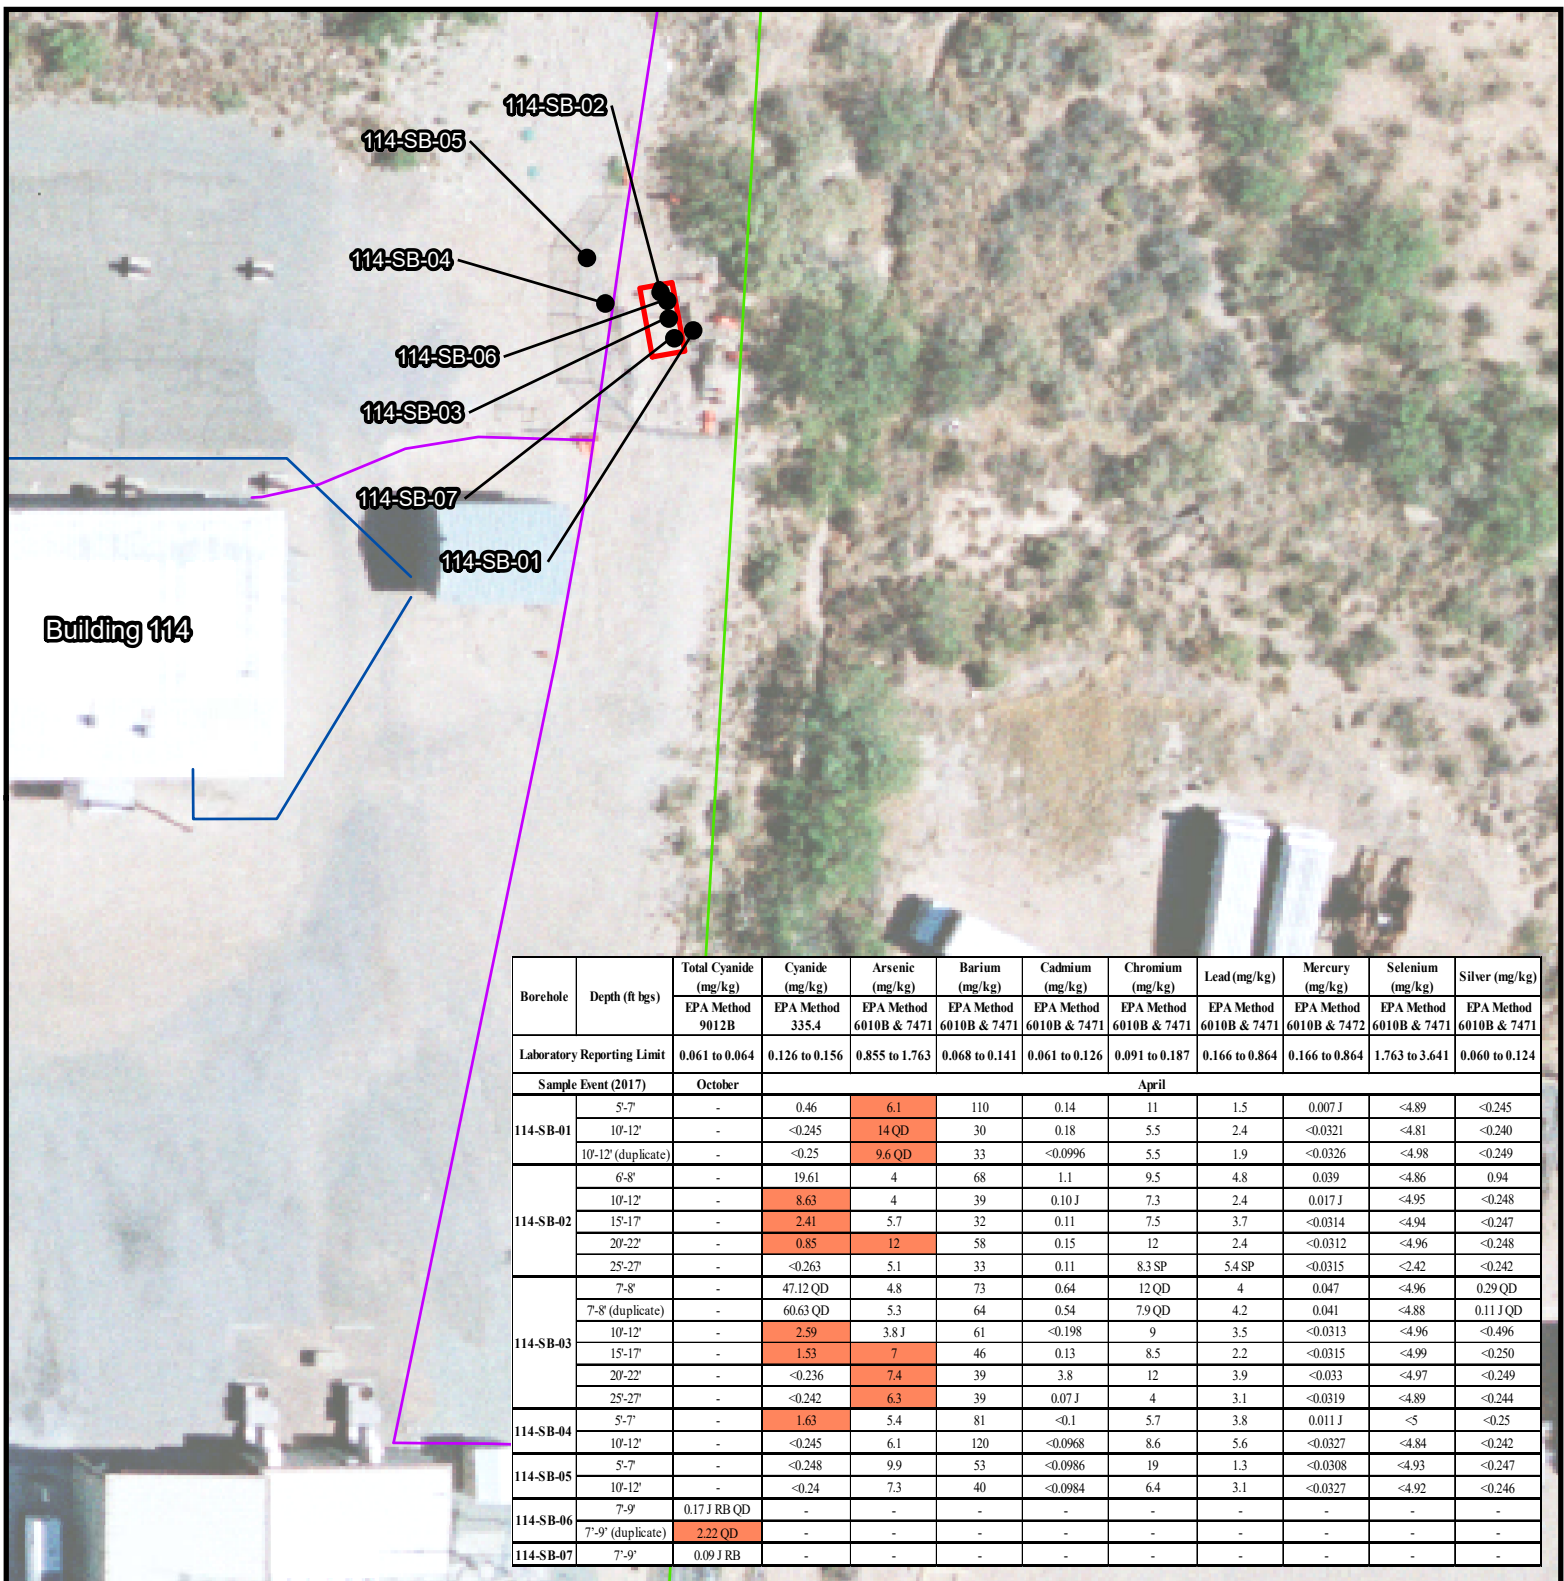
### Building 114 Septic Tank Soil Boring Locations and Utilities

- Building 114 Septic Tank Soil Borings
- Telephone Lines
- Fiber Optic Lines
- Water Lines
- Building 114 Septic Tank Footprint

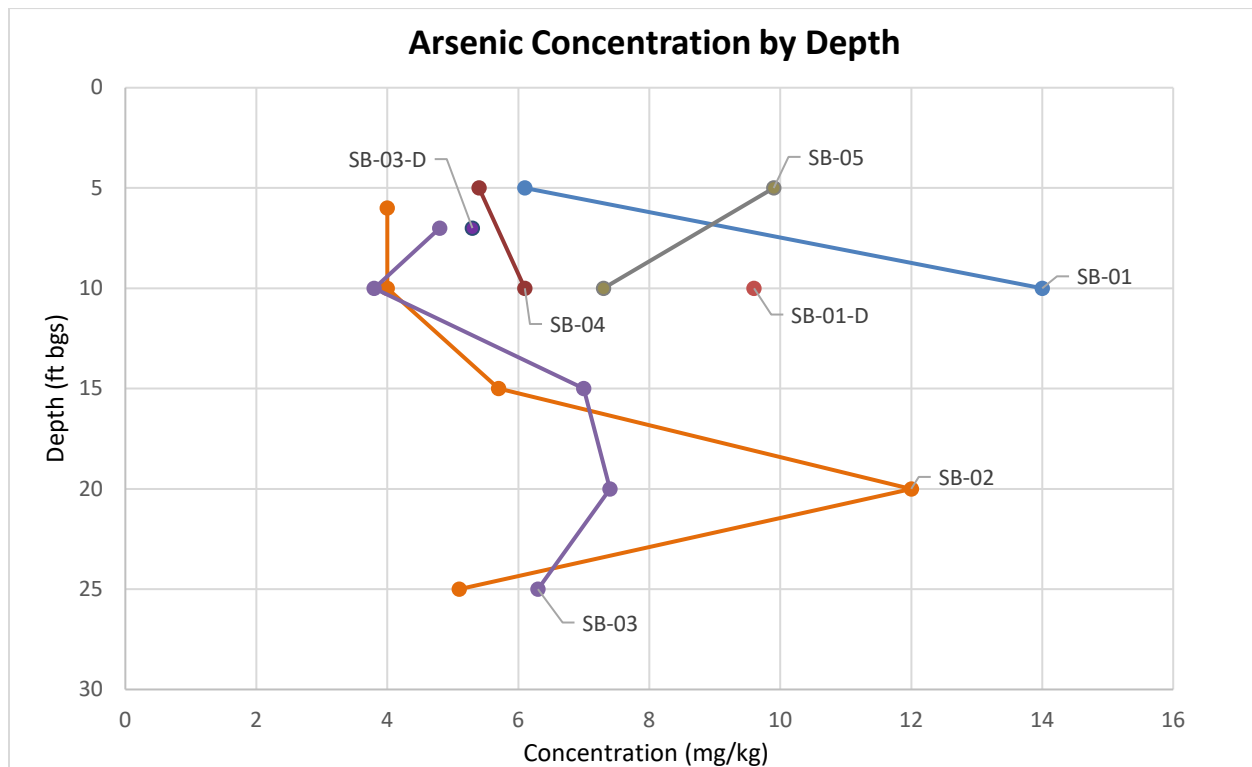
**Arsenic Sample Concentrations Versus Depth**

1. Each plot line represents data from one soil boring, i.e., SB-03 includes all primary sample data collected from soil boring 114-SB-03.
2. "D" at the end of a boring label represents duplicate samples.

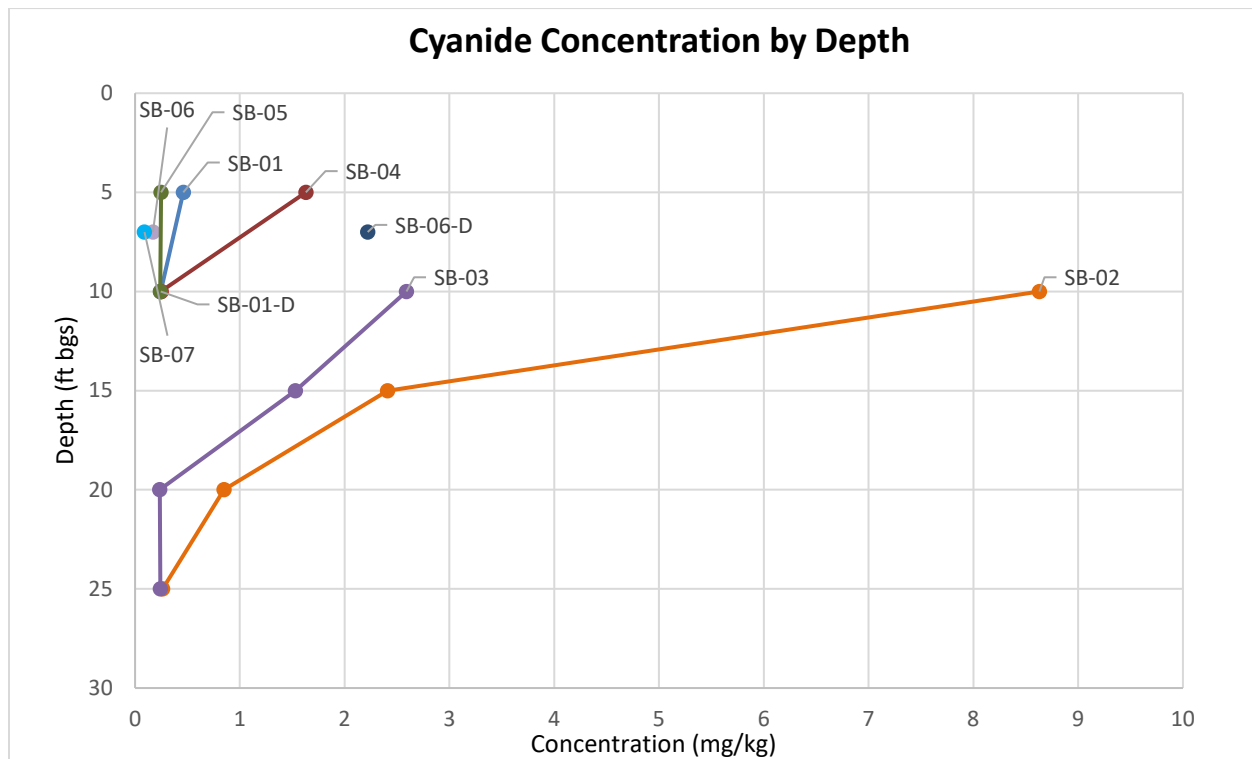
**Cyanide Sample Concentrations Versus Depth**

1. Each plot line represents data from one soil boring, i.e., SB-03 includes all primary sample data collected from soil boring 114-SB-03.
2. "D" at the end of a boring label represents duplicate samples.

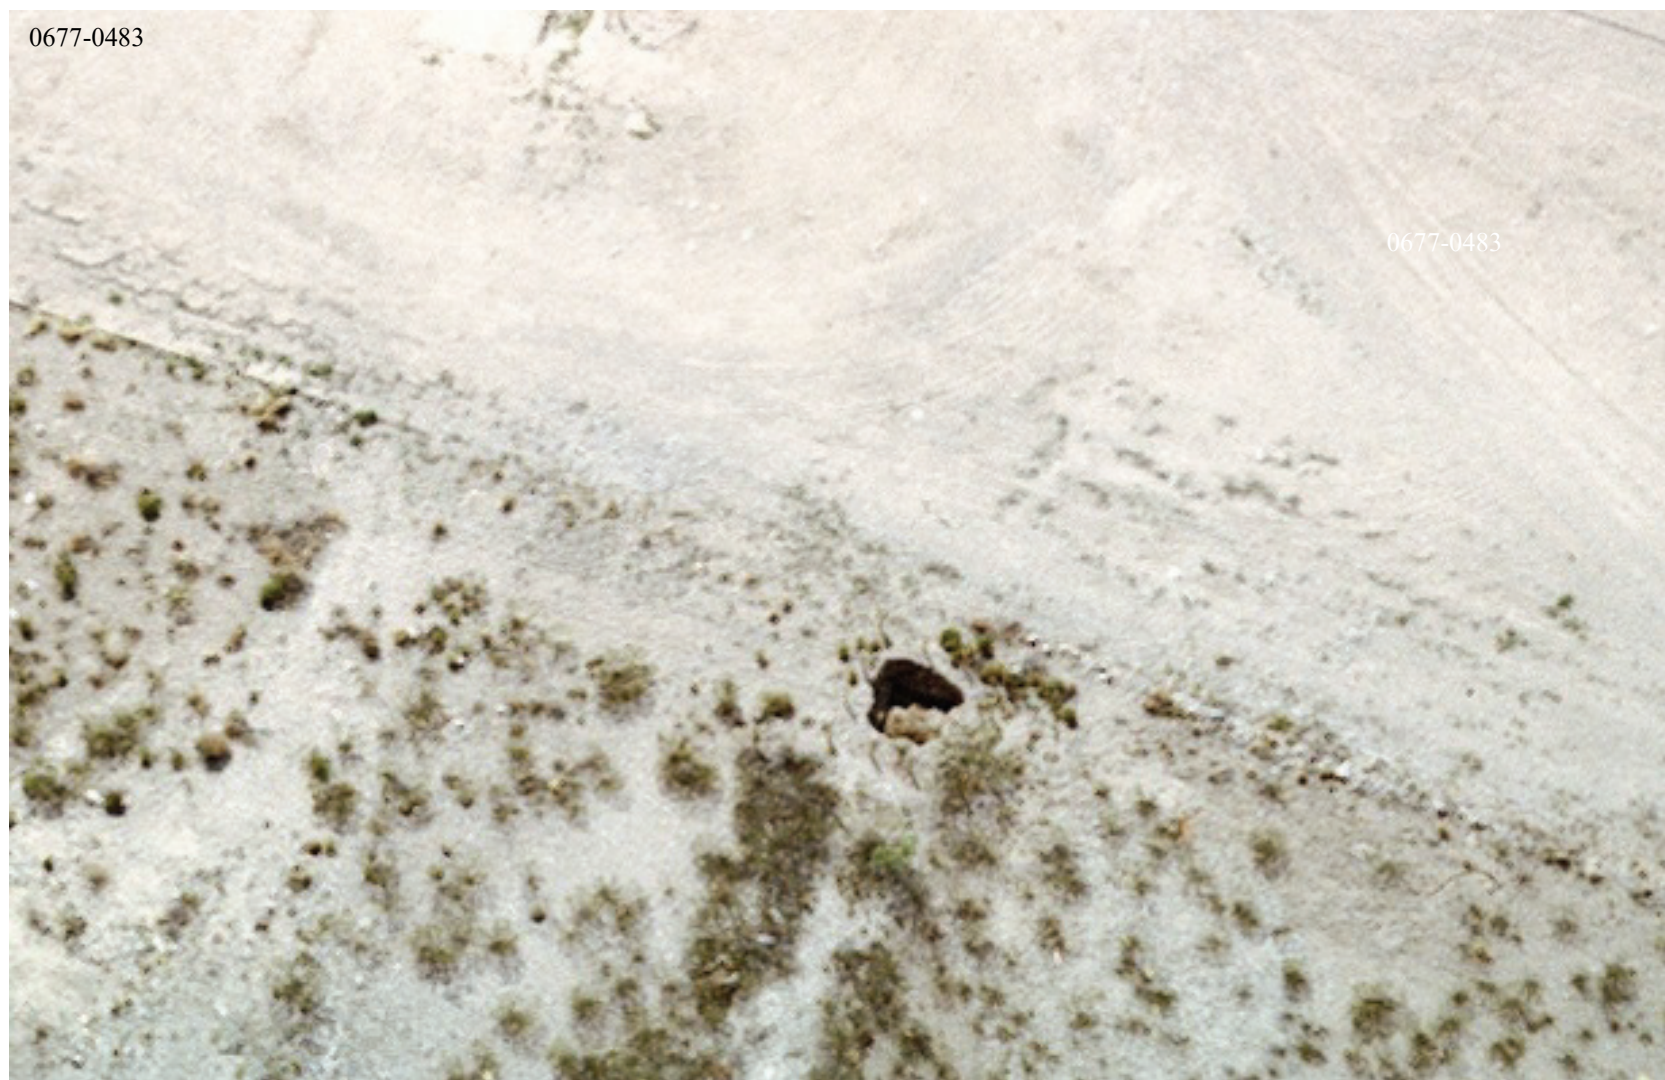
**Figure A.2**

Picture showing open pit at location of 250 Area septic tank. This may represent removal of the tank in June 1977.

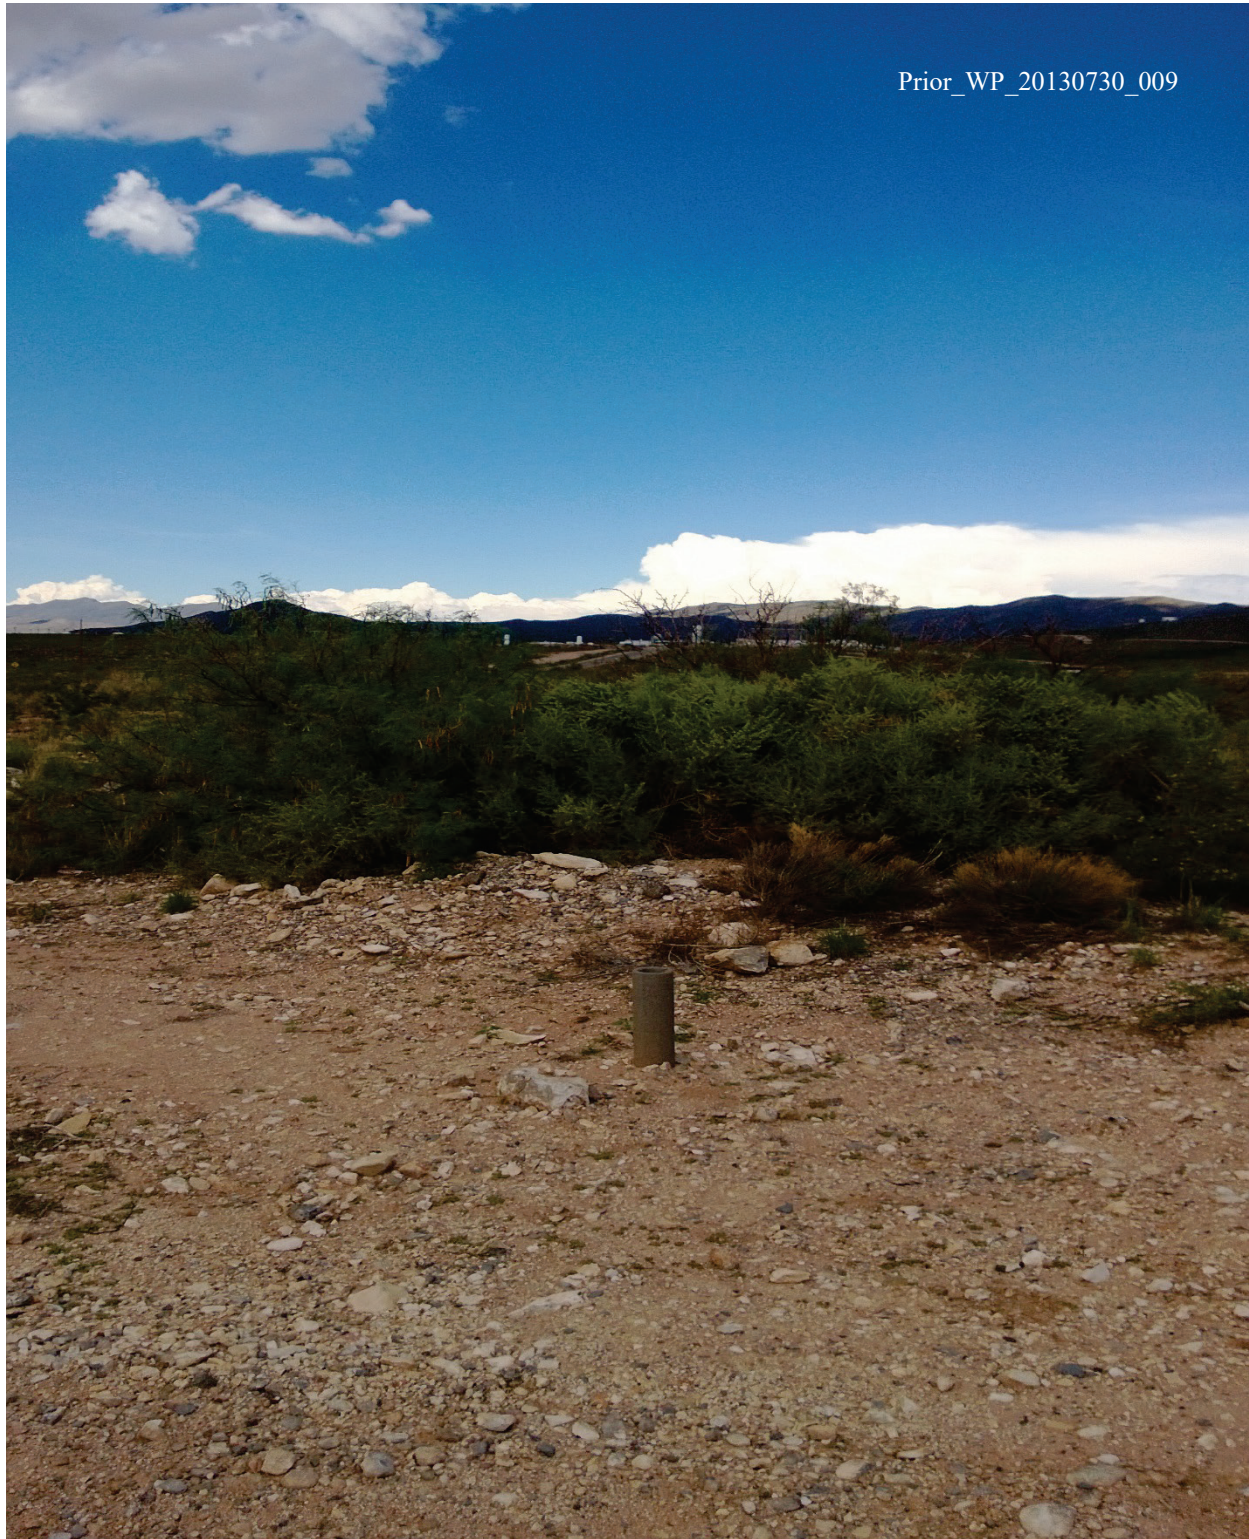
**Figure A.3**

Building 114 septic tank (SWMU 22) showing surface vent pipe.

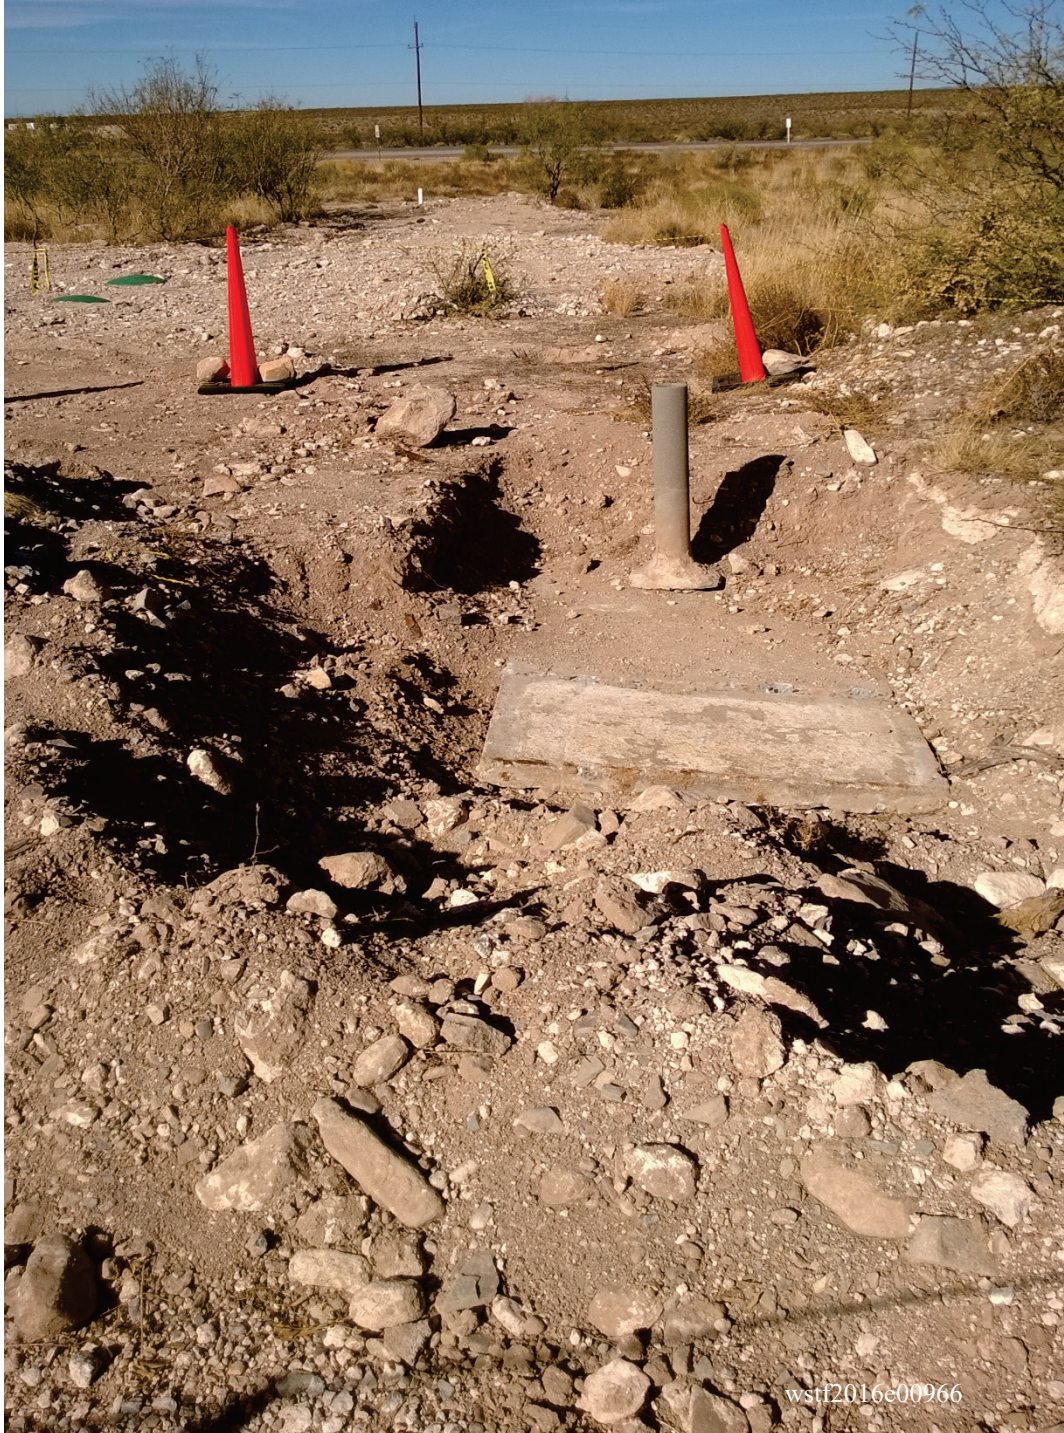
**Figure A.4**

This photograph shows the Building 114 (SWMU 22) septic tank during excavation.

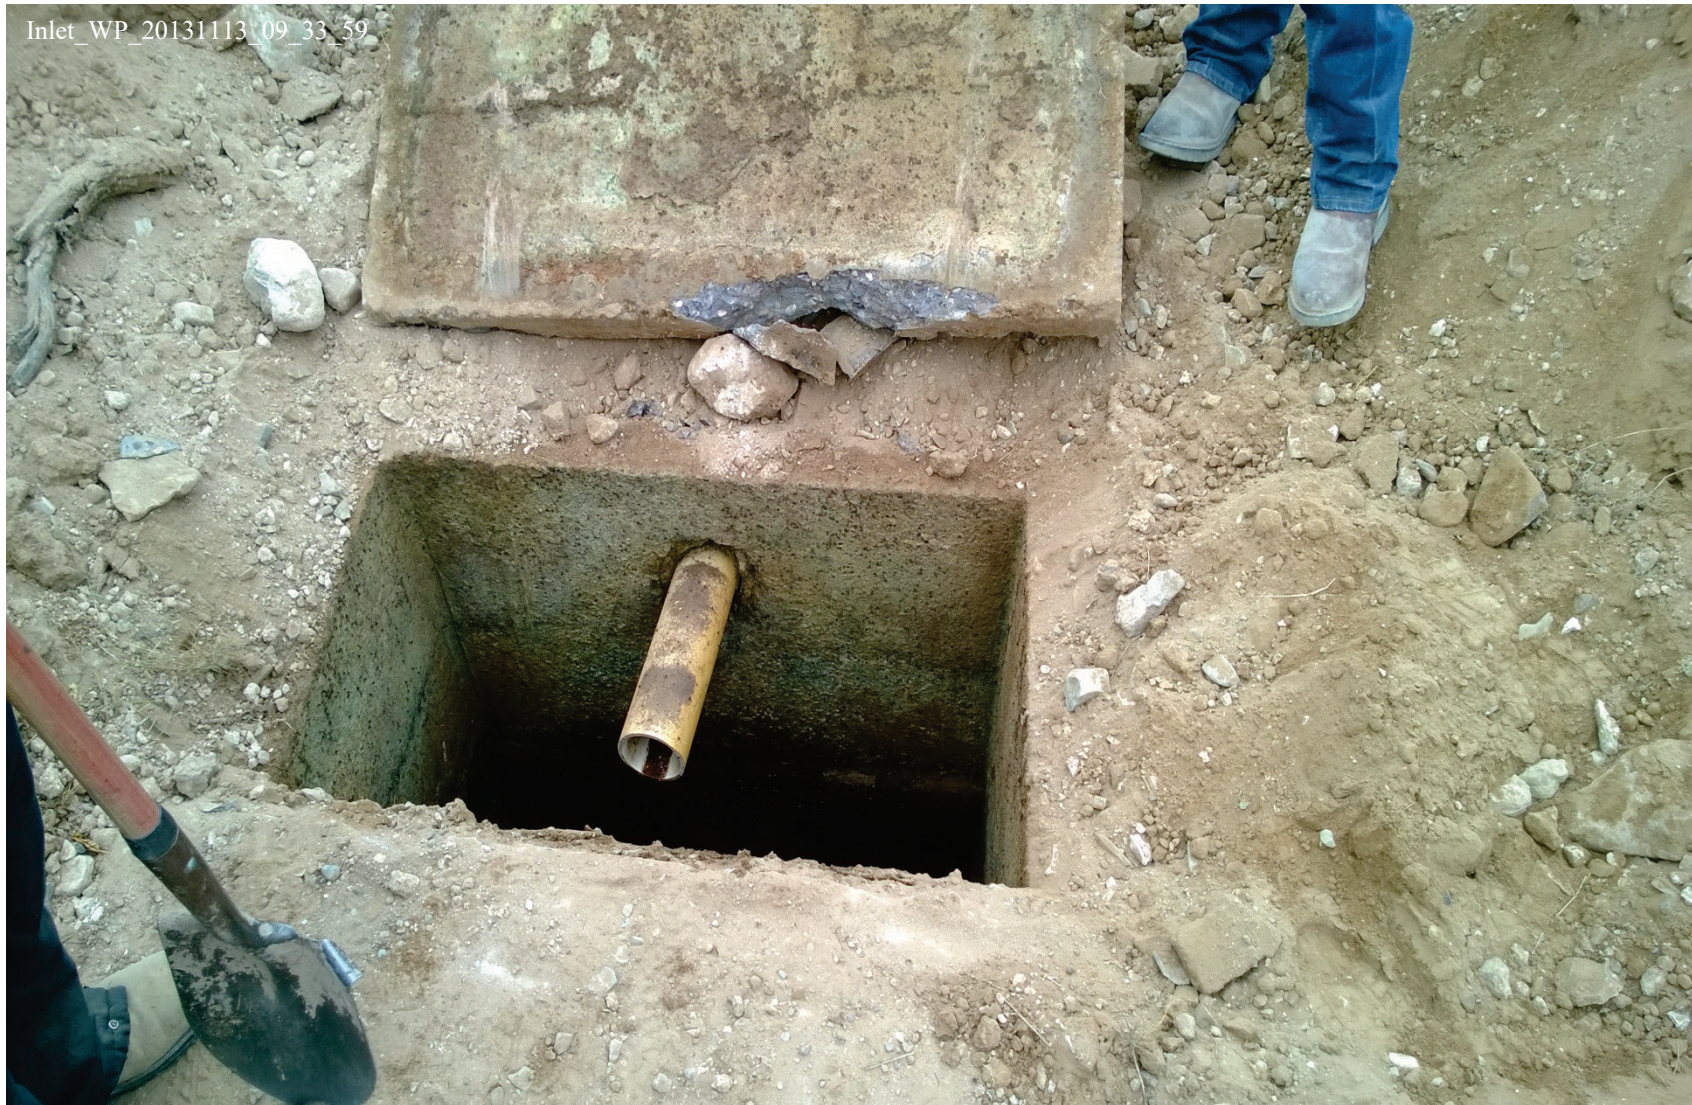
**Figure A.5**

**SWMU 22 – Inlet Pipe (View to the northeast)**

Photograph showing the inlet pipe (from Building 114 to the septic tank) for SWMU 22.

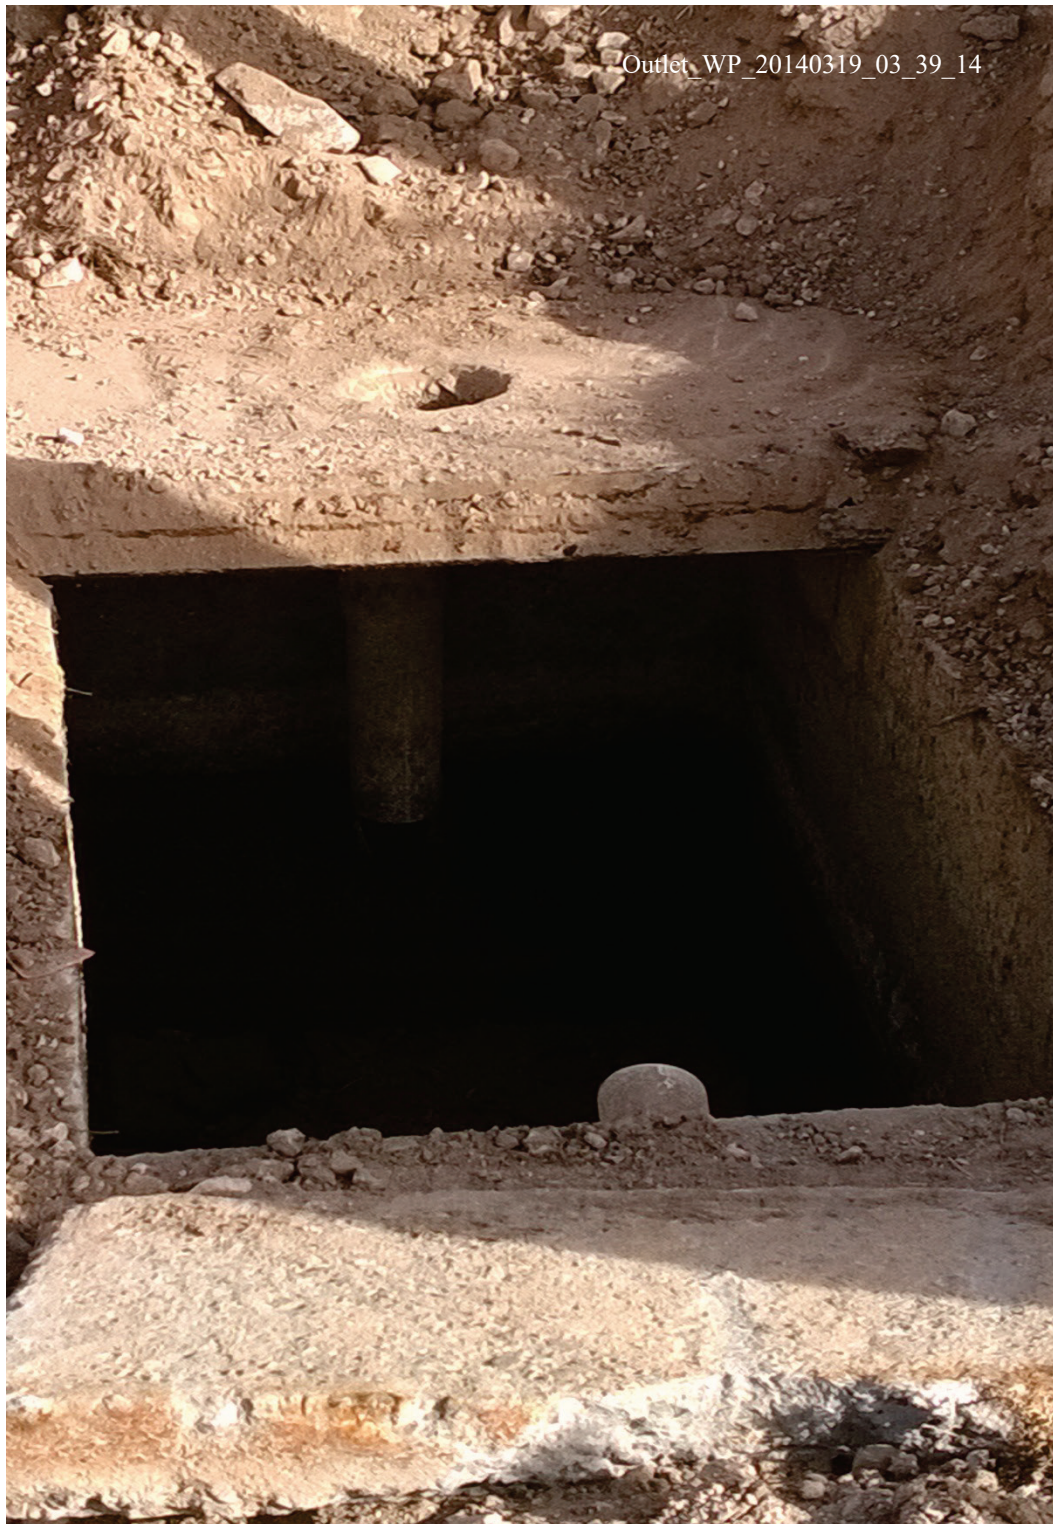
**Figure A.6**

The vertical pipe is the vent. At the bottom of the vertical pipe, a dark area shows the entry to the discharge pipe from the septic tank (with no evidence of discharge within the pipe).

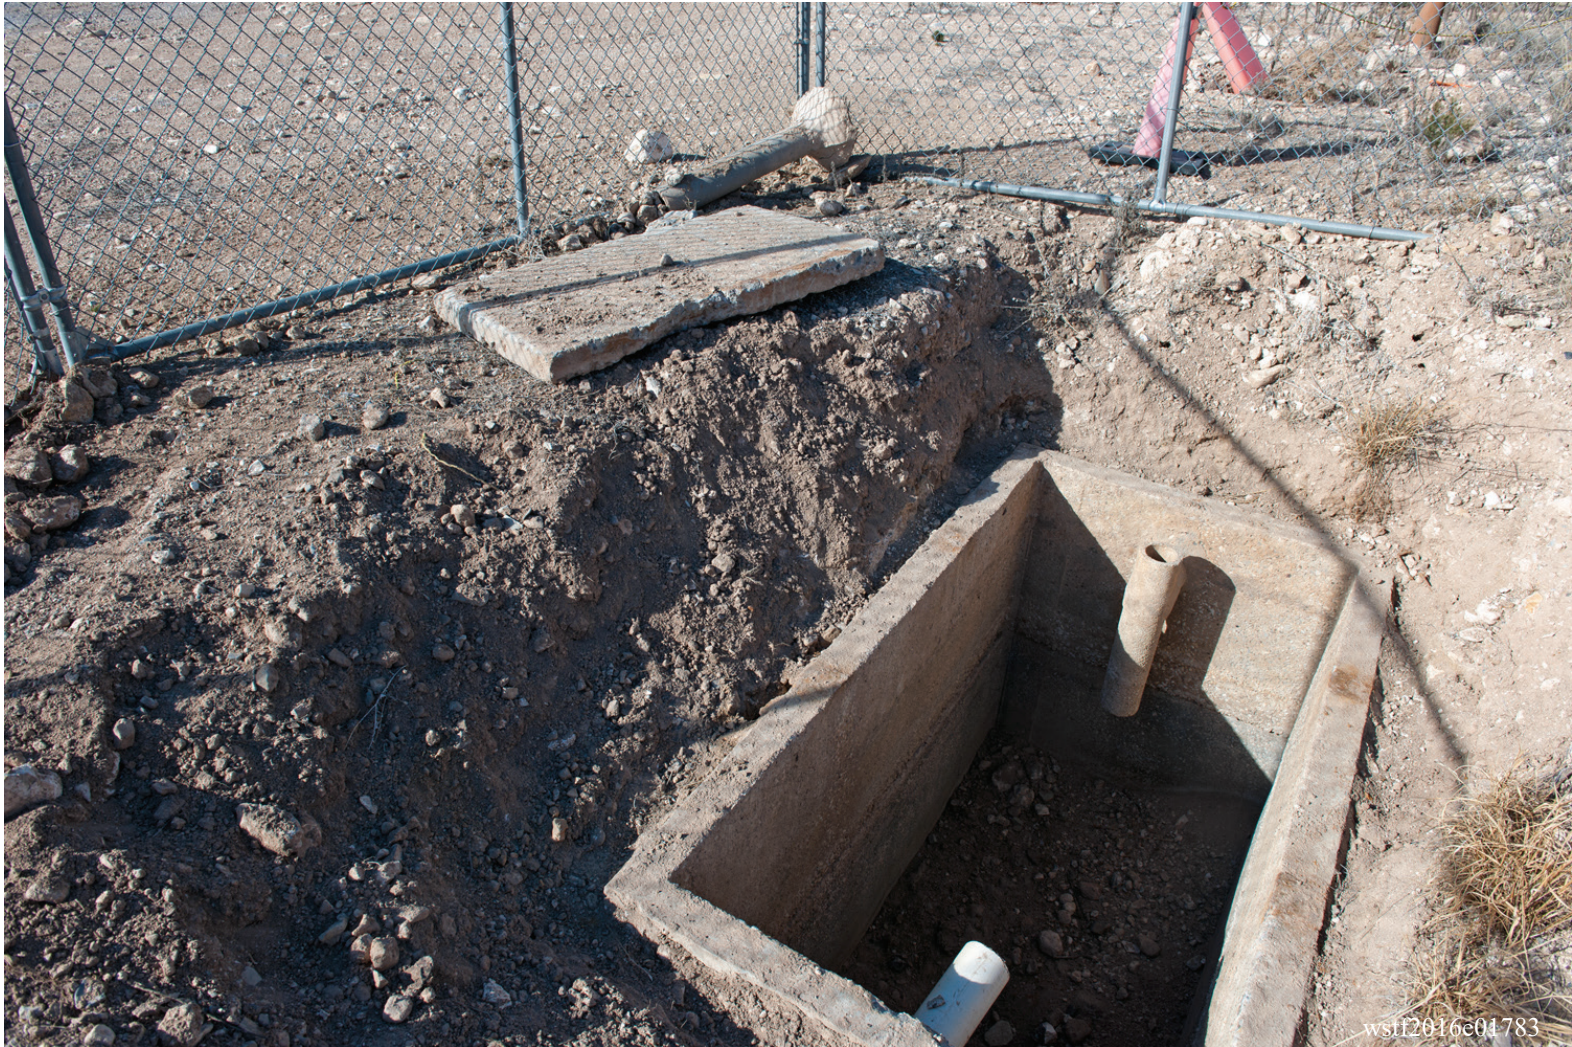
**Figure A.7**

Building 114 (SWMU 22) septic tank. The surface vent can be seen with the tank top at the upper left of the photo. This photo was taken prior to removal of the tank. The tank contained no bottom.

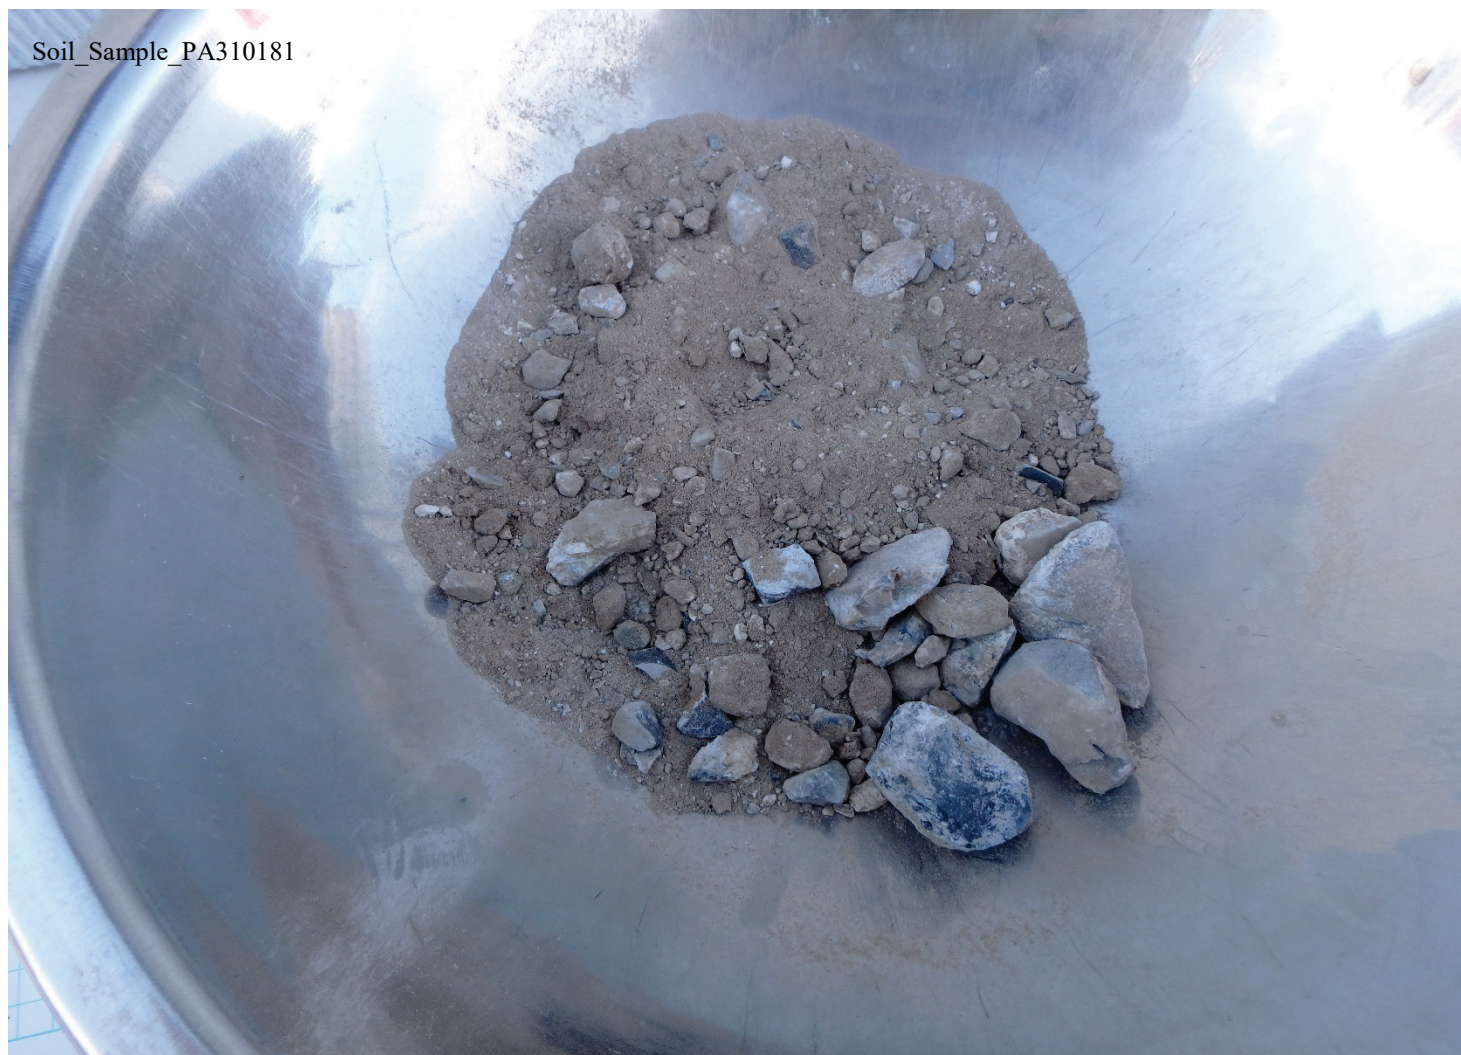
Soil sample is from boring 114-SB-07 at 7 to 9 ft bgs and was typical of the soil encountered during the drilling investigation. Soil is shown here within a stainless steel bowl.

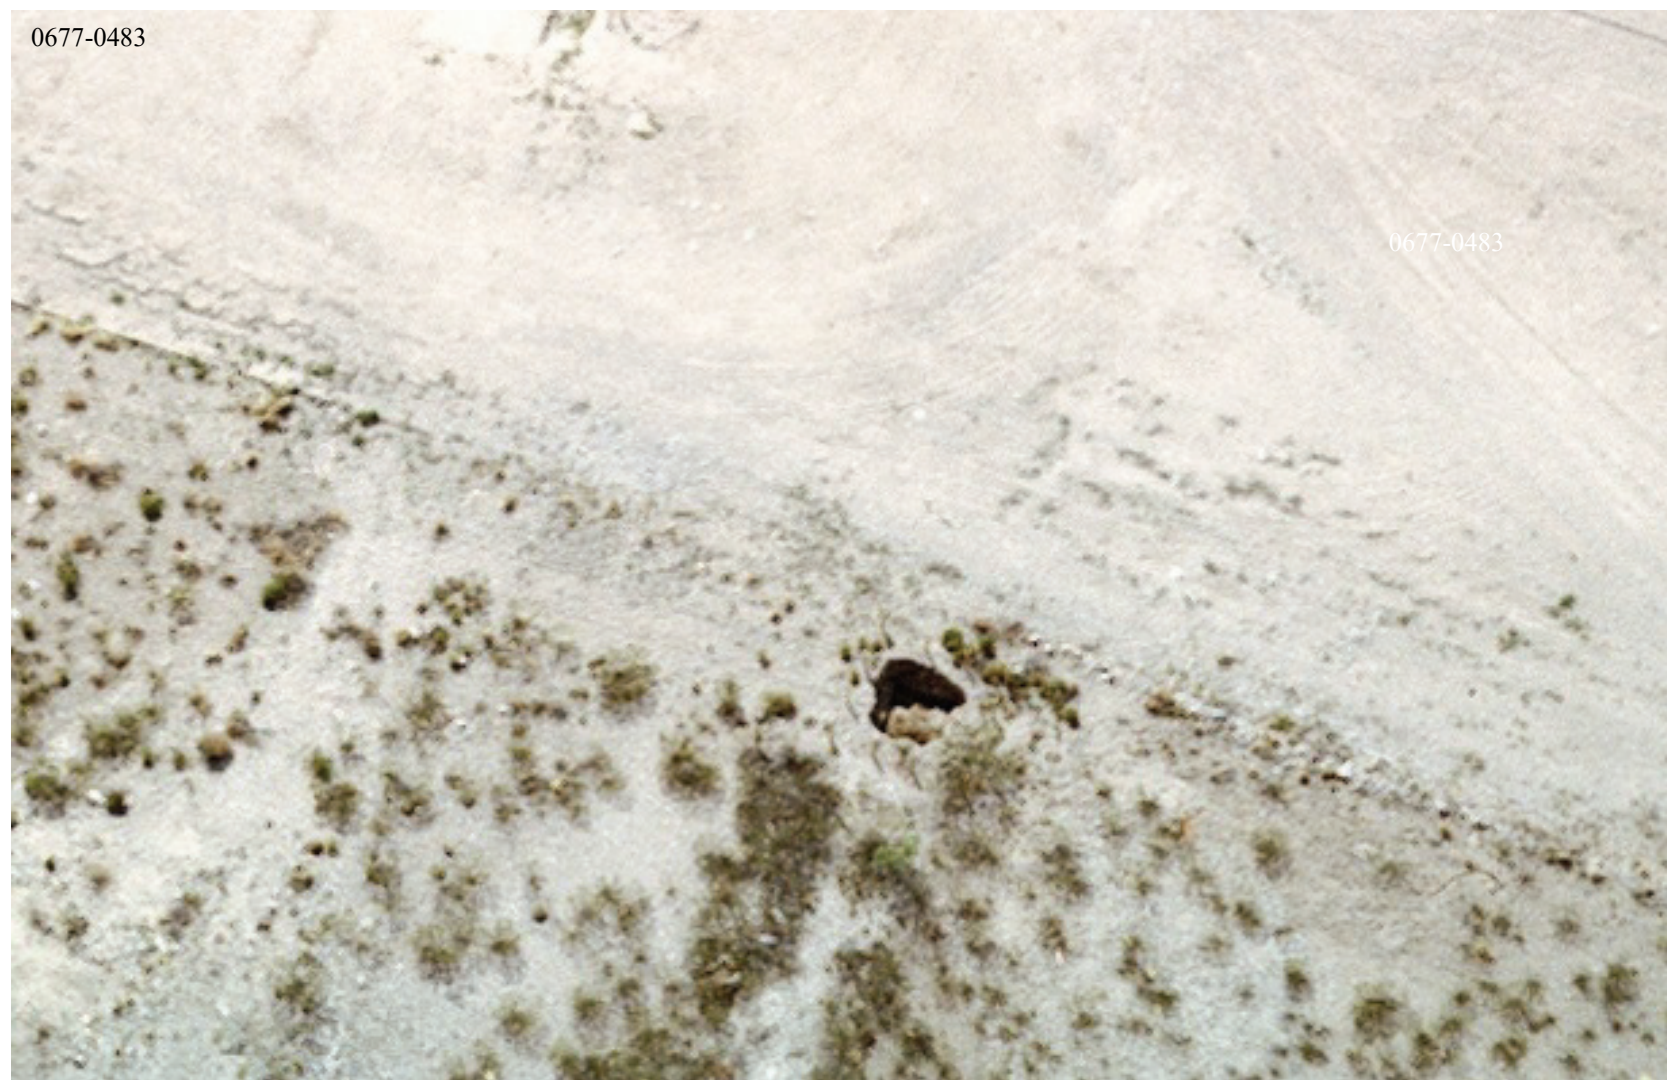
Picture showing open pit at location of 250 Area septic tank. This may represent removal of the tank in June 1977.
