Subject: Response to Approval with Modifications Revised WSTF Septic Tanks  
(SWMUs 21-27) Investigation Report

## Comments for Approval with Modifications of the Revised WSTF Septic Tanks (SWMUs 21-27) Investigation Report

# **White Sands Test Facility Industrial Areas and Septic Tanks**

# Building 114 Septic Tank (SWMU 22) Site Conceptual Exposure Model

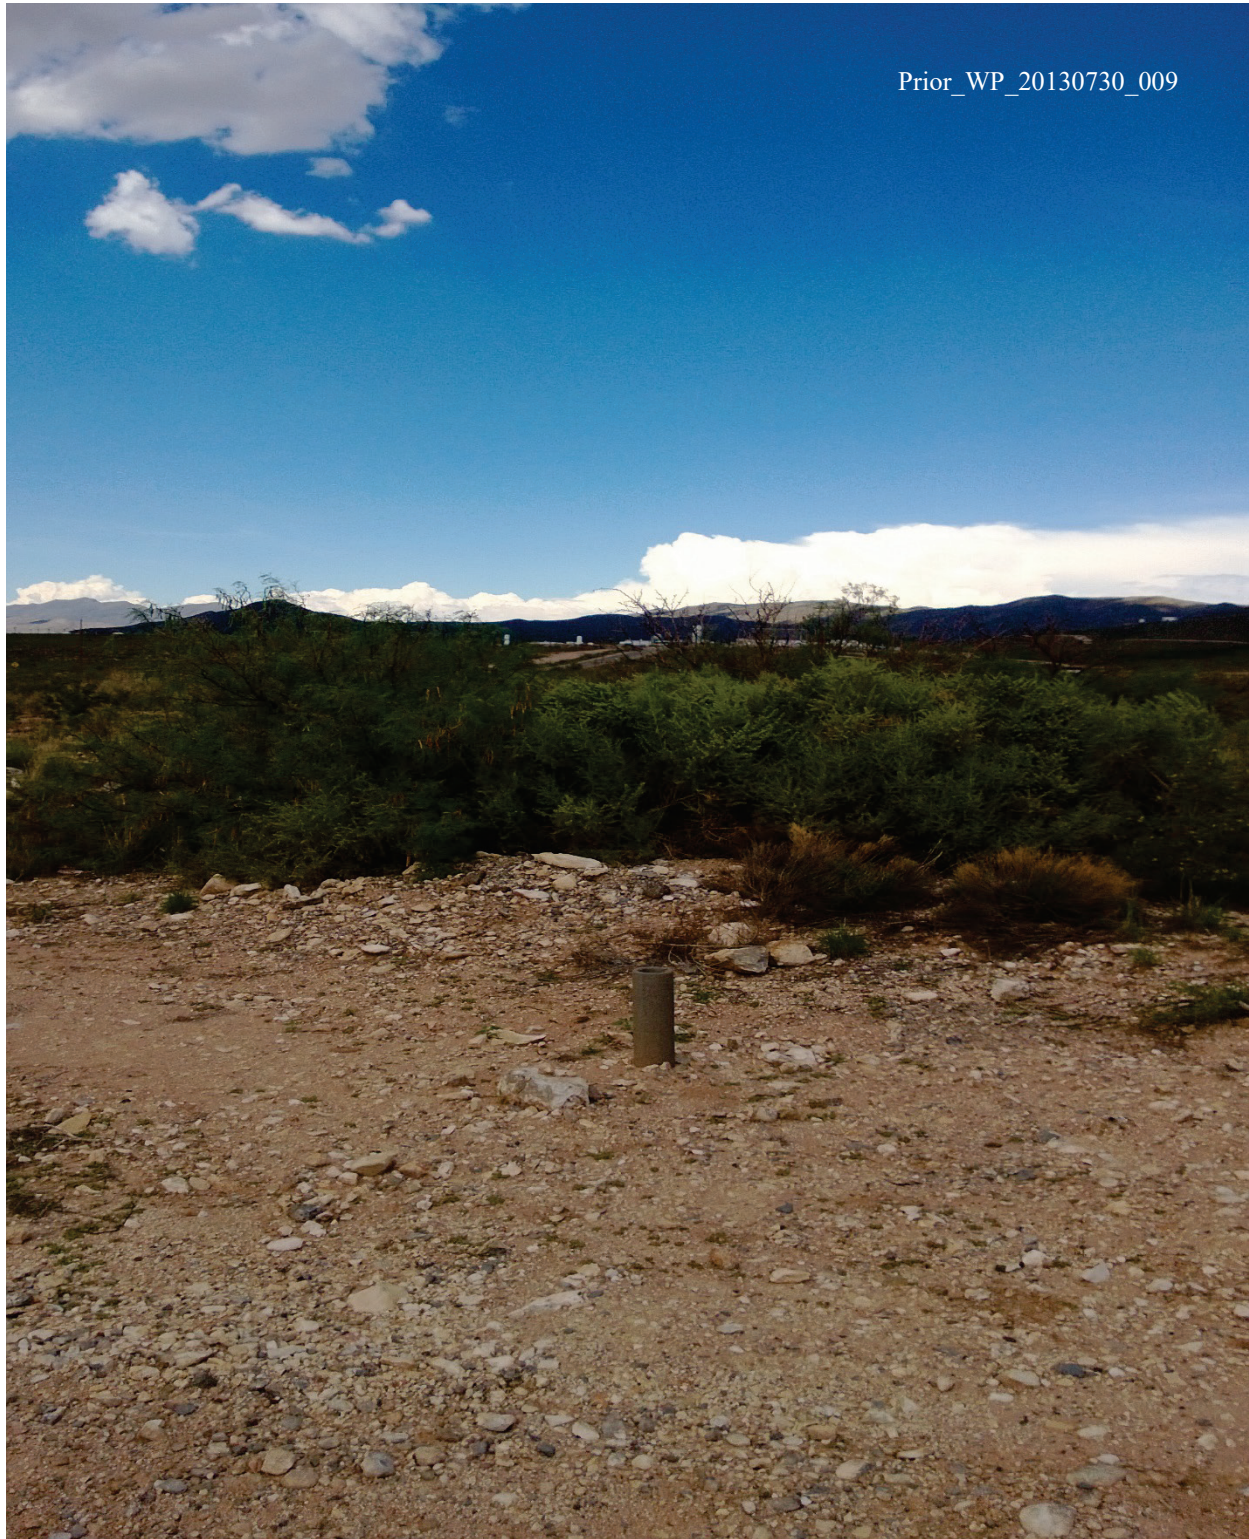
Building 114 septic tank (SWMU 22) showing surface vent pipe.

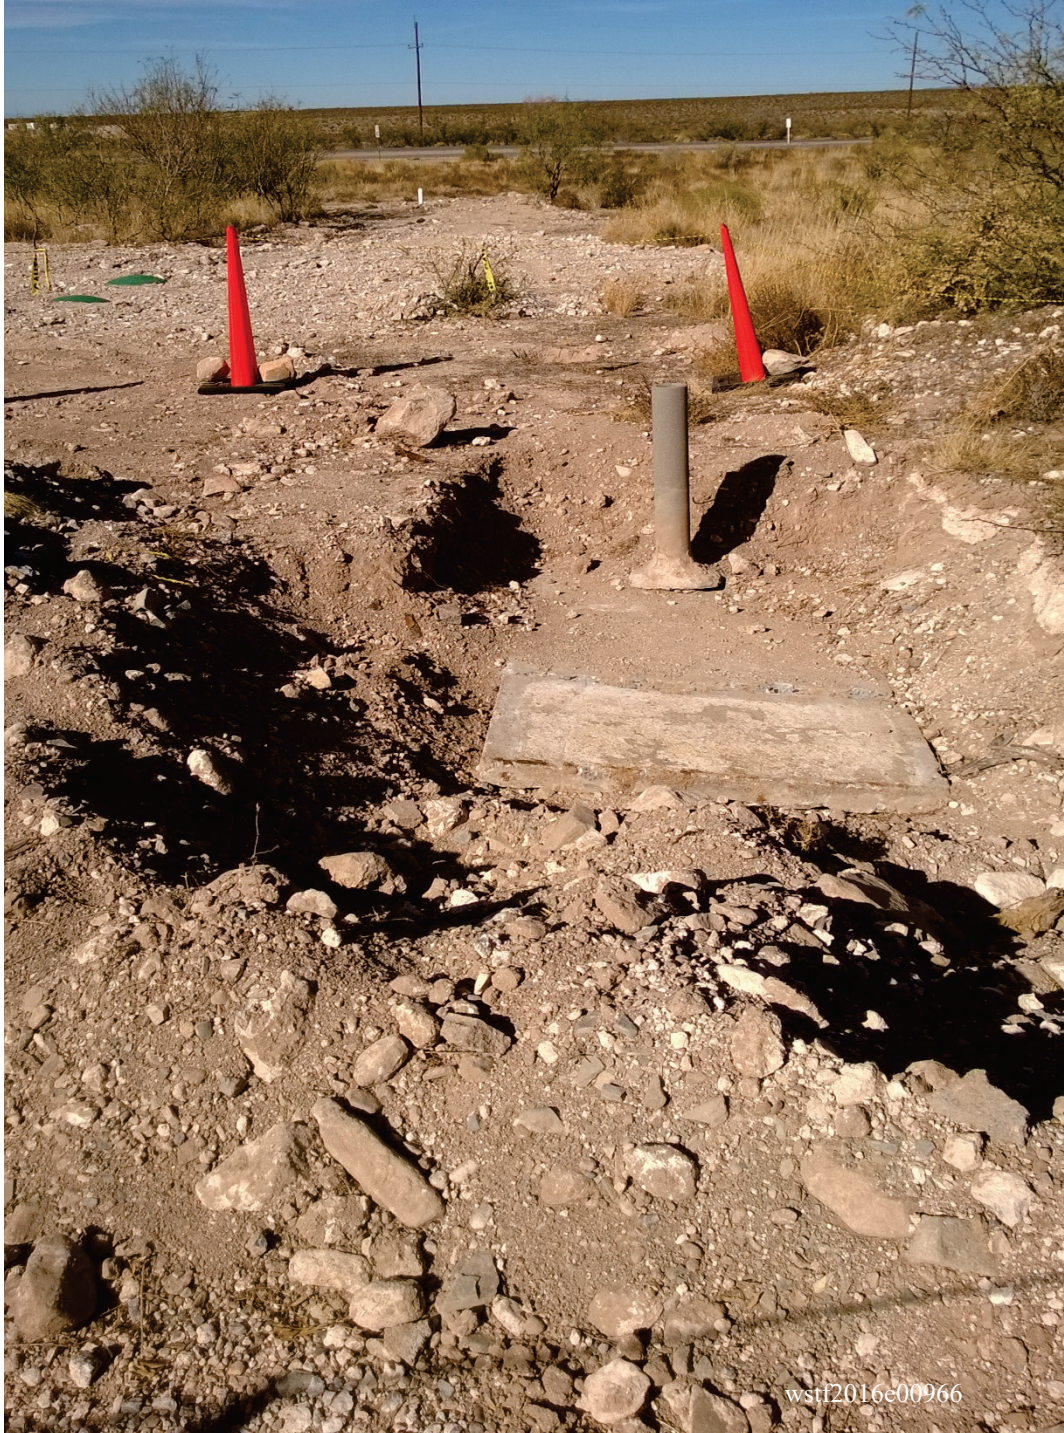
This photograph shows the Building 114 (SWMU 22) septic tank during excavation.

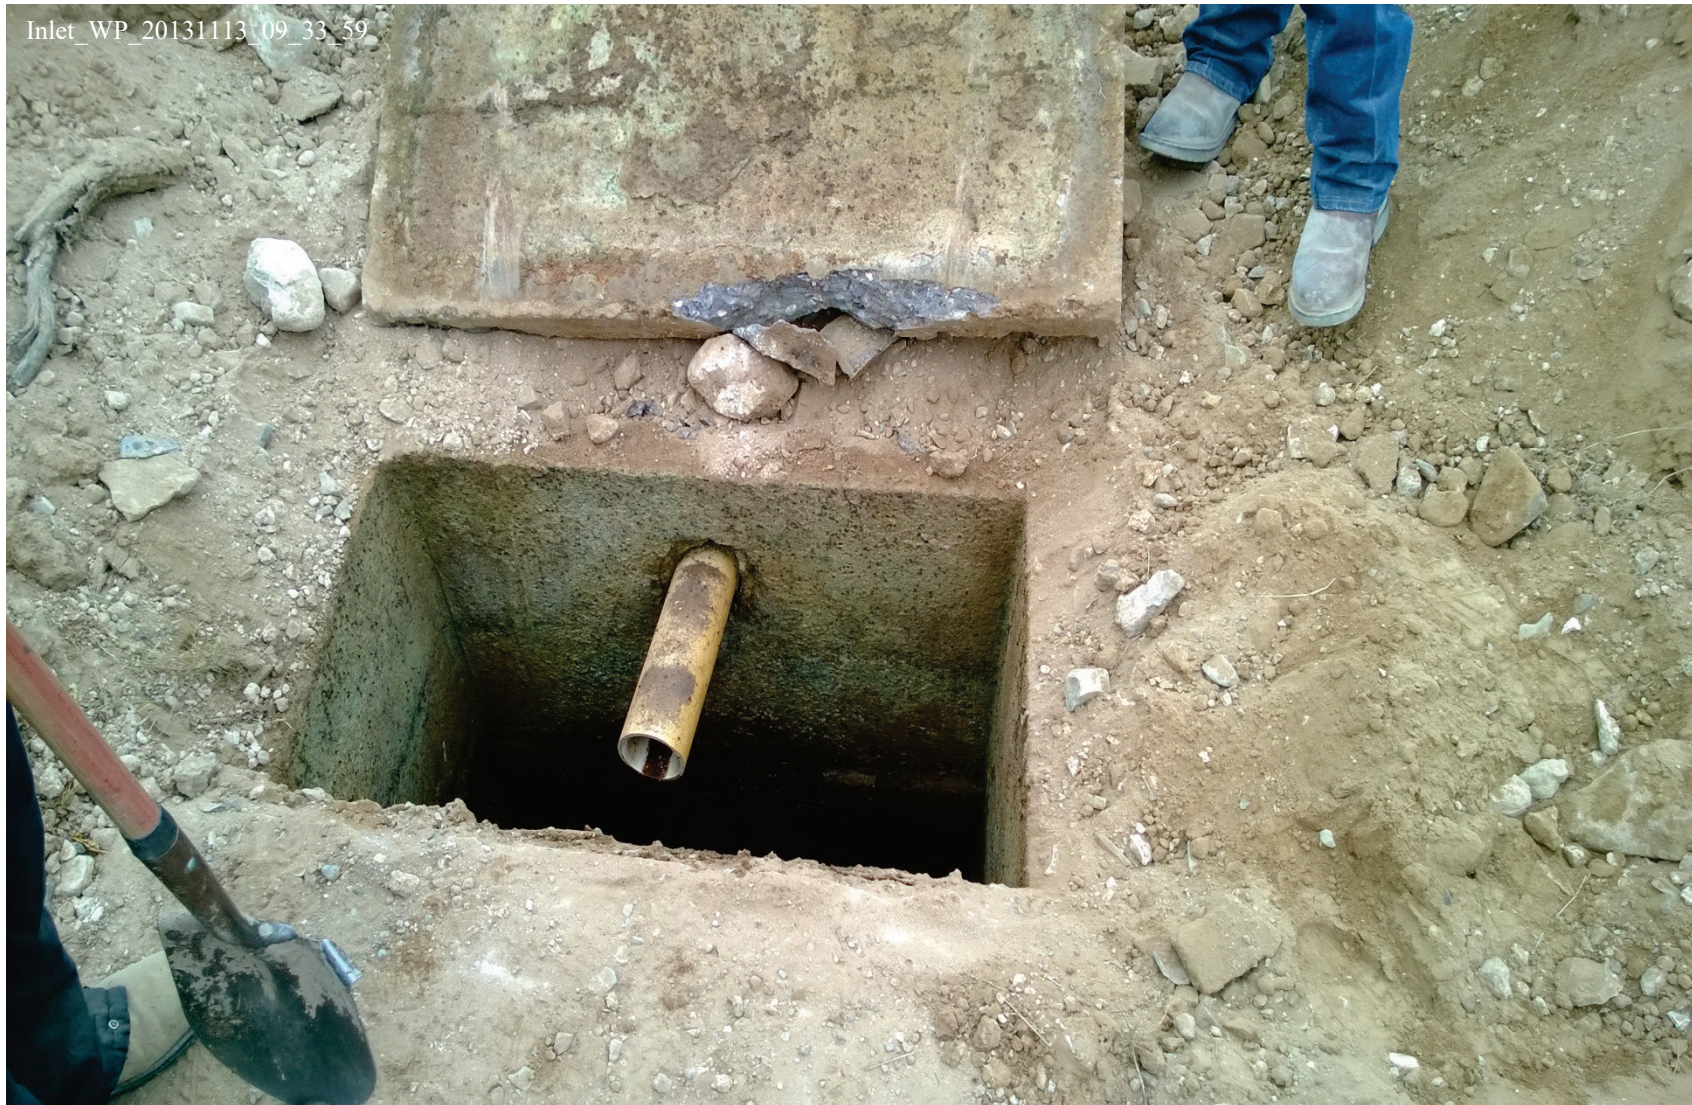
**SWMU 22 – Inlet Pipe (View to the northeast)**

Photograph showing the inlet pipe (from Building 114 to the septic tank) for SWMU 22.

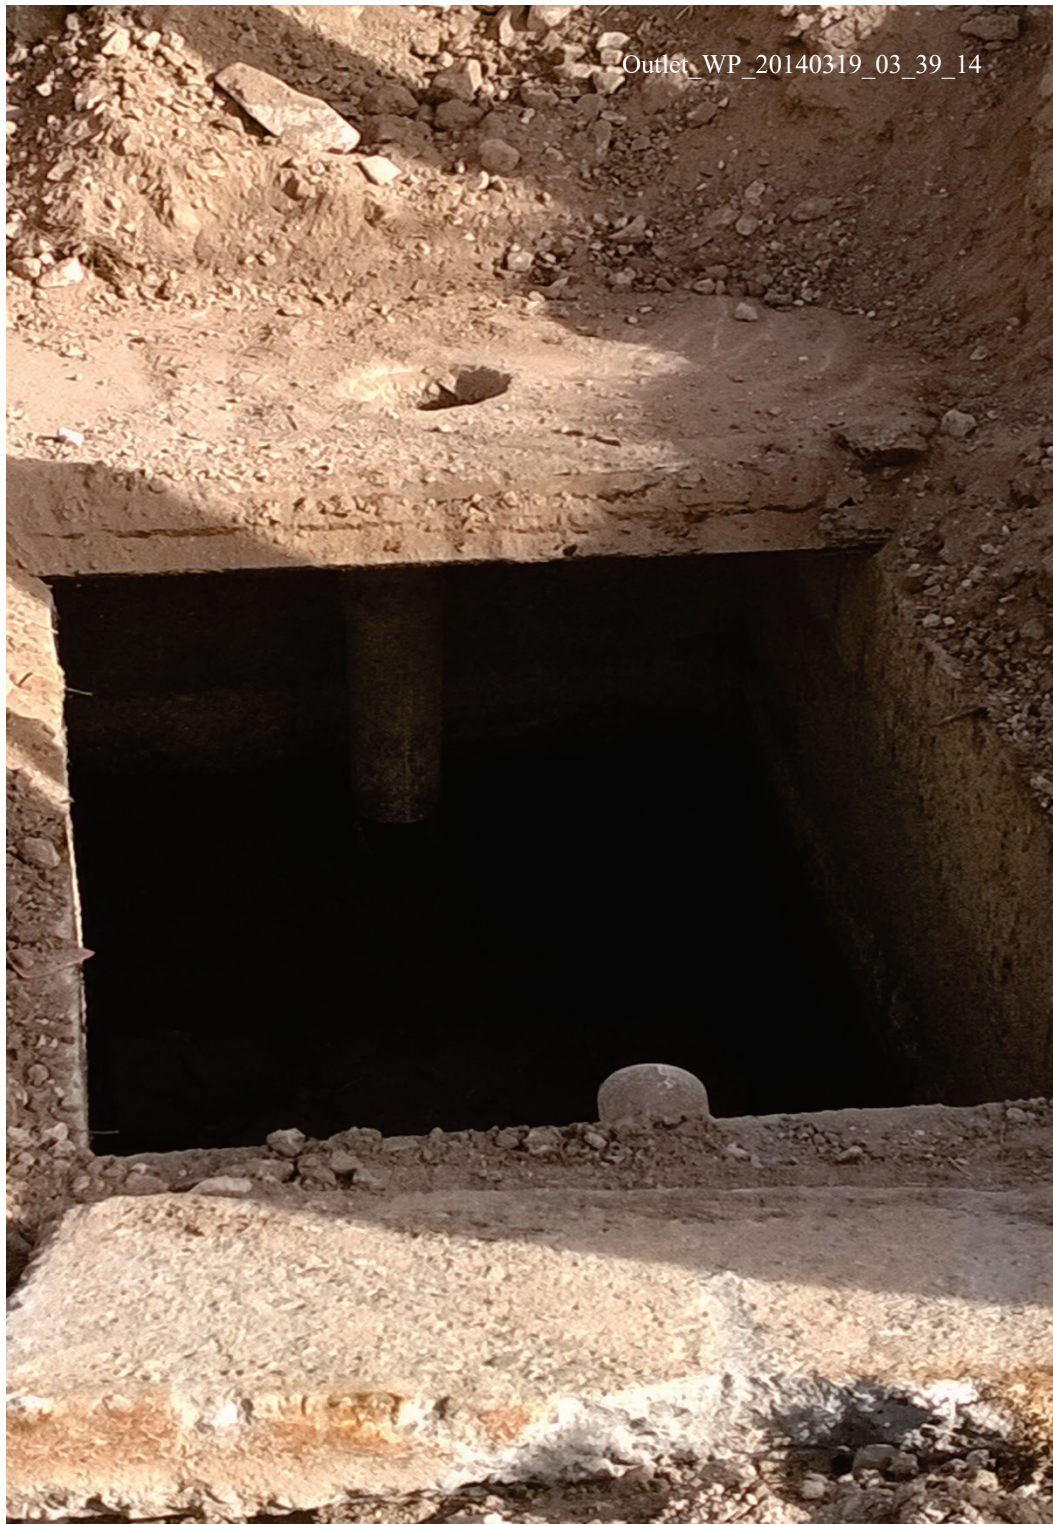
The vertical pipe is the vent. At the bottom of the vertical pipe, a dark area shows the entry to the discharge pipe from the septic tank (with no evidence of discharge within the pipe).

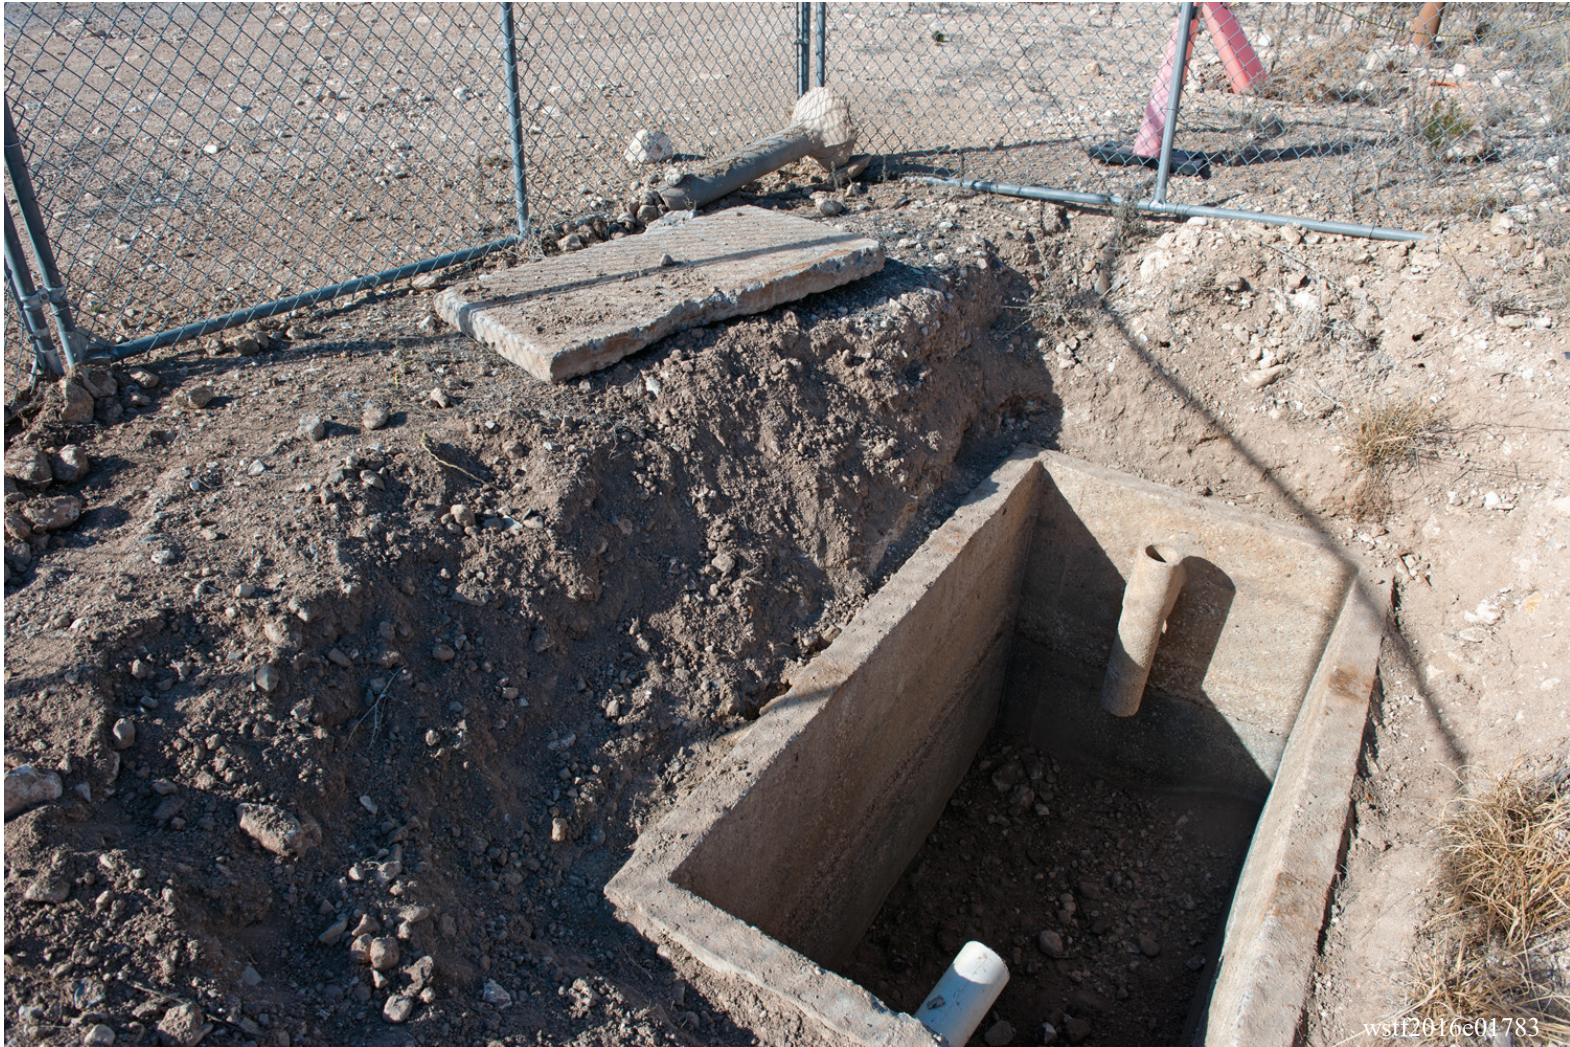
Building 114 (SWMU 22) septic tank. The surface vent can be seen with the tank top at the upper left of the photo. This photo was taken prior to removal of the tank. The tank contained no bottom.

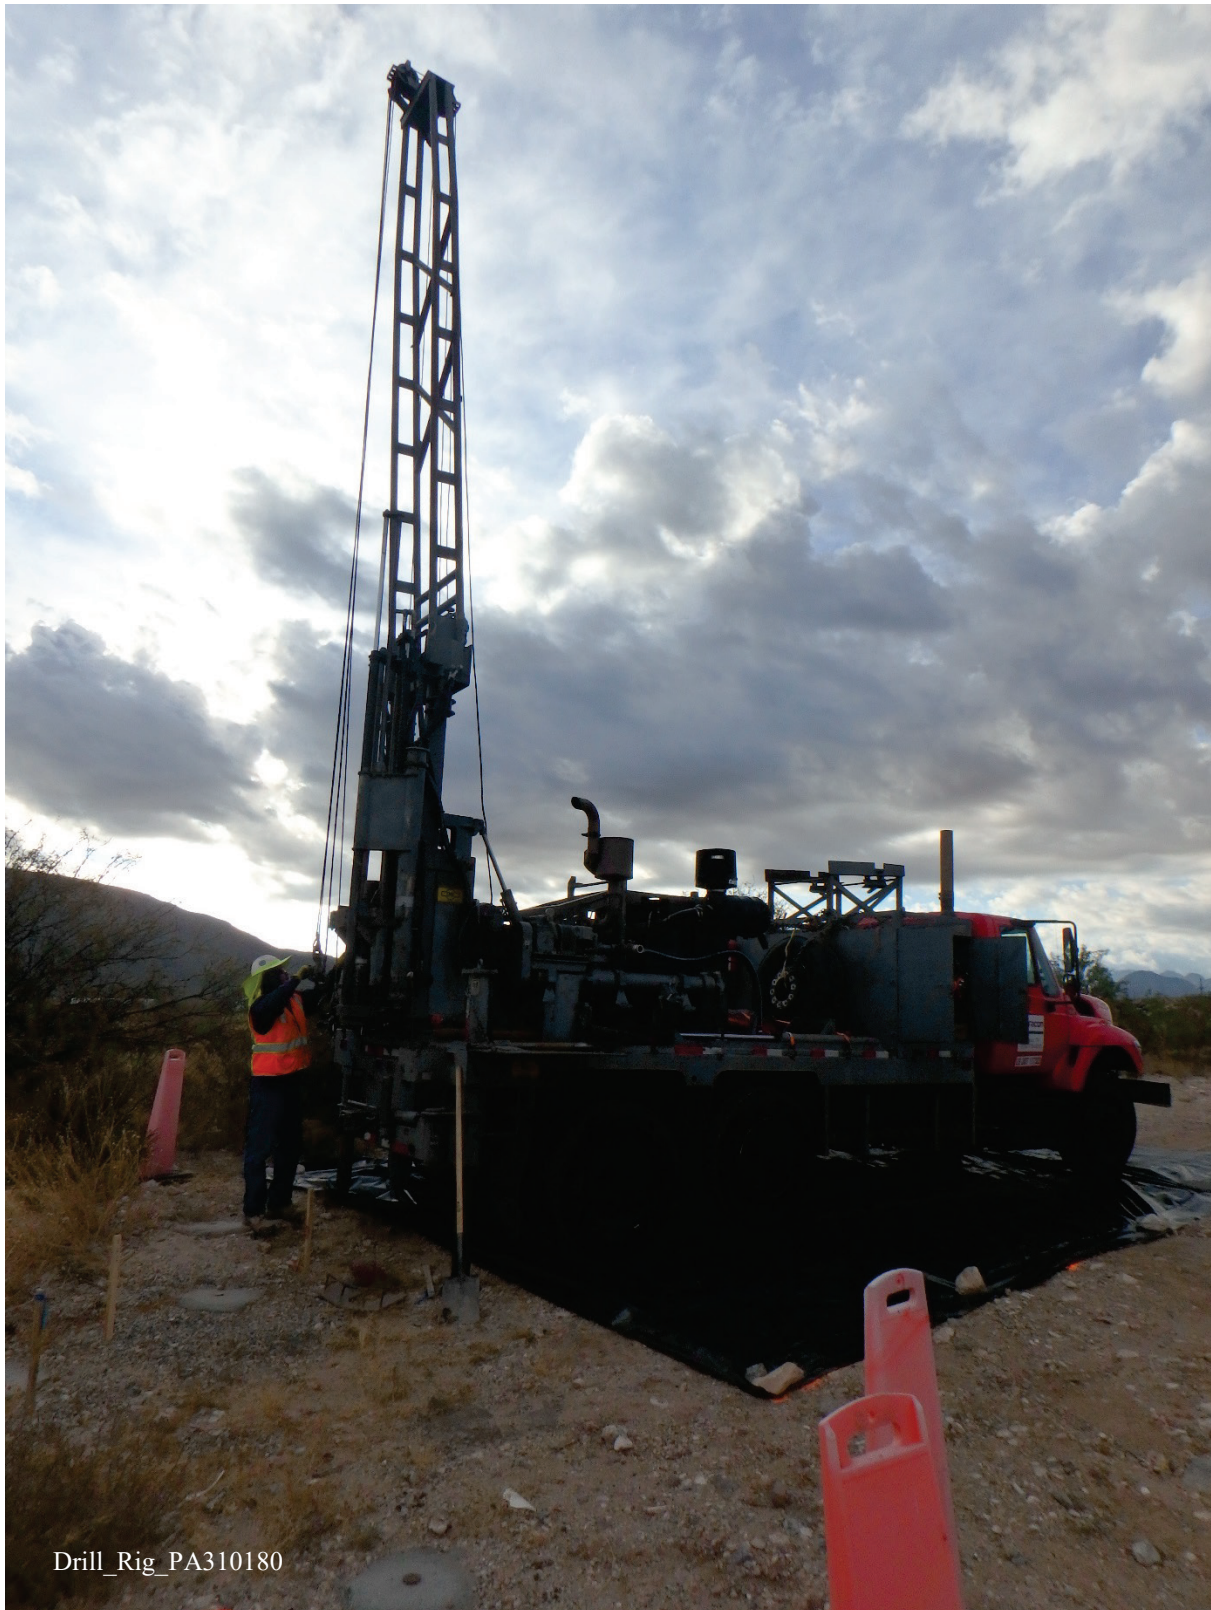
**SWMU 22 – Drill Rig (View to the east)**

Drill rig (CME-75 Hollow Stem Auger) at SWMU 22.

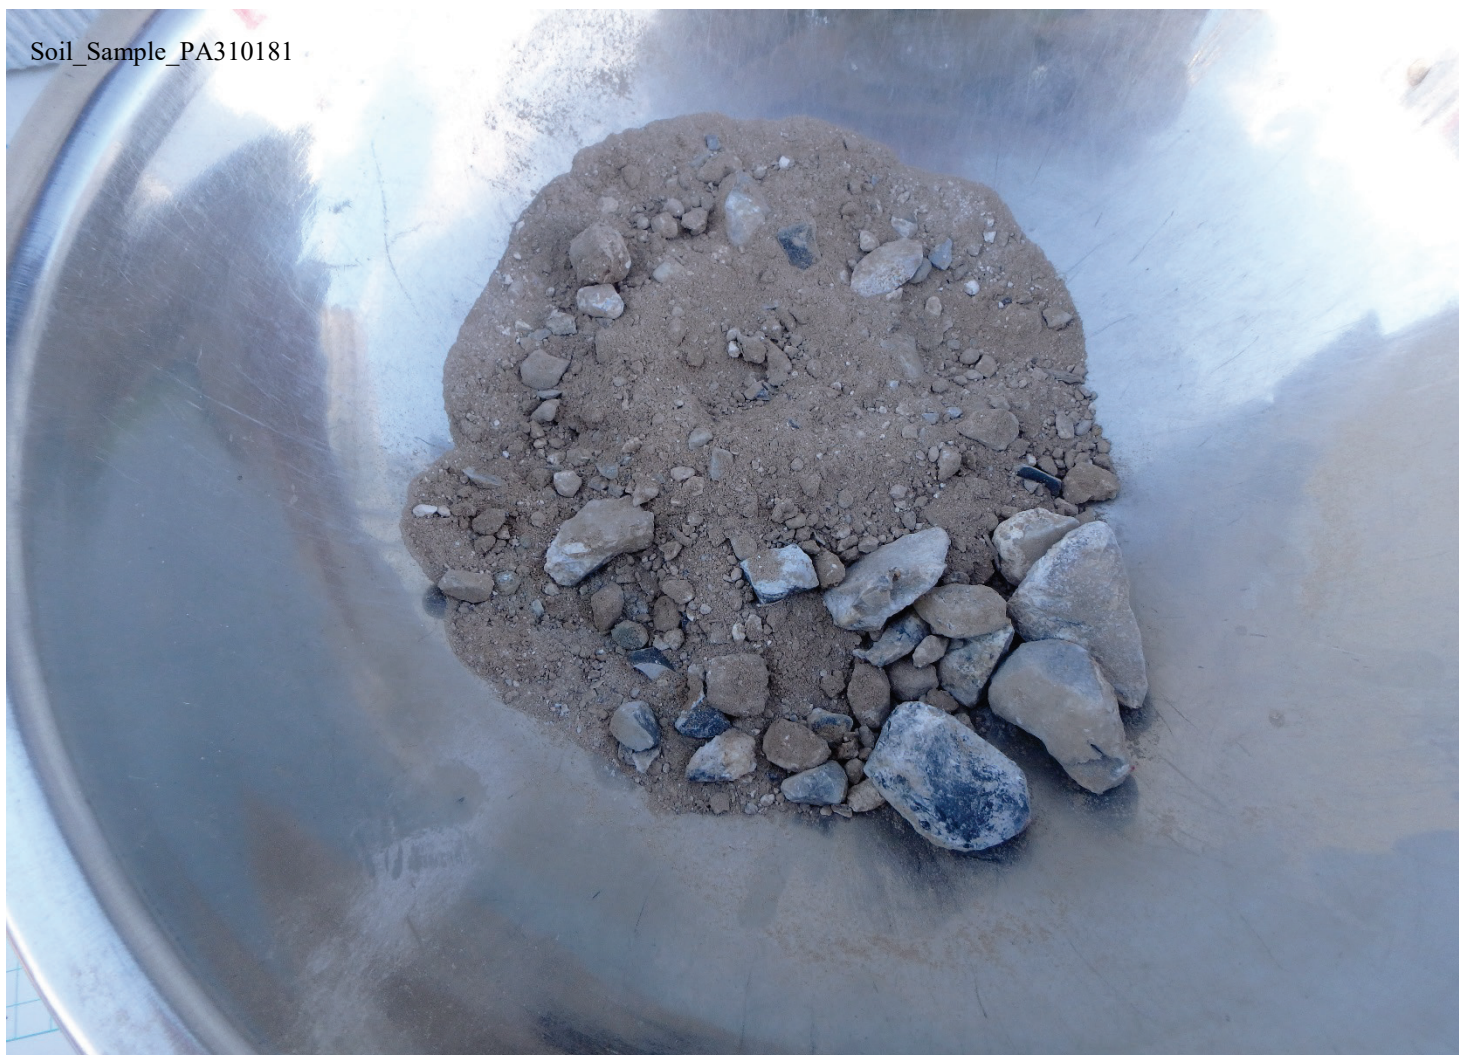
Soil sample is from boring 114-SB-07 at 7 to 9 ft bgs and was typical of the soil encountered during the drilling investigation. Soil is shown here within a stainless steel bowl.
