# THE TOOTHBRUSH HACK

Collaborative problem solving, a jumper lead,  
and a toothbrush turned around an unsuccessful  
late-August spacewalk.

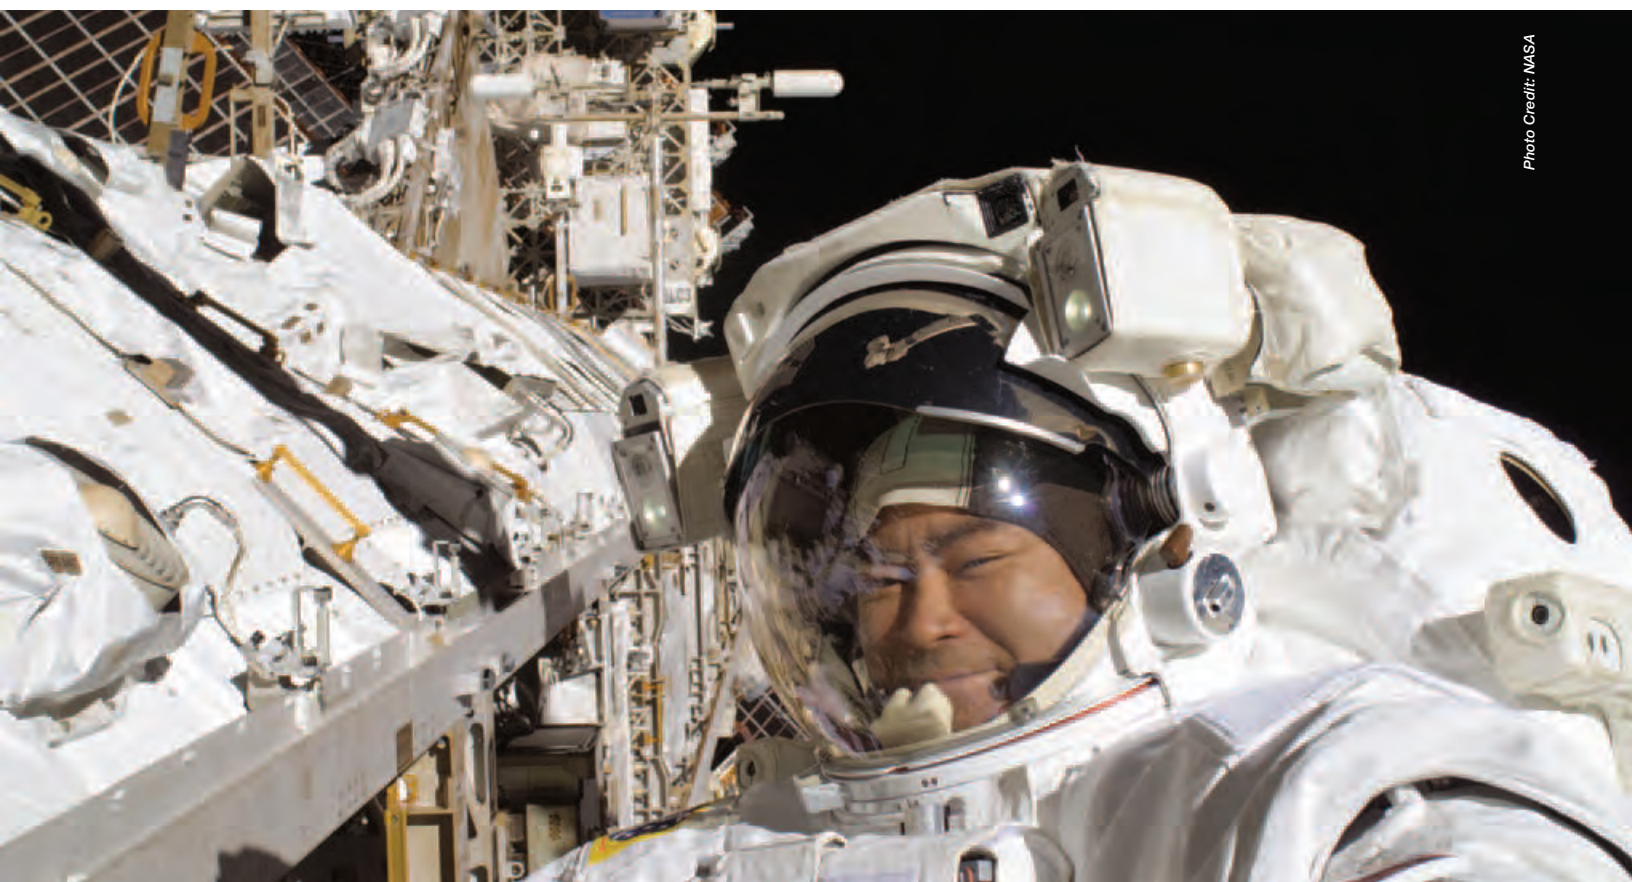
*Japan Aerospace Exploration Agency Astronaut Aki Hoshide participates in a third session of extravehicular activity. During the 6-hour, 28-minute spacewalk, Hoshide and NASA Astronaut Sunita Williams (out of frame) completed the installation of a main bus switching unit that was hampered by a possible misalignment and damaged threads where a bolt must be placed. They also installed a camera on the International Space Station’s robotic arm, Canadarm2.*

Fortunately, this did not come to pass. On Wednesday, September 5, Williams and Hoshide conducted another spacewalk. They cleaned and lubricated the receptacle and threads, drove down the bolt, and successfully installed the MBSU.

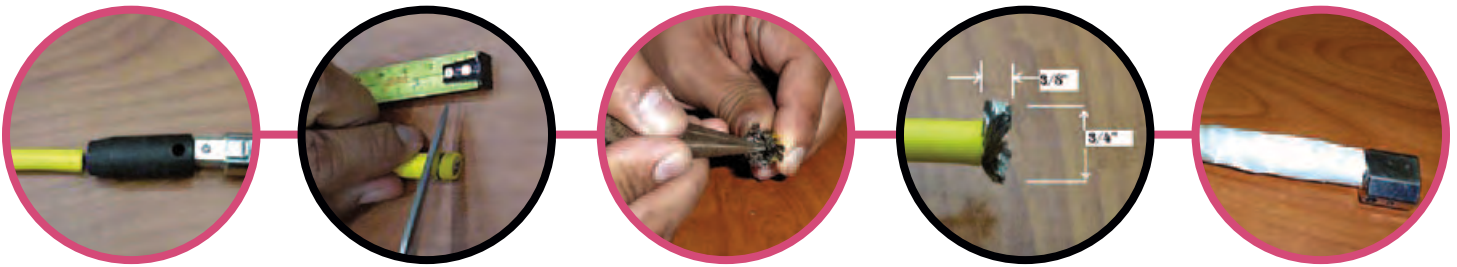
*Images of the jumper cable modified to create the wire brush tool.*

Badillo and another team member started making prototypes. Badillo grabbed a 4-gauge jumper lead identical to one found on ISS, removed the insulation from one end, and frayed the wires inside, creating a brush. The team liked what Badillo developed and improved upon the tool by using EVA tape to make the flimsy lead firm and finding ways to ensure the crew could grab and maneuver the tool with their oven-mitt-like gloves.

By Saturday morning, the team had ready for the crew their procedures and tools: a wire brush made out of a jumper lead and a modified bargain-brand toothbrush.
