**FINAL  
FOURTH FIVE-YEAR REVIEW  
NATIONAL AERONAUTICS AND SPACE ADMINISTRATION  
LANGLEY RESEARCH CENTER  
HAMPTON, VIRGINIA**

**August 2026**

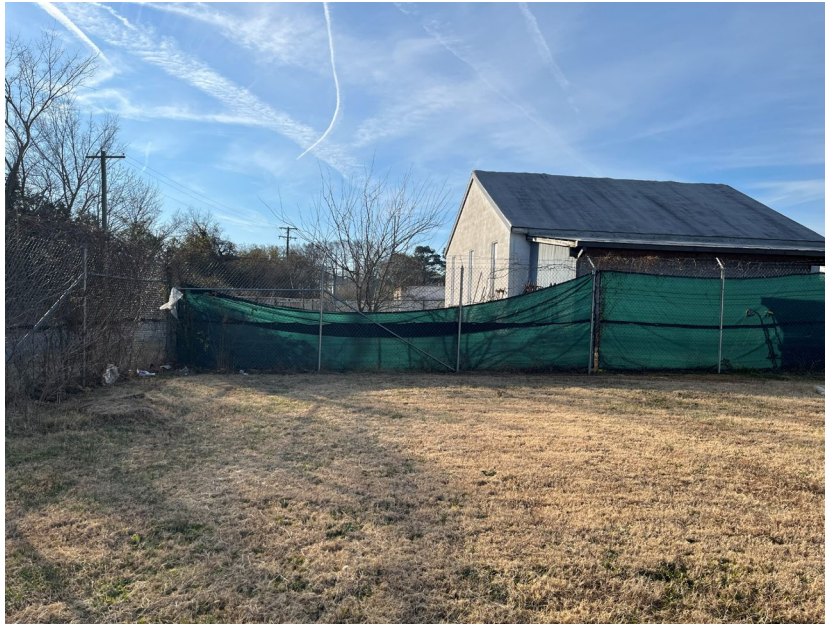
Photograph No.: 3

Description: The privacy cover falling off of the fence in the SE corner.

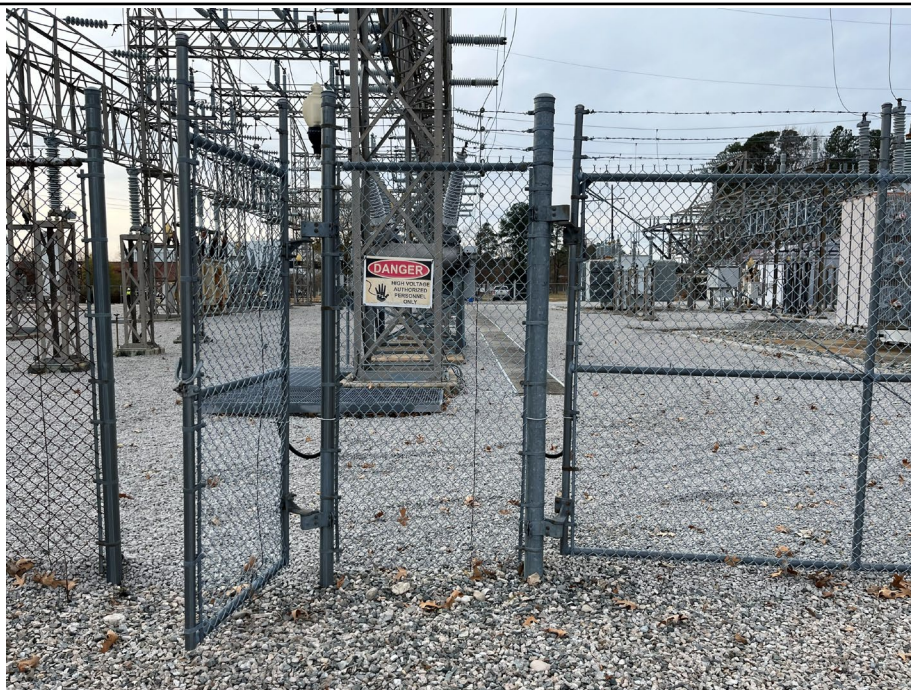
| Photograph No.: 26 | Location: Stratton Substation<br>Photographer: Eddie Weiss | Direction: Facing southeast<br>Date: December 17, 2025 |

Description: Restricted access sign near MW-04C.

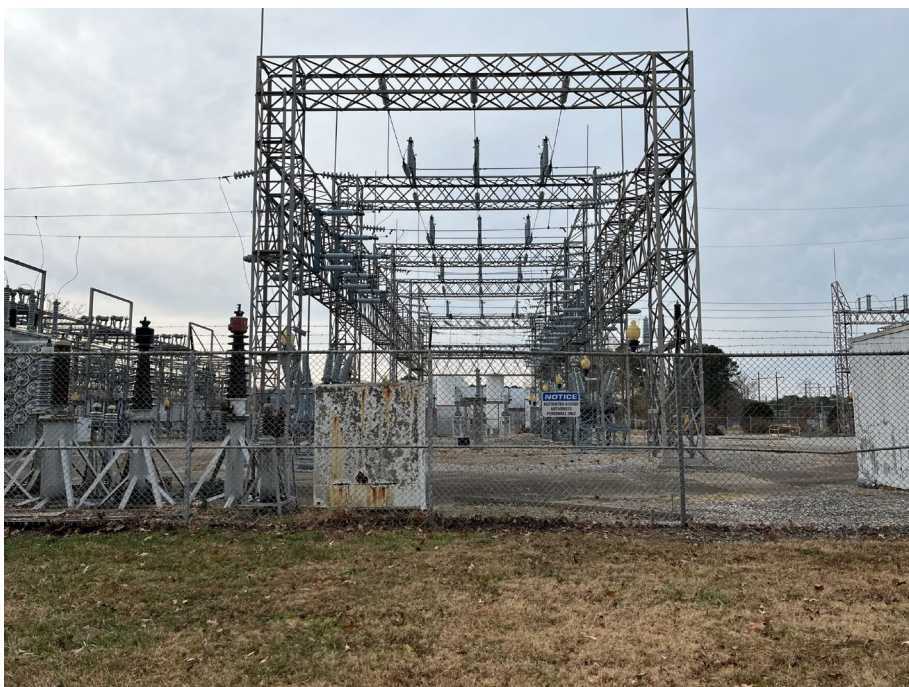
| Photograph No.: 36 | Location: Stratton Substation<br>Photographer: Eddie Weiss | Direction: Facing southwest<br>Date: December 17, 2025 |

Description: Fence and LUC sign on the northern side, near MW-01C.

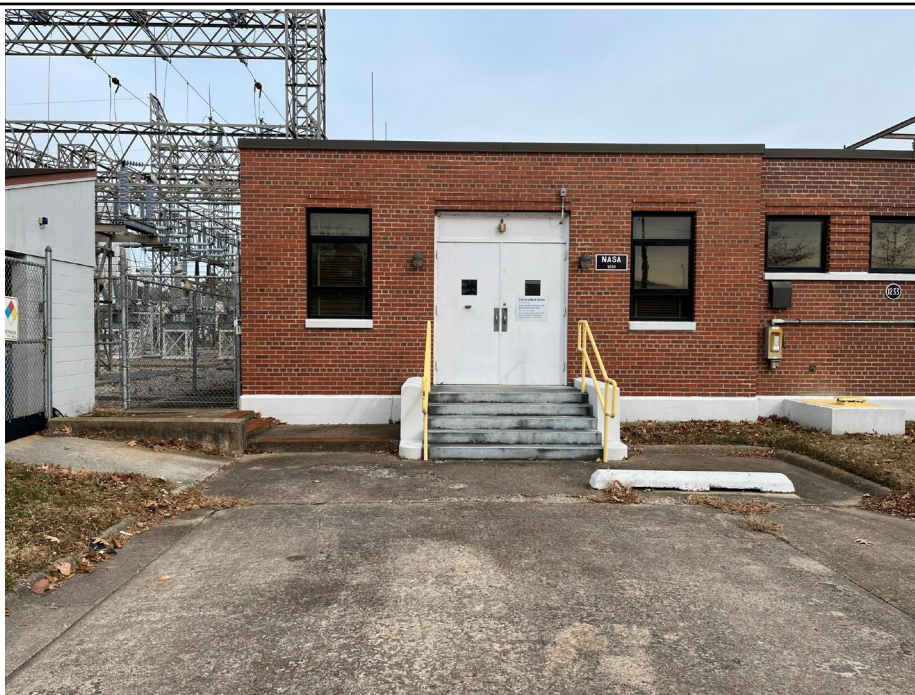
Photograph No.: 44

Description: The gate closest to Building 1233. The gate was open and a car was parked in the driveway for a crew to work inside of the substation.

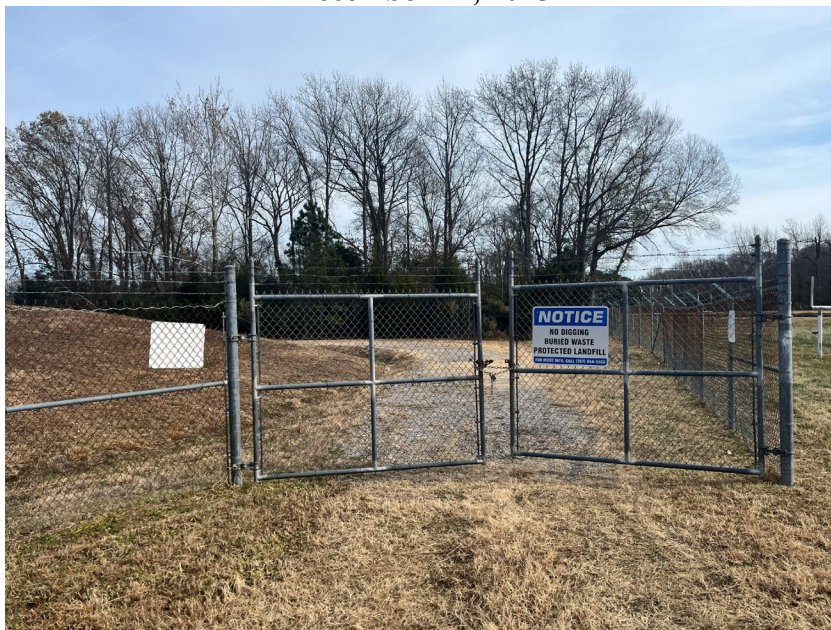
Photograph No.: 53

Description: Closed entry gate to the CDL with LUC signage containing facility contact information.

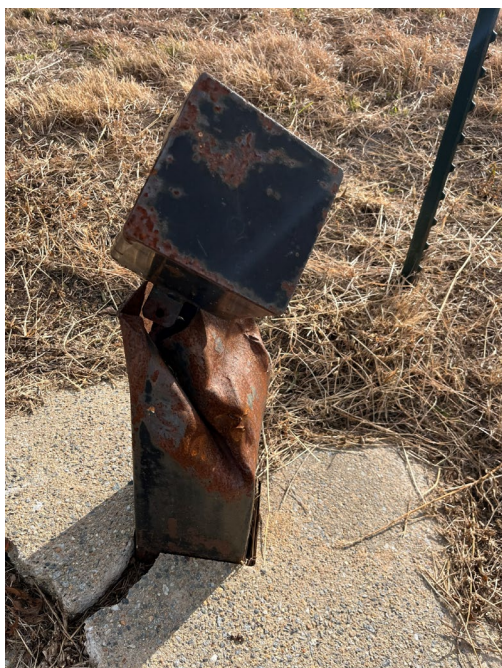
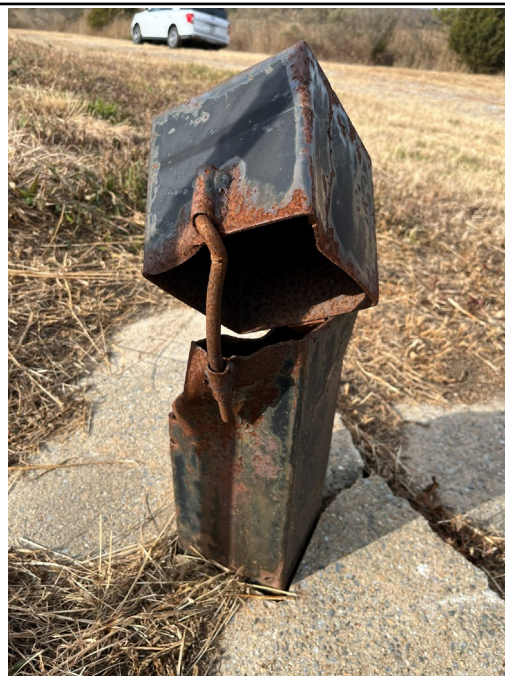
| Photograph No.: 90 | Location: CDL<br>Photographer: Eddie Weiss | Direction: Facing well<br>Date: December 17, 2025 |

Description: MW-45 damaged

- CDL: Minor repairs are needed at three of the monitoring wells at the site.

Status: Repairs to existing monitoring wells are ongoing and are conducted as part of O&M activities.

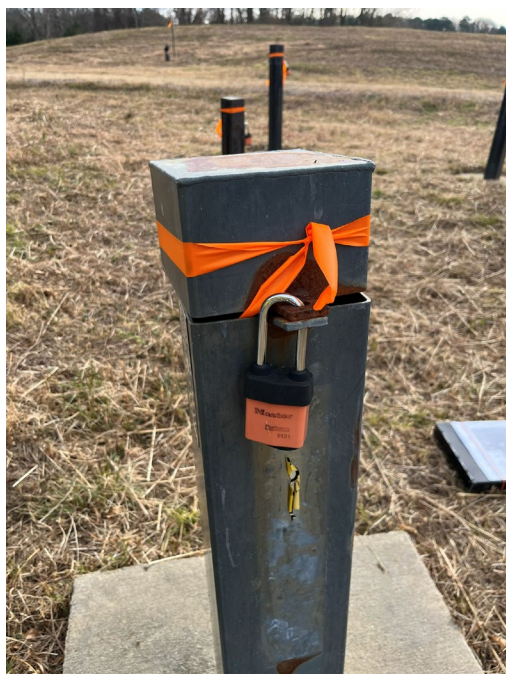
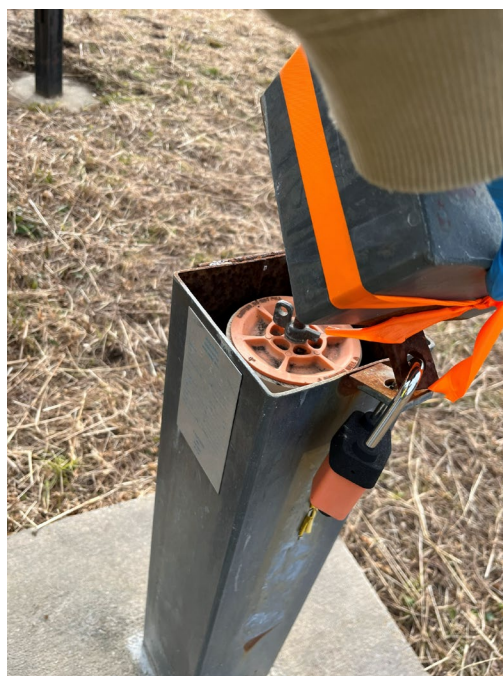
| Photograph No.: 94 | Location: CDL<br>Photographer: Eddie Weiss | Direction: Facing well<br>Date: December 17, 2025 |

Description: MW-44. Protective casing lid is broken at the hinge.
