Types of Lunar Soil Erosion

Vernier-Engine Firings

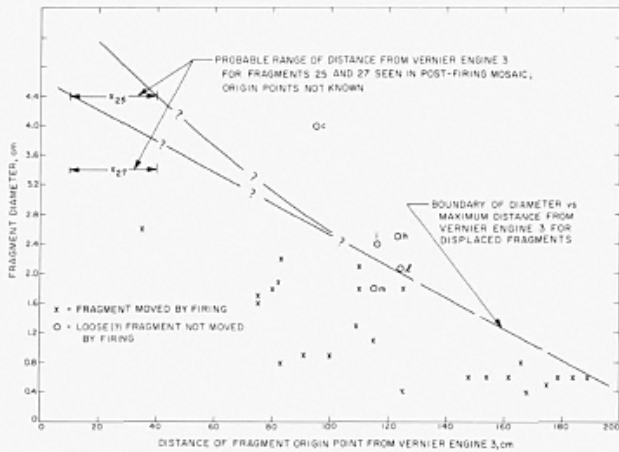
FIGURE 4-19.—Graph of diameter versus distance for fragments moved by the Surveyor V vernier engine 3 static firing. The dashed line represents the probable maximum sizes for fragments that could be moved by the firing at distances ranging from 10 to 200 cm.

(1) Viscous erosion. A thin layer of soil was removed from beneath and adjacent to the vernier engines (fig. 4-17). Erosion of soil during the firing extended to distances at least up to 1.9 meters from the engines. As shown in the controlled³ mosaics (fig. 4-18), the soil layer near vernier engine 3 and adjacent to the sensor head was substantially disturbed by the firing. Some of the soil and rock fragments moved by the firing are identified on these annotated mosaics. The largest fragment known to have been moved is 4.4 cm in diameter. Television pictures indicate that, at least in some places, soil was disturbed by viscous erosion to depths probably greater than 1 cm for distances up to 60 cm from engine 3. As shown in figure 4-18, soil at *E*, beside rock *a*, was eroded to a depth of about 1 cm. The trail (fig. 4-18(a)) left by rock *H* as it rolled downslope is no longer visible (fig. 4-18(b)). Figure 4-19 shows the relative distance that fragments of different sizes can be moved by gases striking the lunar surface with surface pressures equivalent to those of vernier engine 3 (ref. 4-3). This figure shows that fragments up to 4 or 5

cm in diameter were moved at distances up to approximately 20 cm; whereas, at distances of 200 cm, only fragments up to 0.4 cm in diameter were moved.

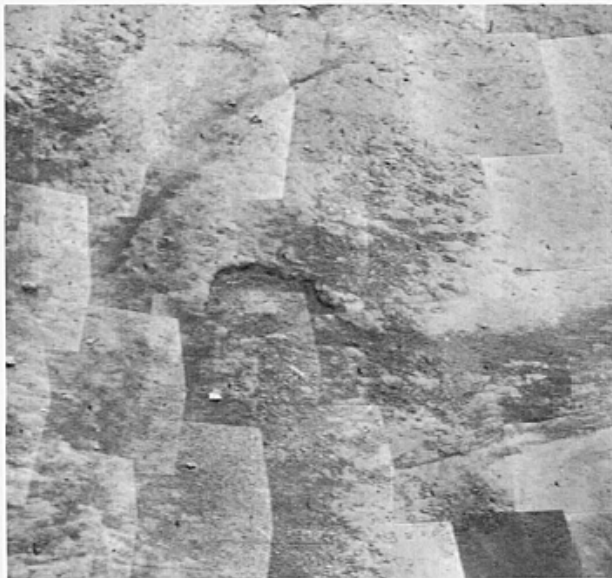
FIGURE 4-23.—Mosaic of computer-processed pictures, showing rays of fine, dark soil deposited by Surveyor V vernier engine 2 during the hop (Nov. 15 and 16, 1967, Catalog 6-SE-43C).

Figure 4-22 is a mosaic of computer-enhanced pictures of the first landing site identifying the double imprints formed by the footpads and the single imprints formed by the crushable blocks during the original landing; the locations of the vernier engines before liftoff for the hop are also shown. On figure 4-22, the major areas of erosion caused by vernier-engine exhaust gases are identified with capital letters. Areas *A-E* represent erosion principally attributed to vernier engine 2, areas *G-I* to engine 3, and areas *K-N* to engine 1 (ref. 4-4). Enlargements of the main erosion areas for each engine are shown in figures 4-23 through 4-25.

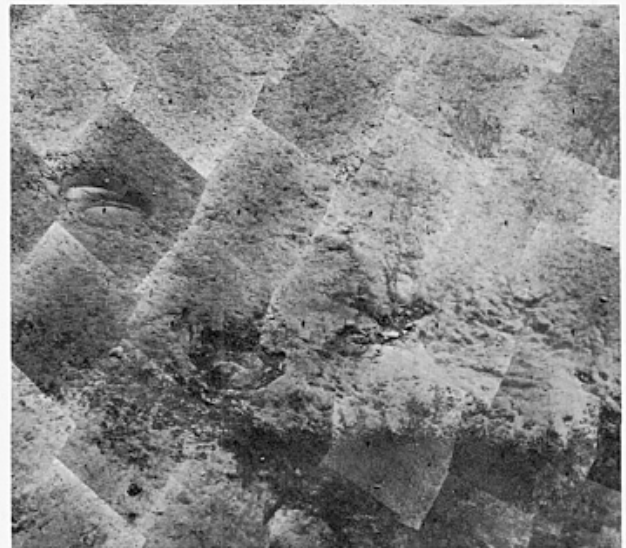
FIGURE 4-24.—Mosaic of computer-processed pictures, showing imprints of footpad 3 and crushable block 3 made during the initial landing and soil disturbance caused by Surveyor VI vernier engine 3 during the hop (Nov. 15 and 16, 1967, Catalog 6-SE-43B).

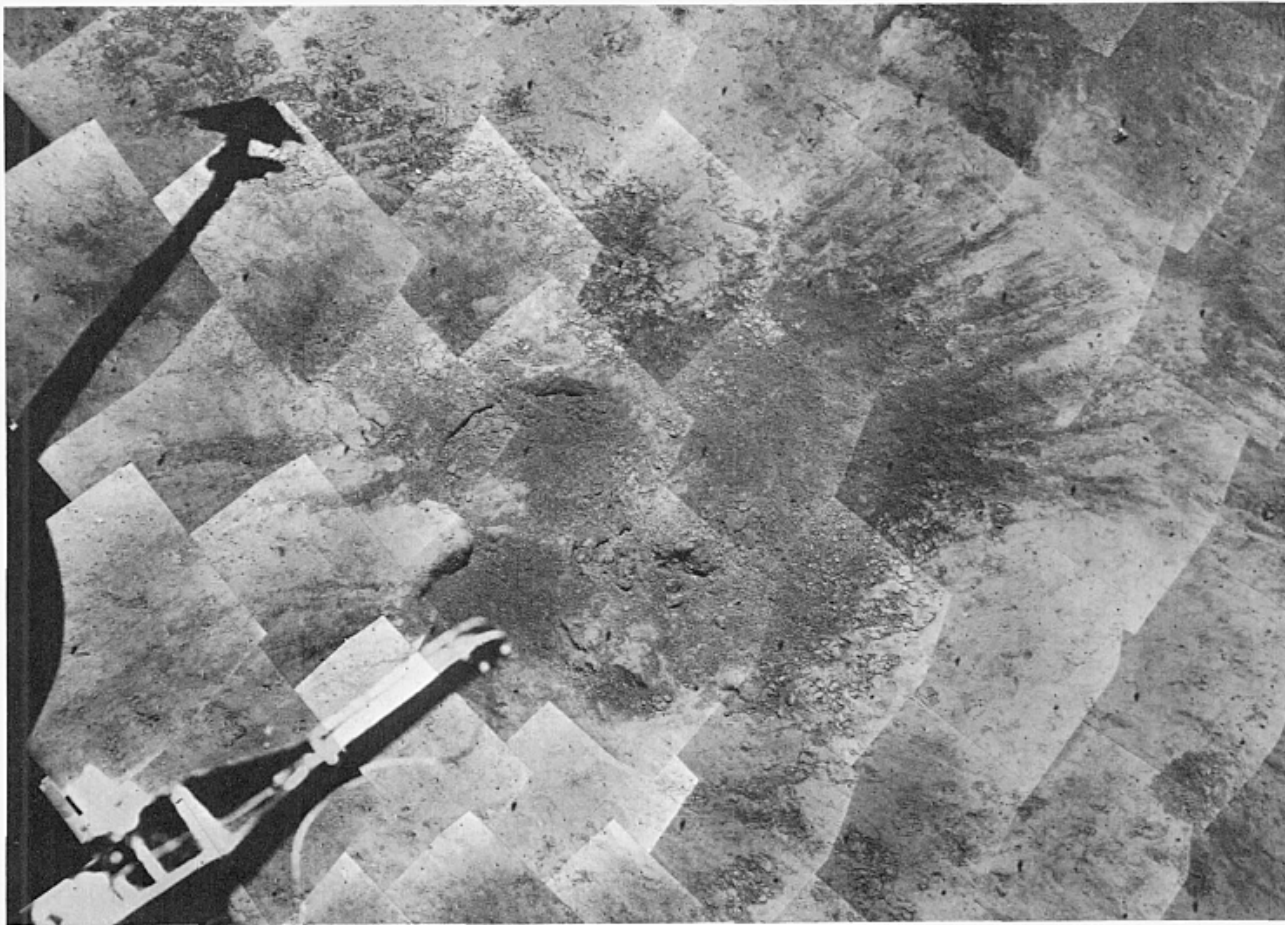
FIGURE 4-25.—Mosaic of computer-processed pictures, showing crushable block 1 impact area and soil disturbance caused by Surveyor VI vernier engine 1 during the hop (Nov. 15 and 16, 1967, Catalog 6-SE-43A).

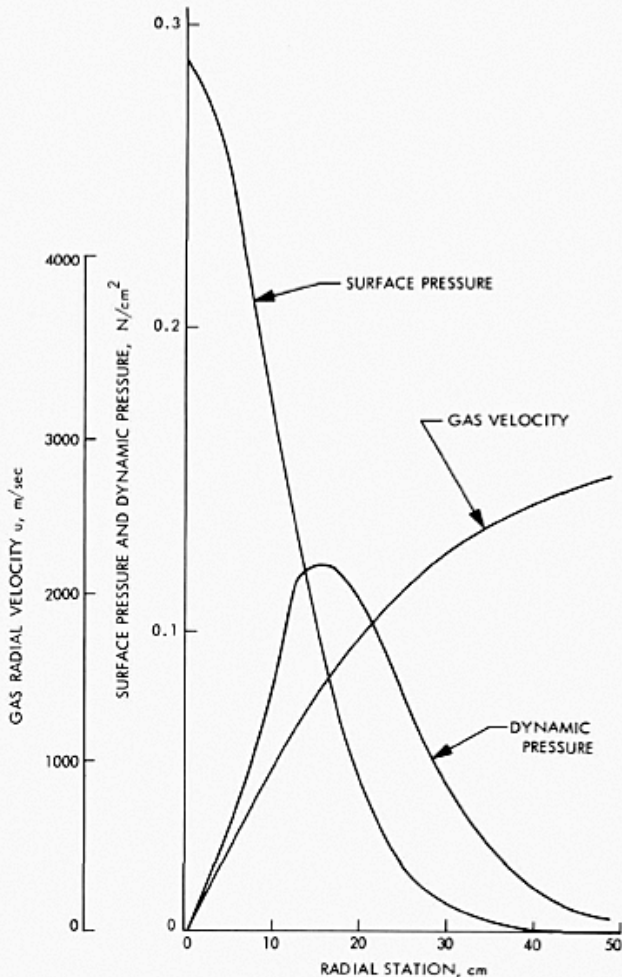
FIGURE 4-27.—Theoretical static pressure, dynamic pressure, and exhaust gas radial velocity at the surface of a plane, parallel to the engine nozzle exit plane; engine thrust=120 N, nozzle exit plane height=39.4 cm.

The maximum static and dynamic surface pressures listed in table 4-3 are values obtained from Roberts' theory (refs. 4-14 and 4-15). Figure 4-27 shows the relationship between these pressures and gas velocity versus radial distance. The dynamic pressure is equal to $\rho u^2/2$, where ρ is the gas mass density and u the radial velocity of the gas along the surface. The values for the Surveyor V static firing correspond to the engine thrusts and nozzle heights given in table 4-3. The pressures given for Surveyors III and VI are the maximum values encountered during the second Surveyor III landing event and Surveyor VI hop, respectively. During these maneuvers, maximum engine thrusts and minimum nozzle heights did not occur simultaneously; therefore, the lifted maximum surface pressures did not correspond to both maximum thrusts and minimum nozzle heights.
