COLUMBIA

ACCIDENT INVESTIGATION BOARD

Report Volume I

August 2003

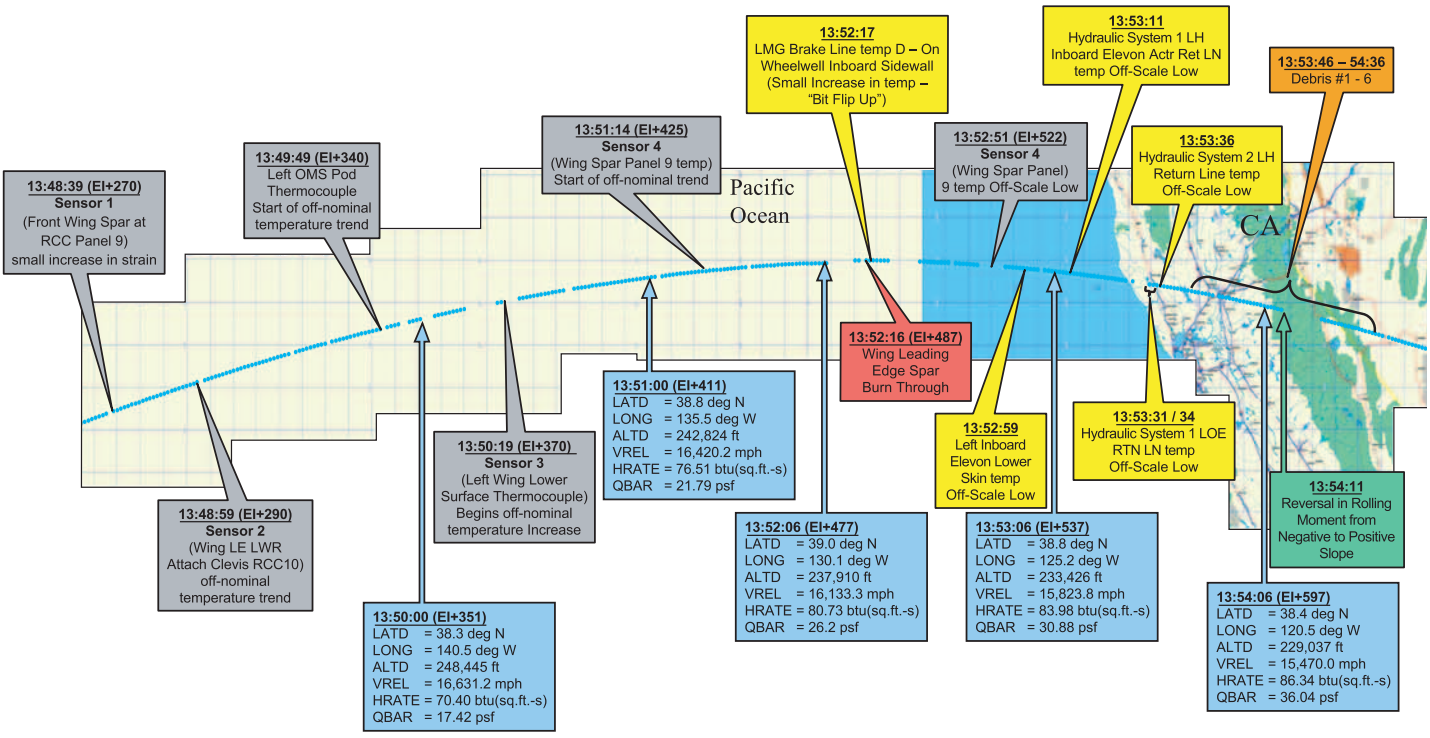
At 8:48:39 a.m. (EI+270), a sensor on the left wing leading edge spar showed strains higher than those seen on previous *Columbia* re-entries. This was recorded only on the Modular Auxiliary Data System, and was not telemetered to ground controllers or displayed to the crew (see Figure 2.6-1).

Figure 2.6-1. This simplified timeline shows the re-entry path of Columbia on February 1, 2003. The information presented here is a composite of sensor data telemetered to the ground combined with data from the Modular Auxiliary Data System recorder recovered after the accident. Note that the first off-nominal reading was a small increase in a strain gauge at the front wing spar behind RCC panel 9-left. The chart is color-coded: blue boxes contain position, attitude, and velocity information; orange boxes indicate when debris was shed from the Orbiter; green boxes are significant aerodynamic control events; gray boxes contain sensor information from the Modular Auxiliary Data System; and yellow boxes contain telemetered sensor information. The red boxes indicate other significant events.

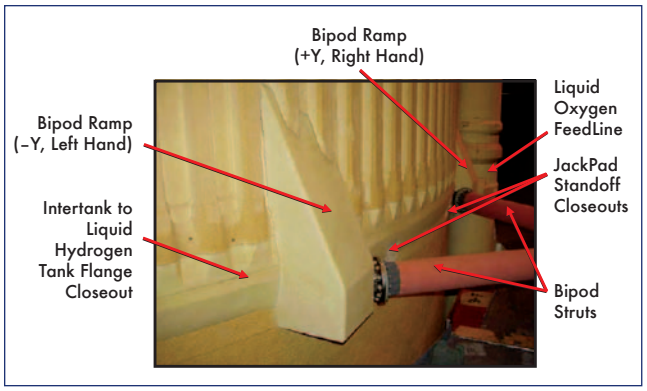
Figure 3.2-2. The exterior of the left bipod attachment area showing the foam ramp that came off during the ascent of STS-107.

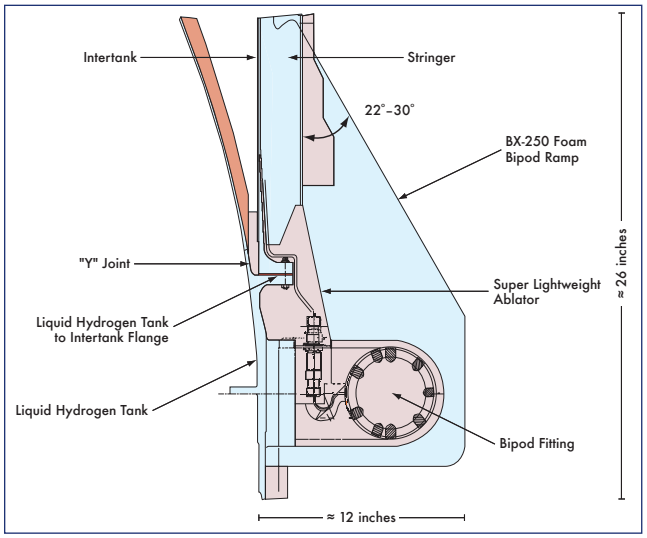
Figure 3.2-3. Cutaway drawing of the bipod ramp and its associated fittings and hardware.

The External Tank is attached to the Solid Rocket Boosters by bolts and fittings on the thrust panels and near the aft end of the liquid hydrogen tank. The Orbiter is attached to the External Tank by two umbilical fittings at the bottom (that also contain fluid and electrical connections) and by a "bipod" at the top. The bipod is attached to the External Tank by fittings at the right and left of the External Tank centerline. The bipod fittings, which are titanium forgings bolted to the External Tank, are forward (above) of the intertank-liquid hydrogen flange joint (see Figures 3.2-2 and 3.2-3). Each forging contains a spindle that attaches to one end of a bipod strut and rotates to compensate for External Tank shrinkage during the loading of cryogenic propellants.

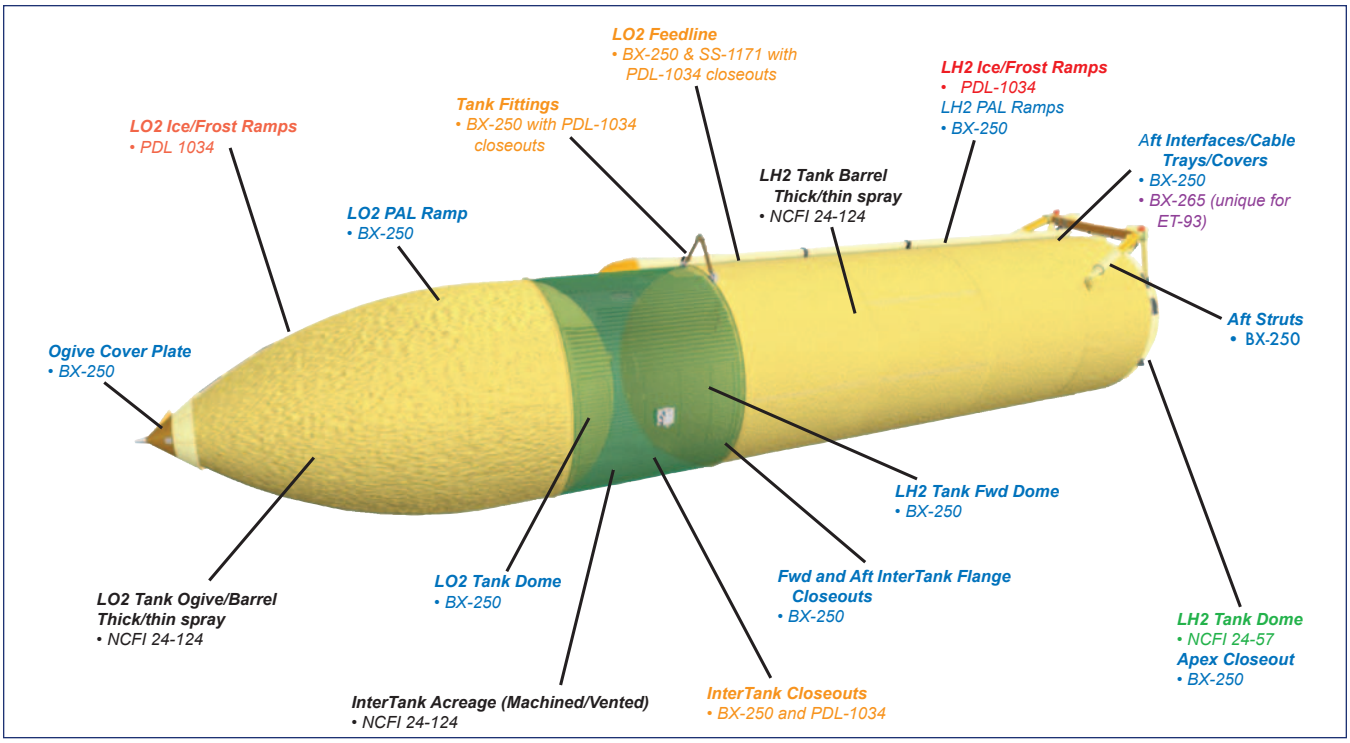
Figure 3.2-4. Locations of the various foam systems as used on ET-93, the External Tank used for STS-107.

oxygen and hydrogen in a liquid state, and to maintain the temperature of external parts high enough to prevent ice and frost from forming on the surface. Figure 3.2-4 summarizes the foam systems used on the External Tank for STS-107.

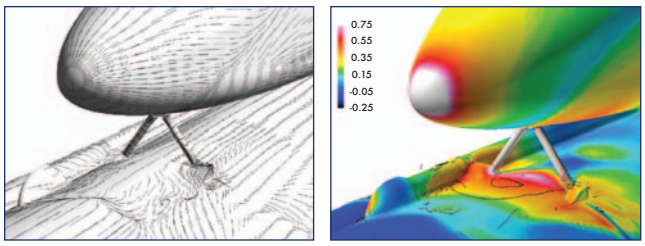
Figure 3.2-5. Computational Fluid Dynamics was used to understand the complex flow fields and pressure coefficients around bipod strut. The flight conditions shown here approximate those present when the left bipod foam ramp was lost from External Tank 93 at Mach 2.46 at a 2.08-degree angle of attack.

Further complicating this problem, foam does not have the same properties in all directions, and there is also variability in the foam itself. Because it consists of small hollow cells, it does not have the same composition at every point. This combination of properties and composition makes foam extremely difficult to model analytically or to characterize physically. The great variability in its properties makes for difficulty in predicting its response in even relatively static conditions, much less during the launch and ascent of the Shuttle. And too little effort went into understanding the origins of this variability and its failure modes.

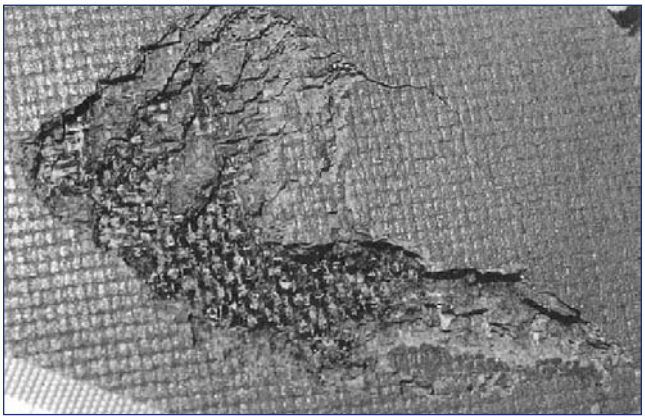
Figure 3.3-2. Damage on the outer surface of RCC panel 10-right from Atlantis after STS-45.

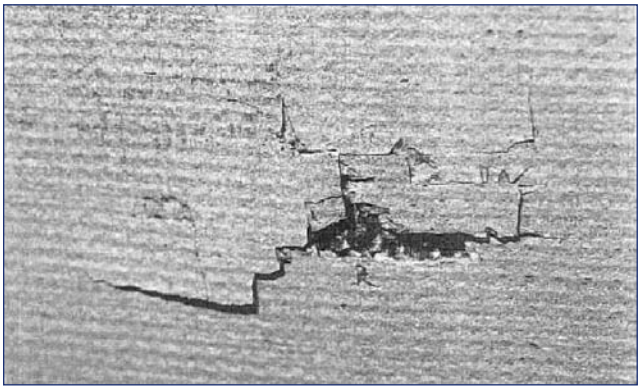
Figure 3.3-3. Damage on the inner surface of RCC panel 10-right from Atlantis after STS-45.

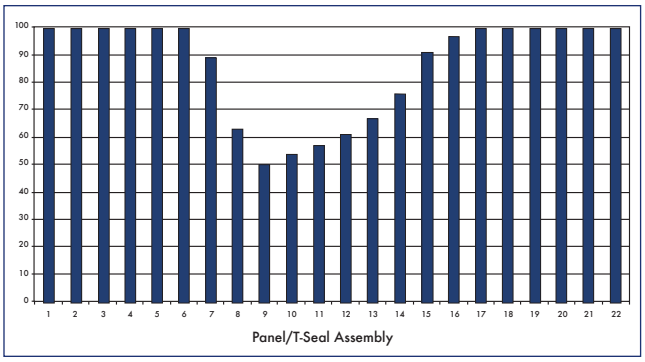
For the first five missions of *Columbia*, the RCC components were not coated with Type A sealant, and had shorter mission service lives than the RCC components on the other Orbiters. (*Columbia*'s panel 9 has the shortest mission service life of 50 flights as shown in Figure 3.3-4.) The predicted life for panel/T-seals 7 through 16 range from 54 to 97 flights.[7]

Figure 3.3-4. The expected mission life for each of the wing leading edge RCC panels on Columbia. Note that panel 9 has the shortest life expectancy.

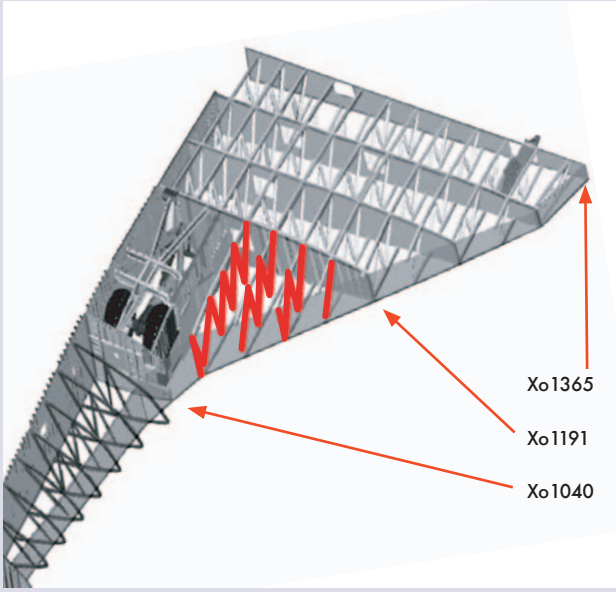
The mid-wing area on the left wing, behind where the breach occurred, is supported by a series of trusses, as shown in red in the figure below. The mid-wing area is bounded in the front and back by the Xo1040 and Xo1191 cross spars, respectively. The numerical designation of each spar comes from its location along the Orbiter's X-axis; for example, the Xo1040 spar is 1,040 inches from the zero point on the X-axis. The cross spars provide the wing's structural integrity. Three major cross spars behind the Xo1191 spar provide the primary structural strength for the aft portion of the wing. The inboard portion of the mid-wing is the outer wall of the left wheel-well, and the outboard portion of the mid-wing is the wing leading edge spar, where the RCC panels attach.

The major internal support structures in the mid-wing are constructed from aluminum alloy. Since aluminum melts at 1,200 degrees Fahrenheit, it is likely these truss tubes in the mid-wing were destroyed and wing structural integrity was lost.

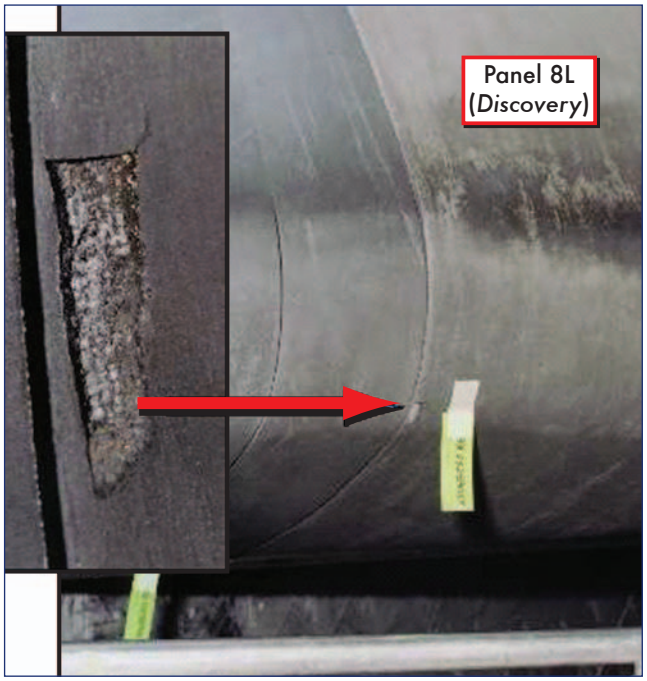
Figure 3.3-5. RCC panel 8-left from Discovery had to be scrapped after STS-103 because of the damage shown here.

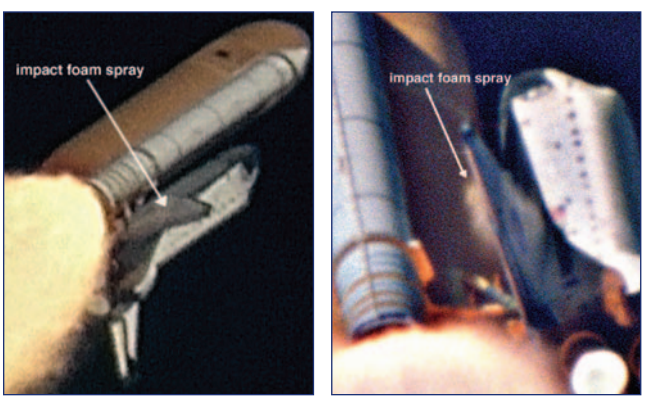
At 81.9 seconds after launch of STS-107, a sizable piece of foam struck the leading edge of *Columbia*'s left wing. Visual evidence established the source of the foam as the left bipod ramp area of the External Tank. The widely accepted implausibility of foam causing significant damage to the wing leading edge system led the Board to conduct independent tests to characterize the impact. While it was impossible to determine the precise impact parameters because of uncertainties about the foam's density, dimensions, shape, and initial velocity, intensive work by the Board, NASA, and contractors provided credible ranges for these elements. The Board used a combination of tests and analyses to conclude that the foam strike observed during the flight of STS-107 was the direct, physical cause of the accident.

Figure 3.4-1 (color enhanced and "de-blurred" by Lockheed Martin Gaithersburg) and Figure 3.4-2 (processed by the National Imagery and Mapping Agency) are samples of the type of visual data used to establish the time of the impact (81.9 seconds), the altitude at which it occurred (65,860 feet), and the object's relative velocity at impact (about 545 mph relative to the Orbiter).

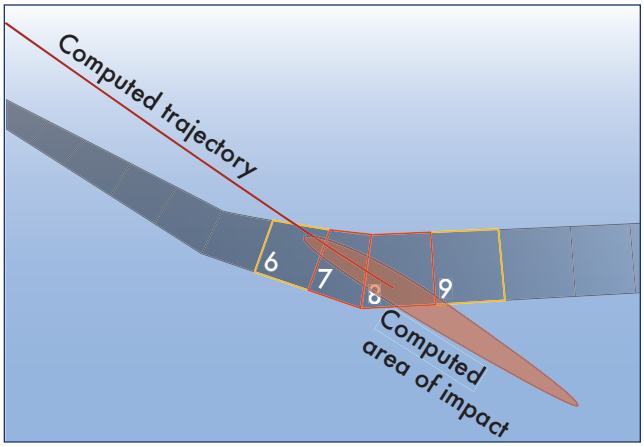
Figure 3.4-3: The best estimate of the site of impact by the center of the foam.

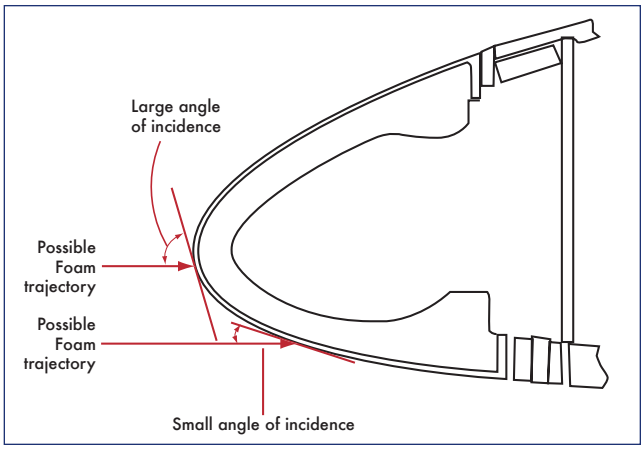
Image analysis determined that the foam was moving almost parallel to the Orbiter's fuselage at impact, with about a five-degree angle upward toward the bottom of the wing and slight motion in the outboard direction. If the foam had hit the tiles adjacent to the leading edge, the angle of incidence would have been about five degrees (the angle of incidence is the angle between the relative velocity of the projectile and the plane of the impacted surface). Because the wing leading edge curves, the angle of incidence increases as the point of impact approaches the apex of an RCC panel. Image and transport analyses estimated that for impact on RCC panel 8, the angle of incidence was between 10 and 20 degrees (see Figure 3.4-4).[9] Because the total force delivered by the impact depends on the angle of incidence, a foam strike near the apex of an RCC panel could have delivered about twice the force as an impact close to the base of the panel.

Figure 3.4-4. This drawing shows the curve of the wing leading edge and illustrates the difference the angle of incidence has on the effect of the foam strike.

The precise impact location of the foam determined the impact angle because the debris was moving almost parallel to the Orbiter's fuselage at impact. Tile areas would have been hit at very small angles (approximately five degrees), but the curvature of the leading edge created angles closer to 20 degrees (see Figure 3.4-4).

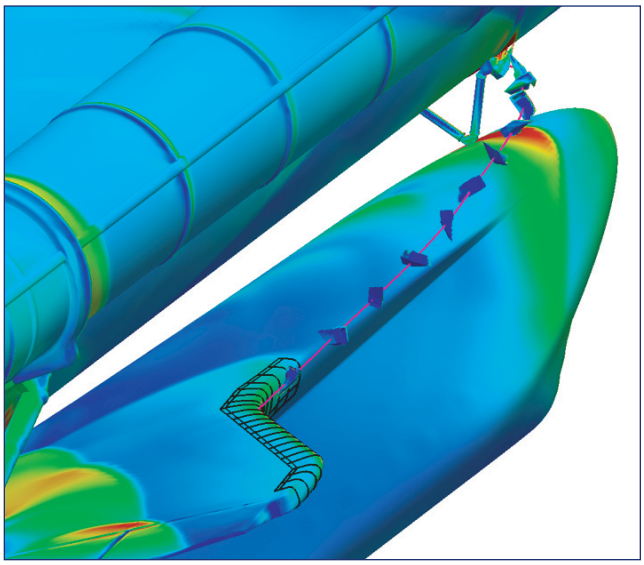
Figure 3.4-6. These are the results of a trajectory analysis that used a computational fluid dynamics approach in a program called CART-3D, a comprehensive (six-degree-of-freedom) computer simulation based on the laws of physics. This analysis used the aerodynamic and mass properties of bipod ramp foam, coupled with the complex flow field during ascent, to determine the likely position and velocity histories of the foam.

The undetermined and yet certainly irregular shape of the foam introduced substantial uncertainty about its estimated aerodynamic characteristics. Appendix D.8 contains an independent analysis conducted by the Board to confirm that the estimated range of ballistic coefficients of the foam in Figure 3.4-6 was credible, given the foam dimension results from the image analyses and the expected range of the foam density. Based on the results in Figure 3.4-7, the physical dimensions of the bipod ramp, and the sizes and shapes of the available barrels for the compressed-gas gun used in the impact test program described later in this chapter, the Board and the NASA Accident Investigation Team decided that a foam projectile 19 inches by 11.5 inches by 5.5 inches, weighing 1.67 pounds, and with a weight density of 2.4 pounds per cubic foot, would best represent the piece of foam that separated from the External Tank bipod ramp and was hit by the Orbiter's left wing. See Section 3.8 for a full discussion of the foam impact testing.

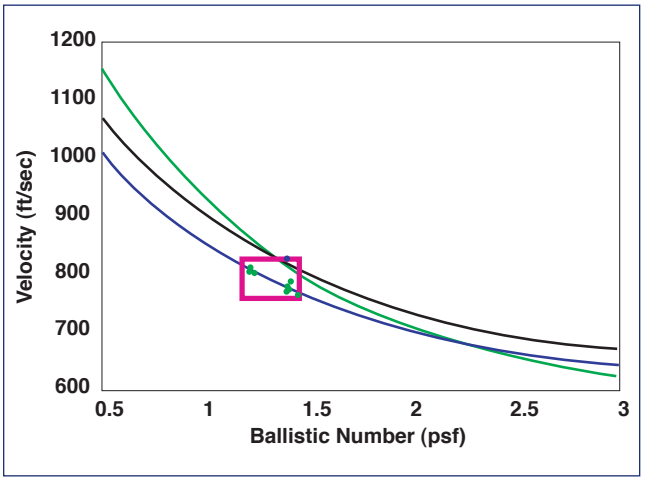
Figure 3.4-7. The results of numerous possible trajectories based on various assumed sizes, shapes, and densities of the foam. Either the foam had a slightly higher ballistic coefficient and the Orbiter struck the foam at a lower speed relative to the Orbiter, or the foam was more compact and the wing struck the foam at a higher speed. The "best fit" box represents the overlay of the data from the image analysis with the transport analysis computations. This data enabled a final selection of projectile characteristics for impact testing.

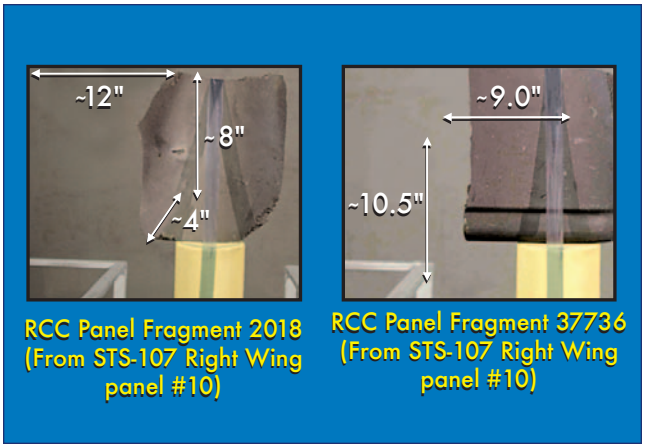
Figure 3.5-1. These representative RCC acreage pieces matched the radar cross-section of the Flight Day 2 object.

In the Advanced Compact Range at the Air Force Research Laboratory in Dayton, Ohio, analysts tested 31 materials from the Orbiter's exterior and payload bay. Additional supercomputer radar cross-section predictions were made for Reinforced Carbon-Carbon T-seals. After exhaustive radar cross-section analysis and testing, coupled with ballistic analysis of the object's orbital decay, only a fragment of RCC panel would match the UHF radar cross-section and ballistic coefficients observed by the Space Surveillance network. Such an RCC panel fragment must be approximately 140 square inches or greater in area to meet the observed radar cross-section characteristics. Figure 3.5-1 shows RCC panel fragments from *Columbia*'s right wing that represent those meeting the observed characteristics of object 2003-003B.[10]

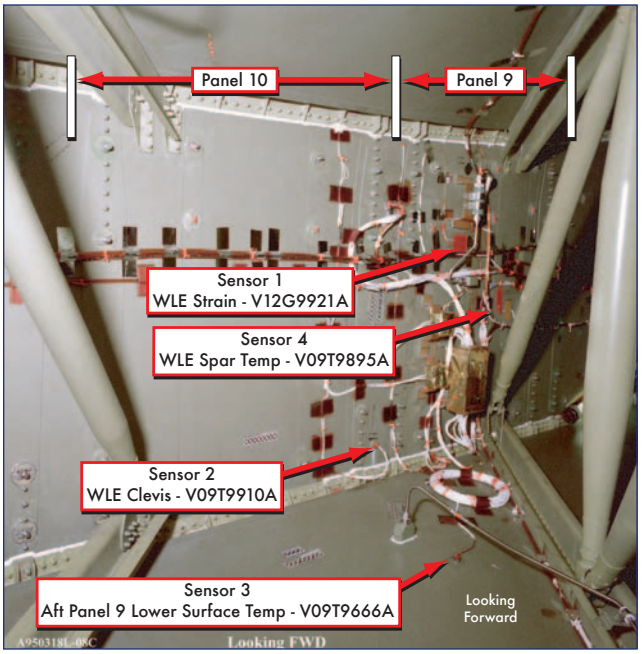
Figure 3.6-2. Location of sensors on the back of the left wing leading edge spar (vertical aluminum structure in picture). Also shown are the round truss tubes and ribs that provided the structural support for the mid-wing in this area.

At EI+270, the Modular Auxiliary Data System recorded the first unusual condition while the Orbiter was still over the Pacific Ocean. Four sensors, which were all either inside or outside the wing leading edge spar near Reinforced Carbon-Carbon (RCC) panel 9-left, helped tell the story of what happened on the left wing of the Orbiter early in the re-entry. These four sensors were: strain gauge V12G9921A (Sensor 1), resistance temperature detector V09T9910A on the RCC clevis between panel 9 and 10 (Sensor 2), thermocouple V07T9666A, within a Thermal Protection System tile (Sensor 3), and resistance temperature detector V09T9895A (Sensor 4), located on the back side of the wing leading edge spar behind RCC panels 8 and 9 (see Figure 3.6-2).

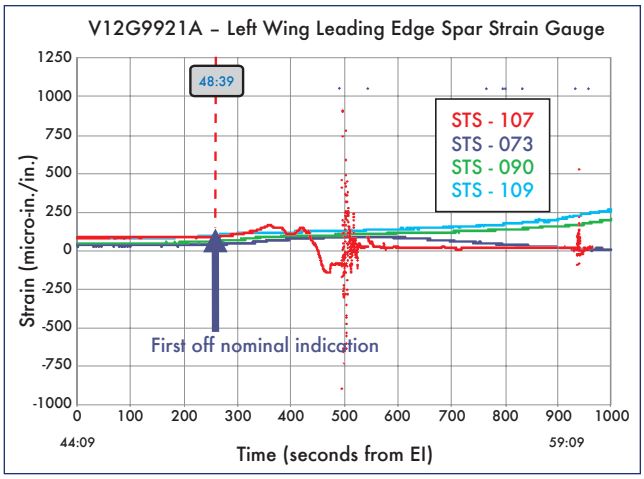
Figure 3.6-3. The strain gauge (Sensor 1) on the back of the left wing leading edge spar was the first sensor to show an anomalous reading. In this chart, and the others that follow, the red line indicates data from STS-107. Data from other Columbia re-entries, similar to the STS-107 re-entry profile, are shown in the other colors.

Sensor 1 provided the first anomalous reading (see Figure 3.6-3). From EI+270 to EI+360, the strain is higher than that on previous *Columbia* flights. At EI+450, the strain reverses, and then peaks again in a negative direction at EI+475. The strain then drops slightly, and remains constant and negative until EI+495, when the sensor pattern becomes unreliable, probably due to a propagating soft short, or "burn-through" of the insulation between cable conductors caused by heating or combustion. This strain likely indicates significant damage to the aluminum honeycomb spar. In particular, strain reversals, which are unusual, likely mean there was significant high-temperature damage to the spar during this time.

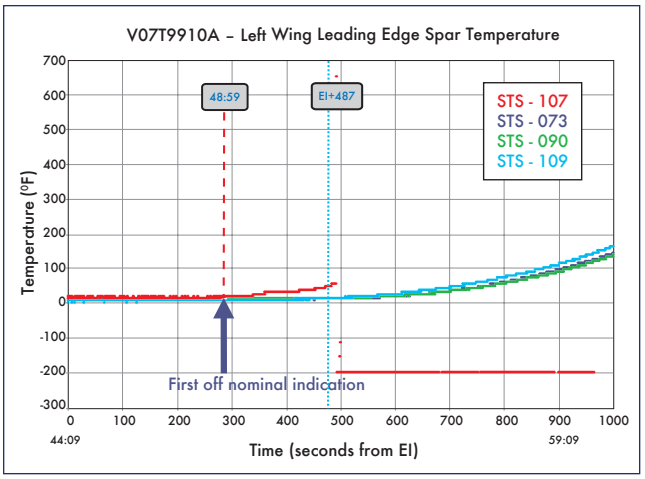
Figure 3.6-4. This temperature thermocouple (Sensor 2) was mounted on the outside of the wing leading edge spar behind the insulation that protects the spar from radiated heat from the RCC panels. It clearly showed an off-nominal trend early in the re-entry sequence and began to show an increase in temperature much earlier than the temperature sensor behind the spar.

At EI+290, 20 seconds after Sensor 1 gave its first anomalous reading, Sensor 2, the only sensor in the front of the left wing leading edge spar, recorded the beginning of a gradual and abnormal rise in temperature from an expected 30 degrees Fahrenheit to 65 degrees at EI+493, when it then dropped to "off-scale low," a reading that drops off the scale at the low end of the sensor's range (see Figure 3.6-4). Sensor 2, one of the first to fail, did so abruptly. It had indicated only a mild warming of the RCC attachment clevis before the signal was lost.

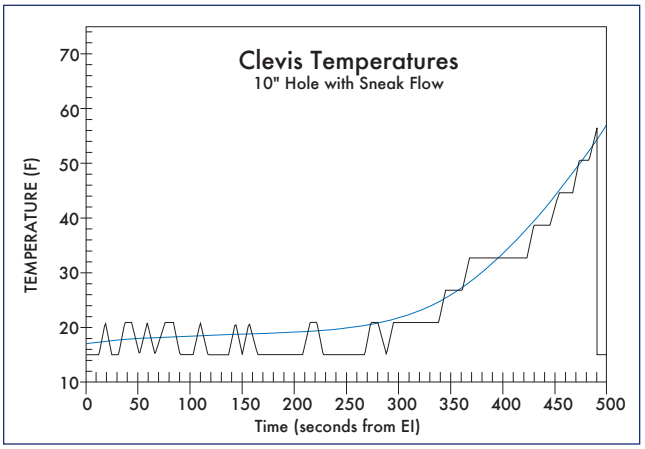
A series of thermal analyses were performed for different sized holes in RCC panel 8 to compute the time required to heat Sensor 2 to the temperature recorded by the Modular Auxiliary Data System. To heat the clevis, various insulators would have to be bypassed with a small amount of leakage, or "sneak flow." Figure 3.6-5 shows the results of these calculations for, as an example, a 10-inch hole, and demonstrates that with sneak flow around the insulation, the temperature profile of the clevis sensor was closely matched by the engineering calculations. This is consistent with the same sneak flow required to match a similar but abnormal ascent temperature rise of the same sensor, which further supports the premise that the breach in the leading edge of the wing occurred during ascent. While the exact size of the breach will never be known, and may have been smaller or larger than 10 inches, these analyses do provide a plausible explanation for the observed rises in temperature sensor data during re-entry.

Figure 3.6-5. The analysis of the effect of a 10-inch hole in RCC panel 8 on Sensor 2 from EI to EI+500 seconds. The jagged line shows the actual flight data readings and the smooth line the calculated result for a 10-inch hole with some sneak flow of superheated air behind the spar insulation.

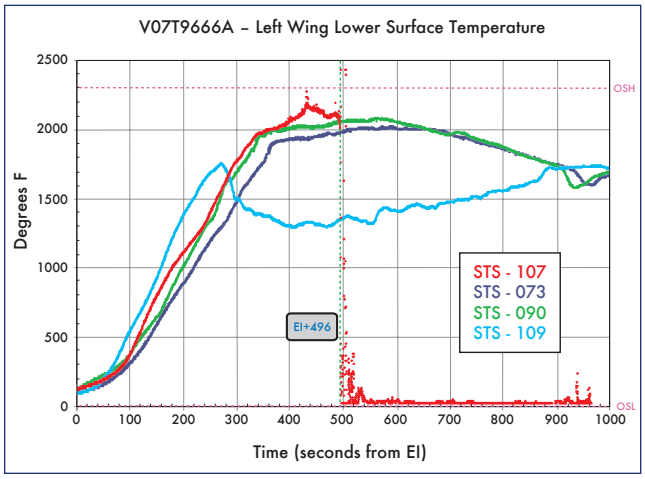
Figure 3.6-6. As early as EI+370, Sensor 3 began reading significantly higher than on previous flights. Since this sensor was located in a thermal tile on the lower surface of the left wing, its temperatures are much higher than those for the other sensors.

The readings of Sensor 3, which was in a thermal tile, began rising abnormally high and somewhat erratically as early as EI+370, with several brief spikes to 2,500 degrees Fahrenheit, significantly higher than the 2,000-degree peak temperature on a normal re-entry (Figure 3.6-6). At EI+496, this reading became unreliable, indicating a failure of the wire or the sensor. Because this thermocouple was on the wing lower surface, directly behind the junction of RCC panel 9 and 10, the high temperatures it initially recorded were almost certainly a result of air jetting through the damaged area of RCC panel 8, or of the normal airflow being disturbed by the damage. Note that Sensor 3 provided an external temperature measurement, while Sensors 2 and 4 provided internal temperature measurements.

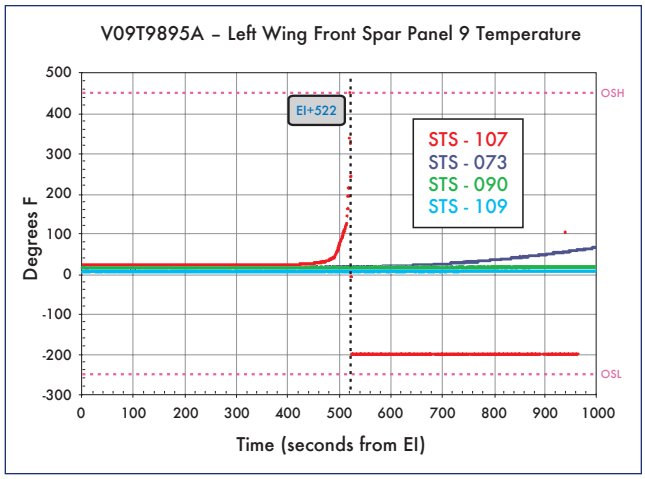
Sensor 4 also recorded a rise in temperature that ended in an abrupt fall to off-scale low. Figure 3.6-7 shows that an abnormal temperature rise began at EI+425 and abruptly fell at EI+525. Unlike Sensor 2, this temperature rise was extreme, from an expected 20 degrees Fahrenheit at EI+425 to 40 degrees at EI+485, and then rising much faster to 120 degrees at EI+515, then to an off-scale high (a reading that climbs off the scale at the high end of the range) of 450 degrees at EI+522. The failure pattern of this sensor likely indicates destruction by extreme heat.

Figure 3.6-7. Sensor 4 also began reading significantly higher than previous flights before it fell off-scale low. The relatively late reaction of this sensor compared to Sensor 2, clearly indicated that superheated air started on the outside of the wing leading edge spar and then moved into the mid-wing after the spar was burned through. Note that immediately before the sensor (or the wire) fails, the temperature is at 450 degrees Fahrenheit and climbing rapidly. It was the only temperature sensor that showed this pattern.

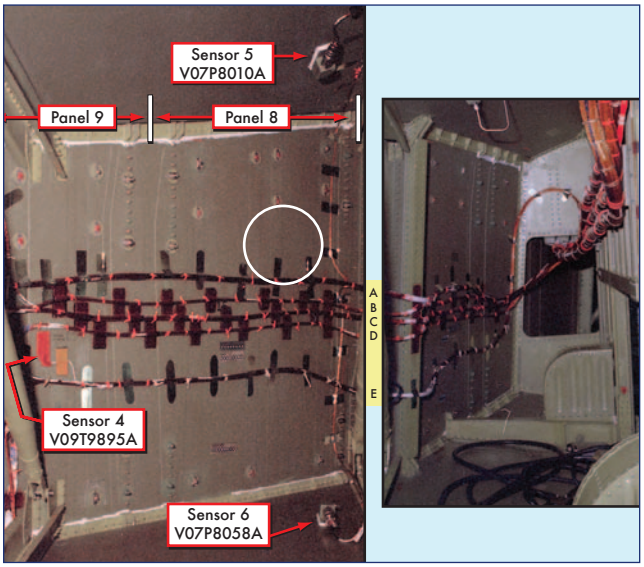
Figure 3.6-8. The left photo above shows the wiring runs on the backside of the wing leading edge behind RCC panel 8 – the circle marks the most likely area where the burn through of the wing leading edge spar initially occurred at EI+487 seconds. The right photo shows the wire bundles as they continue forward behind RCC panels 7 and 6. The major cable bundles in the upper right of the right photo carried the majority of the sensor data inside the wing. As these bundles were burned, controllers on the ground began seeing off-nominal sensor indications.

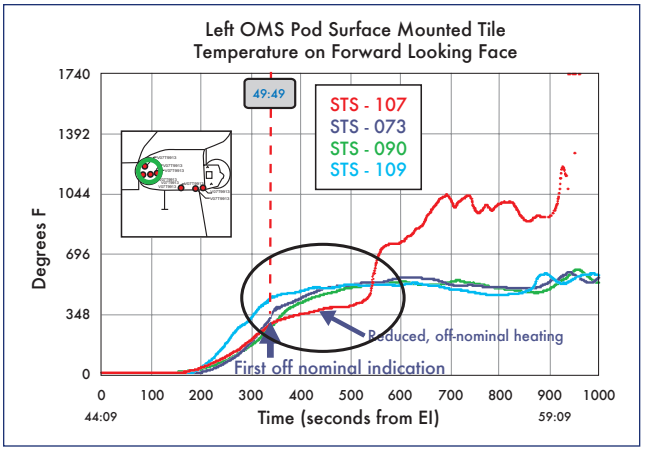
Figure 3.6-9. Orbital Maneuvering System (OMS) pod heating was initially significantly lower than that seen on previous Columbia *missions. As wing leading edge damage later increased, the OMS pod heating increased dramatically. Debris recovered from this area of the OMS pod showed substantial pre-breakup heat damage and imbedded drops of once-molten metal from the wing leading edge in the OMS pod thermal tiles.*

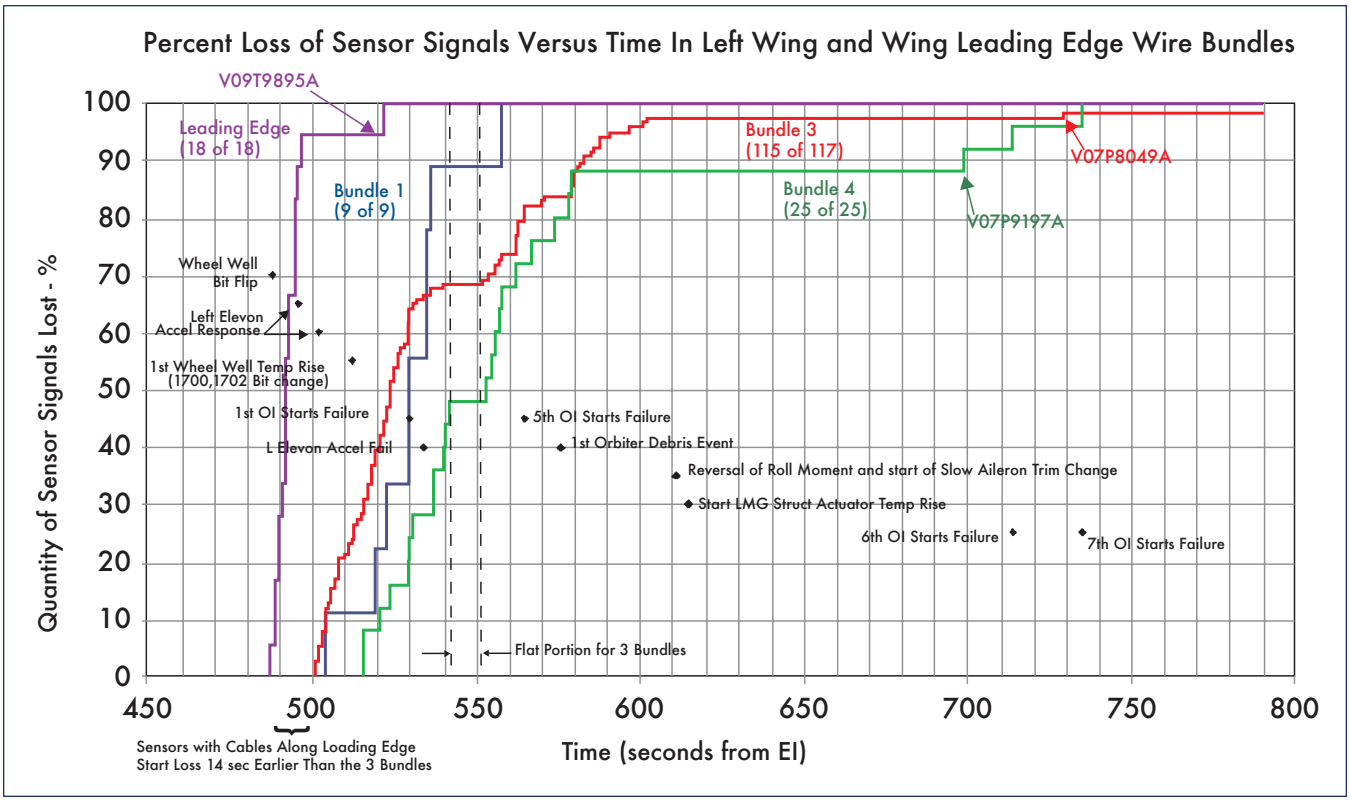
Fourteen seconds after the loss of the first sensor wire on the wing leading edge spar at EI+487, a sensor wire in a bundle of some 150 wires that ran along the upper outside corner of the left wheel well showed a burn-through. In the next 50 seconds, more than 70 percent of the sensor wires in three cables in this area also burned through (see Figure 3.6-10). Investigators plotted the wiring run for every left-wing sensor, looking for a relationship between their location and time of failure.

Figure 3.6-10. This chart shows how rapidly the wire bundles in the left wing were destroyed. Over 70 percent of the sensor wires in the wiring bundles burned through in under a minute. The black diamonds show the times of significant timeline sensor events.

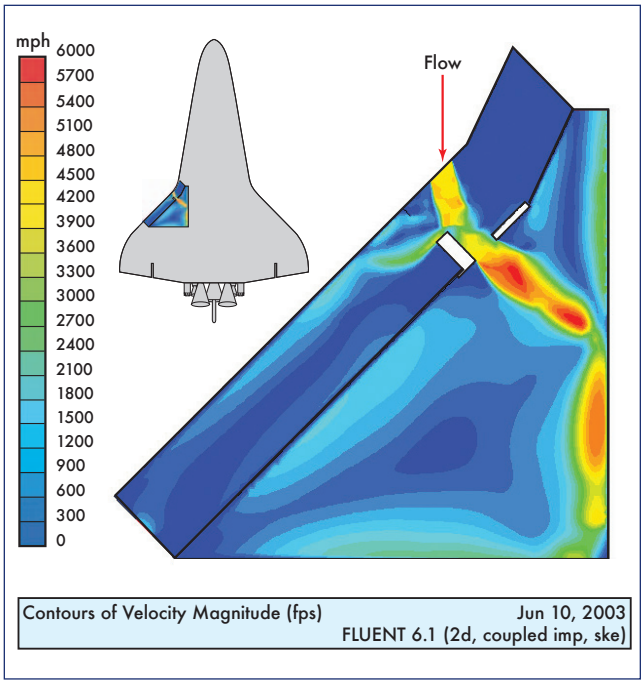
Later computational fluid dynamics analysis of the mid-wing area behind the spar showed that superheated air flowing into a breached RCC panel 8 and then interacting with the internal structure behind the RCC cavity (RCC ribs and spar insulation) would have continued through the wing leading edge spar as a jet, and would have easily allowed superheated air to traverse the 56.5 inches from the spar to the outside of the wheel well and destroy the cables (Figure 3.6-11). Controllers on the ground saw these first anomalies in the telemetry data at EI+613, when four hydraulic sensor cables that ran from the aft part of the left wing through the wiring bundles outside the wheel well failed.

Figure 3.6-11. The computational fluid dynamics analysis of the speed of the superheated air as it entered the breach in RCC panel 8 and then traveled through the wing leading edge spar. The darkest red color indicates speeds of over 4,000 miles per hour. Temperatures in this area likely exceeded 5,000 degrees Fahrenheit. The area of detail is looking down at the top of the left wing.

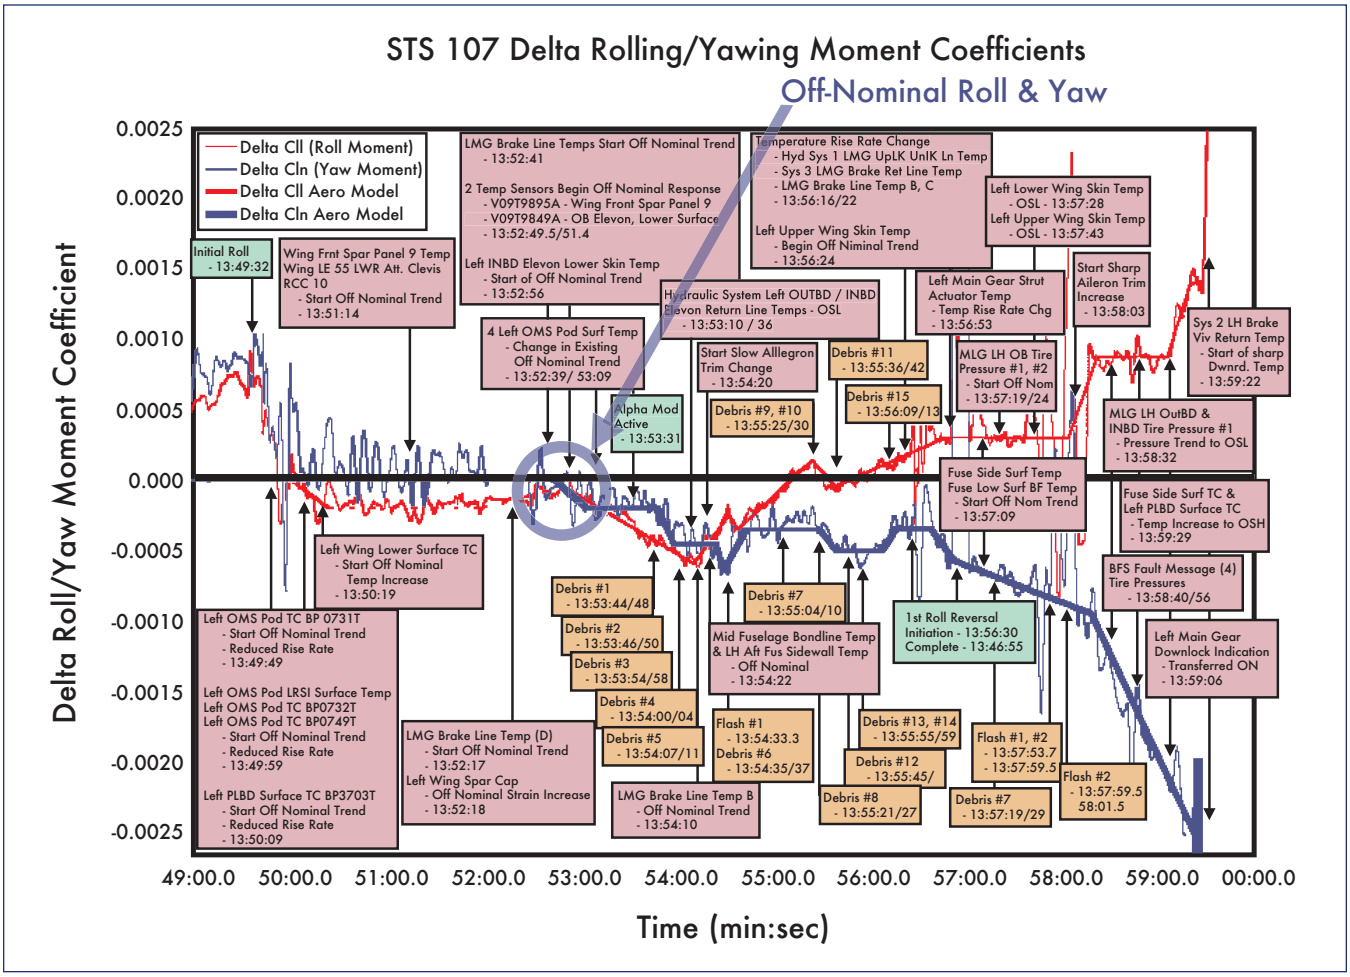
Aerodynamic roll and yaw forces began to differ from those on previous flights at about EI+500 (see Figure 3.6-12). Investigators used flight data to reconstruct the aerodynamic forces acting on the Orbiter. This reconstructed data was then compared to forces seen on other similar flights of *Columbia*

Figure 3.6-12. At approximately EI+500 seconds, the aerodynamic roll and yaw forces began to diverge from those observed on previous flights. The blue line shows the Orbiter's tendency to yaw while the red line shows its tendency to roll. Nominal values would parallel the solid black line. Above the black line, the direction of the force is to the right, while below the black line, the force is to the left.

and to the forces predicted for STS-107. In the early phase of fight, these abnormal aerodynamic forces indicated that *Columbia*'s flight control system was reacting to a change in the external shape of the wing, which was caused by progressive RCC damage that caused a continuing decrease in lift and a continuing increase in drag on the left wing.

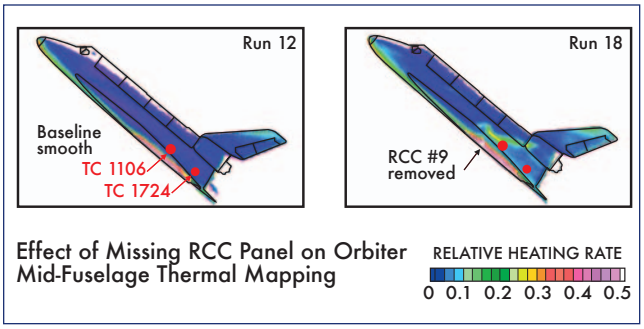
Figure 3.6-13. The effects of removing RCC panel 9 are shown in this figure. Note the brighter colors on the front of the OMS pod show increased heating, a phenomenon supported by both the OMS pod temperature sensors and the debris analysis.

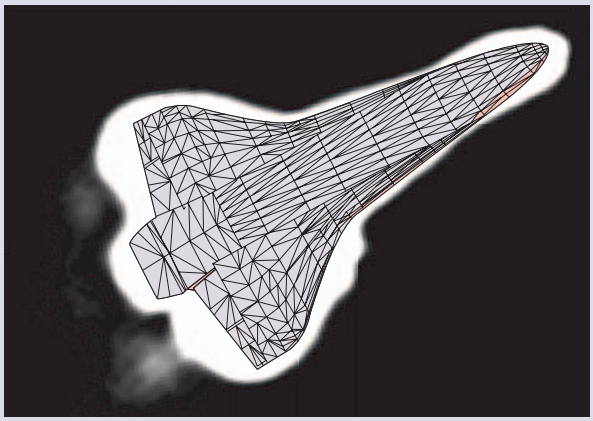
The image shows an unusual condition on the left wing, a leading-edge disturbance that might indicate damage. Several analysts concluded that the distortion evident in the image likely came from the modification and interaction of shock waves due to the damaged leading edge. The overall appearance of the leading-edge damage at this point on the trajectory is consistent with the scenario.

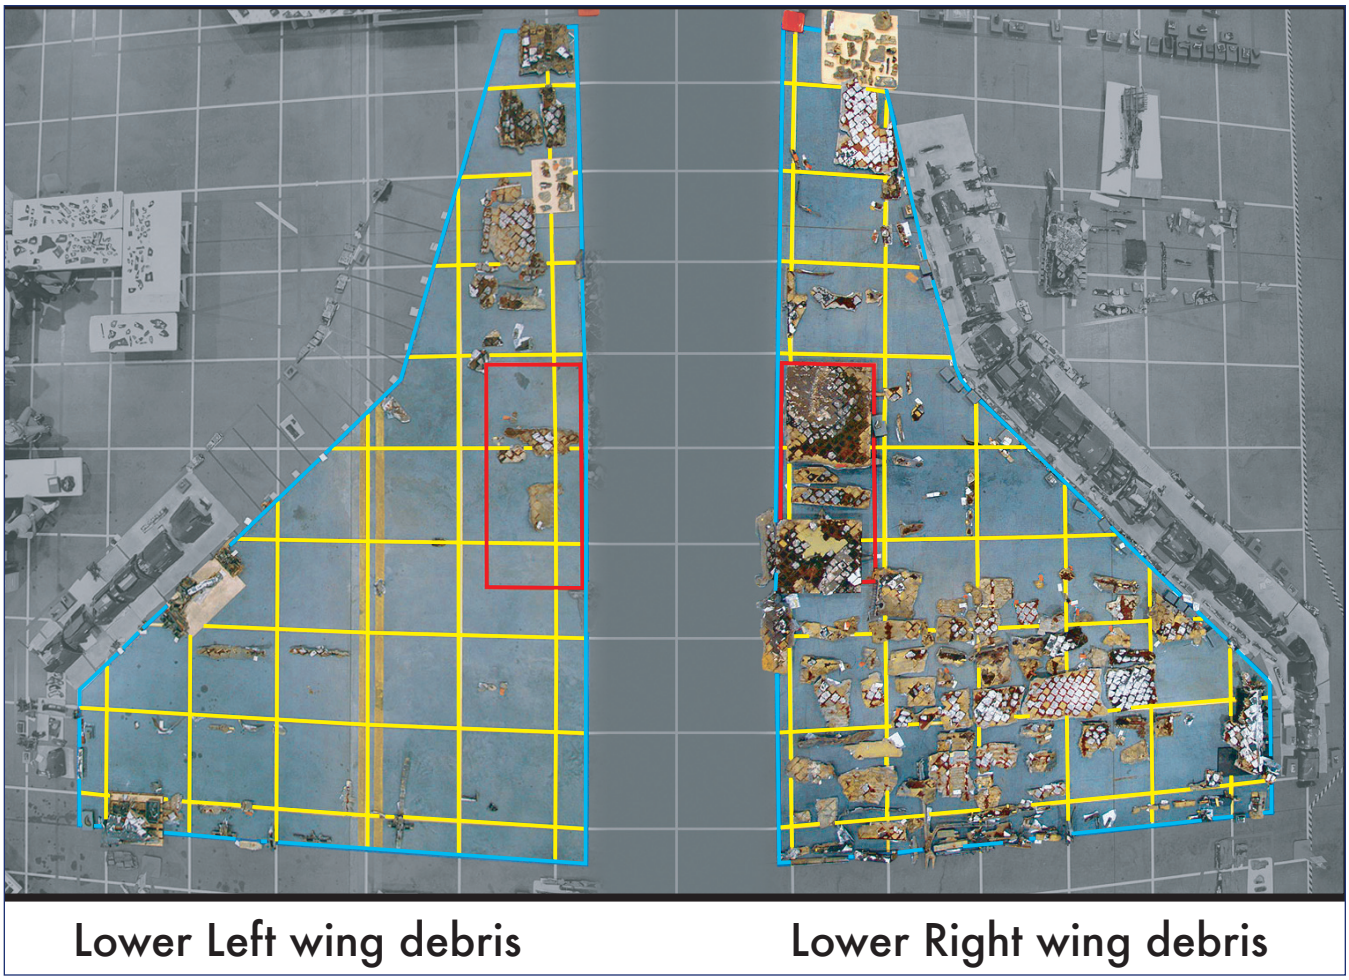
Figure 3.7-1. Comparison of amount of debris recovered from the left and right wings of Columbia. Note the amount of debris recovered from areas in front of the wheel well (the red boxes on each wing) were similar, but there were dramatic differences in the amount of debris recovered aft of each wheel well.

Detailed analysis of the debris revealed unique features and convincing evidence that the damage to the left wing differed significantly from damage to the right, and that significant differences existed in pieces from various areas of the left wing. While a substantial amount of upper and lower right wing structure was recovered, comparatively little of the upper and lower left wing structure was recovered (see Figure 3.7-1).

The difference in recovered debris from the Orbiter's wings clearly indicates that after the breakup, most of the left wing succumbed to both high heat and aerodynamic forces, while the right wing succumbed to aerodynamic forces only. Because the left wing was already compromised, it was the first area of the Orbiter to fail structurally. Pieces were exposed to higher heating for a longer period, resulting in more heat damage and ablation of left wing structural material. The left wing was also subjected to superheated air that penetrated directly into the mid-body of the wing for a substantial period. This pre-heating likely rendered those components unable to absorb much, if any, of the post-breakup heating. Those internal and external structures were likely vaporized during post-breakup re-entry. Finally, the left wing likely lost significant amounts of the Thermal Protection System prior to breakup due to the effect of internal wing heating on the Thermal Protection System bonding materials, and this further degraded the left wing's ability to resist the high heat of re-entry after it broke up.

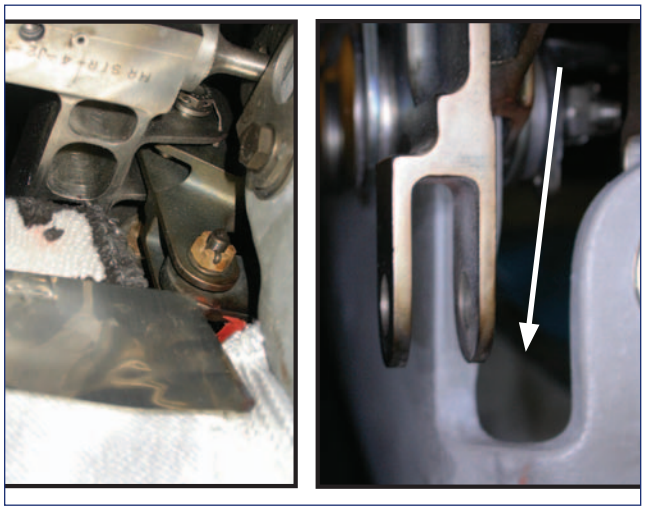
Figure 3.7-2. Each RCC panel has a U-shaped slot (see arrow) in the back of the panel. Once superheated air entered the breach in RCC panel 8, some of that superheated air went through this slot and caused substantial damage to the Thermal Protection System tiles behind this area.

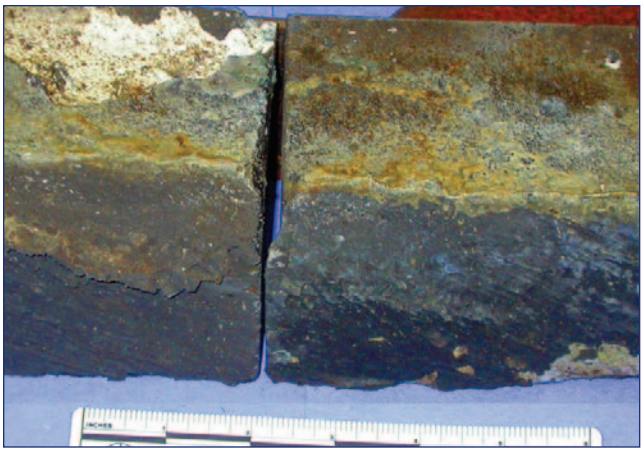
Figure 3.7-3. Superheated airflow caused erosion in tiles around the RCC panel 8 and 9 interface. The tiles shown are from behind the area where the superheated air exited from the slot in Figure 3.7-2. These tiles showed much greater thermal damage than other tiles in this area and chemical analysis showed the presence of metals only found in wing leading edge components.

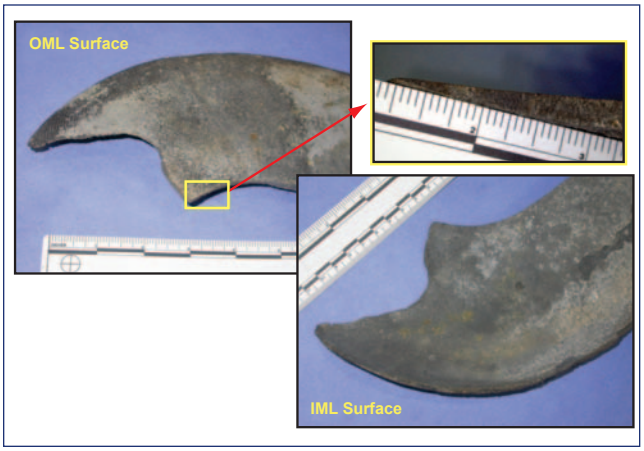
Figure 3.7-4. The outboard rib of panel 8 and the inboard rib of panel 9 showed signs of extreme heating and erosion. RCC erosion of this magnitude was not observed in any other location on the Orbiter.

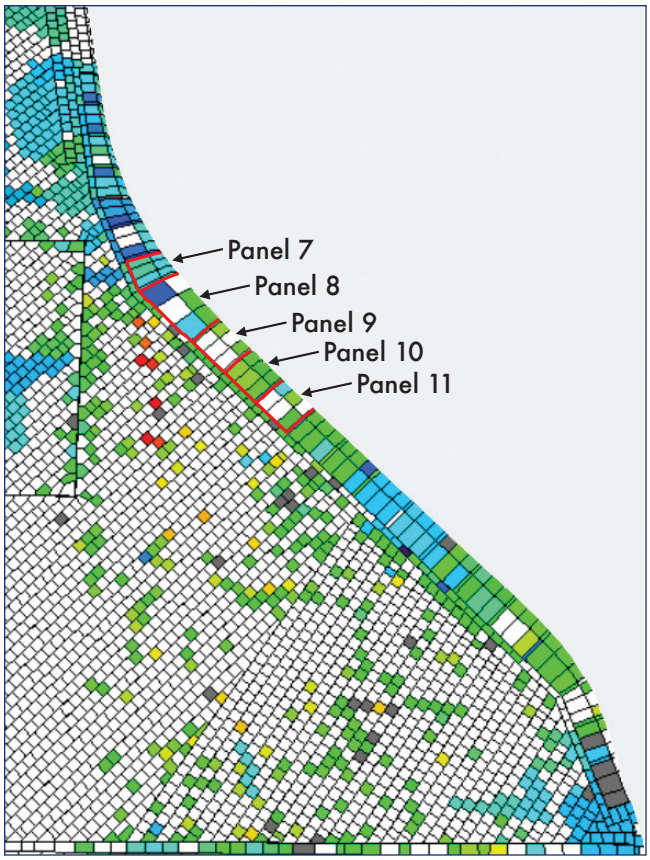
Figure 3.7-6. The tiles recovered farthest west all came from the area immediately behind left wing RCC panels 8 and 9. In the figure, each small box represents an individual tile on the lower surface of the left wing. The more red an individual tile appears, the farther west it was found.

An analysis of where tiles were found on the ground also yielded significant evidence of the breach location. Since most of the tiles are of similar size, weight, and shape, they would all have similar ballistic coefficients and would have behaved similarly after they separated from the Orbiter. By noting where each tile fell and then plotting its location on the Orbiter tile map, a distinctive pattern emerged. The tiles recovered farthest west all came from the area immediately behind the left wing RCC panel 8 and 9 (see Figure 3.7-6), which suggests that these tiles were released earlier than those from other areas of the left wing. While it is not conclusive evidence of a breach in this area, this pattern does suggest unique damage around RCC panels 8 and 9 that was not seen in other areas. Tiles from this area also showed evidence of a brown deposit that was not seen on tiles from any other part of the Orbiter. Chemical analysis revealed it was an Inconel-based deposit that had come from inside the RCC cavity on the left wing (Inconel is found in wing leading edge attachment fittings). Since the streamlines from tiles with the brown deposit originate near left RCC panels 8 and 9, this brown deposit likely originated as an outflow of superheated air and molten metal from the panel 8 and 9 area.
