COLUMBIA

ACCIDENT INVESTIGATION BOARD

Report Volume I

August 2003

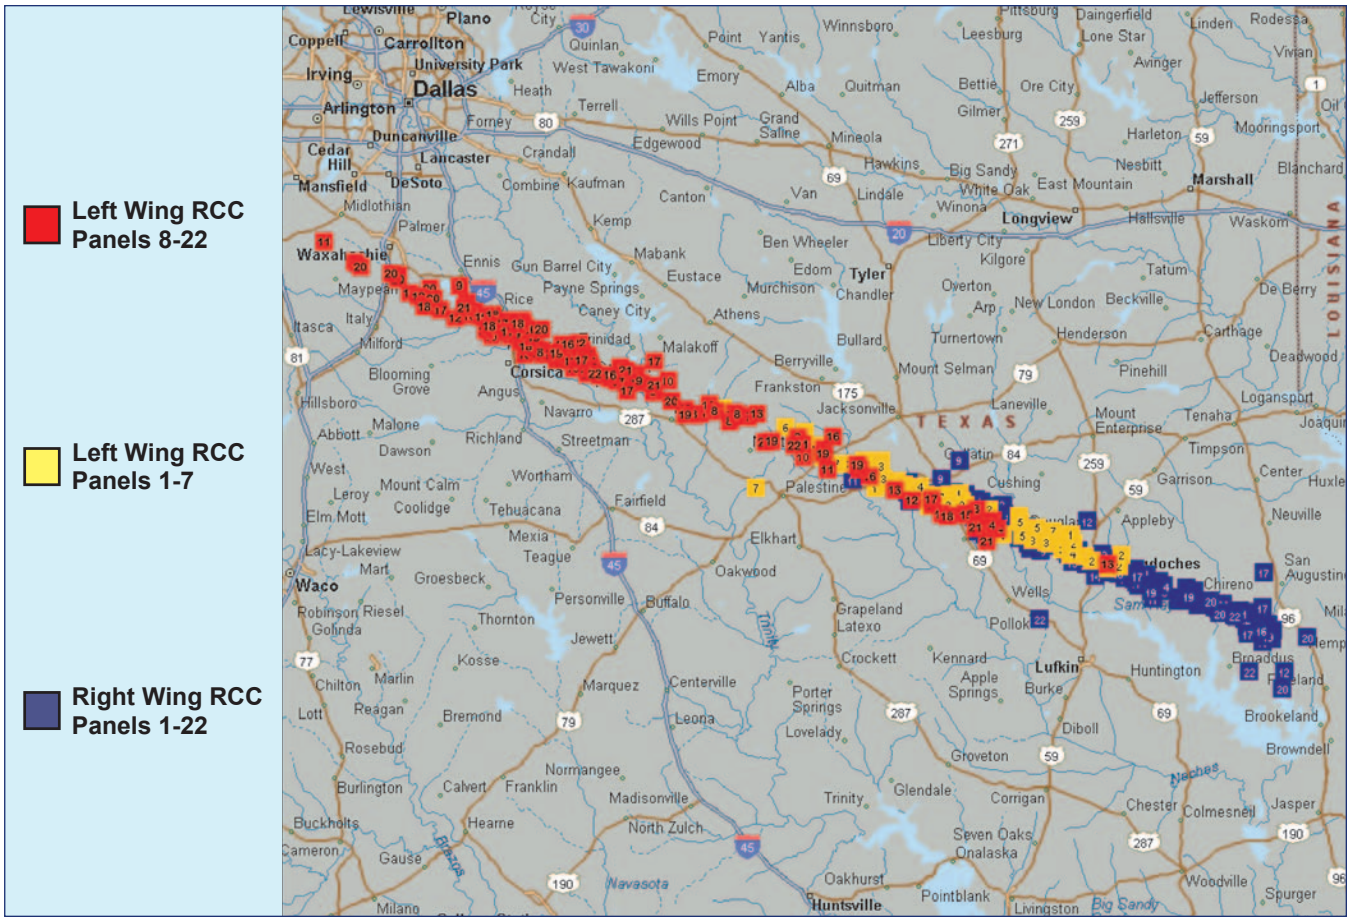
The location of debris on the ground also provided evidence of where the initial breach occurred. The location of every piece of recovered RCC was plotted on a map and labeled according to the panel the piece originally came from. Two distinct patterns were immediately evident. First, it was clear that pieces from left wing RCC panels 9 through 22 had fallen the farthest west, and that RCC from left wing panels 1 through 7 had fallen considerably farther east (see Figure 3.7-5). Second, pieces from left wing panel 8 were

Figure 3.7-5. The location of RCC panel debris from the left and right wings, shown where it was recovered from in East Texas. The debris pattern suggested that the left wing failed before the right wing, most likely near left RCC panels 8 and 9.

found throughout the debris field, which suggested that the left wing likely failed in the vicinity of RCC panel 8. The early loss of the left wing from RCC panel 9 and outboard caused the RCC from that area to be deposited well west of the RCC from the inboard part of the wing. Since panels 1 through 7 were so much farther to the east, investigators concluded that RCC panels 1 through 7 had stayed with the Orbiter longer than had panels 8 through 22.

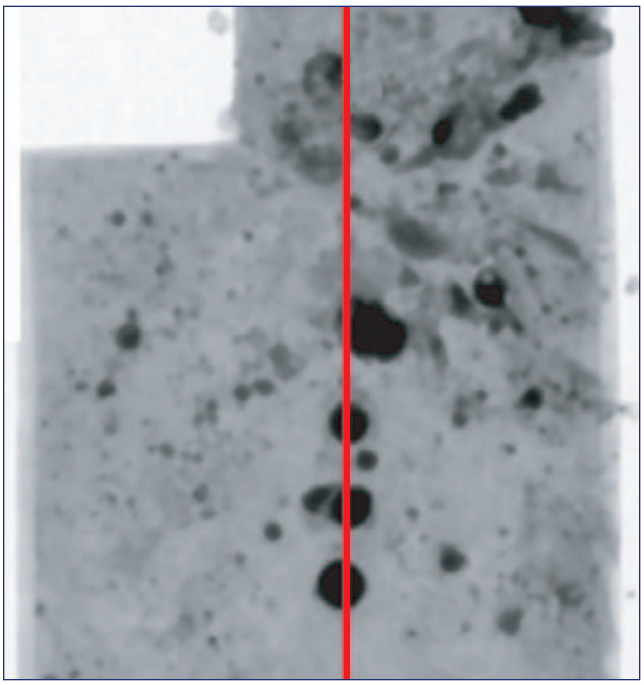
Figure 3.7-7. X-ray analysis of RCC panel 8-left showed a bottom-to-top pattern of slag deposits.

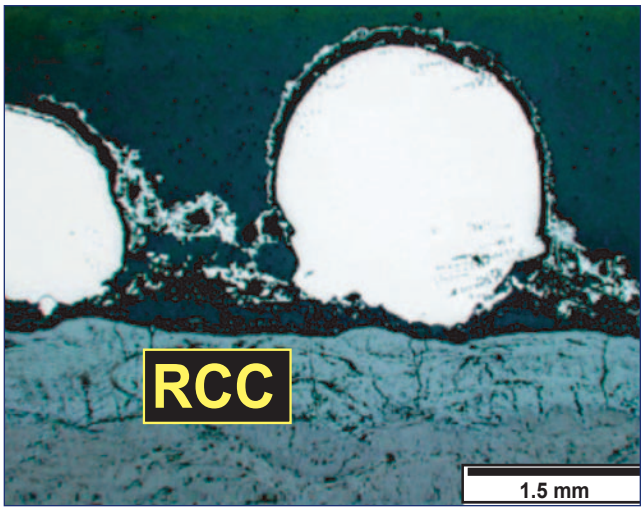
Figure 3.7-8. Spheroids of Inconel 718 and Cerachrome were deposited directly on the surface of RCC panel 8-left. This slag deposit pattern was not seen on any other RCC panels.

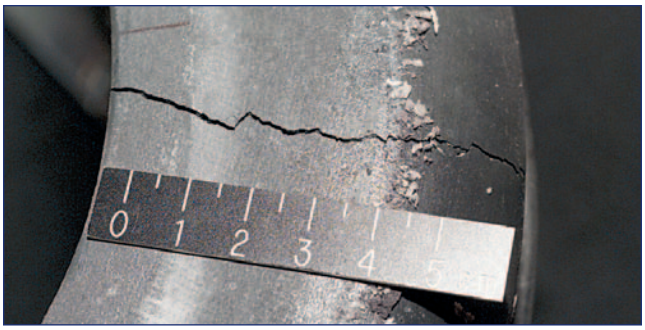
Figure 3.8-6. A 5.5-inch crack on the outboard portion of RCC Panel 6 during testing.

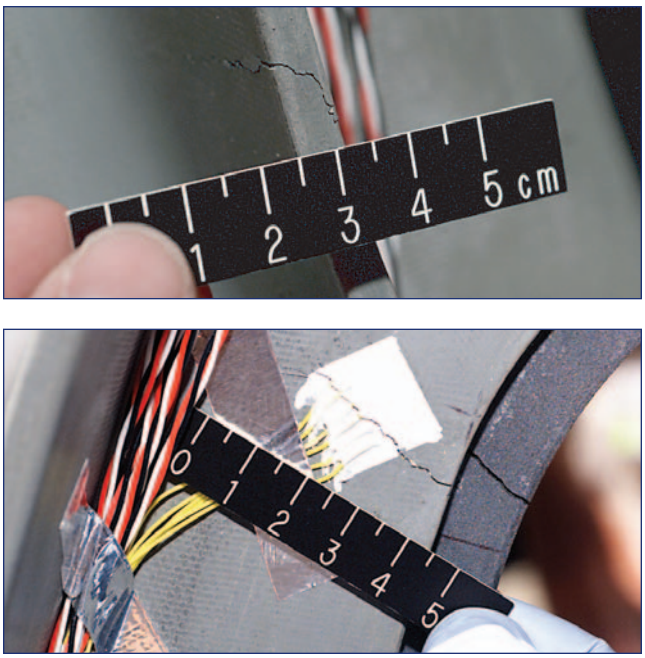
Figure 3.8-7. Two views of the crack in the T-seal between RCC Panels 6 and 7.

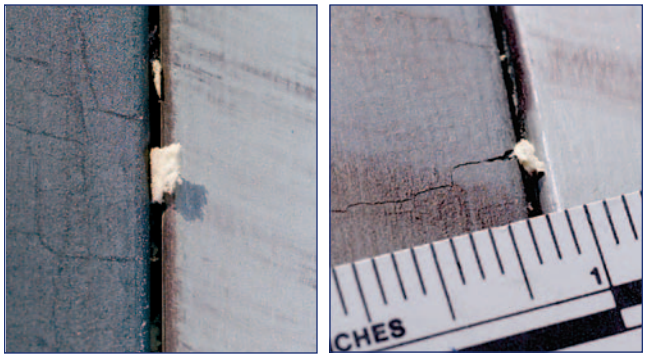
Figure 3.8-8. Two views of foam lodged into the slit during tests.

Figure 3.8-9. The large impact hole in Panel 8 from the final test.

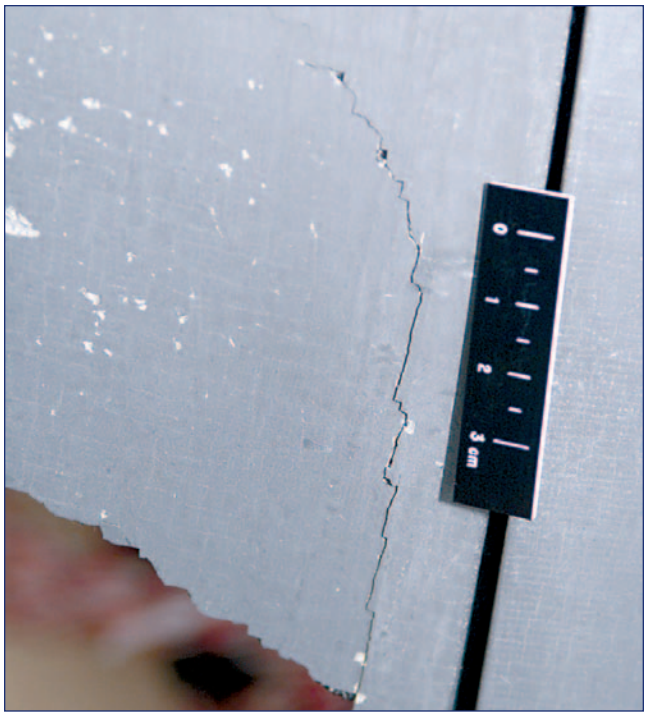
Figure 3.8-10. Numerous cracks were also noted in RCC Panel 8.

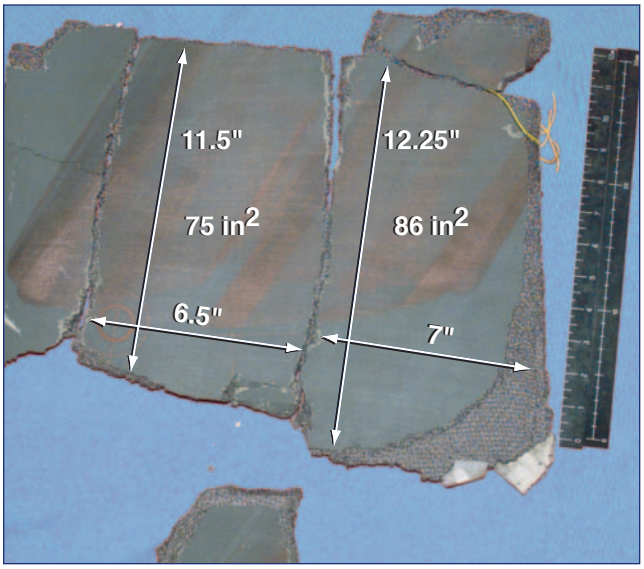
Figure 3.8-11. Three large pieces of debris from the panel face sheet were lodged within the hollow area behind the RCC panel.

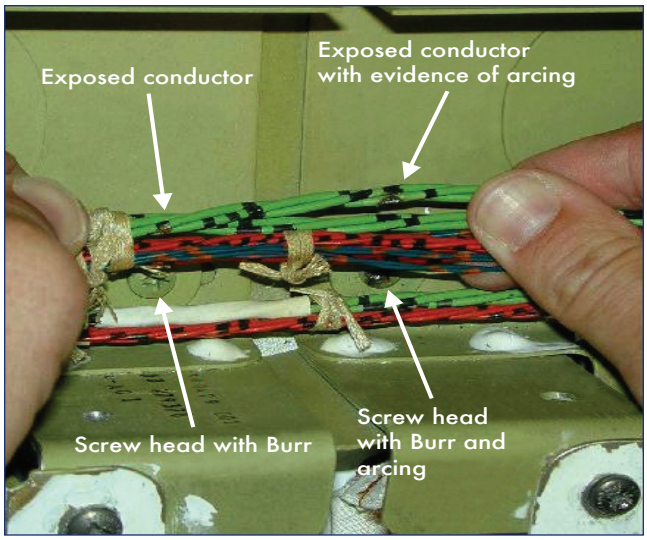
Figure 4.2-2. Arc tracking damage in Kapton wiring.

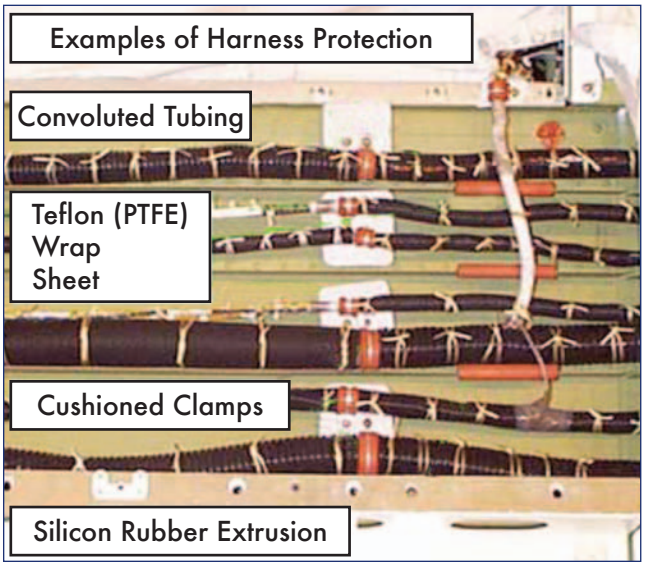
A typical wiring bundle is shown in Figure 4.2-3. Wiring nonconformances are corrected by rerouting, reclamping, or installing additional insulation such as convoluted tubing, insulating tape, insulating sheets, heat shrink sleeving, and abrasion pads (see Figure 4.2-4). Testing has shown that wiring bundles usually stop arc tracking when wires are physically separated from one another. Further testing under conditions simulating the Shuttle's wiring environment demonstrated that arc tracking does not progress beyond six inches. Based on these results, Boeing recommended that NASA separate all critical paths from larger wire bundles and individually protect them for a minimum of six inches beyond their separation points.[4] This recommendation is being adopted through modifications performed during scheduled Orbiter Major Modifications. For example, analysis of telemetered data from 14 of *Columbia*'s left wing sensors (hydraulic line/wing skin/wheel temperatures, tire pressures, and landing gear downlock position indication) provided failure signatures supporting the scenario of left-wing thermal intrusion, as opposed to a catastrophic failure (extensive arc tracking) of Kapton wiring. Actual NASA testing in the months following the accident, during which wiring bundles were subjected to intense heat (ovens, blowtorch, and arc jet), verified the failure signature analyses. Finally, extensive testing and analysis in years prior to STS-107 showed that, with the low currents and low voltages associated with the Orbiter's instrumentation system (such as those in the left wing), the probability of arc tracking is commensurately low.

Figure 4.2-4. Typical wiring harness protection methods.
