NASA

SECTION 7

System Integration Inputs Were Matched Against Orbiter Tile/RCC to Determine Critical Locations

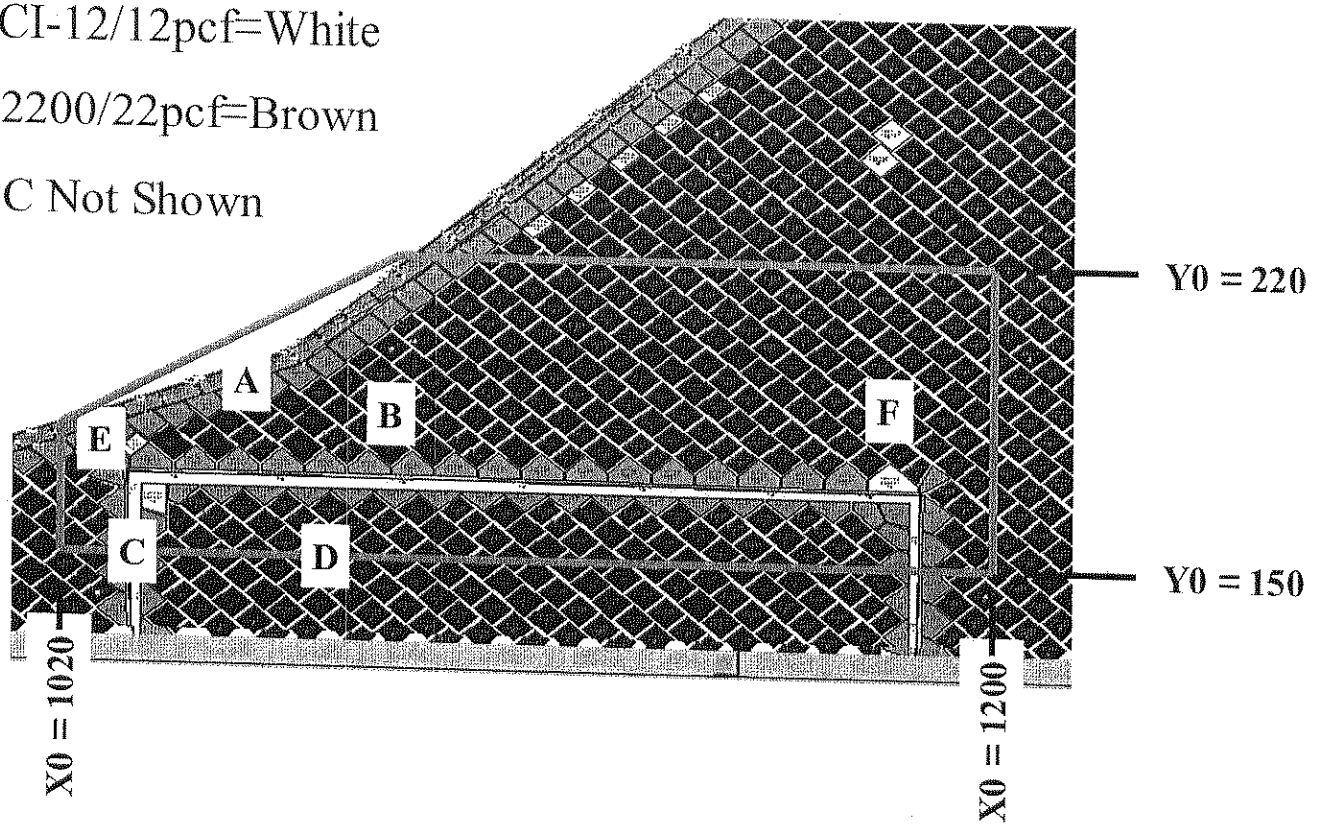
LI-900/9pcf=Black

FRCI-12/12pcf=White

LI-2200/22pcf=Brown

RCC Not Shown

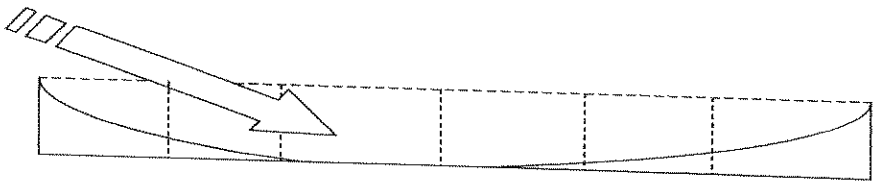
Damage Results From "Crater" Equations Show Significant Tile Damage

- "Crater" indicates that multiple tiles would be taken down to densified layer
  - However, program was designed to be conservative due to large number of unknowns
  - Crater reports damage for test conditions that show no damage

Debris Size = 20" x 16" x 6"

(Density = 2.4 lb/ft^3)

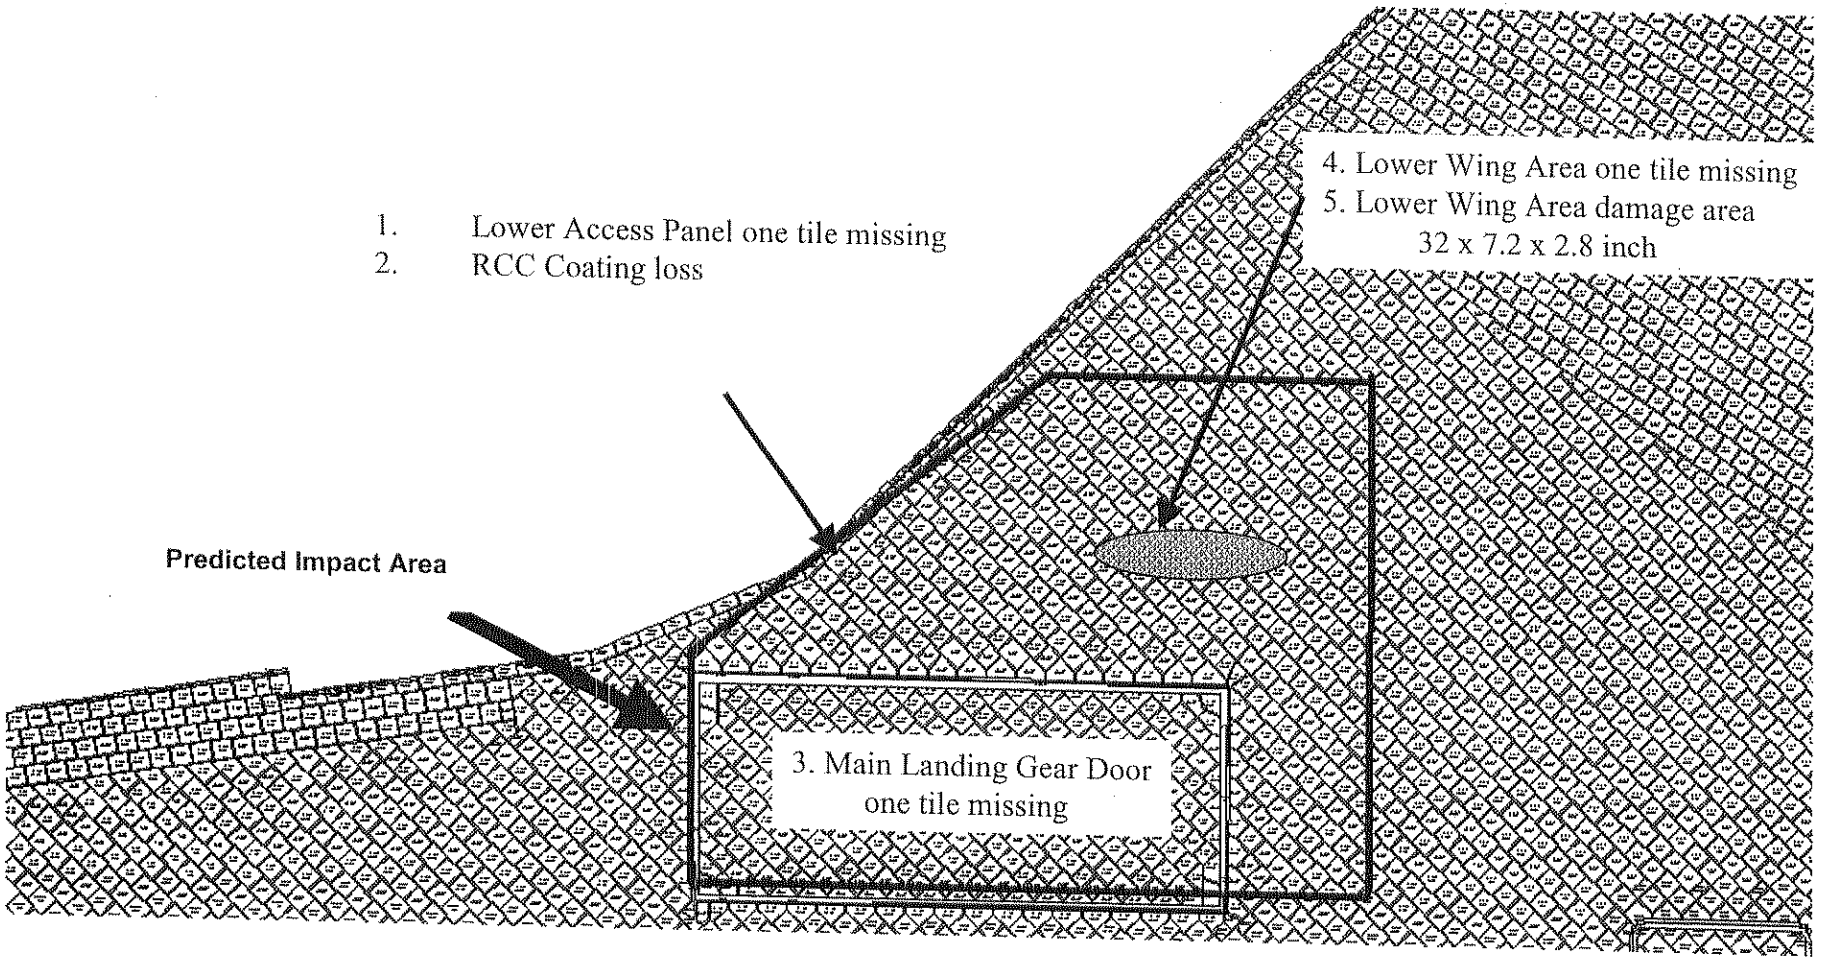
Thermal Analysis Assessment of Debris Impacted Lower Surface in STS-107 Mission Locations

Impacted Lower Surface Location Thermal Predictions

Case	Location	Assumptions	Results
1	Access Panel (one tile missing)	Loss to last layer of TMM Densified layer ~ .2 inches	Temperature of Al Tube Carrier 790 °F No issue
2	RCC Panel 9 Lower Flange OML (Coating Missing)	Coating loss and Carbon substrate exposed	Substrate thickness: 0.193 inches Loss .09 inches No issue
3	Main Landing Gear Door (one tile missing)	Loss to last 2 layers of TMM Densified layer ~ .4 inches	Temperature of Structure 540 °F No issue
4	Lower Wing Area (one tile missing)	Loss to last 2 layers of TMM Densified layer ~ .4 inches	Temperature below 350 °F design req. No issue
5	Lower Wing Area (32 x 7.2 x 2.8 Inch) Damage	Loss to last layers of TMM Densified layer ~ .2 inches	
6	Main Landing Gear Door (several tiles Lost)	Loss to last layers of TMM Densified layer ~ .2 inches

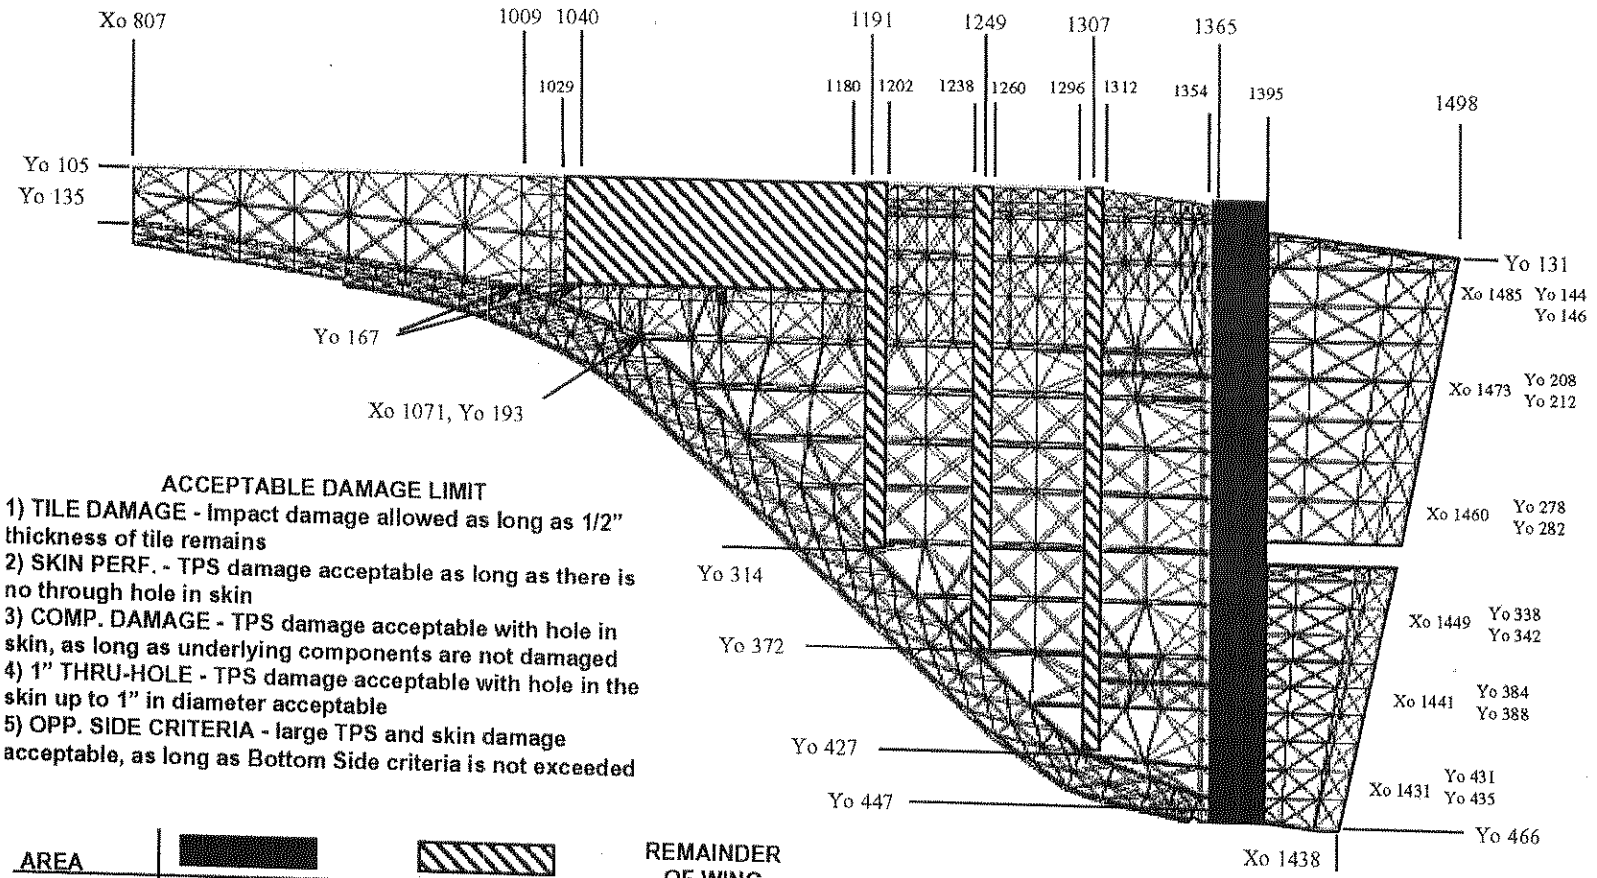
Wing Lower Surface M/OD Failure Criteria

ACCEPTABLE DAMAGE LIMIT

1) TILE DAMAGE - Impact damage allowed as long as 1/2" thickness of tile remains
2) SKIN PERF. - TPS damage acceptable as long as there is no through hole in skin
3) COMP. DAMAGE - TPS damage acceptable with hole in skin, as long as underlying components are not damaged
4) 1" THRU-HOLE - TPS damage acceptable with hole in the skin up to 1" in diameter acceptable
5) OPP. SIDE CRITERIA - large TPS and skin damage acceptable, as long as Bottom Side criteria is not exceeded

AREA			REMAINDER OF WING
Top Side	3) COMP. DAMAGE	3) COMP. DAMAGE	5) OPP. SIDE CRITERIA
Bottom Side	1) TILE DAMAGE	2) SKIN PERF.	4) 1" THRU-HOLE
