Micrometeoroid and Orbital Debris (MMOD) Risk Overview

Eric Christiansen

NASA Johnson Space Center

July 2014

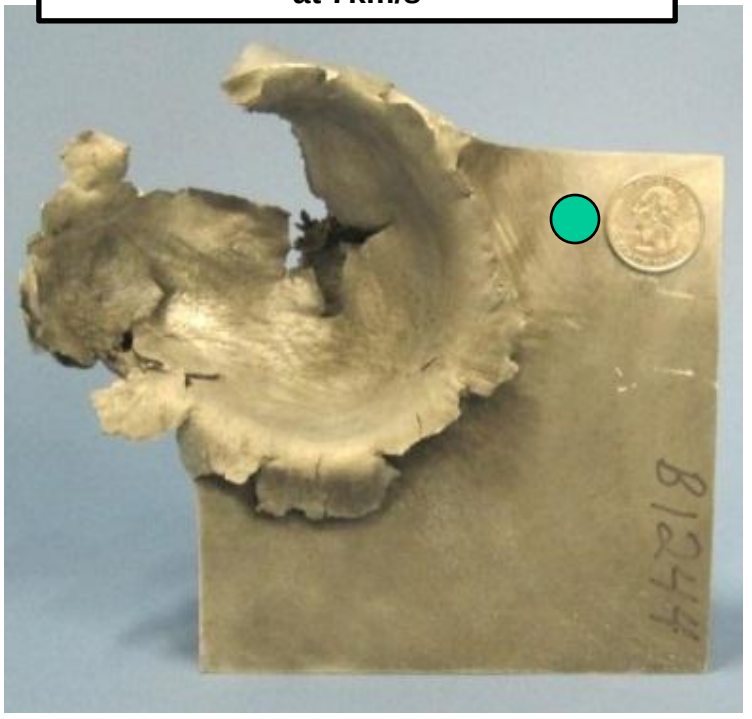
Damage from a 1.3cm diameter sphere at 7km/s

Comparison of size of projectile to size of impact crater

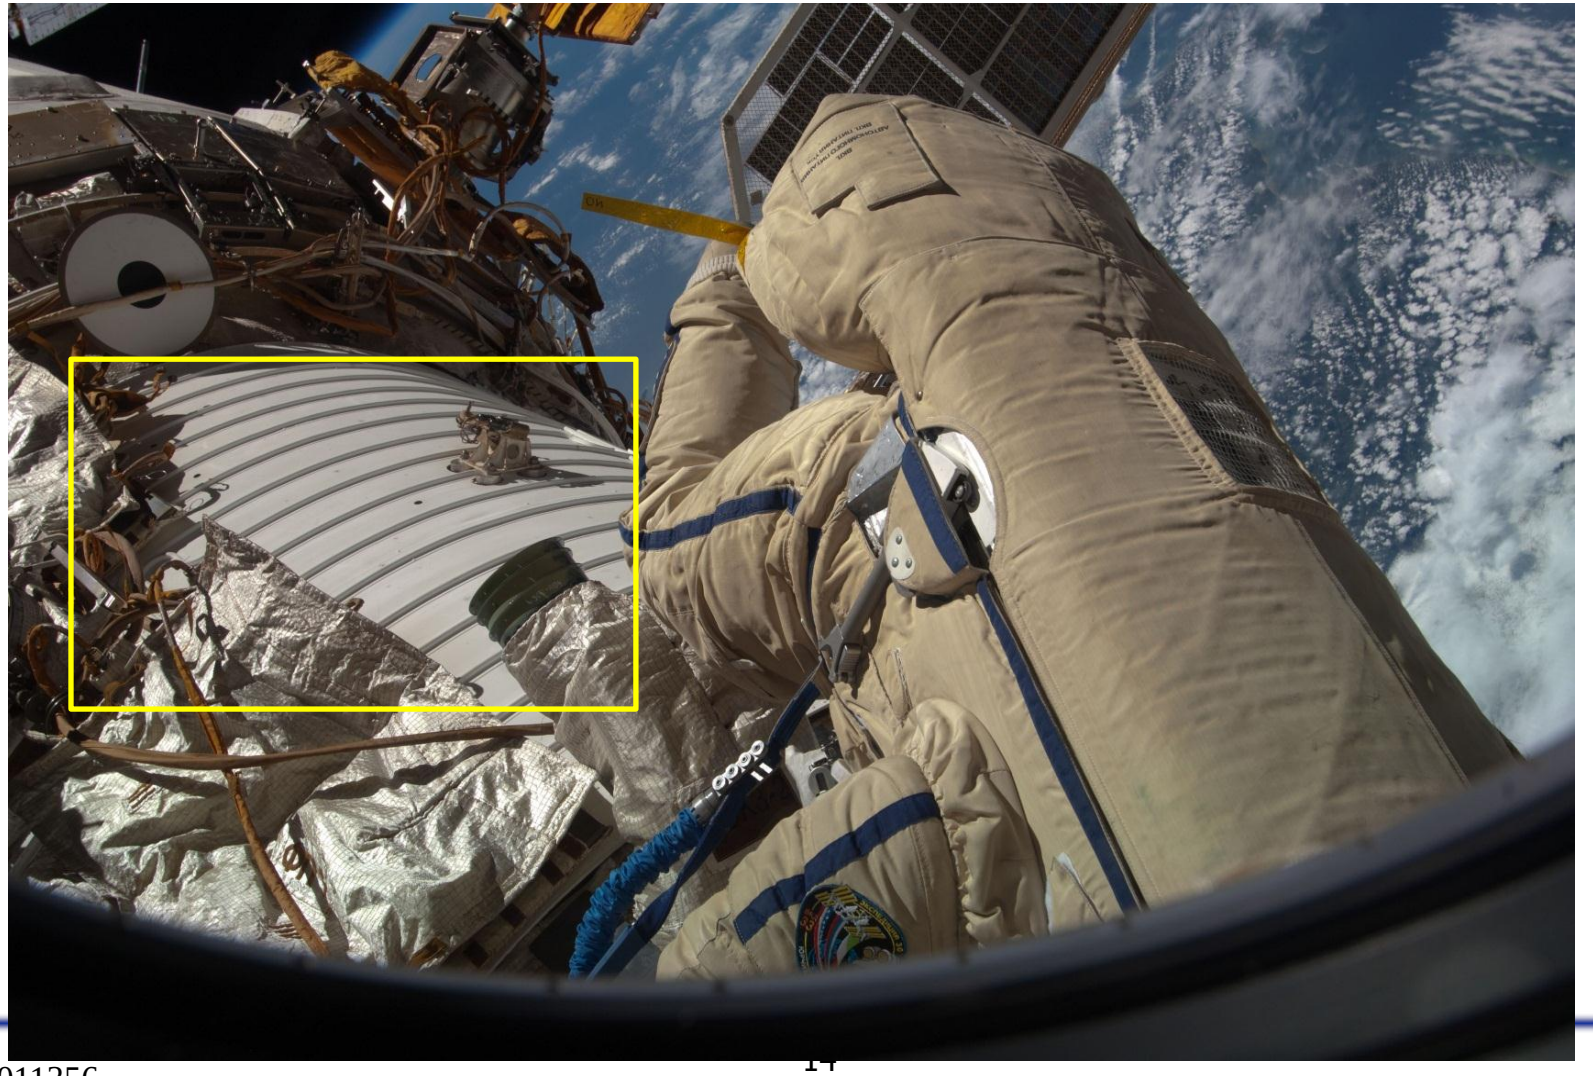
ISS036e011356

- **MMOD impact damages observed to ISS radiator panels during Russian EVA (June 2013)**

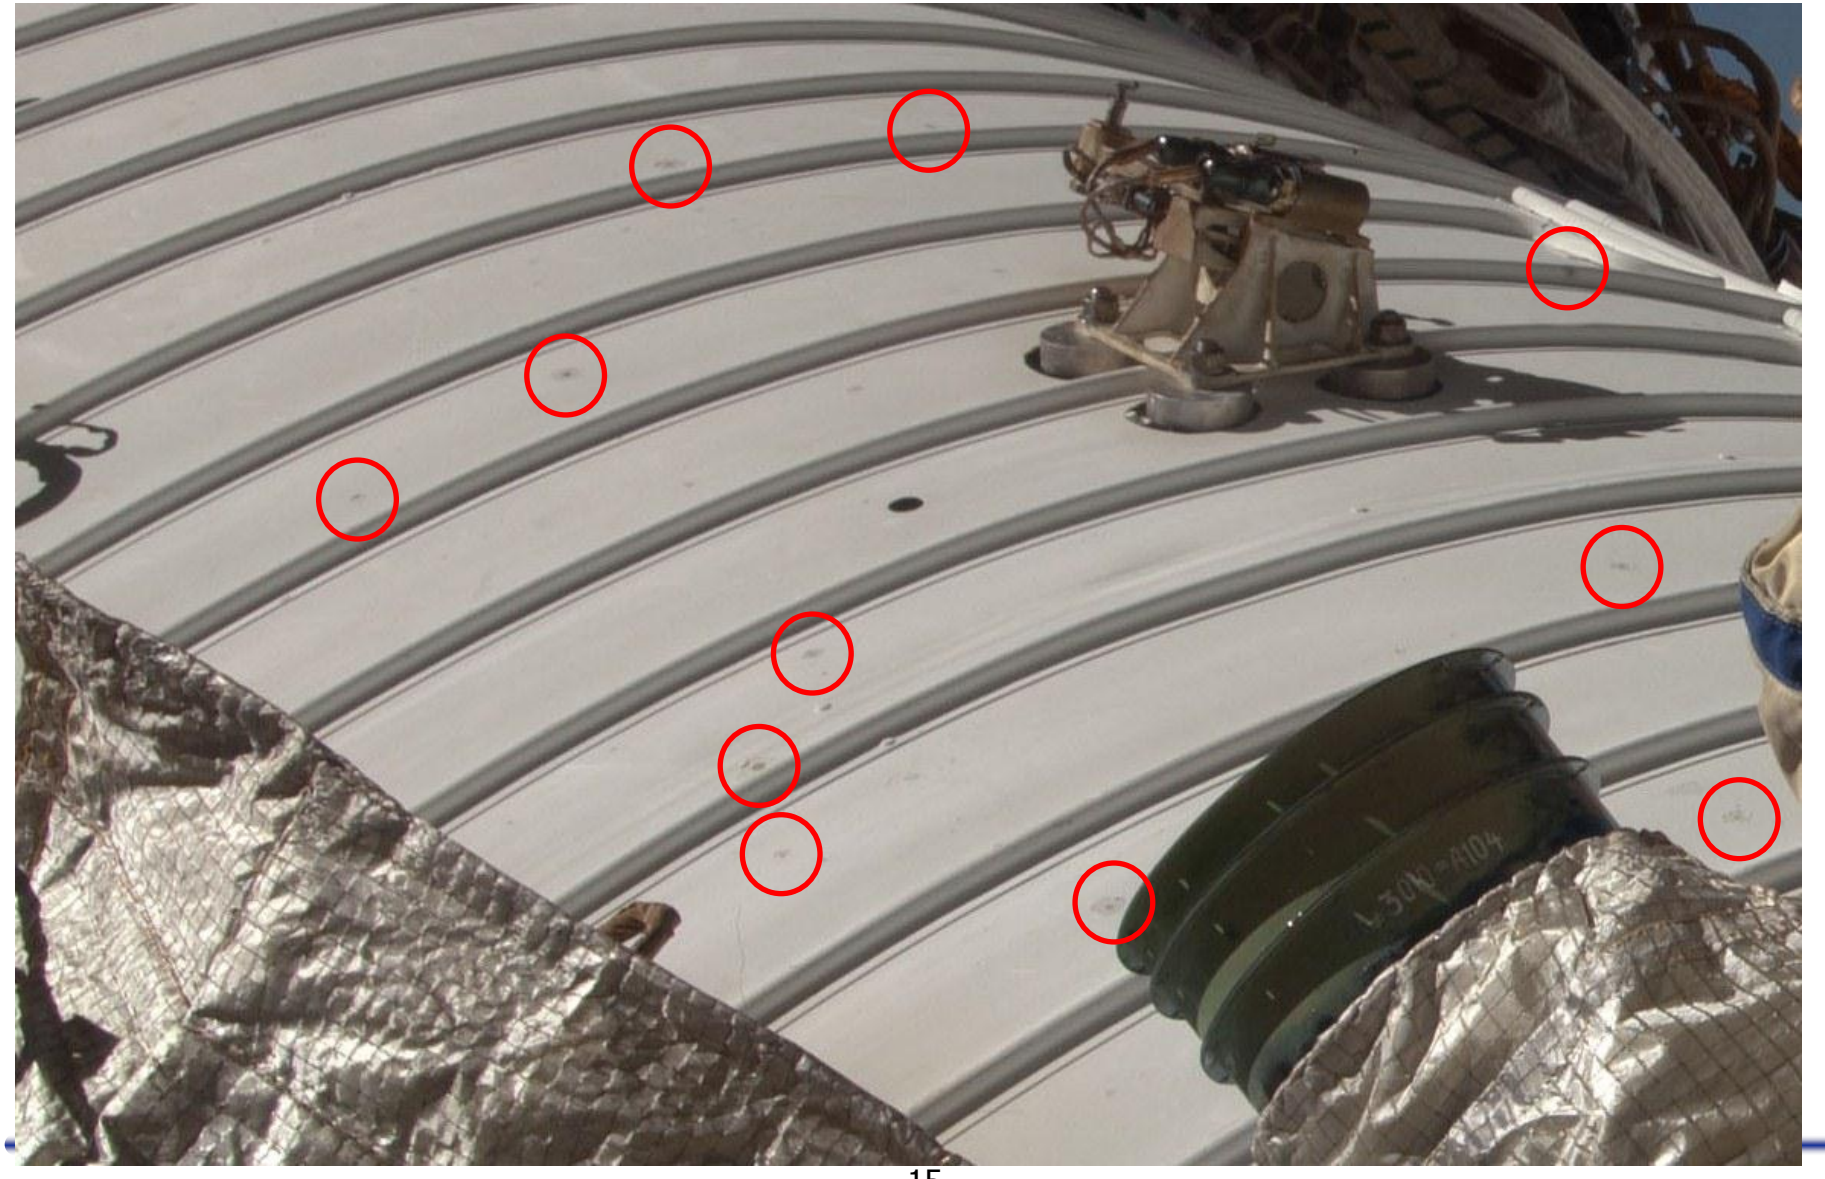
ISS036e011356

MMOD Damage to ISS Radiators

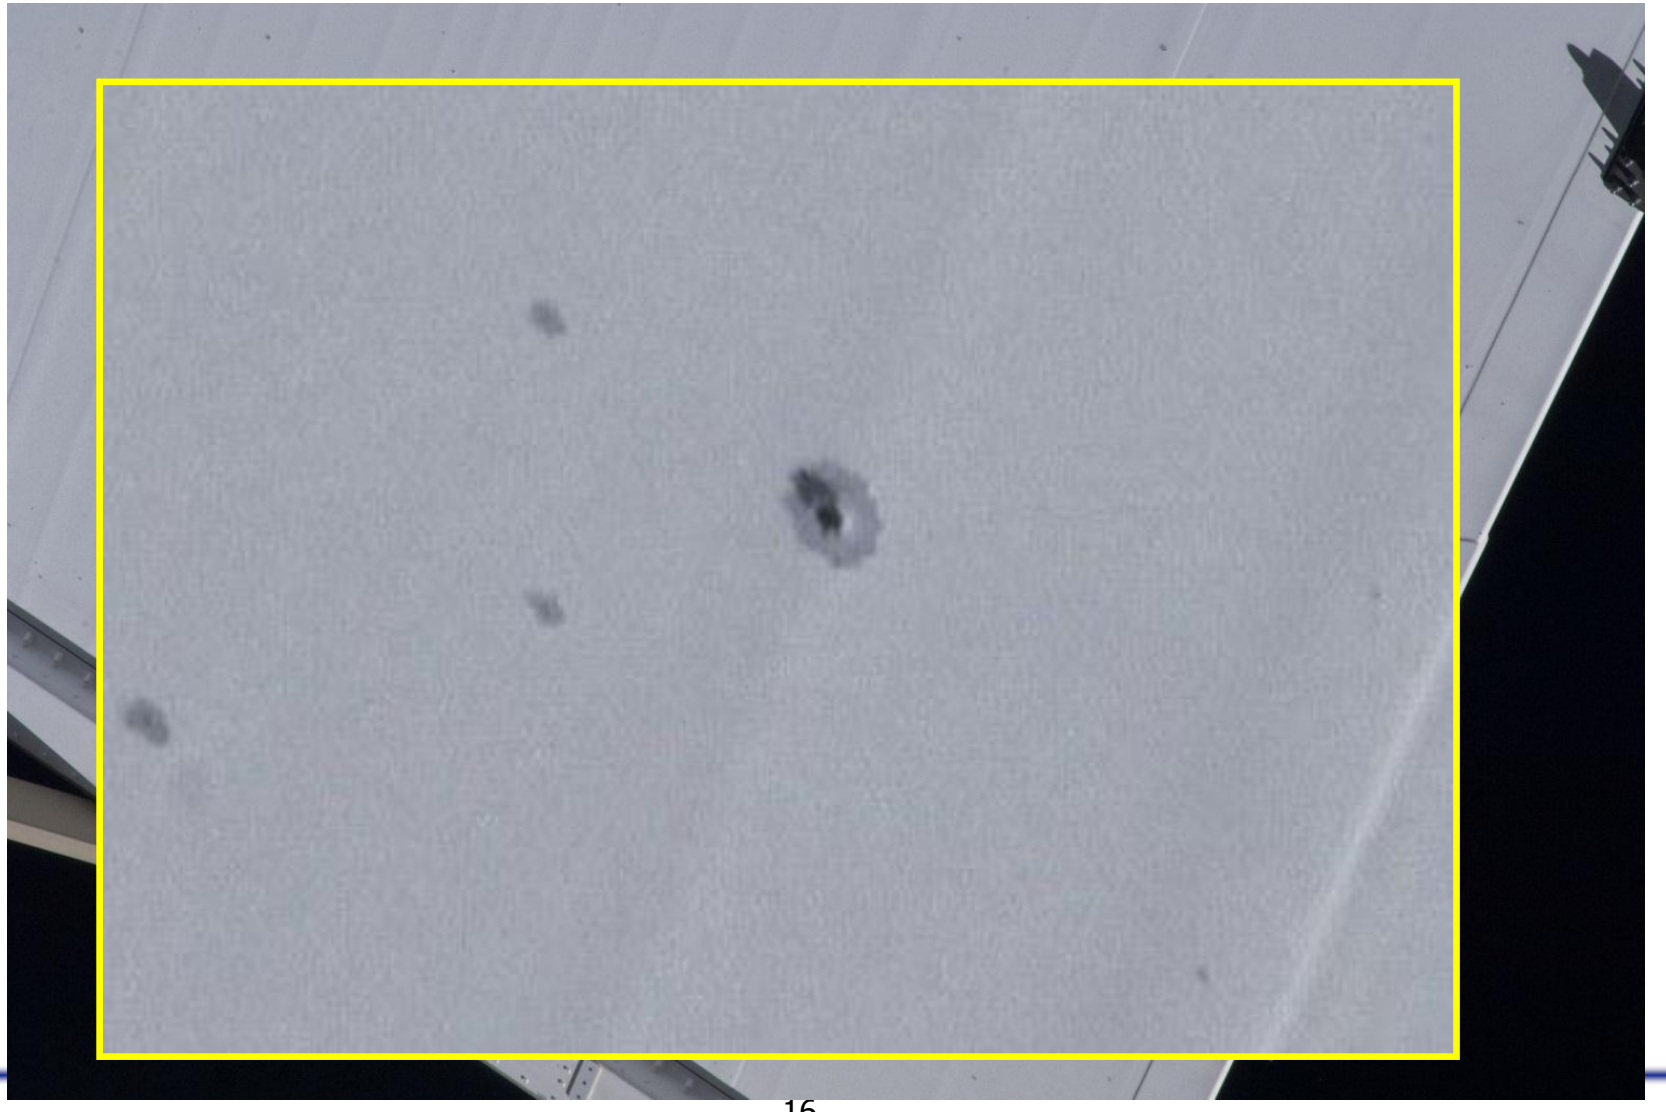
ISS036e037365

- **MMOD impact damages observed to ISS radiator panels (Aug. 2013)**

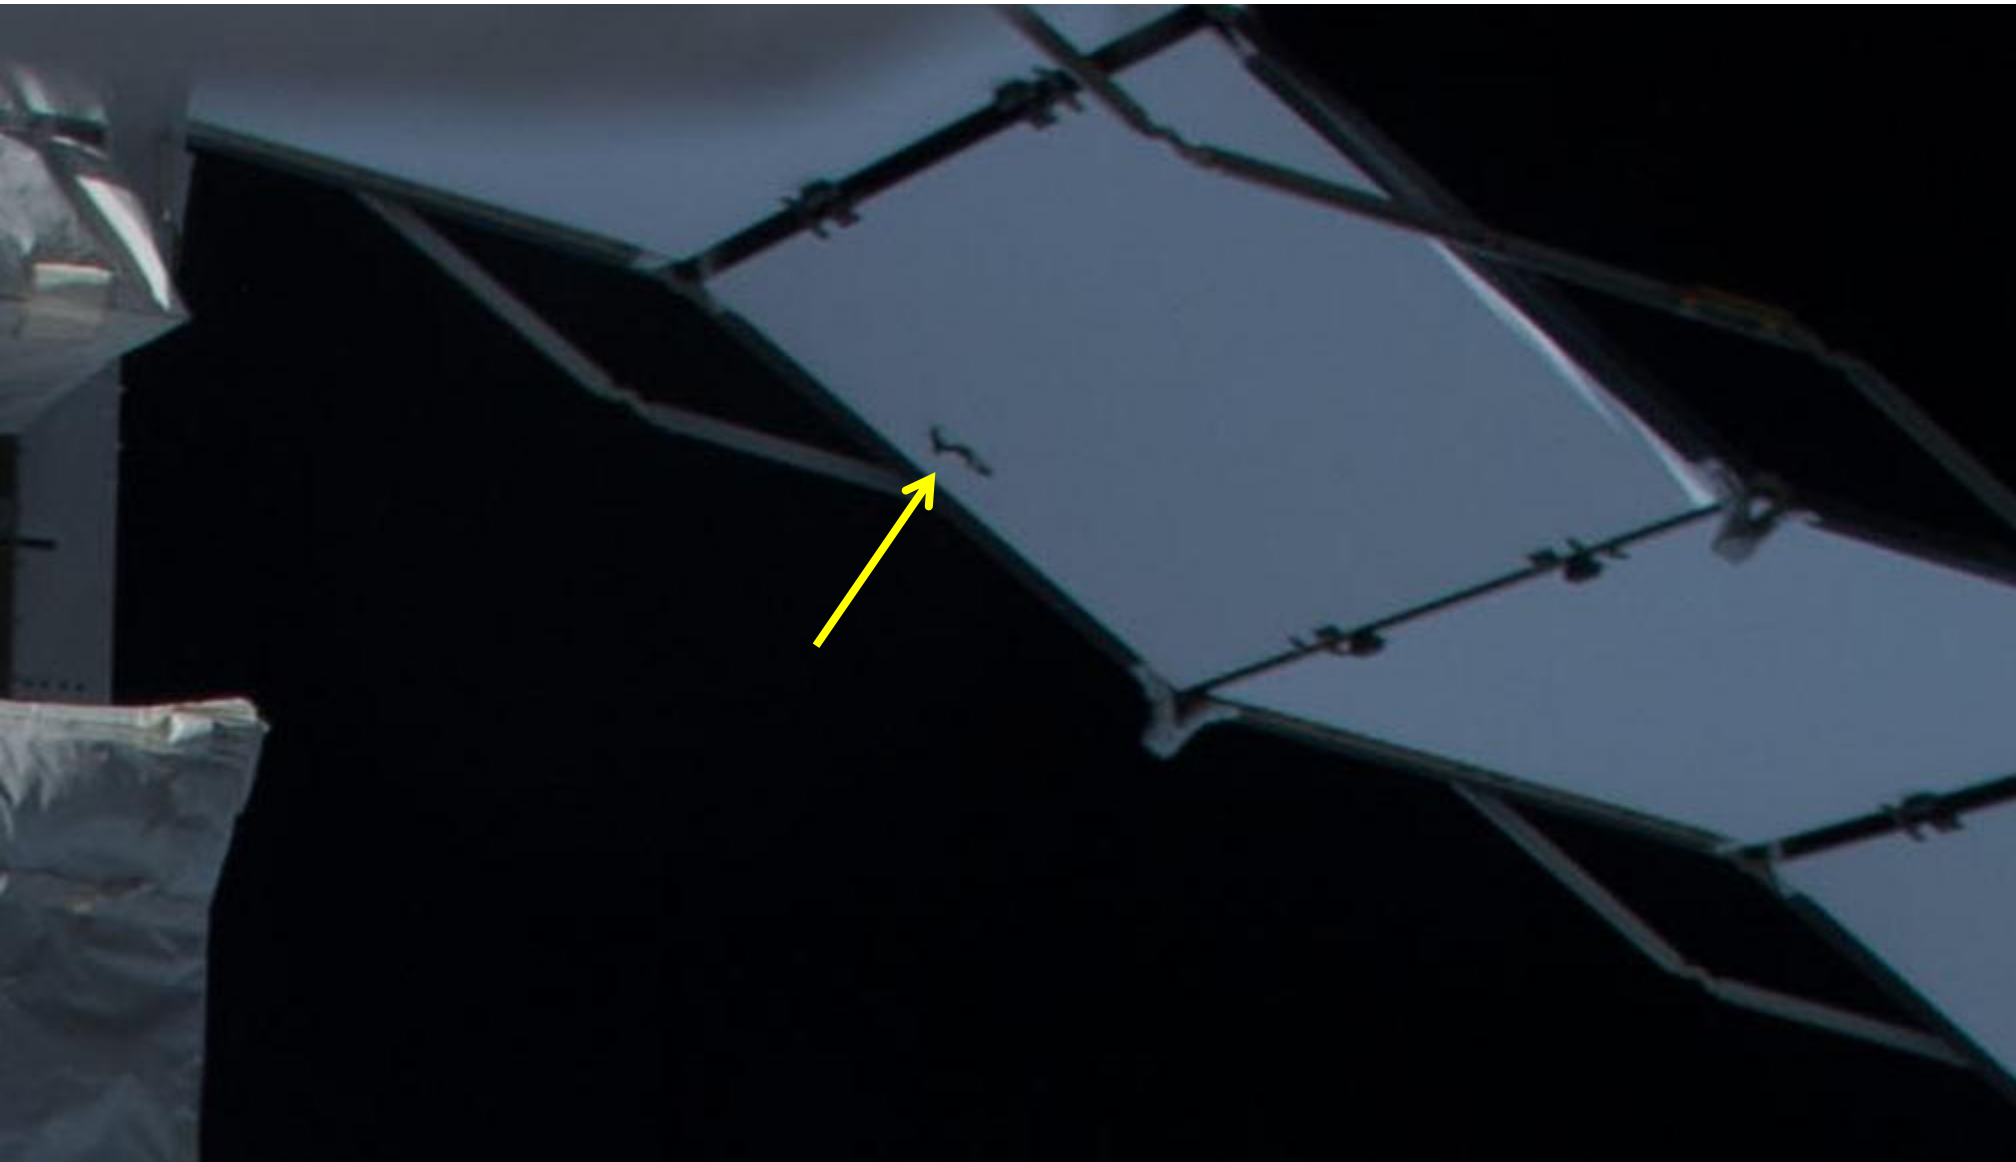
P4 photovoltaic radiator

- **Initial indication found on 6/30/2014**

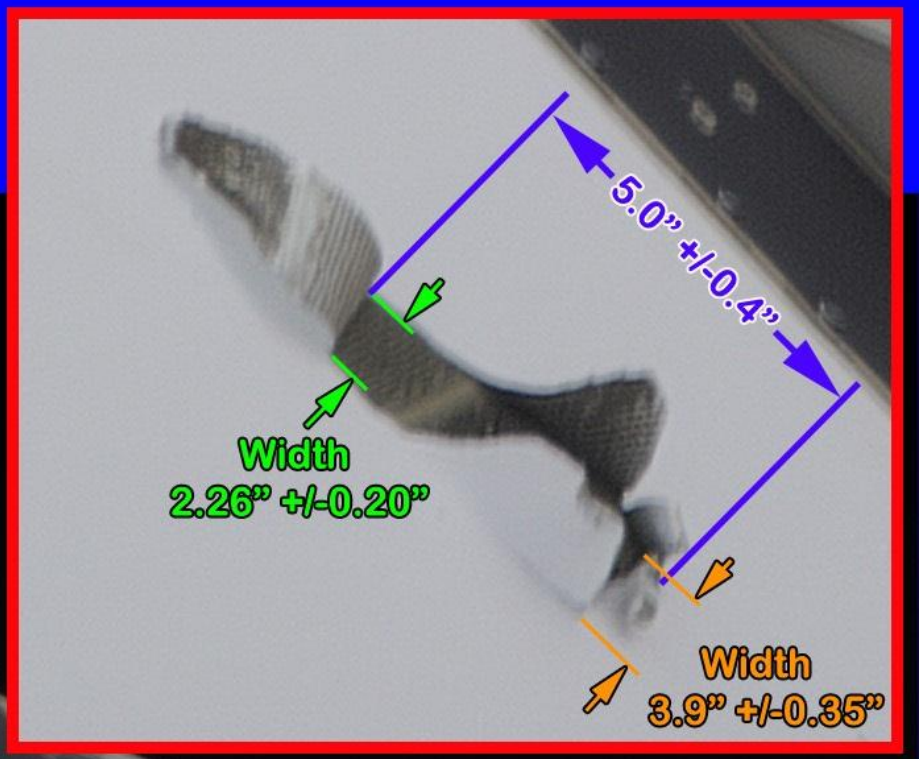
Measurement of P4-PVR Radiator Damage
"2A" Side of Panel 3

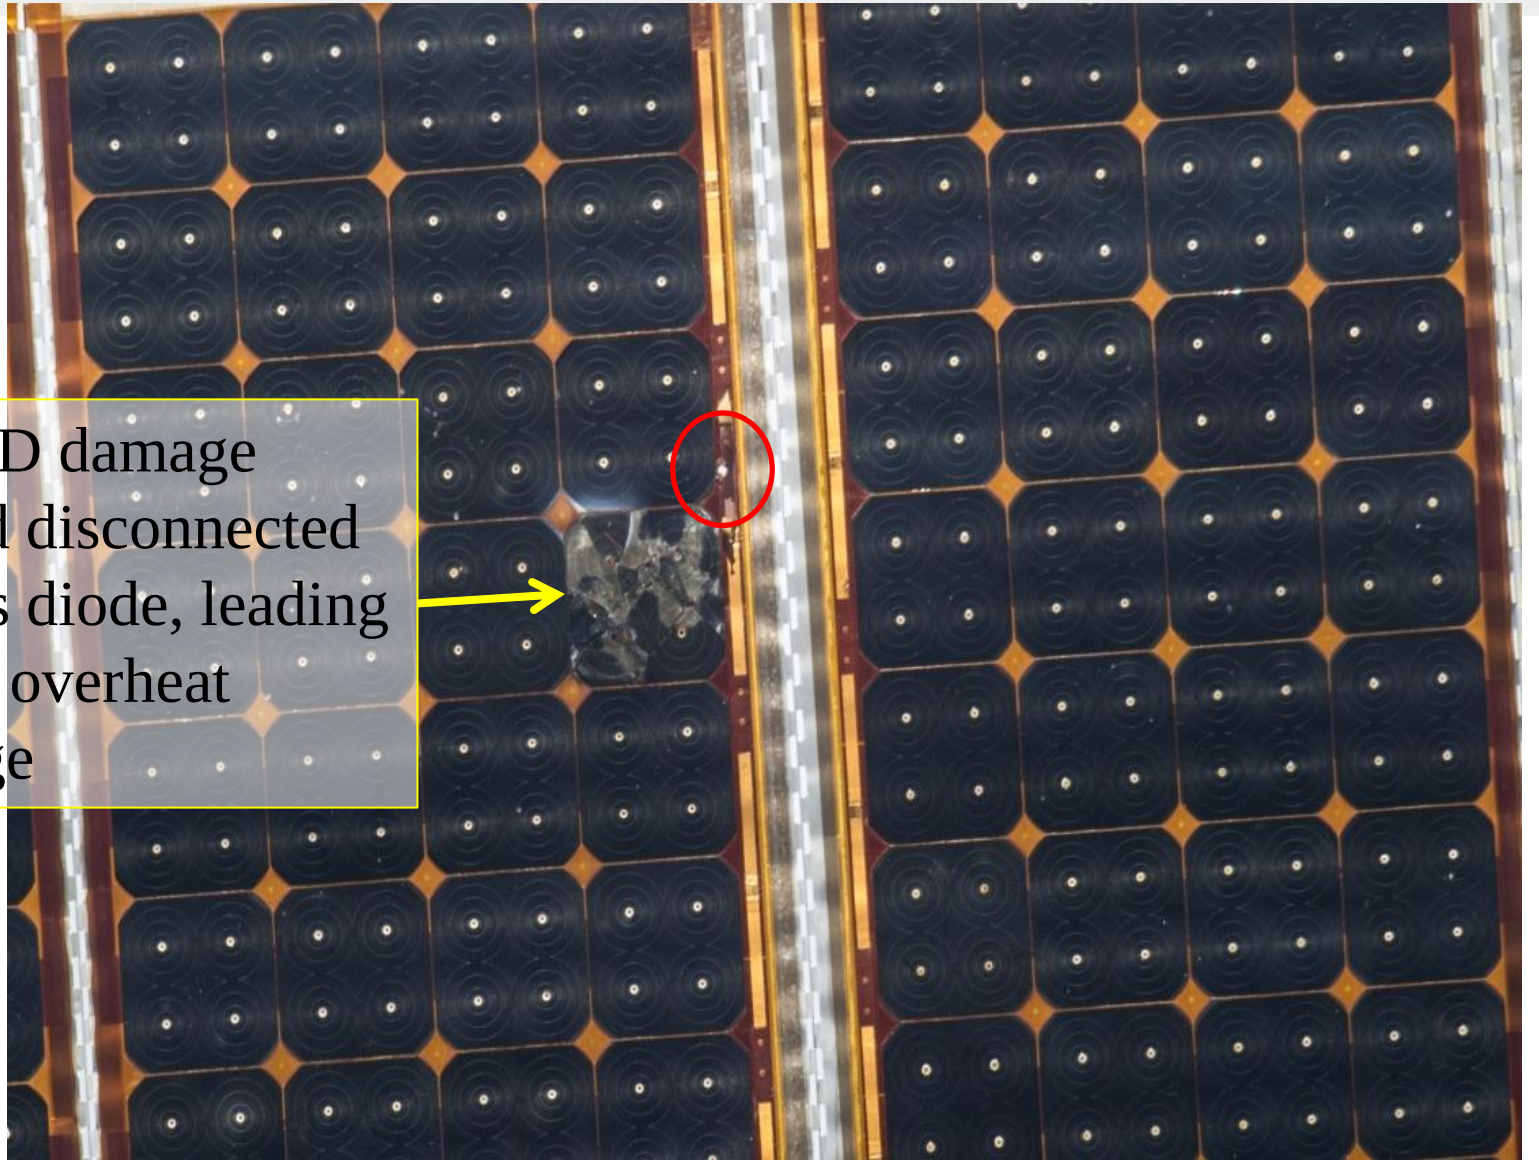
MMOD damage caused disconnected bypass diode, leading to cell overheat damage

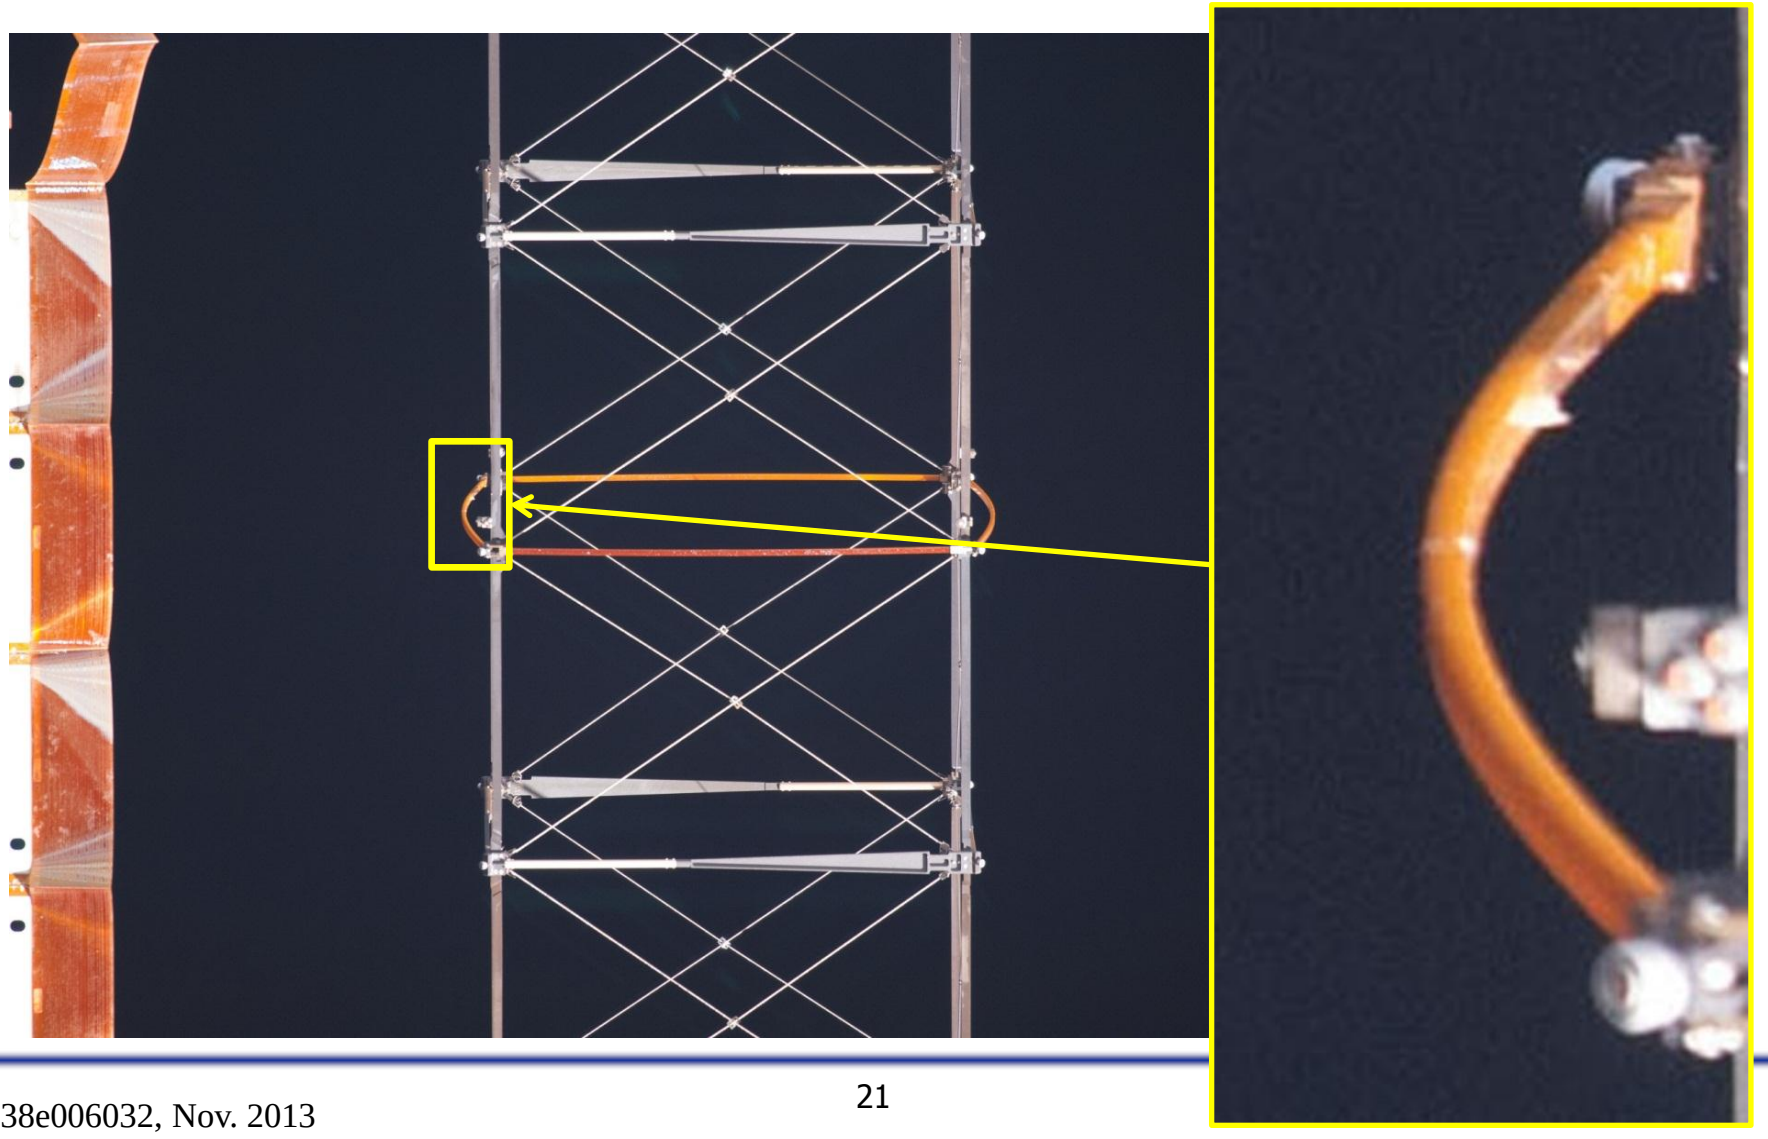
ISS038e006032, Nov. 2013

- **Elements of the solar array masts have been damaged from MMOD impacts**

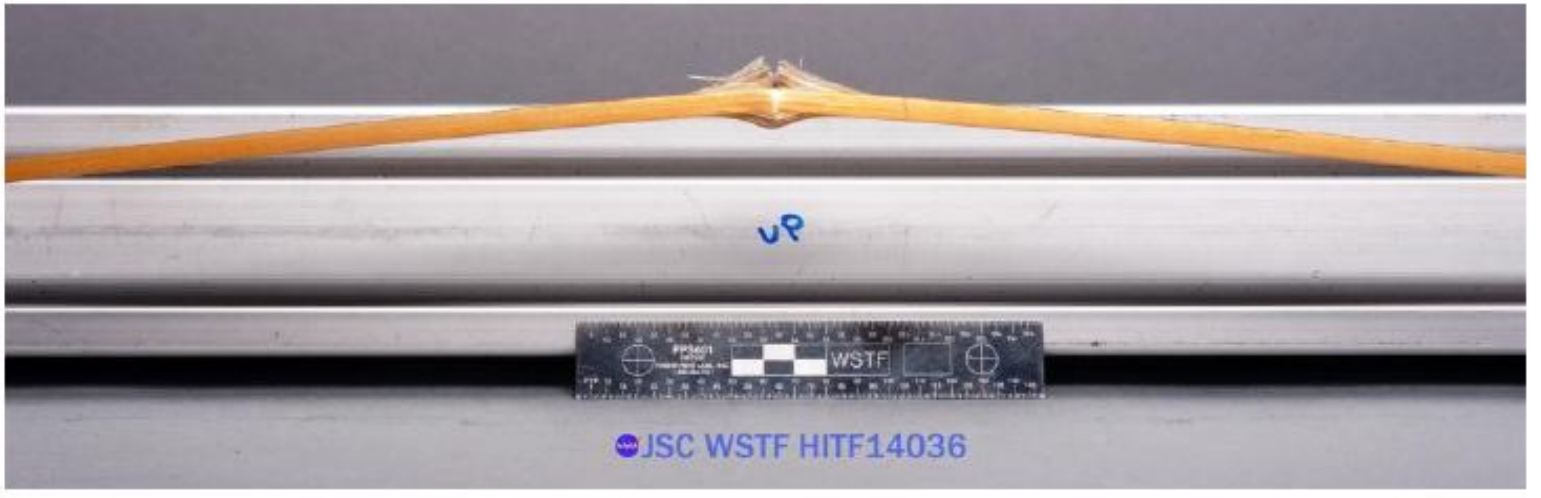
- **Mast elements have been hypervelocity impact tested and structurally tested to assess residual strength for ISS life extension**

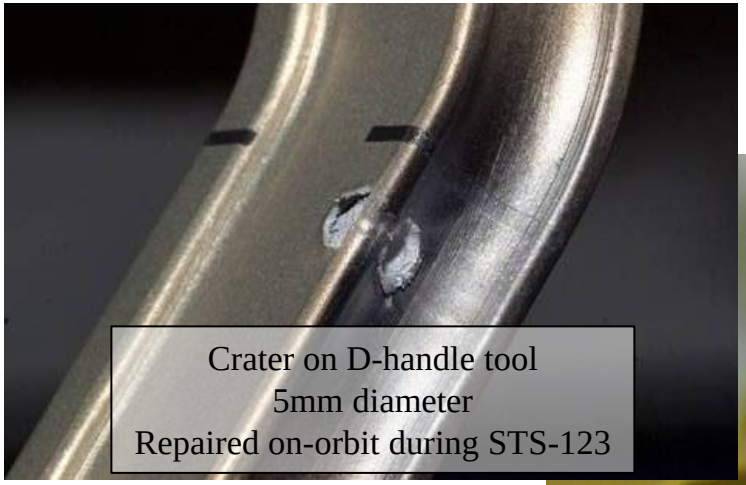
- **Many craters noted to ISS handrails and EVA tools**
- **Sharp crater lips have lead to cuts on EVA gloves**
- **EVA terminated early on STS-118 due to glove cuts**
- **Modifications to EVA suit and ISS EVA procedures necessary to reduce cut glove risk from MMOD damage**

Crater on D-handle tool
5mm diameter
Repaired on-orbit during STS-123

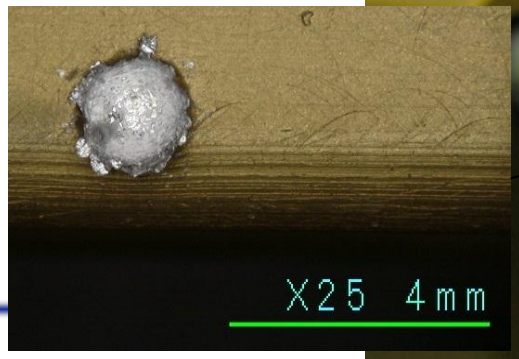
Crater on ISS pump module handrail
1.85mm diameter x 0.8mm deep
Returned STS-135

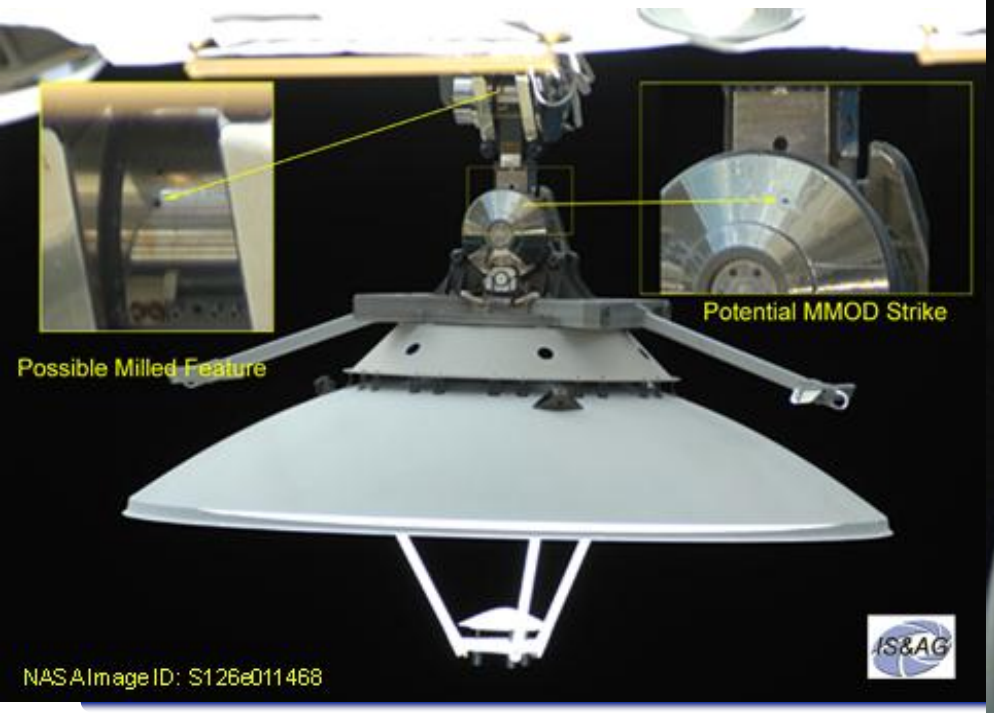
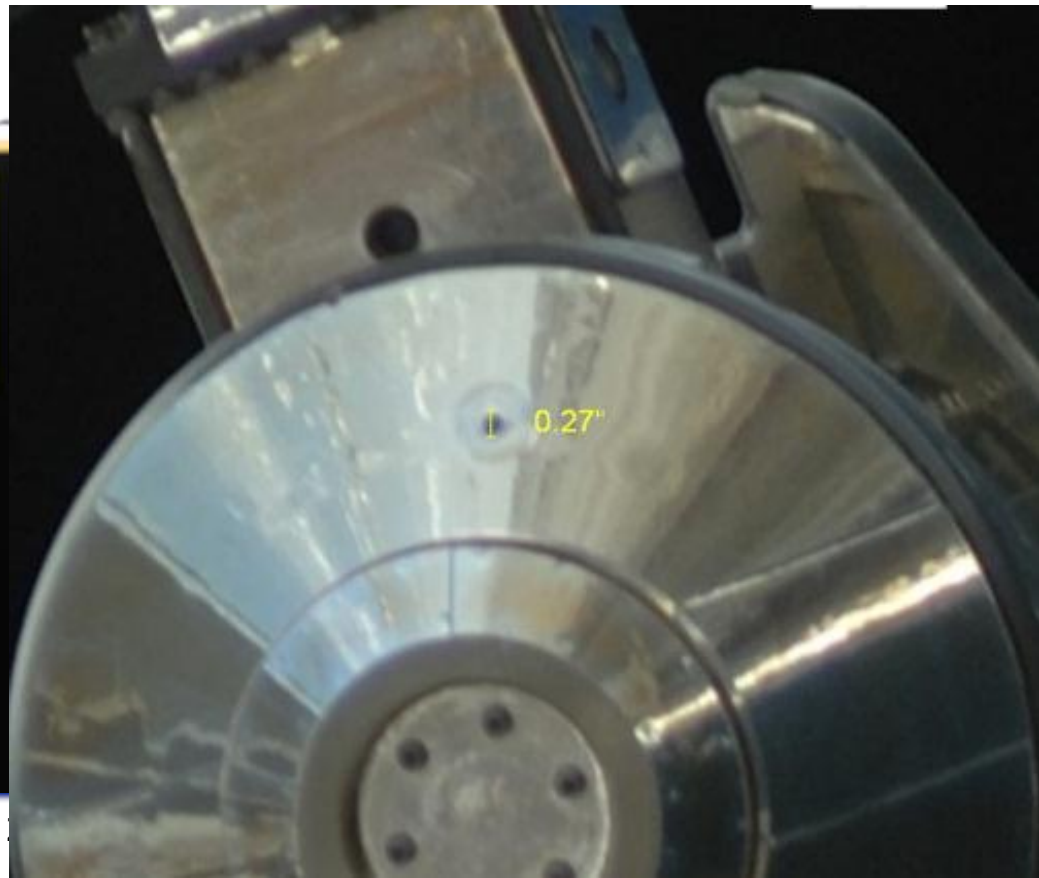
Ku-band antenna

- **An MMOD Strike was seen on the ISS Ku Antenna Gimbal Gear Cover. The image was captured during Mission ULF2 / STS-126.**
- **Interior damage?**

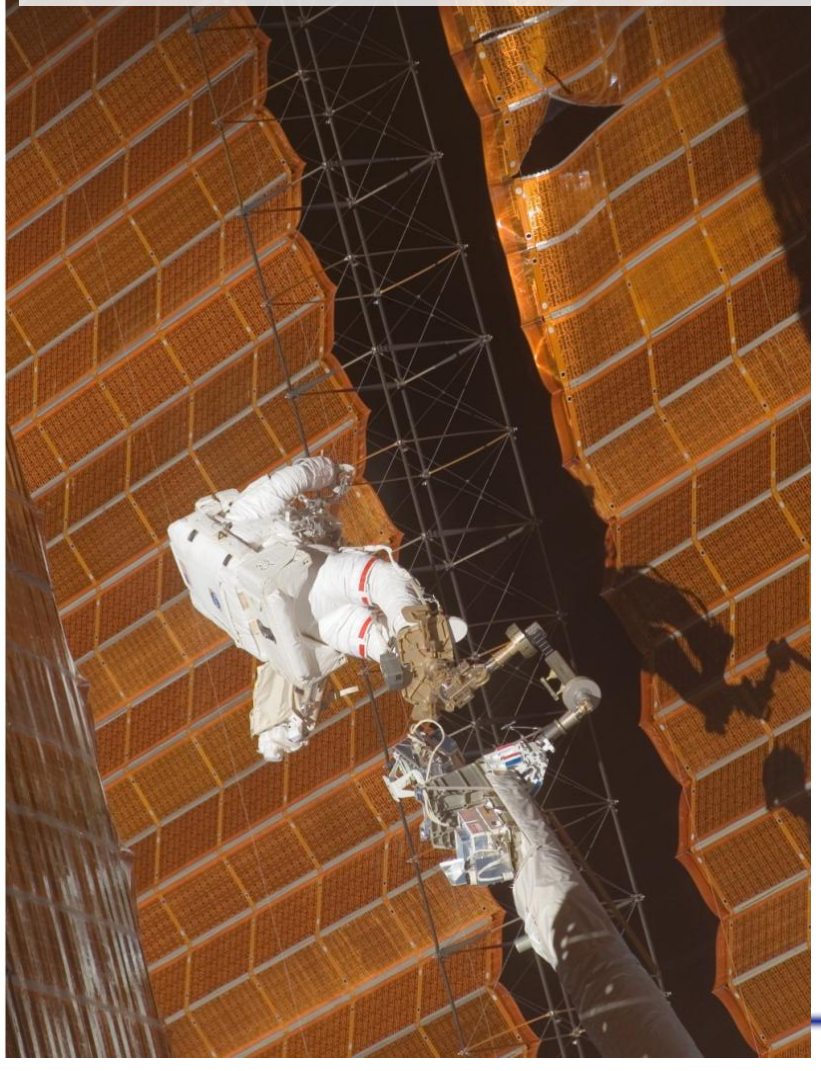
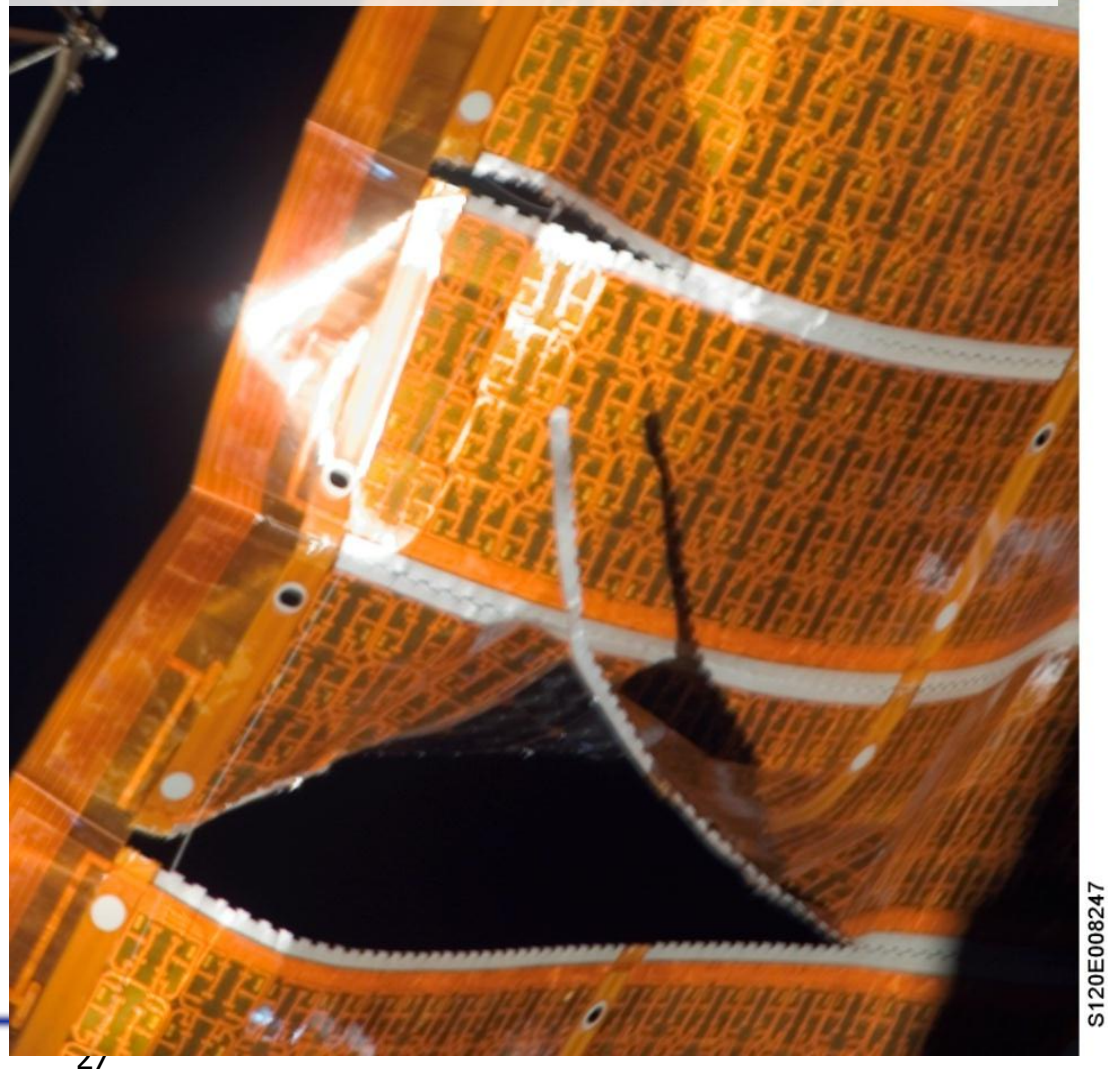
STS-120 Solar Array Wing (SAW) EVA repair was caused by MMOD impact damage

During STS-120 two solar array wings were removed from Z1 truss and relocated to P6 location. During re-deployment, the 4B solar array wing was torn in two places, due to a snagged guide wire. The guide wire was removed and "cuff-links" added to stabilize the array.

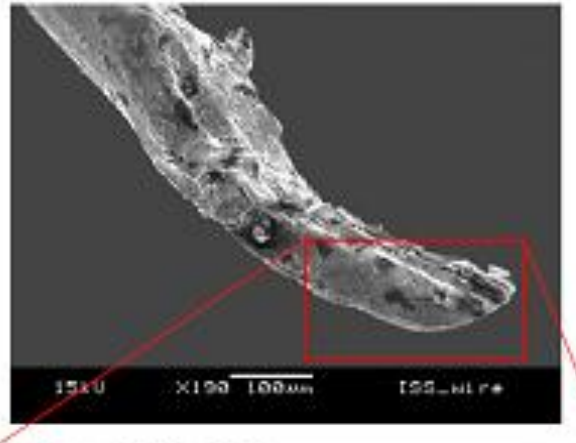
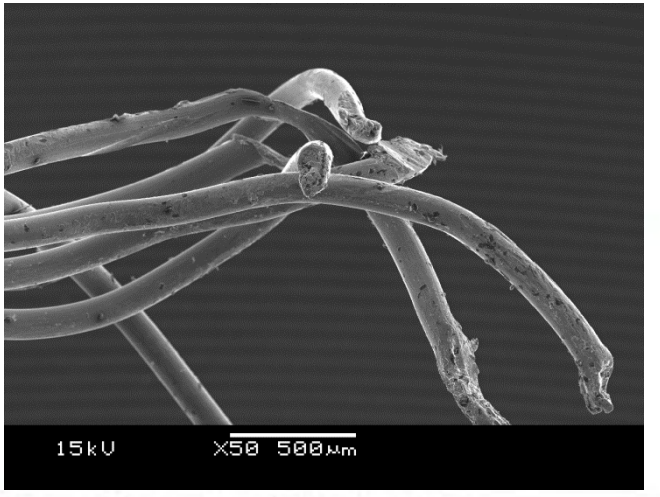
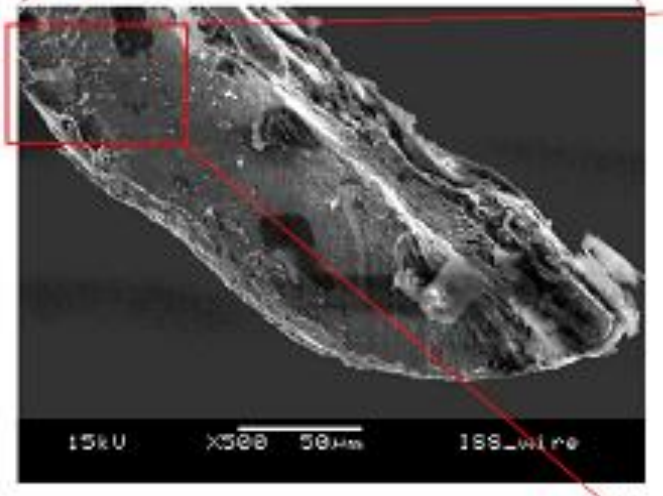
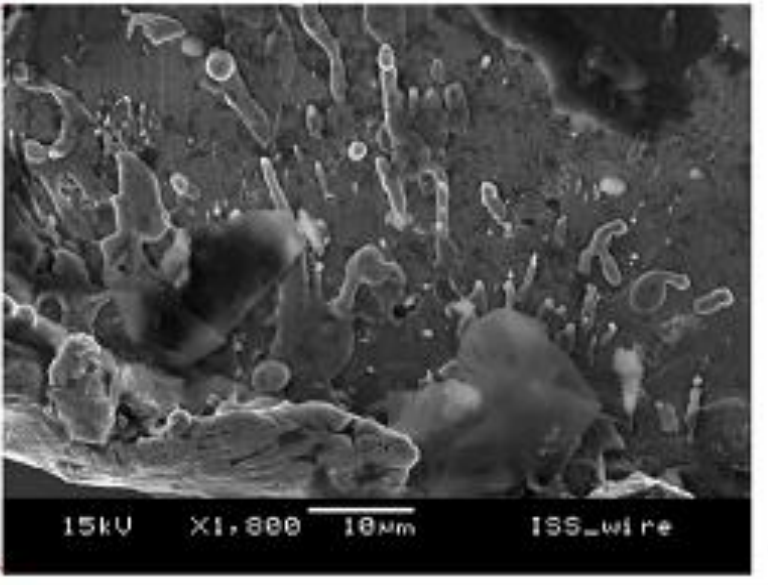
Scanning Electron Microscope EDXA Evaluation of retrieved guide wire

7 of 21 wires in the guide wire cable were broken, causing the guide wire to hang-up in a solar array grommet.
3 of the 7 cut wires exhibited evidence of extensive melt at broken ends, indicative of MMOD impact.

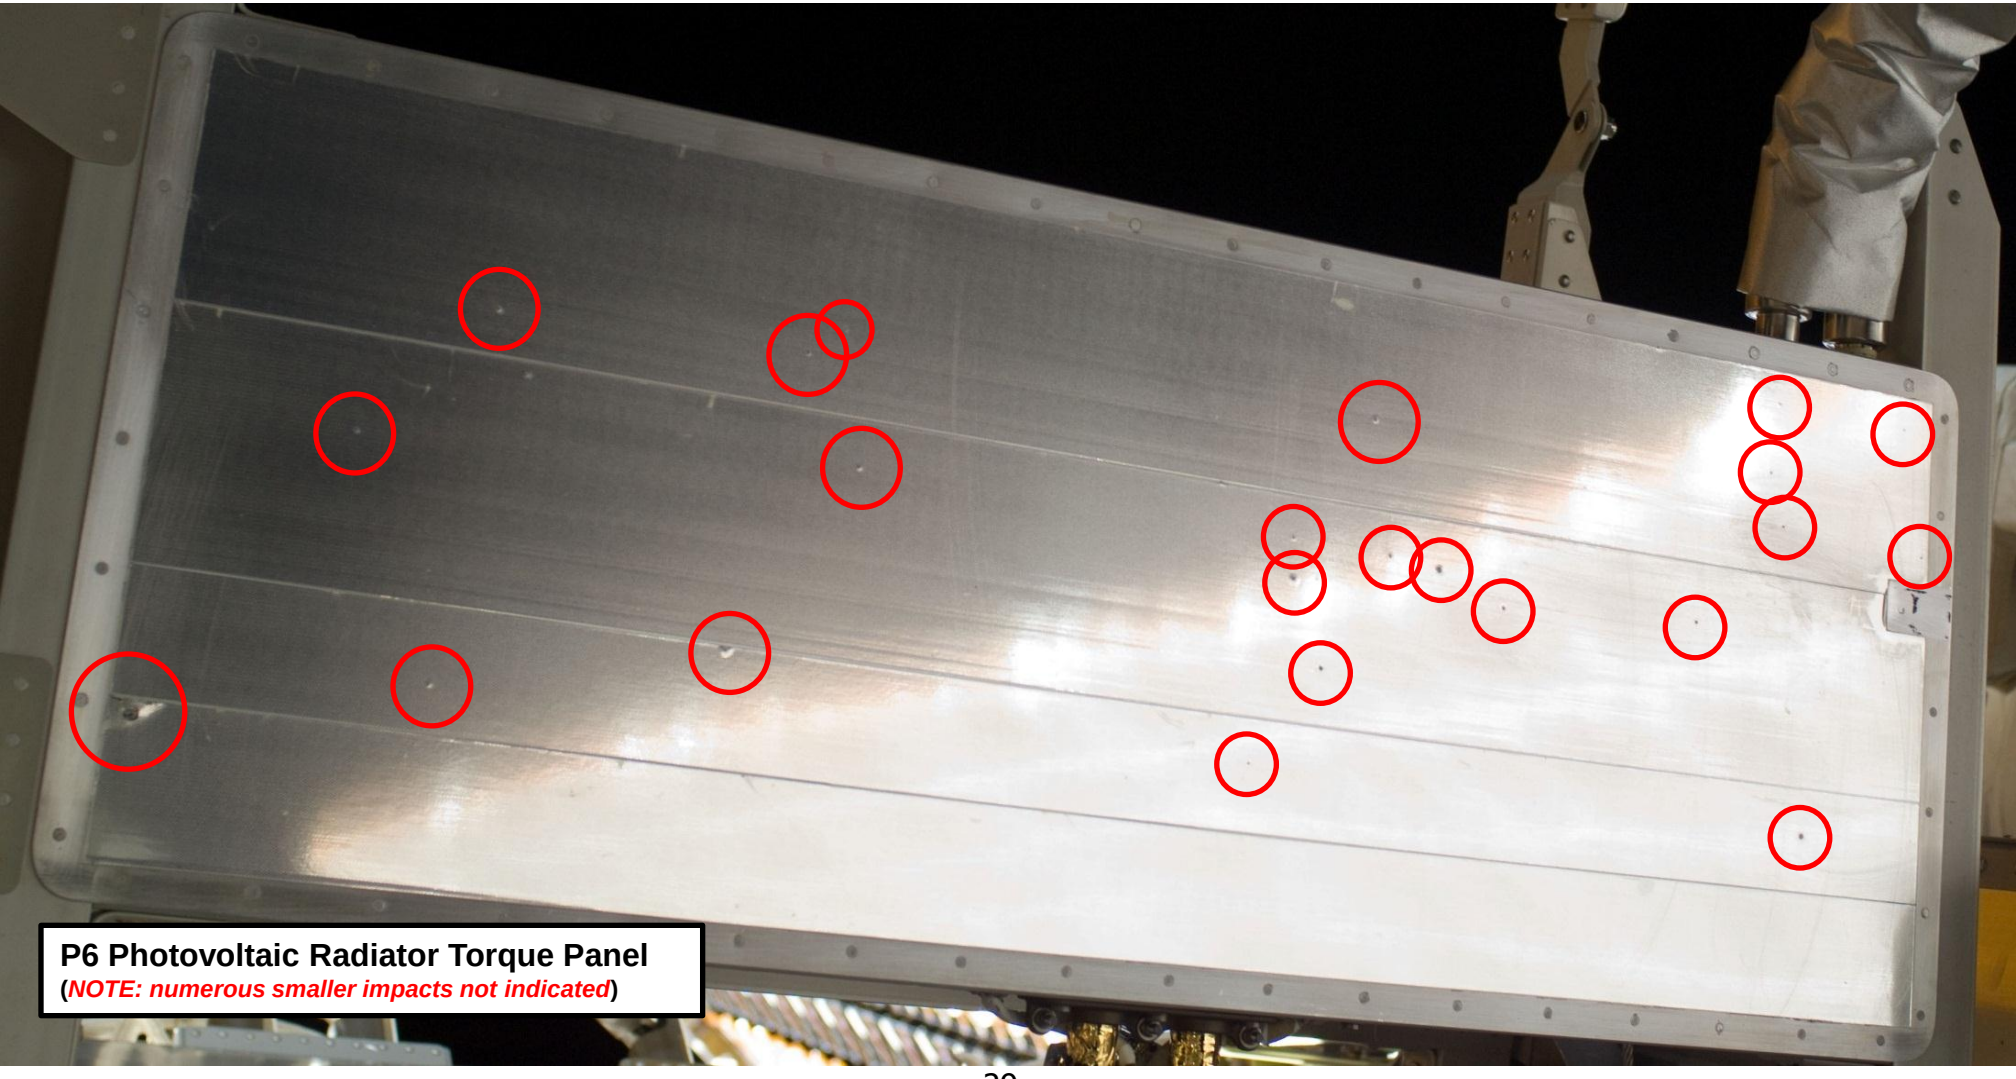
ISS033e017859

- **MMOD impact damages observed to radiator panel during EVA-20 (Nov. 2012)**

P6 Photovoltaic Radiator Torque Panel
(***NOTE: numerous smaller impacts not indicated***)
