Micrometeoroid and Orbital Debris (MMOD) Risk Overview

Eric Christiansen

NASA Johnson Space Center

July 2014

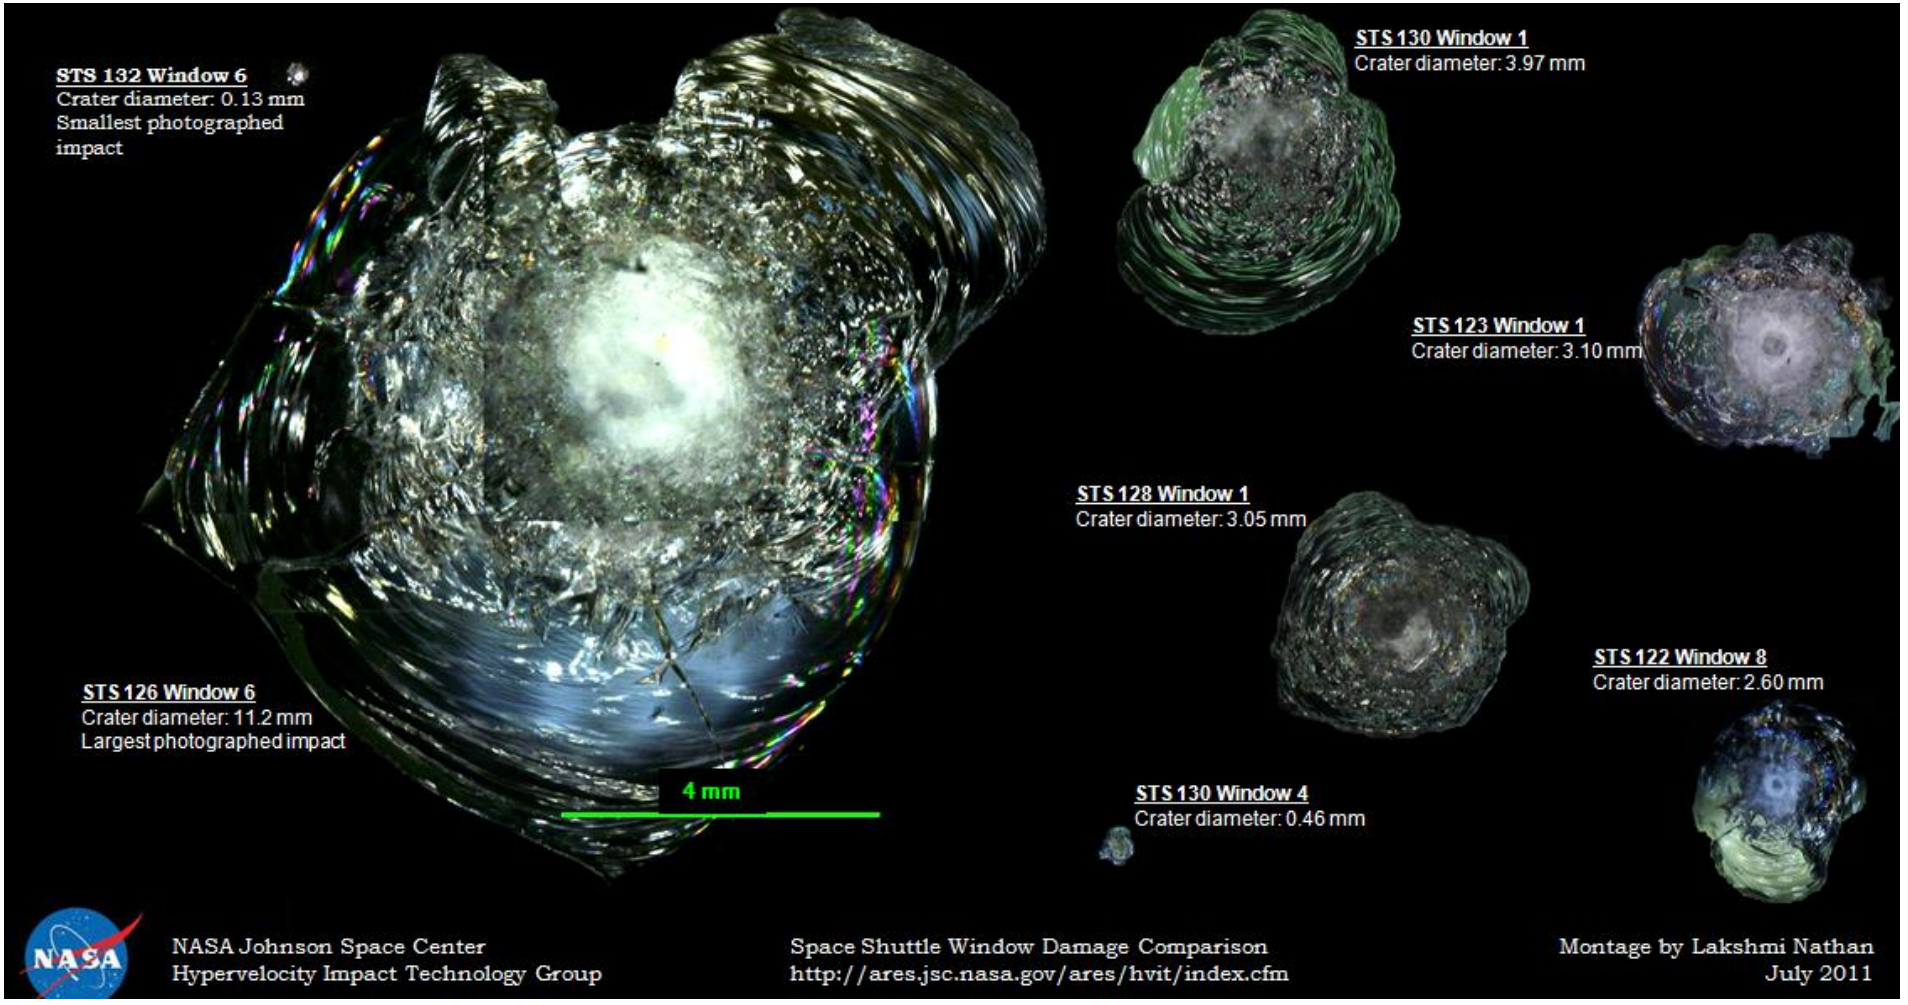
Sampling of Shuttle Window MMOD Impact Craters

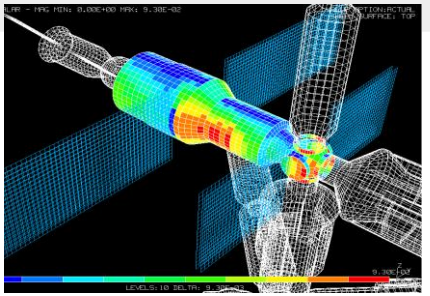
- **Service Module (SM) identified as high penetration risk using Bumper risk analysis**
  - large cone region
  - forward sides of small diameter cylinder
- **Shields designed and tested, EVA installed**
  - 23 augmentation shields for the cone region
  - 5 augmentation shields for the cylinder region
- **28 shields reduced SM MMOD risk by 30%**

High-risk (red)
Low-risk (blue)

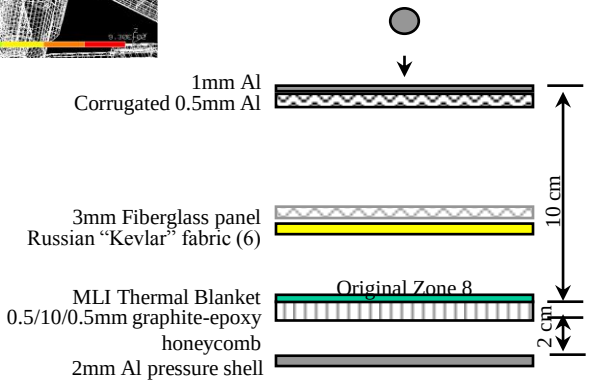
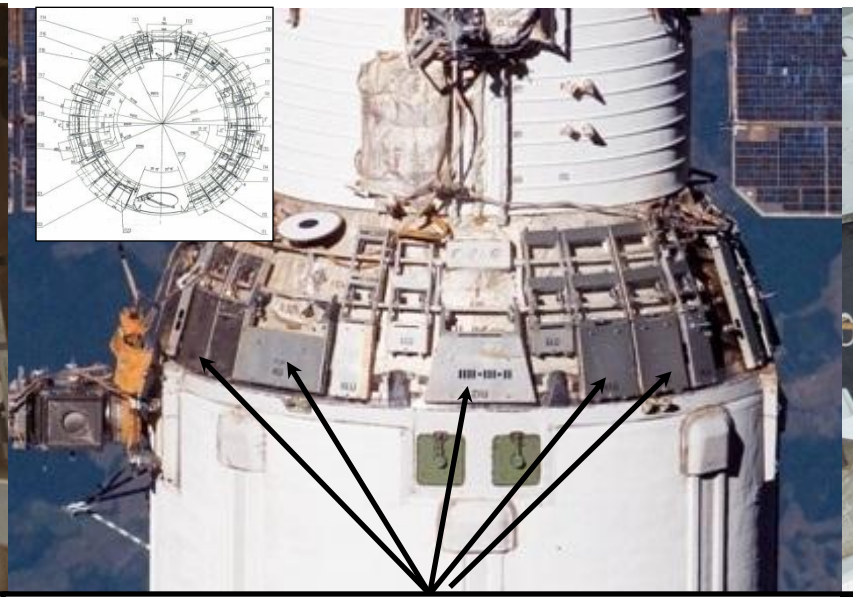
SM "conformal" augmentation shield

EVA Installation	23 "conformal" panels on cone region	5 panels on small diameter cylinder
