NASA-STD-3001 Technical Brief

EVA Mishaps

OCHMO-TB-040
Rev B

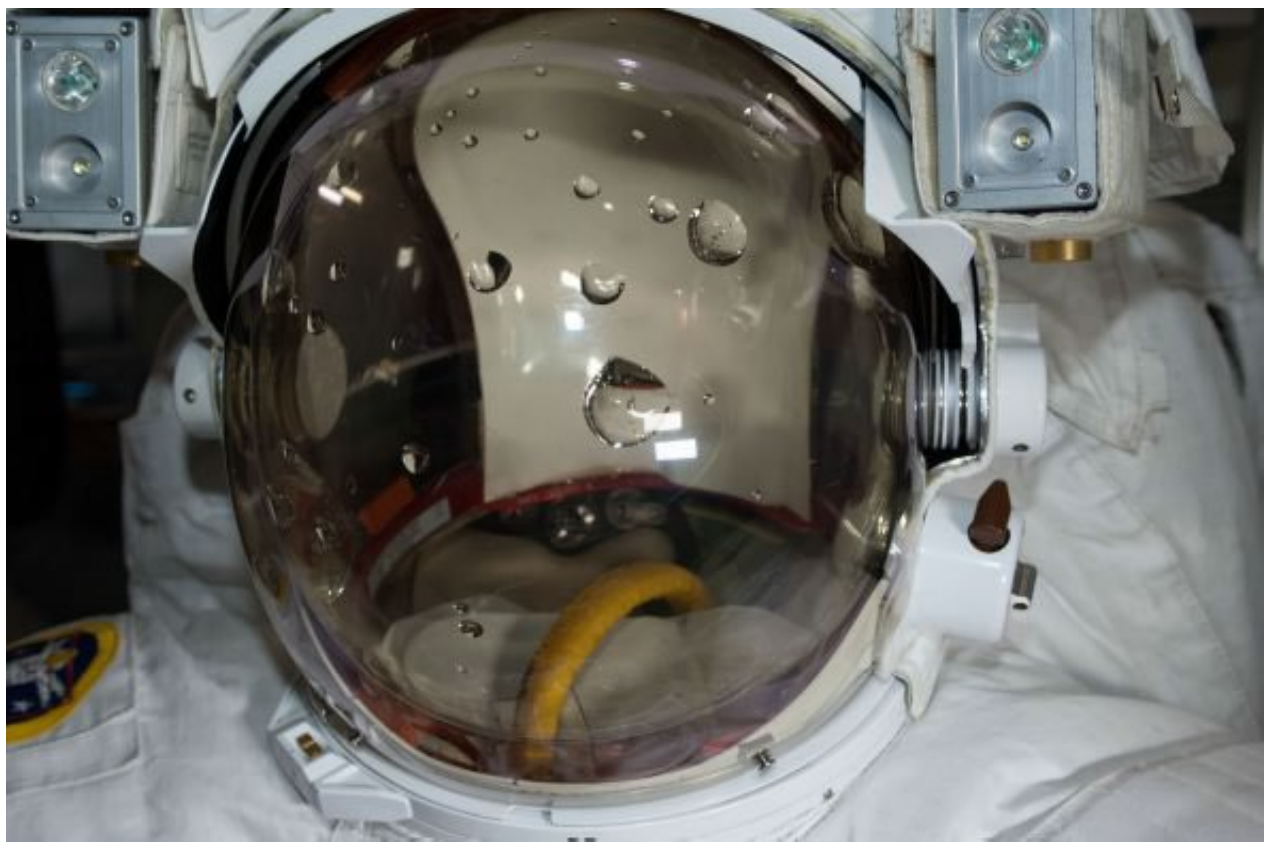
ISS-36: An hour into EVA 3, a large amount of water had collected in astronaut Luca Parmitano's suit and helmet. He was unable to complete his to-do list, had impaired visibility, and ran the risk of suffocating. The EVA was terminated early and he was assisted back into the airlock. Water intrusion is a common occurrence among EVA mishaps. ***Relevant Technical Requirement: [V2 9024] Fluid/Gas Release. From: NASA-STD-3001 Volume 2 Rev D***

Water inside Luca Parmitano's helmet

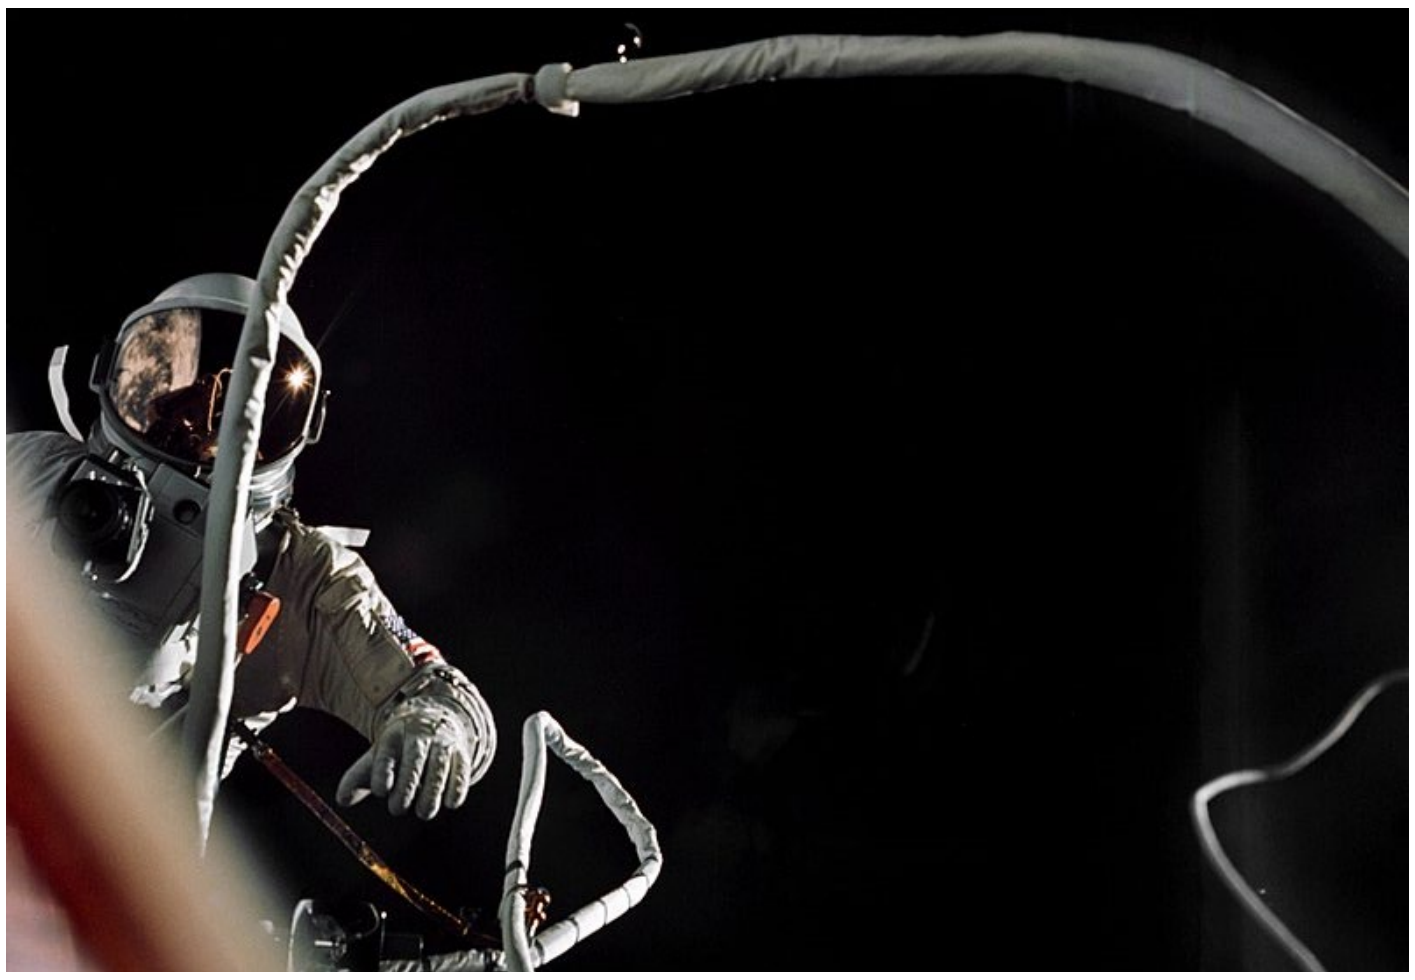
Example Events
Gemini 9: Over the course of his spacewalk, Gene Cernan's EVA suit became frayed and torn in spots along his back. As a result, he experienced painful heat exposure and suffered burns. Additionally, the workload required by the EVA overloaded the suit's cooling system; Cernan became overheated and exhausted, and his visor completely fogged up. ***Relevant Technical Requirements: [V2 9027] Equipment Protection, [V2 11031] Relative Suit Humidity, [V2 11037] Suited Metabolic Rate Measurement, [V2 11038] Suited Metabolic Rate Display. From: NASA-STD-3001 Volume 2 Rev D***

Gene Cernan Gemini 9 EVA June 5, 1996
