Lessons Learned from  
Accidents Involving  
Remotely Piloted and  
Autonomous Aircraft

# Crash Course

Peter W. Merlin

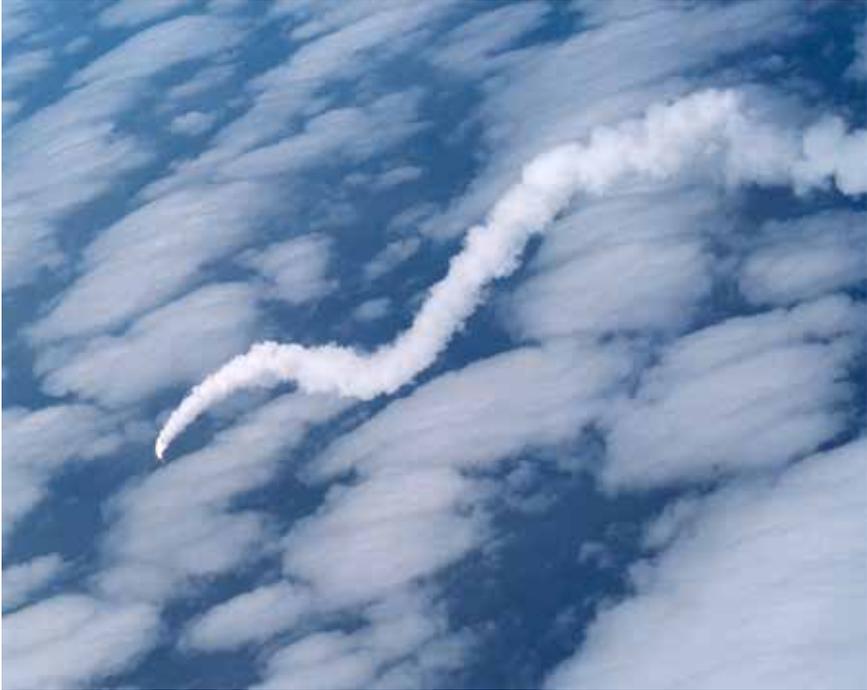
Divergent roll oscillatory motion caused by excessive control-system gain resulted from inadequate analytical modeling that allowed engineers to overestimate system safety margins. NASA

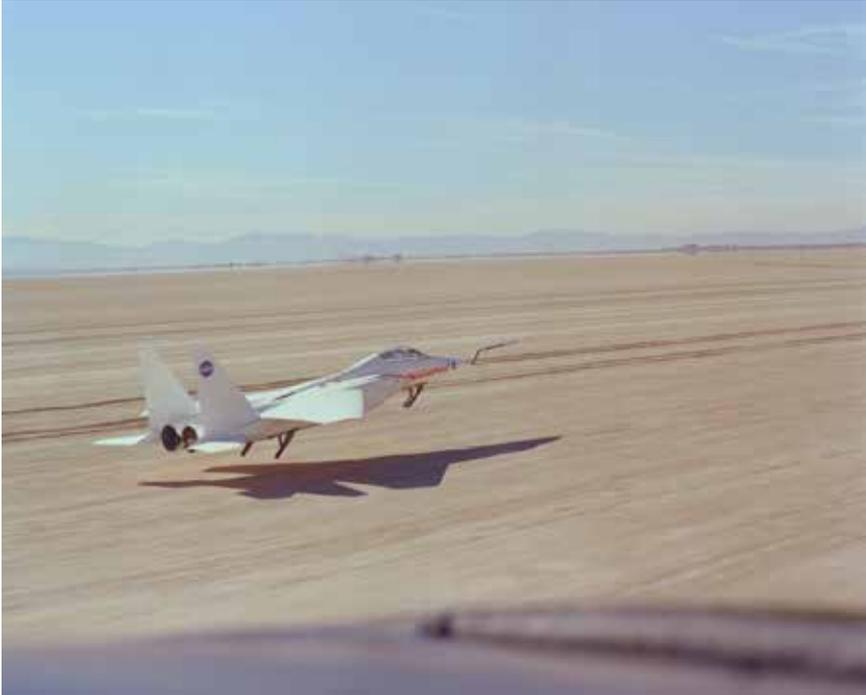
The F-15 RPRV was eventually modified with skids for landings on the dry lakebed at Edwards. NASA

As a result of this successful remotely piloted landing, and considering previous parachute recovery difficulties, further use of MARS was discontinued. The RPRV was modified with landing skids, and all flights thereafter ended with horizontal touchdowns on the lakebed.<sup>24</sup>

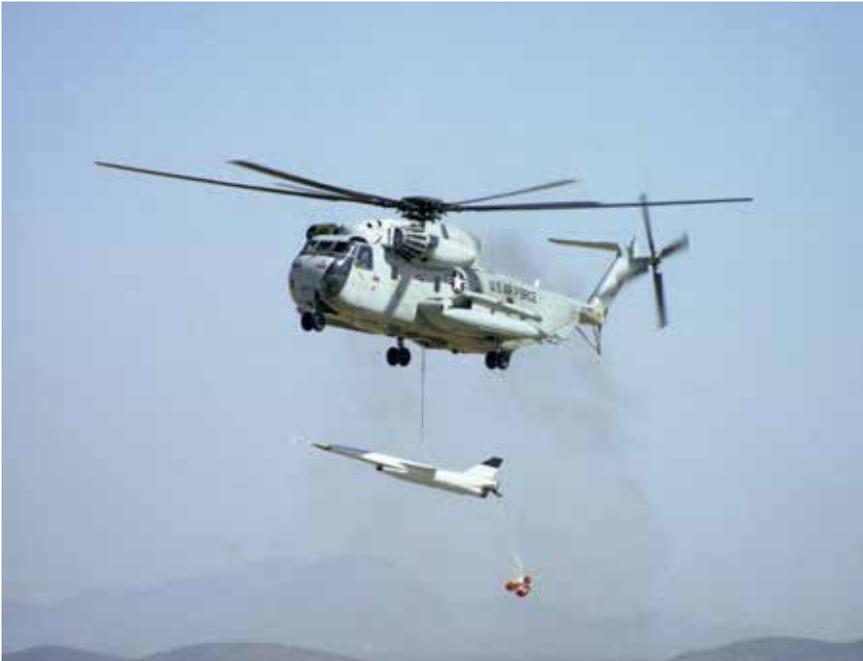
The DAST-1 vehicle is seen here following a typical MARS recovery. NASA

an order of magnitude more than had been encountered in wind tunnel tests. Investigators determined that although the tip-mass system apparently worked as designed, the effectiveness of the system was not as predictable and did not stop the wing flutter even after the wingtip separated completely.<sup>20</sup>

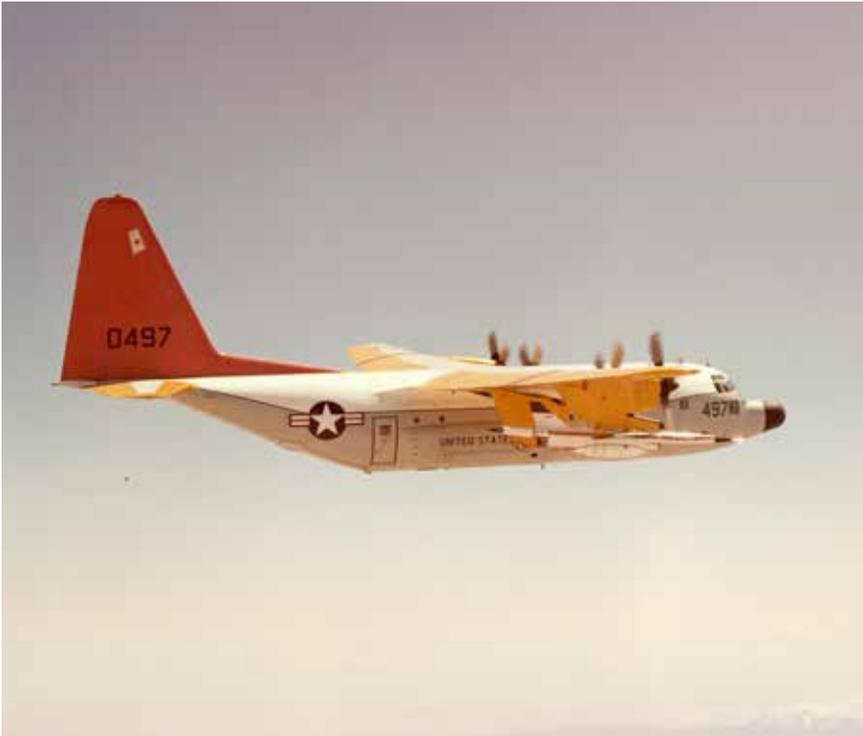
In 1983, a DC-130A was used as a mother ship for the DAST-2. Following two captive flights, the first launch attempt ended in failure. NASA

The next three flight attempts were also aborted, the first due to a drone engine temperature warning, the second because of the loss of telemetry, and a third for unspecified reasons prior to taxi.<sup>28</sup>

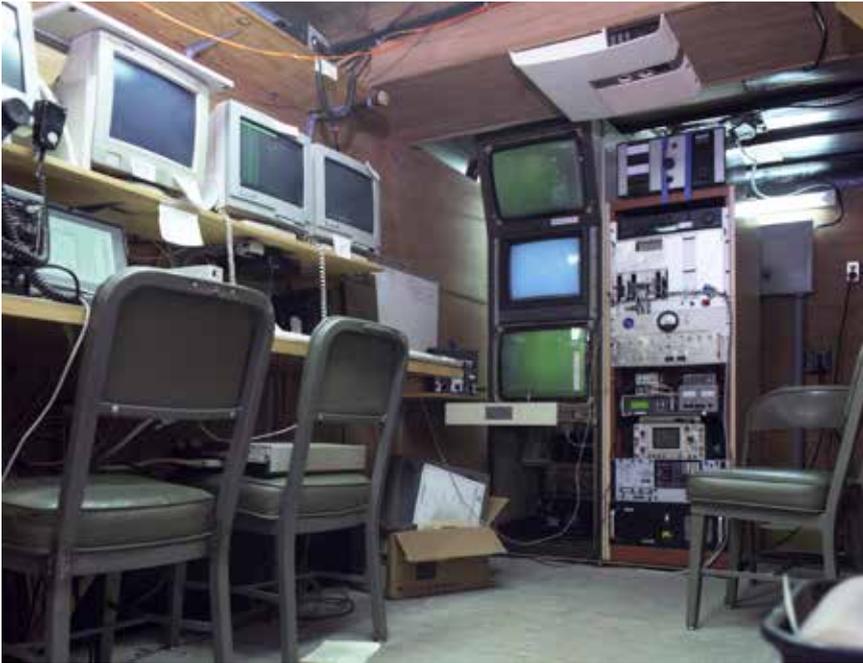
The Perseus GCS included positions for a pilot and several systems monitors. NASA

Several human factors contributed to the mishap. These were related to deficiencies in the design of the GCS as well as GCS team training.

First, displays in the GCS provided poor situational awareness. This precluded adequate mission monitoring and led to the test team's inability to detect the gyro failure. The control panel featured a very limited set of caution and warning annunciators and no autopilot-mode annunciation. Caution and warning indicators were primarily focused on catastrophic engine failures. None were used to indicate sensor failures. Although telemetry data were available to both the test director and flight-test engineer, the data were presented in a tabular format only, on one of 10 selectable pages. System limits were not indicated by these displays. Operating autopilot modes had to be determined by examination of the autopilot switches. At the time of the mishap, the test director was unable to see these switches due to the GCS layout and was unaware that the airspeed-hold autopilot had been switched back on.<sup>11</sup>

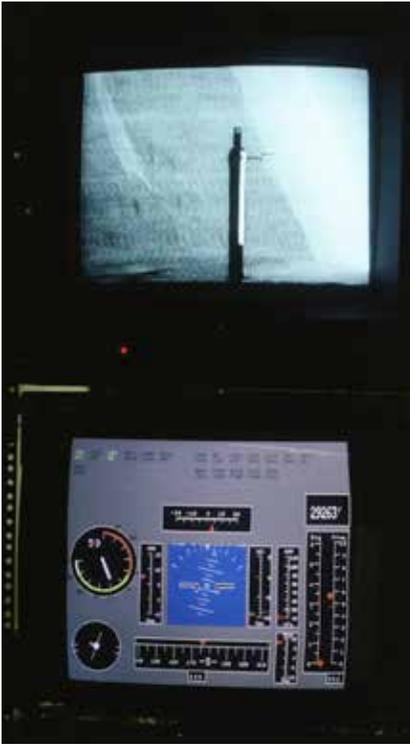
Two screens provided the Perseus pilot with outside visual reference (top) and virtual-cockpit instruments. NASA

screens caused pilots to focus on the head-up display on the center screen, precluding the ability to easily correlate and analyze aircraft flight information. Postflight analysis revealed that a vertical gyro failure could have been diagnosed from the information available on the three CRT displays.

Failure to correlate the displayed information also resulted from the pilot's lack of confidence in the fidelity of the attitude instrument display, which had a relatively slow update rate. During the flight, the instrument-panel display indicated the effects of erratic attitude information from the vertical gyro. That this display did not correlate with the head-up display on the center screen was a clear indication of a failing gyro. The aircraft appeared to stabilize at a nominal wings-level attitude just prior to loss of control, contributing to the pilot's belief that the pitch axis was healthy and leading to his reengagement of the failing pitch (airspeed-hold) autopilot.<sup>12</sup>

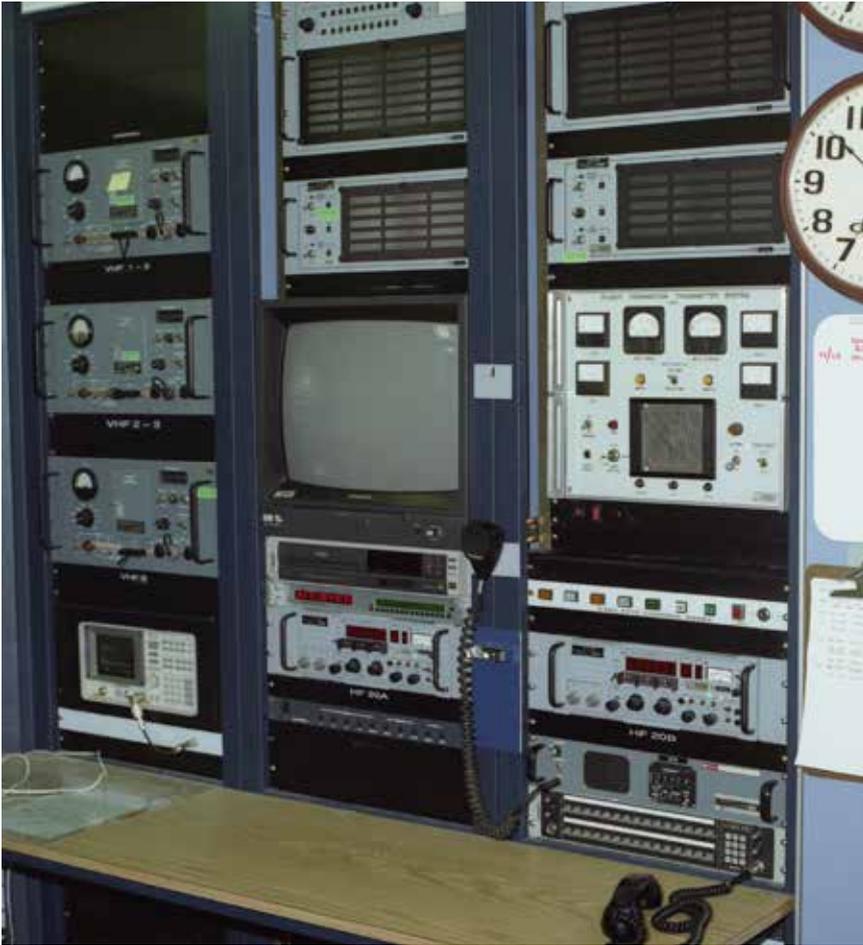
The Theseus FTS panel was designed to allow the RSO to shut down the airplane's engines and fire two rocket-deployed parachutes in the event of an emergency. NASA

command had no effect. Investigators concluded that operator error was the single factor leading to the FTS failure.<sup>13</sup>

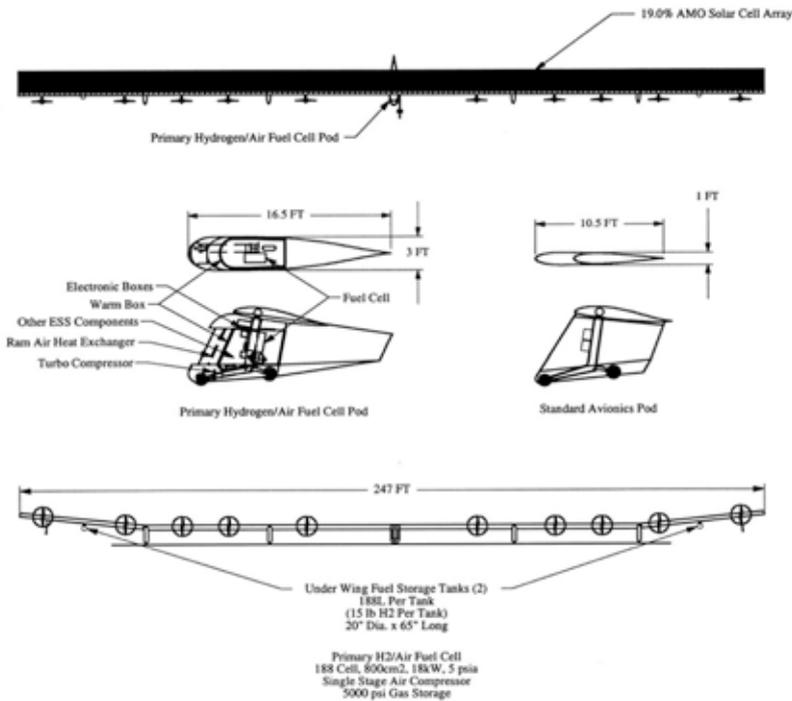
Addition of a center-mounted 520-pound fuel cell and two 165-pound fuel tanks beneath the outer wing panels changed the Helios Prototype from a span-loader to a point-loaded configuration. NASA

would have required only two regenerative fuel cell pods located about one-third the distance from aircraft centerline to the wingtips. Installation of three pods for the PFCS configuration resulted in increased point loading.

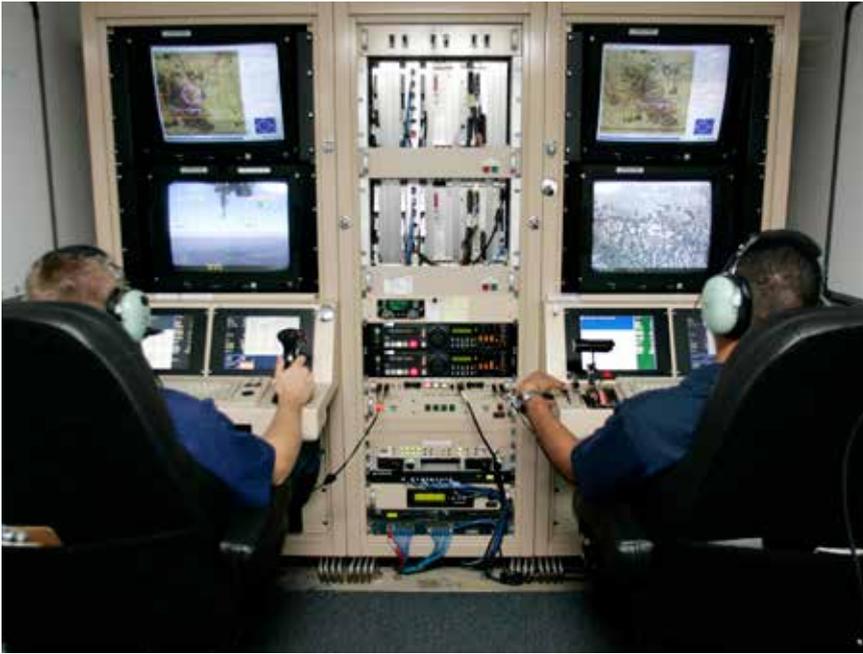
CBP agents operated the MQ-9 from a standard GCS, with identical consoles for pilot and sensor operator. CBP

According to the checklist, before switching control from one station to another, the primary pilot is supposed to match control positions on both consoles. In this case, the pilot failed to do this, he later told investigators, because he was “in a hurry.”<sup>5</sup> As a result, the situation lever, which had been used to lock the camera iris, was now in the fuel shutoff position. In aviation, this is known as a “switchology” error. The term refers to techniques used to ensure the proper settings of switches on control panels.

As is frequently the case, this mishap might have been easily avoided. A simple switch lockout could have prevented the pilot from inadvertently shifting aircraft control from one console to the other until the condition lever positions matched. Such a device—used effectively in everything from automobiles to nuclear weapons—would have provided a final opportunity to avoid disaster.<sup>16</sup>

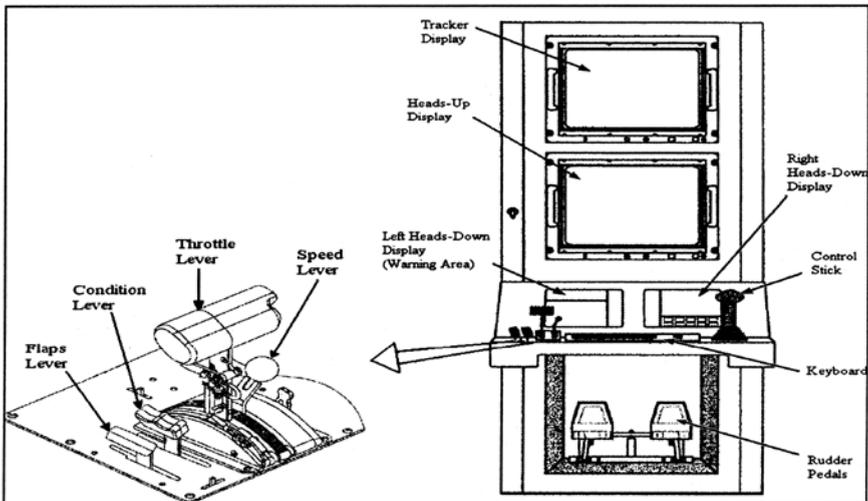
When PPO-1 is used as the primary aircraft control interface, movement of the “condition lever” to the forward position opens and closes the fuel valve. Moving the lever full aft closes the fuel valve and feathers the propeller. NTSB

When the pilot switched control to PPO-2, the condition lever was still centered. In camera-control mode, this locked the iris, but in flight-control mode, it cut off fuel flow to the engine. As the engine sputtered to a halt, the MQ-9 began to descend. The pilot noticed the change in altitude but failed to discern the cause. Also unaware of the situation, the avionics technician advised him to shut down the ground-data terminal so that the MQ-9 would begin its programmed lost-link procedure. Normally, this would cause the MQ-9 to autonomously climb to 15,000 feet and fly a predetermined course until uplink could be reestablished. Without engine power, however, the aircraft descended until it was below the range of line-of-sight communications and contact was lost. The MQ-9 crashed in a sparsely populated residential area, but there were no injuries or damage to private property.<sup>6</sup>

Investigators also examined the switch configuration on the PPO consoles. In the pilot configuration, the control lever was used to control both the fuel valve and propeller feather servo. This lever had a linear analog range running from zero to 100 percent, divided into thirds for normal operation, engine shutdown, and propeller-feather/engine-shutdown. A shutdown engine could be restarted if the switch was positioned in the normal range and engine controls were in auto mode. The system was programmed to attempt automatic restart if propeller speed fell below 1,488 rpm and the condition lever was in the normal run range. The engine could not be restarted with the lever in the shutdown range because this closed the fuel valve, shutting off fuel flow to the engine.
