NASA Independent Review Team
SpaceX CRS-7 Accident Investigation Report
Public Summary

Date of Event: June 28th, 2015

Date of Report: March 12th, 2018

Public Summary

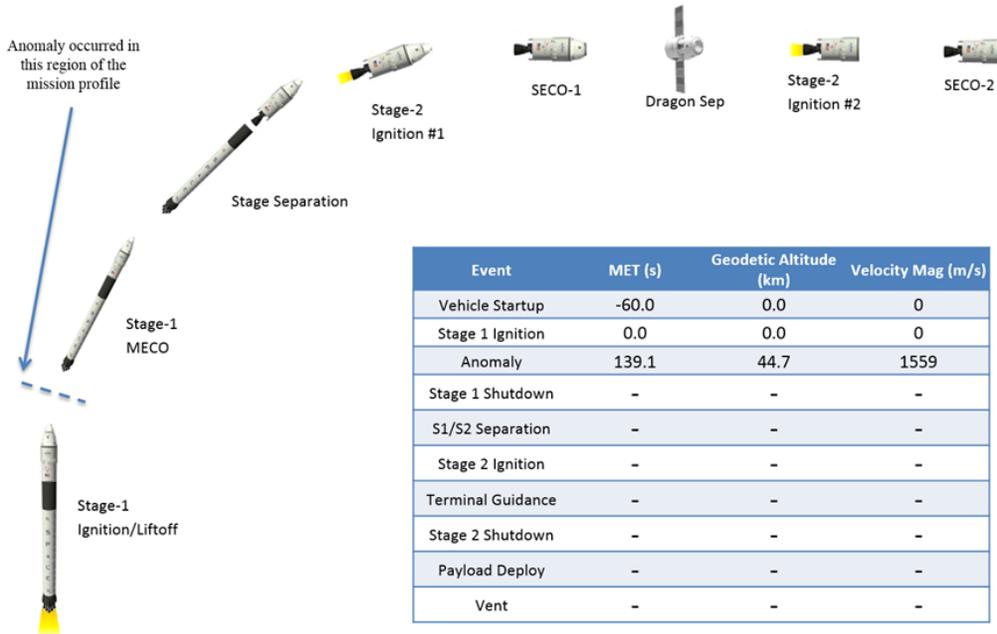
Figure 1. SpX CRS-7 Planned Ascent Sequence

The SpX CRS-7 mission consisted of a SpaceX Falcon 9 version 1.1 launch vehicle and a Dragon spacecraft loaded with 4303 lbs (1952 kgs) of cargo. At approximately 139 seconds into flight, the launch vehicle experienced an anomalous event in the upper stage liquid oxygen (LOx) tank, resulting in the loss of the mission. The first stage of the vehicle, including all nine Merlin 1D engines, operated nominally. The Dragon spacecraft also indicated no anomalous behavior prior to the mishap, and survived the second stage event, continuing to communicate with ground controllers until it dropped below the horizon. Figure 2 shows a gaseous cloud emanating from the launch vehicle. Figure 3 shows the disintegration of the launch vehicle. Table 1 identifies the events seen on the video.
