RELEASE : 10-269

NASA Releases Report About Australia Balloon Mishap

The Nuclear Compton Telescope Balloon Launch Mishap Investigation Board was established on May 12, 2010, in accordance with NPR 8621.1, "NASA Procedural Requirements for Mishap and Close Call Reporting, Investigating, and Recordkeeping." The Investigating Authority was appointed to obtain and analyze evidence and facts; conduct necessary testing; impound property, equipment, and records; identify the causal and contributing factors relating to the mishap; and to recommend appropriate actions to prevent a similar mishap from recurring.

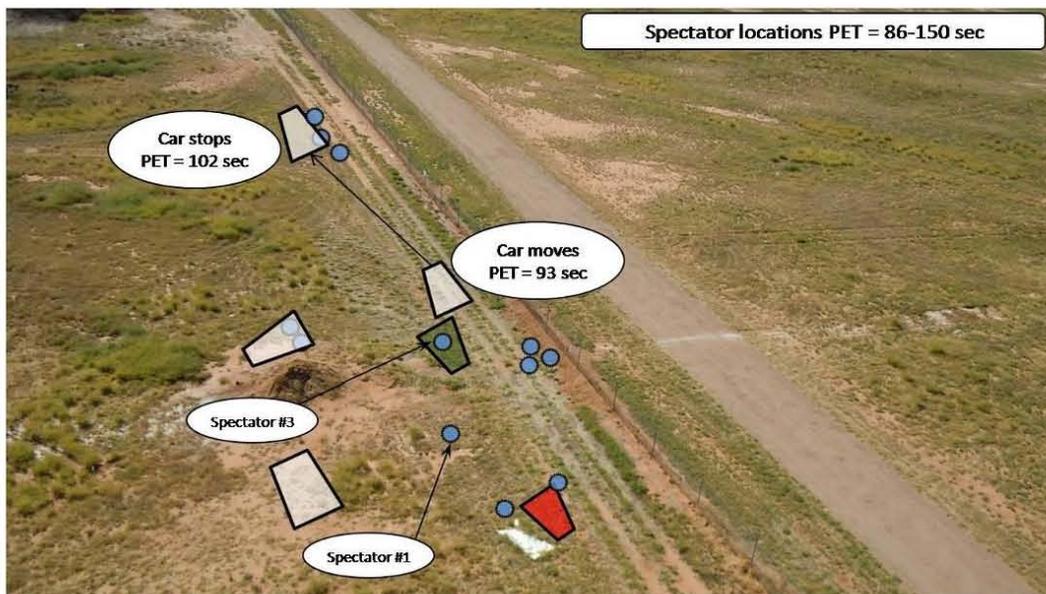
Figure 21. Spectator Location at PET 86-150 Seconds

Key Event 39: At about **PET=105 sec**, the launch vehicle arrived at the perimeter fence and stopped. The LD realized that the mission would have to be aborted, but because spectators were in the flight path, did not order an abort. After several seconds at the fence, the LD ordered the vehicle to be backed away from the fence. Spectator locations during this event are shown in Figure 21.

Key Events 41 through 43: The vehicle began backing away at **PET=118 sec** and continued backing until about **PET=150 sec**. At this time, the vehicle no longer had traction to continue backing as a result of the tires slipping in the loose soil. At this point, the launch vehicle was still about 150 ft beyond the Category A Hazard Area (fixed interpretation). The LD instructed the LVD to proceed forward and make a left turn in an attempt to move the system away from the spectators. Spectator locations during this event are shown in Figure 21.

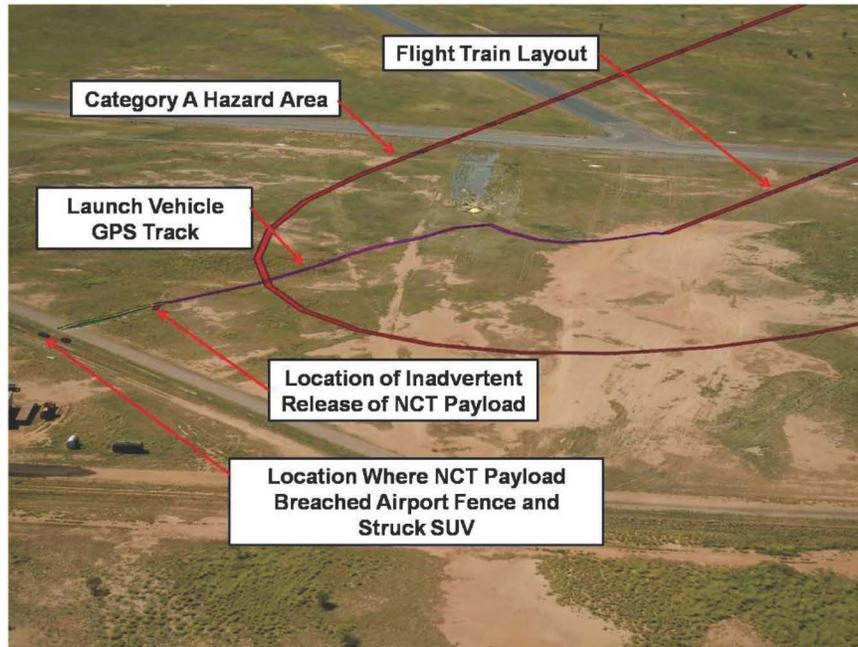
Figure 22. Location of Mishap Site at the Alice Springs Airport

Key Event 44: During the left turn, the payload inadvertently released from the launch vehicle at **PET=171 sec**. The balloon pulled the payload downwind, where it breached the Airport security fence and continued moving towards spectators’ cars and spectators who were in the path of the payload’s motion. Spectators were able to run to safety.

During the dragging event, a call was made by the CM to abort the balloon. The mishap site and spectator locations at the time of the mishap are shown in Figures 22 through 25.

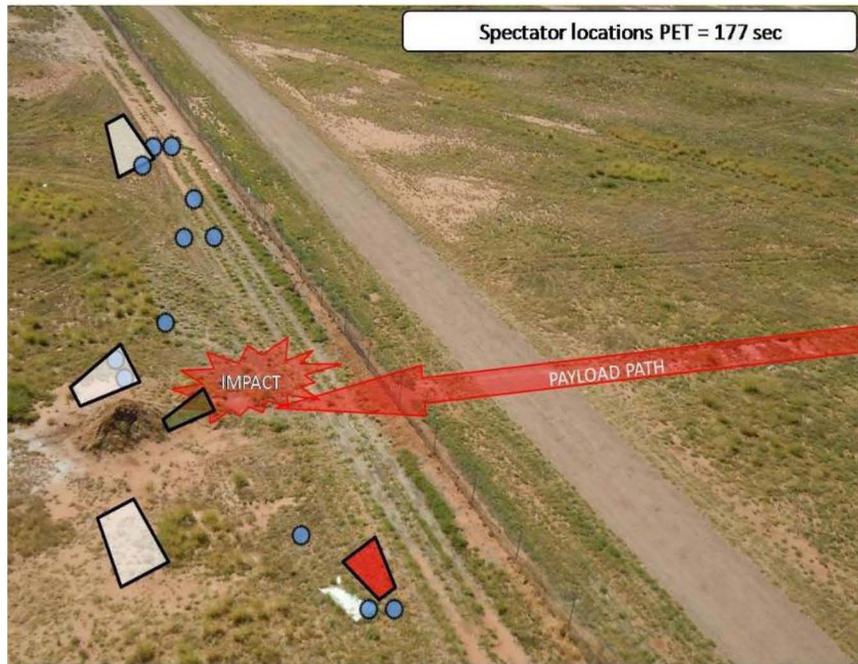
Figure 26. Spectator Location at PET 177 Seconds

Key Event 47: At PET=177 s the dragging payload hit a spectator’s vehicle. At approximately the same time, the abort command was sent, releasing the balloon from the top of the parachute. After the balloon was separated from the parachute, the payload came to rest. Spectator locations at the time of impact and property damage are shown in Figures 26 and 27.

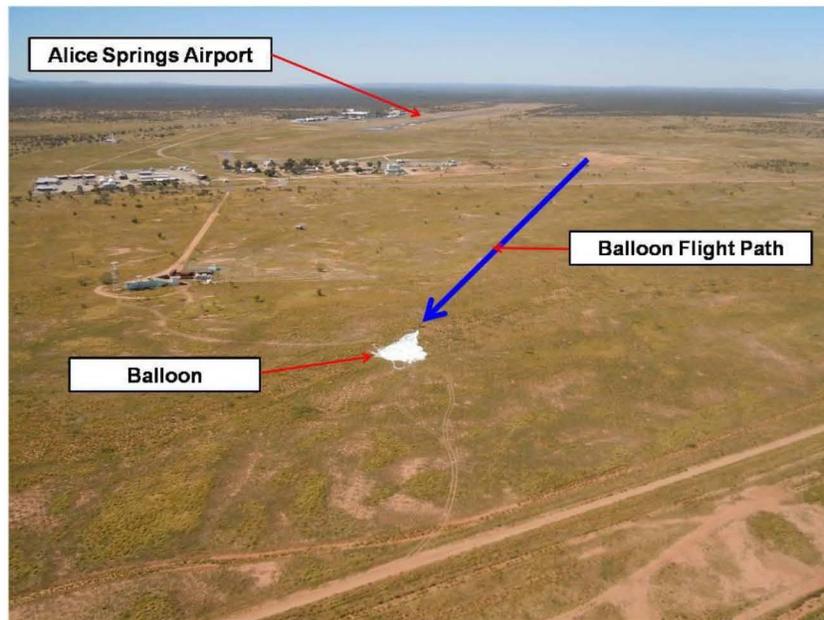
Figure 28. Balloon Landing Location

Key Event 49: The parachute and flight train were fully on the ground by **PET=199 sec**. The balloon came to rest on the ground some time later about ¼ miles downwind in a field outside the airport indicated in Figure 28.

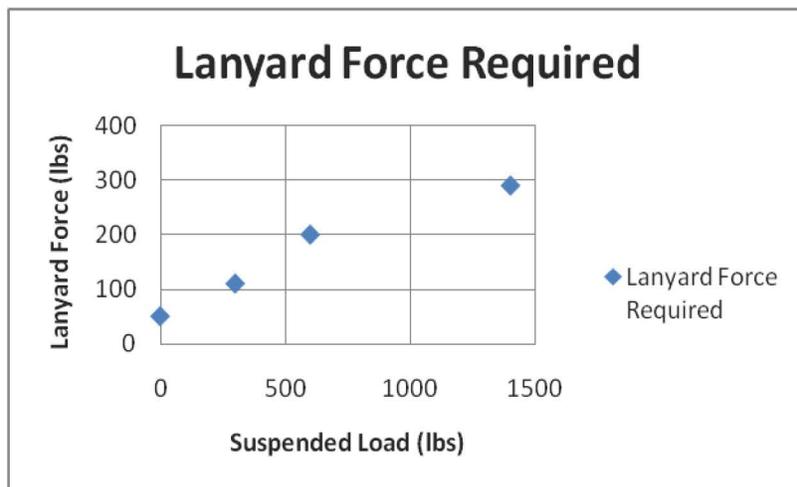
Figure 35. Lanyard Pull Force vs. Pear Ring Load

Summary of Test—A simple test was performed aimed at discovering the approximate forces required to pull the lanyard cable and retract the safety restraint cable release pin. The pear ring hanging from the release pin was subjected to a range of loading from zero to 1400 lb in order to determine the relationship between the pin loading and the load required to pull the release lanyard. The resulting lanyard forces ranged from approximately 50 lb at no load to 300 lb at 1400 lb load and are shown in Figure 35. The full test report is contained in Appendix C.

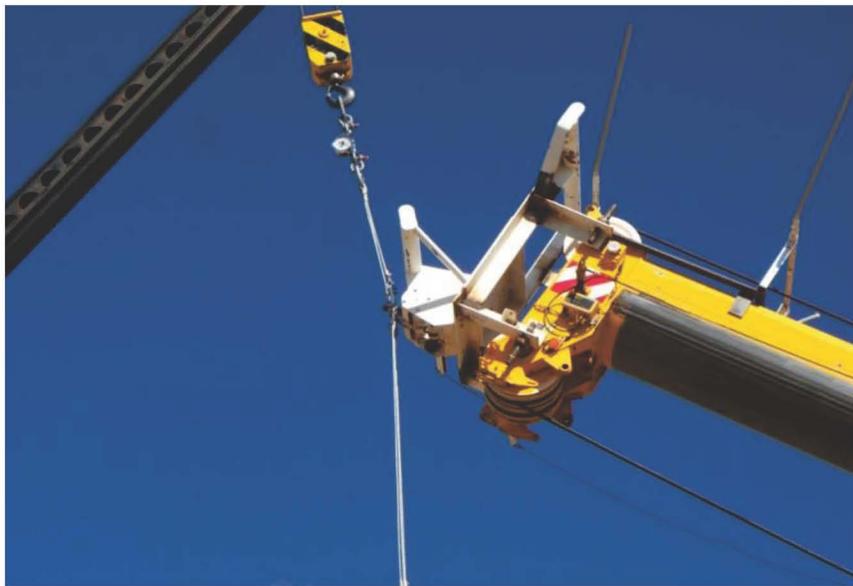
Figure 36. Field Test 2 Configuration

Background—Evidence indicated that there was an attempt to pull the lanyard cable that retracts the release pin during the launch attempt, but the lanyard did not release the pin as expected. This test was designed to determine the approximate lanyard force required to release the pin under loaded conditions. For this test, the balloon loads were simulated by applying loads with a crane through a cable harness and then through the truck plate. The configuration is shown in Figure 36.

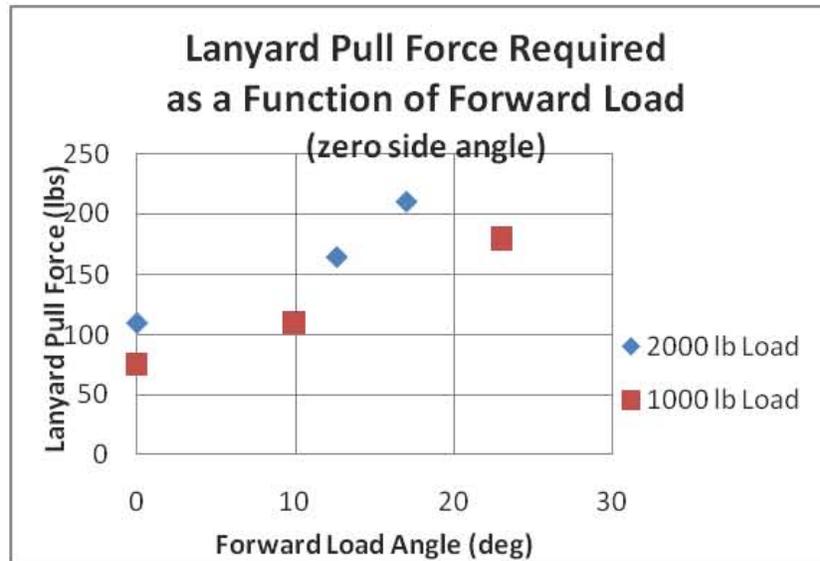
Figure 37. Lanyard Pull Force vs. Truck Plate Loading

ratings for safety, and (2) To keep the required lanyard loads small enough for two people to be able to actuate the release. Loads of approximately 1000 and 2000 lb were applied at forward and side angles of approximately 8 degrees and 15 degrees, including combinations of forward and side angles. The resulting lanyard forces ranged from approximately 100 lb at 1000 lb applied with zero forward and side angles (pulling straight up) to approximately 215 lb at 2000 lb with 15-degree forward angle and 0-degree side angle. Sample data are shown in Figure 37. The full test report is contained in Appendix C-1.

Test Conclusions—The results of this test were generally as anticipated. Increasing loads through the truck plate increased the lanyard pull force. Increasing forward load angle increased the lanyard pull force. Increasing side angle increased the lanyard force only mildly, except for some combined load conditions where the lanyard force appeared to decrease.

Considering that the designed free lift (net lifting force on the launch pin) is about 985 lb, the lanyard force required for a balloon directly overhead would seem reasonable at about 80 pounds (in a no-wind condition). However, the tests indicate that with relatively small forward angles of 10 to 15 degrees (balloon ahead of the launch crane), the lanyard force could rise to 125 to 150 pounds. Adding loads created by the wind on the balloon could easily result in required lanyard pull forces well in excess of 200 pounds.

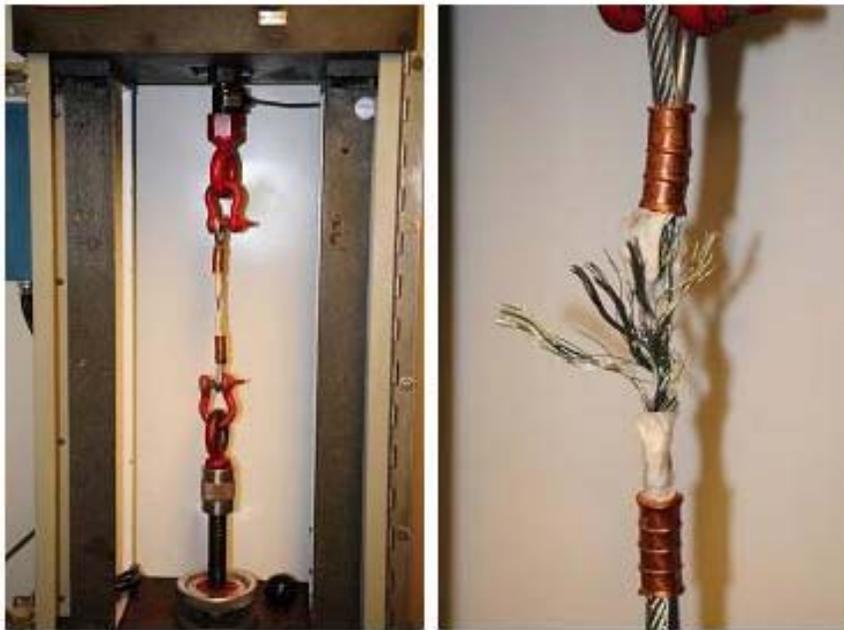
Figure 38: Safety Restraint Cable Strength Test Configuration

Summary of Test—A simple destructive pull test was performed at WFF on safety restraint cable sets similar to those used for the NCT launch attempt to determine the actual break strength of the safety restraint cables. The cable sets were supplied by the CSBF. Two break tests were performed showing the breaking strength to be 8,000 (+/- 20) lb. Figure 38 shows the test setup.

Significance of the Test—Forces in the range of 7,000 pounds (cable specification) to 8,000 pounds (pull test of representative cables) must have existed in order to rupture the restraint cables.

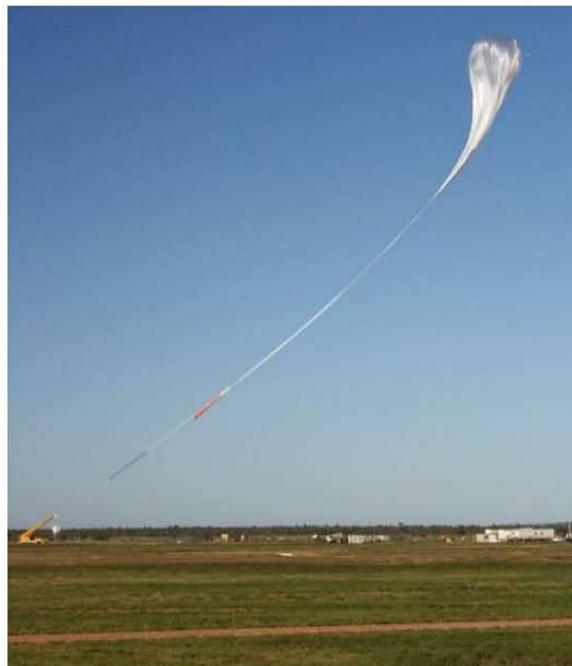
Figure 39. Catenary When Launch Vehicle Arrives at Fence

The system of structural elements and forces produces a complex catenary (the catenary is the characteristic curved shape typically produced by the combination of weight and tension forces on a suspended cable-like structure). The geometry is well represented in Figure 39, which shows the system upon arrival at the Airport fence.

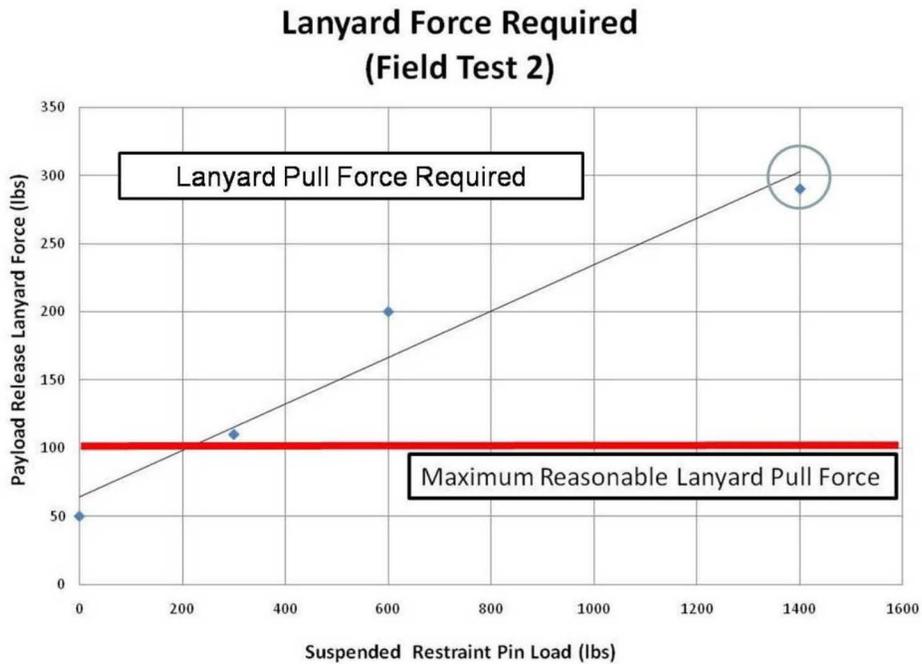
Figure 41. Required Lanyard Pull Force at Time of Launch Attempt

Using the data from Field Test 1, the resulting lanyard pull force would be predicted to be in excess of 300 lb (test data only covered up to 1400 lb suspended). Predicted loads on the launch mechanism and the resulting required lanyard pull force at the time of the launch attempt are shown in Figures 40 and 41.

Using the dynamic analysis and assuming the attempted lanyard actuation was before the vehicle began to slow, the lanyard force would be estimated as low as 200 lb. Therefore it is estimated that at the time of the launch attempts, the predicted lanyard pull force resulting from the balloon and flight train catenary was likely in the range of 200 to 300 lb. The required pull force during the launch

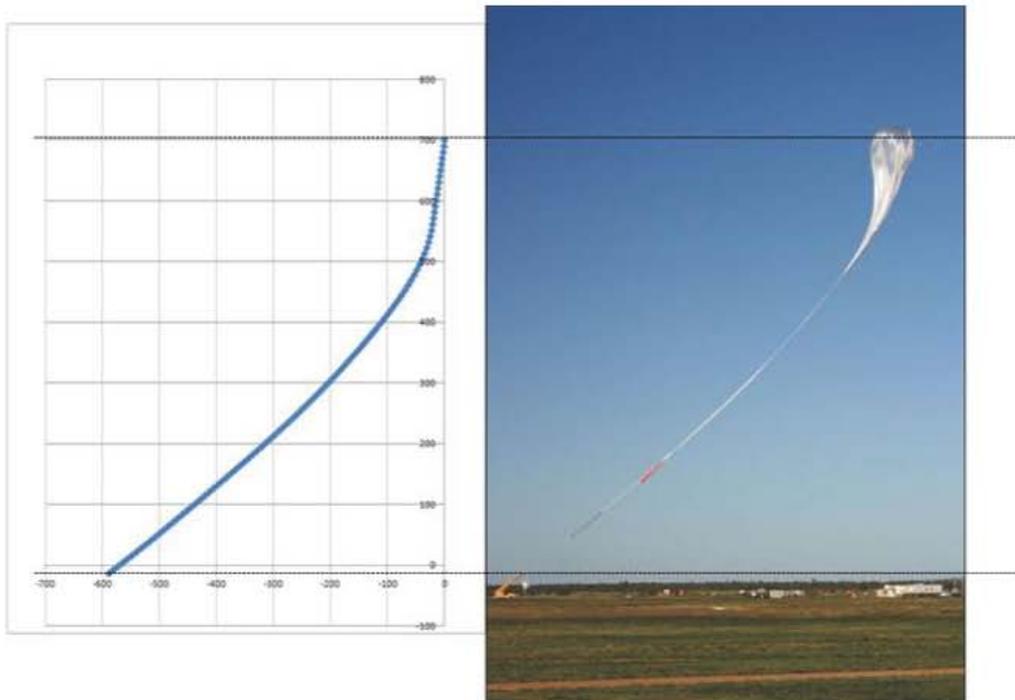
Figure 42. Static Catenary Assessment

The catenary Steady State Equilibrium analysis solution produced a good geometric fit with the photographic evidence as shown in Figure 42 when the launch vehicle was stopped at the Airport fence. The necessary forces at the truck plate to support the system weight and drag through the catenary were calculated to be approximately 9350 lb at approximately 38 degrees from horizontal. The associated horizontal drag force component was approximately 7300 lb.

Those forces are reacted at the launch head pin (this is not the *release* pin). The launch head pin has an operation angle of approximately 25 degrees from the horizontal as determined from photographic evidence. Resolving these applied forces along the launch head pin gives a force along the pin direction of about 9200 lb. Considering the contribution of the payload weight on the bottom of the truck plate leaves a force of approximately 6300 lb transmitted directly to the restraint cable pair, pear ring and release pin. This compares to the specified ultimate load of the restraint cables of 7000 lb each, or 14,000 lb for the pair.

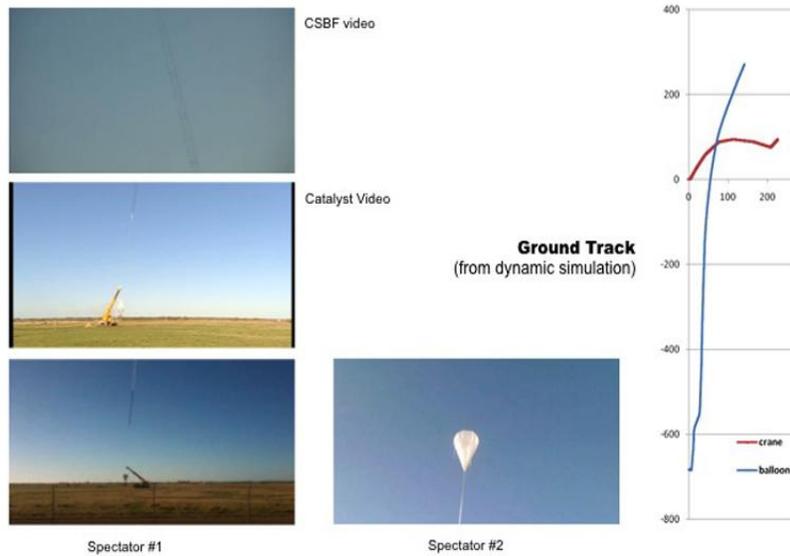
Figure 46. Video Evidence and Ground Tracks for Key Event 27

Key Event 27 PET = 44 seconds
Launch crane turns left after sweeping right turn

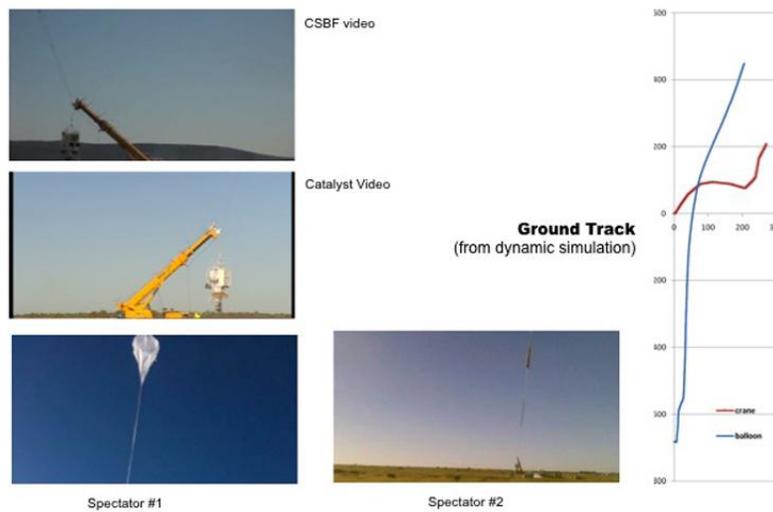
Figure 47: Video Evidence and Ground Tracks for Key Event 30

Key Event 30 PET = 62 seconds
Launch crane slows down due to loss of traction

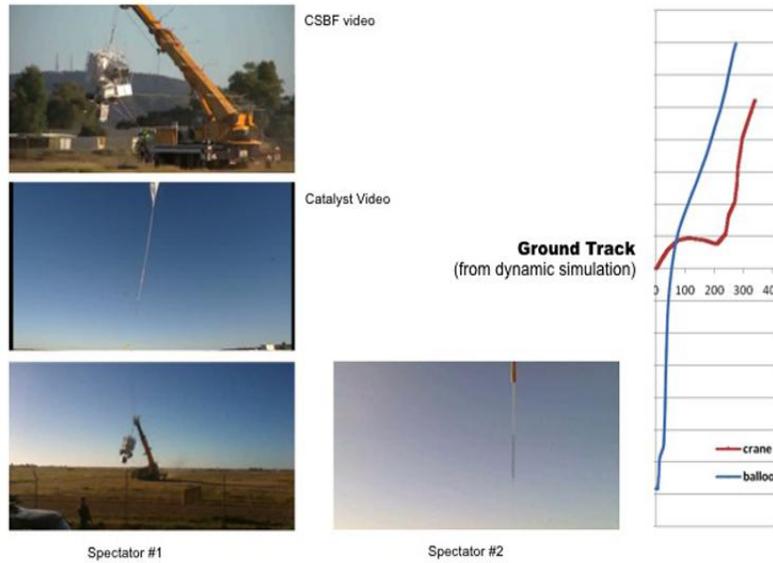
Figure 48. Video Evidence and Ground Tracks for Key Event 34

Key Event 34 PET = 86 seconds Launch crane slows down for launch attempt

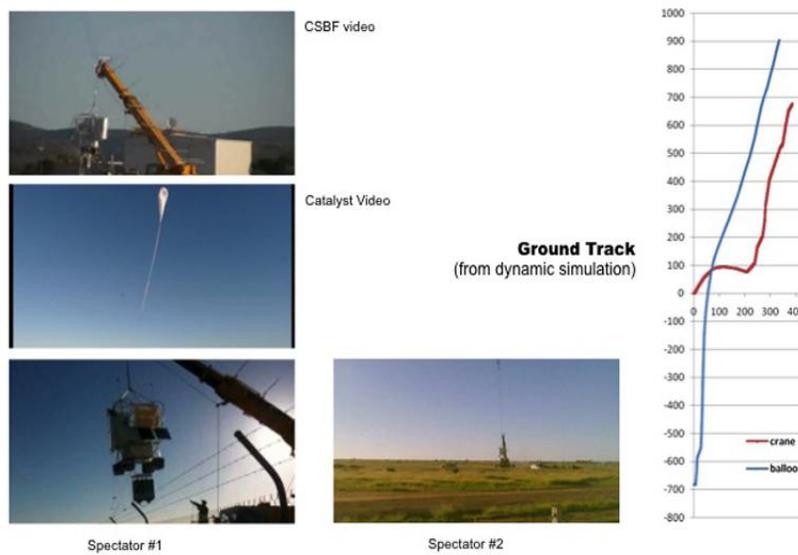
Figure 49. Video Evidence and Ground Tracks for Key Event 39

Key Event 39 PET = 105 seconds Launch crane stops at Airport perimeter fence

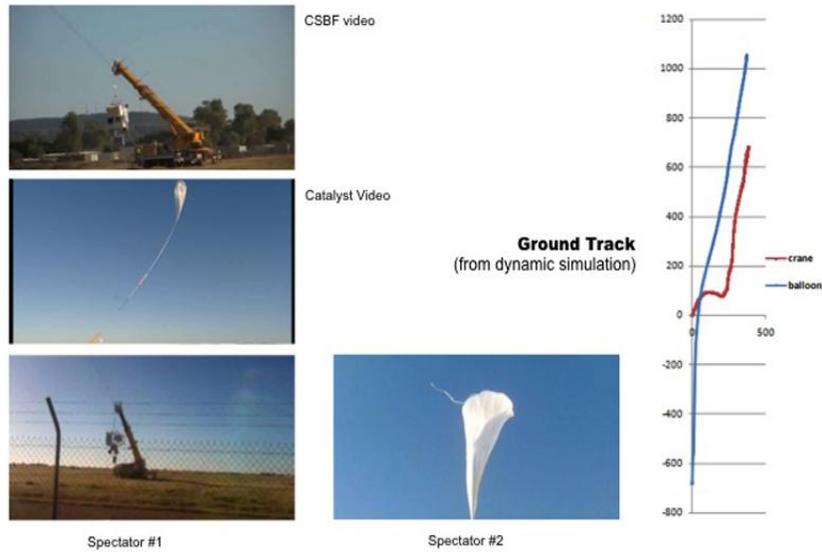
Figure 50. Video Evidence and Ground Tracks for Key Event 43

**Key Event 43 PET = 150 seconds
Launch crane starts left turn after backing up**

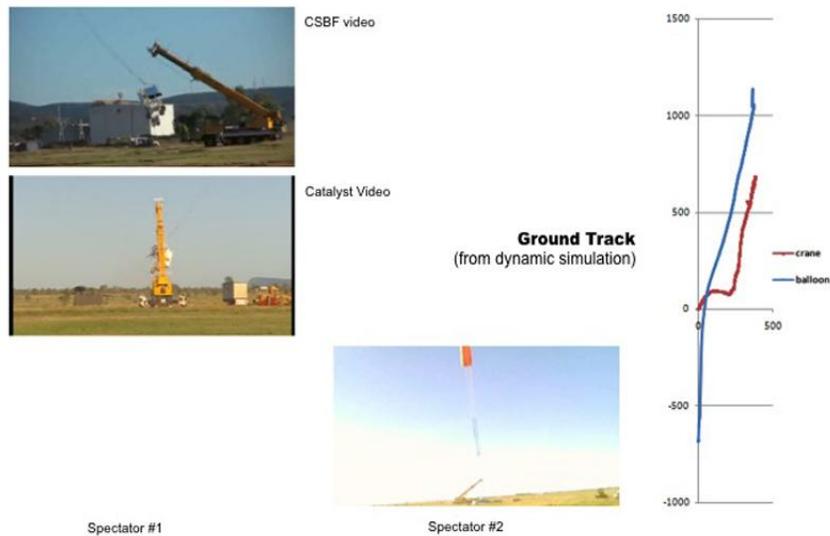
Figure 51. Video Evidence and Ground Tracks for Key Event 45

**Key Event 45 PET = 171 seconds
NCT payload inadvertently separates from launch crane**

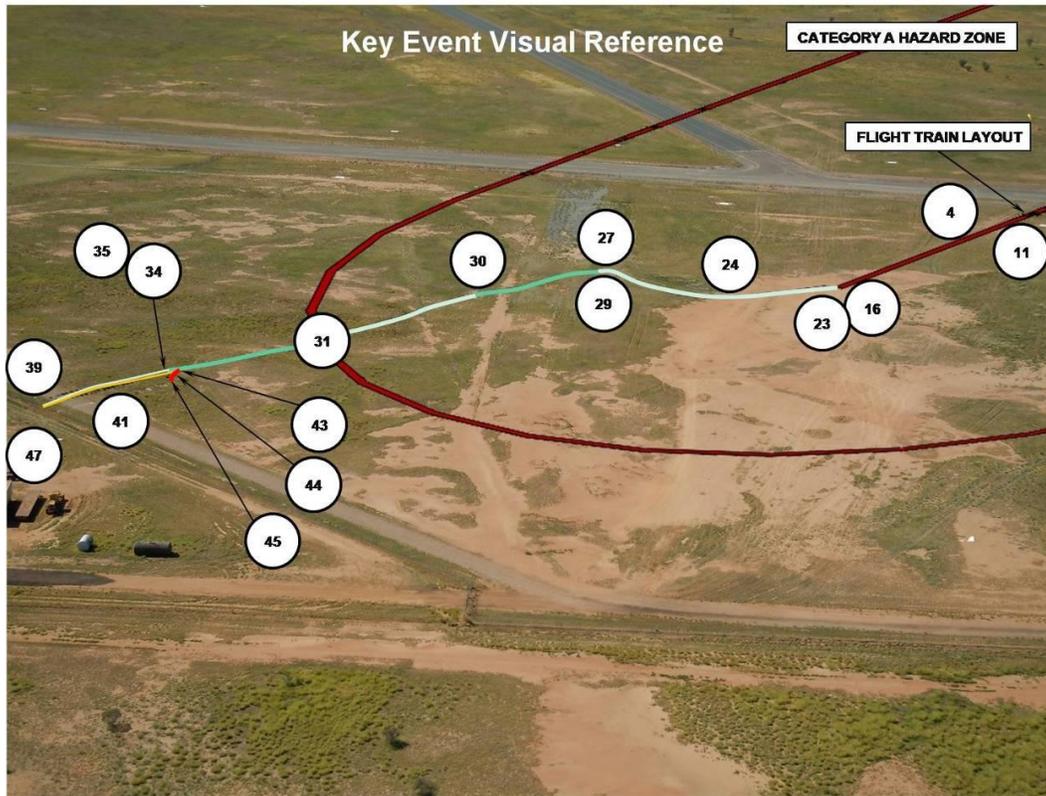
Figure 52. Significant Key Event Visual Reference

While gathering data, the MIB developed and maintained a timeline of the events leading up to the mishap. This timeline initially started with the events immediately prior to the mishap. As the RCA progressed, the time line expanded further back in time to include events that were related to the intermediate causes and the proximate causes. The MIB time-synchronized all six video evidence recordings to help determine the PET of events following spool release. The detailed timeline is shown below in Table 3. Significant key events from this timeline are shown overlaid with the launch vehicle's GPS track in Figure 52.

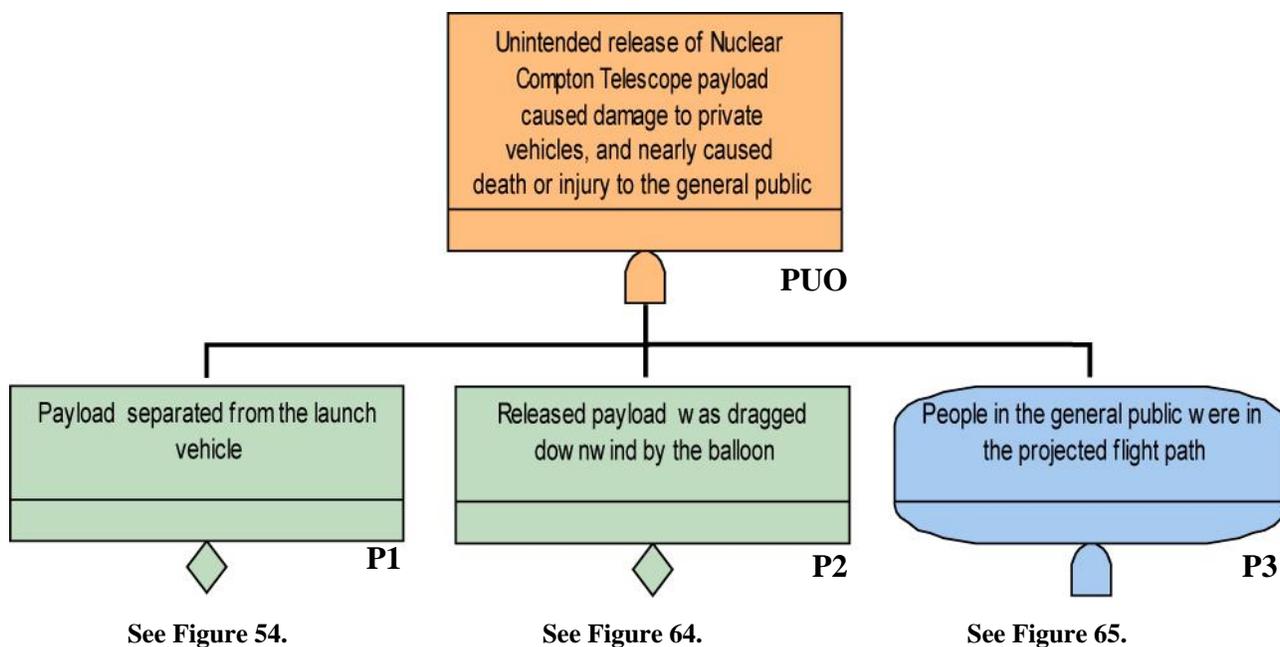
Figure 53. Primary Undesired Outcome and Proximate Causes

The MIB identified three Proximate Causes that resulted in the Primary Undesired Outcome: **Unintended release of Nuclear Compton Telescope payload caused damage to private vehicles, and nearly caused death or injury to the general public (PUO).** Figure 53 shows the Primary Undesired Outcome and Proximate Causes.

The Proximate Causes are the events that occurred, including any condition(s) that existed immediately before the Primary Undesired Outcome that directly resulted in the occurrence of the Primary Undesired Outcome and, if eliminated or modified, would have prevented the Primary Undesired Outcome. These are also known as the direct causes. First, **the payload separated from the launch vehicle (P1)**, then **the released payload was dragged downwind by the balloon (P2)**, and the condition existed that **people in the general public were in the projected flight path (P3).**

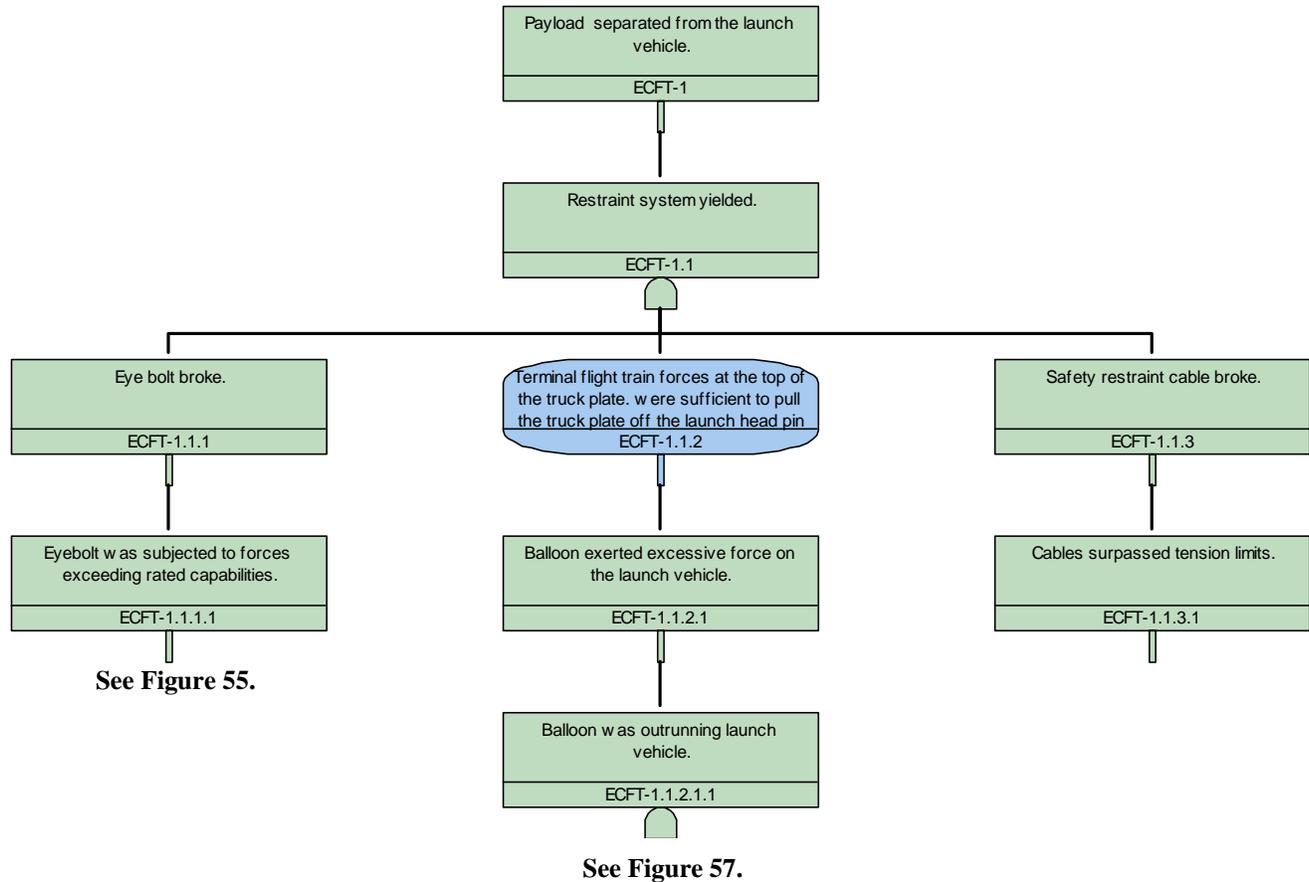
Figure 54. Payload Separated From Launch Vehicle

Per video and witness interview, the payload unexpectedly separated from the launch vehicle after several vehicle maneuvers at Alice Springs Airport. The factors leading to the payload separation are as follows:

1. The balloon exerted excessive force on the launch vehicle. Based on video evidence, the distance (projected on the ground) between the balloon and the launch vehicle caused a significant horizontal force on the launch vehicle.

- a. According to video evidence, the balloon was outrunning the launch vehicle and the challenge to catch it was becoming too great.
- C. Safety restraint cable broke. This was verified by inspection of the impounded hardware. The safety restraint cable was used to secure the payload to the launch vehicle. Based on video evidence, test results and analysis, the board determined that the tension in the cable surpassed the cable’s rated limits and subsequently the cable broke. The causes follow the same line of reasoning for item A. above and will not be repeated in the report.

- B. Balloon exerted excessive force on the launch vehicle. The balloon being significantly ahead of the vehicle caused a large horizontal force on the launch vehicle. This was evident from video and analysis. The logic continues the flow in the middle branch of Figure 54.

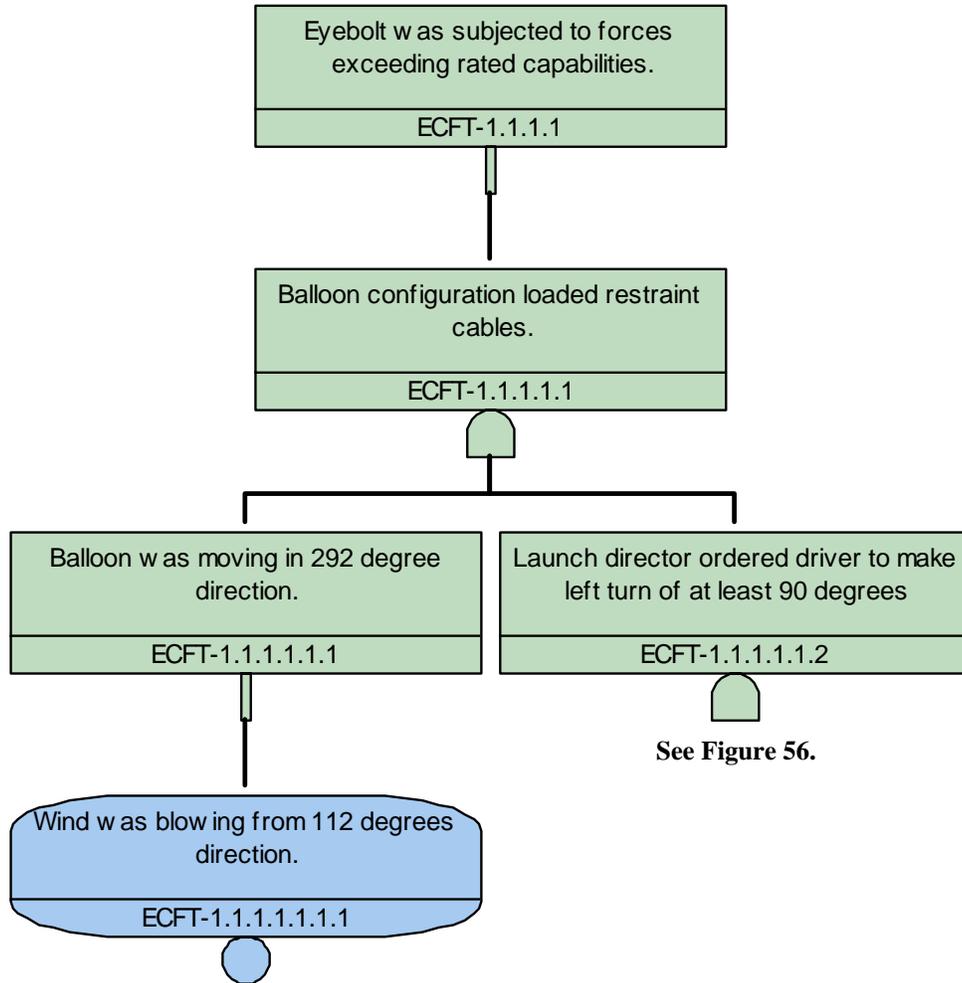
Figure 55. Eyebolt Was Subjected to Forces Exceeding Rated Capabilities

- A. According to video evidence, testing, and analysis, the balloon configuration loaded the restraint cables. The relative position of the balloon to the launch vehicle placed a significant tensile load on the restraint cables that secured the payload to the launch vehicle.
1. According to written meteorology records, the balloon was moving in a 292-degree direction, relative to magnetic north, along with the direction of the wind.
 2. According to video evidence and interview, the launch director ordered the driver to make a left turn of at least 90 degrees. This motion directly opposed the balloon motion, maximizing the stress applied to the system used to secure the payload to the launch vehicle.
 - a. According to meteorology records, the wind was blowing from the 112 degree direction.

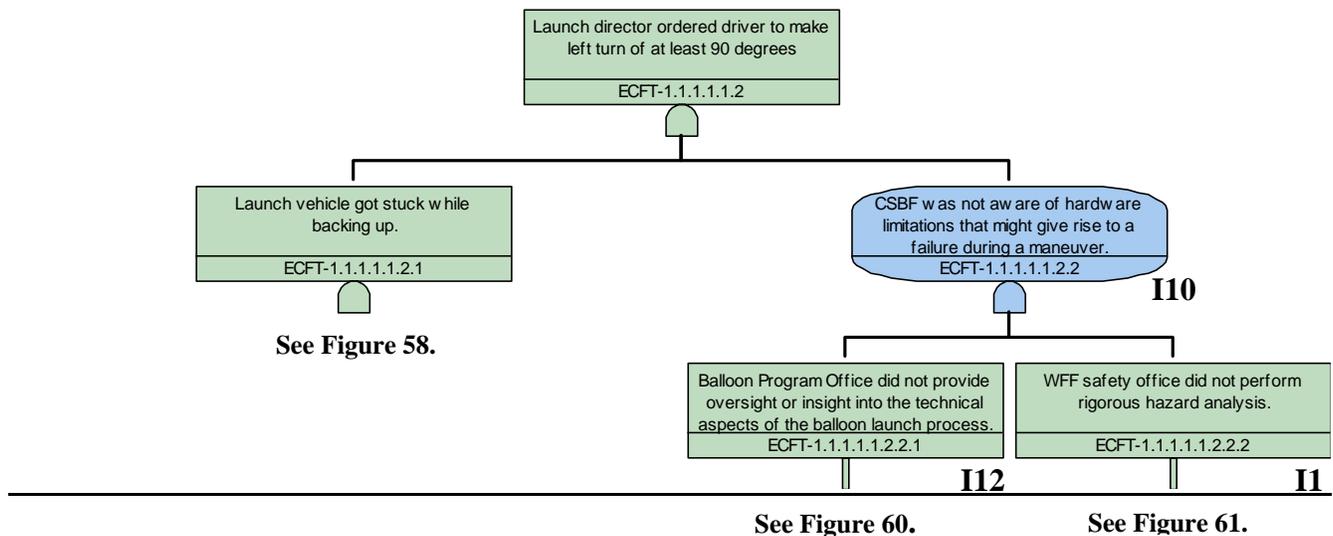
Figure 56. Launch Director Ordered Driver to Make a Left Turn of at Least 90 Degrees

- A. Video evidence and interviews indicated that the launch vehicle got stuck while backing up. The wind and terrain prevented the vehicle from moving a safe distance from the spectators.
- B. Based on interviews and the lack of specific reference in the hardware documentation evidence received by the board, it became apparent that CSBF was not aware of hardware limitations that might give rise to failure during a maneuver. There were no limitations put on what types or durations of maneuvers under what wind or terrain conditions might cause the hardware to exceed its strength limitations. **Intermediate Cause I10**
1. Interview evidence indicated that the BPO did not provide oversight or insight into the technical aspects of the balloon launch process. The technical implementation is left to CSBF through the performance-based contract. **Intermediate Cause I12**

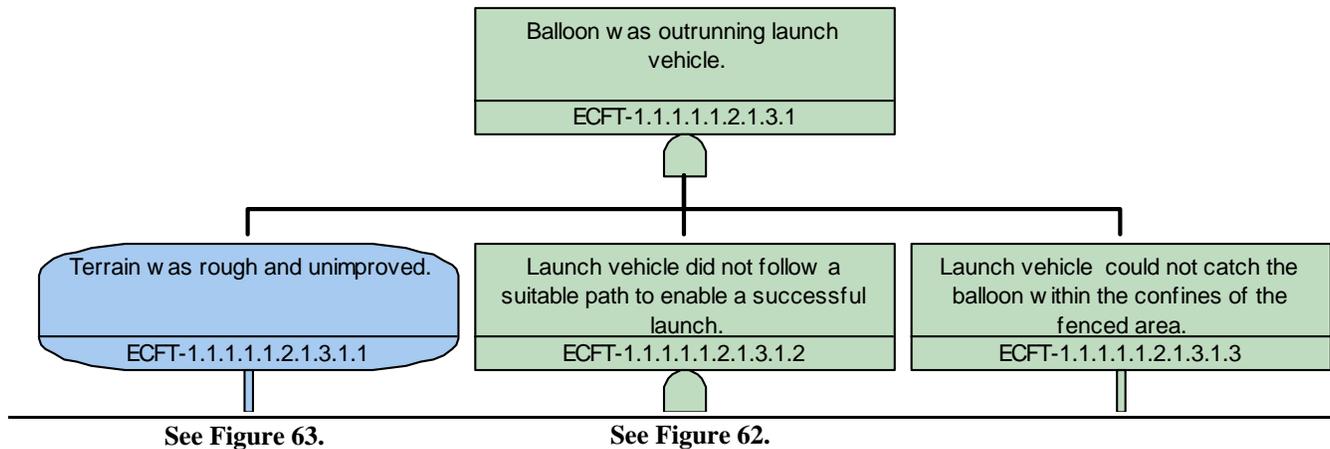
Figure 57. Balloon Was Outrunning the Launch Vehicle

- A. The terrain was rough and unimproved. Interviews and site inspection indicate that the terrain was loose and sandy in spots, not an ideal setting for traction.
- B. The launch vehicle did not follow a suitable path to enable a successful launch. Video evidence indicates that the vehicle took inefficient and, in some cases, overly sharp turns to catch the balloon.
- C. Launch vehicle could not catch the balloon within the confines of the fenced area. This is due to the fact that the flight train layout (direction, in particular) restricted the range of motion for the launch vehicle (block not shown). This is indicated from video evidence.

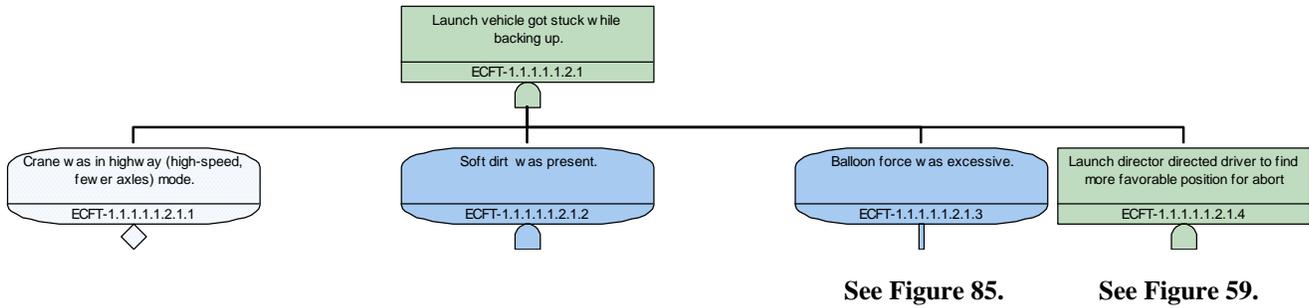
Figure 58. Launch Vehicle Got Stuck While Backing Up

- A. The crane was in highway (high-speed, two-axle) mode, according to information provided from the BPO. This enabled higher speed motion with a better chance to catch the balloon while it was ahead, but there was accordingly less traction when really needed. Strictly speaking, this is a contributing factor, but the fact is that whatever mode the crane was in would have been a contributing factor and there was no determination by the board that any possible mode would have made more of a contribution to this mishap.

- B. Soft dirt was present, based on on-site inspection and interviews. This permitted less traction when there was high tension from the balloon. The rest of this branch is not shown, but the logic leads to a combination of recent rainy weather and Root Cause R6.

- C. Balloon force was excessive. The vehicle could not overcome the force with the traction available. This was based on analysis and simulation.
- D. Launch director directed driver to find more favorable position for abort, based on interview and video evidence. He did not want to abort with people ahead, in-line with the balloon.

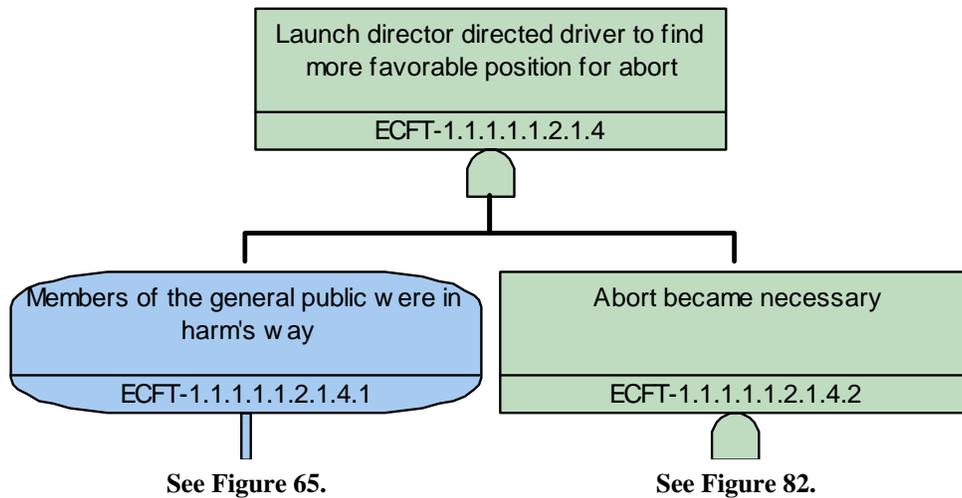
Figure 59. Launch Director Directed Driver to Find a More Favorable Position for Abort

- A. People in the general public were in harm's way. People behind the fence were at risk due to the hazard of falling balloon and flight train hardware.
- B. Abort became necessary. It became clear that based on all of the factors and previous attempts to launch that there would not likely be a chance for successful launch.

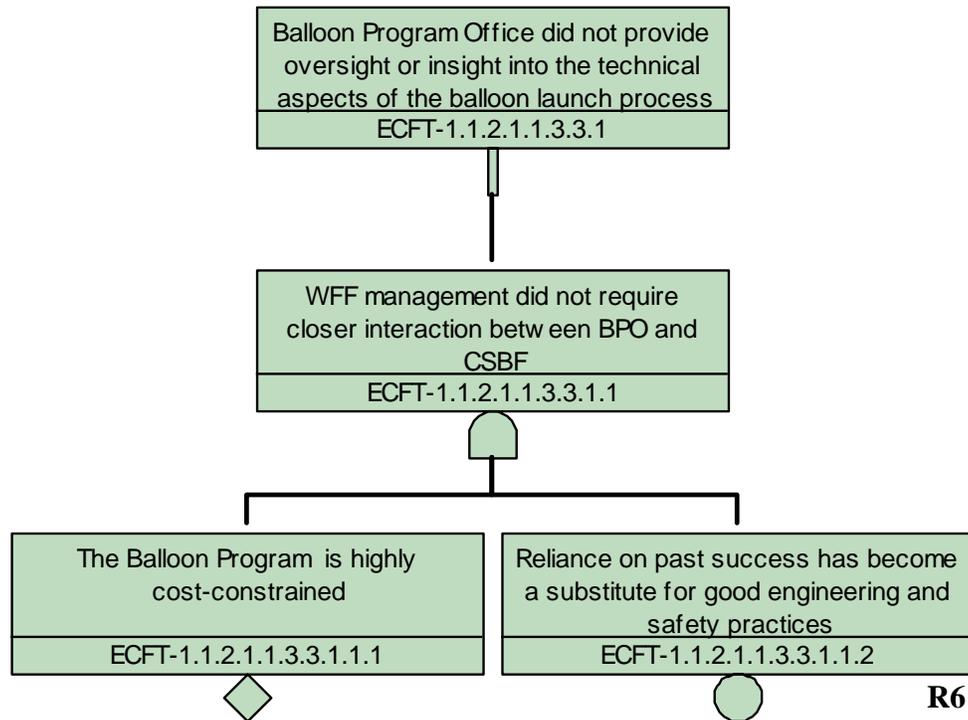
Figure 60. Balloon Program Office Did Not Provide Oversight or Insight Into the Technical Aspects of the Balloon Launch Process

- A. WFF management did not require close interaction between BPO and CSBF. This is evident from interviews.
1. The Balloon Program is highly cost-constrained. Interviews have indicated the perception that too much burden on the balloon program with additional requirements “will kill the balloon program.”
 2. Reliance on past success has become a substitute for good engineering and safety practices. Interviews have indicated a consistent theme that the balloon program success rate has been sufficiently high, so therefore there have not been problems to correct or additional scrutiny required. **Root Cause R6.**

- a. CSBF relied on real-time judgment rather than written procedures. The general approach has been to train the launch crew in a general sense and have them respond to the events with good judgment. This is evident from documentation and interview. The rest of this branch follows with the logic in Figure 60.
- b. CSBF relied on “on-the-job training” rather than written procedures. On-the-job training is used in place of explicit rules and procedures. This is evident from documentation and interview. The rest of this branch follows with the logic in Figure 60.
- c. CSBF has not analyzed the system to establish the acceptable range for launch. There is no evidence that anything but training and visual determination is used to decide when launch can take place. The rest of this branch leads to the same cause as determined from Figure 60.

- A. Training did not provide sufficient guidance to deal with all credible situations during launch. Interviews indicated that there is no specific training element to deal with anomalies or unexpected occurrences. The rest of the branch follows Figure 60.

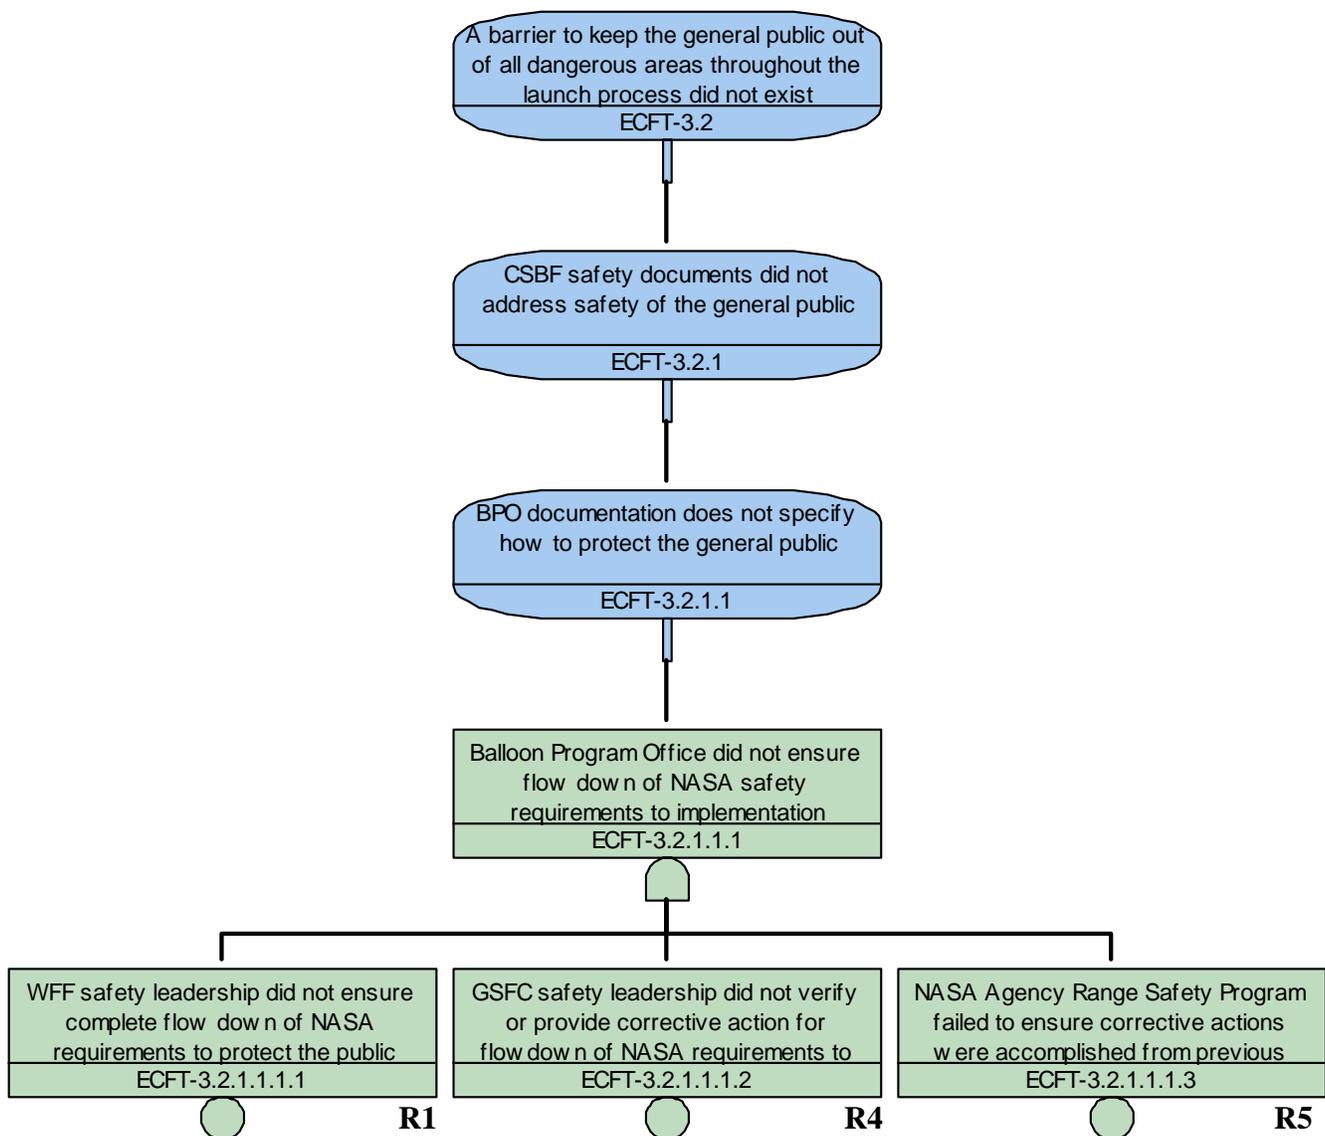
Figure 65. The General Public Was in the Projected Flight Path

An unusual situation occurred in the Balloon mishap at Alice Springs in which people of the general public, namely spectators, were in the projected flight path. The conditions leading to this were in essence a collection of failed or missing (but perhaps expected or perceived) barriers and controls, described as follows. This situation is indicated by video and photographic evidence, and interviews.

- B. There was no barrier in place to keep the general public out of all dangerous areas throughout the launch process. There was free access to a broad area downwind of the balloon to spectators and passers-by on public roads. There was a fence that kept unauthorized personnel out of an area downwind of the balloon but it still allowed people to be present within a hazardous area. This is indicated by video evidence, documentation, interview, and on-site assessment.

- D. The Balloon Ground Safety Plan did not keep people in a safe area as implemented as evidenced by video, documentation, and interview. The ground safety plan identified a set of hazards, but did not identify the actual hazard that was involved in this mishap--that of a heavy payload with high potential and mechanical energy. The plan defined a hazard zone, but it was not clear whether the zone was fixed or moving. There were no markings for the zone; the crew identified the boundaries by landmarks in the terrain. There was nothing to prevent the launch vehicle or targets from breaching the zone and nothing to indicate when the zone would be breached. If the zone were moving, there would be no practical way to use it as a barrier. If the zone were fixed, the size wasn't sufficient to cover the actual hazard area.
