RELEASE : 10-269

NASA Releases Report About Australia Balloon Mishap

The Nuclear Compton Telescope Balloon Launch Mishap Investigation Board was established on May 12, 2010, in accordance with NPR 8621.1, "NASA Procedural Requirements for Mishap and Close Call Reporting, Investigating, and Recordkeeping." The Investigating Authority was appointed to obtain and analyze evidence and facts; conduct necessary testing; impound property, equipment, and records; identify the causal and contributing factors relating to the mishap; and to recommend appropriate actions to prevent a similar mishap from recurring.

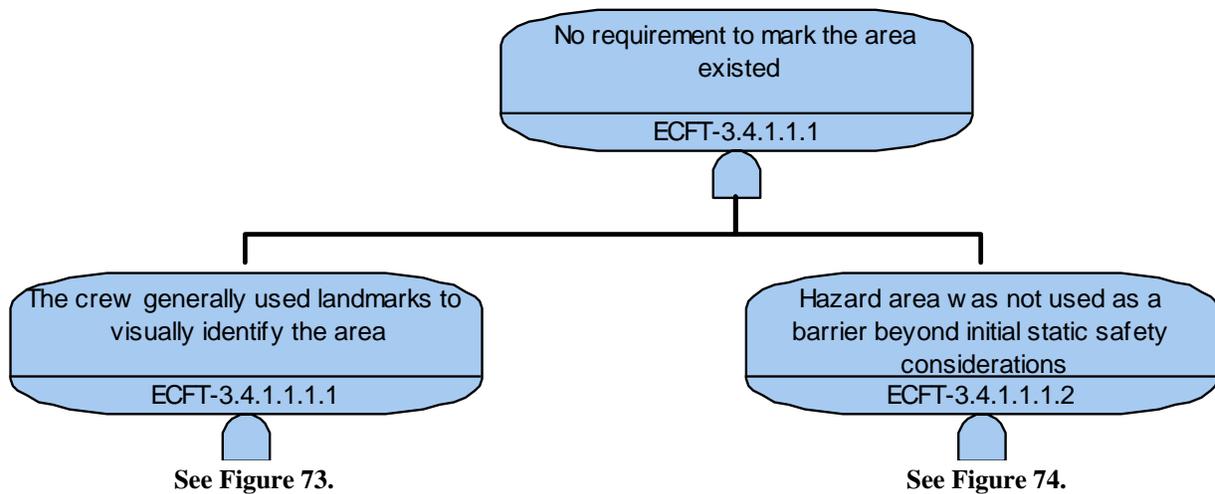
Figure 71. The Category a Hazard Area Did Not Keep People in a Safe Area as Implemented

- A. The Category A Hazard Area was not well-defined. There are several different interpretations of the area within the BPO and CSBF. This was evident from review of documentation.

1. No requirement to mark the area existed, based on review of documentation. Henceforth, there was no way for anyone to tell when it was close to being breached.
2. No distinction is made as to whether the zone is fixed or moving, as indicated from documentation. The definition of the zone would tend to lean towards it being a moving area, but a moving area would not be implementable. A fixed area would be insufficient to cover the most relevant hazards during launch. The BPO believes the zone to be moving while CSBF believes the zone to be fixed.

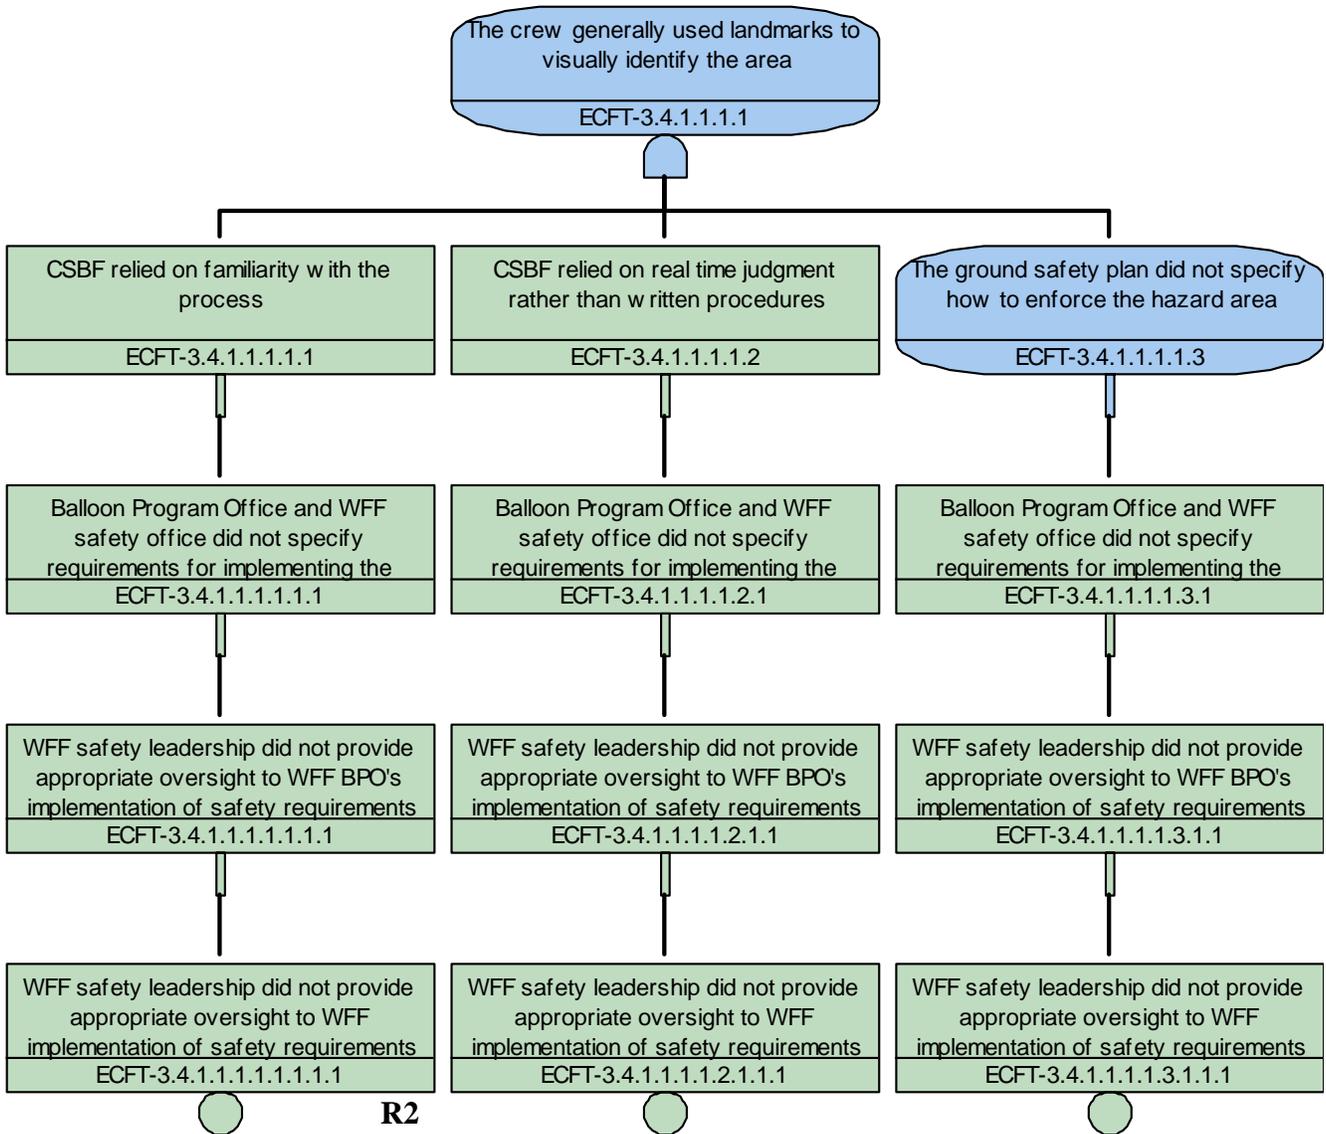
Figure 72. No Requirement to Mark the Area Existed

- A. The crew generally used landmarks to visually identify the area. Interviews indicate that during set up for launch the crew would loosely walk off the hazard area and take mental note of identifying features at the edges of the zone.
- B. The hazard area was not used as a barrier beyond initial static safety considerations. There is no evidence that there is any consideration of the Category A Hazard Area once the launch vehicle begins to move.

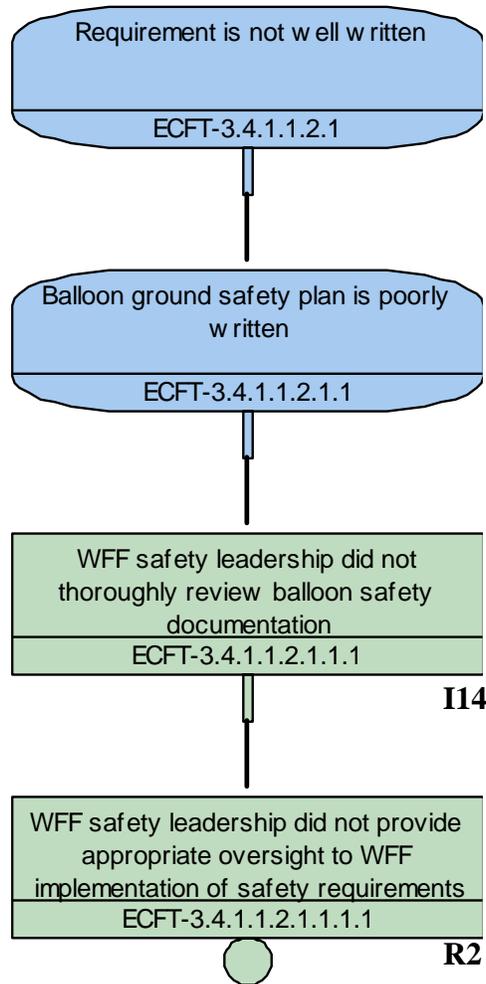
Figure 75. No Distinction Is Made as to Whether the Zone Is Fixed or Moving

- A. The requirement is not well-written. There is no specific discussion about what happens when the vehicle moves or how one would determine whether the zone is breached in practice. This is evident from review of the Ground Safety Plan.
- B. The crew doesn't generally rely on written procedures, according to documentation and interviews. Training and experience are the primary means to successfully launch balloons.

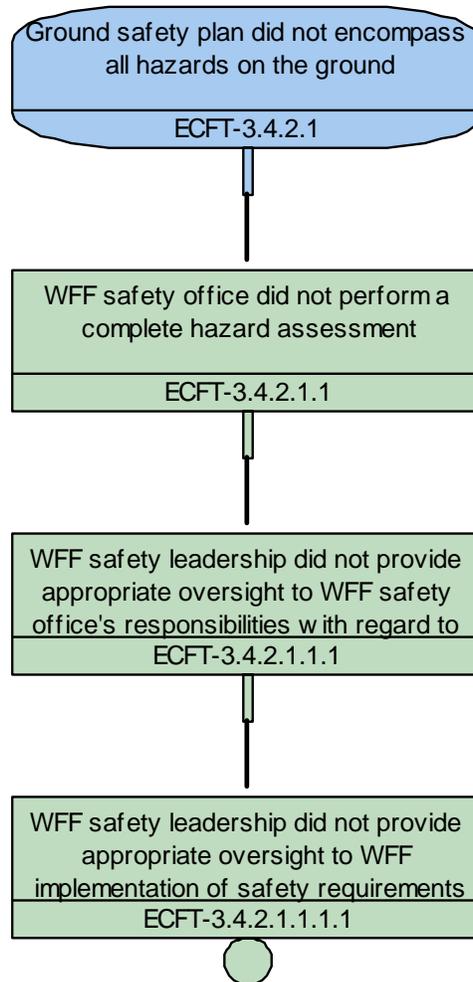
Figure 79. The Ground Safety Plan Did Not Encompass All Hazards on the Ground

- A. WFF Safety Office did not perform a complete hazard assessment. The WFF Safety Office is responsible, according to RSM 2002 Rev B, for developing the ground safety plan. This plan includes the only reference in the balloon safety documentation to hazards during ground operations. Only a subset of the actual hazards during ground operations is indicated and no full hazard analysis exists.
1. WFF safety leadership did not provide appropriate oversight to WFF Safety Office's responsibilities with regard to the balloon program. The safety leadership at WFF fully delegated responsibilities that had full bearing on safety of the public to the WFF Safety Office without any indication of audit or review of all aspects of safety. The remainder of the logic flow is as in several previously-described branches.

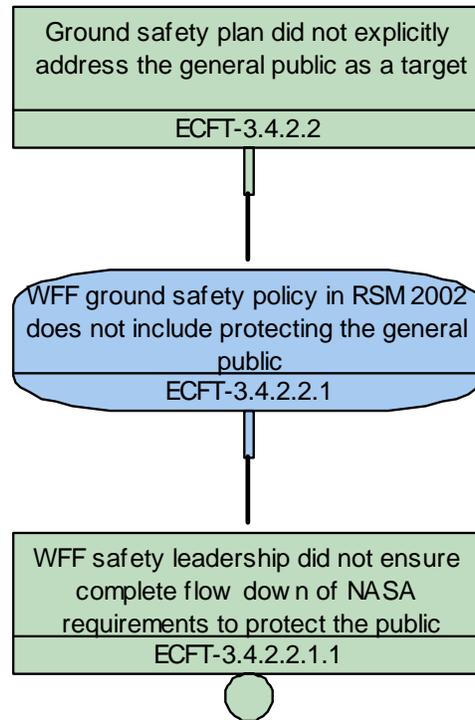
Figure 80. The Ground Safety Plan Did Not Explicitly Address the General Public as a Target

- A. WFF ground safety policy in RSM 2002 (Rev B) does not include protecting the general public. Dangers to the general public during ground operations were not understood or acknowledged.
1. WFF safety leadership did not ensure complete flow down of NASA requirements to protect the public. RSM 2002 does not account for hazards to the general public during ground operations and protection of the public is not addressed in the CSBF documentation.

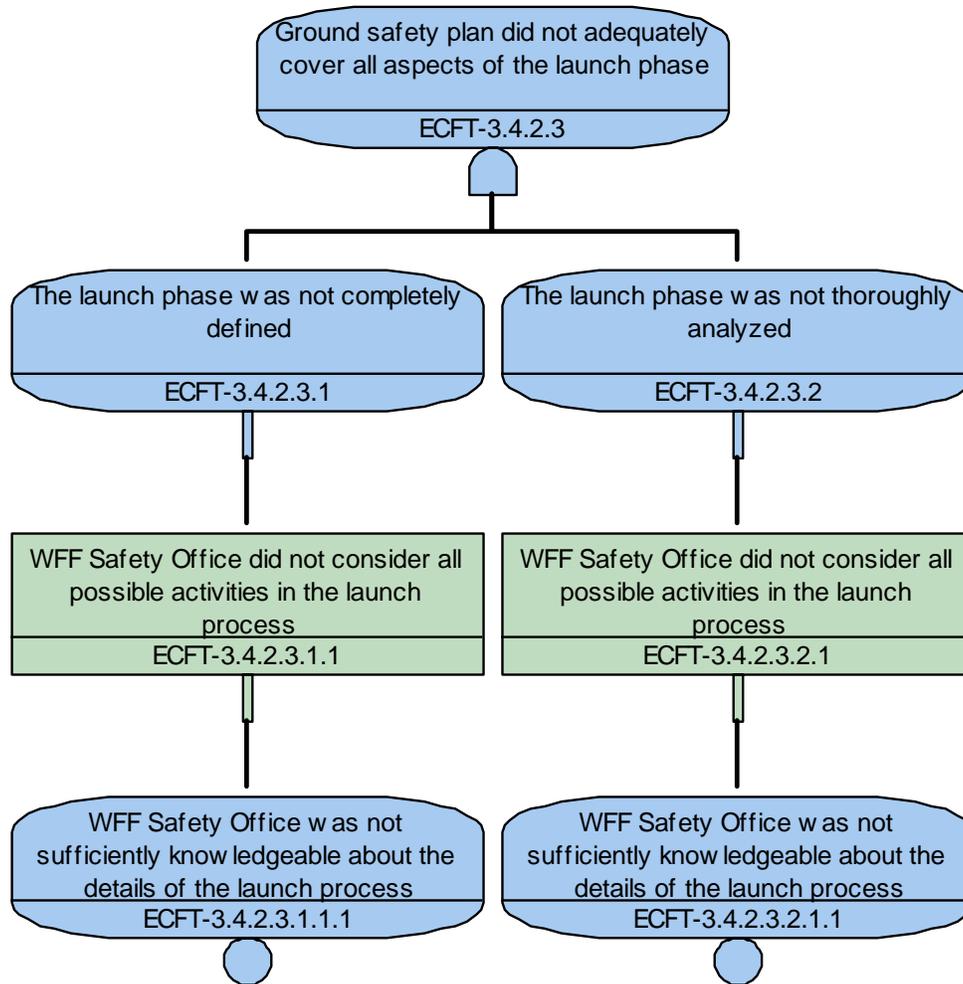
Figure 81. The Ground Safety Plan Did Not Adequately Cover All Aspects of the Launch Phase

- A. The launch phase was not completely defined. The process of moving the launch vehicle to chase the balloon, aligning the launch vehicle with the balloon, and attempting launch is not expressed in the Ground Safety Plan’s description of the launch phase. This is indicated in documentation.

- a. WFF Safety Office was not sufficiently knowledgeable about the details of the launch process. In particular, hazards to the public were not identified in the ground safety plan.

- B. The launch phase was not thoroughly analyzed. Key hazardous elements of launch operations were not addressed for the process of chasing the balloon to attempt launch. This was evident from review of the Ground Safety Plan. The remainder of the logic follows as in item A.

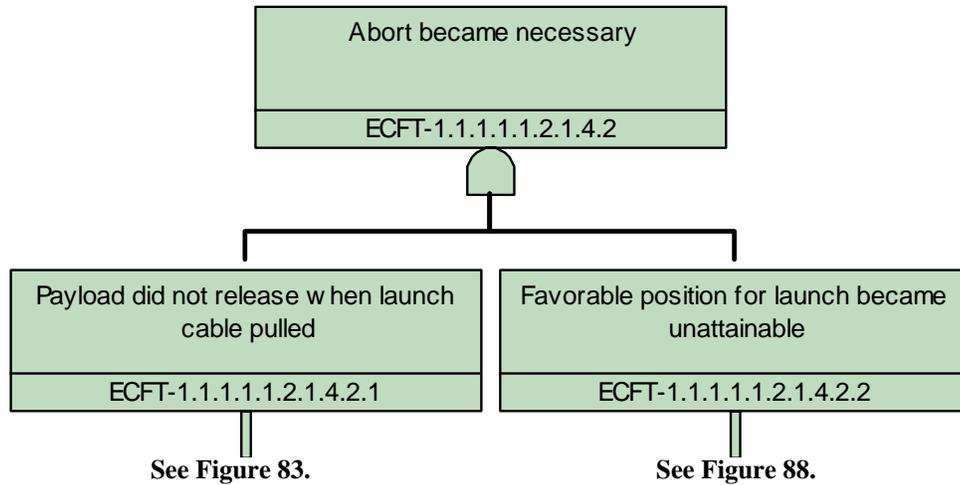
Figure 82. Abort Became Necessary

- A. Payload did not release when launch cable pulled. The pull force was insufficient to move the pin back from the pear ring and hence the payload remained attached to the launch vehicle. This was evident from video, test, and analysis.
 - B. Favorable position for launch became unattainable. With limited space based on the fence and the spectators, the balloon became too far offset from an appropriate position above the launch vehicle to ever be able to reach a position where launch would be feasible. This was evident from video and analysis.
-

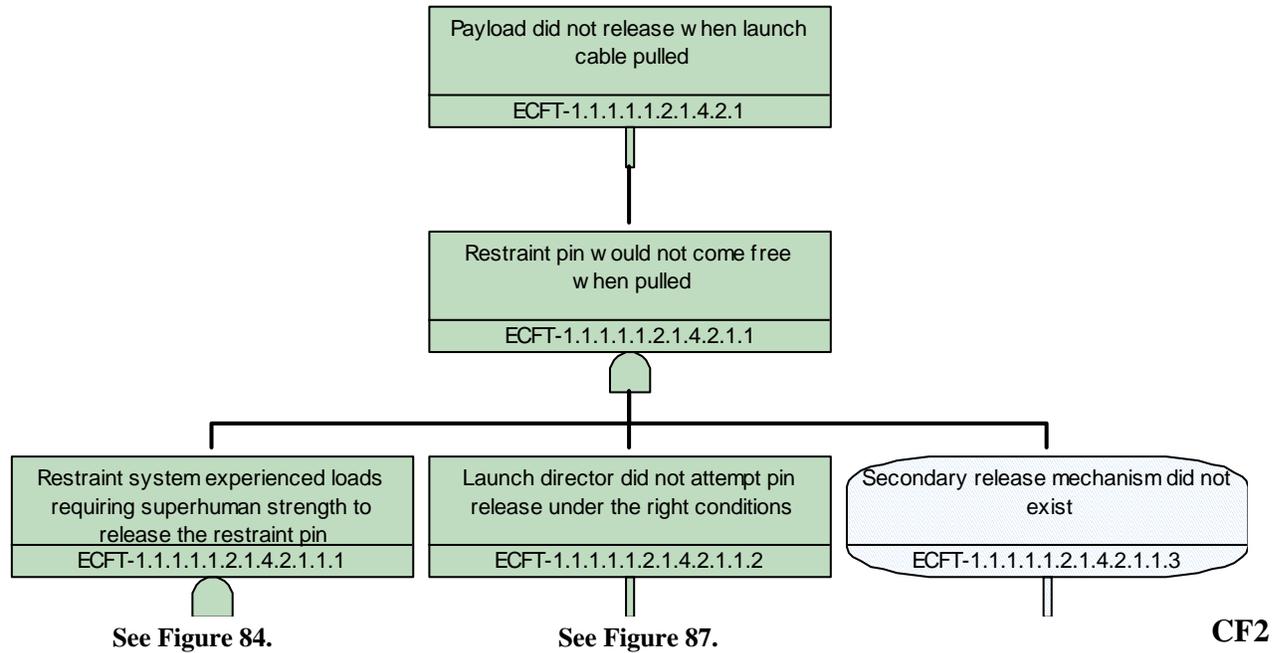
Figure 83. Payload Did Not Release When Launch Cable Was Pulled

- A. Restraint pin would not come free when pulled. The combined friction and spring force was higher than the force resolved at the pin from pulling the lanyard, according to video, analysis, and test.

2. Launch director did not attempt pin release under the right conditions. The angle of the balloon relative to the vertical from above the launch vehicle was too great, causing a significant shear force on the pin, resulting in a significant friction force, preventing its release. This was indicated from analysis.

3. A secondary release mechanism did not exist. Had there been a secondary mechanism that was not subject to the shear and friction force combination that limited the launch director's ability to release the pin, the payload may have released successfully. Analysis shows that the catenary angle, while large, would not likely have caused the payload to pendulum down and hit the ground upon launch. **Contributing Factor 2.** This leads to root cause R6 in the next block and is not shown again here.

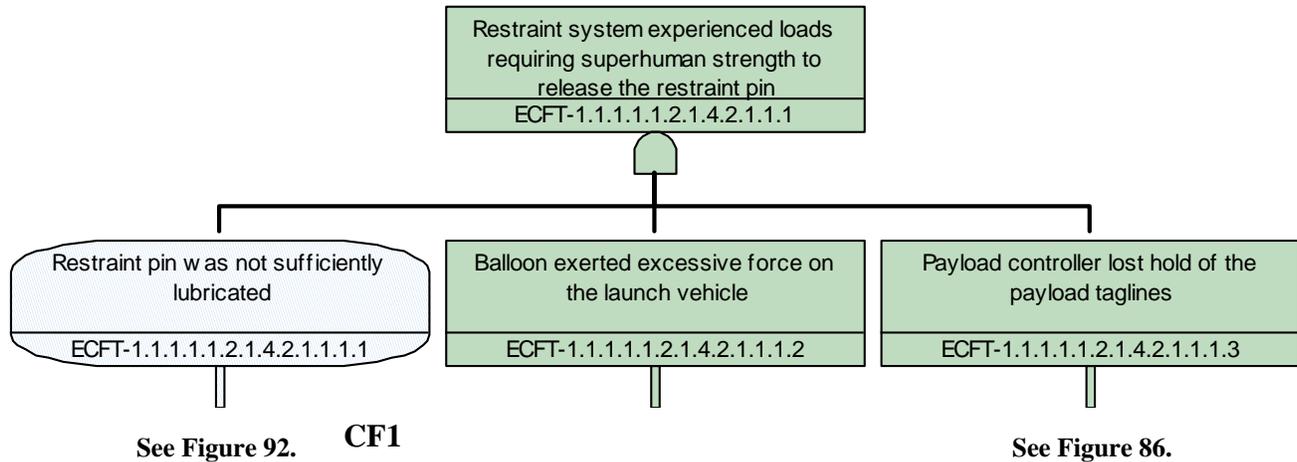
Figure 84. Release Mechanism Experienced Loads Requiring Superhuman Forces to Enable Release

- A. Restraint pin was not sufficiently lubricated. While there is no evidence of requirements to lubricate the pin, without lubricant, the amount of friction force due to shear force imparted by horizontal motion or pull of the balloon can be arbitrary, and require a tremendous force to overcome. This was evident from analysis. **Contributing Factor 1.**

- B. Balloon exerted excessive force on the launch vehicle. The balloon being significantly ahead of the vehicle caused a large horizontal force on the launch vehicle. This was evident from video and analysis. The logic continues the flow in the middle branch of Figure 54.

- C. Payload controller (aka the payload launch assistant) lost hold of the taglines. When the straps used to stabilize the payload during launch were lost, it created a dynamic load on the launch mechanism adding to the force on the pin that the launch director would have to overcome for successful launch. This was evident from video and analysis.

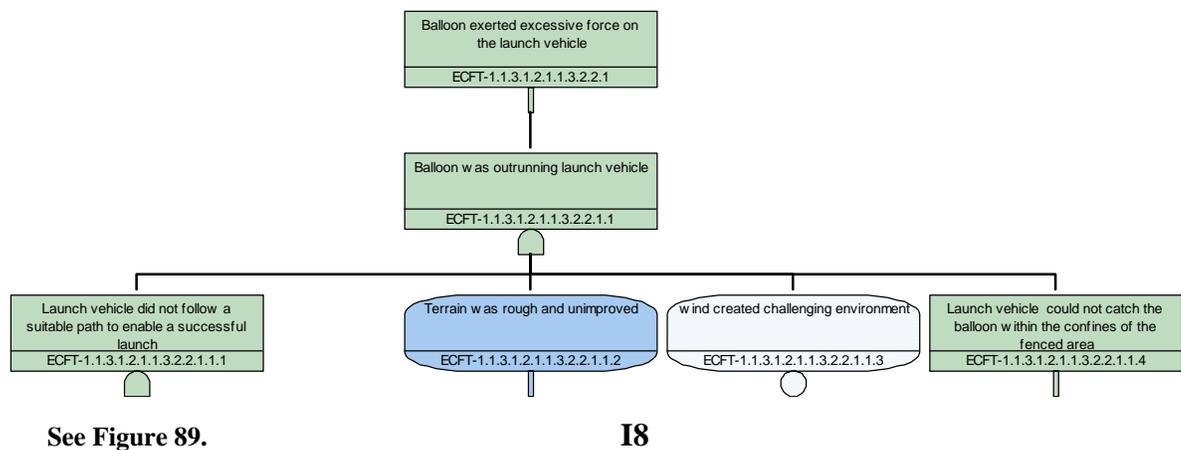
Figure 85. Balloon Exerted Excessive Force on the Launch Vehicle

- A. The balloon was outrunning the launch vehicle. The balloon was ahead and getting further ahead and more and more challenging to catch.
1. Launch vehicle did not follow a suitable path to enable a successful launch. Some of the turns taken by the launch vehicle caused the vehicle to lose ground on catching the balloon. This is evident from interviews and video.
 2. Terrain was rough and unimproved. Logic in Figure 63 follows and is not repeated here.
Intermediate Cause I8.
 3. The launch vehicle could not catch the balloon within the confines of the fenced area. The combination of speed limitations of the crane and the limited travel range of the vehicle due to the layout of the flight train and limited area prevented the launch vehicle from being able to catch the balloon (block not shown). This is evident from videos and documentation.

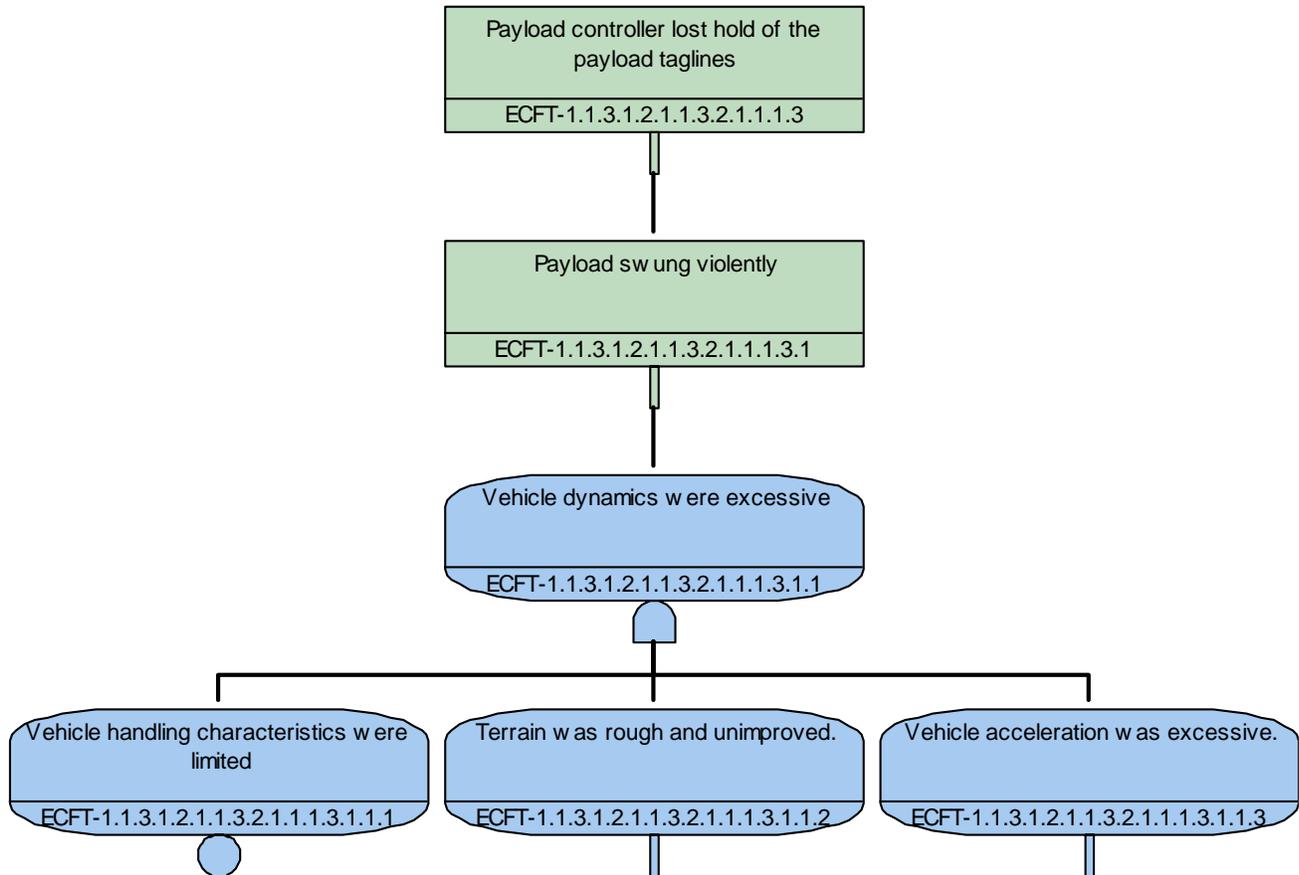
Figure 86. Payload Controller Lost Hold of the Taglines

- A. The payload swung violently, as observed in video evidence. This caused additional stresses on the hardware and made it more difficult to successfully release the payload from the vehicle.
1. Vehicle dynamics were excessive. Motions of the vehicle were imparting into the payload, as apparent from video evidence.
 - a. Vehicle handling characteristics were limited. There was, expectedly, a finite amount of speed, shock absorption, and lateral control capability.
 - b. Terrain was rough and unimproved. (See Figure 63.)
 - c. Vehicle acceleration was excessive. Specifically the deceleration due to a sudden stop caused a jolt, as evident from the video. The sudden stop was in order to make a launch attempt (block not shown).

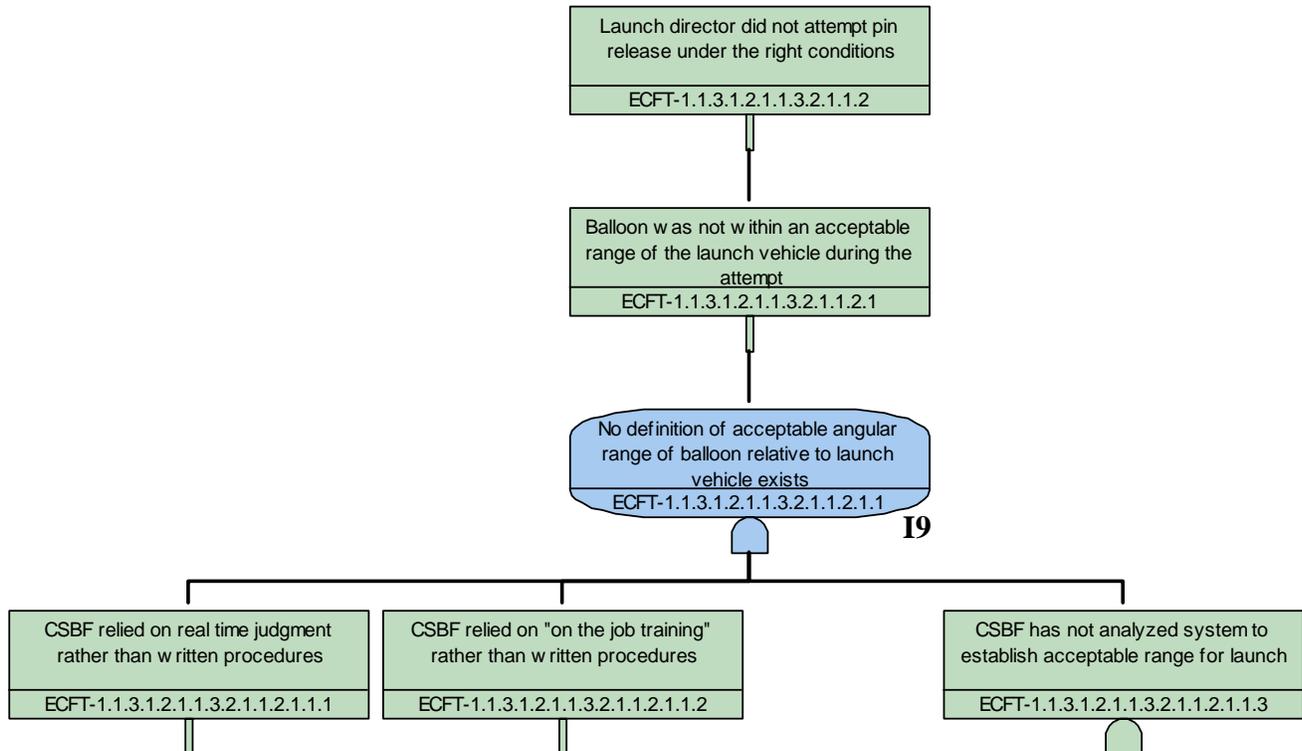
Figure 87. Launch Director Did Not Attempt Release Under the Right Conditions

A. Balloon was not within an acceptable range of the launch vehicle during the attempt. Analysis and test showed that the large angle with the vertical caused a significant shear force and hence friction force, which ultimately prevented the pin from releasing.

- a. CSBF relied on real-time judgment rather than written procedures. The general approach has been to train the launch crew in a general sense and have them respond to the events with good judgment. This is evident from documentation and interview. The rest of this branch follows with the logic in Figure 60.
- b. CSBF relied on “on-the-job training” rather than written procedures. On-the-job training is used in place of explicit rules and procedures. This is evident from documentation and interview. The rest of this branch follows with the logic in Figure 60.
- c. CSBF has not analyzed the system to establish the acceptable range for launch. There is no evidence that anything but training and visual determination is used to decide when launch can take place. The rest of this branch leads to the same cause as determined from Figure 60.

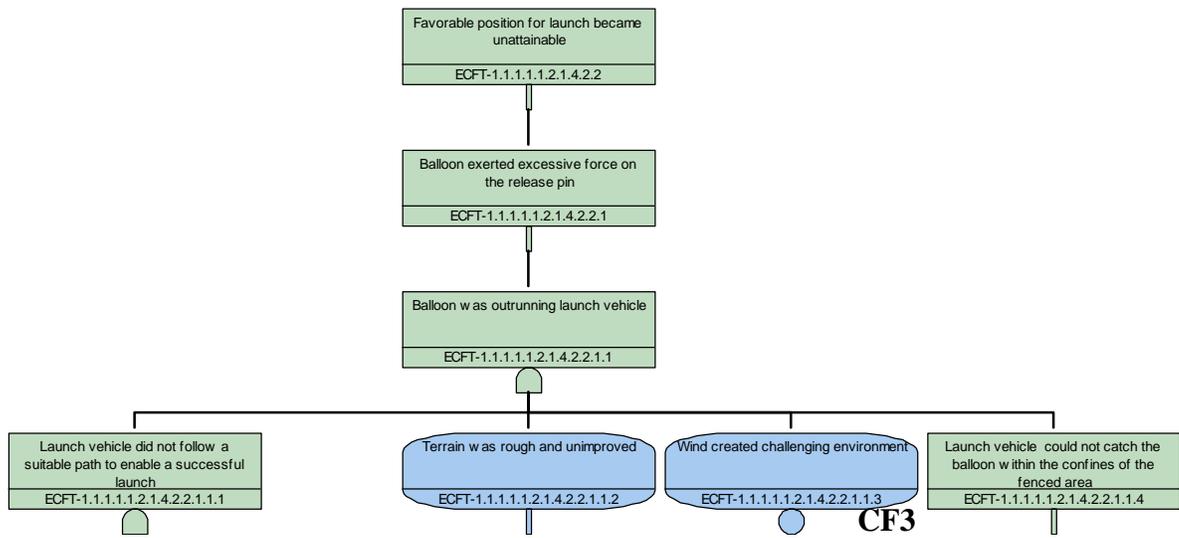
Figure 88. A Favorable Position for Launch Became Unattainable

- A. Balloon exerted excessive force on the launch vehicle. This branch follows essentially the same logic path as that in Figure 84, with the addition of the “wind created challenging environment” block. Although the wind was not greater than allowable specifications, according to interview, it was strong enough to make the process of catching the balloon more challenging (**Contributing Factor 3**).

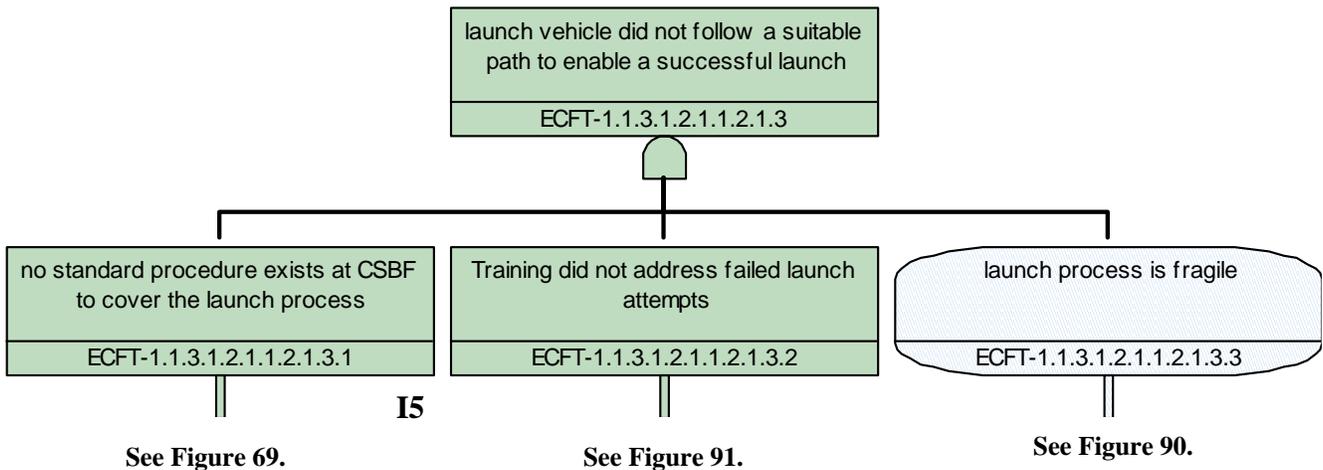
Figure 89. Launch Vehicle Did Not Follow a Suitable Path to Enable a Successful Launch

- A. No standard procedure exists at CSBF to cover the launch process. Given that the launch process is a hazardous operation, the contract with CSBF requires written procedures. This is evident from interview and documentation. **Intermediate Cause I5**

- B. Training did not address failed launch attempts. In particular, there is insufficient guidance for dealing with any anomalous or contingency situations. This is evident from interview and documentation. **Intermediate Cause I6**
- C. The launch process is fragile. Without explicit procedures and due to the dependency on visual assessment and good judgment, the launch process is highly sensitive to errors in judgment, perception, and visualization. This is evident from interview and documentation. **Contributing Factor 4**

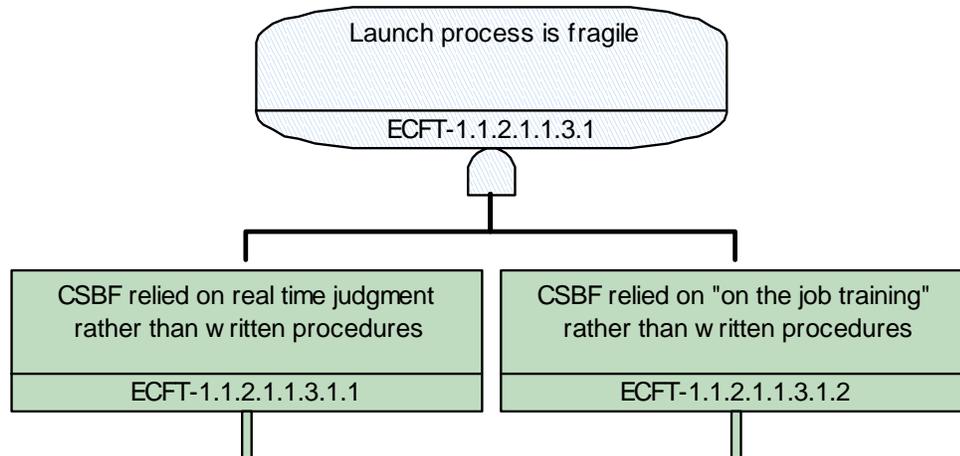
Figure 90. The Launch Process Is Fragile

- A. CSBF relied on real-time judgment rather than written procedures. Interview and documentation review indicate that the process of launching the balloon is not something that is written down, but rather is something of an art based on the observation of the surroundings and some general, unwritten guidelines. This block next leads to Root Cause R6: Reliance on past success has become a substitute for good engineering and safety practices.
- B. CSBF relied on “on-the-job training” rather than written procedures. Interview and documentation review indicate that on-the-job training is the means for conveying the process of launching the balloon, rather than writing down a procedure. This block next leads to Root Cause R6 as well.

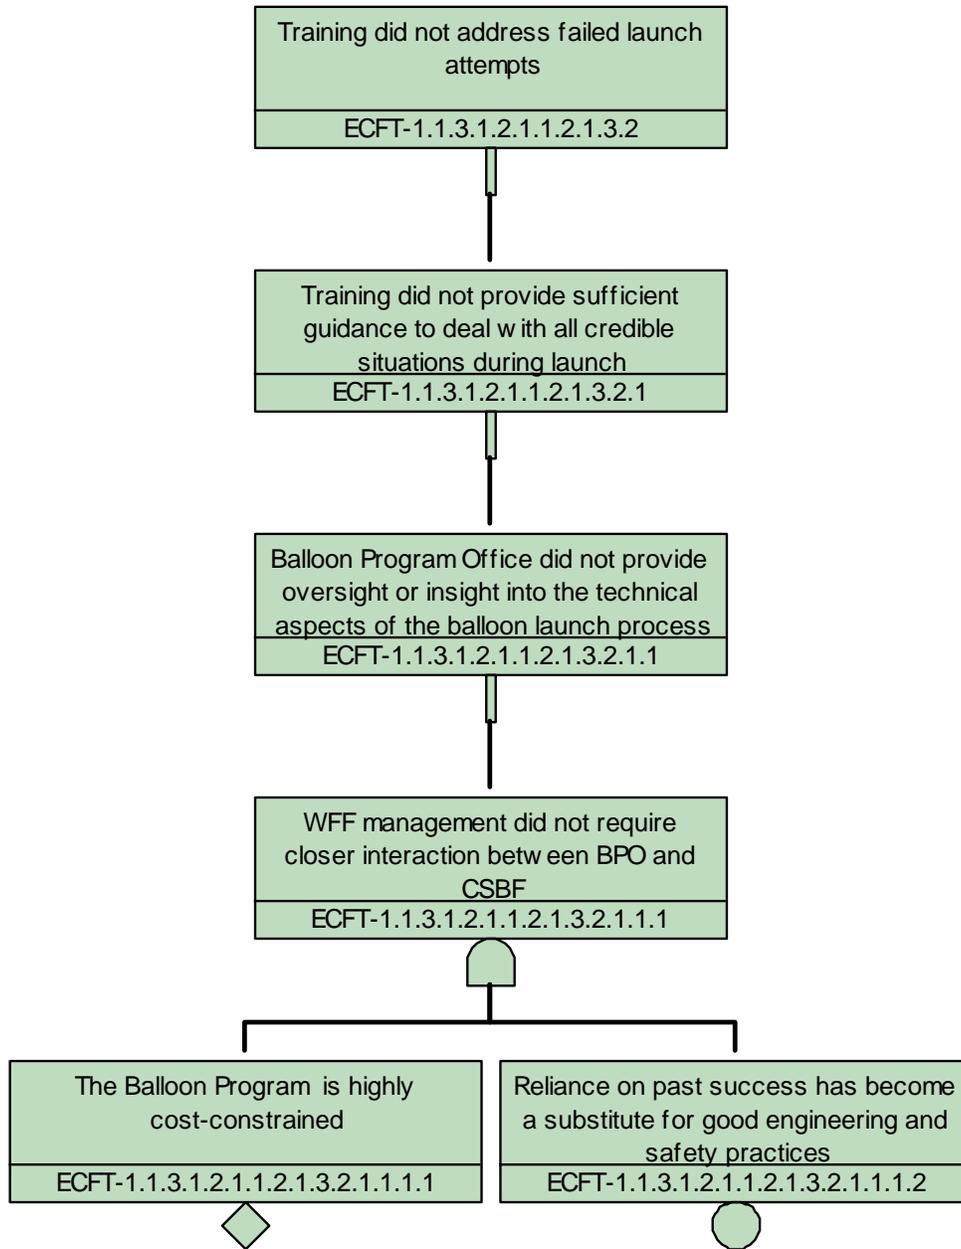
Figure 91. Training Did Not Address Failed Launch Attempts

- A. Training did not provide sufficient guidance to deal with all credible situations during launch. Interviews indicated that there is no specific training element to deal with anomalies or unexpected occurrences. The rest of the branch follows Figure 60.

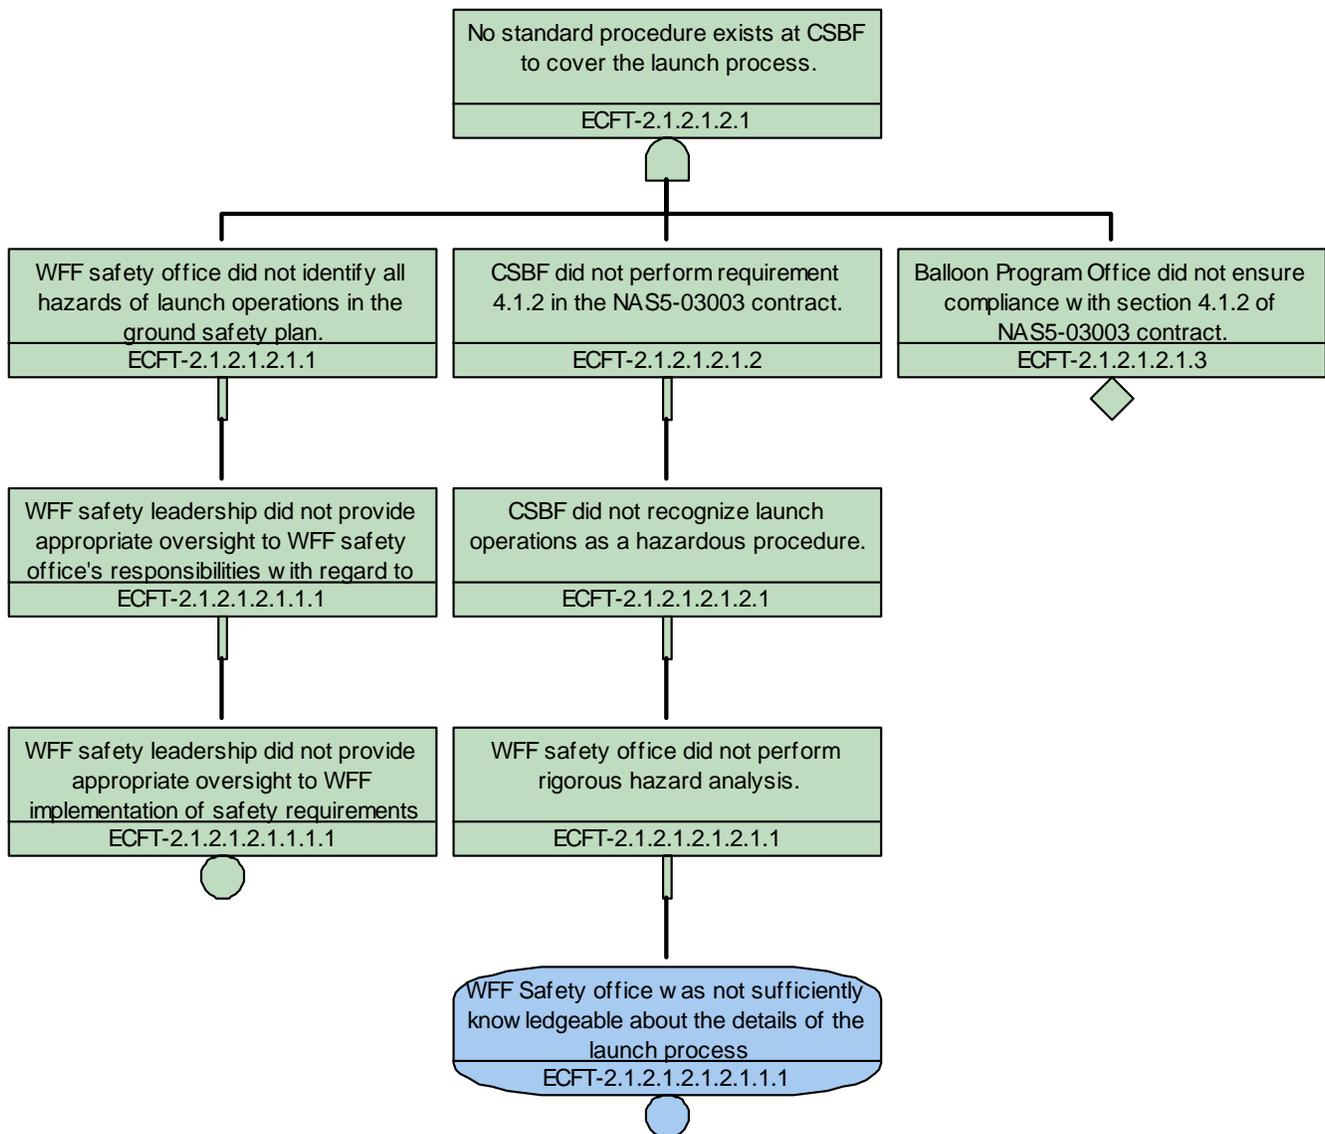
Figure 93. Repeated From PUO—No Standard Procedure Exists at CSBF to Cover the Launch Process

This cause traces down to three causes including 1) WFF Safety Office not identifying all hazards, 2) CSBF not establishing written procedures for hazardous operations and the 3)BPO not ensuring compliance with the NAS-03003 contract (which requires written procedures for hazardous operations).

The focus of these three intermediate causes for the PUO is to address the hazards and hazardous operations that target humans, specifically the public. For SUO1, the interpretation of these three intermediate cause and all causes that flow down from them must be expanded to include the assets as targets for the hazards. Likewise, causes associated with safety oversight must include safety of the assets.

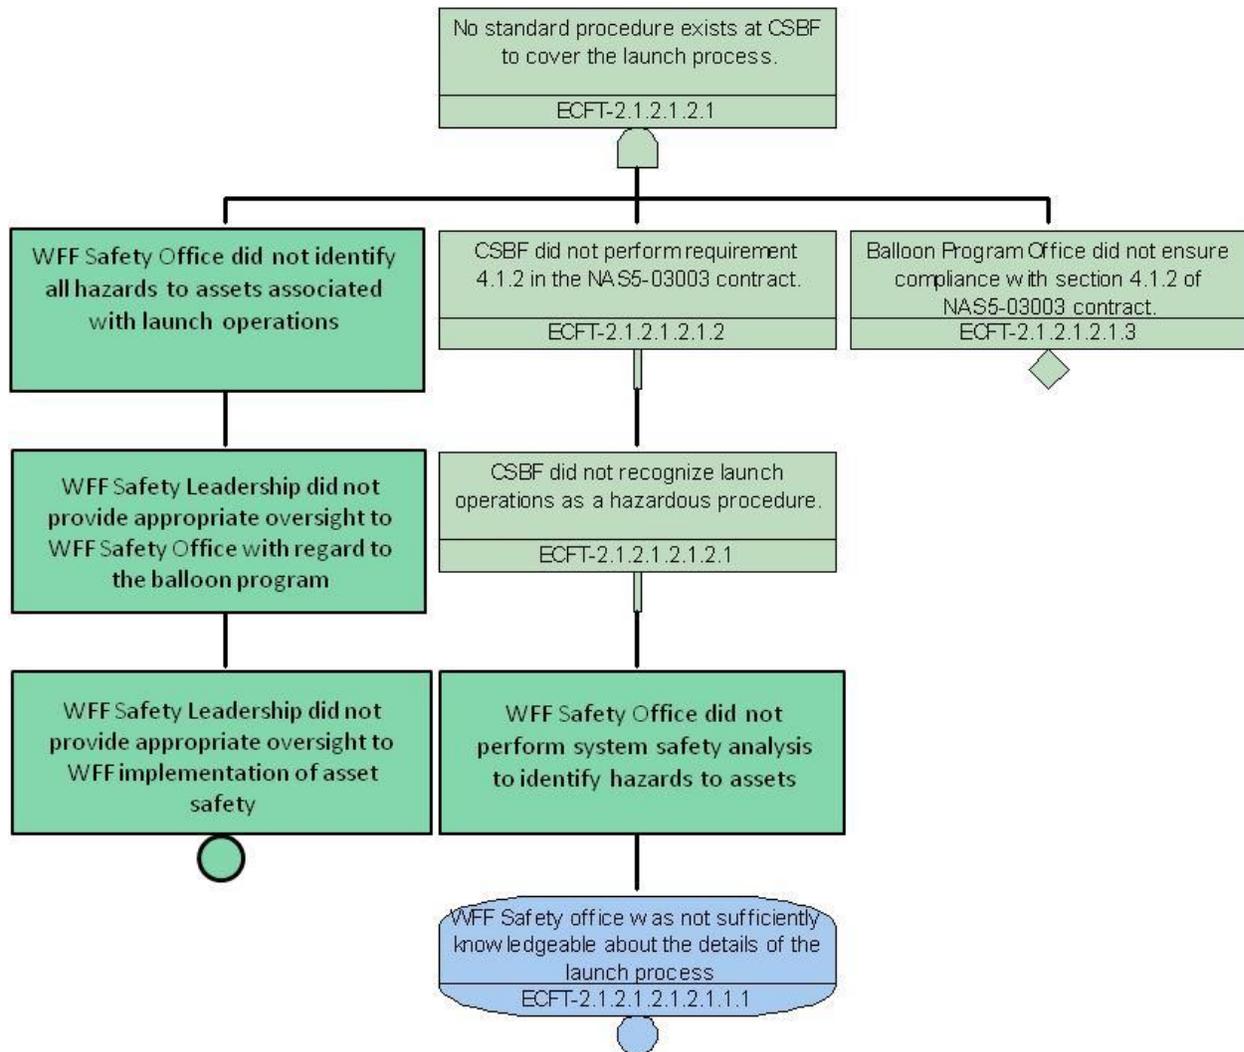
Figure 94. SUO1 - No Standard Procedure Exists at CSBF to Cover the Launch Process

It is evident from the documentation review that the value of the science payload was considered as part of the mission planning (820-CMPP-1002 “NCT Mission Project Plan). However, the protection for this significant asset (as well as for assets such as the balloon, helium, and other facility assets) is not well addressed in any process documentation.

- A. **WFF Safety Leadership did not provide appropriate oversight to WFF SMA with regard to the balloon program.** There is no evidence that the leadership of the WFF Safety Office or Facility management required the consideration of hazards to assets in documentation, including procedures.

1. **WFF Safety Leadership did not provide appropriate oversight to WFF asset safety.**
Root Cause SR1

B. **WFF SMA did not perform systems safety analysis to identify hazards to assets.**

Intermediate Cause SII Through the interview process, it was communicated that in general the launch operation is a hazardous operation for both humans and assets. This is also evident from the review of launch videos, including the NCT mishap data. The board found no documentation to show that the hazards to the assets were identified or analyzed as part of the system safety process for this mission.

Recommendation: WFF safety leadership should review and become knowledgeable about all safety requirements and plans implemented for the balloon program and ensure the proper flow-down of all safety requirements, including but not limited to NPR 8715.3 and NPR 8715.5 in order to protect the public, NASA workforce, high-value equipment and property and the environment.

Recommendation: WFF Safety Office should perform a complete hazard analysis, in accordance with NPR 8715.5, section 3.2 Range Safety Analysis. All phases of the balloon launch process should be considered. This hazard analysis should be validated by independent review.

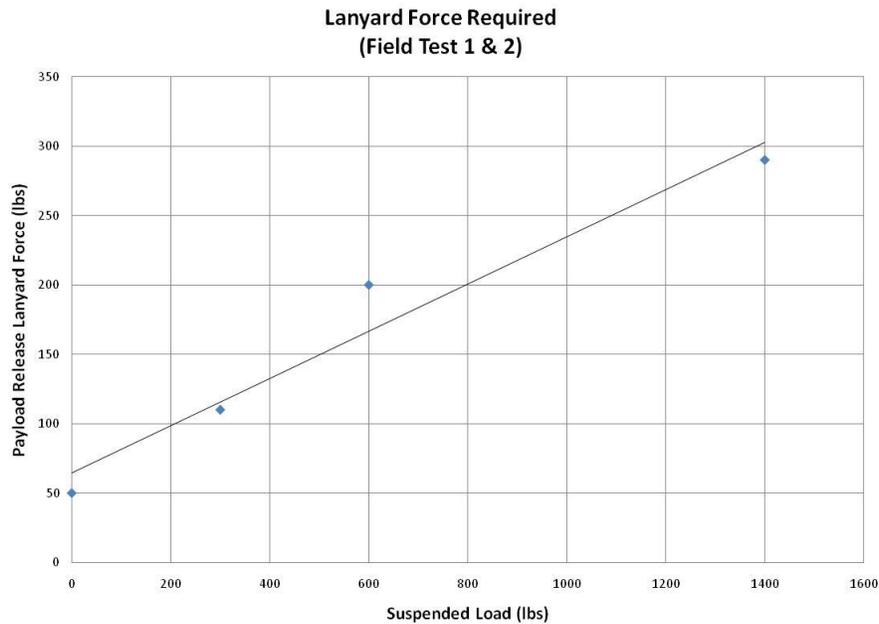
Figure C1-12. Field Tests 1 & 2 Results: Direct Loading of Restraint Pin with Least Squares Best Fit Line

Suspended Load	Units	Lanyard Force Required	Units	Uncertainty
0 lb		47 lb		+/- 5 lbs
0 lb		54 lb		+/- 5 lbs
0 lb		50 lb		+/- 5 lbs
300 lb		110 lb		+/- 10 lbs
600 lb		200 lb		+/- 10 lbs
1400 lb		290 lb		+/- 10 lbs

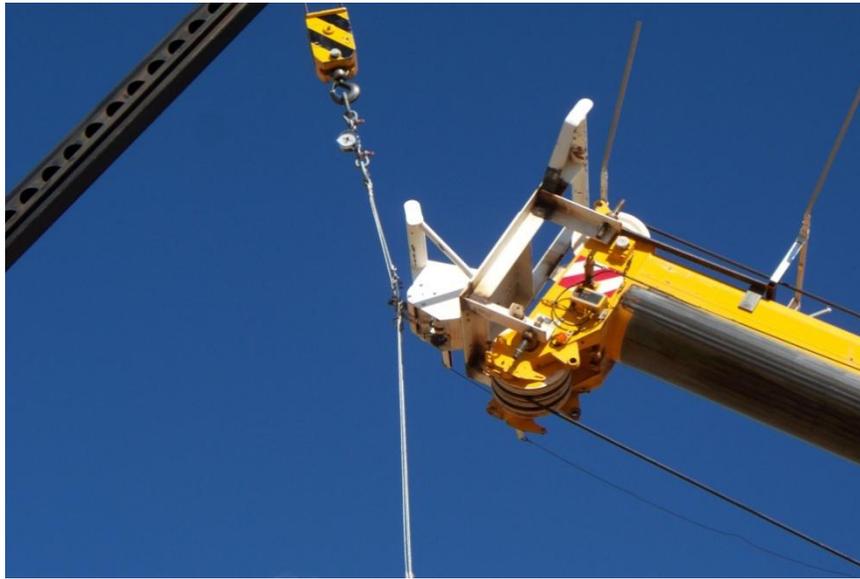
Figure C1-14. Basic Loading Set-Up for Forward Load Angle

Significance of the test: During launch operations, if the net upwards force on the truck plate is applied at an angle forward of normal to the bottom of the launch pin, a component of that force will be carried by the restraint cables and pear ring into the restraint pin. The purpose of the restraint hardware is to prevent the truck plate from coming free from the launch pin before it is desired. A concomitant result is that normal (or shear) loading on the restraint pin is a factor of the various forces on the cable ladder introduced by the buoyant and aerodynamic forces on the balloon and by the gondola. A forward angle (balloon ahead of the launch vehicle) of the flight train loading tends to pull the truck plate away from the launch head and toward the end of the launch pin. (See Figure C1-15)

This action extends the restraint cables and loads the restraint pin. Generally, the greater the forward angle, the greater part of the force is reacted at the restraint pin.

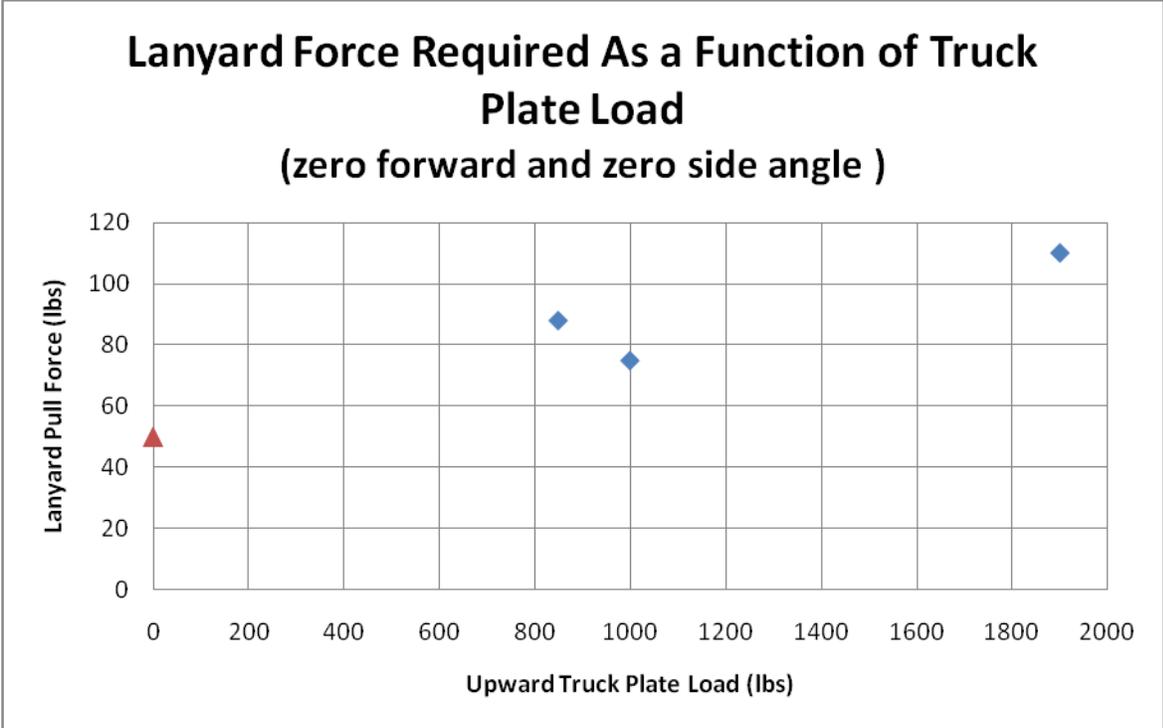
Figure C1-18. Lanyard Force vs Vertical Load (Data at zero load is taken from Test 1)

The results of this test were generally as anticipated. Increasing loads increased the lanyard pull force. Increasing forward load angle increased the lanyard pull force. Increasing side angle increased the lanyard force only mildly, except for some combine load conditions where the lanyard force appeared to decrease.

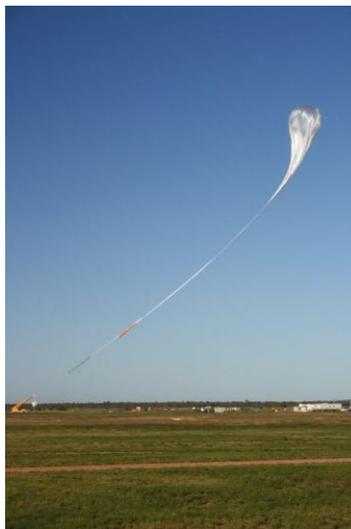
Figure C2-1. Image of the NCT Balloon System at the Airport Fence

The catenary Steady State Equilibrium (Static) analysis for the crane positioned at the Airport fence solution produced a reasonable geometric fit with the photographic evidence as is shown in figure C2-2. The necessary forces at the truck plate to support the system weight and drag through the catenary were calculated to be approximately 9280 lbs. at approximately 38 degrees from horizontal. Matching the observed catenary required a drag adjustment factor of about 0.65 resulting in a total horizontal drag force of about 7300 lbs.

At the fence condition, the results of the independent Dynamic Analysis confirm the estimated horizontal drag force to be about 7200 lbs and the flight train angle with the horizontal at the crane to approximately 38 degrees. The total load at the crane head for this analysis is 9300 lbs.

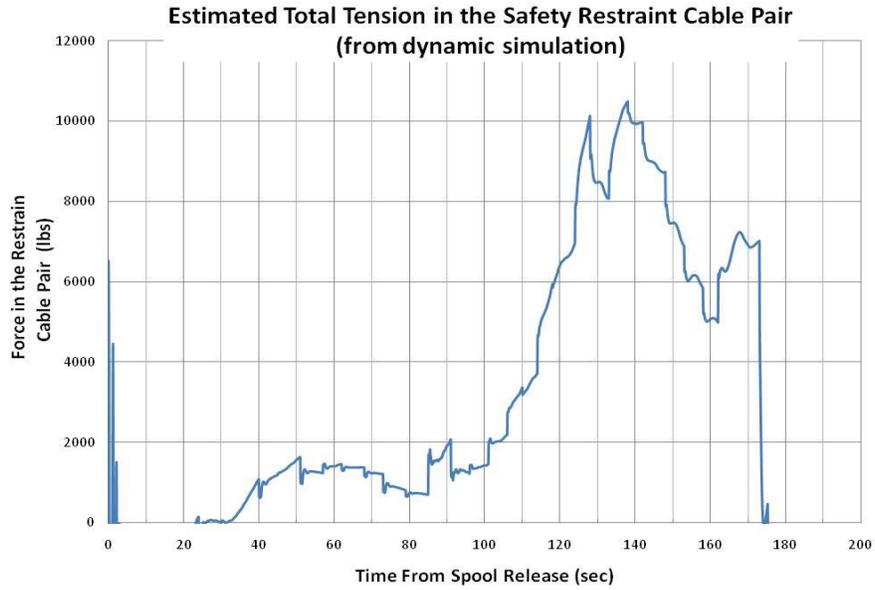
Figure C2-5. Safety Restraint Cable Forces (pair) vs Time Estimates from Dynamic Simulation

The estimates of the cable forces during the backing maneuver are consistent with the restraint cables not breaking during this maneuver. However, when used in this manner, the estimated safety factor based on the cable specification was only about 1.3 for this particular situation. The loading due to pendulous motion or wind gusts may have taken the system to a near failure condition.
