RELEASE : 10-269

NASA Releases Report About Australia Balloon Mishap

The Nuclear Compton Telescope Balloon Launch Mishap Investigation Board was established on May 12, 2010, in accordance with NPR 8621.1, "NASA Procedural Requirements for Mishap and Close Call Reporting, Investigating, and Recordkeeping." The Investigating Authority was appointed to obtain and analyze evidence and facts; conduct necessary testing; impound property, equipment, and records; identify the causal and contributing factors relating to the mishap; and to recommend appropriate actions to prevent a similar mishap from recurring.

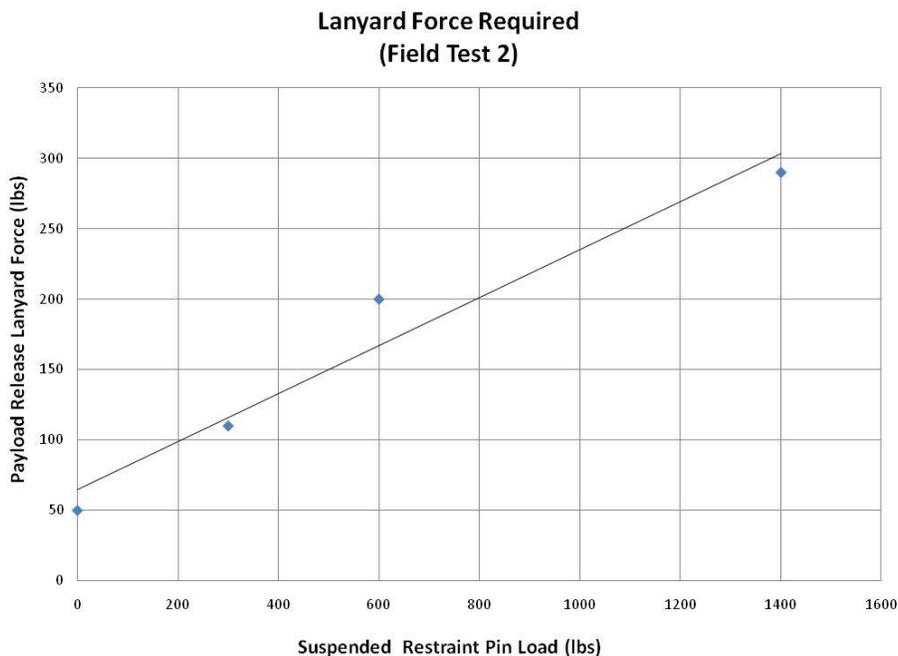
Figure C2-8. Release Lanyard Pull Force vs Pear Ring (equivalent total restraint cable) Loading

Using the data from Field Test 1 repeated below in Figure C2-8, the resulting lanyard pull force would be predicted to be about 320 lbs (test data only covered up to 1400 lbs applied load). The 300+ pounds of pull force required to release the payload exceeded the maximum reasonable human capability of about 100 lbs. Human factors research (Das and Wang, International Journal of Occupational Safety and Ergonomics, 2004, Vol. 10, No 1, 43-58 and Aghazadeh, Advances in Industrial Ergonomics VI, Taylor and Francis, 2010) suggests that realizable downward pull force for a male in standing position is in the range of 85 to 100 lbs.

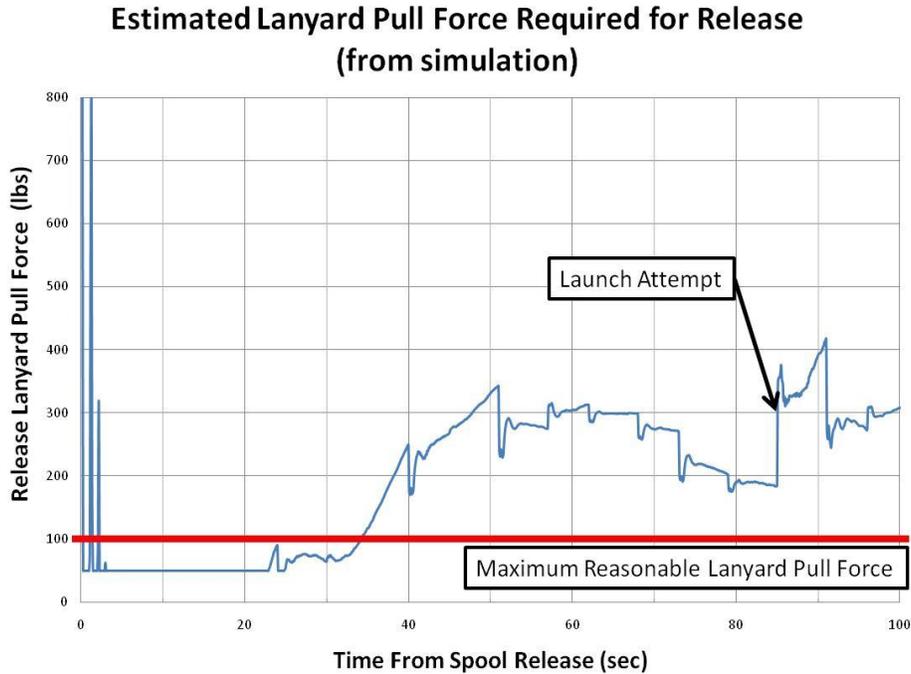
Figure C2-9. Estimated Release lanyard Pull Force vs Time Estimates from Dynamic Simulation

Lanyard force models developed from the Field Test results were coupled with the dynamic model to estimate the pull force throughout the launch timeline. These results are presented in Figure C2-9. Note that pull force is predicted to change quite abruptly at about 86 seconds when the launch vehicle slows for the attempt. This is consistent with the inertial and increased drag loading of the balloon system as the launch vehicle slows. The implication is that an attempt just prior to slowing is predicted to take about 200 lbs, where just after it decelerates is increased to over 300 lbs. The dynamic analysis is consistent with the static analysis regarding the lanyard pull force.

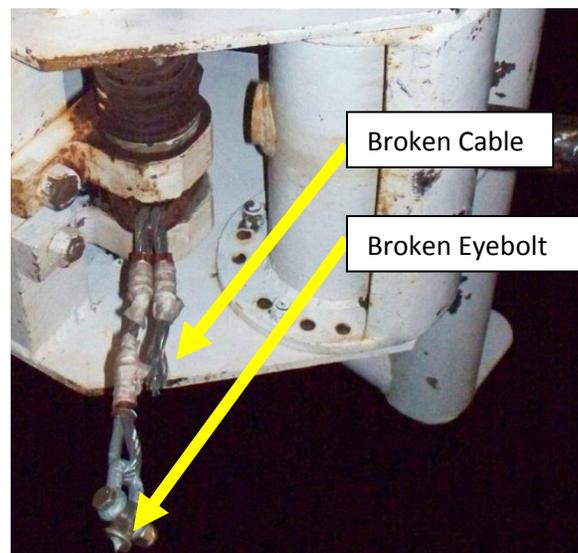
Figure C2-11. Illustration of Broken Cable and Broken Eyebolt

For extensive rotation which would be produced by the configuration at cable rupture, one cable is essentially relieved of force and the entire load is carried by a single cable. Therefore, there was enough load reacted at the truck plate to rupture the single loaded cable assembly carrying the predominance of the load. The second cable assembly would then be subjected to the total local load and would also rupture. The ultimate ratings of the eyebolt that ruptured (after considering the bending loads produced as it was employed) and the cable that ruptured are both less than the predicted load.

The estimated forces produced at the time of the inadvertent release are entirely consistent with the rupture of the restraint cables. The cables likely rupture one at a time as the load was carried first by one, then the next cable. (See Figure C2-11 below)

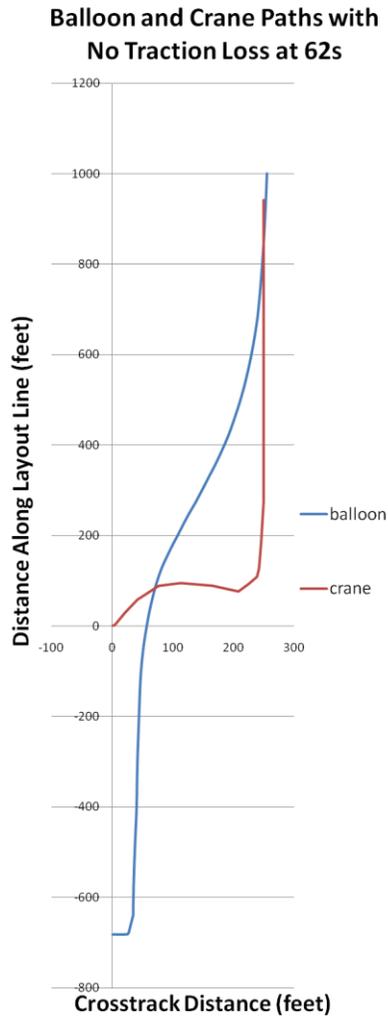
Figure C2-15. Balloon and Crane Ground Tracks for Hypothetical Case of No Traction Loss and Improved Driving Direction

The simulation presented shows that at the time of the actual launch attempts at about 86 seconds, the lanyard pull forces are predicted to be within the range of the operator (less than 100 lbs) if the traction loss had not been a factor and a slightly better driving azimuth had been followed.

Given slightly different conditions, even with the wide right turn that was executed, it is predicted that the NCT launch was possible with the vehicle and hardware compliment that existed. It should be noted that the launch vehicle would have been out of the Category A Hazard Area.
